PHASE I RECONNAISSANCE

CONEFLOWER SOLAR PROJECT

Lyon County, Minnesota

Impact 7G, Inc. Project #MN2322012

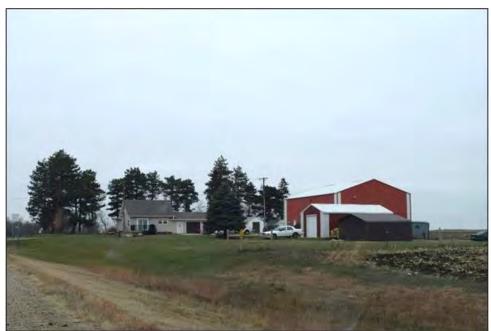
The farmstead was recommended **not eligible** in 1994 when the site form was created. The addition of multiple new structures and the updates to exterior finishes on Feature 1 mean it does not retain integrity of design, setting, materials, workmanship, or feeling. It is still recommended **not eligible** for the National Register of Historic Places. The newer features at this site have not achieved significance within the last 50 years and are also recommended **not eligible** for the National Register of Historic Places and there will be **no effect** on these features by the Project.

Figure 4. Overview of site LY-CUS-00003 facing northeast from public right-of-way. K. Ward 11/10/2023.

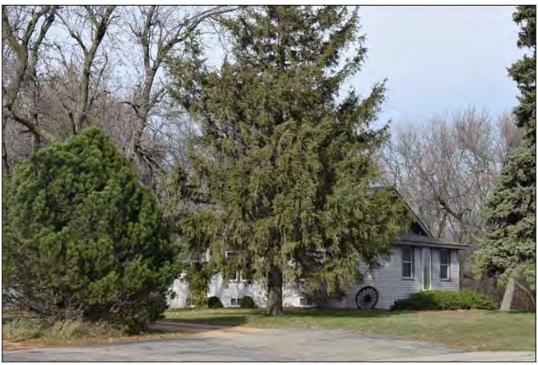
The farmstead was recommended **not eligible** in 1994 when the site form was created. The farmstead did not retain sufficient buildings to clearly show its association during that documentation. Additional updates to all the exterior finishes on the features have caused the site to further lose integrity. It is still recommended **not eligible** for the National Register of Historic Places and there will be **no effect** on these features by the Project.

Figure 6. Feature 1 facing northwest from public right-of-way. K. Ward 11/11/2023.

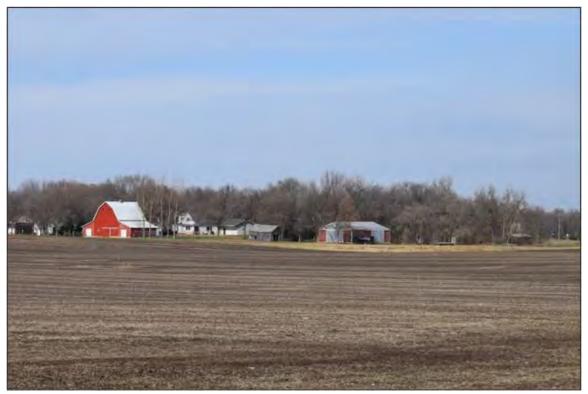
The farmstead was recommended **not eligible** in 1994 when the site form was created. The reasons listed included updated exterior finishes, highly modified features, features that were potentially moved on the site and to the site, as well as recent construction. This information remains accurate and some of the buildings originally included in the site form are no longer at this location. It is recommended **not eligible** for the National Register of Historic Places again after the 2023 site visit. There will be **no effect** on this site by the Project.

Figure 8. Overview of farmstead facing northwest. K. Ward 11/11/2024.

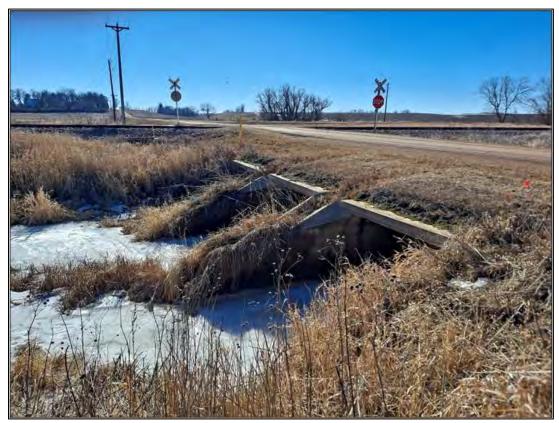
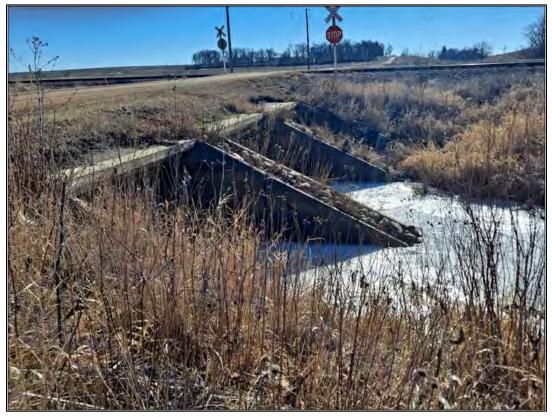
LY-CUS-00011 is a set of three cement culverts over a stream on 230th Avenue in Lyon County, Minnesota. Figures 15 and 16 present photographs of the culverts. A site form was created in 2023 and it was recommended **not eligible** for the National Register of Historic Places at that time. No additional

updates were needed for the description and the recommendation remains as **not eligible** for the National Register of Historic Places and there will be **no effect** by the Project. Photographs were added to the site form because none were provided when the form was created.

Figure 14. Culverts facing northeast. K. Lanno, 2/1/2024.

Figure 15. Culverts facing northwest. K. Lanno, 2/1/2024.

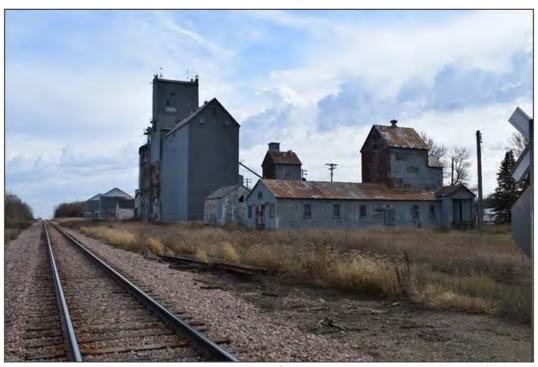
According to information in *Centennial History of Lyon County Minnesota* by Torgny Anderson, the original grain elevator burned down in 1926 but a new elevator was rebuilt on the same location. Additions were constructed periodically through 1970 when the capacity was registered at 120,000 bushels of grain. The current building does not resemble the included photograph in the 1980 site form. The features are significantly larger and based on the time the photograph was taken, this indicates that continued additions were added to the grain elevator complex since the documentation in the 1980s. It has not retained integrity of design, materials, workmanship, or feeling and is recommended **not eligible** for the National Register of Historic Places. There will be **no effect** on this architectural resource by the Project.

Figure 16. Main grain elevator complex, facing southeast. K. Ward 11/10/2023.

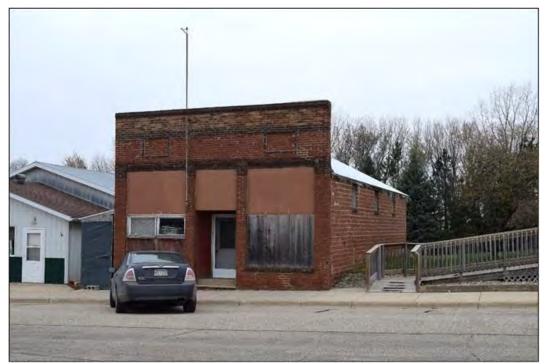
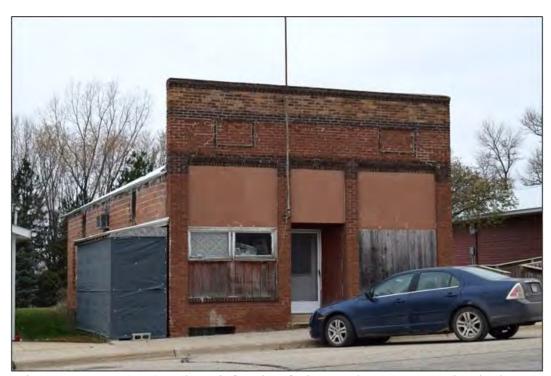
The building was identified as being the post office, hardware store, and grocery store. It appears to no longer be in use. It has not retained integrity of association. The changes to the window openings and the updates to the door and roof, as well as the addition on the south wall have caused this building to not

retain integrity of design, materials, workmanship, or feeling. This building is recommended **not eligible** for the National Register of Historic Places and there will be **no effect** on this resource by the Project.

Figure 20. Front (east) and north facades, facing southwest. K. Ward 11/10/2023.

Figure 21. Front (east) and south facades, facing northwest. K. Ward 11/10/2023.

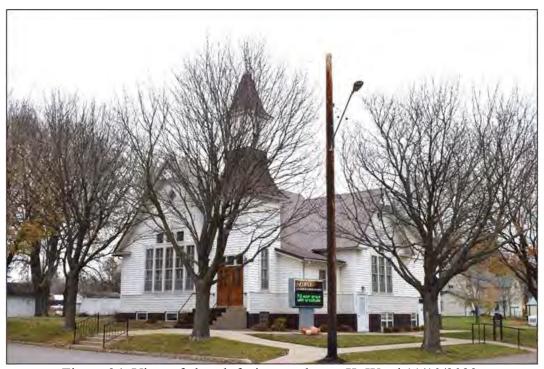
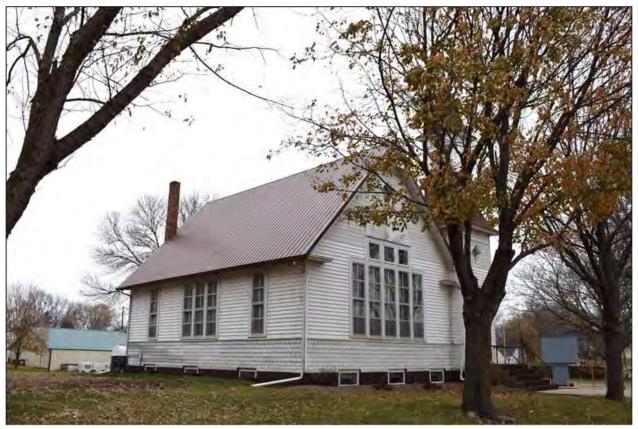
The two additions, the added basement, and updated exterior finishes cause the church to not retain integrity of design, materials, workmanship, or feeling. It is recommended **not eligible** for the National Register of Historic Places and there will be **no effect** on this property by the Project.

Figure 24. View of church facing northeast. K. Ward 11/10/2023.

Figure 26. View of church facing southeast. K. Ward 11/10/2023.

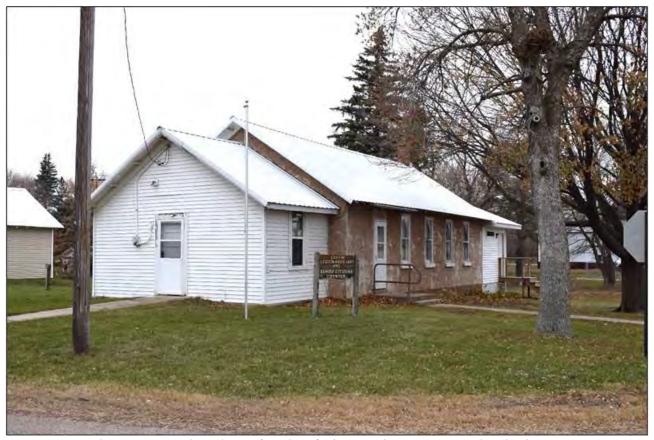
This feature has undergone substantial changes to the building. The two additions on the north and south sides of the building, the updated roof and doors, and the changes to the windows have all caused this building to lose integrity of design, materials, workmanship, and feeling. In addition, this feature was previously the Hoiland Lutheran Chapel before being converted to the Garvin Legion Auxiliary and Senior Citizens Center. A search of the Garvin Legion Auxiliary as well as the Garvin Senior Citizens Center to determine the property address suggests that this building is no longer in use for these purposes. It has not retained association with the Chapel or with the Legion and Senior Center. For these reasons, this feature is recommended **not eligible** for the National Register of Historic Places and there will be **no effect** on this property by the Project.

Figure 27. South and east facades, facing northwest. K. Ward 11/10/2023.

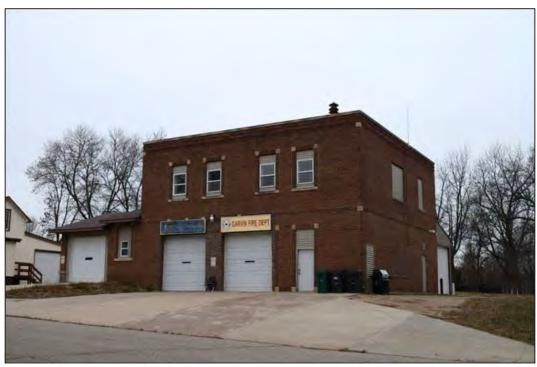
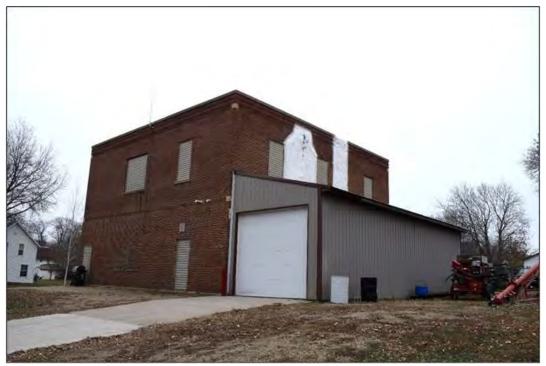
This feature has undergone substantial changes to the exterior causing it to not retain integrity of design, materials, workmanship, and feeling. It is also no longer the Creamery and signs indicate that it is now used for the Garvin Aera First Responders and the Garvin Fire Dept, so it has not retained integrity of association. For these reasons, this building is recommended **not eligible** for the National Register of Historic Places and there will be **no effect** on this resource by the Project.

Figure 28. East and north facade facing southwest. K. Ward 11/10/2023.

Figure 29. North and west facade facing southeast. K. Ward 11/10/2023.

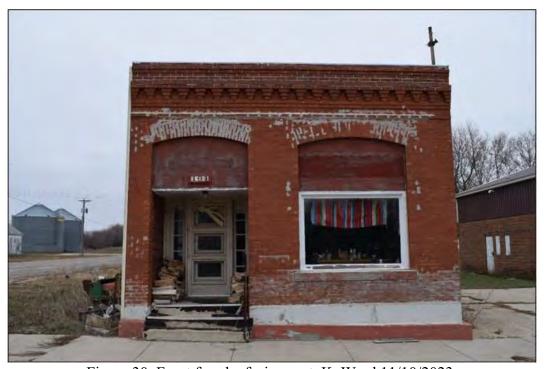
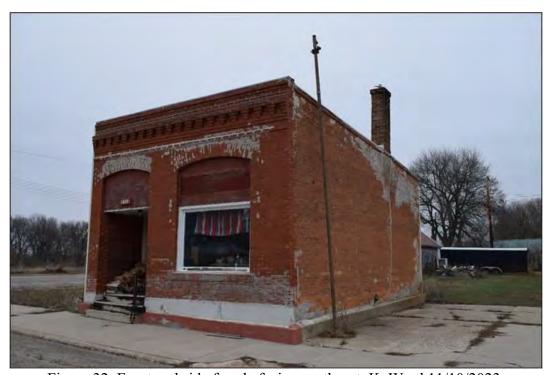
The bank does not meet Criterion A as it is not associated with significant events in our history. It is also not associated with significant persons (Criterion B). This feature does meet Criterion C due to the distinctive characteristics of this style building, however examples in better condition are easily found. The bank also does not meet Criterion D because it is not likely to provide additional information. This building has not retained integrity of design, materials, workmanship, or feeling because of the updated materials on the exterior, the changes to the window and door size and shape within the brick opening. The building was previously a bank, however it no longer retains integrity of association because it is no longer used as a bank, though the exact use of the building cannot be determined. It is possibly abandoned. This building is recommended **not eligible** for the National Register of Historic Places and there will be **no effect** on this architectural resource by the Project.

Figure 30. Front facade, facing east. K. Ward 11/10/2023.

Figure 32. Front and side facade facing northeast. K. Ward 11/10/2023.

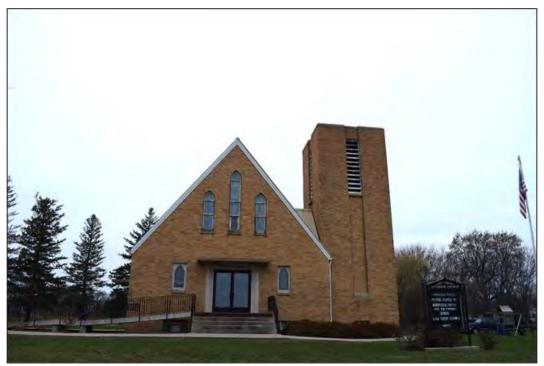
A recommendation of **not eligible** for the NRHP was documented in 1994 due to this feature being less than 50 years of age at the time. The changes to the windows, the added cement ramp on the front

façade, and the updated roof materials cause this building to not retain integrity of design, materials, workmanship, or feeling. For these reasons it is recommended that the church remain **not eligible** for the National Register of Historic Places. There will be **no effect** on this property by the Project.

Figure 34. East facade facing west from public right-of-way. K. Ward 11/10/2023.

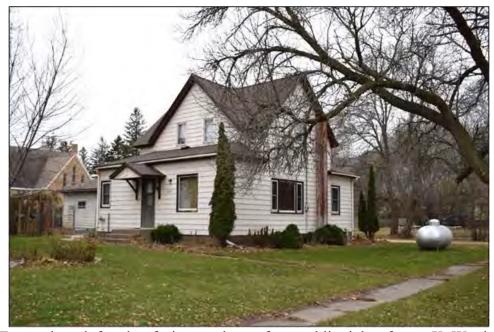
A recommendation of **not eligible** for the National Register of Historic Places was documented in 1994. The changes made since the site form was created have further impacted the structure's integrity. This feature is still recommended **not eligible** for the National Register of Historic Places. There will be **no effect** on this property by the Project.

Figure 36. East and north facades, facing southwest from public right-of-way. K. Ward 11/10/2023.
