In re the Matter of Sherco Unit 3 Energy
Replacement Costs.

DIRECT TESTIMONY OF RICHARD A. POLICH

**THE MINNESOTA DEPARTMENT OF COMMERCE
DIVISION OF ENERGY RESOURCES**

June 16, 2023

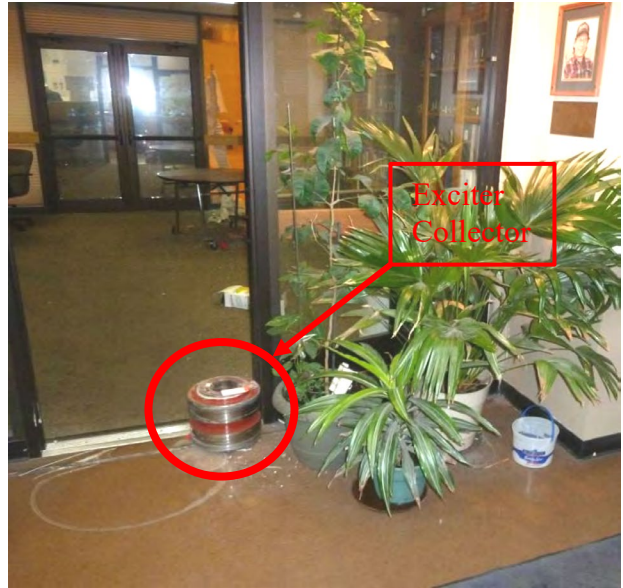
1 causing vibrations which induced
2 bearings failure and caused fractures in
3 the generator shaft and five fractures in
4 the exciter shaft. Oil systems and the
5 generator hydrogen cooling system
6 ruptured and were ignited by
7 overheating bearings. A 200 lb part of
8 the exciter was thrown across the
9 turbine floor and into an operator's
10 room (see figure 8).⁶ In comments filed

Figure 8 - Photograph of liberated exciter collector which came to rest in operator's room.

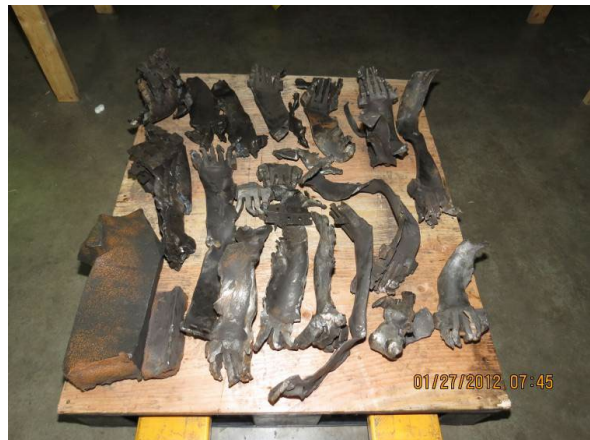
13 The LP turbines sustained the
14 most damage. This damage included
15 damage to the outer exhaust hoods,
16 inner casings, inner shells, and
17 diaphragms at interface points to each
18 turbine component, cracks in the original
19 fabrication welds, damage from flying

Figure 9 - Damaged LP Turbine Blades

1 debris, and out of specification clearances to mating components. The rotors sustained
2 large amounts of bucket damage including loss of buckets as described above. The inner
3 casings sustained the most damage of all the LP components and took the longest to
4 repair.

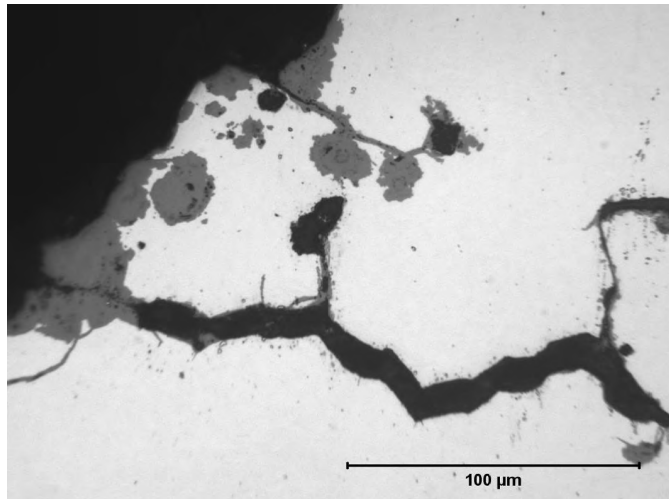
Figure 10 - Photo Micrograph of Portion of Sherco LP Turbine Disk Showing SCC

15 forming a crack in the metal. These cracks will typically propagate in a high stress
16 location of a part, such as a corner or notch. An example of typical SCC locations is
17 shown in Figure 7 where the cracks are in the corner of the tangential dovetail joint. A
18 picture showing SCC in the Sherco 3 LP turbine, stage L-1 disk finger dovetail is shown in
19 Figure 10.²¹

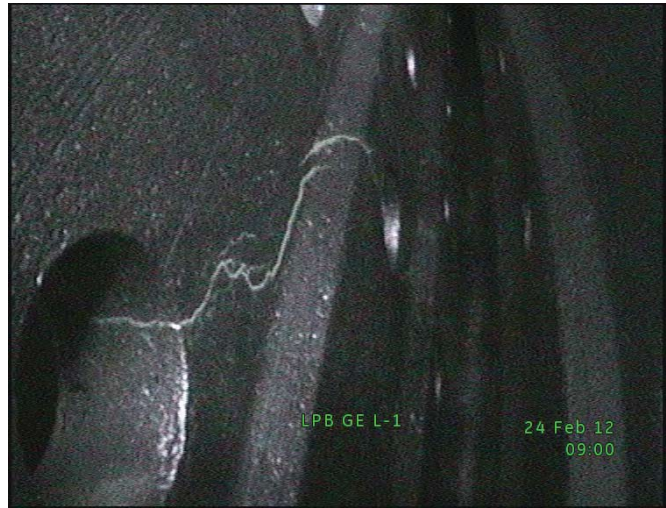
3 A. The Sherco 3 LP turbine “B” rotor
4 disk holding the L-1 buckets failed
5 due to SCC in the pin holes, ledges
6 and base of the finger dovetail
7 joints. It needs to be noted that the
8 failed L-1 disk was on the end of
9 the “B” LP turbine closest to the
10 generator, commonly called the

11 **Figure 13 - LP Turbine "B" L-1 Blade Disk Cracking**

12 “Generator End”. The image in Figure 13 is
13 blacklight photograph of low-pressure turbine
14 “B” L-1 disk rim showing the cracks in finger-
15 root attachment that were revealed with
16 MPI.²² The image in Figure 14 is a portion of
17 the LP turbine L1 buckets liberated during the
18 November 19, 2011, event which has a
19 portion of the turbine rotor disk still attached.²³ The MPI performed after the event

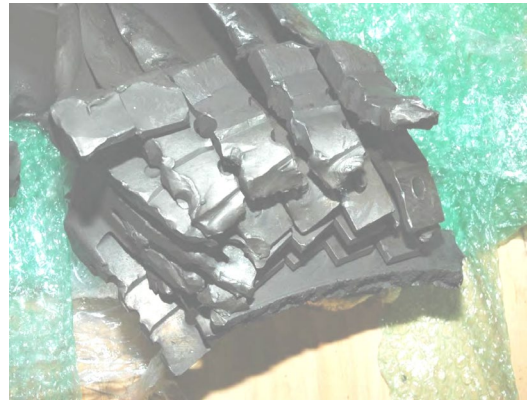
20 **Figure 14 - Liberated L-1 Turbine bucket with Fractured Rotor Disk Attached**

shows that the cracking was prevalent throughout the LP turbine rotor disk that attach
the L-1 buckets to the LP turbine rotor, and would have been found if Xcel had

1 performed non-invasive inspection during the 2011 maintenance outage. Although SCC
2 was the structural failure mechanism that resulted in the November 19, 2011
3 catastrophic failure, it was not the root cause of the failure.

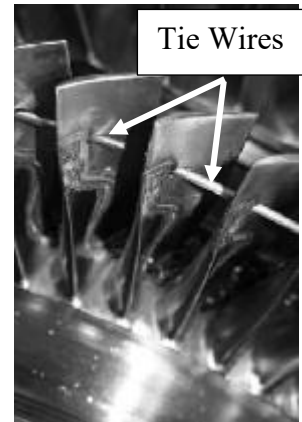
6 A. The Thielsch report next recorded LP maintenance in March
7 1996.³⁶ The primary purpose of this outage was to inspect the L-
8 1 bucket tie wire cracking. Both LP turbines were disassembled
9 and all L-1 buckets removed. Blade tie wires were removed,
10 rotors blasted, and non-destructively inspected of tie wire holes
11 found no issues nor tie wires cracked. The bucket tendons were

12 **Figure 16 - Turbine**
13 **Blade Tie Wire**

14 also ultrasonically inspected with no issues reported. Other minor repairs were
15 performed on the LP turbines. The reports do not identify any inspection of the LP
16 turbines rotor disks using MPI, ultrasound or other non-destructive testing.

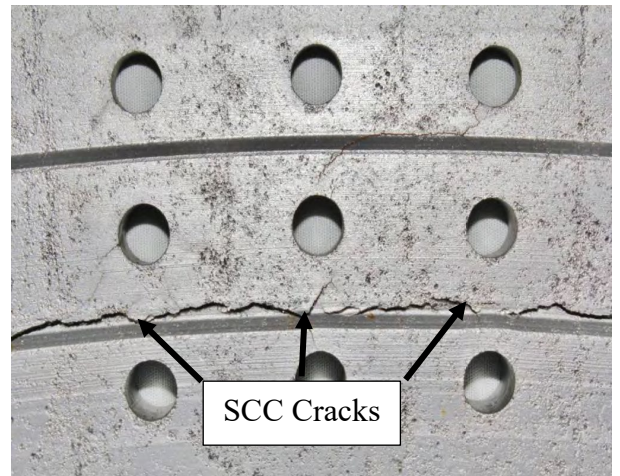
12 A. No. Xcel did not follow GE guidelines on inspection timing nor procedure for inspection
13 of the LP turbine. GE recommends inspection of
14 the turbine rotor for problems like SCC should be
15 performed every three to five years. The
16 inspection for SCC induced cracks in the LP rotor
17 disk requires removal of the buckets from the
18 rotor. Xcel did not perform this type of inspection
19 within the recommended time period. GE

Figure 17 - Photo of L-1 Rotor Disk Finger Dovetail Joint Showing Cracks

20 specifically states the buckets need to be removed from the rotor to test for SCC. Engle
21 Metallurgical, Ltd, performed an RCA of the Sherco 3 LP turbine failure and stated SCC
