I.	Introduction and Qualifications	1
II.	Root Cause Investigation	3
	A. Background on Sherco Unit 3 Turbine-Generator Train	4
	B. The Event	6
	C. The Root Cause Analysis	9
III.	Determined Cause of Failure	10
IV.	Additional Observations and Opinions	17

Statement of Qualifications	Schedule 1
Root Cause Analysis Steam Turbine Generator Event of November 19, 2011	Schedule 2
Root Cause Analysis Report-Figures and Attachments	Schedule 3

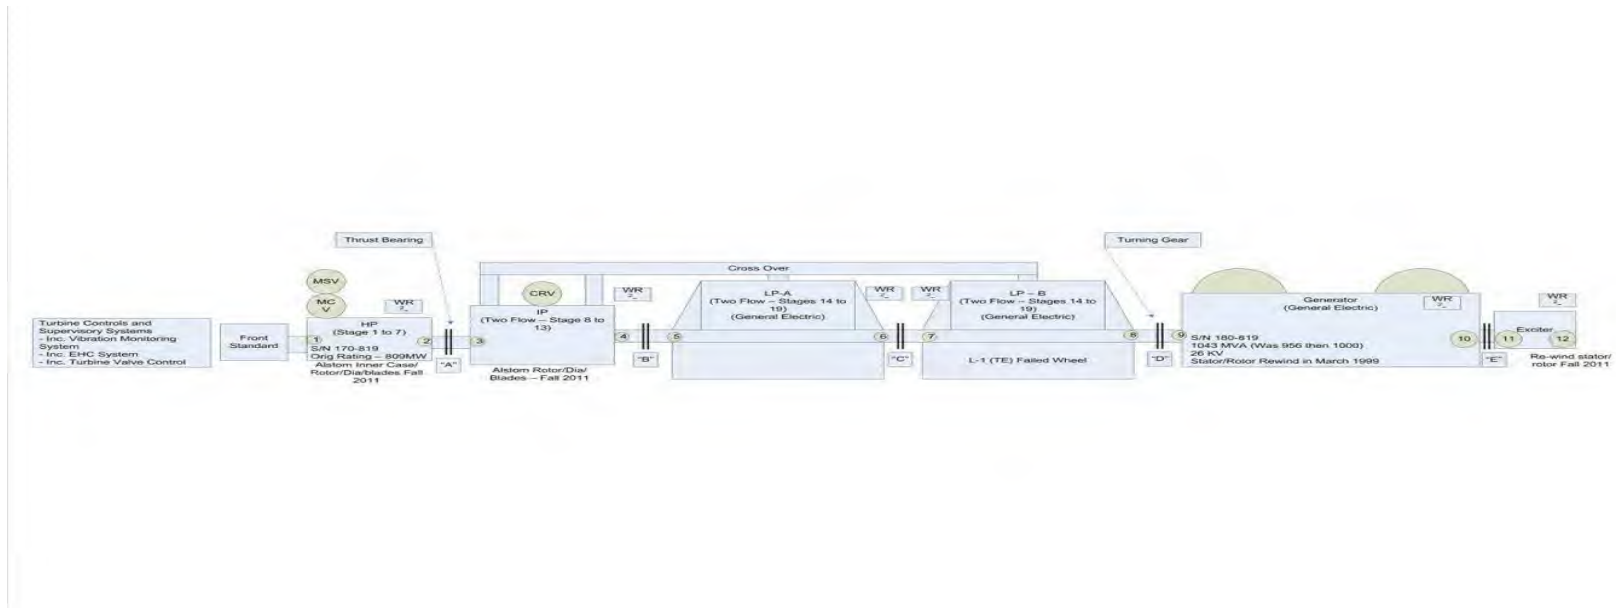
Fig. 1. Pictorial of Unit No. 3 Steam Turbine Generator after Fall 2011 retrofit. Bearing locations identified by small circles with numbers ranging from 1 thru 12.

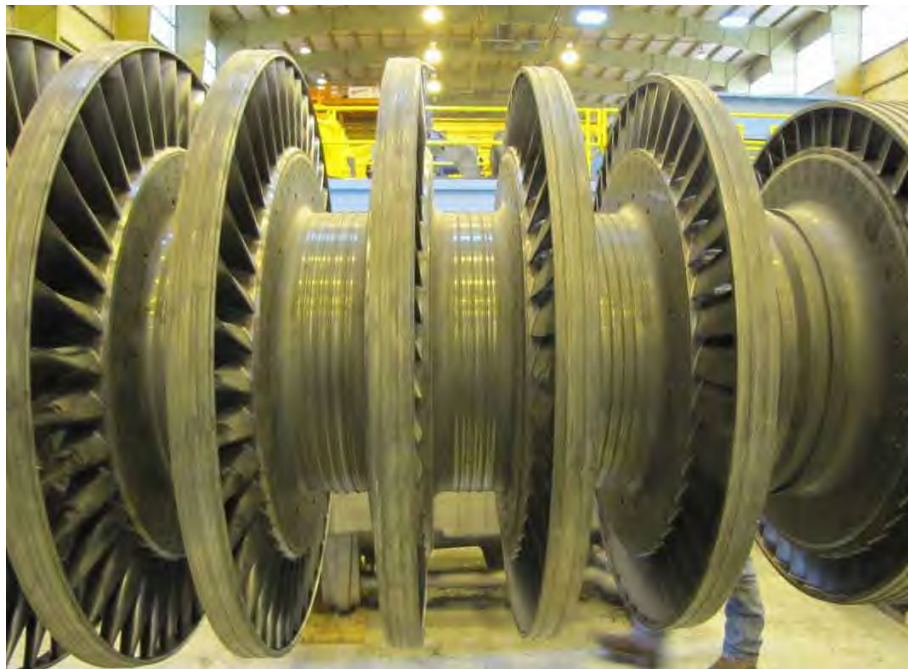
Fig. 13. Close-up photograph of high pressure turbine rotor shown in Fig. 12.

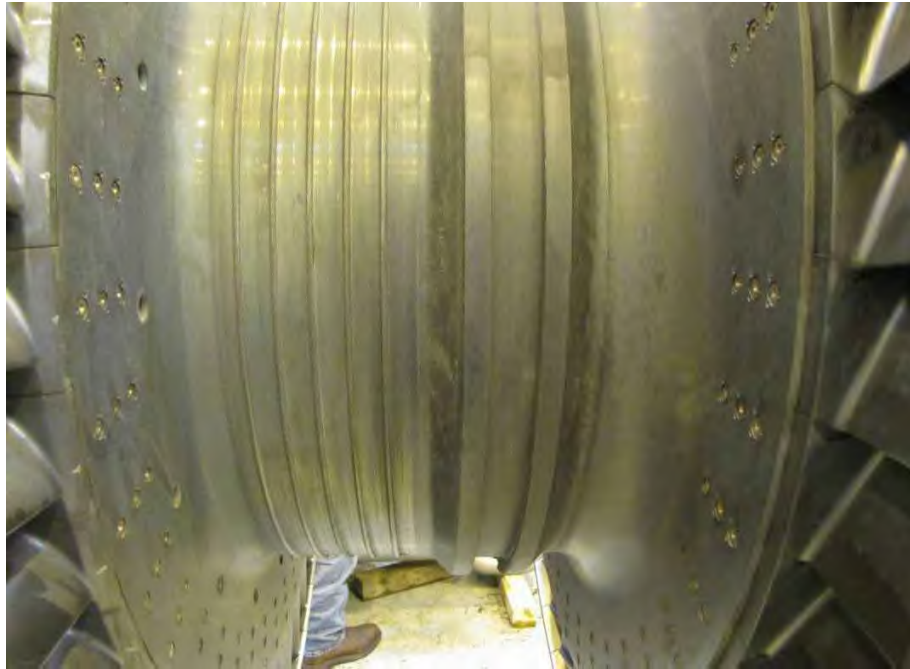
Fig. 18. Photograph of high pressure rotor shown in Fig. 12 showing rub damage to interstage seal areas.

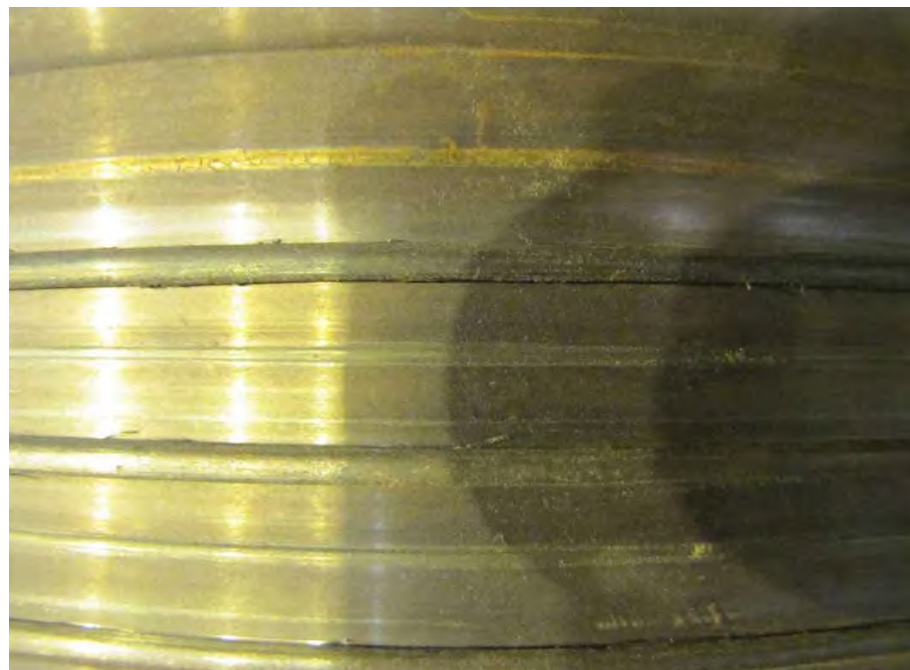
Fig. 19. Photograph of high pressure rotor shown in Fig. 12 showing rub damage to interstage seal areas.

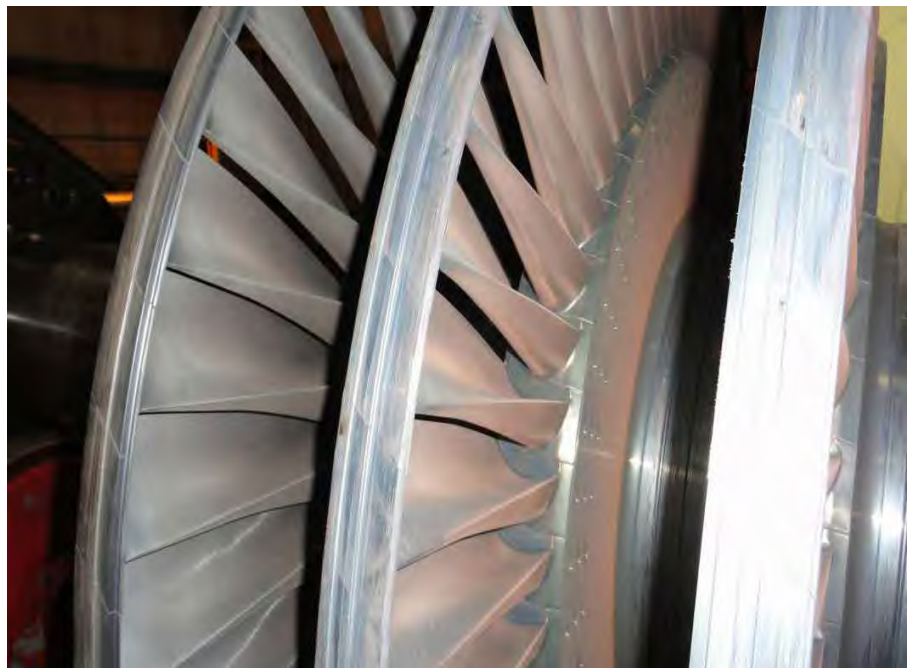
Fig. 33 Close-up of intermediate pressure turbine rotor shown in Fig. 31 showing moderate to heavy rub damage on blade integral shrouds.

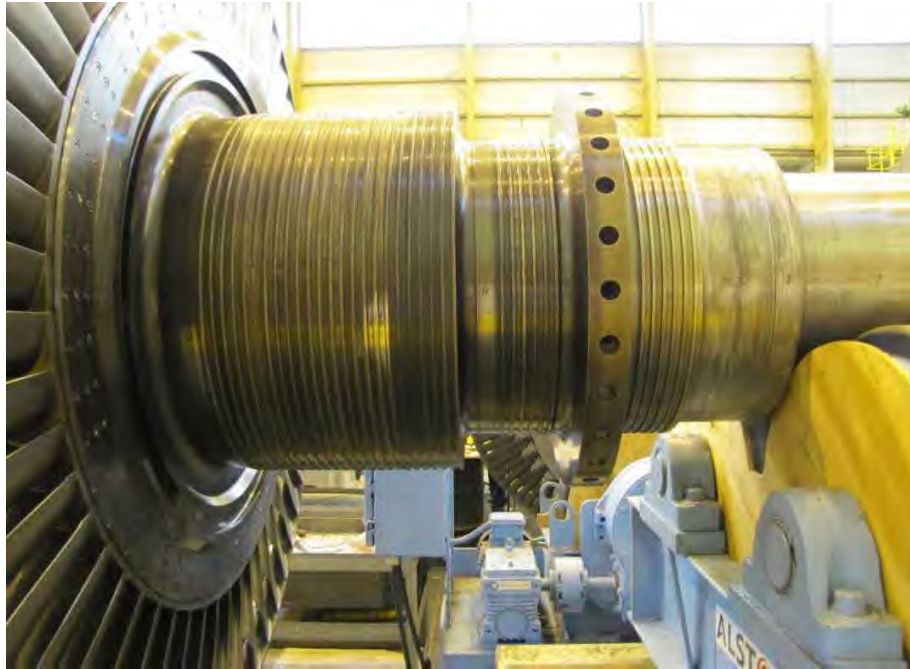
Fig. 34. Close-up photograph of intermediate pressure turbine rotor shown in Fig. 31 showing rub damage seal surfaces.

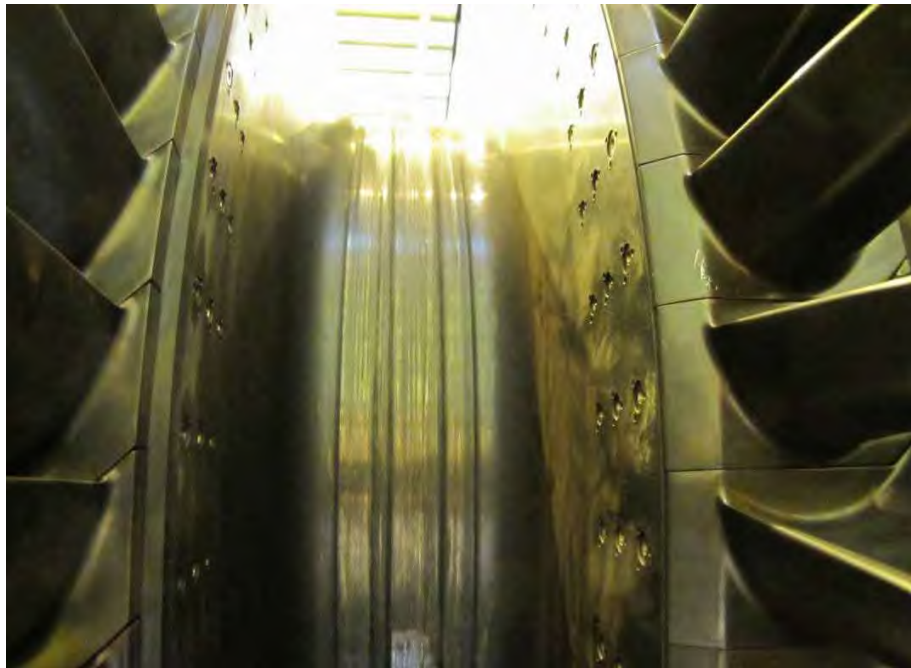
Fig. 37. Close-up photograph of intermediate pressure turbine rotor showing light rub damage on interstage seal surfaces.

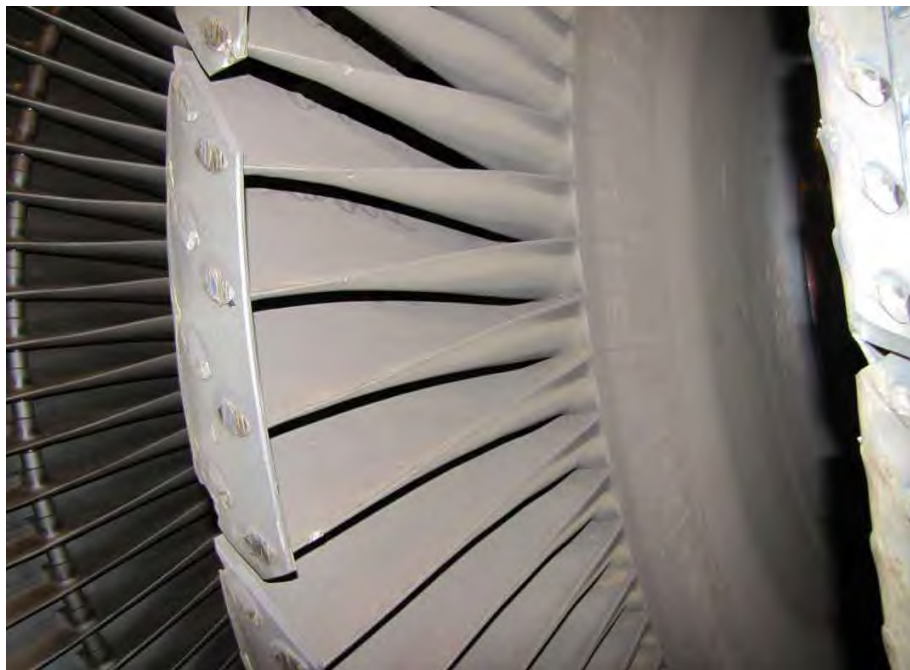
Fig. 49. Generator end of low pressure turbine "A" showing extent of rub damage on L-2 blade covers and tenons.

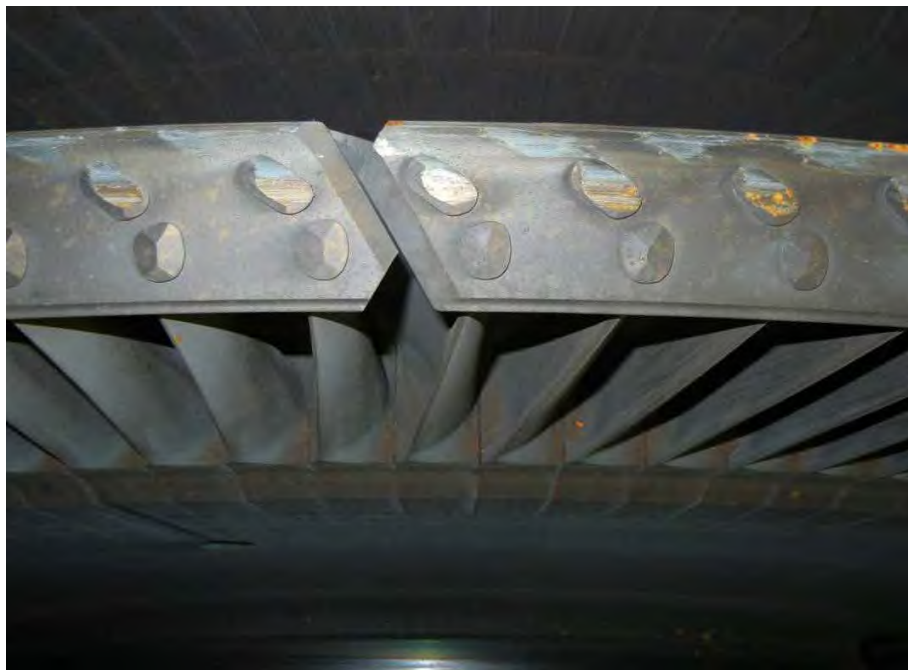
Fig. 51. Close-up of low pressure turbine "A" turbine end L-3 stage blade covers showing extent of rub damage.

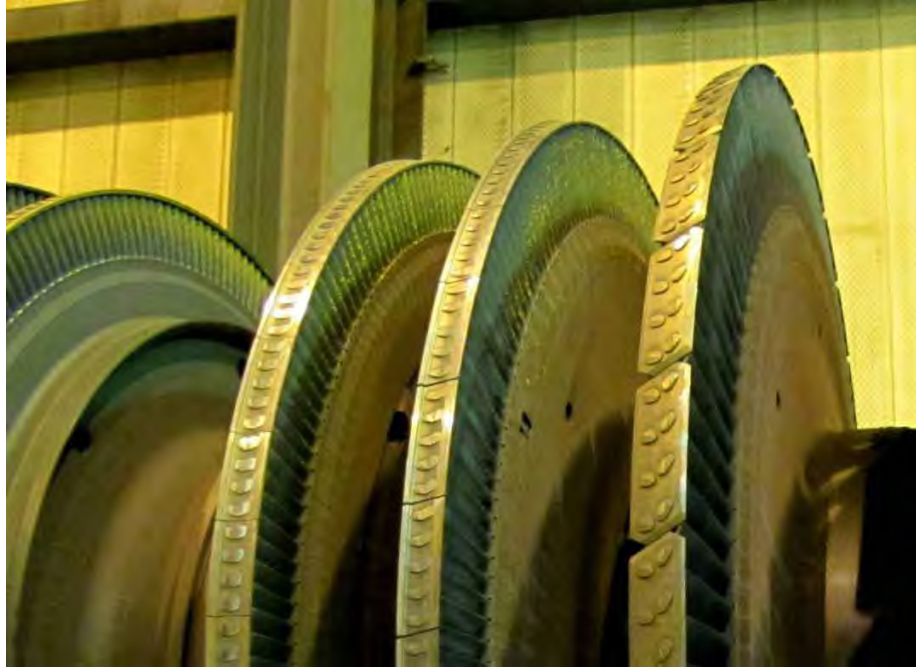
Fig 52. Close-up of low pressure turbine "A" showing rub damage to trailing edges of turbine end L-5 and L-4 blades and leading edges of generator end L-5 stage blades.

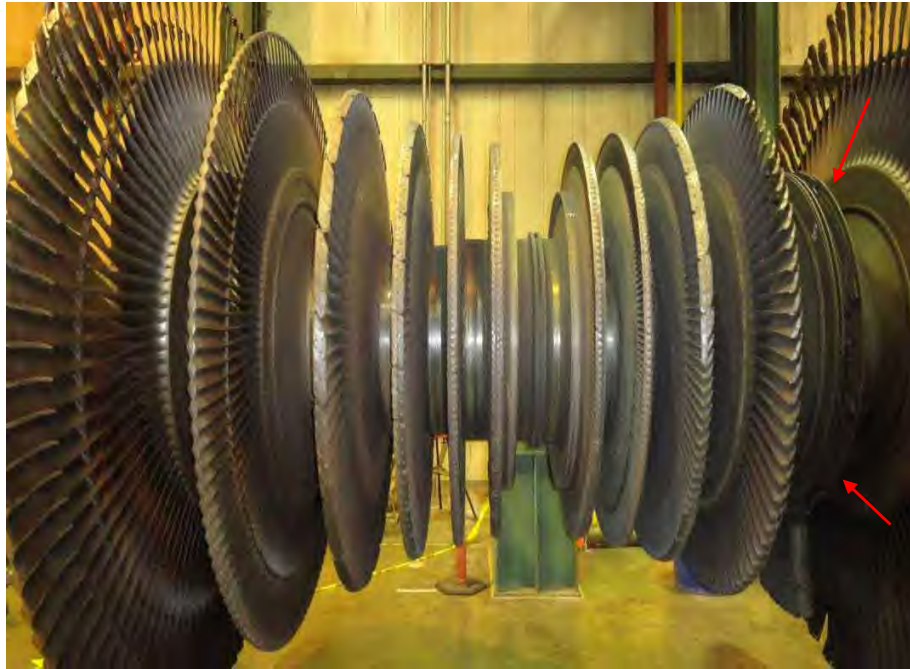
13
14 The presence of the stress corrosion cracks in the finger-pinned blade
15 attachment area of the L-1 row disks reduced the load-carrying capability to a
16 degree that centrifugal loads during the overspeed test exceeded the load-
17 carrying capability of the compromised finger-pinned blade attachment areas.
18 The fractures in the finger-pinned blade attachment areas of the L-1 row disk
19 were the primary failure.

Fig. 56. Photograph of low pressure turbine "B" Rotor showing section of turbine end L-1 stage disk rim which fractured (arrows) through finger root attachments.

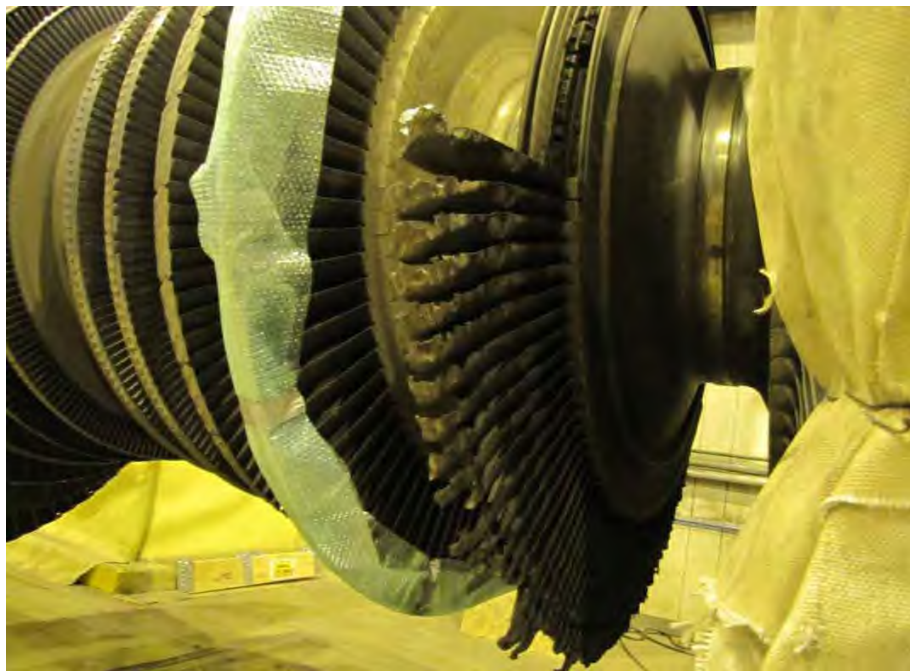
Fig. 57. Close-up of fractured turbine end L-1 stage disk of the low pressure turbine "B" rotor shown in Fig. 55.

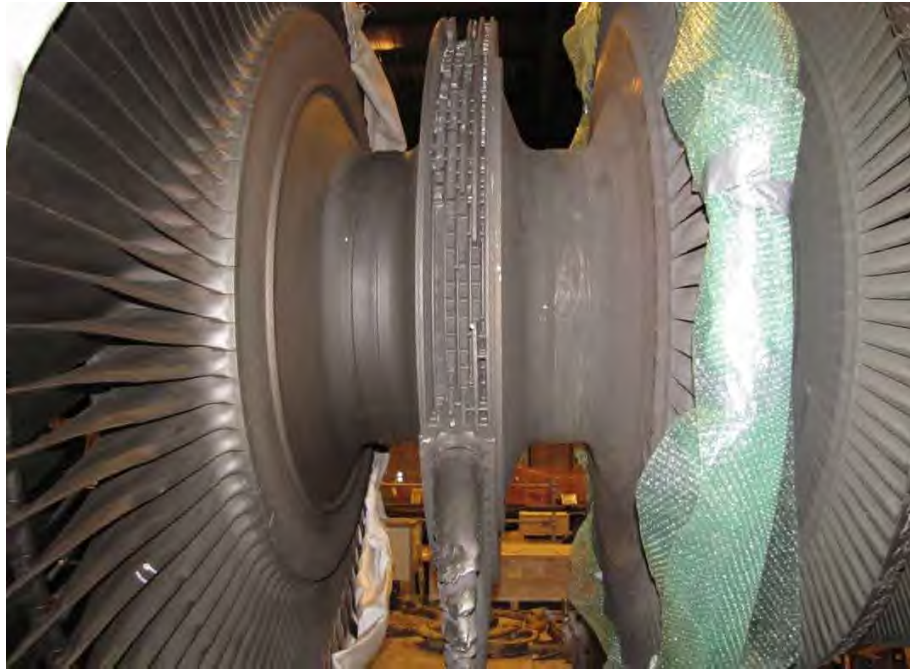
Fig. 58. Close-up of fractured disk section of turbine end L-1 stage on low Pressure turbine "B" rotor shown in Fig. 55.

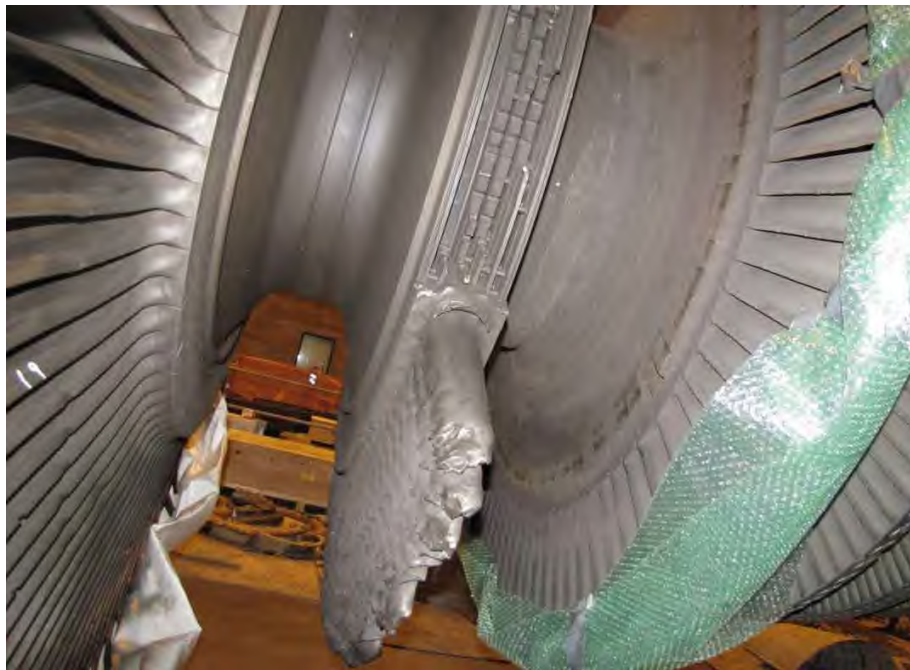
Fig. 59. Close-up of fractured turbine end L-1 stage disk section of low pressure turbine "B" rotor shown in Fig. 55.

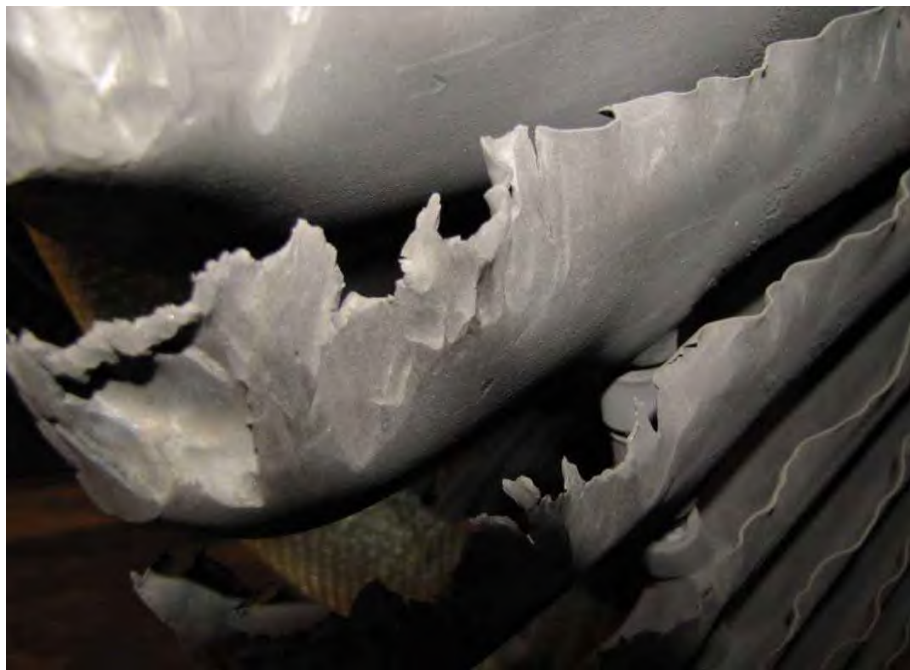
Fig. 61. Close-up photograph of turbine end L-1 stage blades from low pressure turbine "B" rotor shown in Fig. 55.

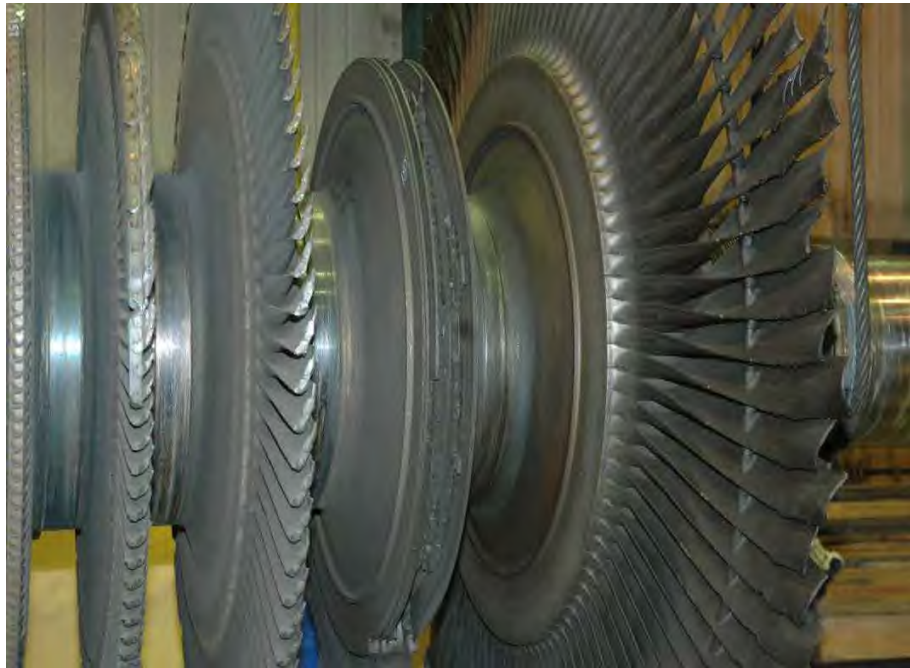
Fig. 67. Photograph of turbine end of low pressure turbine "B" rotor showing missing covers on L-2 and L-3 stage blades.

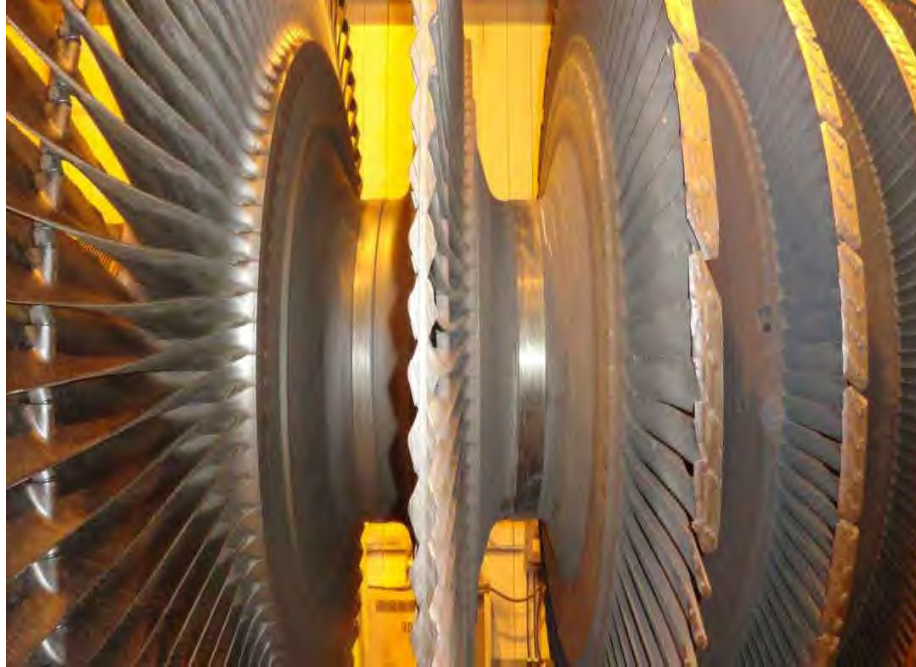
Fig. 70. Photograph of generator end of low pressure turbine "B" showing damage to shrouds on L-1, L-2 and L-3 stages.

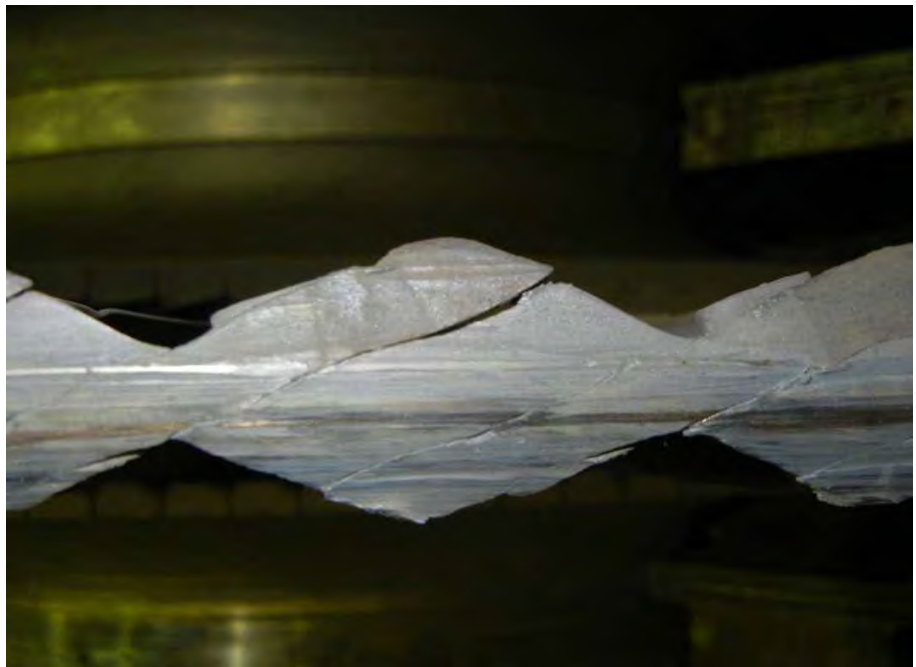
Fig. 71. Close-up photograph of low pressure turbine "B" generator end L-1 blade tips and spacers showing severe rub damage.

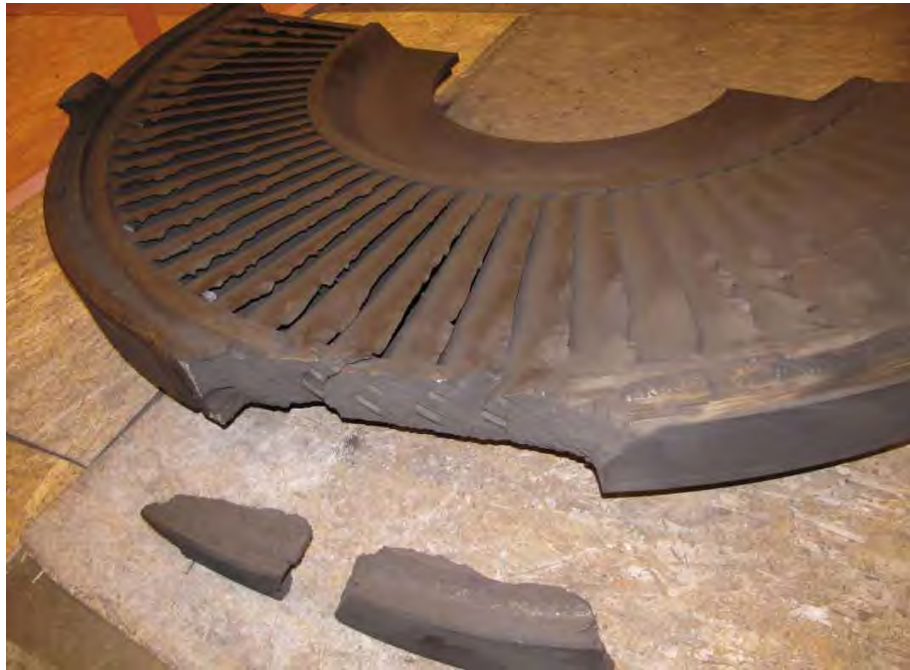
Fig. 78. Photograph of turbine end L-1 stage diaphragm from low pressure turbine "B" rotor showing extent of damage.

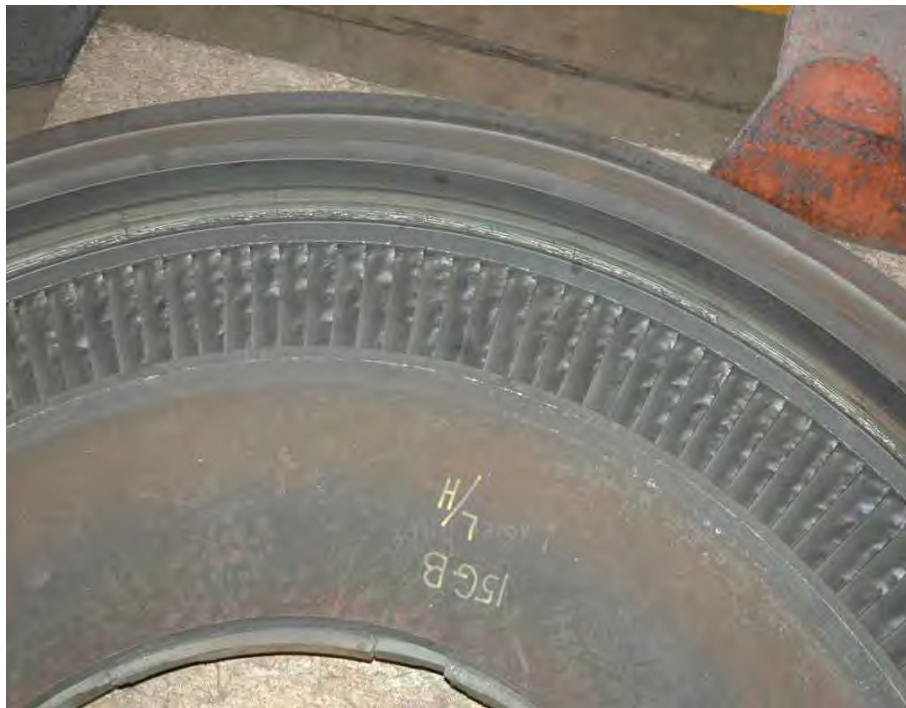
Fig. 81. Photograph of low pressure turbine "B" generator end L-4 stage diaphragm showing extent of impact damage to vane airfoils.

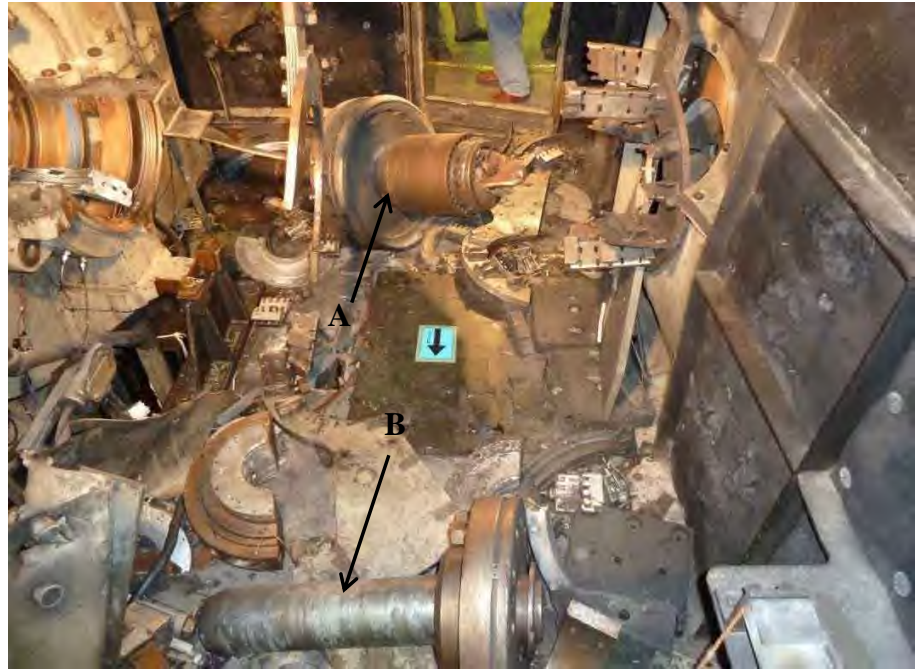
Fig. 104. Photograph of exciter doghouse showing portion of fractured generator shaft (arrow A) and portion of fractured exciter shaft (arrow B).

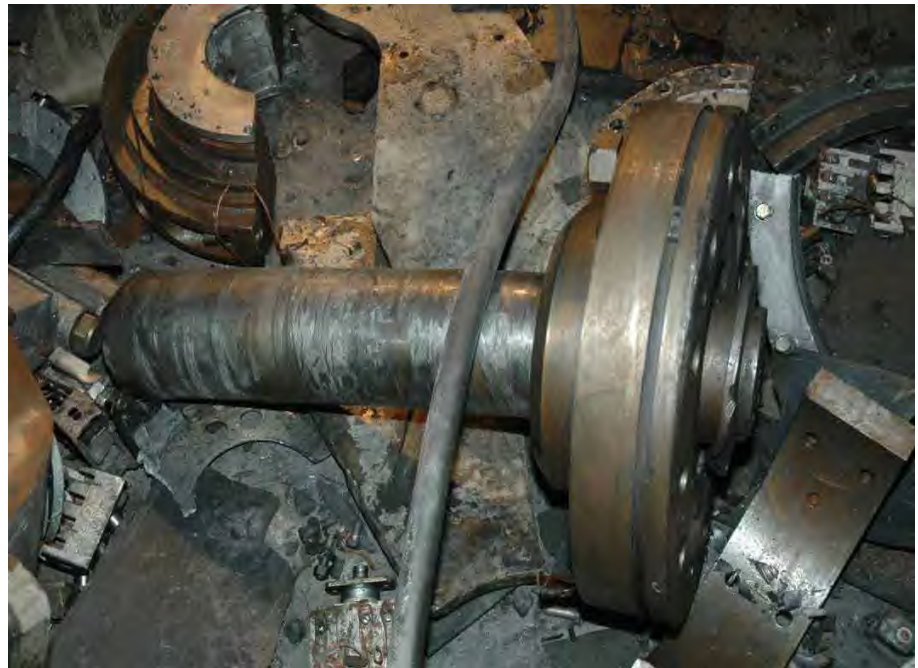
Fig. 107. Photograph of portion of fractured exciter shaft.

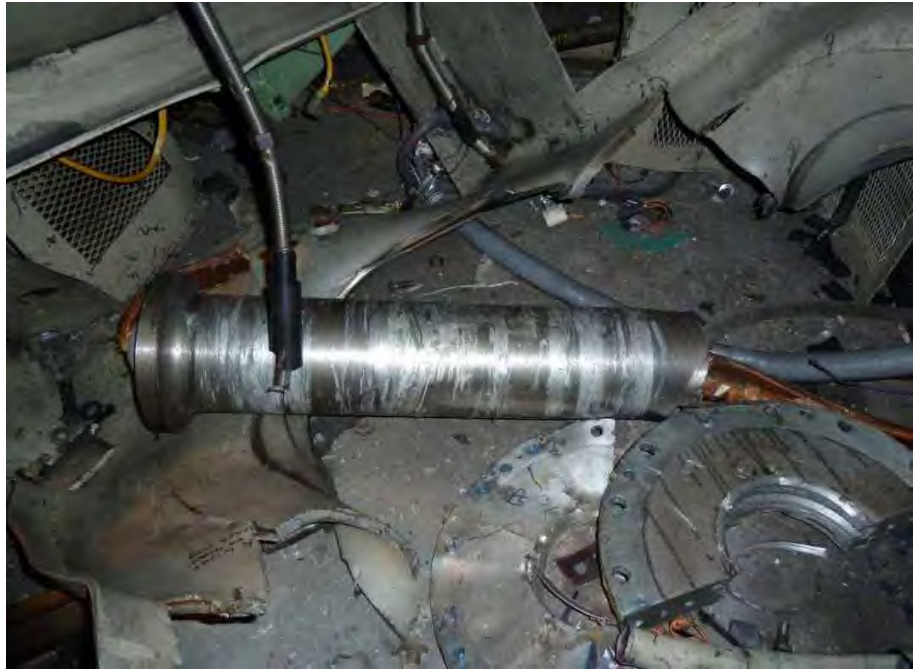
Fig. 108. Photograph of second fracture through exciter shaft.

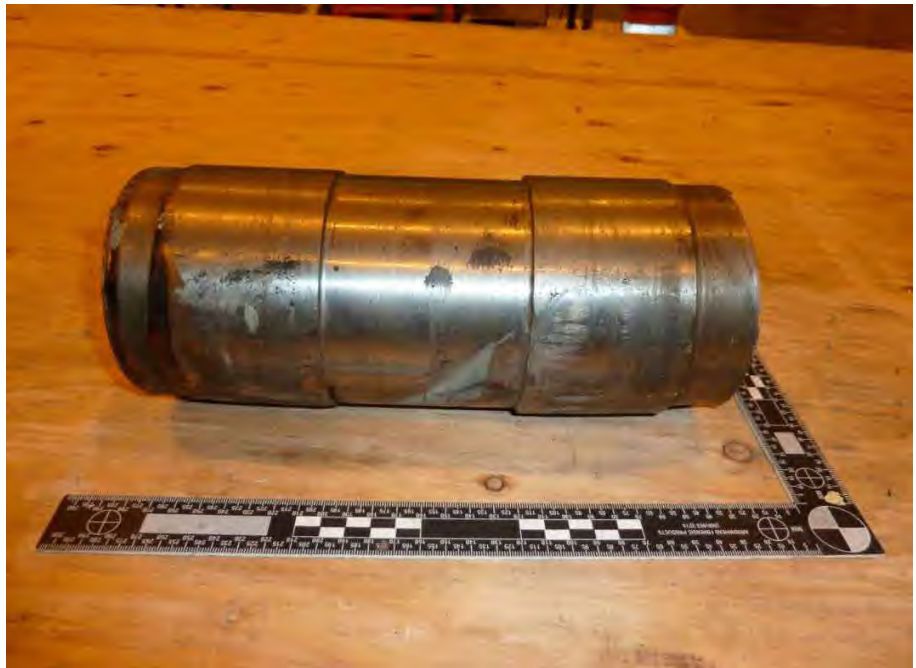
Fig. 109. Photograph of third fracture through exciter shaft at collector end.

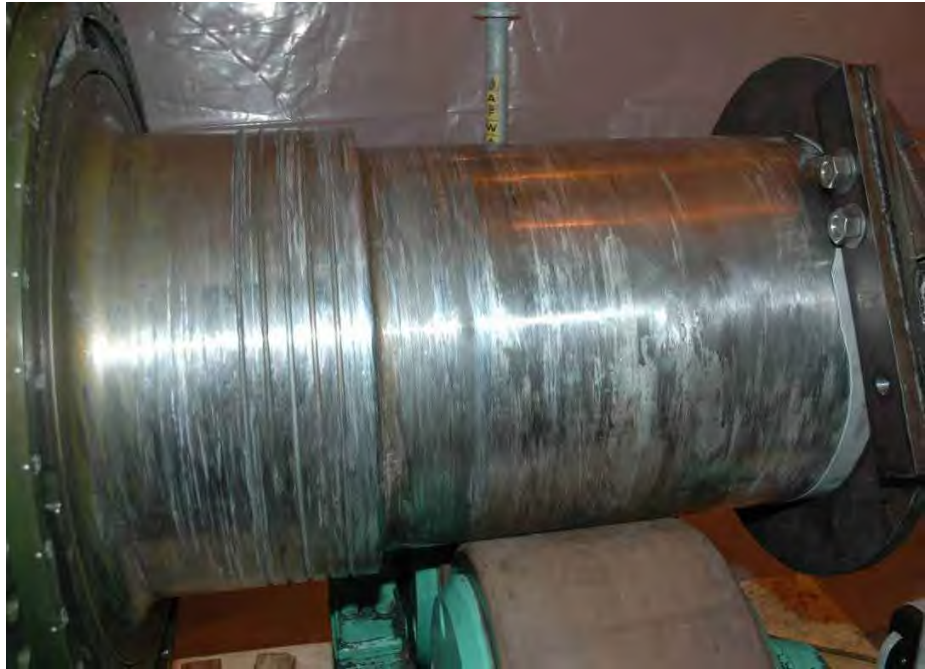
Fig. 112. Generator rotor rub damage.

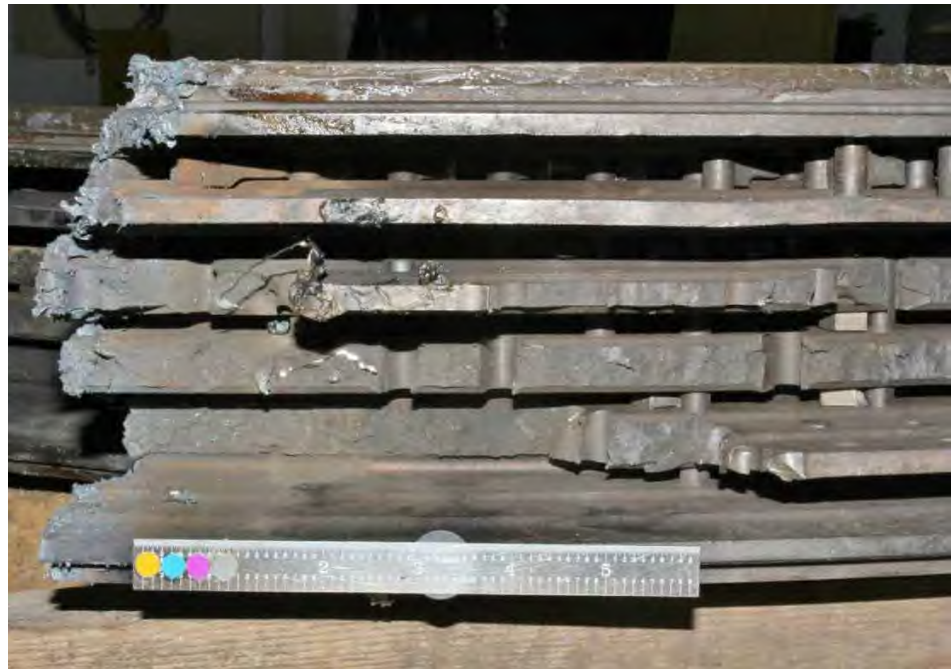
Fig. 121. Close-up photograph of fractures through internal finger pinned blade attachments of the low pressure turbine "B" L-1 disk rim.

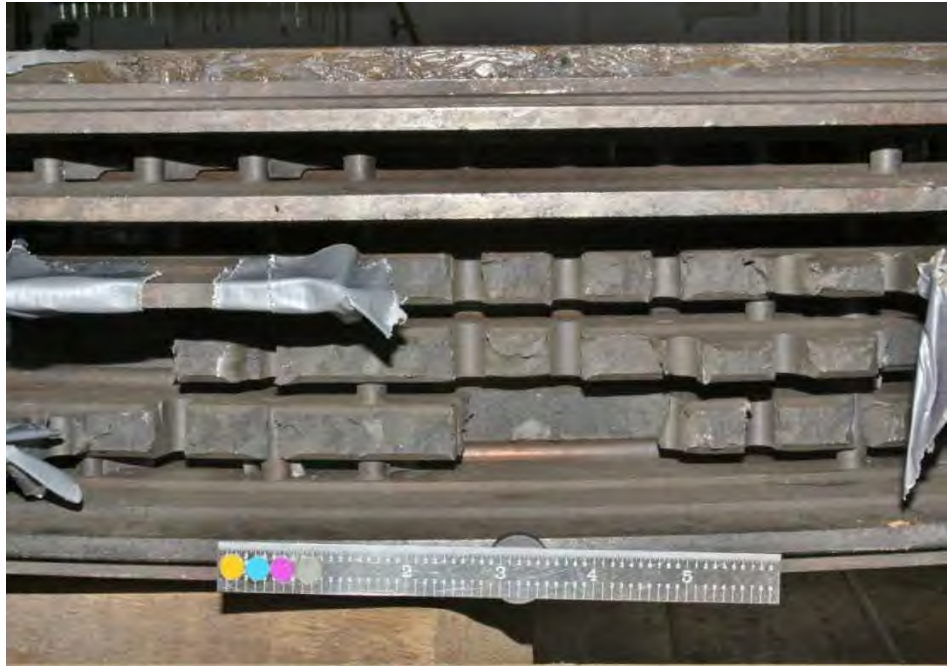
Fig. 122. Close-up photograph of fractures through internal finger pinned blade attachments of the low pressure turbine "B" L-1 disk rim.

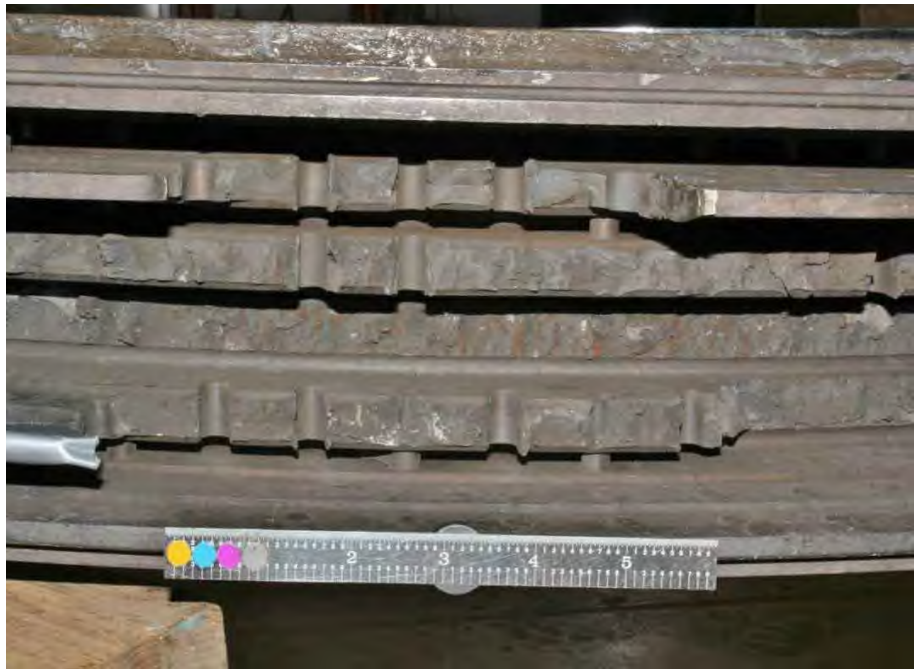
Fig. 123. Close-up photograph of fractures through internal finger pinned blade attachments of the low pressure turbine "B" L-1 disk rim.

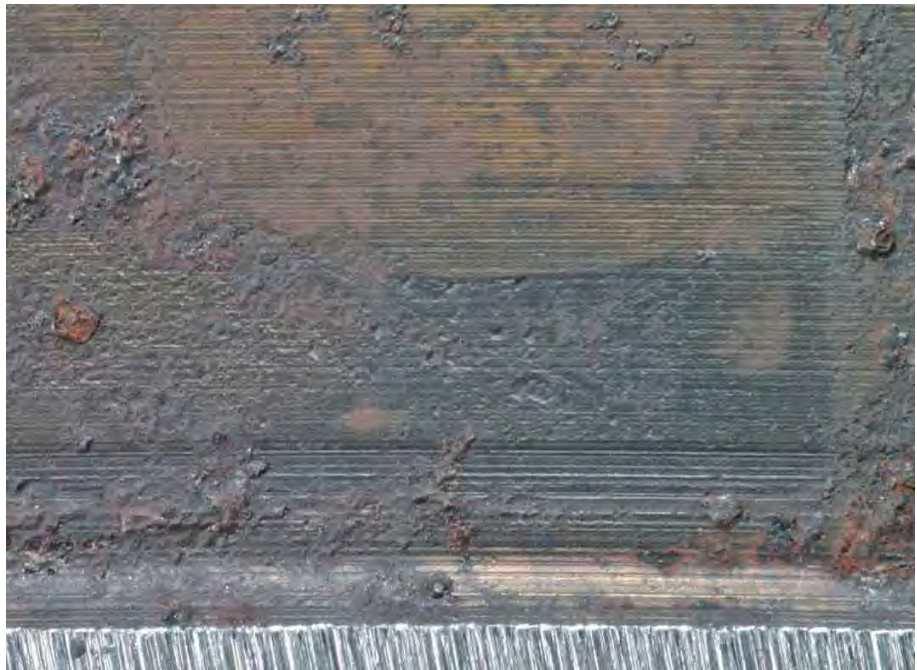
Fig 173. Close-up of finger pinned blade attachment from SID 14875 subsegment "C4" showing extent of corrosion/oxidation, viewed from inlet side.

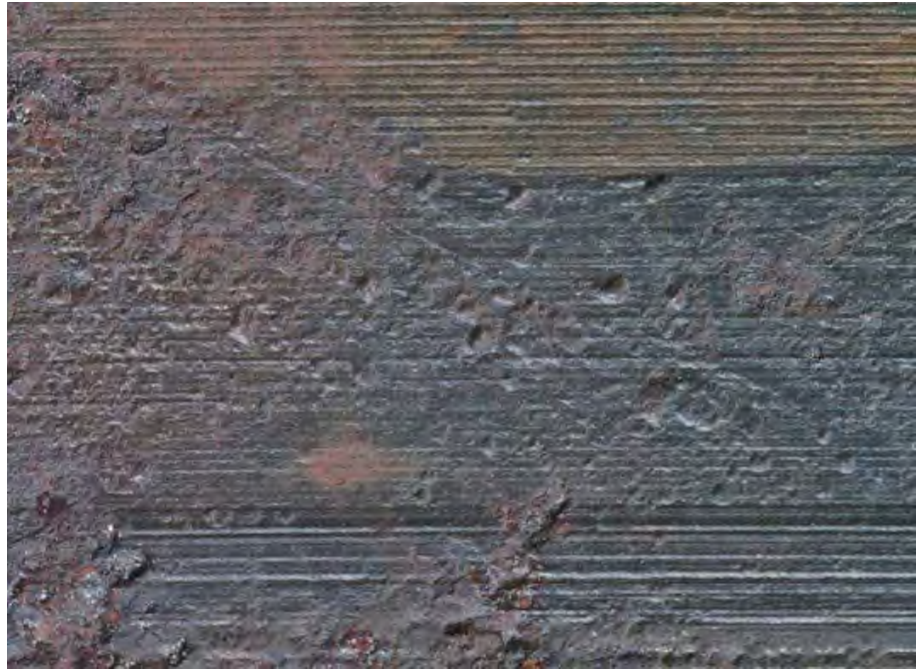
Fig 174. Close-up of finger pinned blade attachment from SID 14875 subsegment "C4" shown in Fig. 173.
