I. INTRODUCTION

A. My Rebuttal Testimony responds to the testimony filed by Mr. Richard Polich, of GDS Associates, Inc., on behalf of the Minnesota Department of Commerce (Department). In particular, I respond to Mr. Polich’s claim that Xcel Energy did not follow “good utility practice” at Sherco Unit 3.

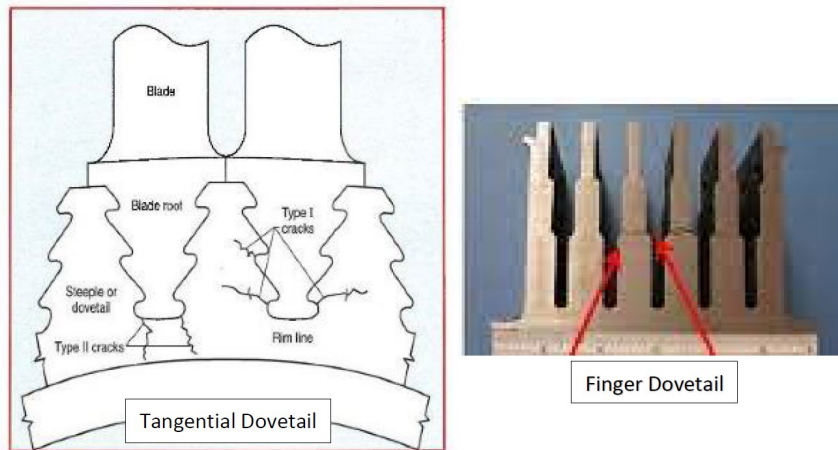
Figure 7 -Sherco LP bucket Attachment Types

11 A. Yes. Mr. Polich suggests that his opinions are based on his steam turbine
12 expertise, however his testimony is riddled with incorrect information. For
13 example, he represents that Figure 7 in his Direct Testimony (reproduced
14 below), represents the “Sherco LP bucket⁶ Attachment Types”—including a
15 tangential entry dovetail:⁷
