# Minnesota Public Utilities Commission

## Staff Briefing Papers

Docket No. IP6928/CS-14-515

In the Matter of the Aurora Distributed Solar, LLC Site Permit for the 100 MW Solar Energy Project Located at Multiple Facilities in Minnesota

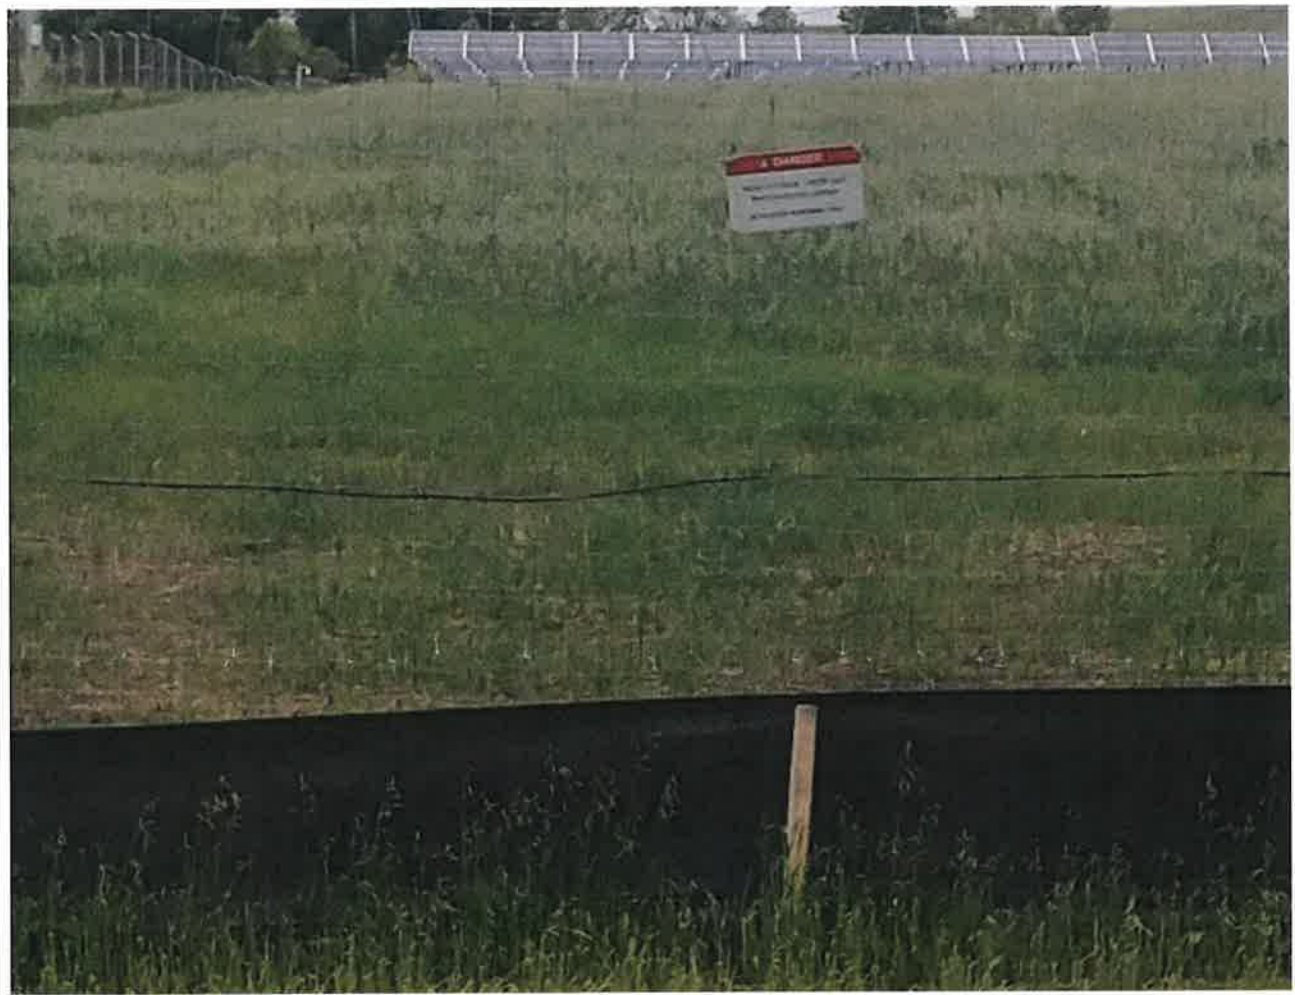
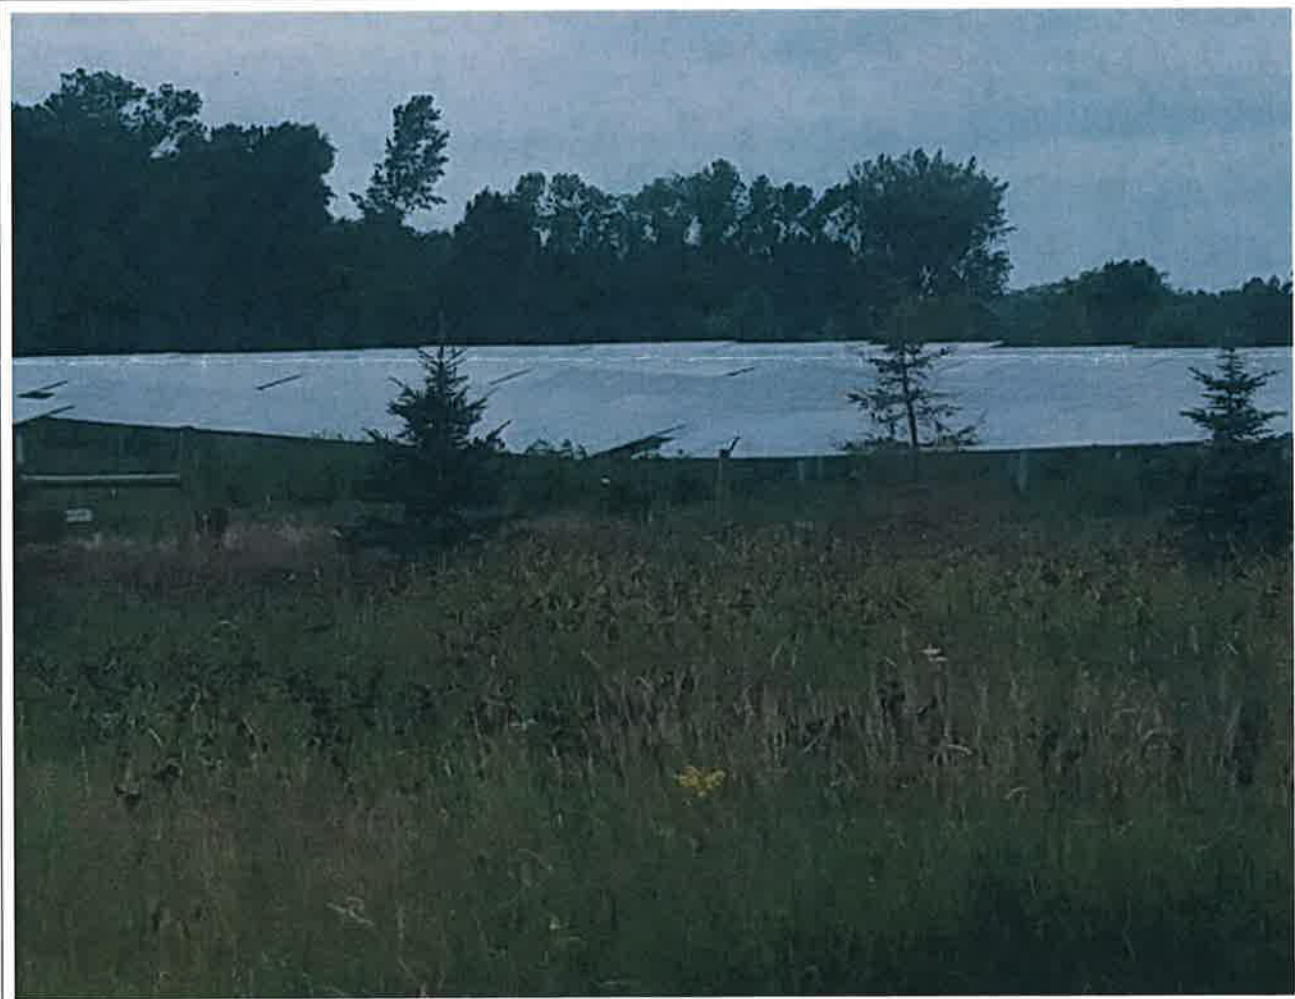
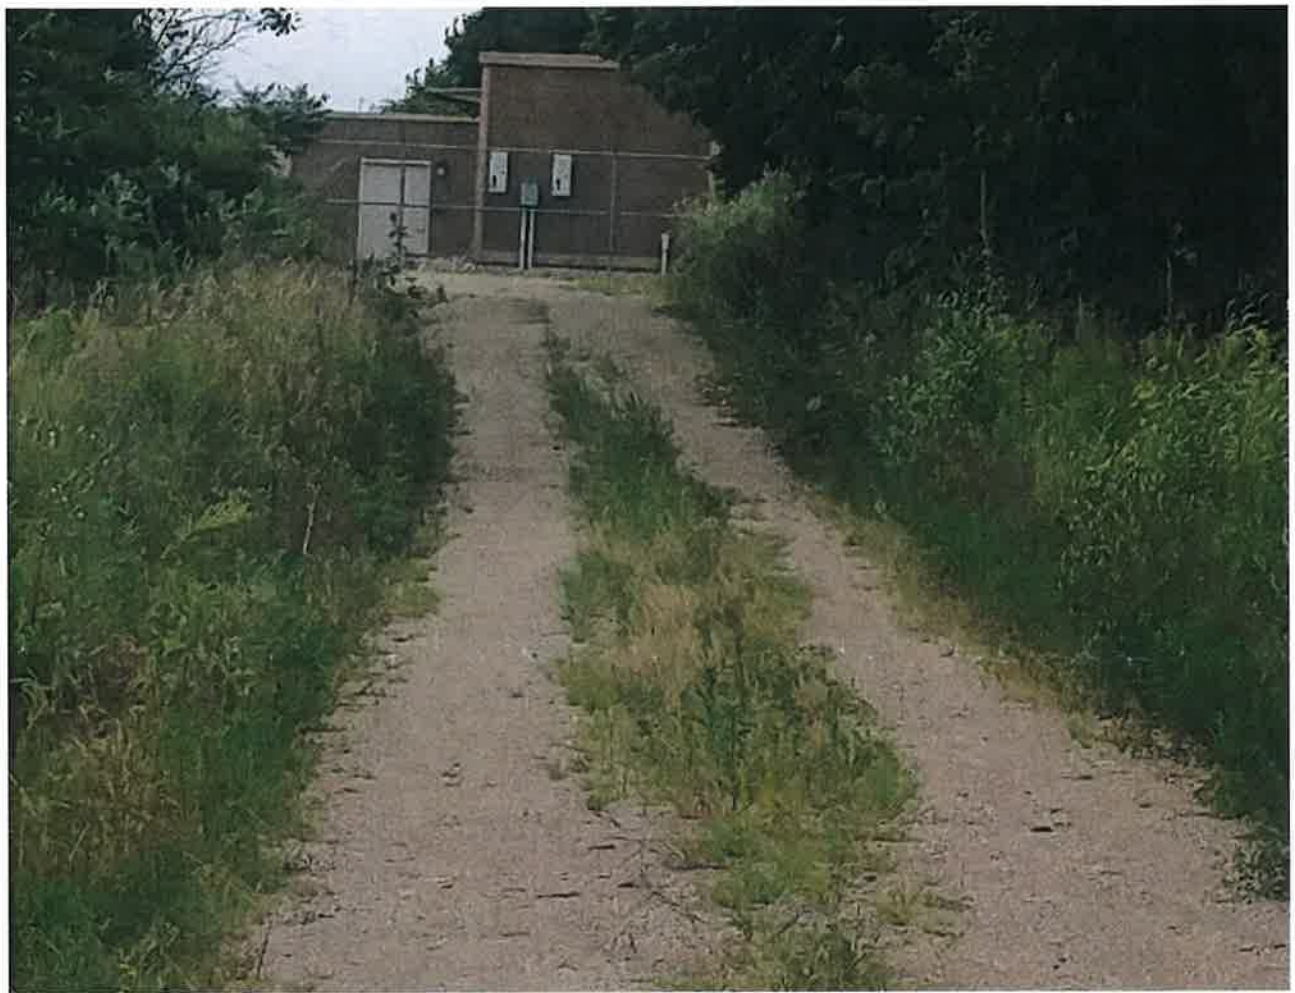
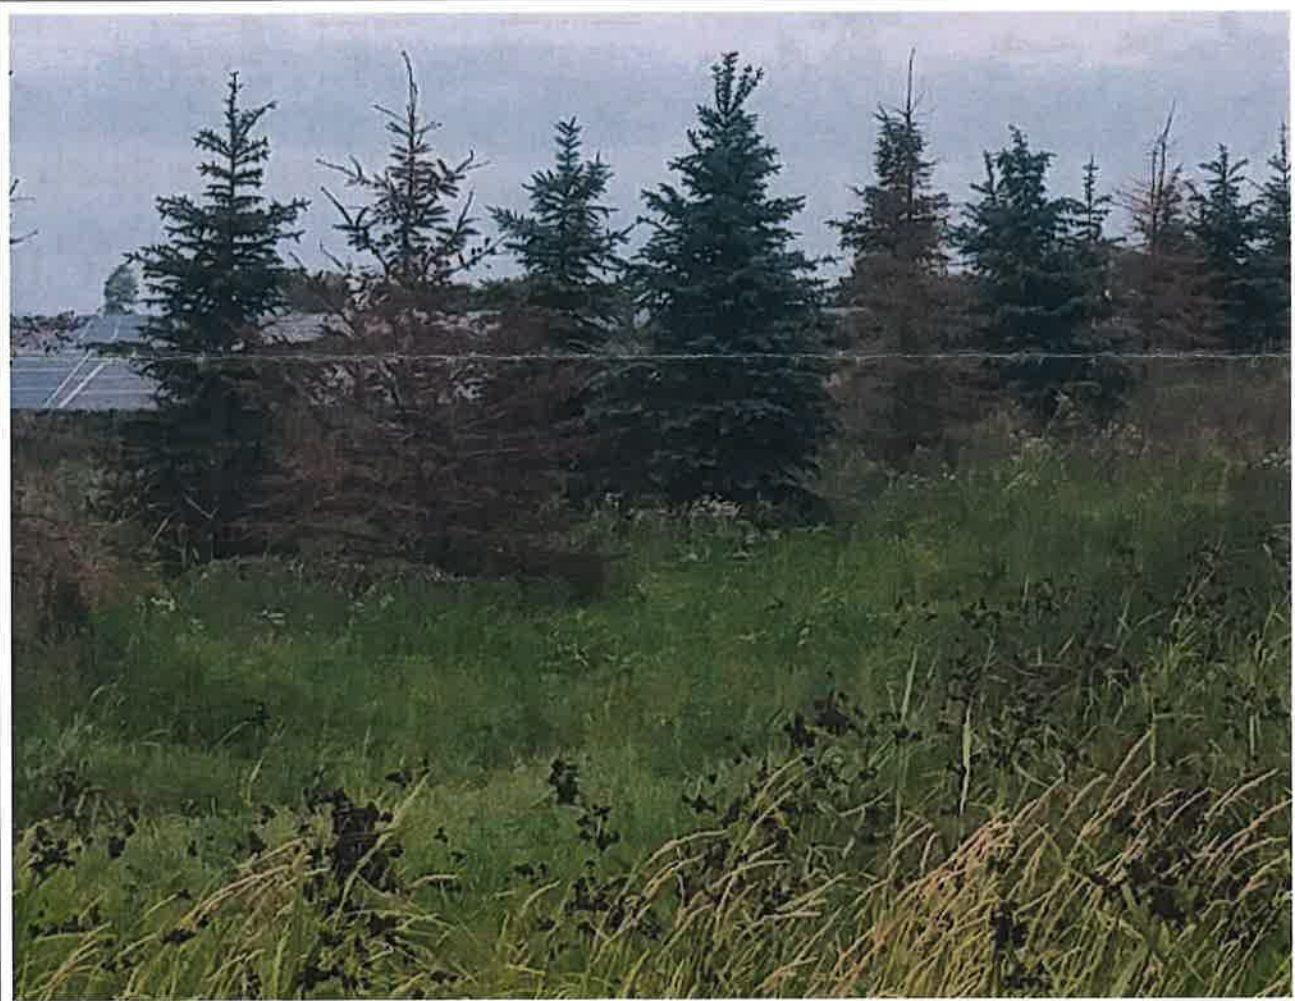
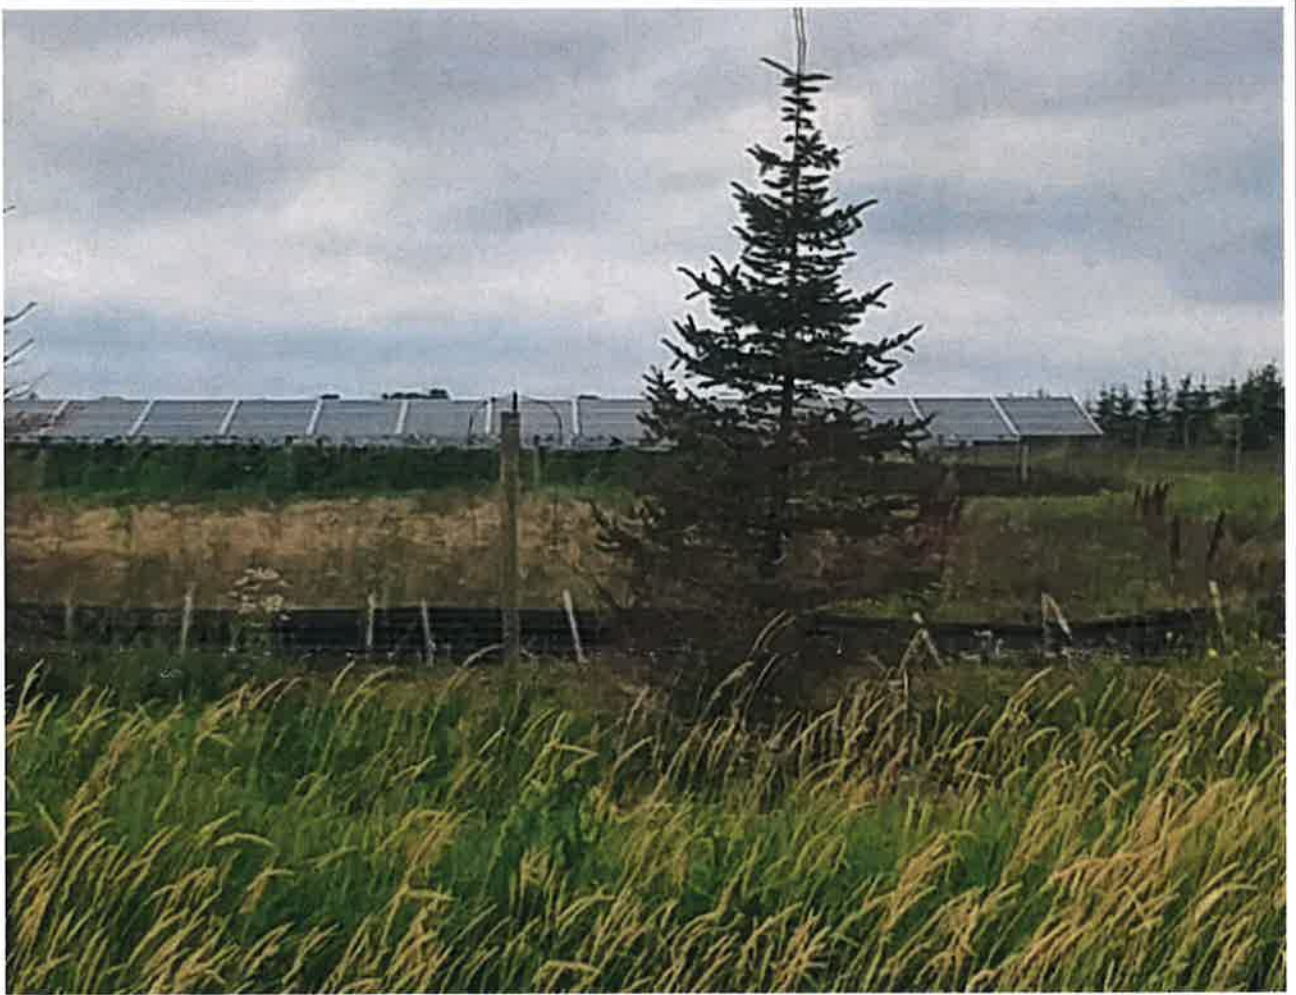
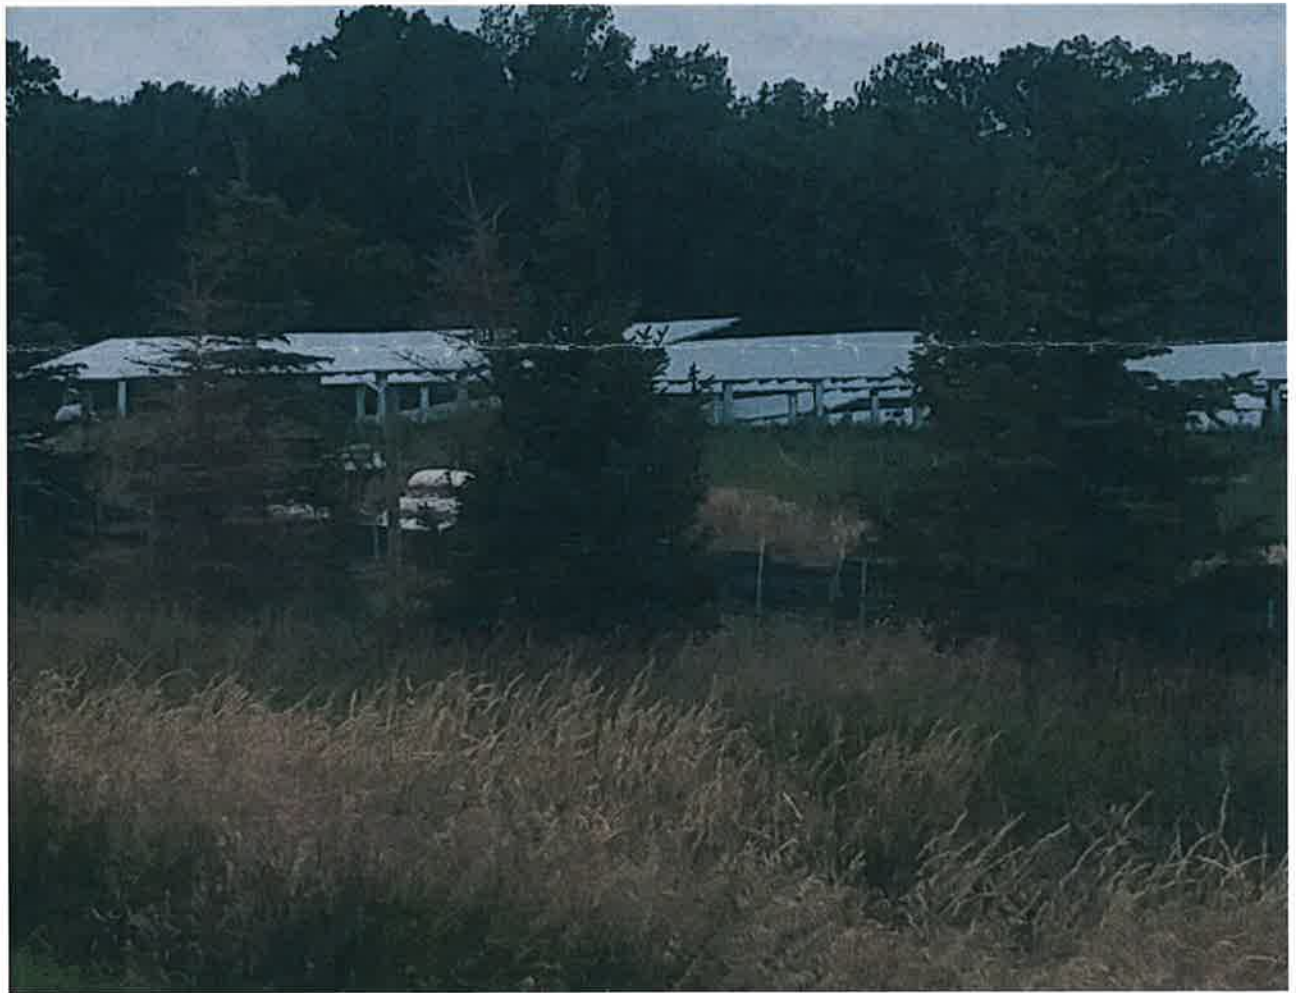
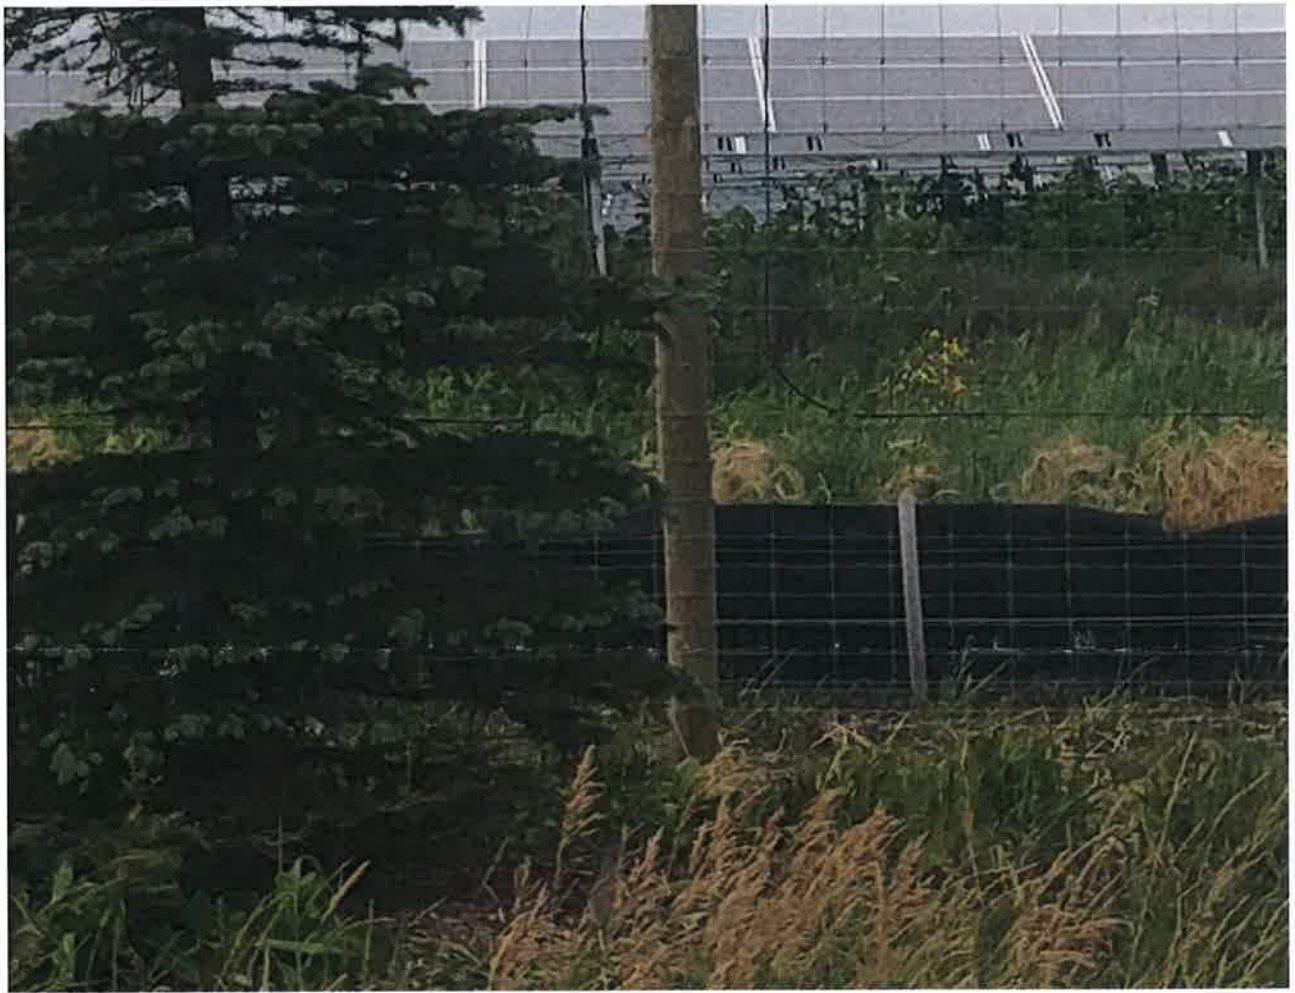
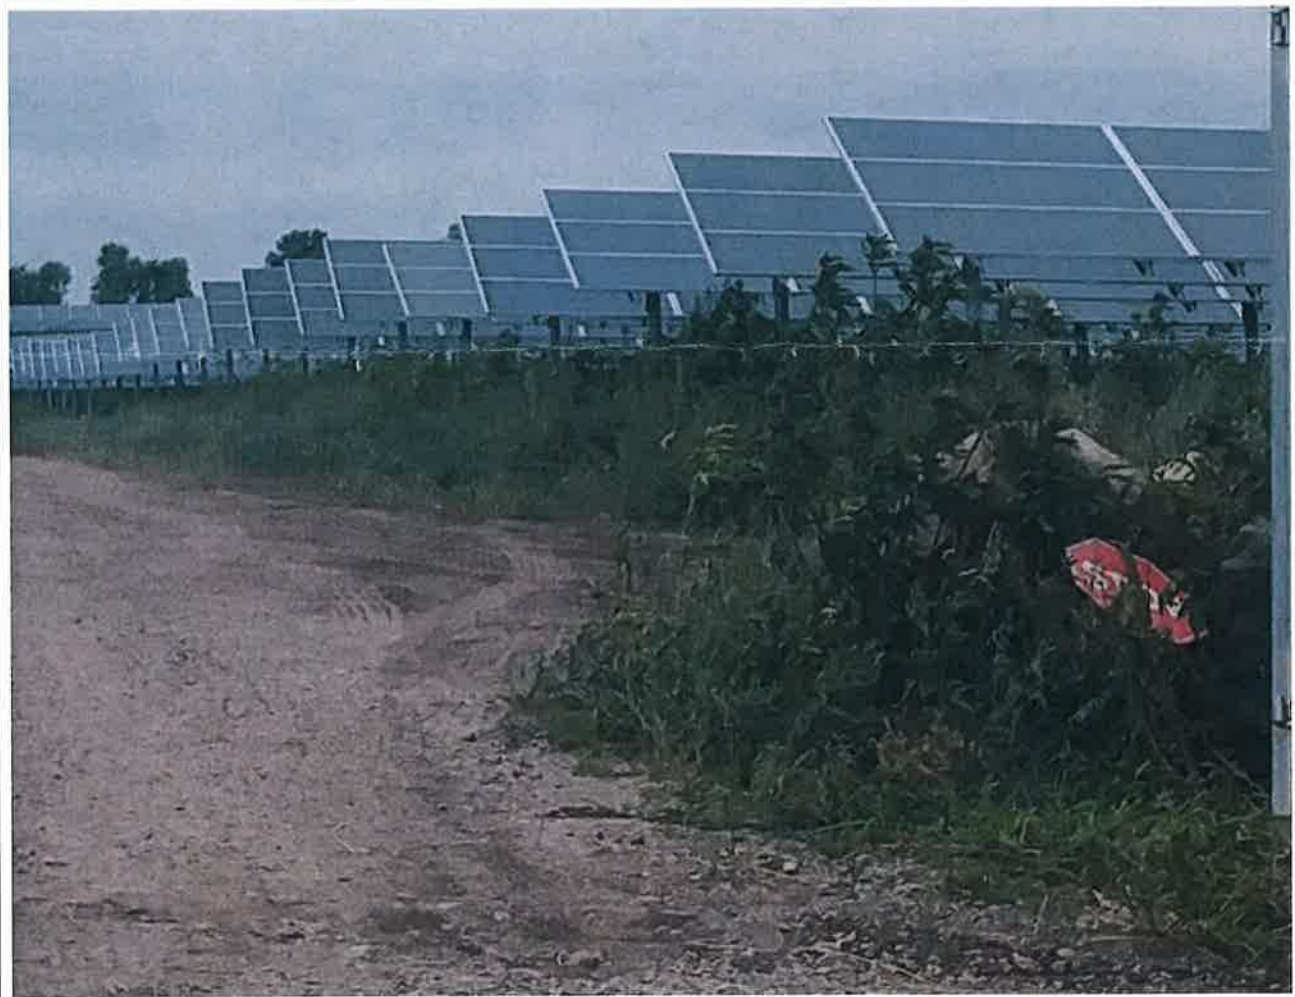
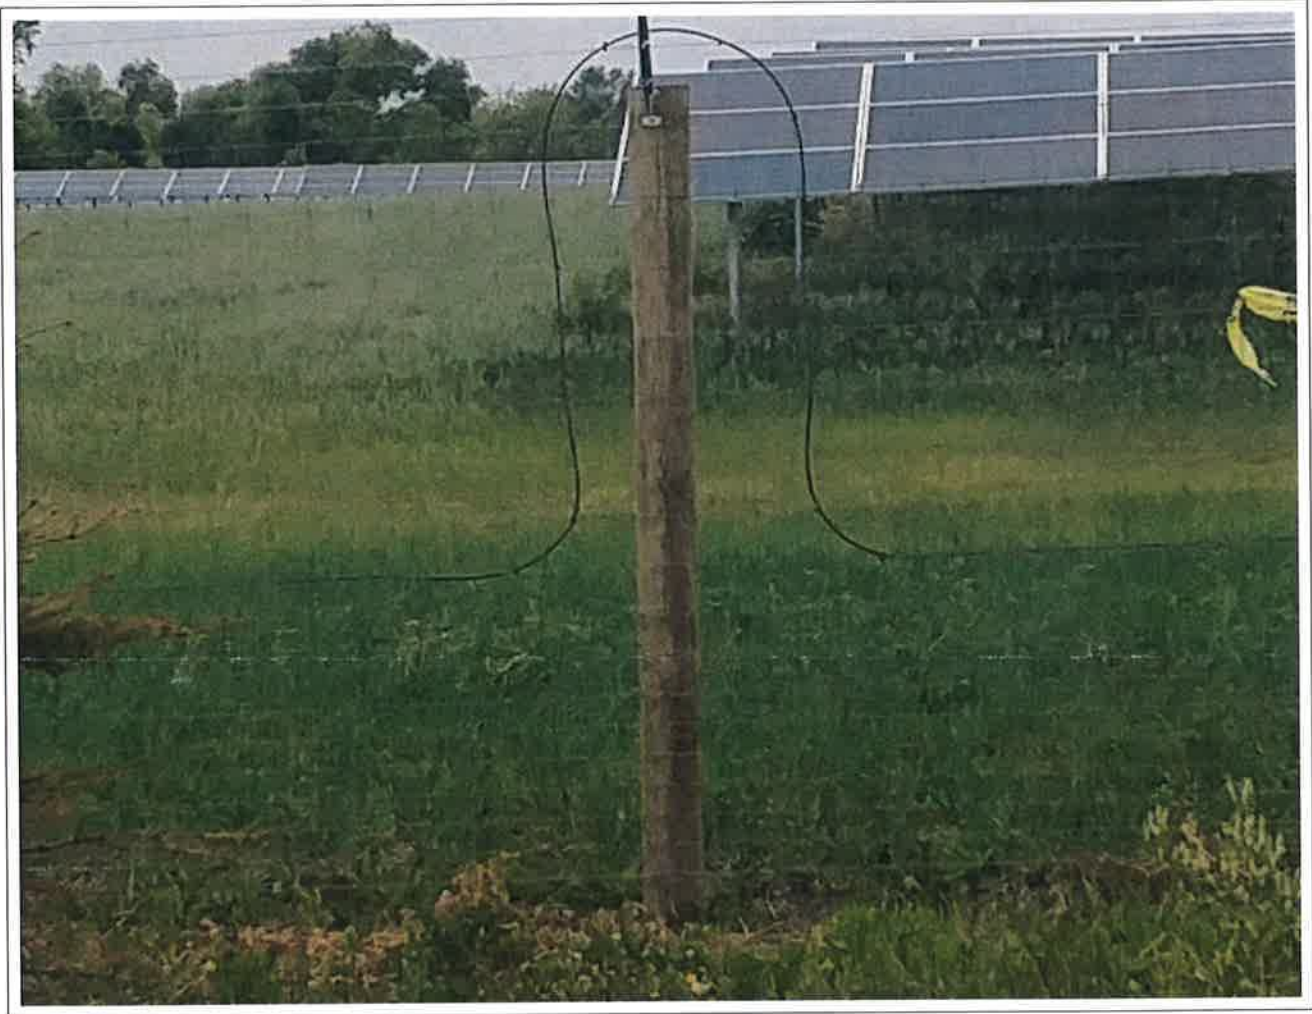
Corina Township filed comments in a similar vein as the City of Annandale. Corina Township provided photo documentation of the Annandale site, and expressed concern about the condition of the Annandale site in regard to the trees that did not establish, noxious weeds, loose wires and a damaged stop sign.

Photographs of the site are included. They show the run-down condition of the property. Corinna Township was assured that the property would be kept in immaculate condition. Corinna Township prides itself on the upkeep of the properties within the Township. This site is an eyesore, with dead trees, tall, possibly noxious weeds, a crumpled up stop sign, and loose wires.

8. Use of the BWSR assessment forms during revegetation.
9. Development of a site specific maintenance plans for each location.
10. Several trees at the Annandale site need to be replaced, Aurora has written assurances with the City that those trees will be established. Aurora plans to replace the trees later this year.

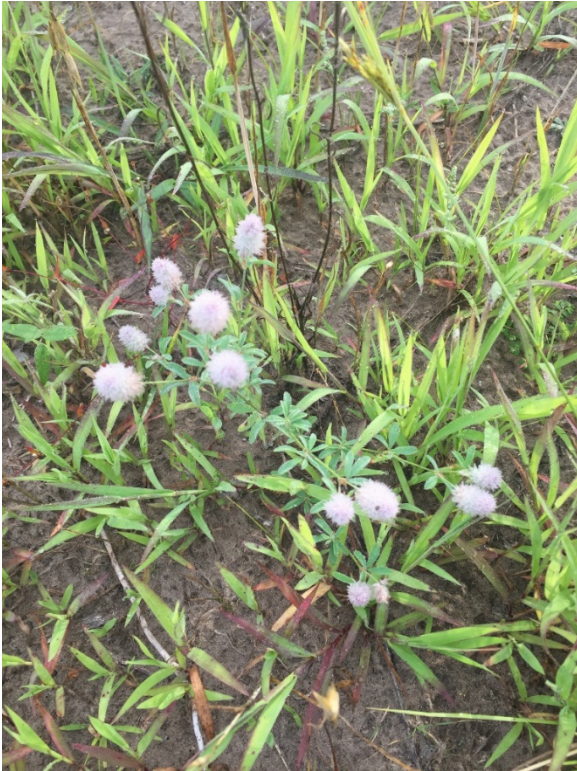
Photo 1: Blooming prairie clover.

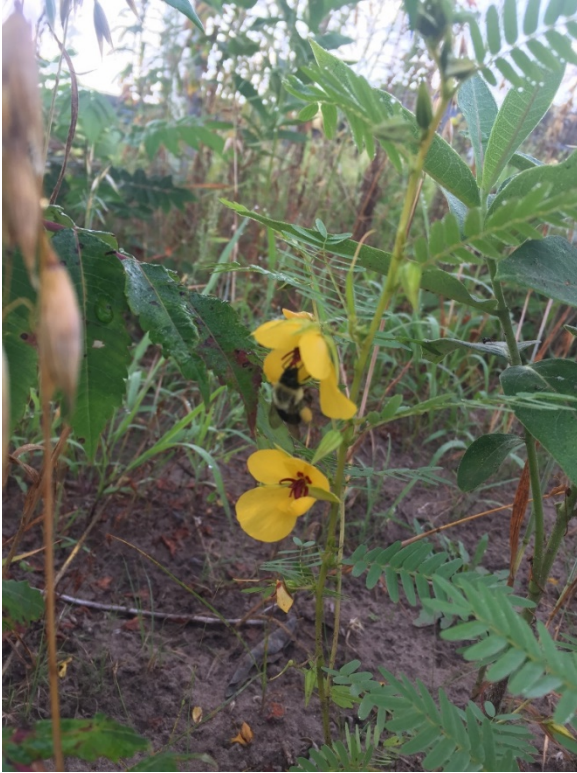
Photo 2: Bumble bee utilizing partridge pea.

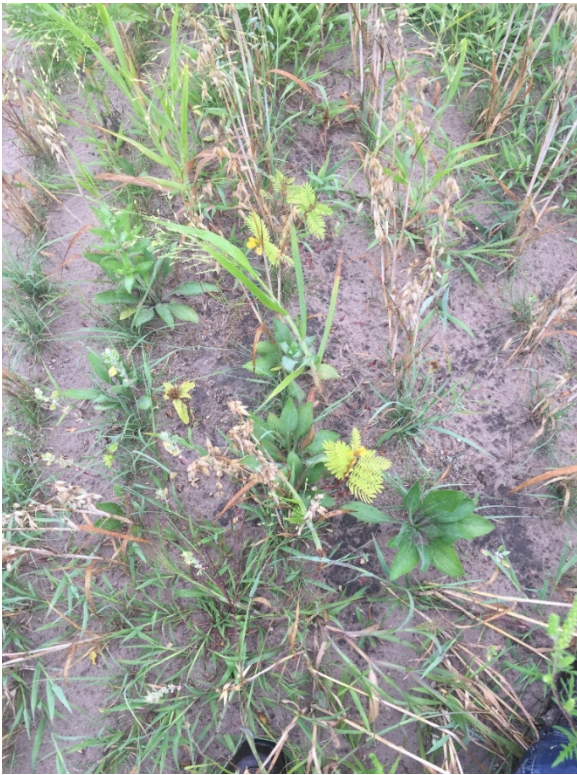
Photo 3: Multiple native species present.

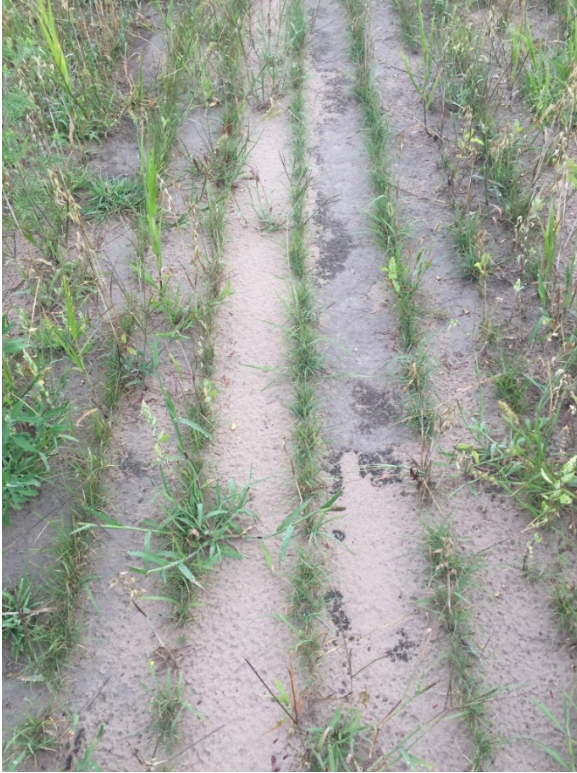
Photo 4: Vegetation emergence in blow-sand accumulation area; establishment is a little slower but dense vegetation is present along drill marks and is expected to provide effective stabilization against further wind erosion.

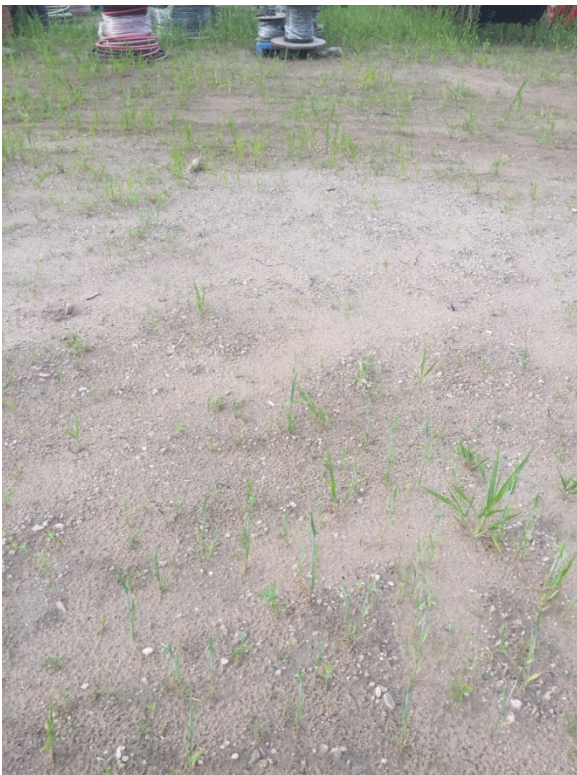
Photo 5: Portions of laydown area have insufficient vegetation establishment due to excessive gravel or vehicle damage.

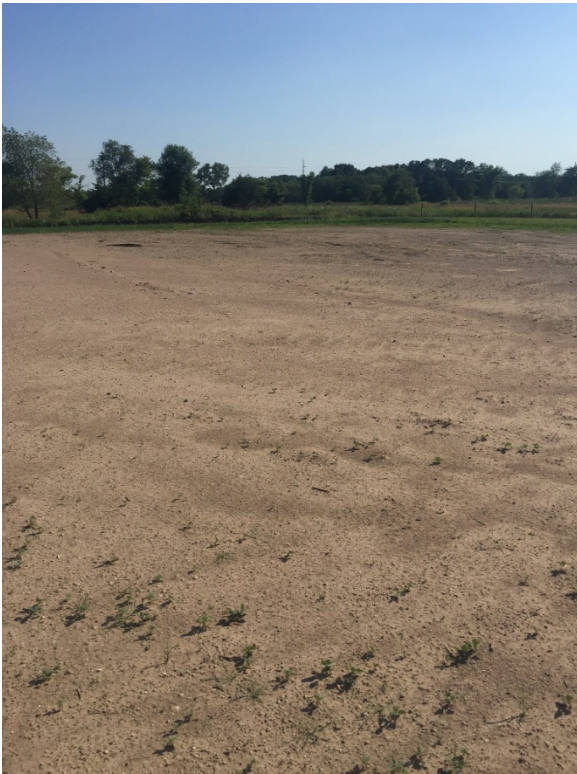
Photo 1: Former laydown area has excessive gravel remaining on surface of topsoil.

- Corrective actions may be identified as vegetation establishment continues to be monitored.

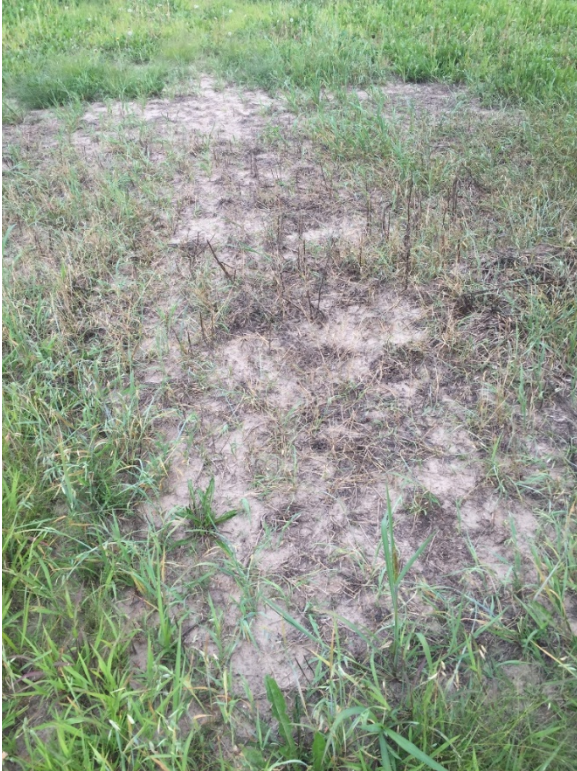
Photo 2: Area with suspected herbicide burn.

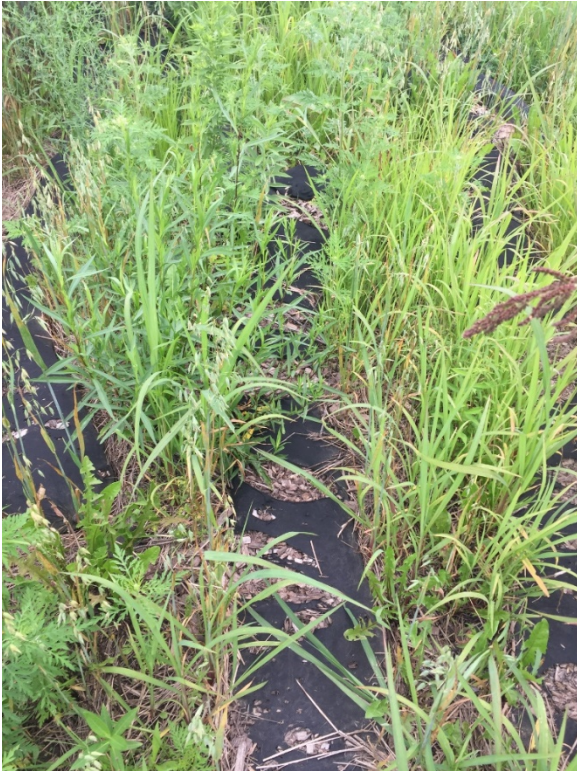
Photo 3: Disintegrating BMPs around central wetland.

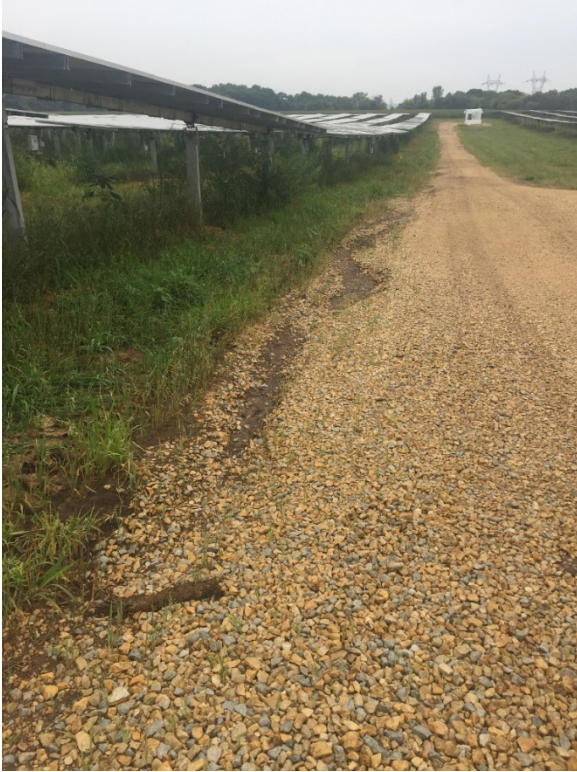
Photo 1: Small erosion channel beginning to establish along central access road.

- Stabilize erosion areas.

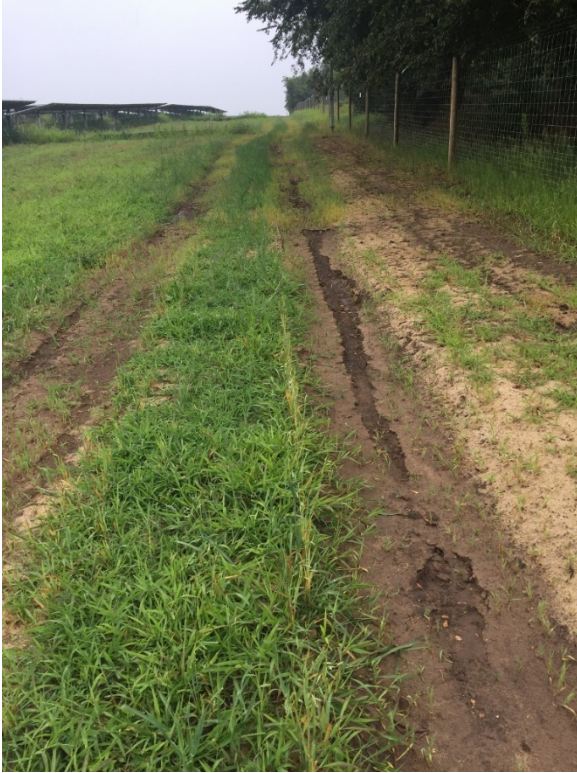
Photo 2: Erosion occurring in wheel track on hydro-mulched slope.

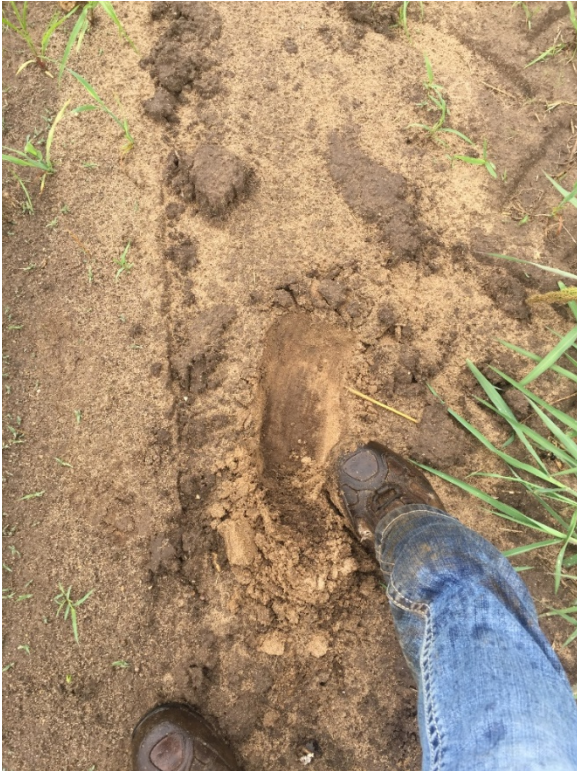
Photo 3: Washed sediment accumulating over topsoil.

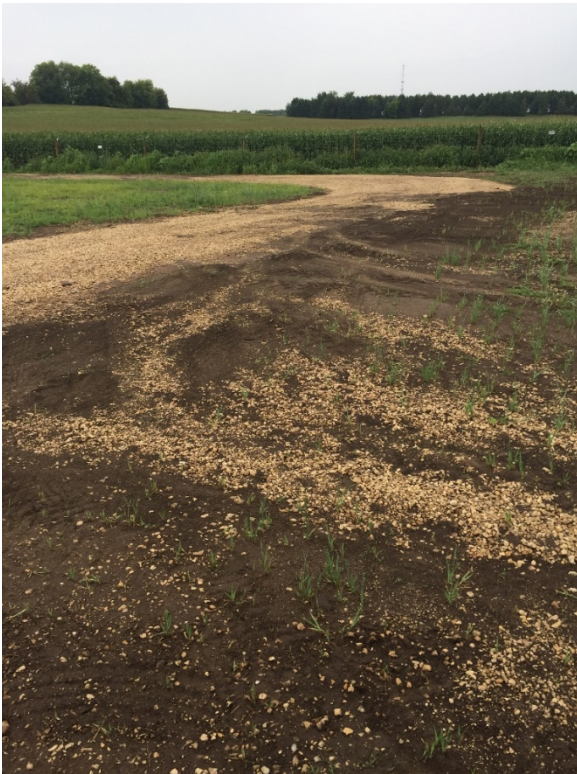
Photo 4: Topsoil washing off of laydown yard onto access road.

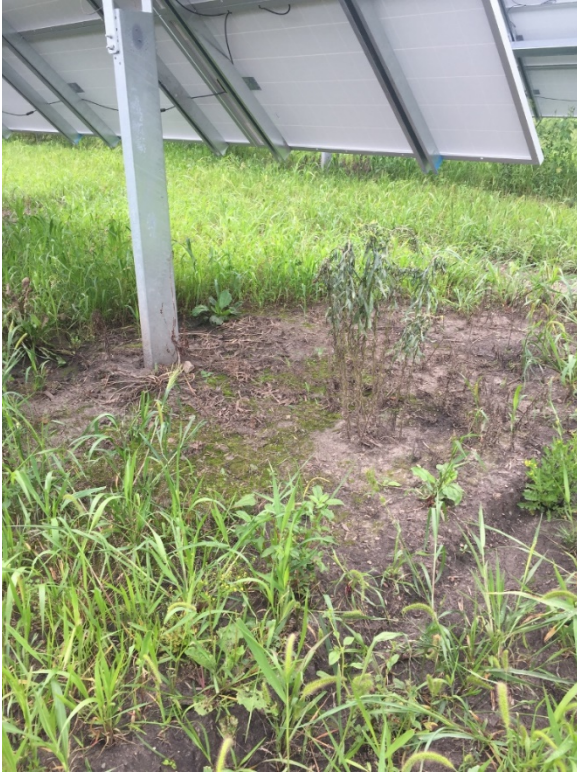
Photo 1: Areas indicative of herbicide residual presence.

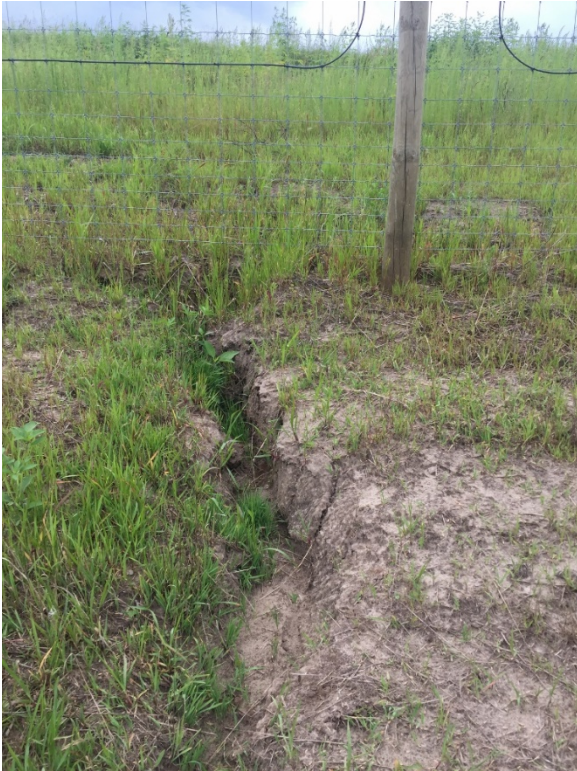
<b>Issues Noted During Inspection:</b>			
<ul style="list-style-type: none"><li>Erosion on southwest slope adjacent to perimeter fence.</li></ul>			
<b>Corrective Actions:</b>			
<p>Corrective actions discussed onsite included:</p> <ul style="list-style-type: none"><li>Correct erosion and stabilize slope.</li></ul>

Photo 2: Erosion beginning to increase on southwest corner of site.
