# Minnesota Public Utilities Commission

## Staff Briefing Papers

Docket No. IP6928/CS-14-515

In the Matter of the Aurora Distributed Solar, LLC Site Permit for the 100 MW Solar Energy Project Located at Multiple Facilities in Minnesota

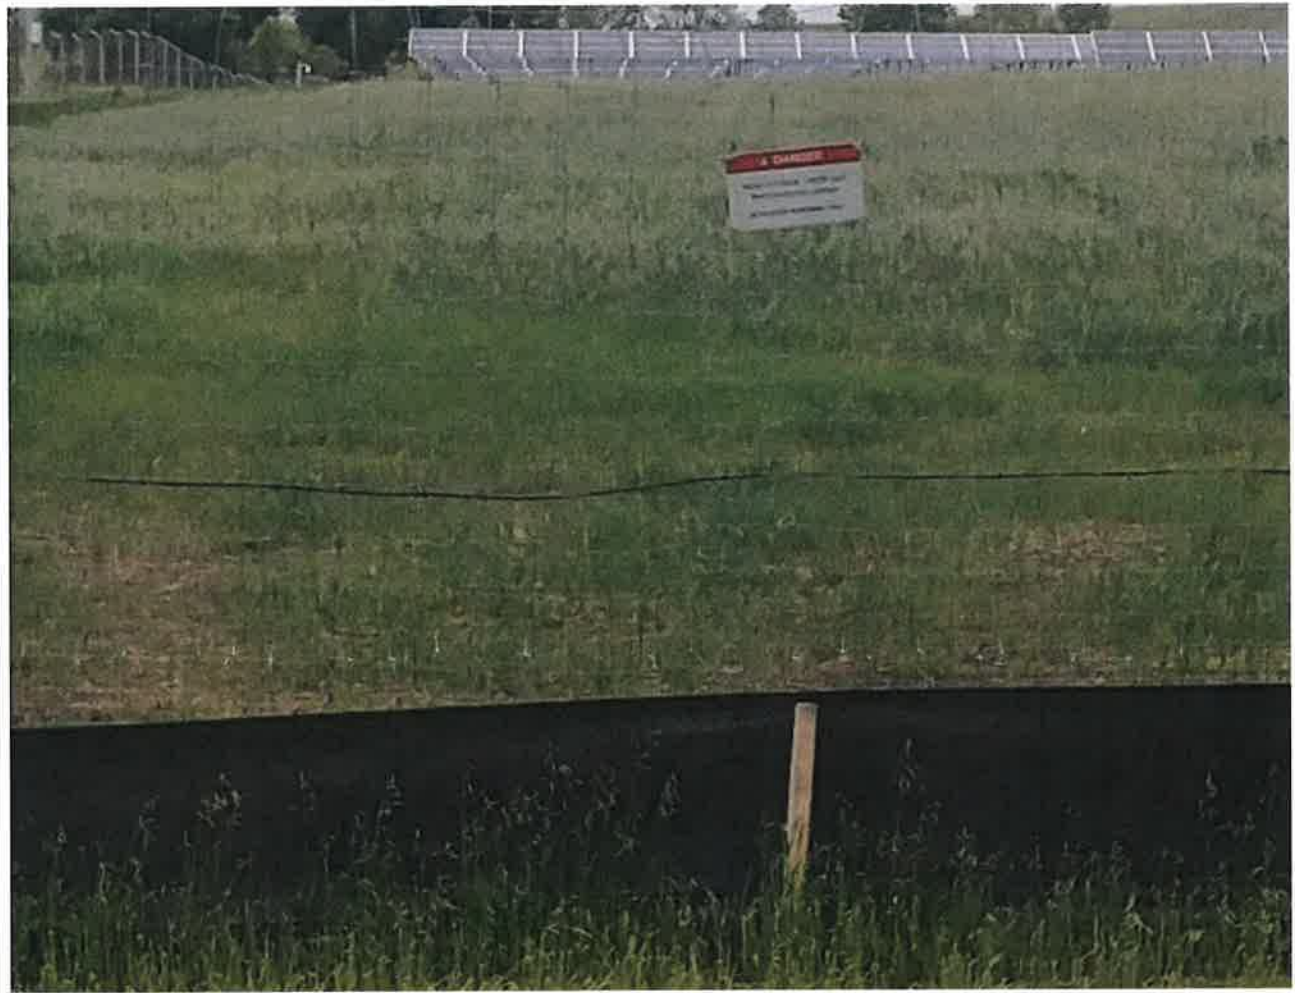
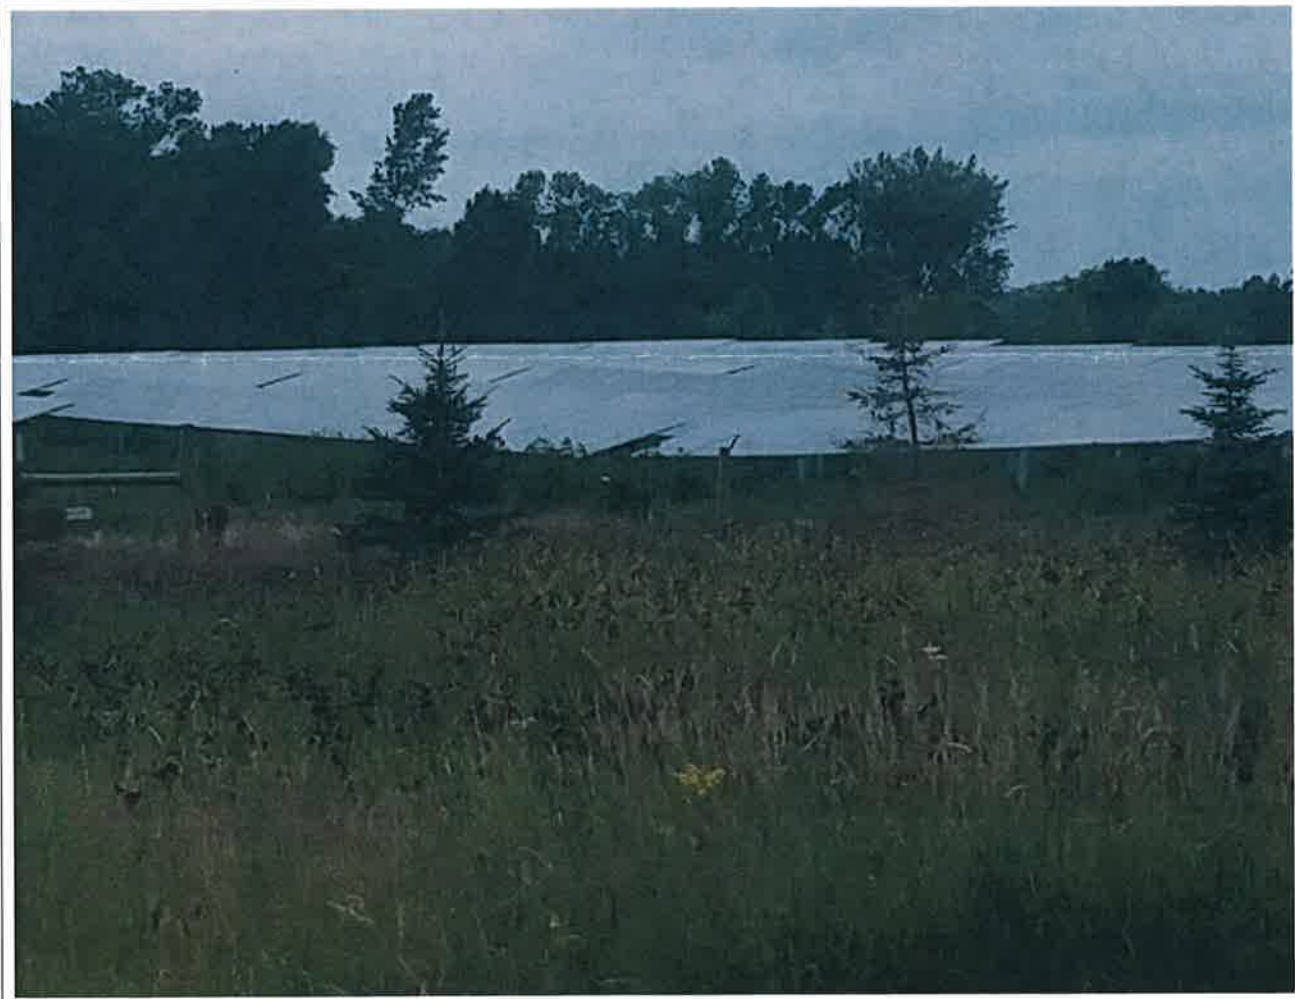
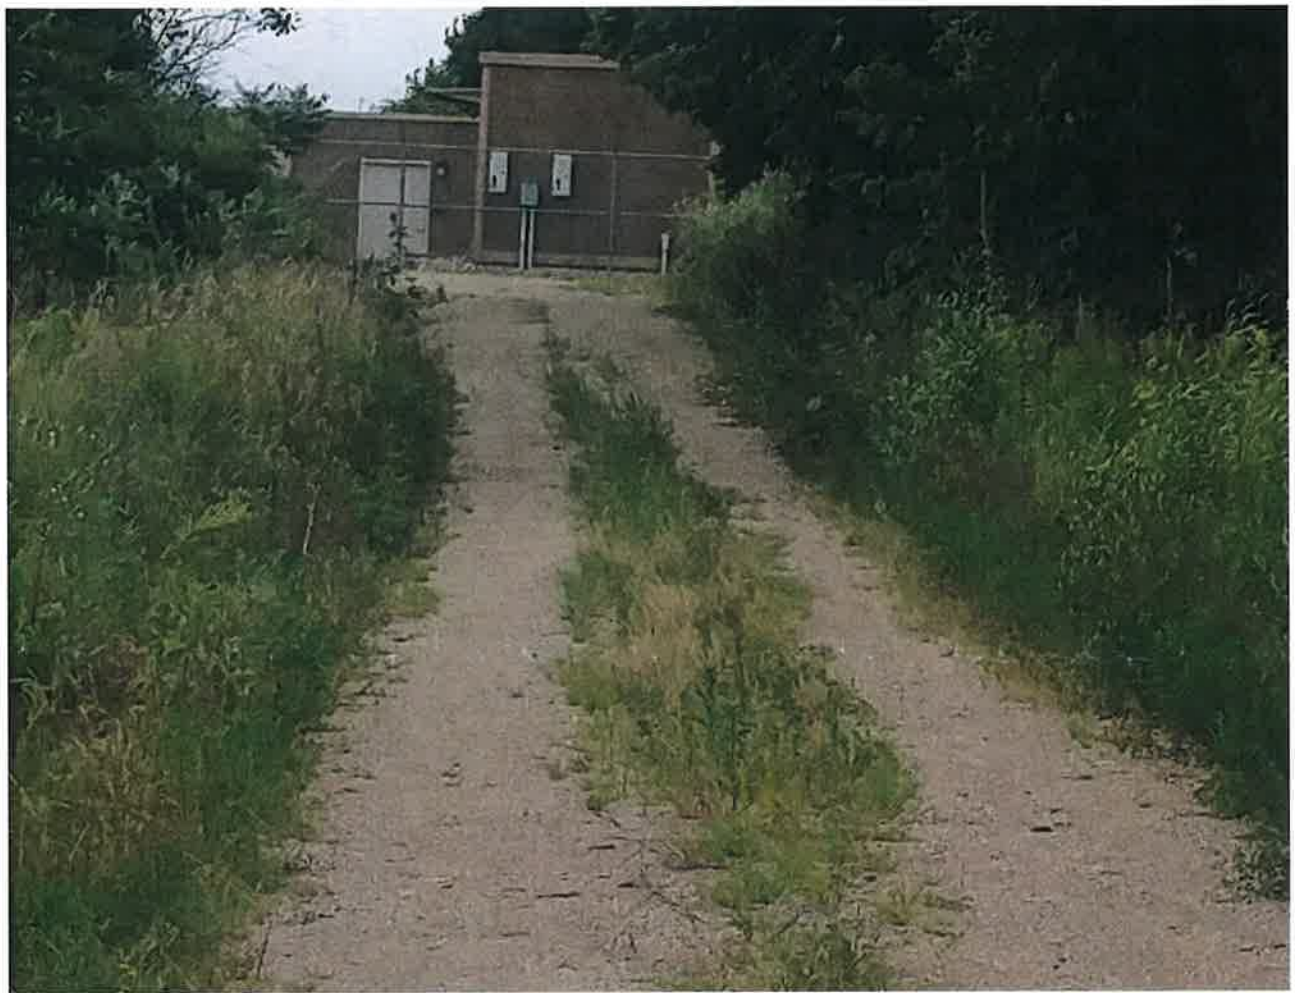
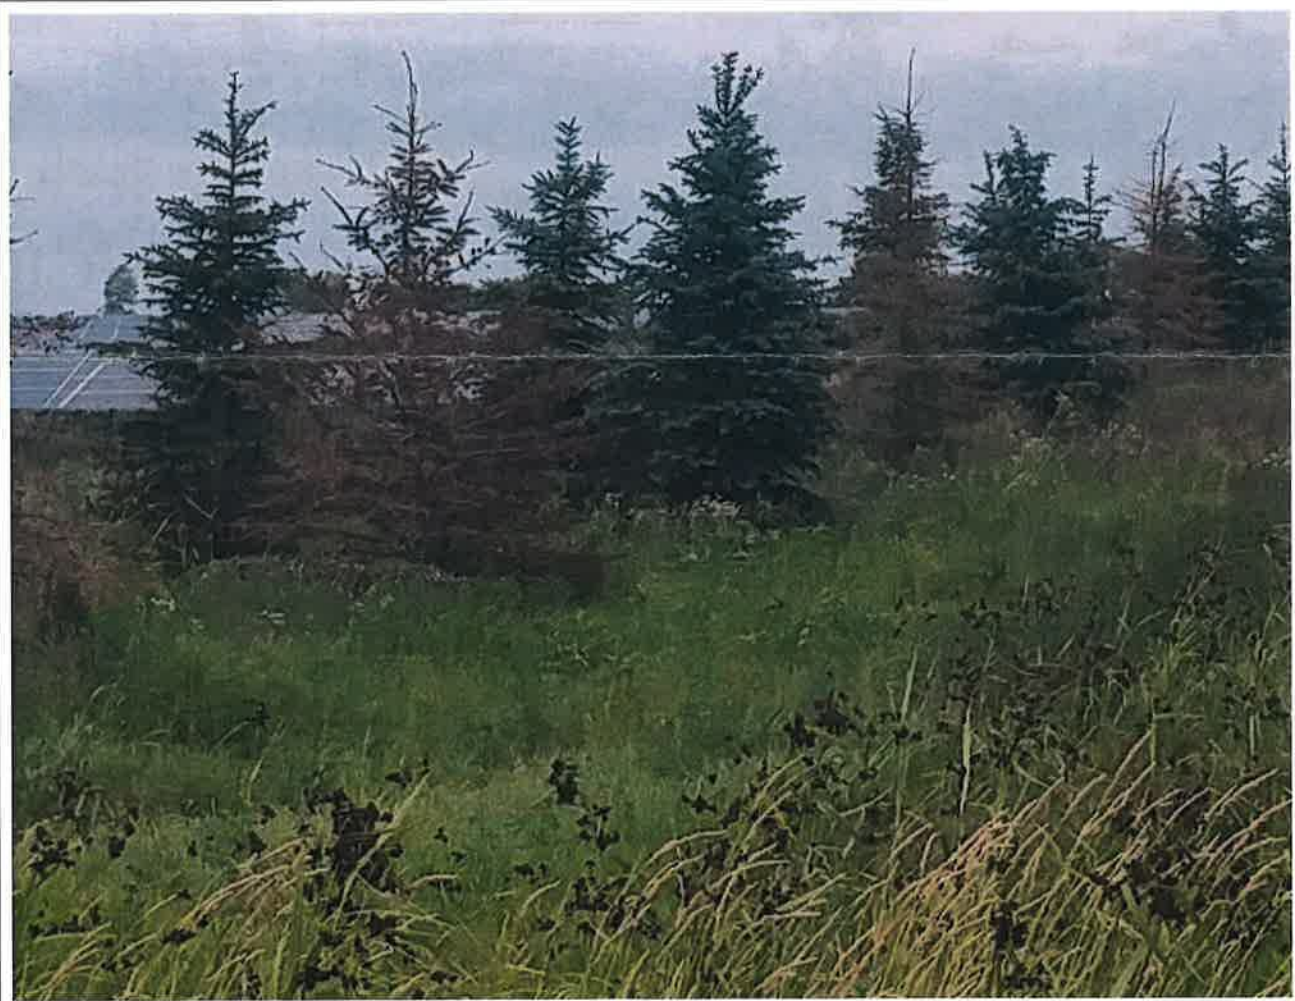
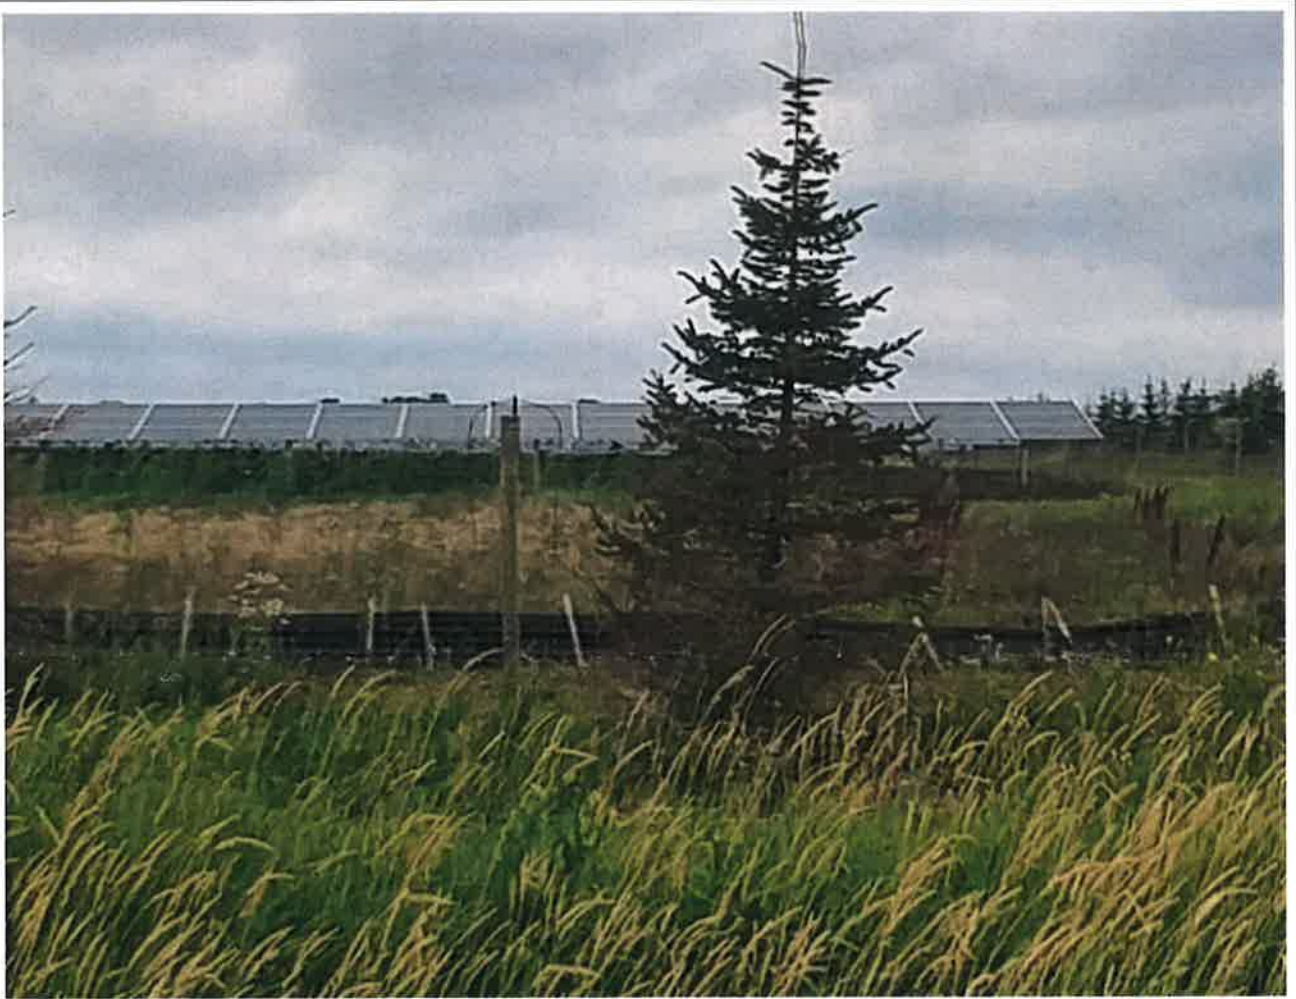
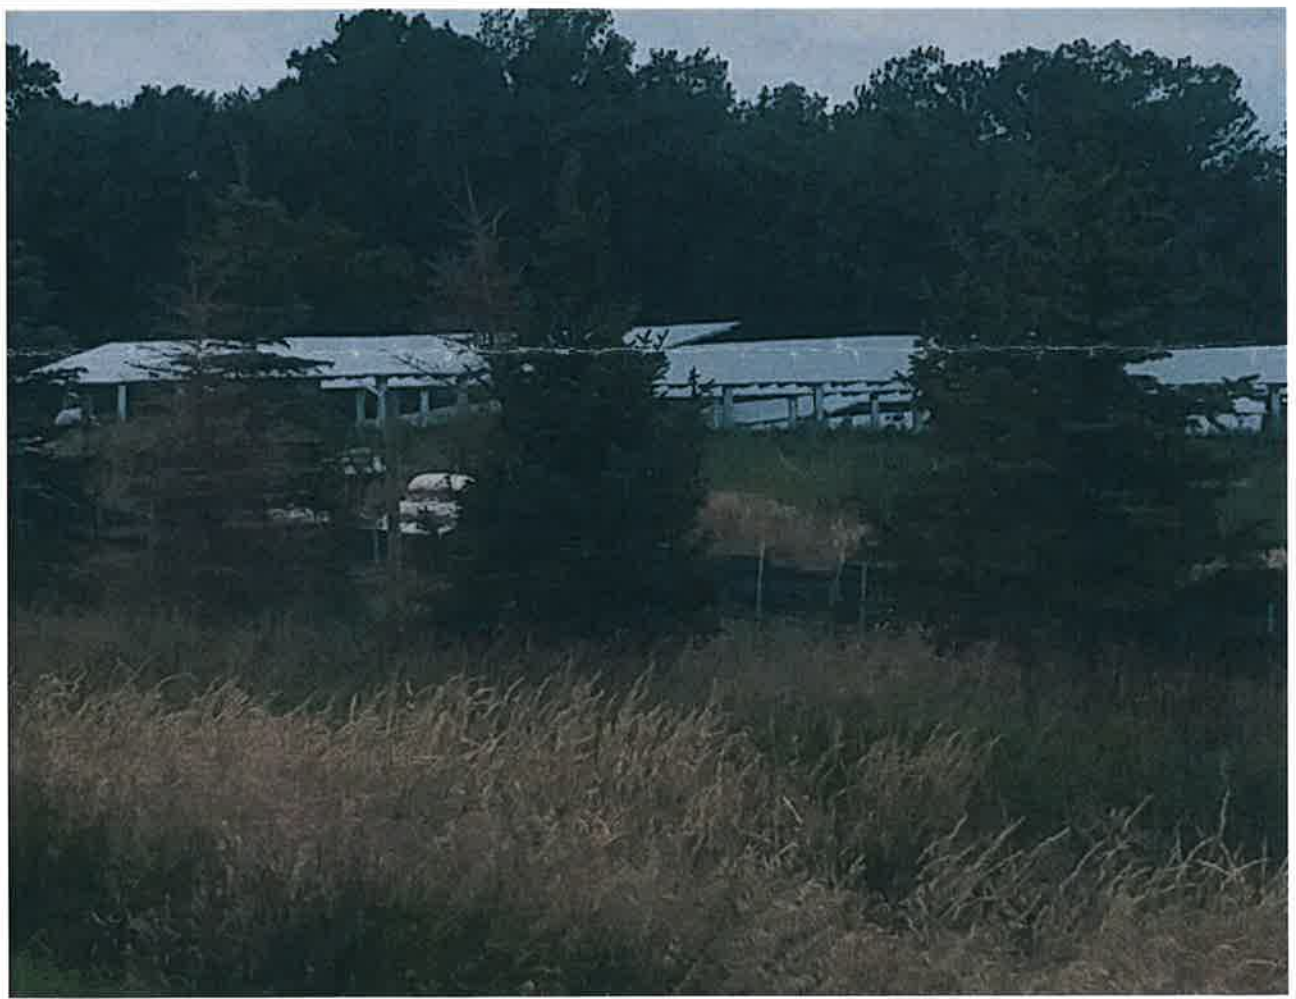
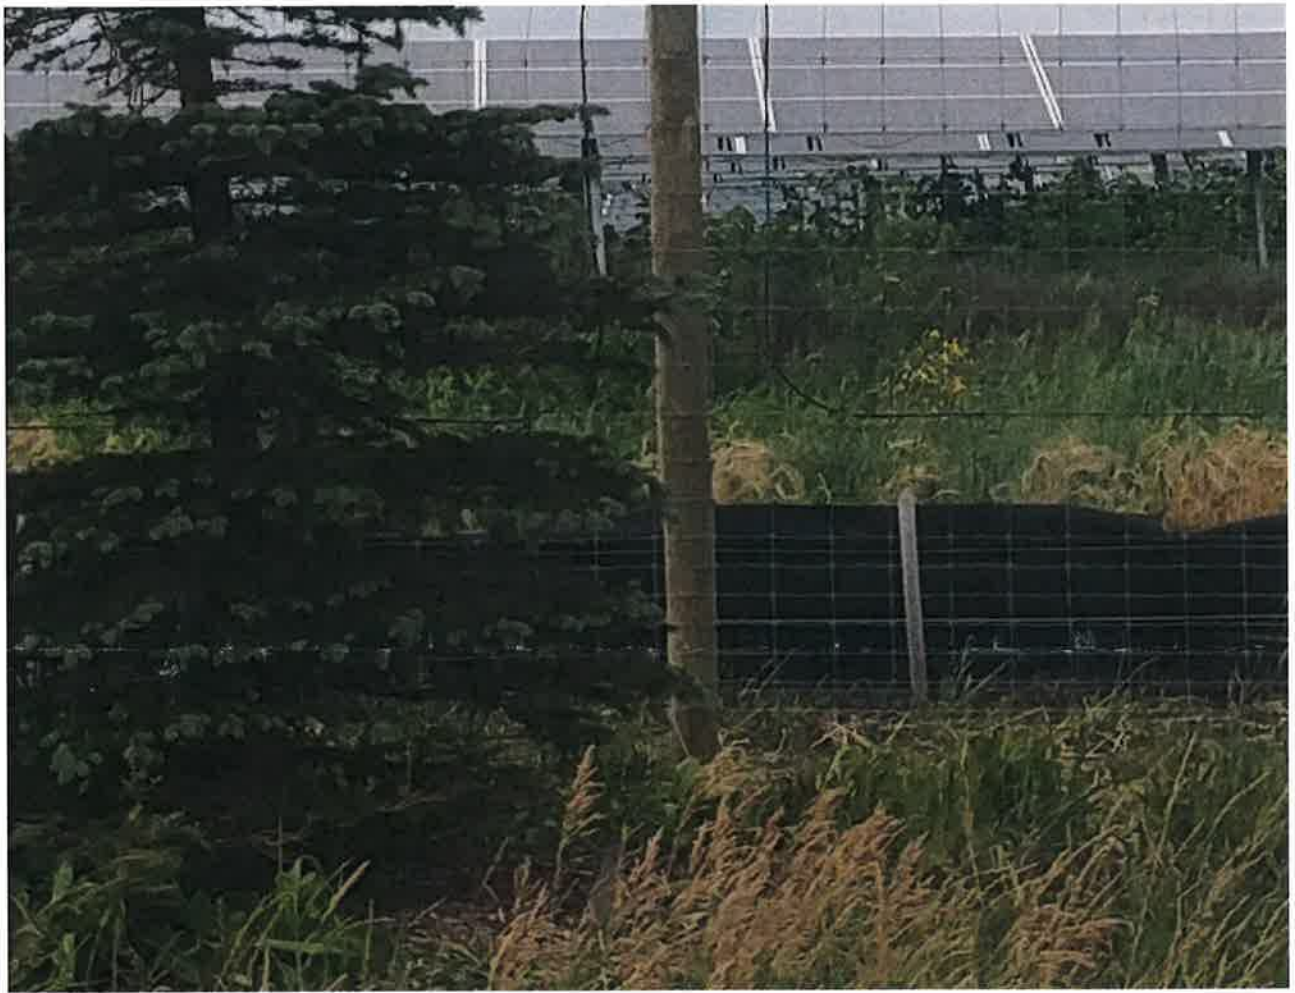
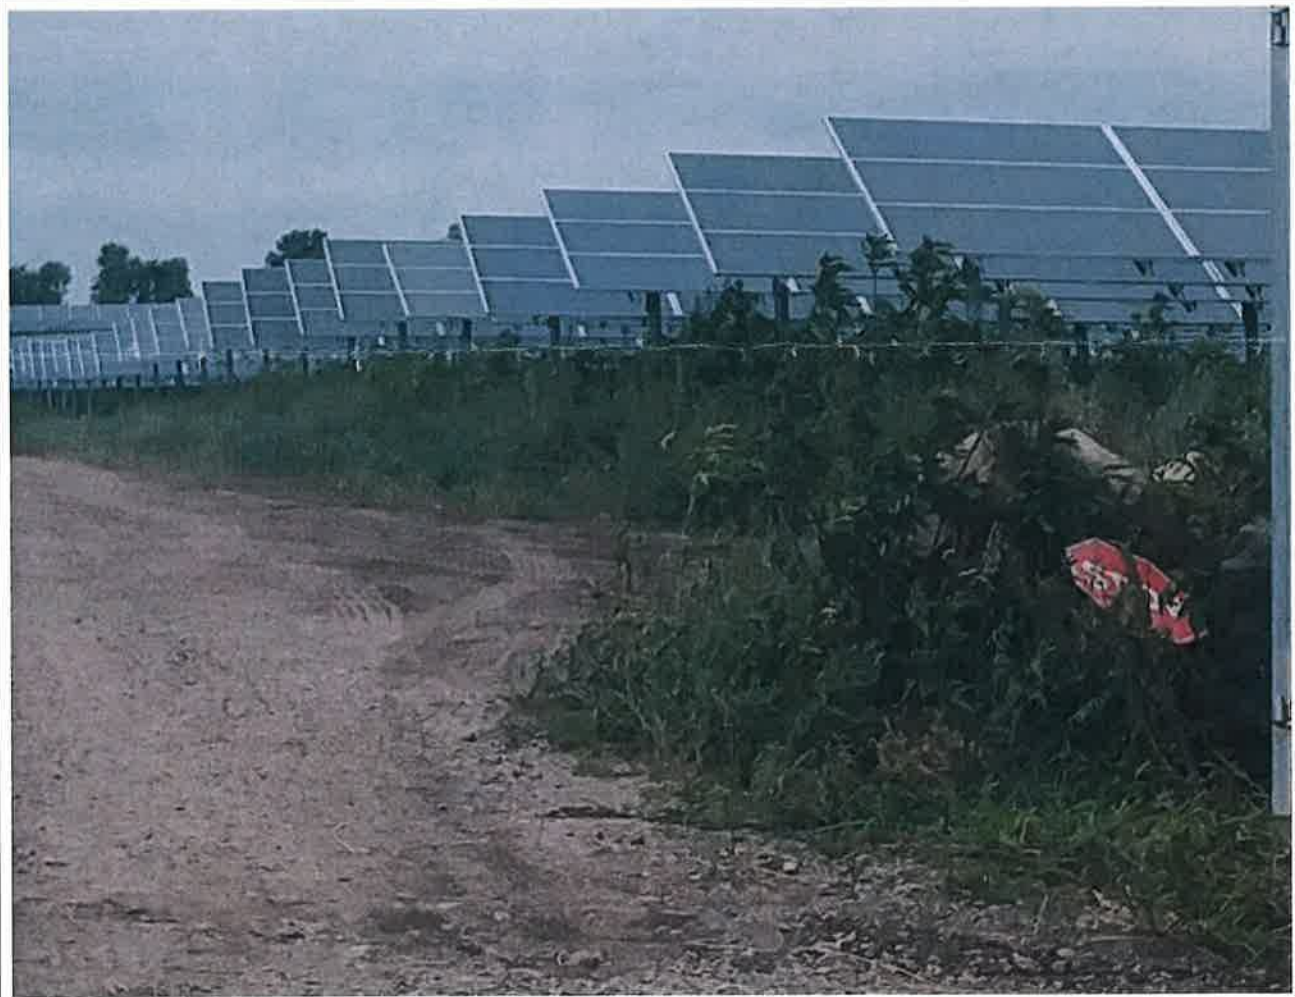
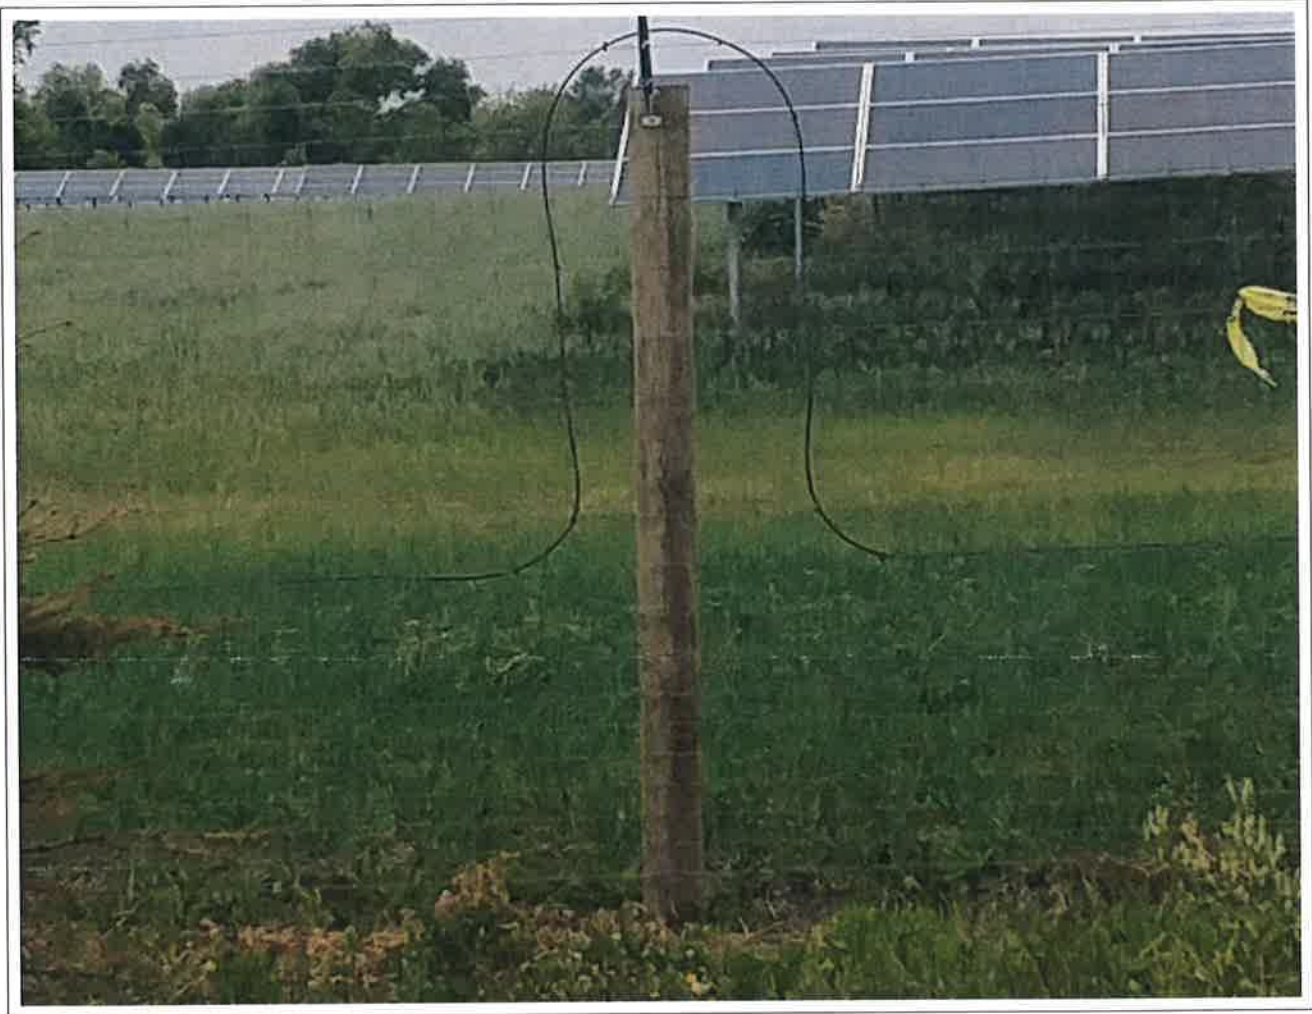
Corinna Township submits this letter in response to the Notice of Comment Period issued on July 13, 2017 regarding the Site Permit issued to Aurora Distributed Solar, LLC. This is specifically in regard to the Annandale site located in Corinna Township.
