SHERCO UNIT 3 OUTAGE  
SUMMARY LISTING

This report details the conditions noted during our inspection of the above unit. The disposition of all deficiencies noted shall be the responsibility of the owner.

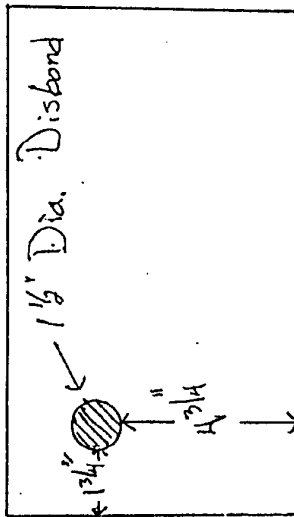
6L

Description or Area	VID	MIT	FIN	TDI	Damage	Location/Comments
Thrust Bearings	X		X	X		Light sporadic disbond around edges of bearings, light pitting.
#1 Bearing	X		X	X		Upper half bearing has randomly isolated 1/8" diameter areas of disbond #4 pad one area and #5 pad twelve areas.
"	X		X	X		Lower half bearing has light sporadic disbond around edges of bearing Pad #6I has a 1.5" diameter area of disbond and pads 7 and 6R have Cracks in babbit, see attached sketch for locations.

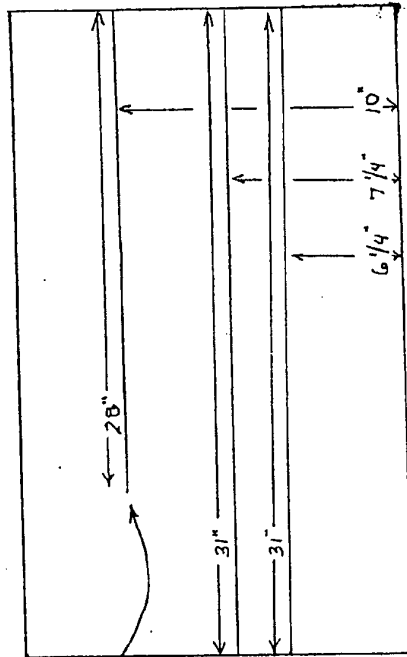
Disbonded 18" wide

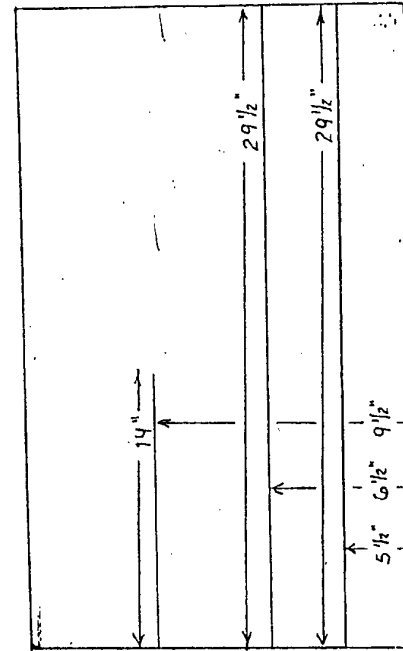
Disbonded 18" wide

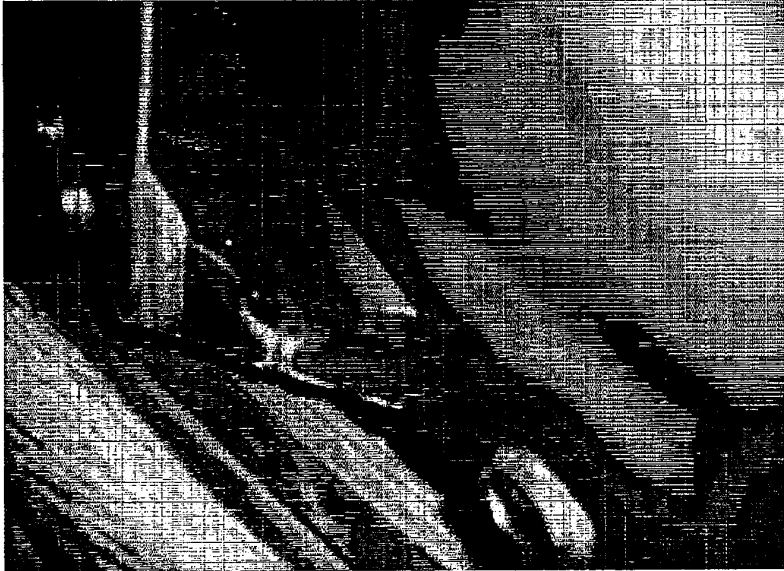
The L-0 blading on both ends show signs of erosion on the Stellite Strips and deposit build up at the blade tips, continuously connected covers, tie knuckles and root radius

The L-0 covers show signs of various degrees of separation between the cover and blade on the discharge side of the leading edge connection (See picture)
