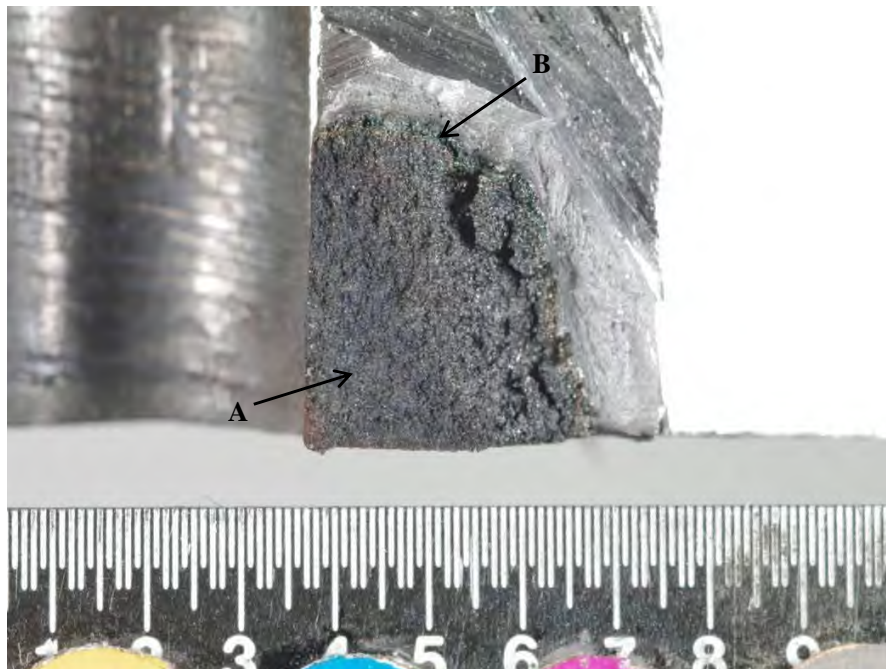
Fig. 190. Photograph of fracture through crack at pin hole in SID 14875 subsegment "C4b" showing areas examined by scanning electron microscope.

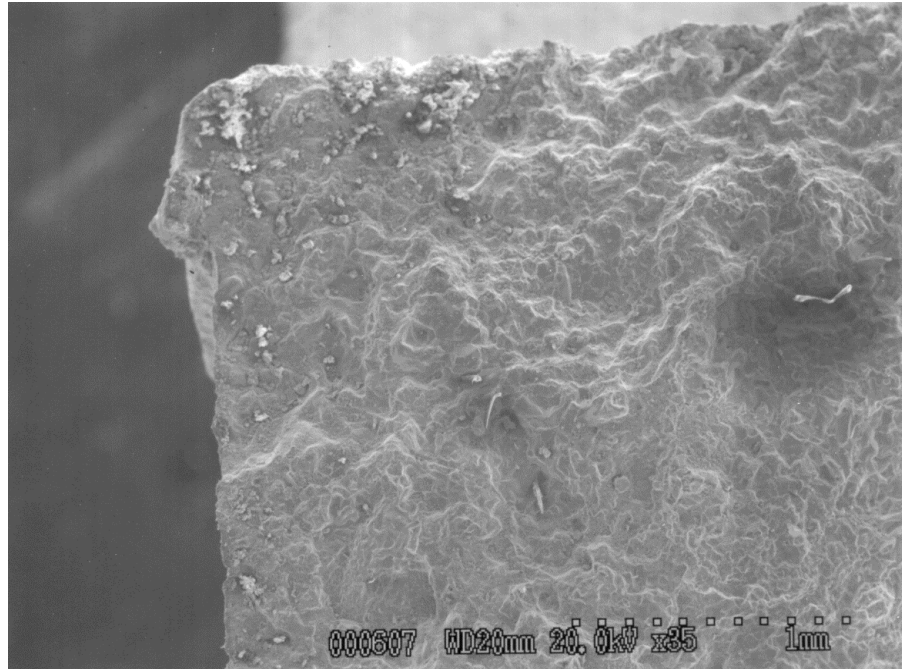
Fig. 191. Scanning electron microscope fractograph of SID 14875 "C4b" Area "A" shown in Fig. 190.

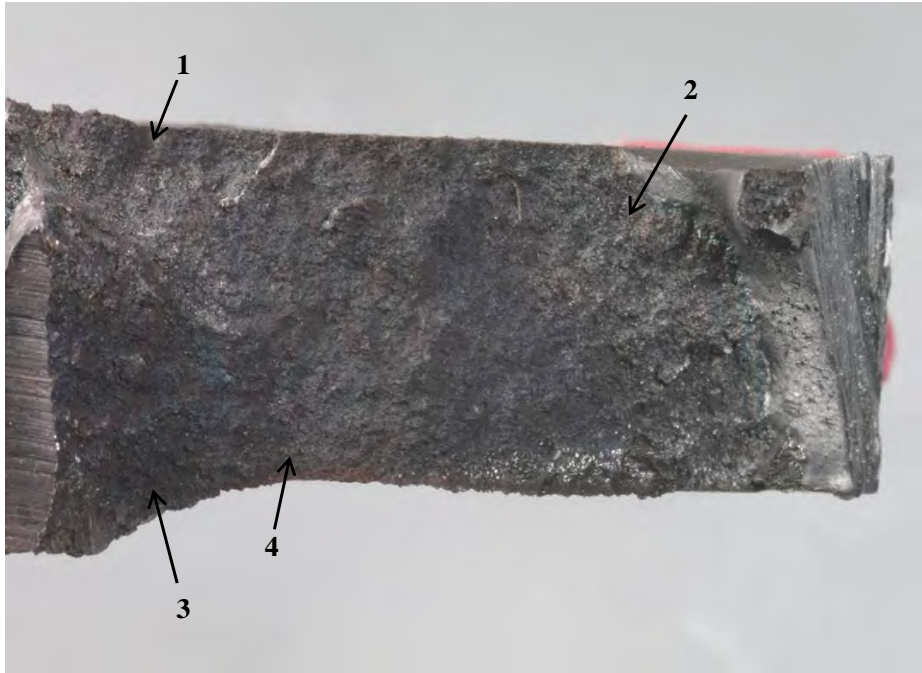
Fig. 196. Close-up photograph of fracture through crack in SID 14875 subsegment "C4d" prior to cleaning, showing areas examined by scanning electron microscopy.

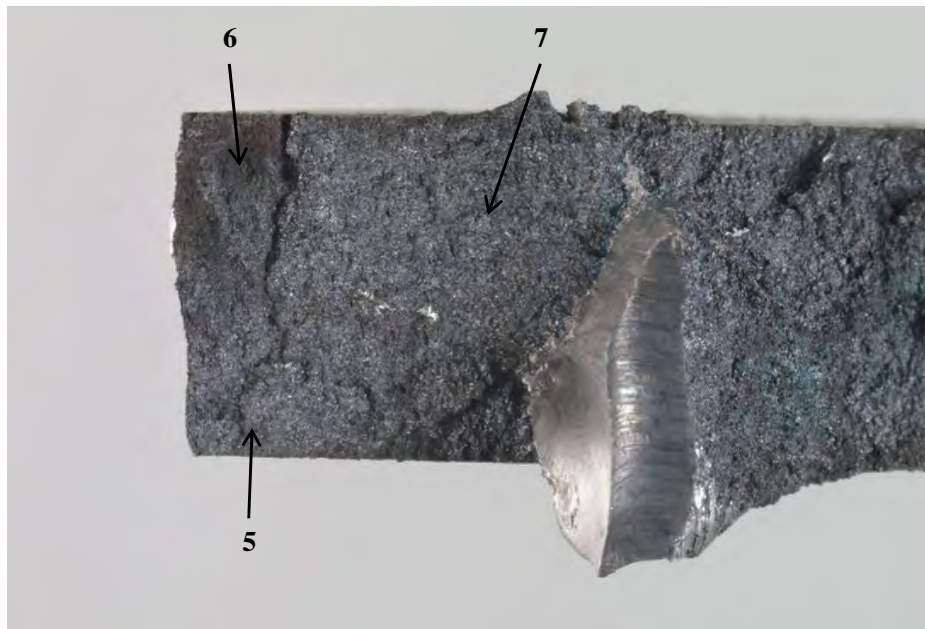
Fig. 197. Photograph of fracture through crack in SID 14875 subsegment "C4d", prior to cleaning, showing areas examined by Scanning electron microscopy.

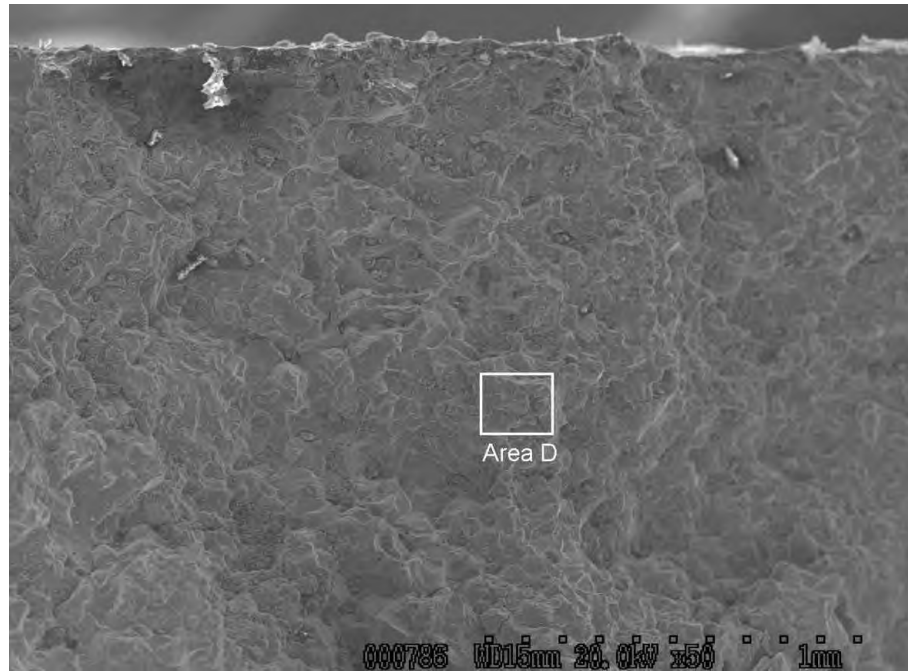
Fig 198. Scanning electron fractograph of crack surface from SID 14875 subsegment "C4d" Area "1" showing EDS area "D".

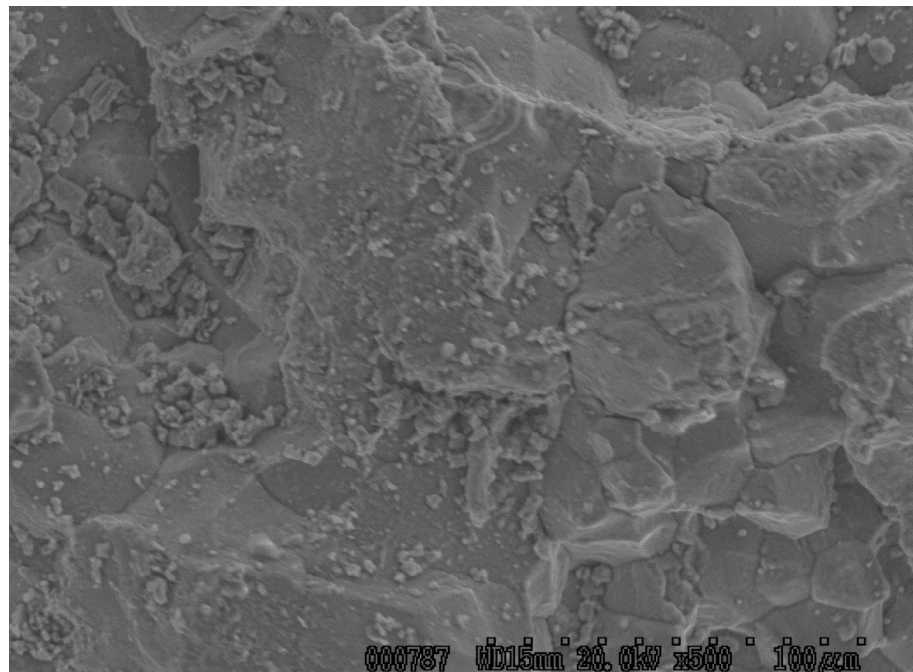
Fig 199. Scanning electron fractograph of crack surface from SID 14875 subsegment "C4d" Area "1".

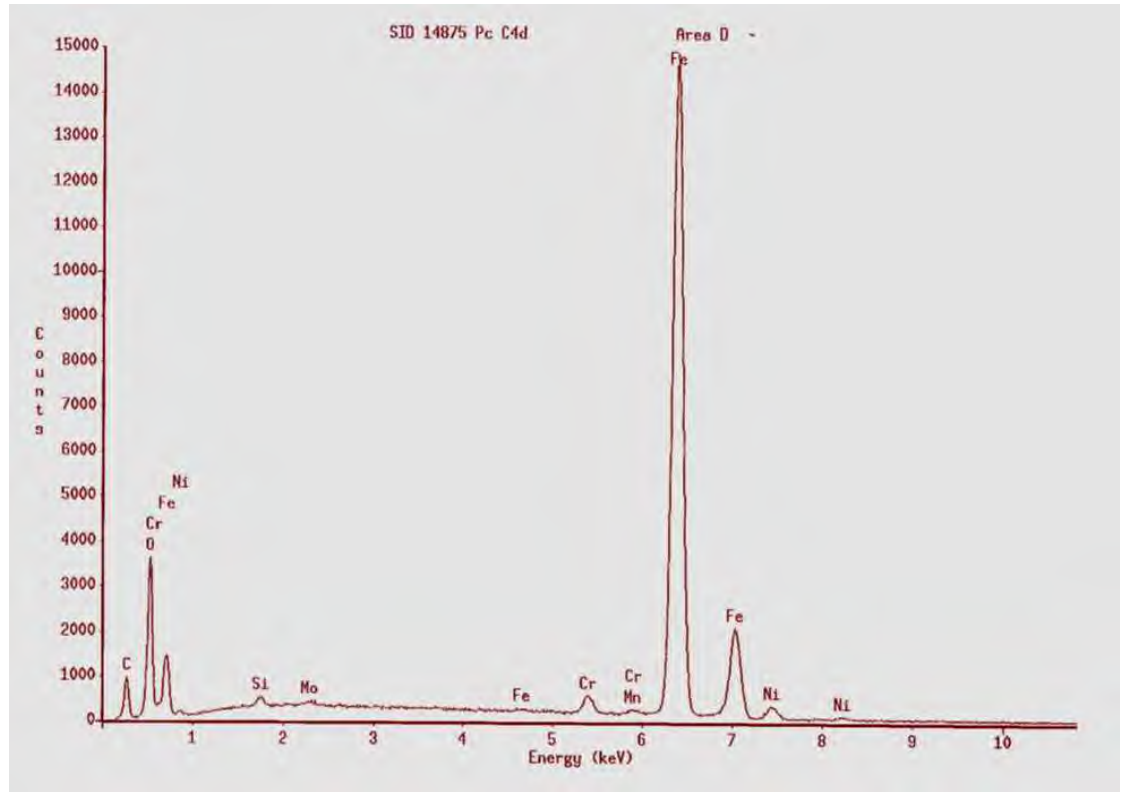
Fig. 200. X-Ray Energy Dispersive Spectrograph of SID 14875 "C4d" Area "1" at area D shown in Fig. 198 .

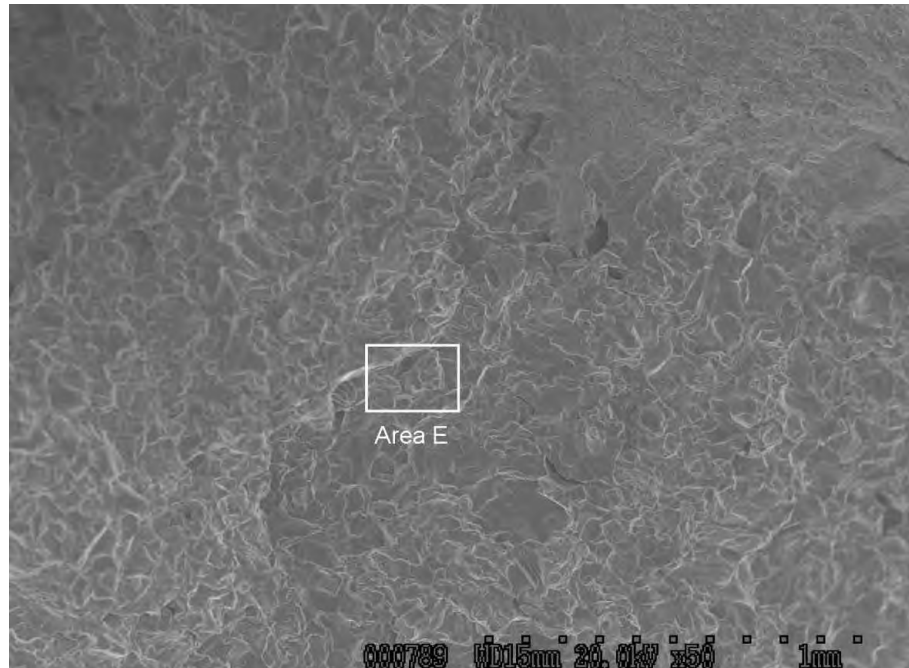
Fig. 201. Scanning electron fractograph of crack surface from SID 14875 subsegment "C4d" Area "2" showing EDS area "E".

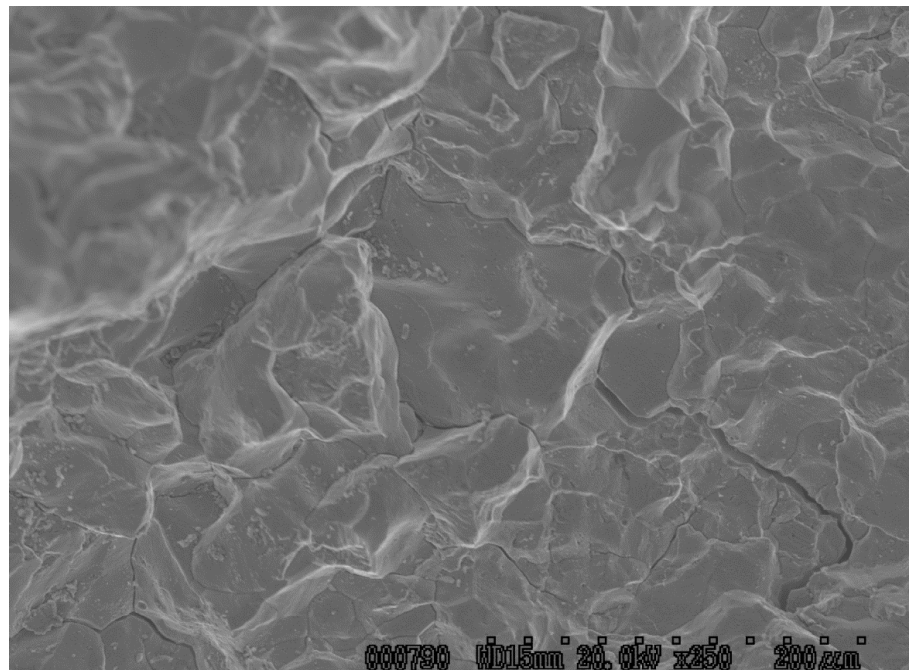
Fig 202. Scanning electron fractograph of crack surface from SID 14875 subsegment "C4d" Area "2".

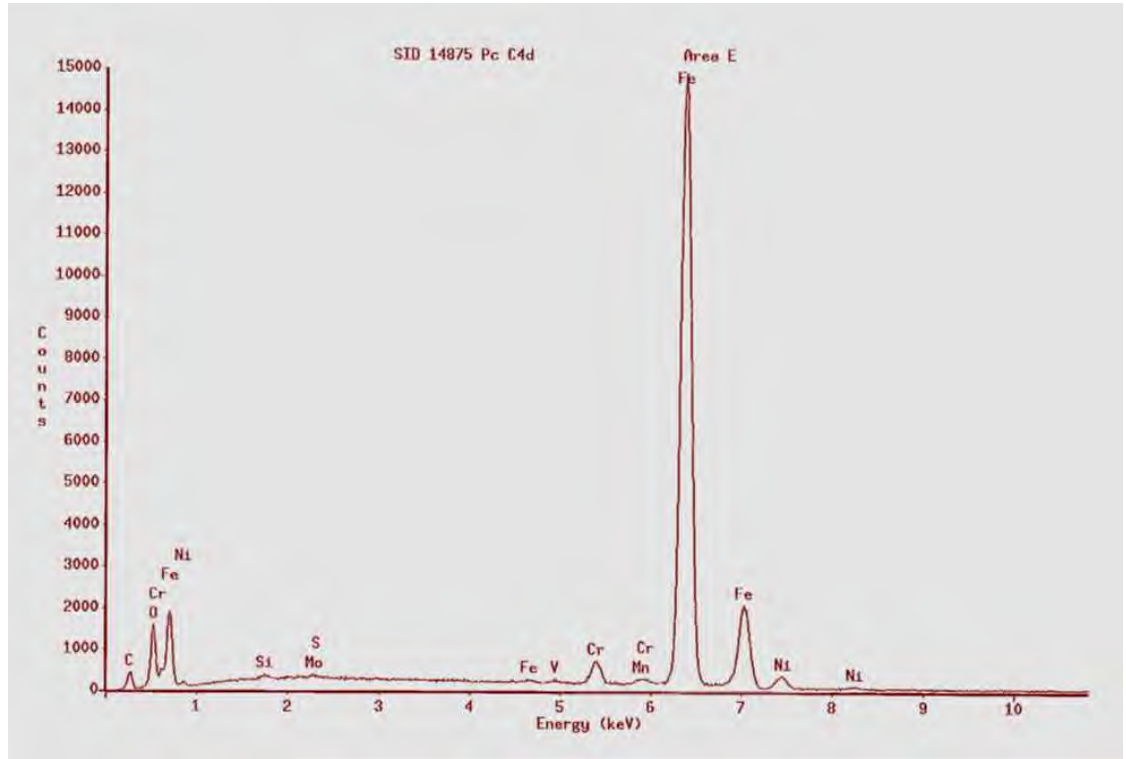
Fig. 203. X-Ray Energy Dispersive Spectrograph of SID 14875 "C4d" Area "2" at Area "E" shown in Fig. 201.

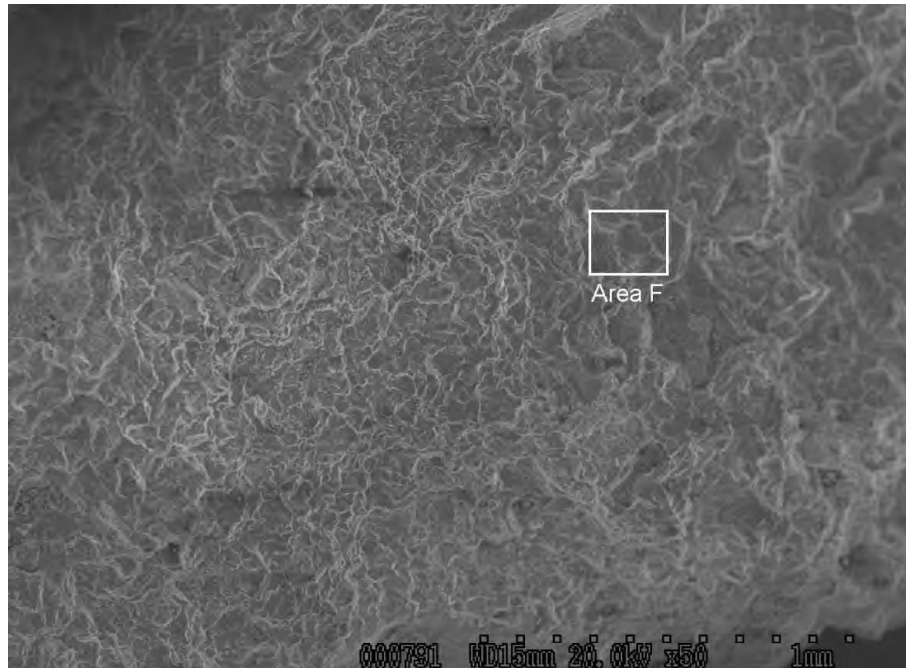
Fig. 204. Scanning electron fractograph of crack surface from SID 14875 subsegment "C4d" Area "3" showing EDS area "F".

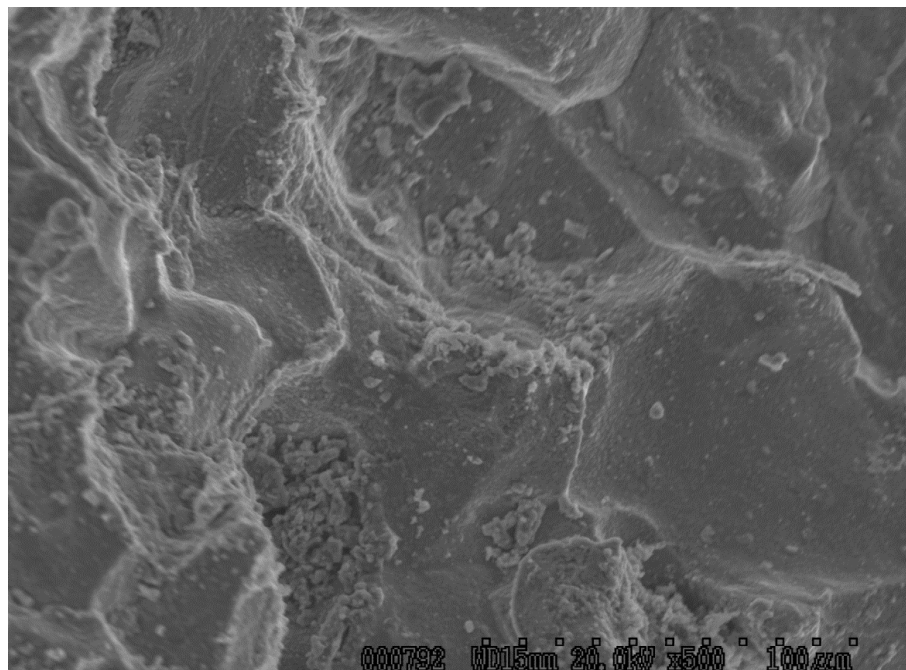
Fig. 205. Scanning electron fractograph of crack surface from SID 14875 subsegment "C4d" Area "3".

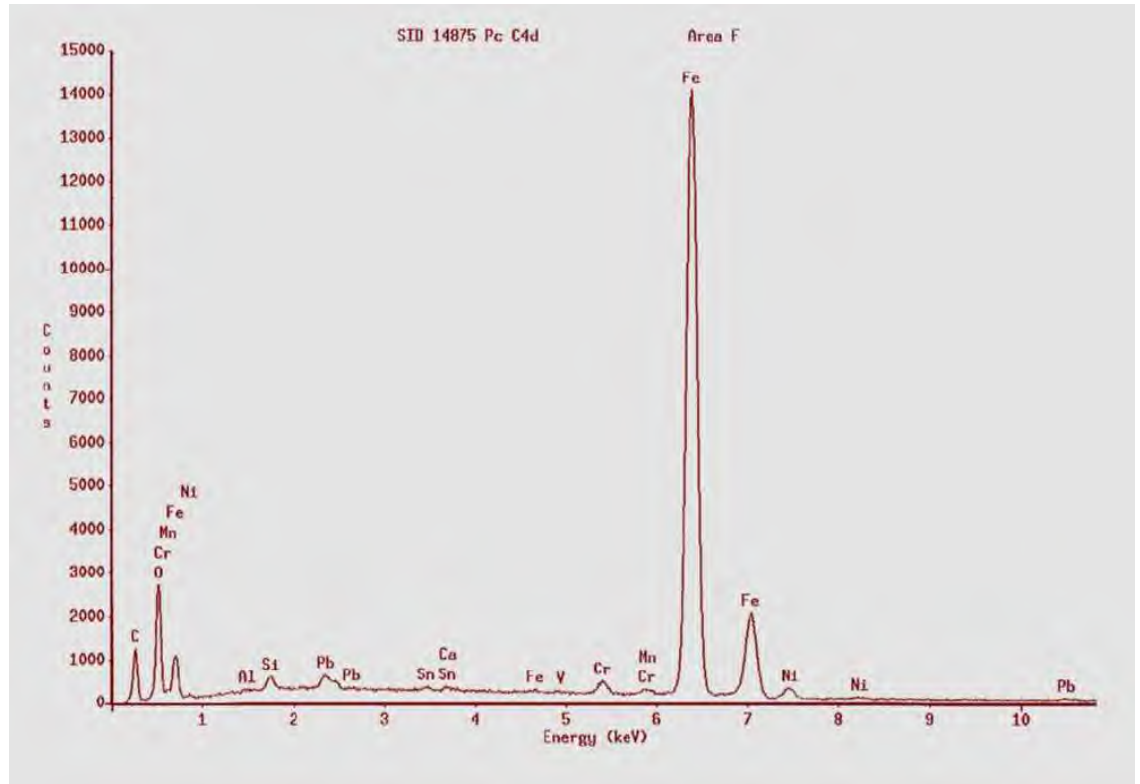
Fig. 206 X-Ray Energy Dispersive Spectrograph of SID 14875 "C4d" Area "3" at area "F" shown in Fig. 204.

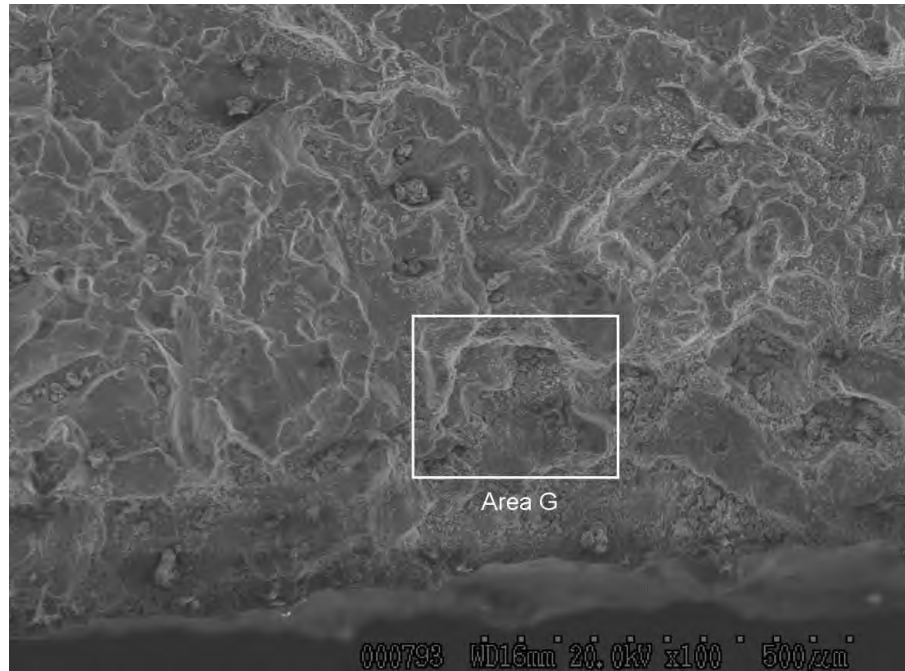
Fig. 207. Scanning electron fractograph of crack surface from SID 14875 subsegment "C4d" Area "4" showing EDS area "G".

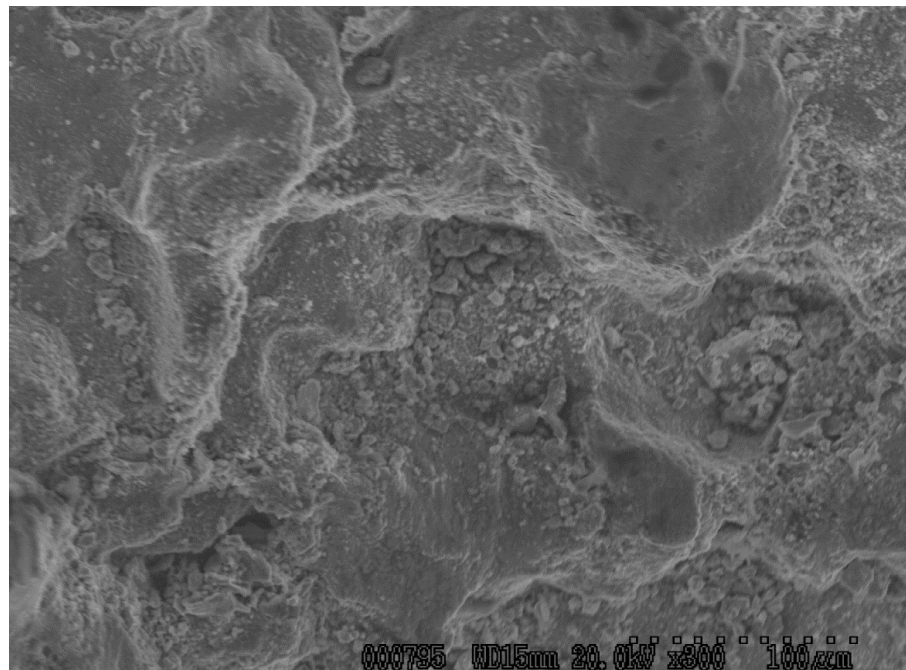
Fig. 208. Scanning electron fractograph of crack surface from SID 14875 subsegment "C4d" Area "4".

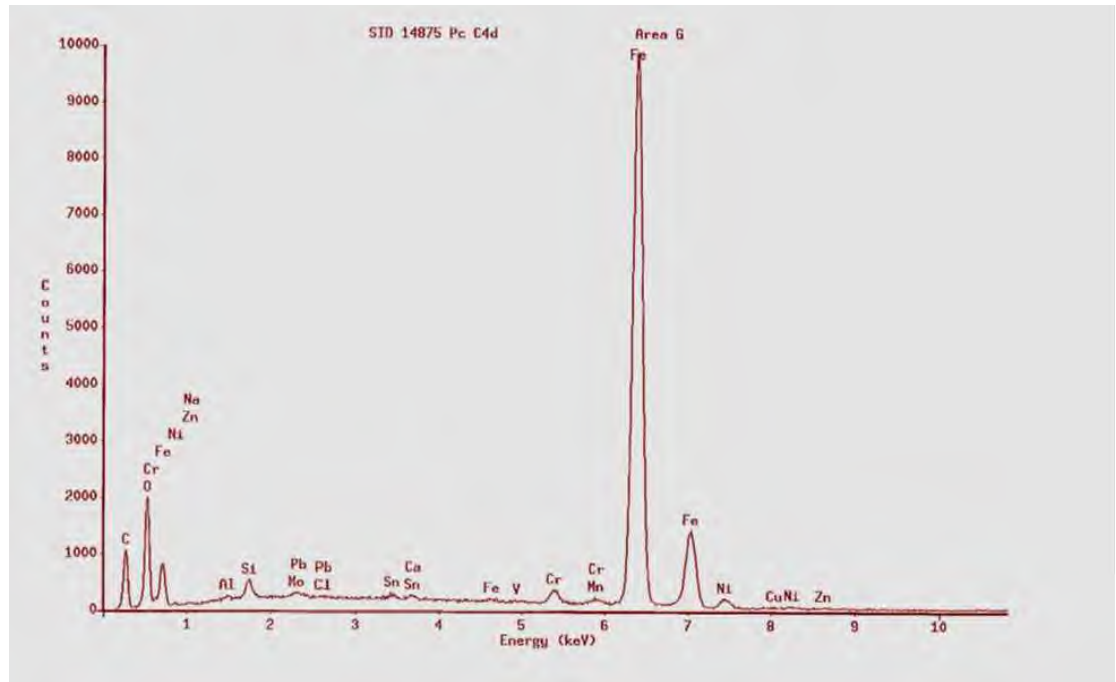
Fig. 209. X-Ray Energy Dispersive Spectrograph of SID 14875 "C4d" Area "4" at area "F" shown in Fig. 207.

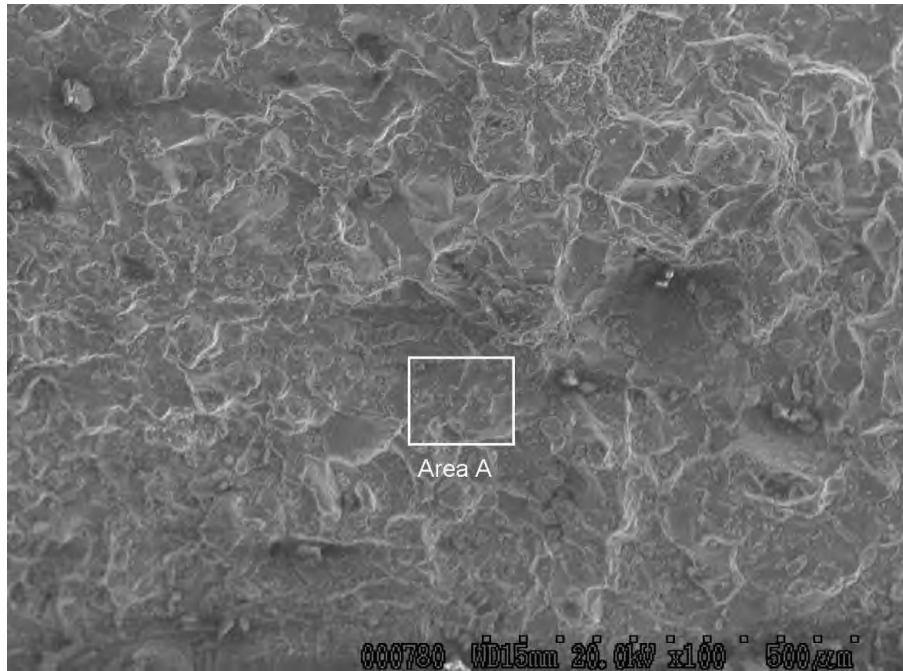
Fig. 210. Scanning electron fractograph of crack surface from SID 14875 subsegment "C4d" Area "5" showing EDS area "A".

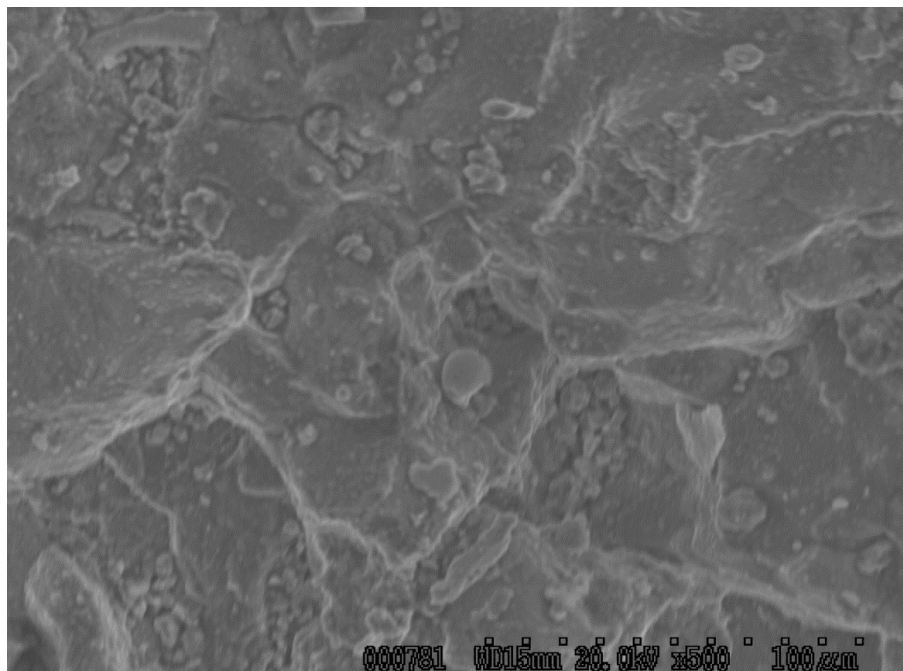
Fig. 211. Scanning electron fractograph of crack surface from SID 14875 subsegment "C4d" Area "5".

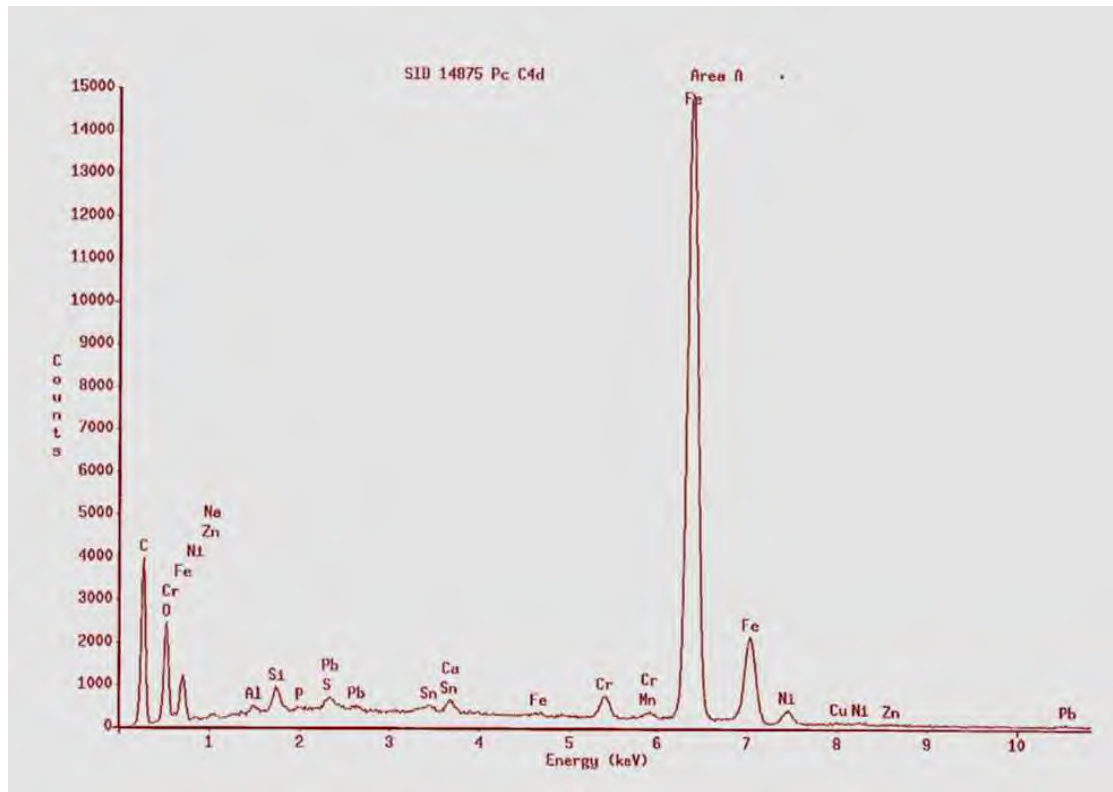
Fig. 212. X-Ray Energy Dispersive Spectrograph of SID 14875 "C4d" Area "5" at area "A" shown in Fig. 210.

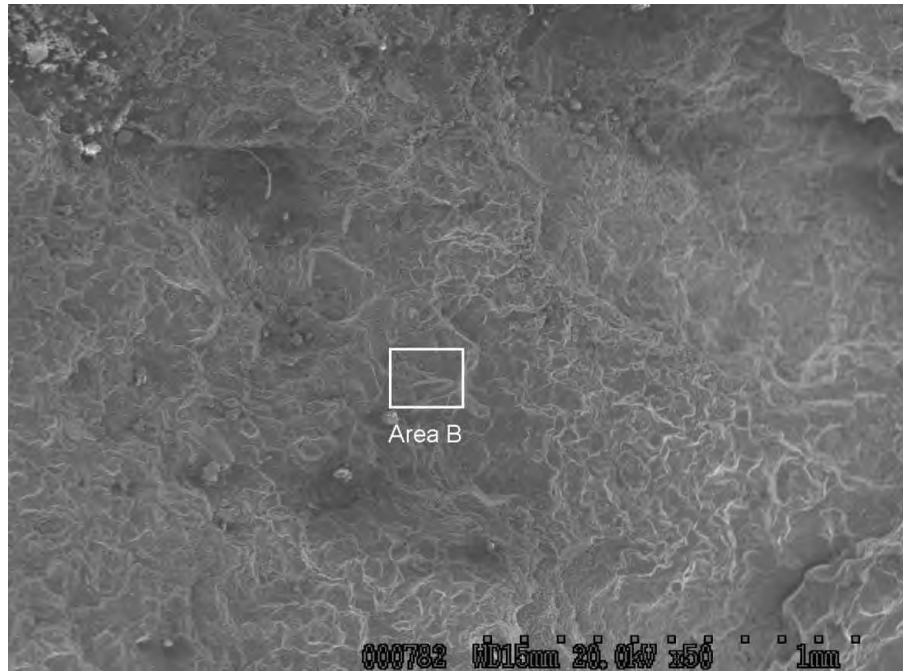
Fig. 213. Scanning electron fractograph of crack surface from SID 14875 subsegment "C4d" Area "6" showing EDS area "B".

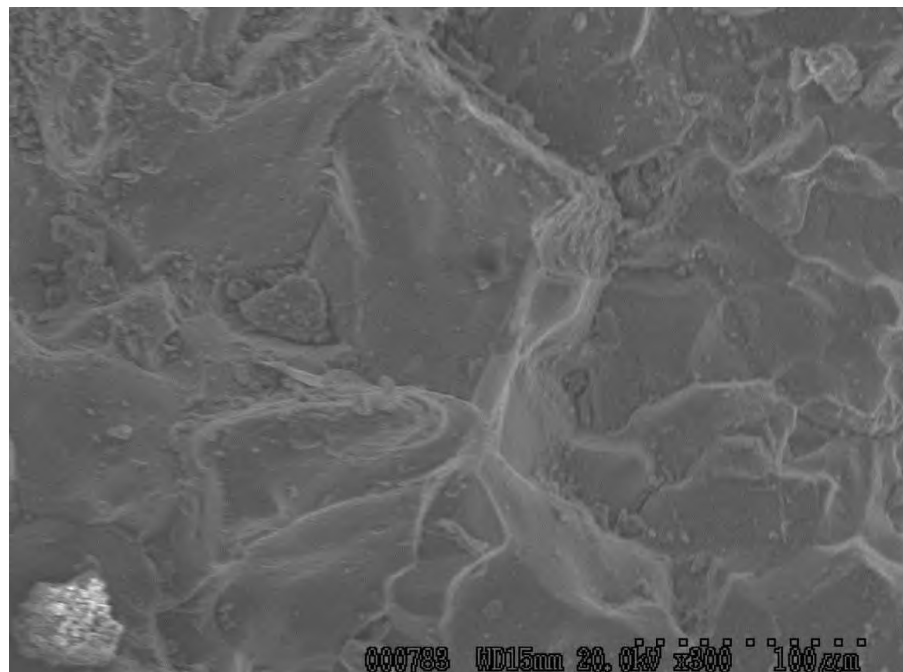
Fig. 214. Scanning electron fractograph of crack surface from SID 14875 subsegment "C4d" Area "6".

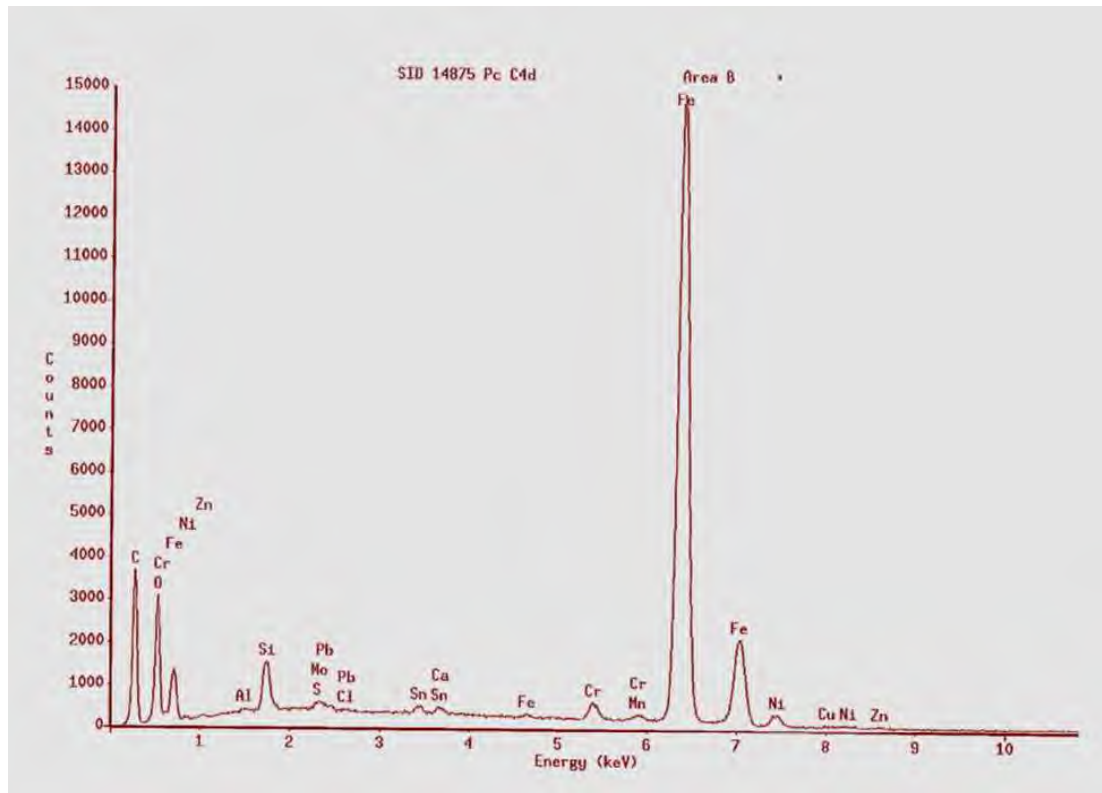
Fig. 215. X-Ray Energy Dispersive Spectrograph of SID 14875 "C4d" Area "6" at area "B" shown in Fig. 213.

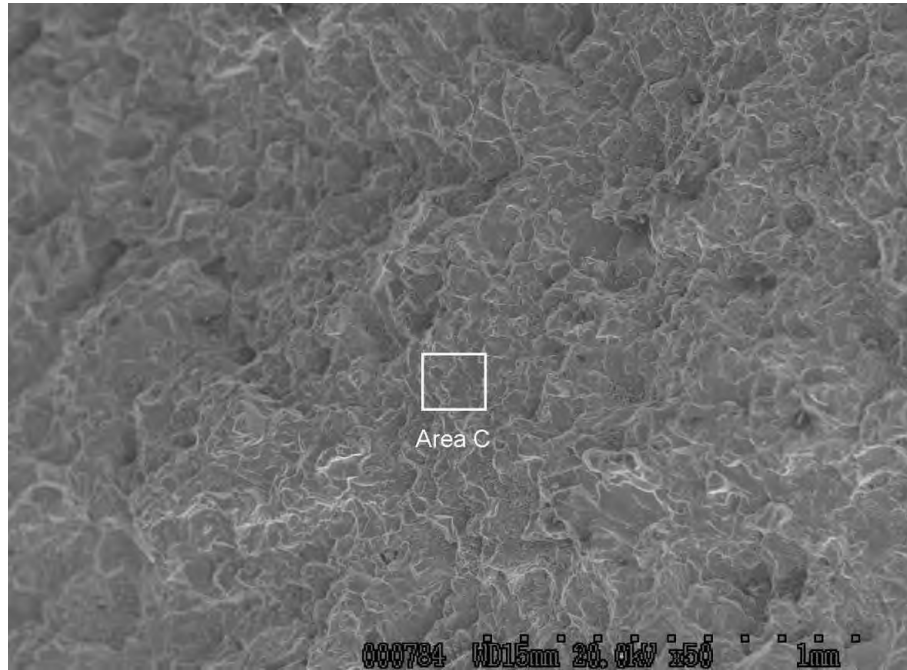
Fig 216. Scanning electron fractograph of crack surface from SID 14875 subsegment "C4d" Area "7" showing EDS area "C".

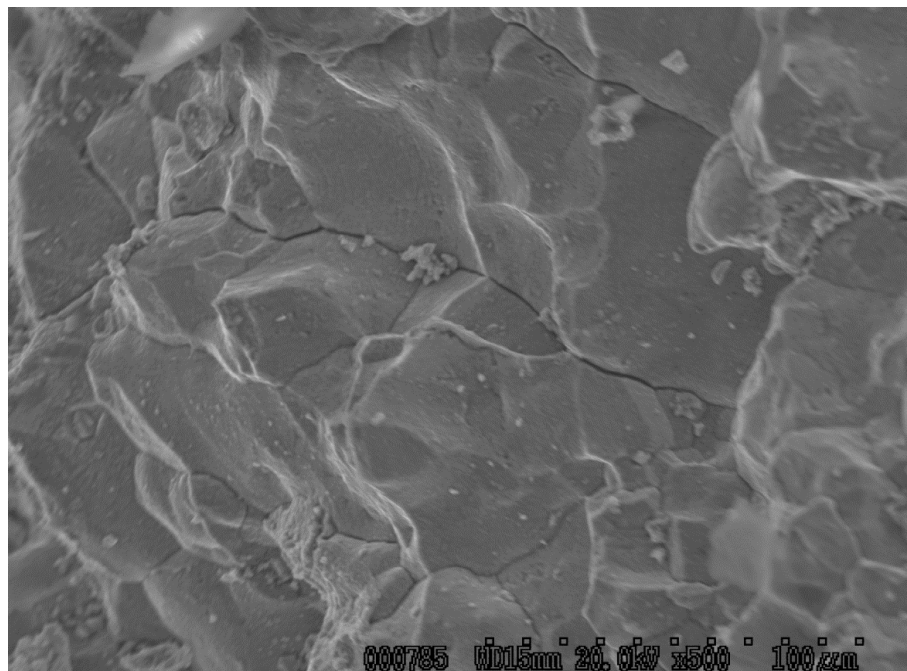
Fig. 217. Scanning electron fractograph of crack surface from SID 14875 subsegment "C4d" Area "7".

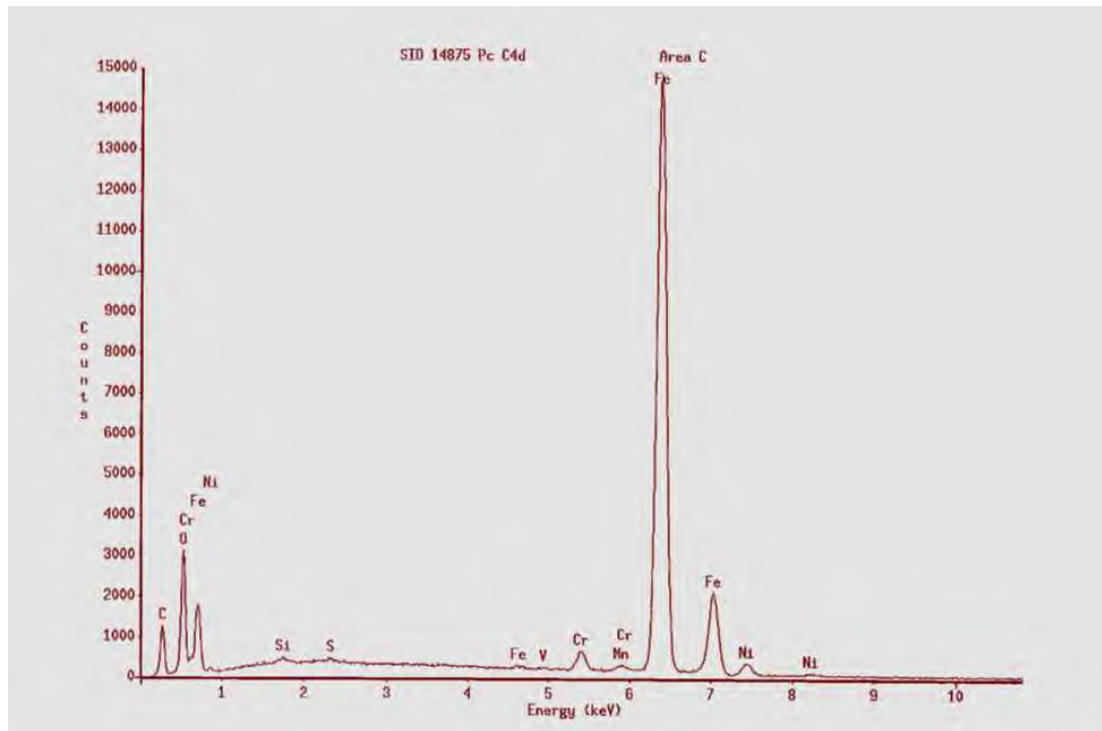
Fig. 218. X-Ray Energy Dispersive Spectrograph of SID 14875 "C4d" Area "7" at area "C" shown in Fig. 216.

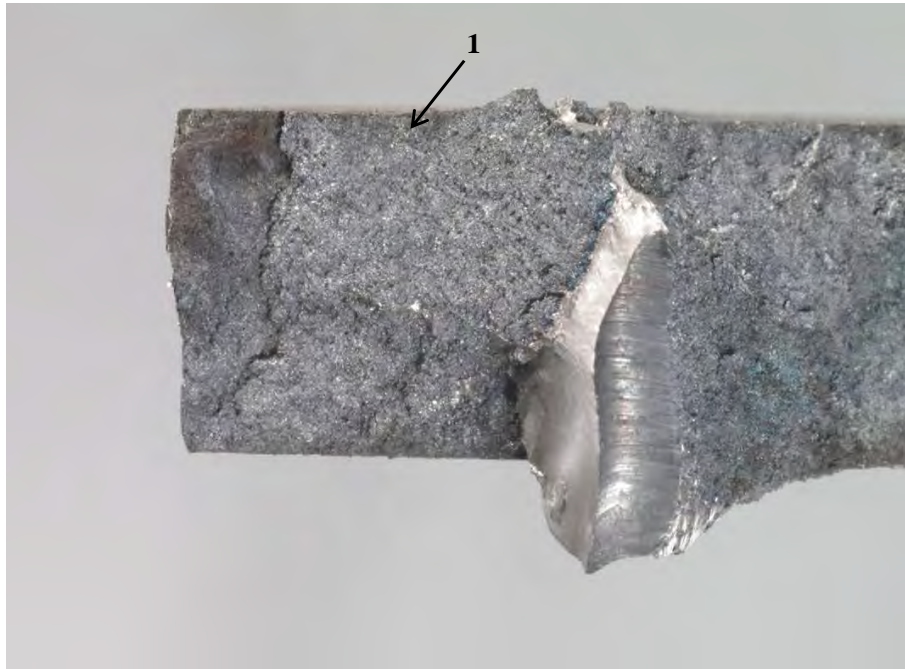
Fig. 219. Photograph of SID 14875 "C4d" fracture, after cleaning, showing areas examined by Scanning Electron Microscopy.

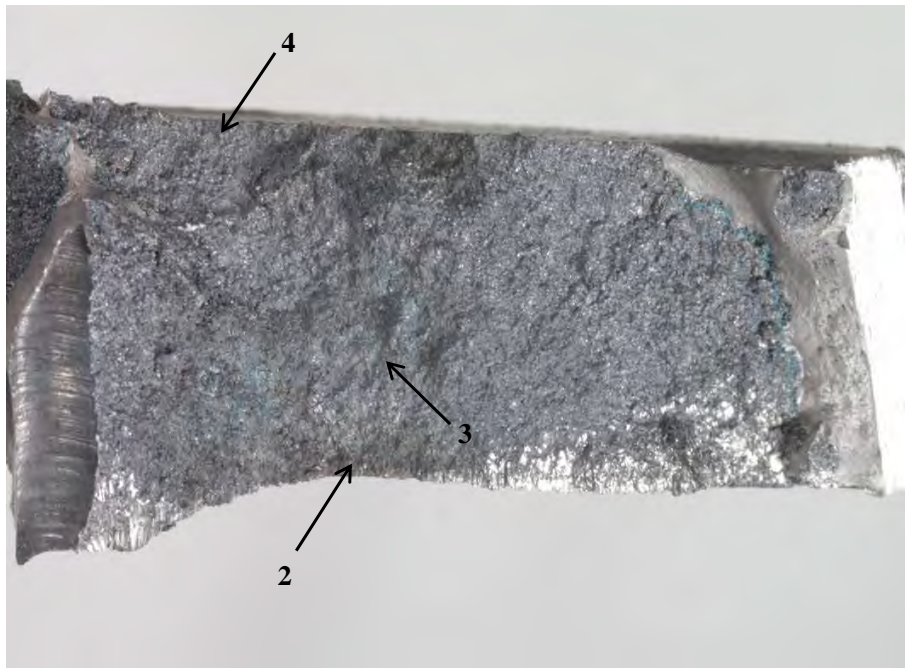
Fig. 220. Photograph of SID 14875 "C4d" fracture, after cleaning, showing areas examined by Scanning Electron Microscopy.

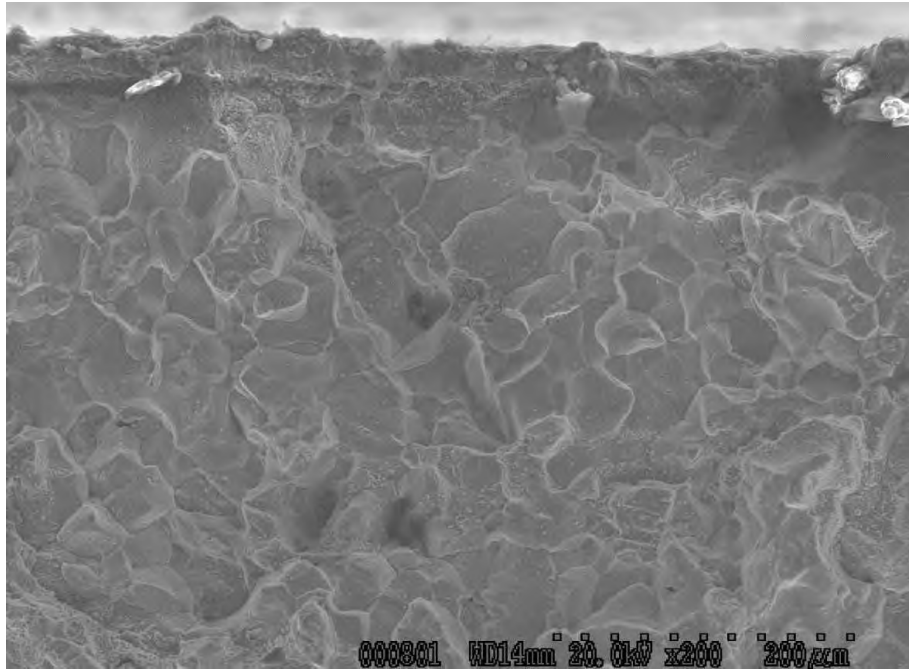
Fig. 221. Scanning electron fractograph of crack surface from SID 14875 subsegment "C4d" Area "1".

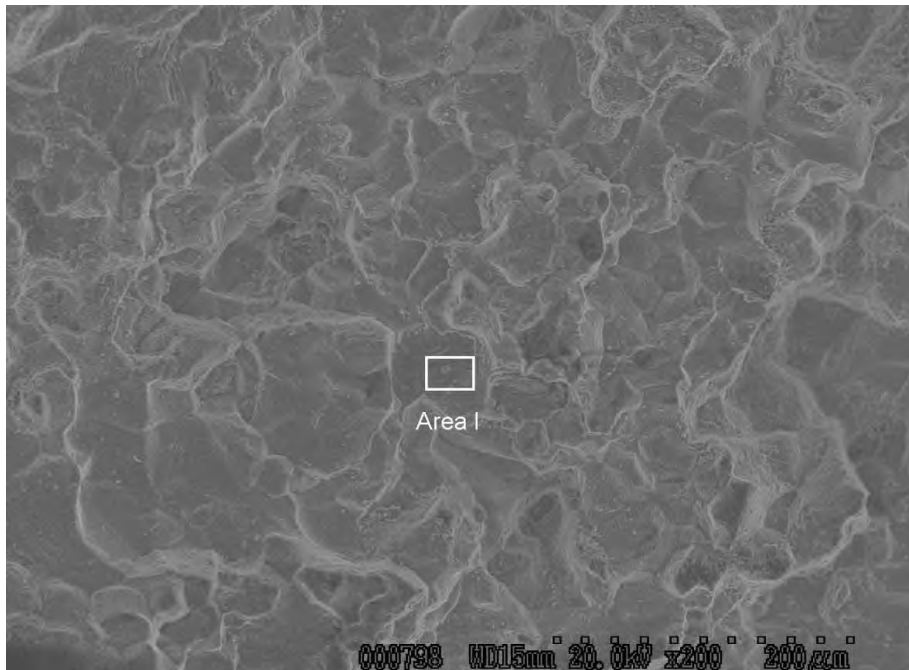
Fig. 222. Scanning electron fractograph of crack surface from SID 14875 subsegment "C4d" Area "2" showing EDS area "I".

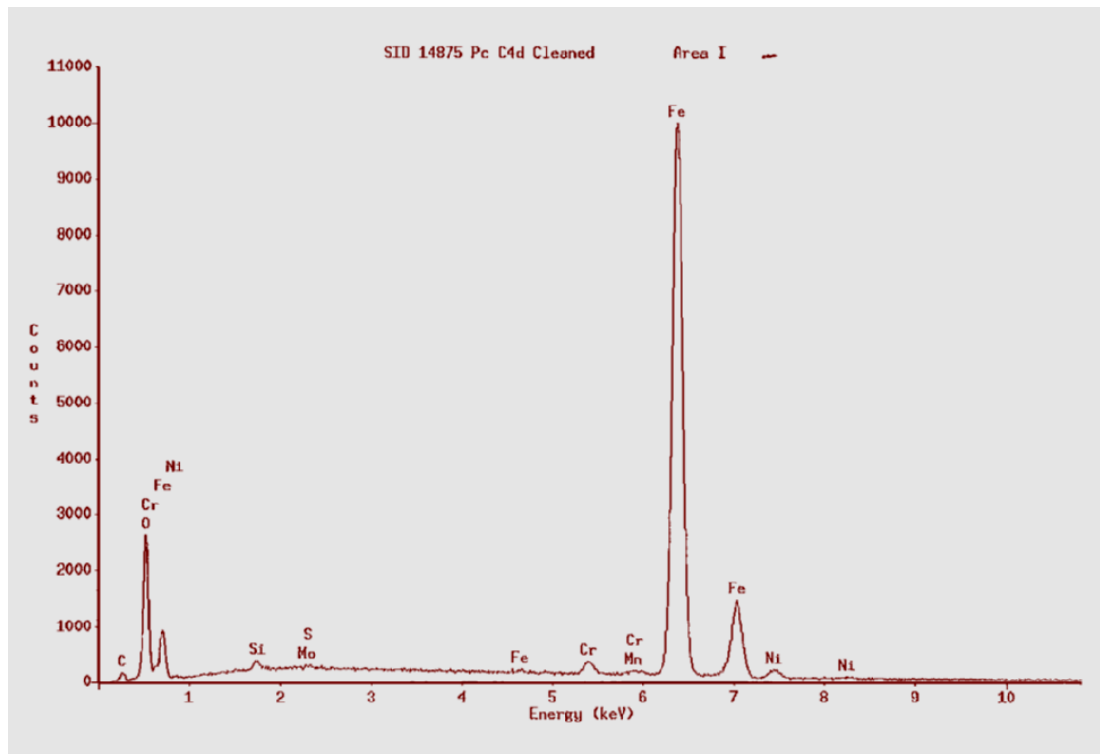
Fig. 223. X-Ray Energy Dispersive Spectrograph of SID 14875 "C4d" Area "2" at area "I" shown in Fig. 222.

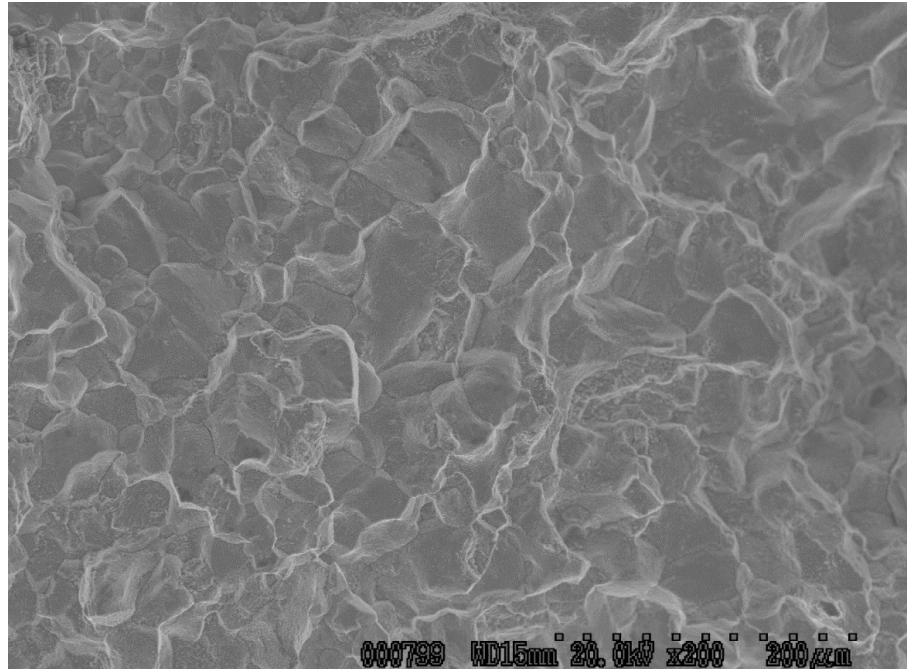
Fig. 224. Scanning electron fractograph of crack surface from SID 14875 subsegment "C4d" Area "3".

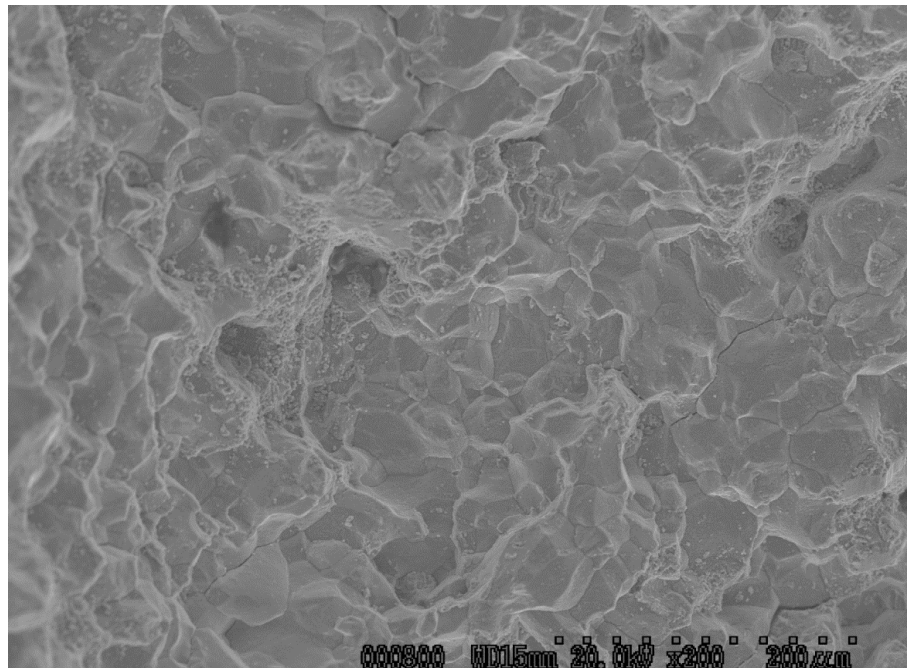
Fig. 225. Scanning electron fractograph of crack surface from SID 14875 subsegment "C4d" Area "4".

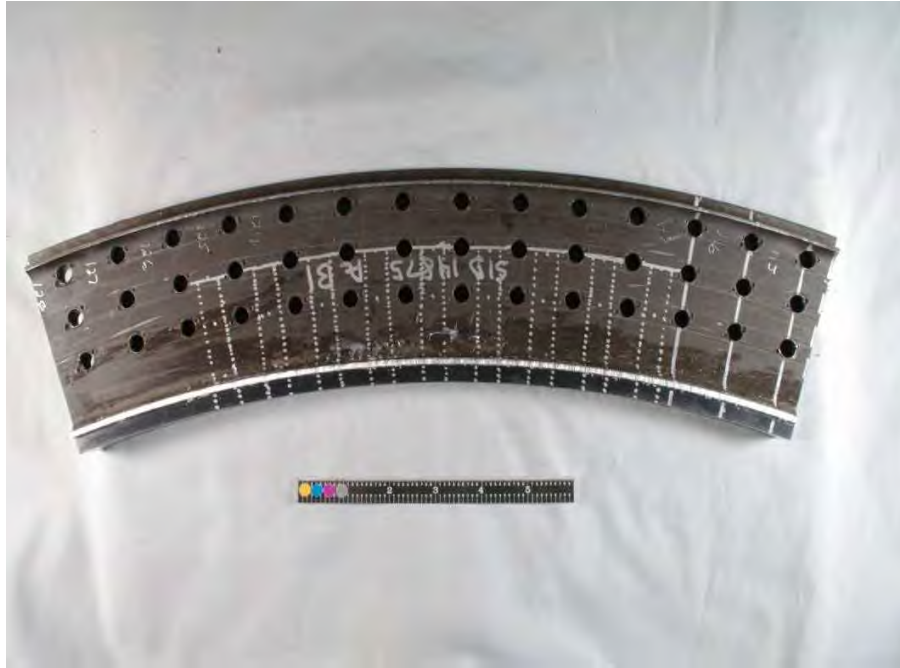
Fig. 226. SID 14875 subsegment "B1" showing layout of mechanical test coupons.
