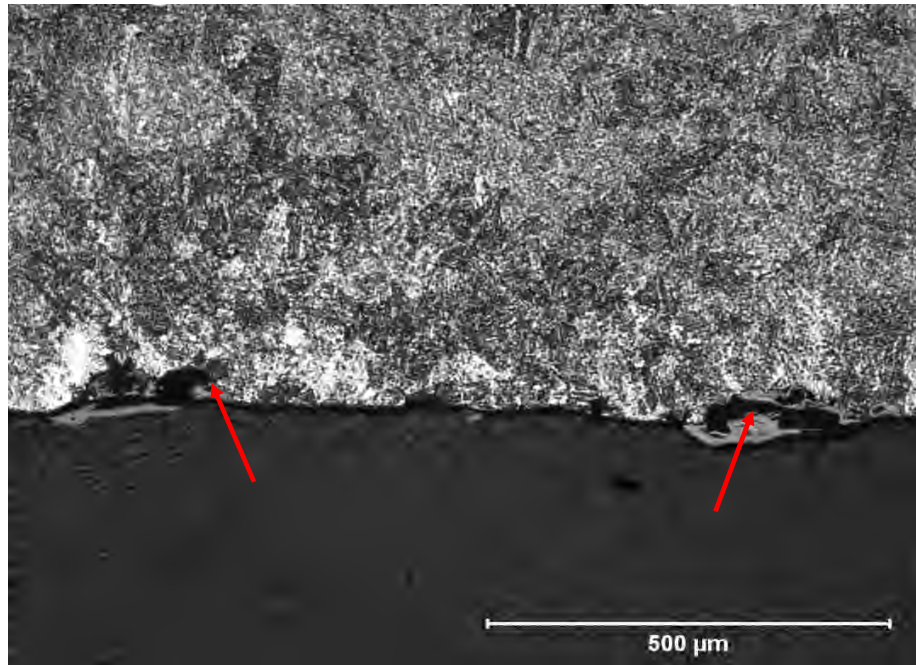
Fig. 235. Photomicrograph of met section L349101. Corrosion pits denoted by arrows.

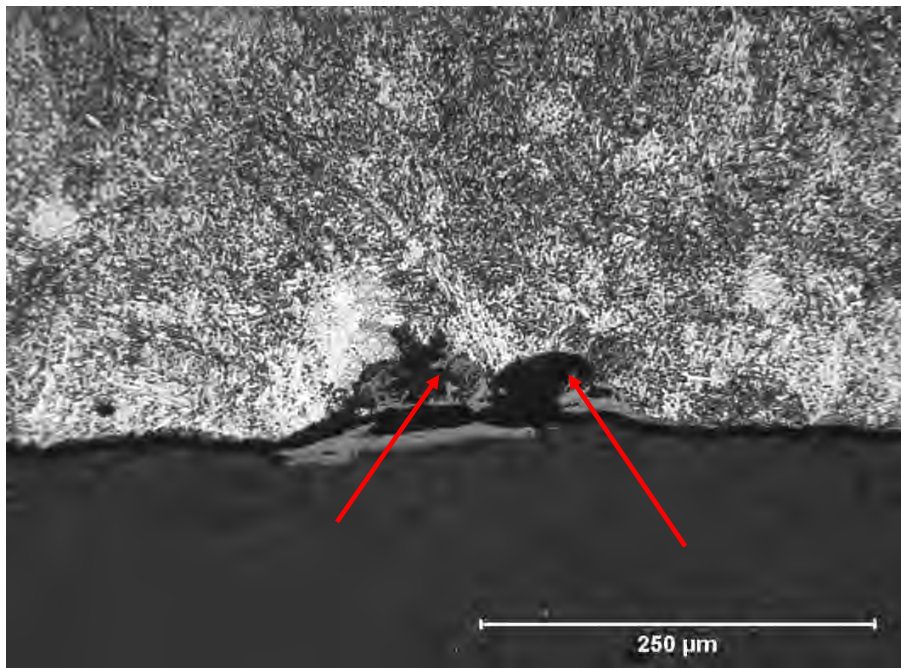
Fig. 236. Photomicrograph of met section L349101. Corrosion pits denoted by arrows.

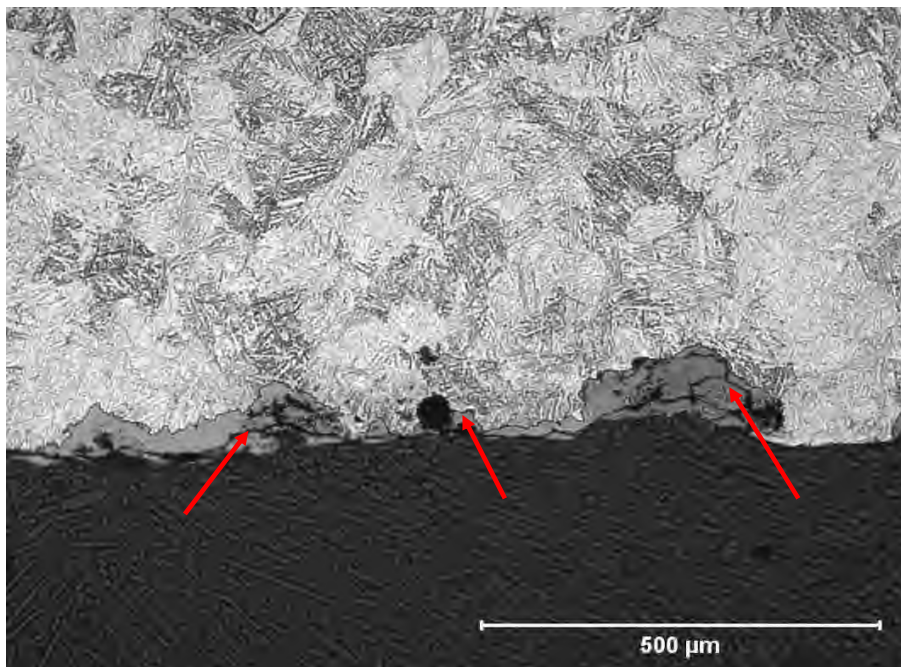
Fig. 237. Photomicrograph of met section L349101. Corrosion pits denoted by arrows.

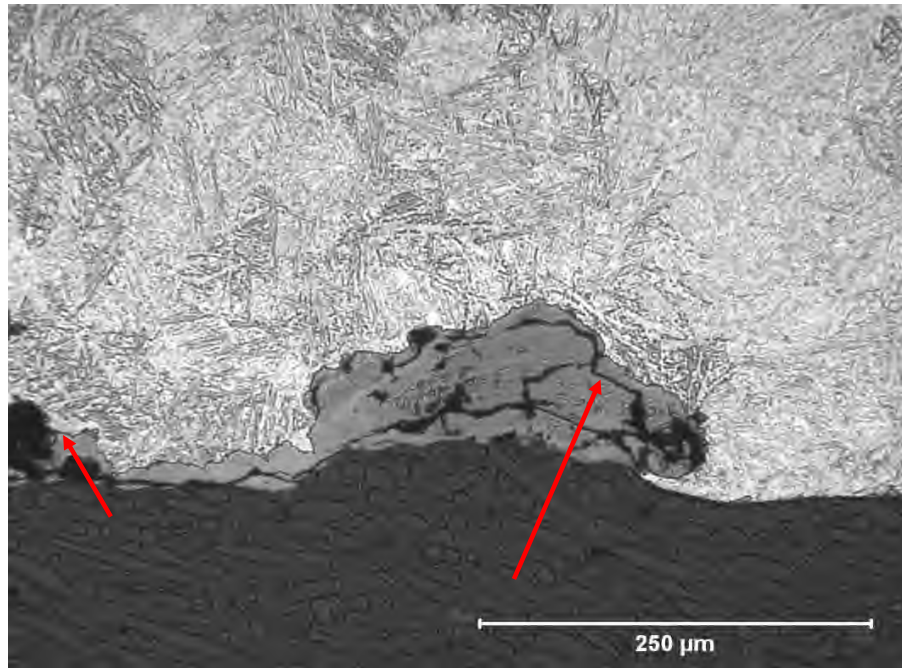
Fig. 238. Photomicrograph of met section L349101. Corrosion pits denoted by arrows.

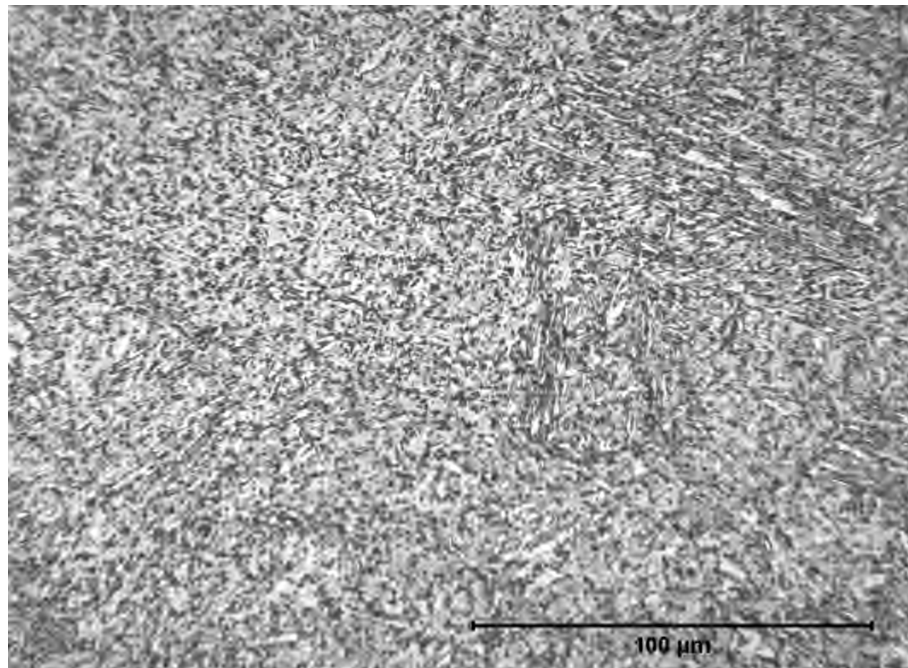
Fig. 239. Photomicrograph of met section L349101.

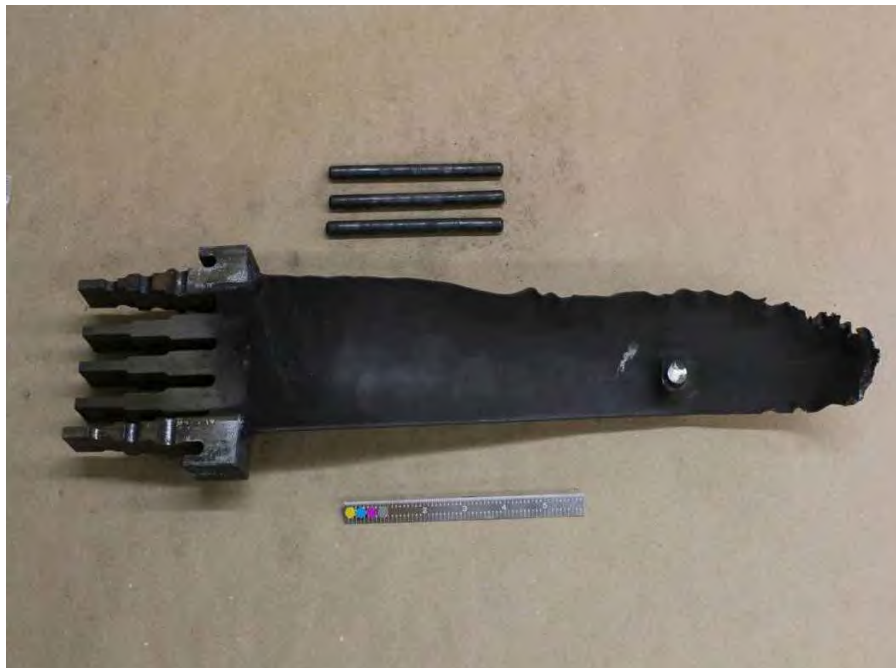
Fig. 277. Photograph of low pressure turbine "B" turbine end L-1 blade removed at the GE Repair Facility in Chicago, IL and received for forensic examination.

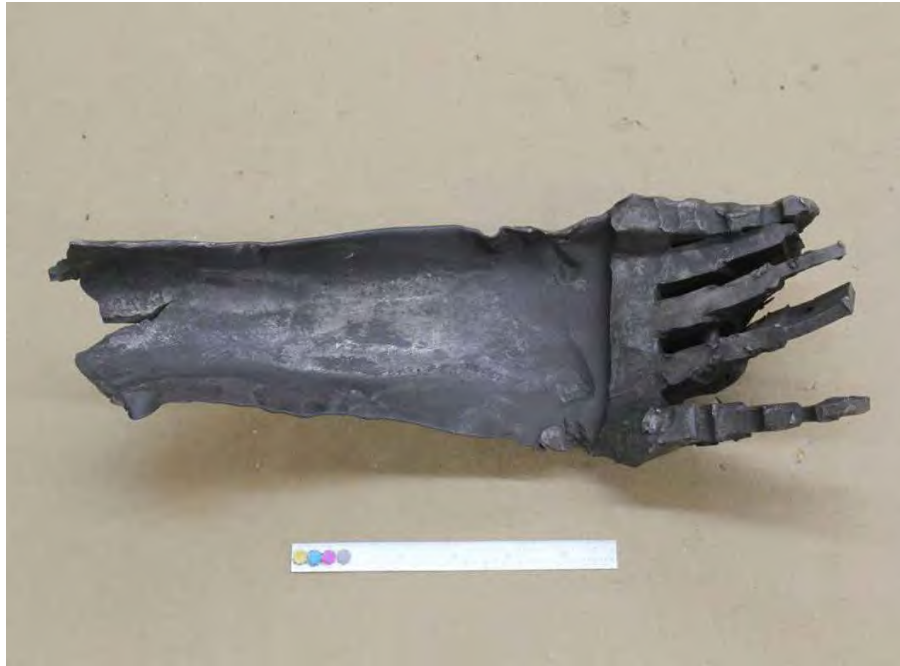
Fig. 278. Photograph of low pressure turbine "B" turbine end L-1 blade which had fractured through the airfoil.

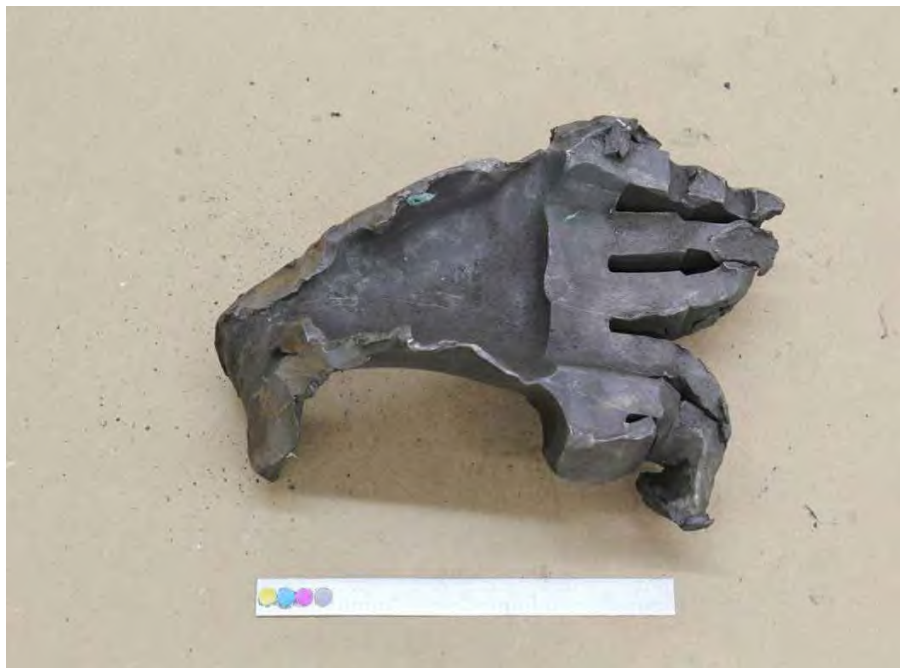
Fig. 279. Photograph of low pressure turbine "B" turbine end L-1 blade which had fractured through the airfoil.

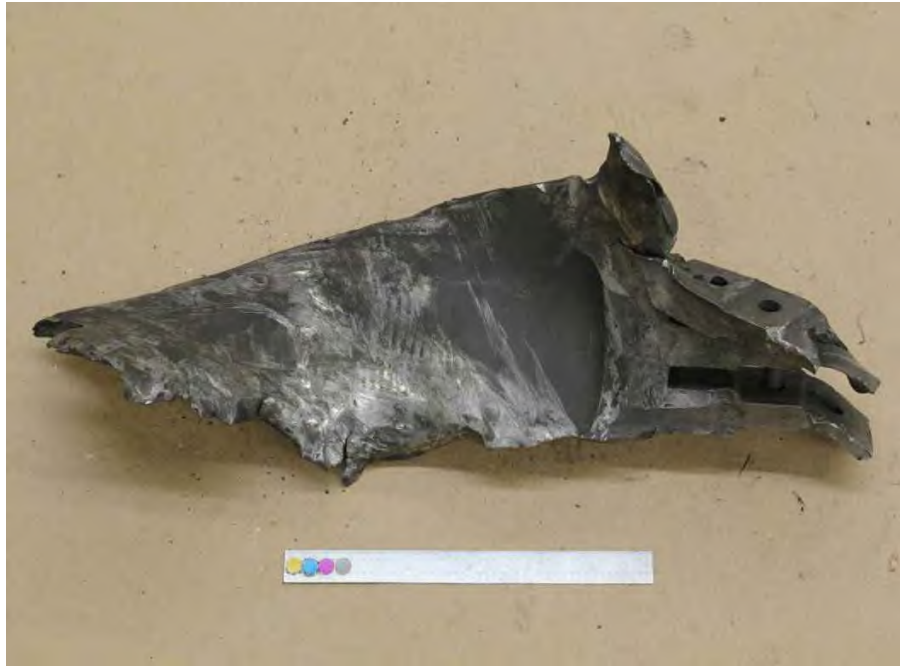
Fig. 280. Photograph of low pressure turbine "B" turbine end L-1 blade which had fractured through the airfoil.

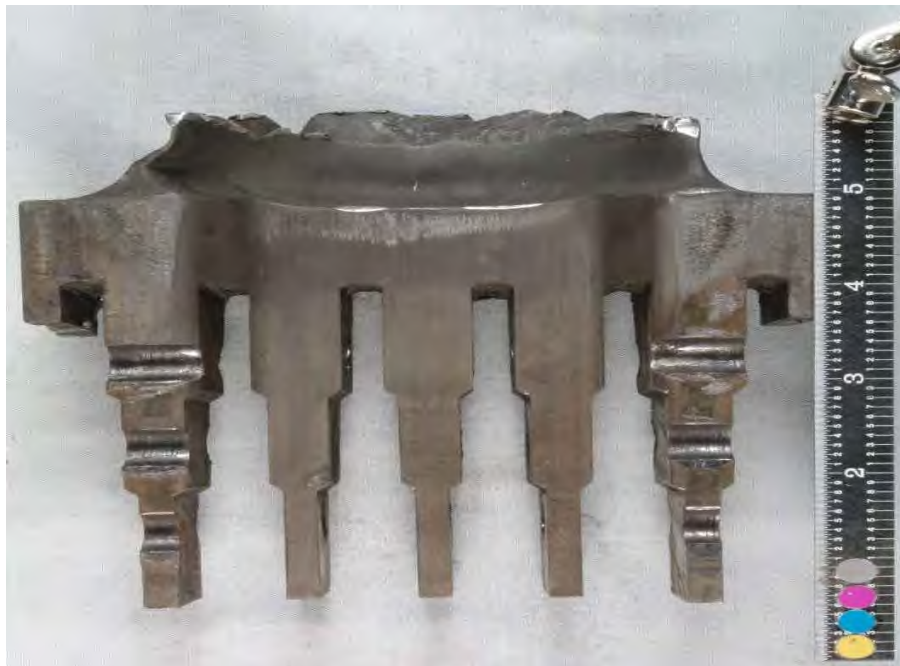
Fig. 281. Photograph of low pressure turbine "B" turbine end L-1 blade which fractured transversely through airfoil just above root platform.

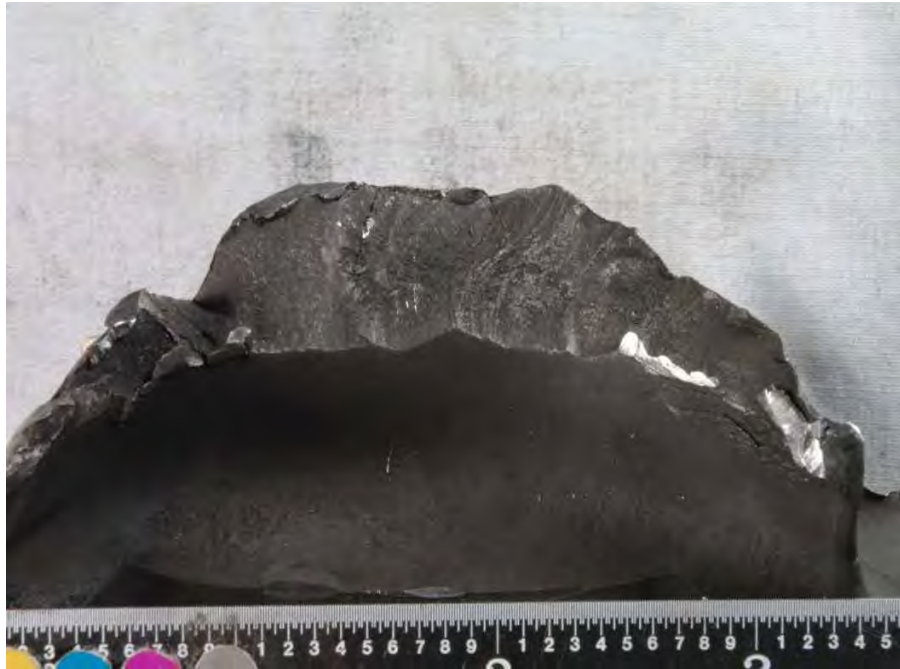
Fig. 282. Close-up photograph of blade airfoil fracture shown in Fig. 281.

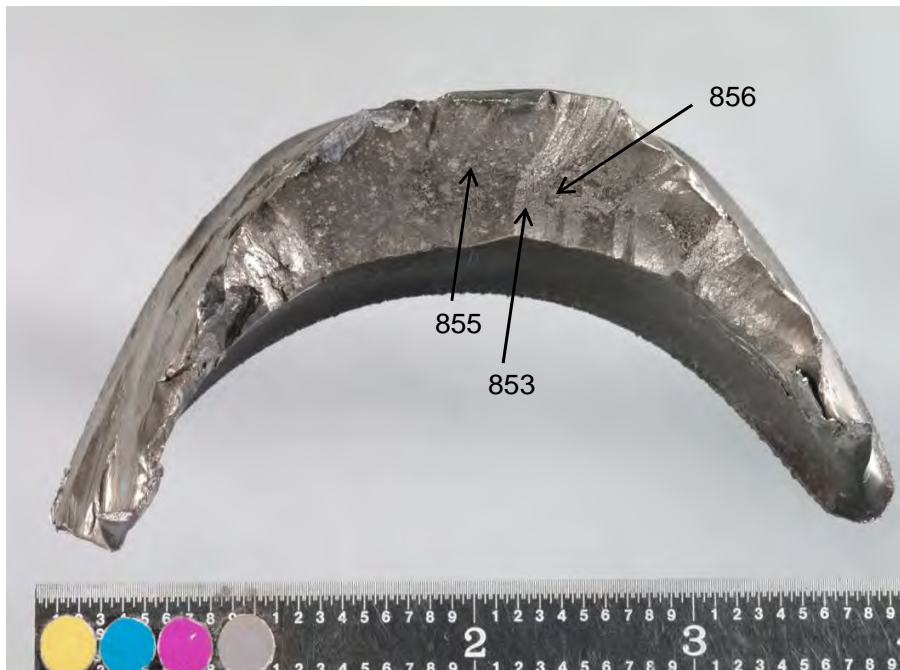
Fig. 283. Close-up photograph of blade airfoil fracture shown in Fig. 281.

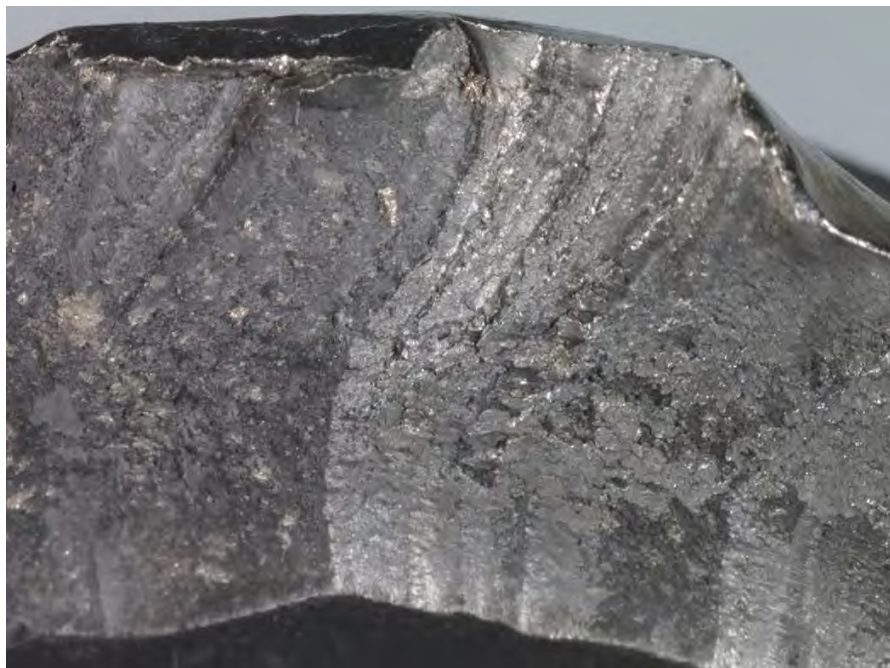
Fig. 284 Close-up photograph of blade airfoil fracture surface shown in Fig. 283.

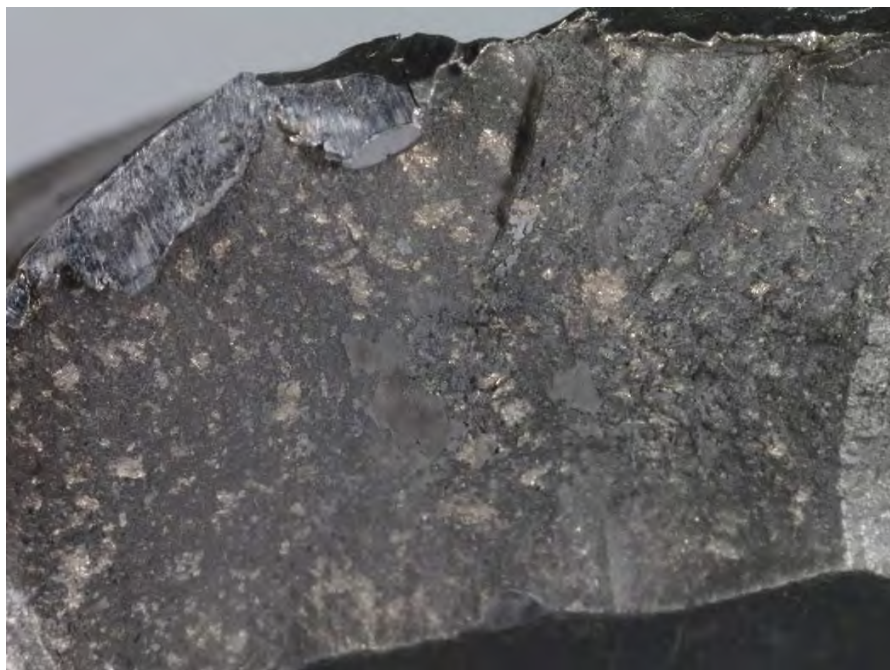
Fig. 285. Close-up photograph of blade airfoil fracture surface shown in Fig. 283.

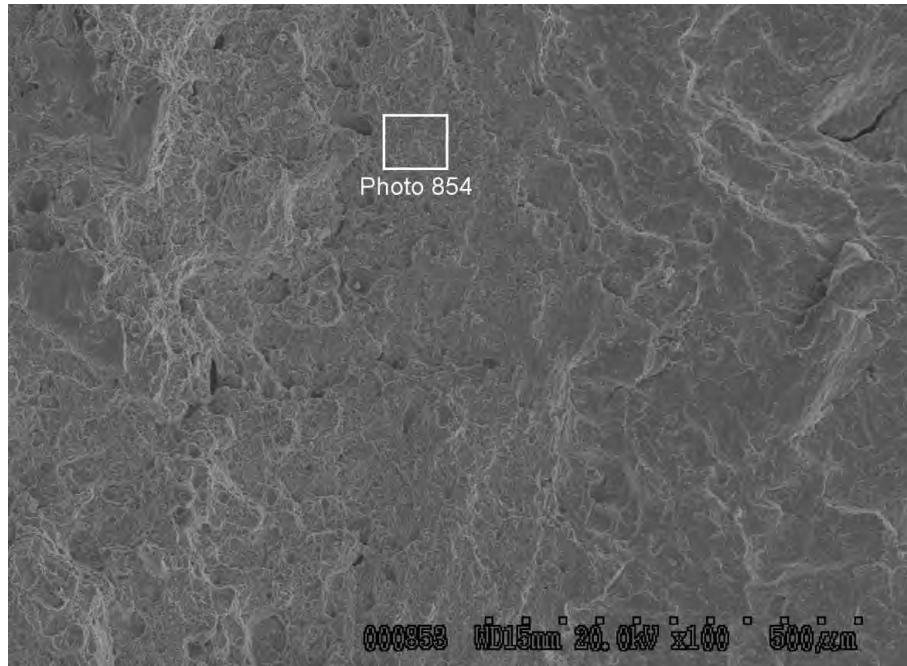
Fig. 286. Scanning electron microscope fractograph of blade airfoil fracture surface at Area "853" shown in Fig. 283.

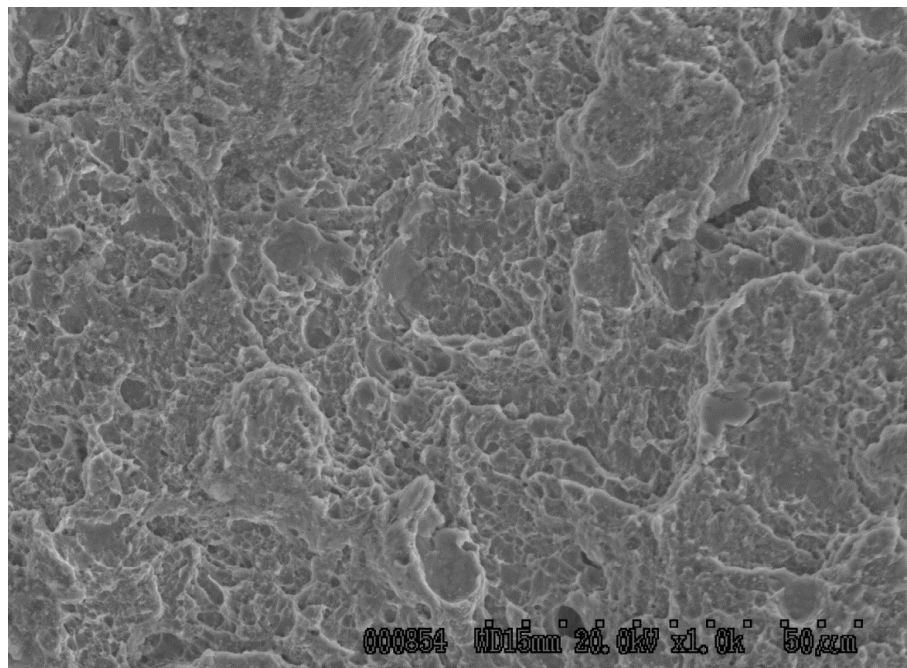
Fig. 287. Scanning electron microscope fractograph of blade airfoil fracture surface at Area "854" shown in Fig. 286.

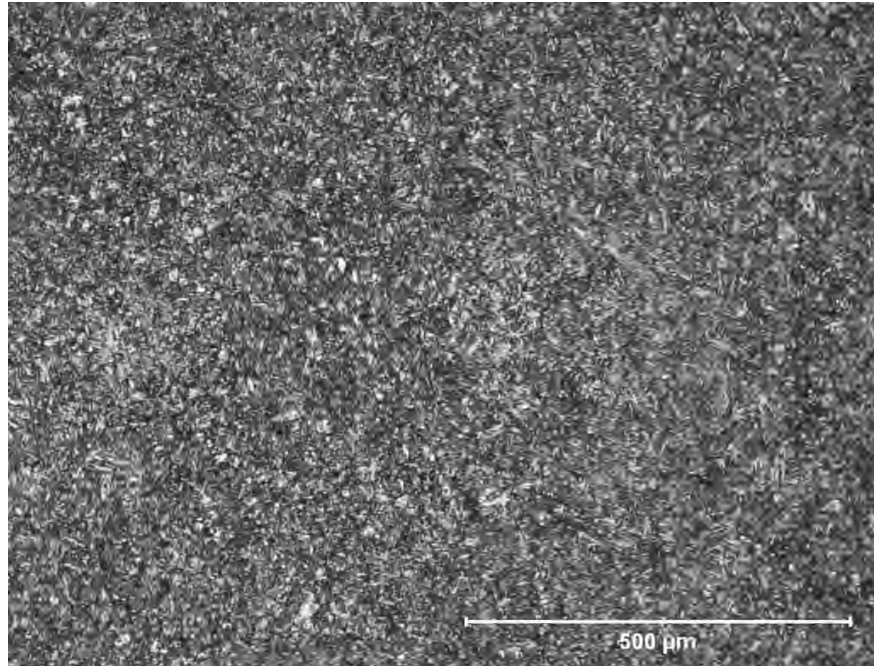
Fig. 290. Photomicrograph of planar section through a finger pinned blade attachment from a low pressure turbine "B" turbine end L-1 blade, SID 14914, Pc "A3".

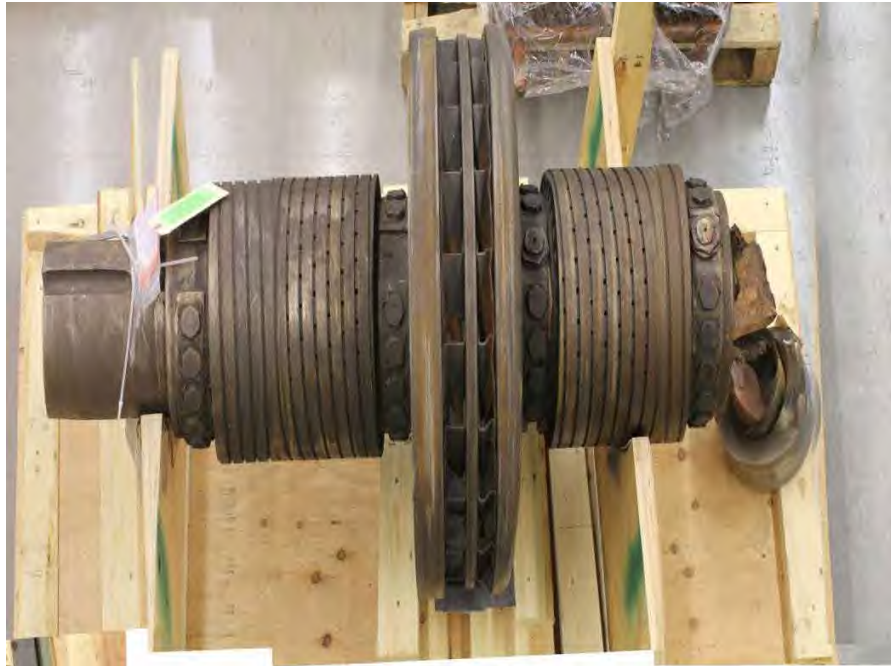
Fig. 307. Aft end of generator shaft which fractured transversely just forward of the generator collector ring.

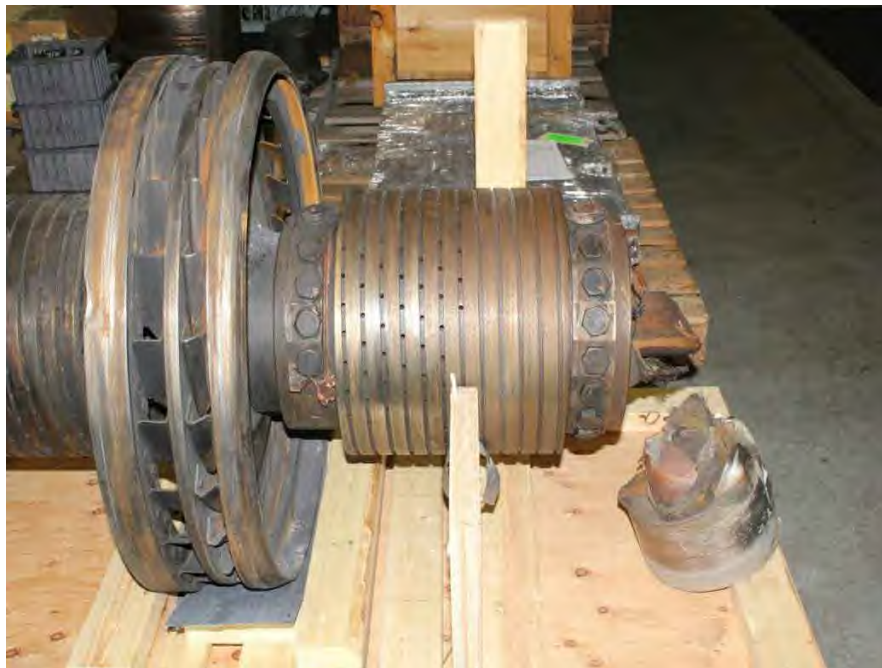
Fig. 308. Forward end of generator shaft shown in Fig. 307 showing both halves of shaft fracture.

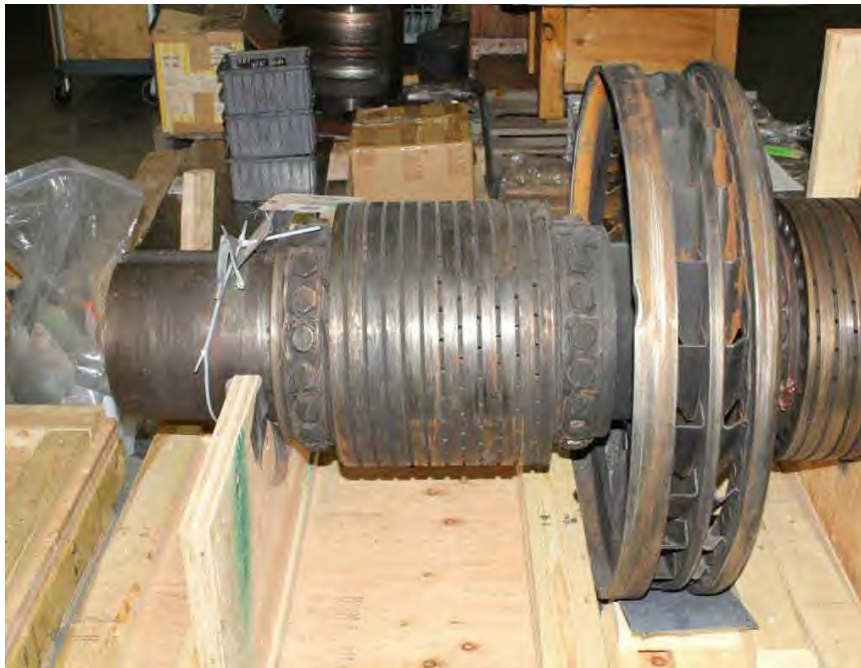
Fig. 309. Aft end of generator shaft.

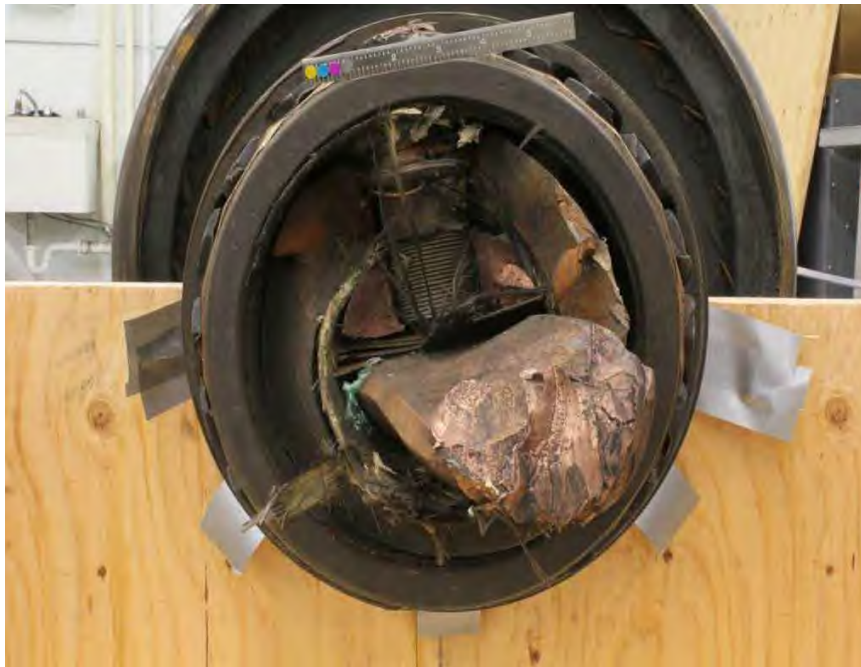
Fig. 310. Aft half of generator shaft fracture.

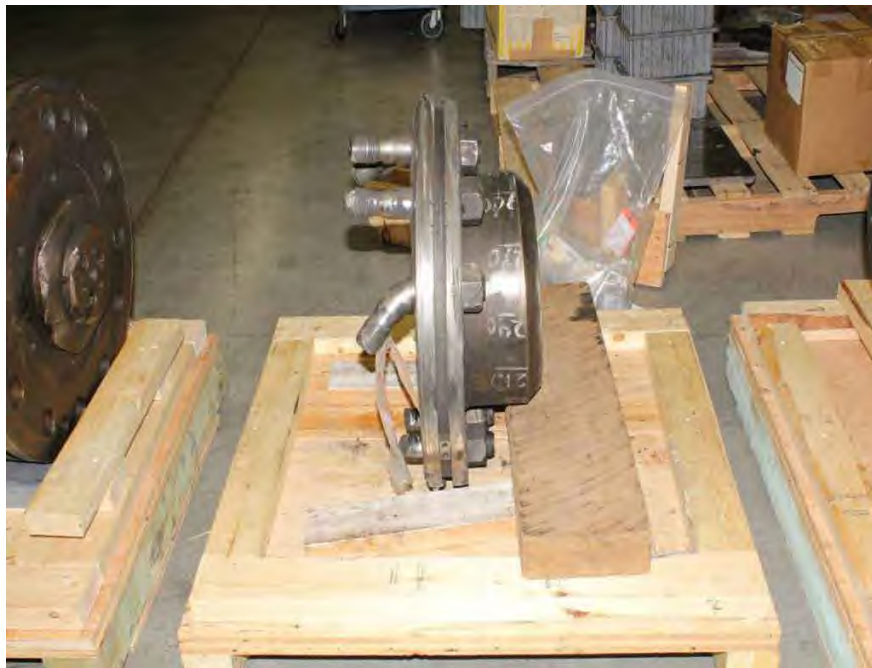
Fig. 312. Generator shaft coupling half which was liberated from generator shaft during turbine event of Nov. 19, 2011.

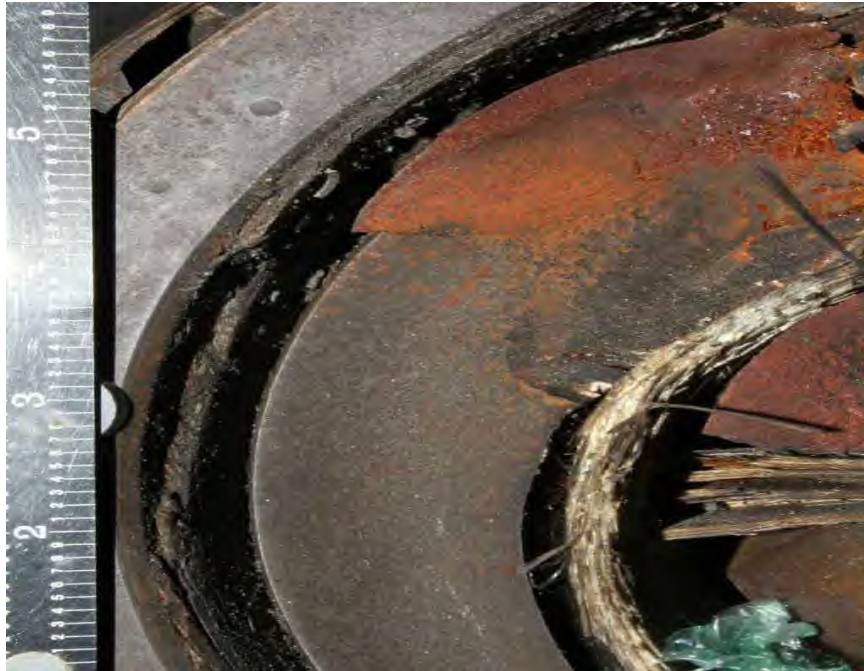
Fig. 313. Close-up photograph of fracture surface of generator shaft aft end fracture half.

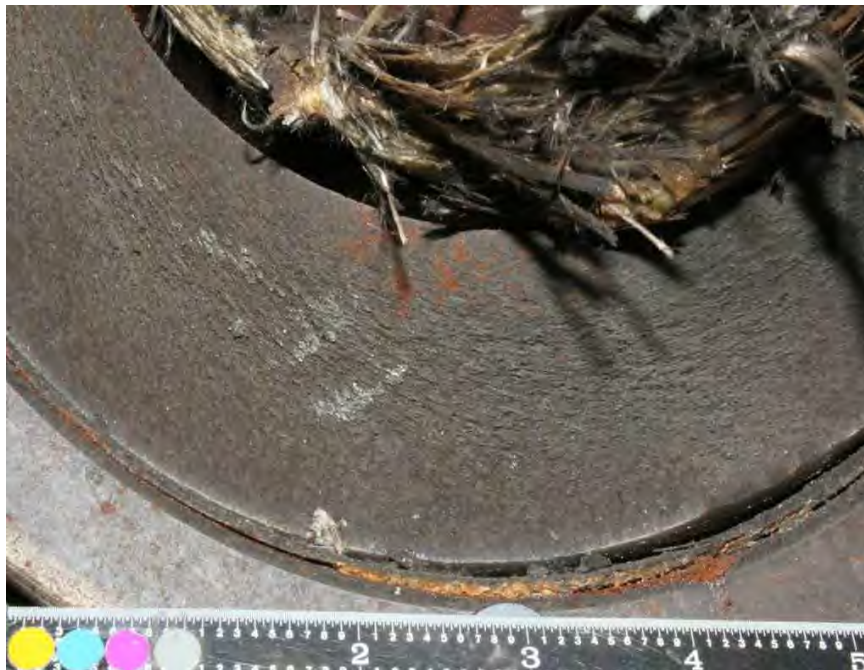
Fig. 314. Close-up photograph of fracture surface of generator shaft aft end fracture half.

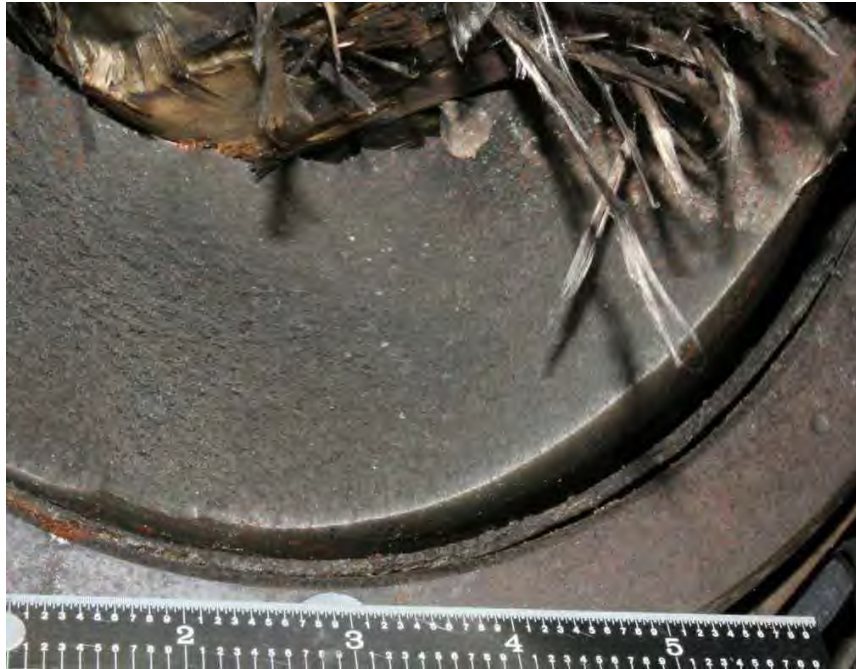
Fig. 315. Close-up photograph of fracture surface of generator shaft aft end fracture half.

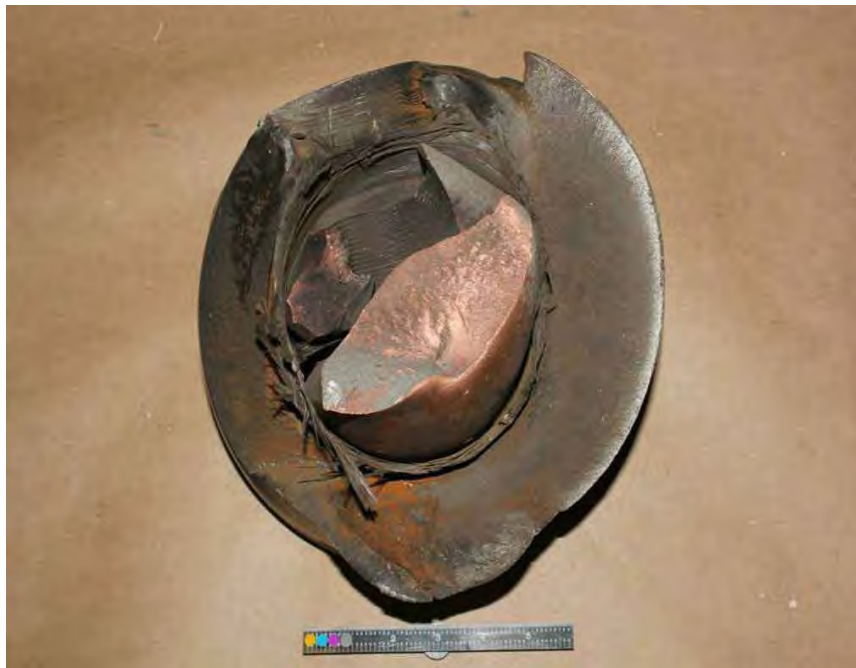
Fig. 316. Close-up photograph of fracture surface of generator shaft forward end fracture half with leads intact.

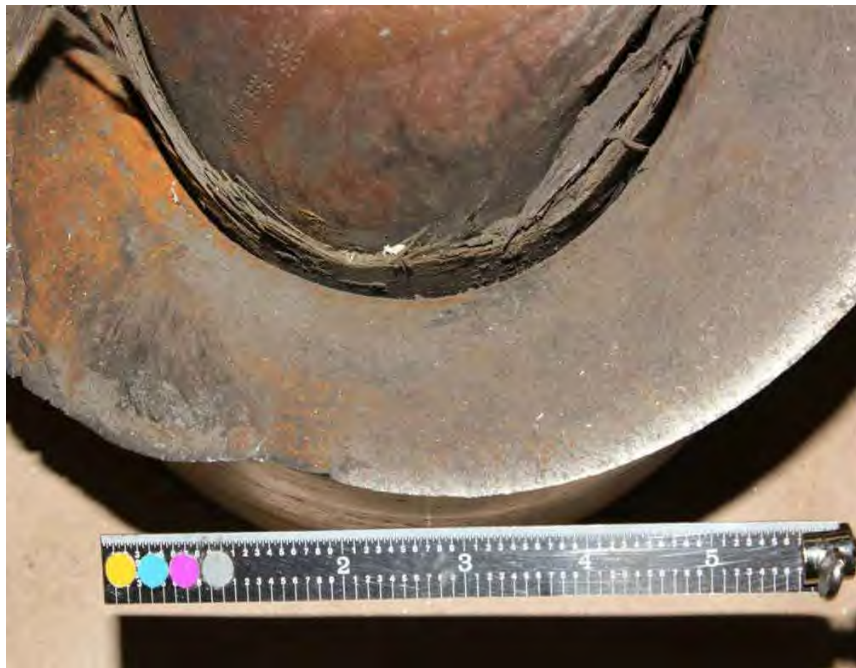
Fig. 318. Close-up photograph of fracture surface of generator shaft forward end fracture half with leads intact.

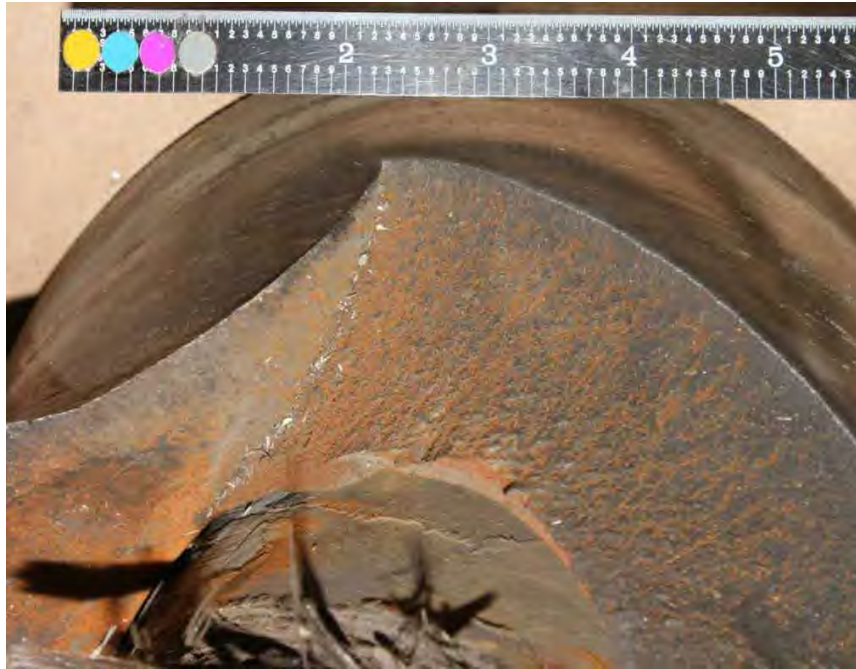
Fig. 319. Close-up photograph of fracture surface of generator shaft forward end fracture half.

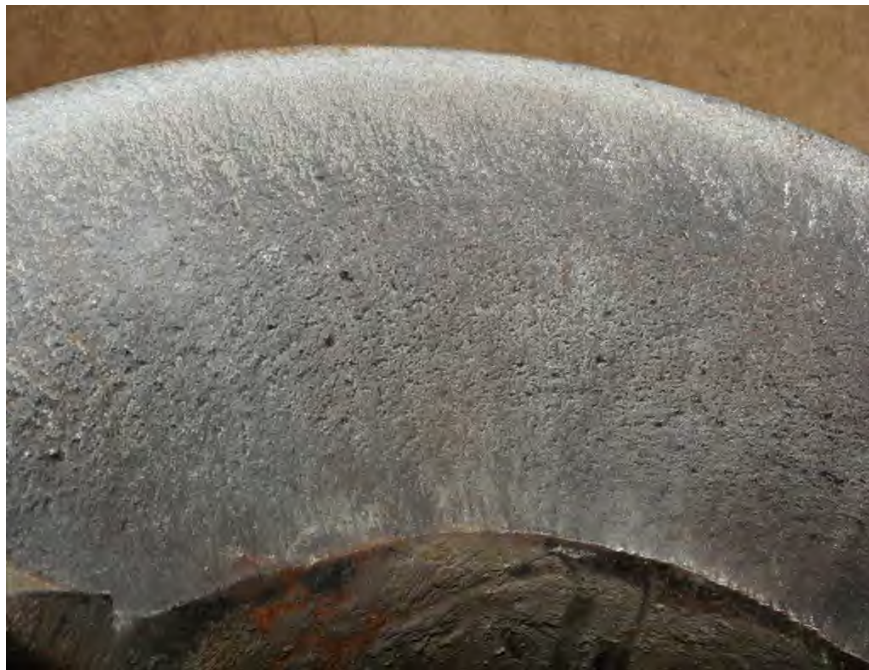
Fig. 320. Close-up photograph of fracture surface of generator shaft forward end fracture half.

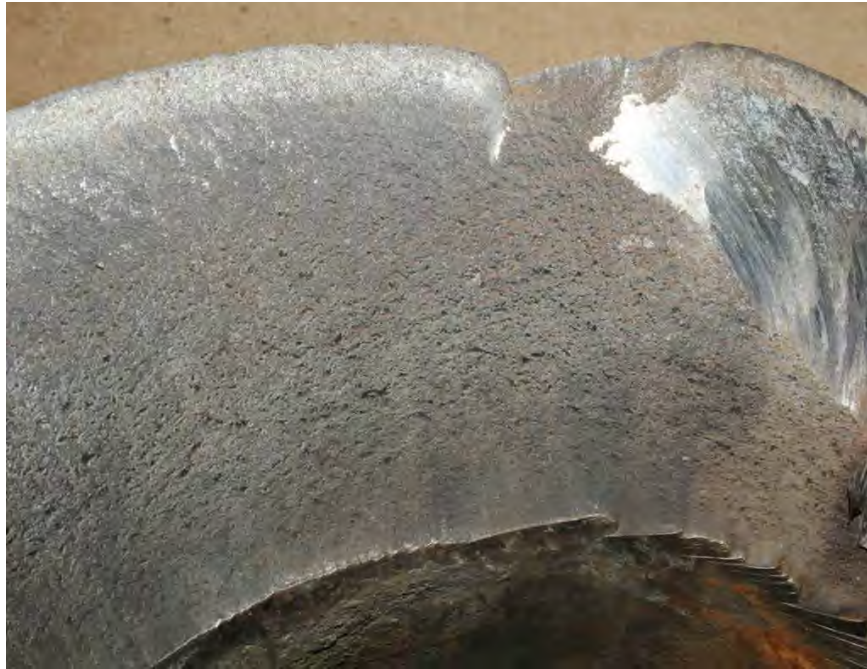
Fig. 321. Close-up photograph of fracture surface of generator shaft forward end fracture half.

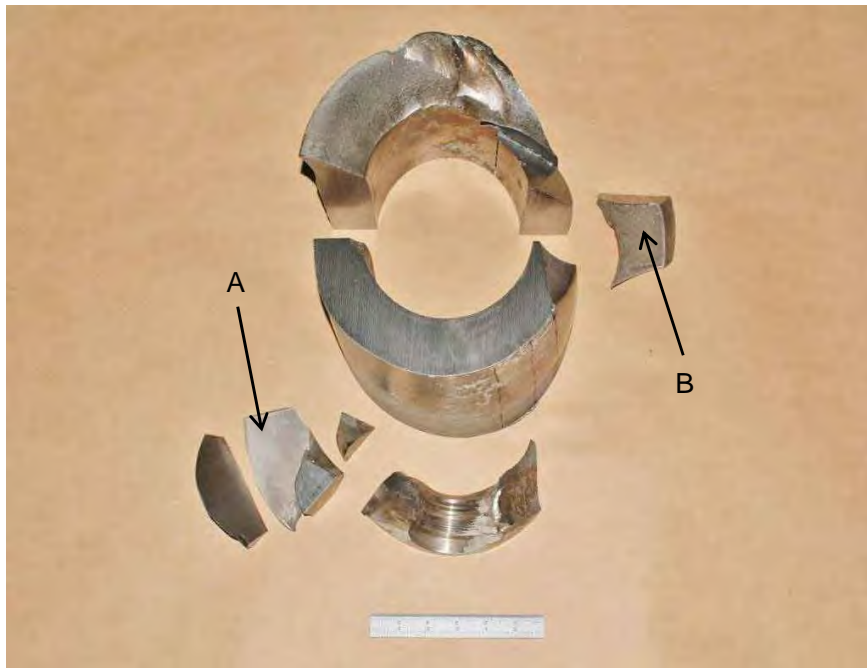
Fig. 322. Close-up photograph of generator shaft forward end fracture half showing two subsegments removed for scanning electron microscope examination.

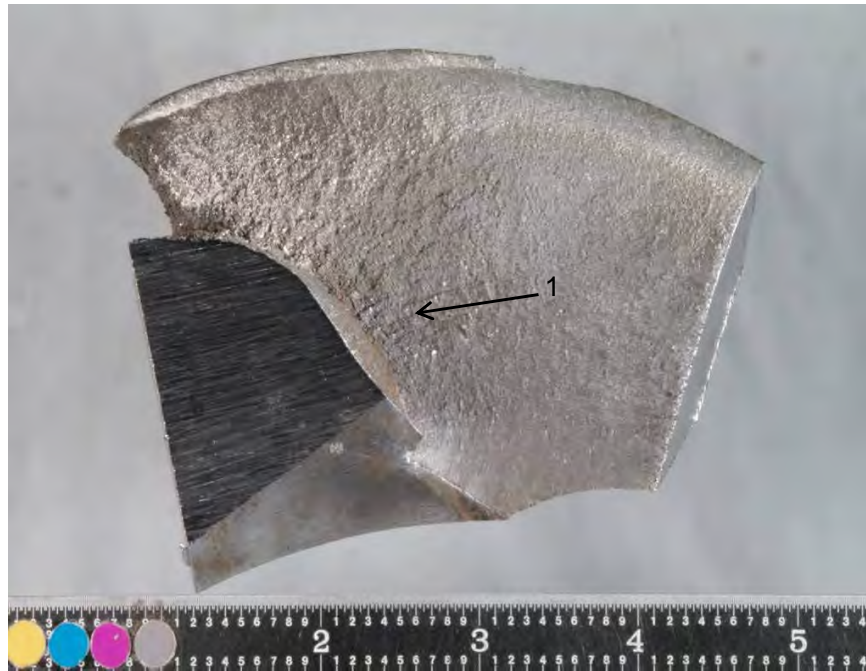
Fig. 323. Close-up photograph of generator shaft fracture subsegment "A" showing location of scanning electron microscope photograph.

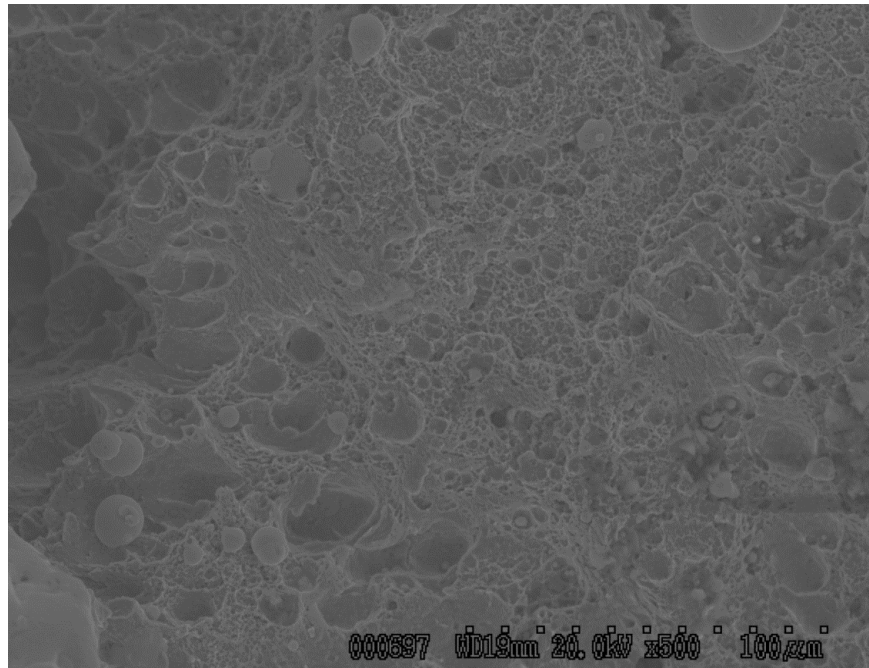
Fig. 325. Scanning electron microscope fractograph of generator shaft fracture subsegment "A", Area 1.

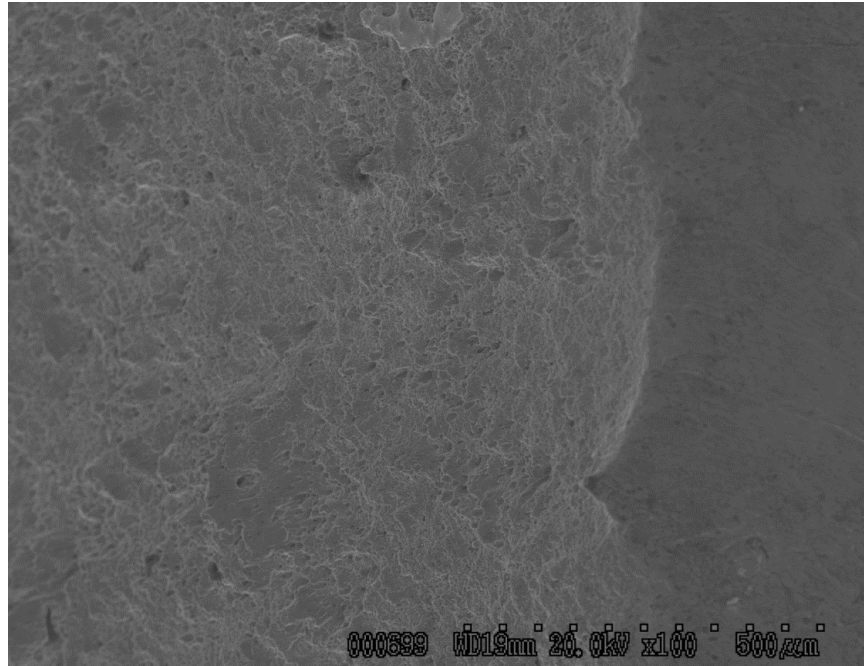
Fig. 327. Scanning electron microscope fractograph of generator shaft fracture subsegment "B", Area 2.

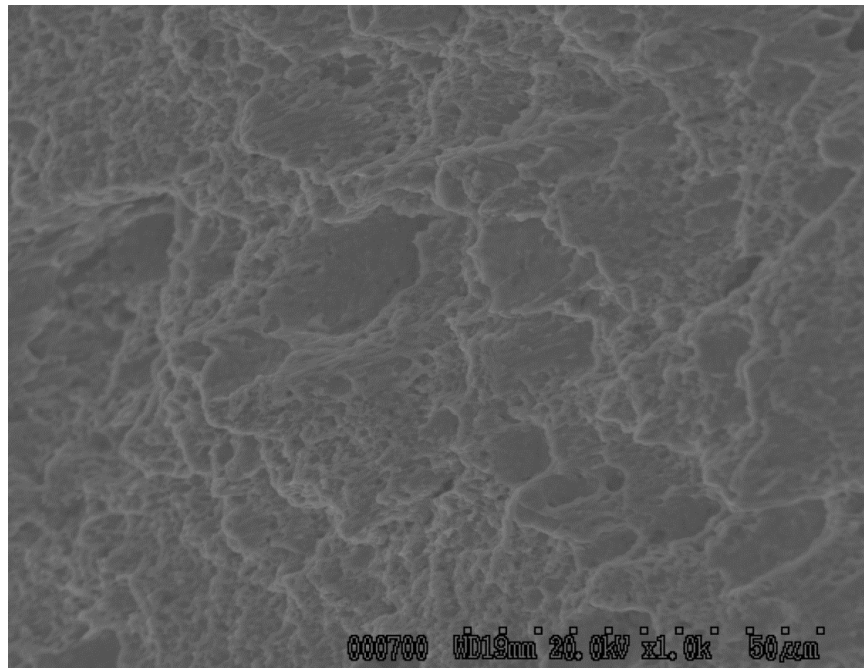
Fig. 328. Scanning electron microscope fractograph of generator shaft fracture subsegment "B", Area 2.
