1 **I. INTRODUCTION AND QUALIFICATIONS**

18 19 **II. SHERCO UNIT 3**

Figure 2
Blade Attachment Styles

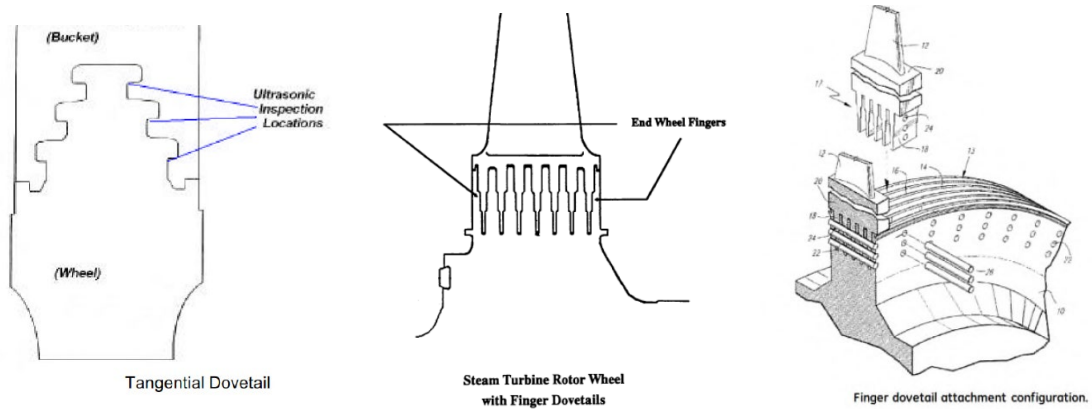
The attachment area for all blades to rotors is referred to as the “dovetail.” The design of the attachment is a contributing factor for defects such as stress corrosion cracking. Detection of these defects may be found using inspection techniques developed by the OEM and other specialty companies. The design also determines the complexity of necessary inspection technique to detect defects.

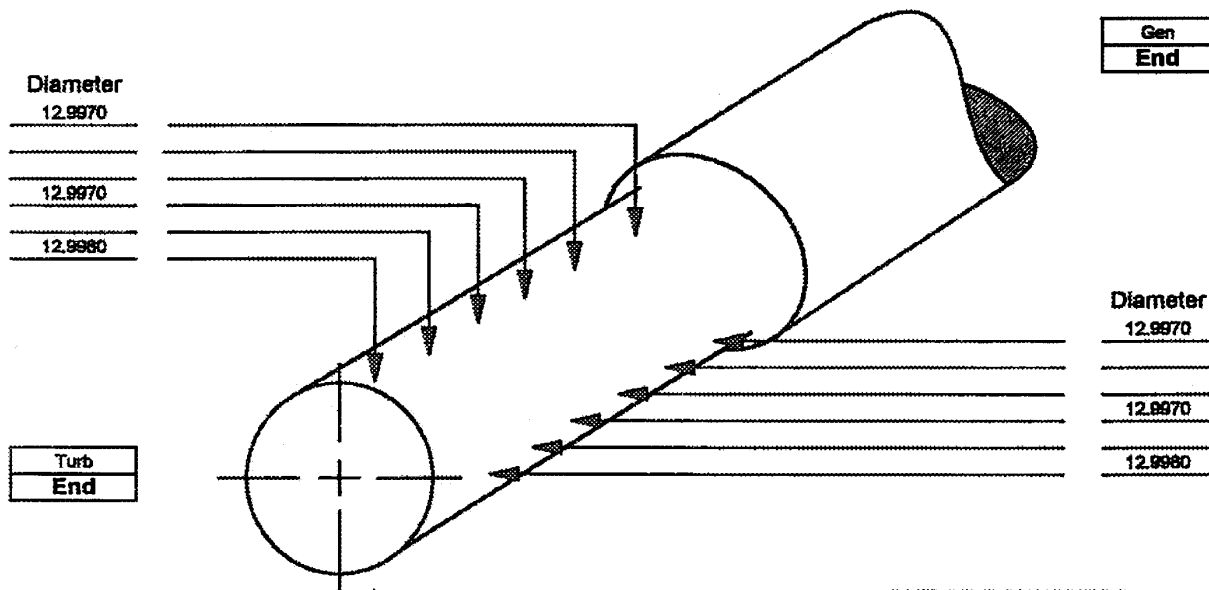
Journal Number 1

0°	90°	All
Maximum	12.9980	12.9980	12.9980
Minimum	12.9970	12.9970	12.9970
Difference	0.0010	0.0010	0.0000
Average	12.9973	12.9973	12.9973

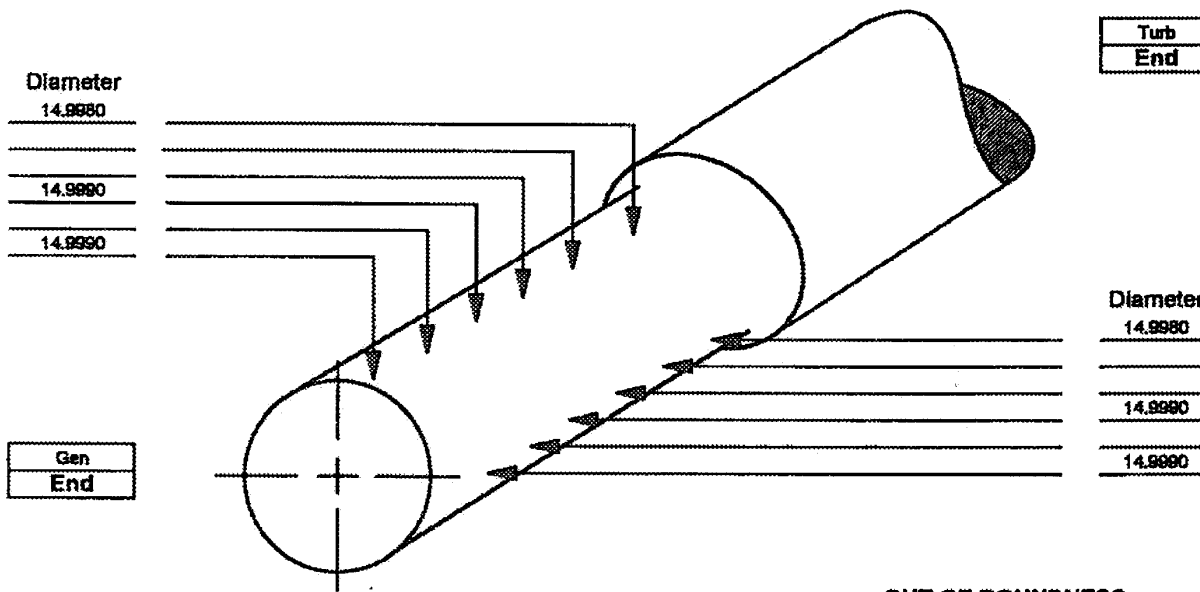
Journal Number 2

0°	90°	All
Maximum	14.9990	14.9990	14.9990
Minimum	14.9980	14.9980	14.9980
Difference	0.0010	0.0010	0.0000
Average	14.9987	14.9987	14.9987

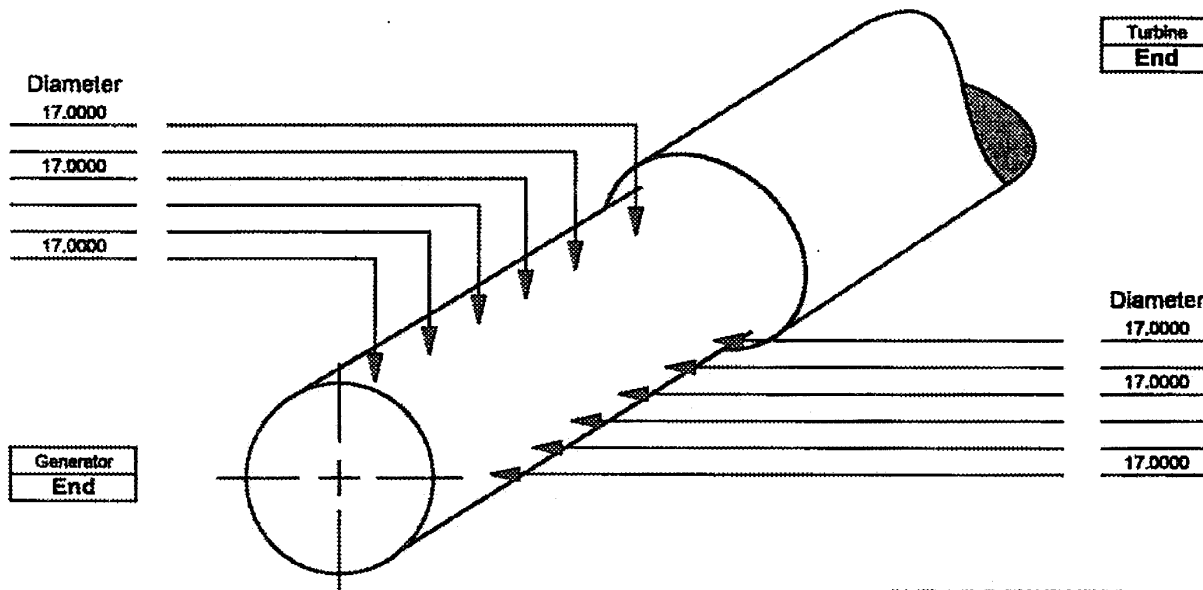
Journal Number 4

0°	90°	All
Maximum	17.0000	17.0000	17.0000
Minimum	17.0000	17.0000	17.0000
Difference	0.0000	0.0000	0.0000
Average	17.0000	17.0000	17.0000

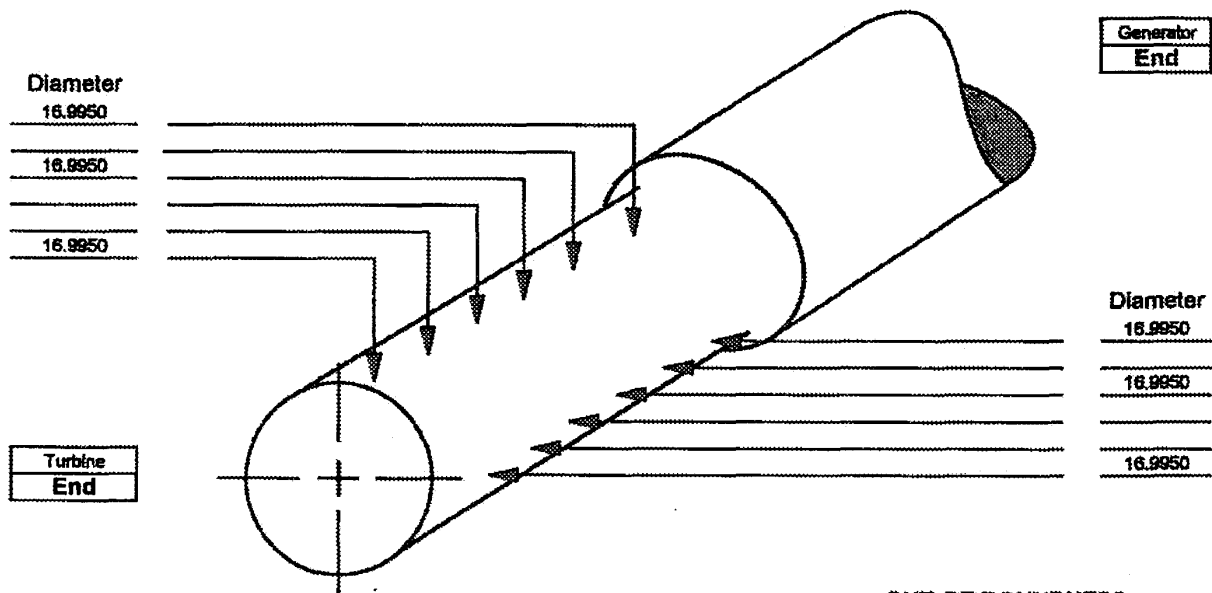
Journal Number 5

0°	90°	All
Maximum	16.9950	16.9950	16.9950
Minimum	16.9950	16.9950	16.9950
Difference	0.0000	0.0000	0.0000
Average	16.9950	16.9950	16.9950

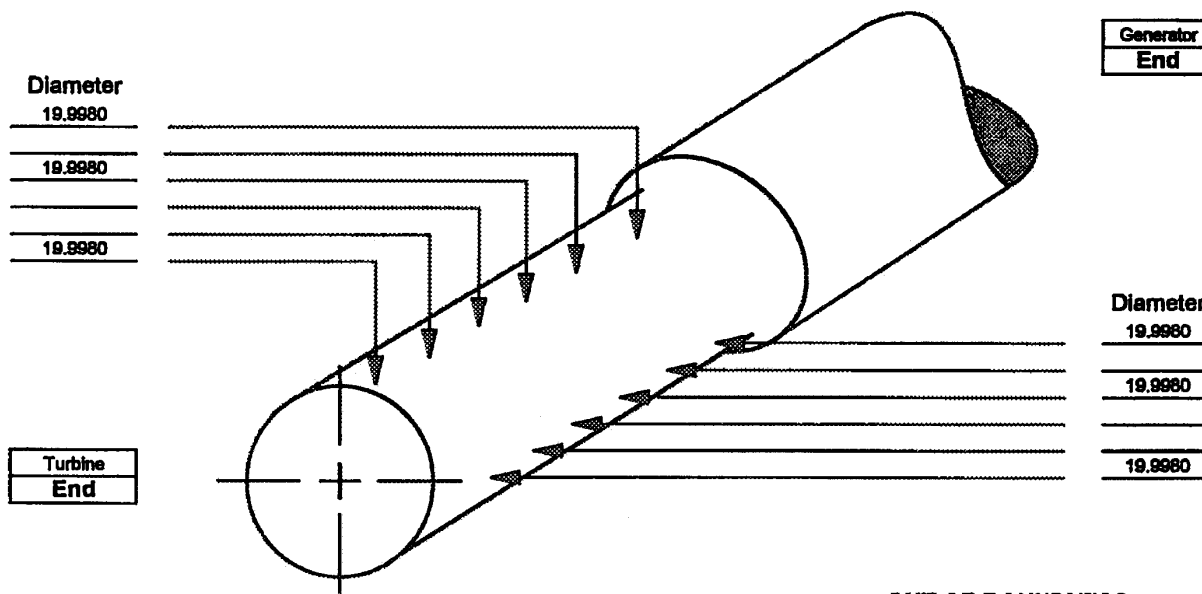
Journal Number 7

0°	90°	All
Maximum	19.9980	19.9980	19.9980
Minimum	19.9980	19.9980	19.9980
Difference	0.0000	0.0000	0.0000
Average	19.9980	19.9980	19.9980

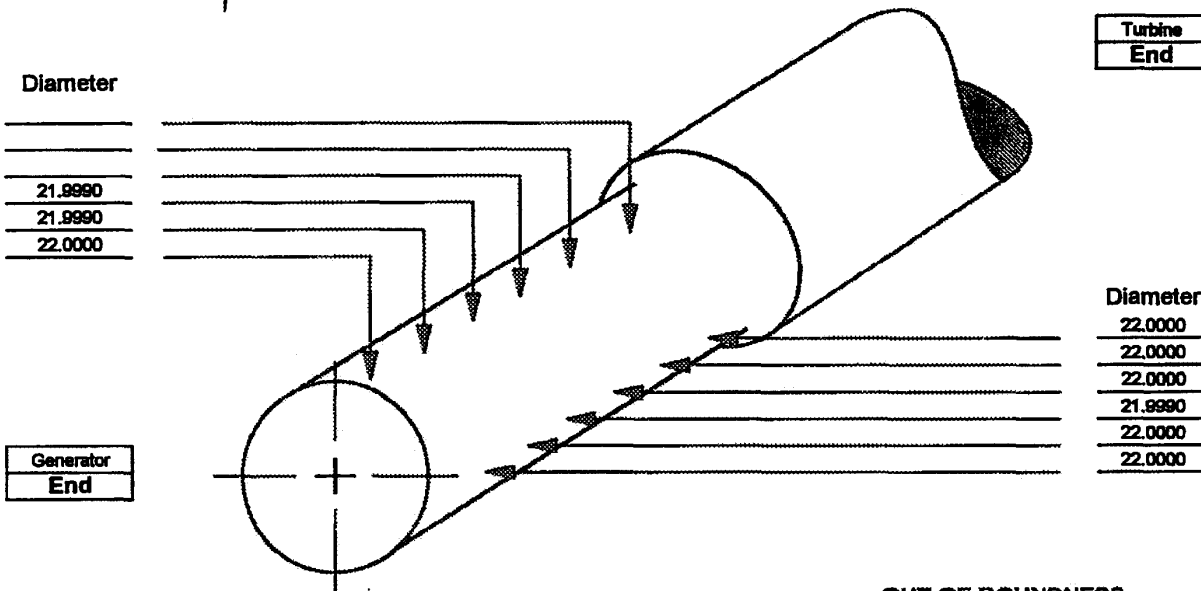
Journal Number 8

0°	90°	All
Maximum	22.0000	22.0000	22.0000
Minimum	21.9990	21.9990	21.9990
Difference	0.0010	0.0010	0.0000
Average	21.9993	21.9996	21.9996
