RE: RIVERSIDE ROOT CAUSE ANALYSIS REPORT

Root Cause Investigation Report

Riverside Generating Station - Unit 7

REPORT NO. 2551958.401 Metallurgical Analysis of Failed Retaining Ring Riverside Generating Station - Unit 7

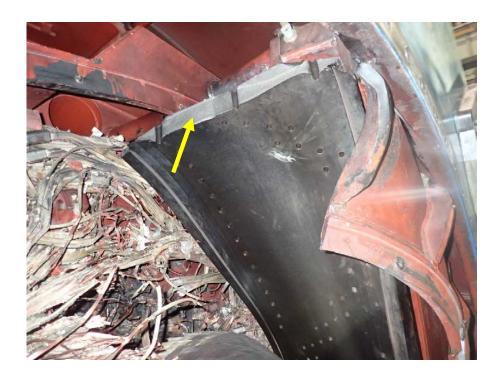
Figure 5. Views of the south (turbine) end of the generator showing damage that occurred during the failure event. Note that some outer components have been removed to permit visual examination of the interior of the generator. The ID surface of the retaining ring is indicated by the arrows in the lower image.

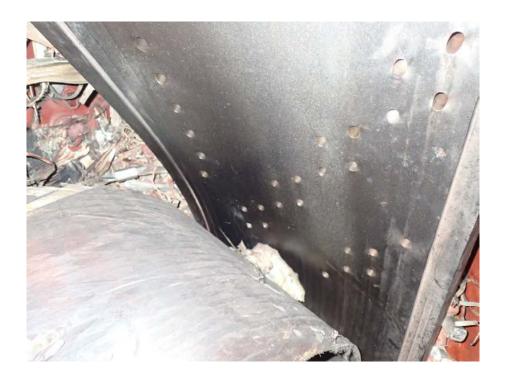
Figure 6. Additional views of the south end of the generator. The upper image shows one of the fractures on the retaining ring (arrow), and the lower image shows damaged windings, broken blades on the hydrogen cooling fan, and other damaged and displaced components.

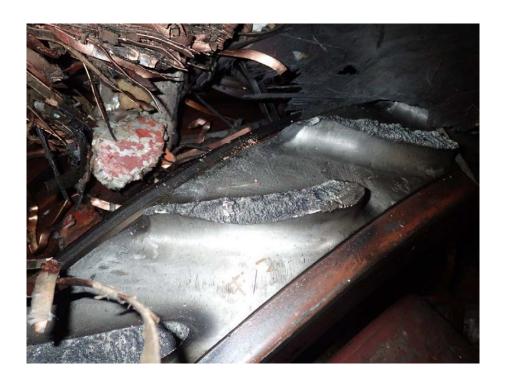
Figure 8. Views of the fracture surface at the lower end of the retaining ring (situated beneath the rotor) (arrow). The lower image is a view of the outboard side of the lower fracture. Debris was blocking clear views of much of the lower fracture surface.

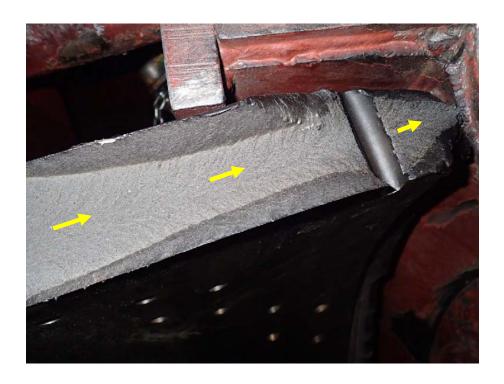
Closer examination of the upper fracture surface on the retaining ring revealed visible features (texture) that indicated the directions of crack propagation at various positions across the fracture (Figures 10 and 11). The fracture plane coincided with three cooling passages (holes) oriented radially through the ring, and the crack growth directions indicated propagation from the central cooling passage towards the outboard and inboard edges of the rings. As the cracks on either side of the central cooling passage reached the outer cooling passages, new cracks were initiated and continued outside of the outer cooling passages.

Figure 10. Views of the upper fracture surface on the retaining ring; the upper image is the inboard side of the fracture, and the lower image is the central part of the fracture. Both images include locations where the overall fracture path coincided with hydrogen cooling passages (radial holes) in the retaining ring. Chevron markings are visible on the fracture surfaces, indicating the crack growth directions (indicated by arrows).

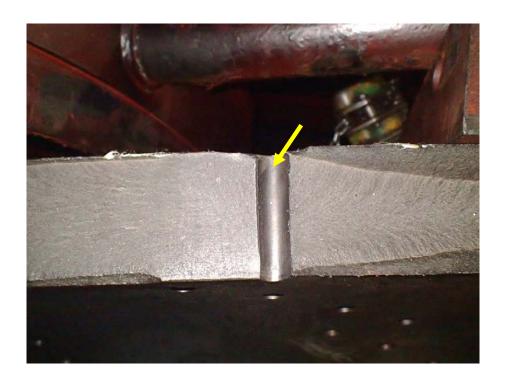
Figure 11. Views of the outboard side of the upper fracture surface on the retaining ring. Both images include a location where the overall fracture path coincided with a hydrogen cooling passage (radial hole) in the retaining ring. Chevron markings are visible on the fracture surfaces, indicating the crack growth directions (indicated by arrows).

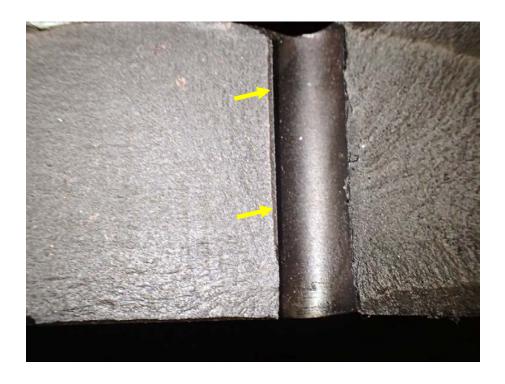
Figure 12. Closer views of the central part of the upper fracture surface on the retaining ring, including one of the cooling passage holes (upper arrow). The ring OD surface is facing up in each image. Note that shear lips are present at the ring OD and ID surfaces from the cooling hole towards the right, and at a distance of a couple of inches from the cooling hole and towards the left (lower arrows).

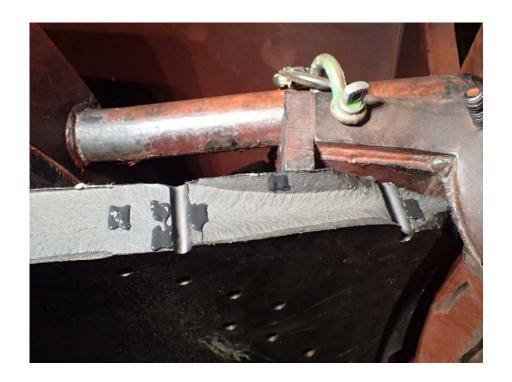
Figure 13. Closer views of the visible fracture surface texture close to the cooling passage hole shown in Figure 12. A thin shear lip is visible along most of the left edge of the hole (arrows).

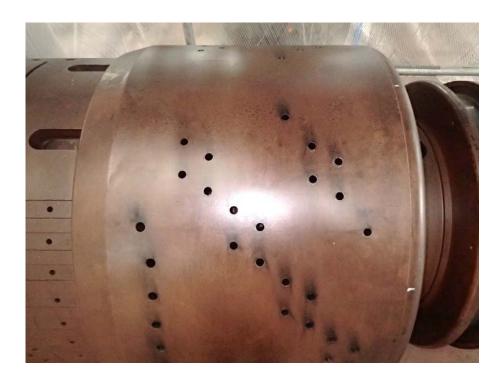
Figure 23. Additional views of the centering ring (upper image) and rotor windings in proximity to the snap ring slot. Localized damage to the rotor is visible in the lower-right image.

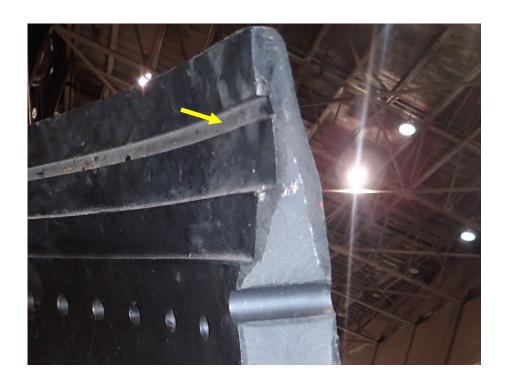
Figure 27. Additional views of the ID surface of the retaining ring, including the upper fracture surface (arrow). In the upper image, visible light variations around the cooling passage holes are due to deformation (elongation) of the ring metal in the areas around the holes.

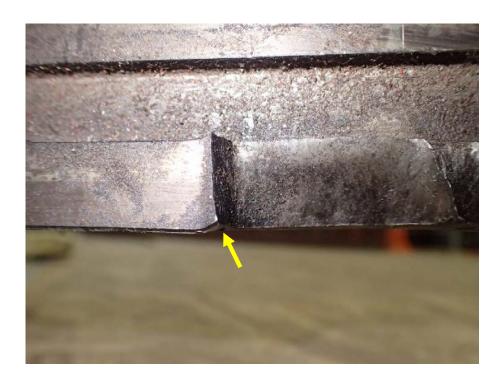
Figure 30. Views of a location of mechanical damage at one of the keyways along the outboard edge of the retaining ring.

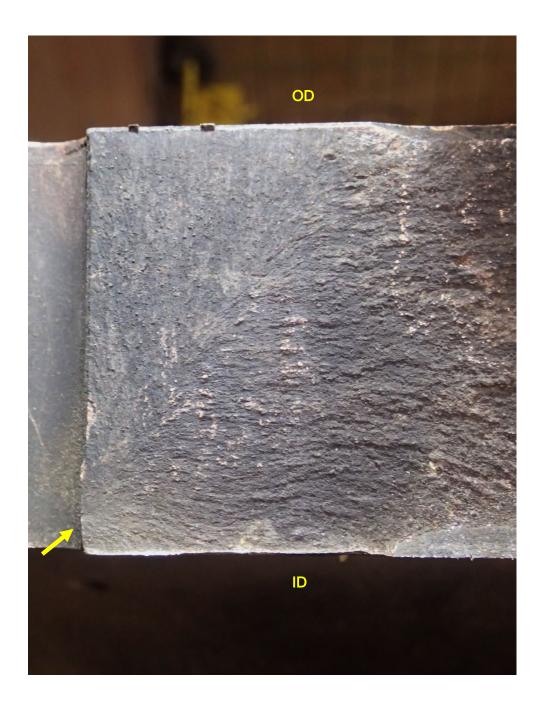
Figure 32. Views of the lower fracture surface on the retaining ring. The upper right image is a closer view of the area near the central cooling passage, and the lower image is a closer view of the same area (rotated 90 degrees clockwise) with side lighting to highlight the fracture surface texture.

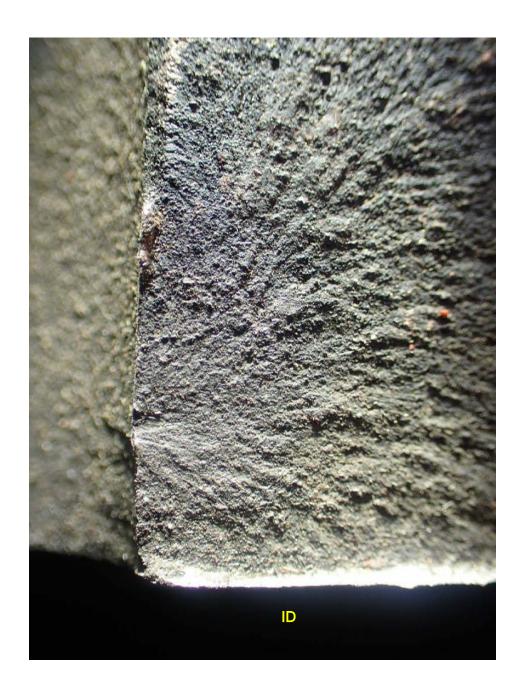
Figure 33. Closer view of the area shown in the lower image of Figure 32. The visible fracture surface texture suggests an origin area at the edge of the cooling passage hole.

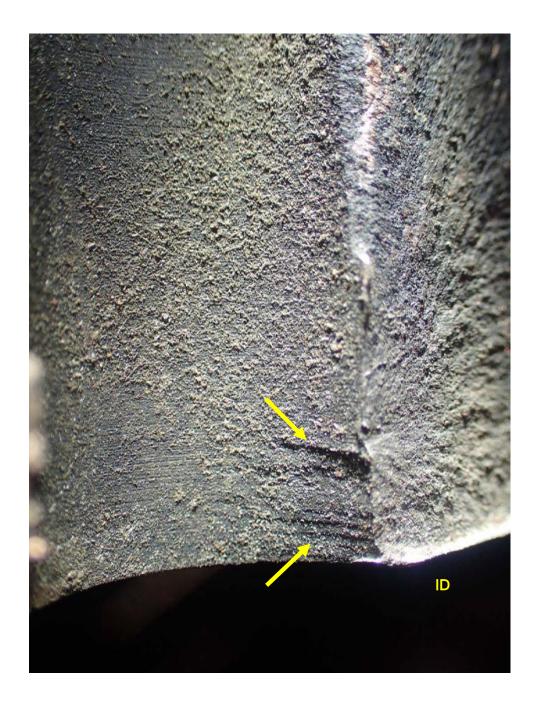
Figure 34. Closer view of the area shown in Figure 33, with side lighting to highlight the fracture surface features. The visible fracture surface texture suggests an origin area at the edge of the cooling passage hole.

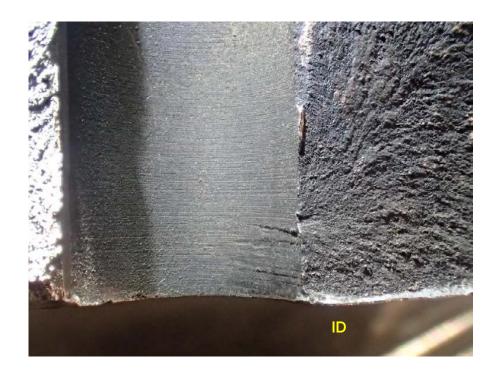
Figure 35. Alternate view of the area shown in Figure 34, with side lighting to highlight surface features. Features that are visible on the cooling passage surface (arrows) coincide with the apparent crack origin area at the edge of the cooling passage hole. Fine debris (mostly fiberglass particulate) is visible on the cooling passage surface.

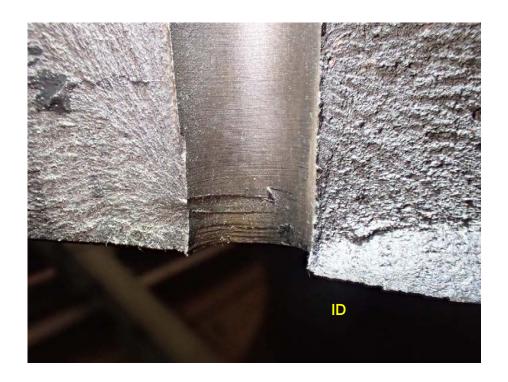
Figure 37. Views of the upper fracture surface on the retaining ring. The upper right image is a closer view of the area near the central cooling passage, and the lower image is a closer view of the same area (rotated 90 degrees counterclockwise); the shiny spot in the lower image is remnant material from the RepliSet sampling. The apparent origin area at the edge of the cooling passage hole is indicated by the arrow.

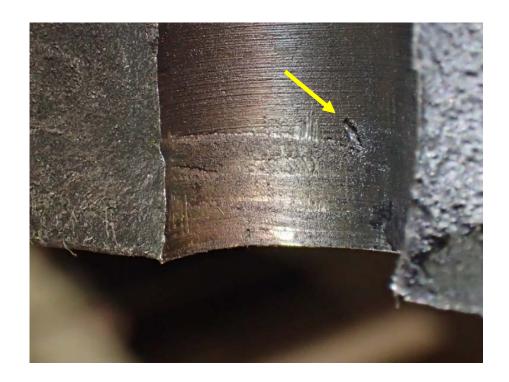
- The position of the particular damage feature that initiated the fatigue crack was at the side of a cooling passage near the middle of the retaining ring. This is considered to be one of the worst locations for a mechanical damage feature, as the stress concentration caused by the feature coincided with the normal stress concentration associated with the hole.

Figure 38. Closer views of the area shown in the lower image of Figure 37, with side lighting to highlight surface texture. Features that are visible on the cooling passage surface (arrows) coincide with the apparent crack origin area at the edge of the cooling passage hole.

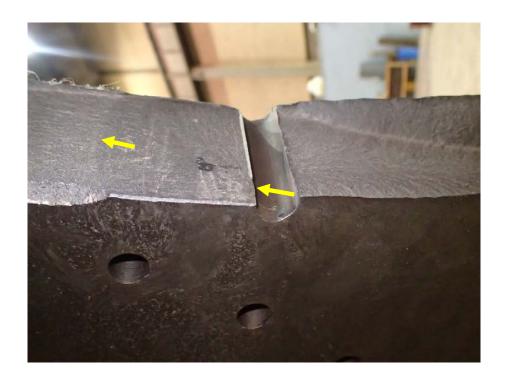
Figure 39. Additional close views, under more direct lighting, of features on the cooling passage surface in proximity to the apparent crack origin area. The visible surface damage included an angled mound of metal that appeared to have been "piled up" during the damage process (arrows).

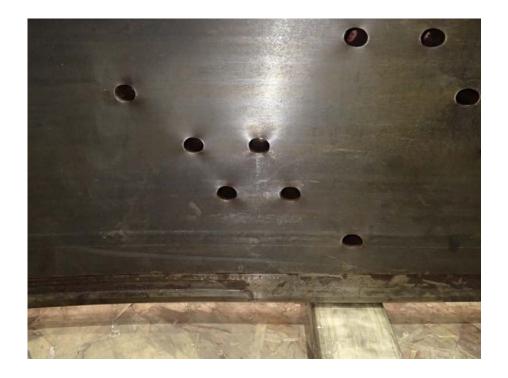
Figure 40. Alternate views of the central cooling passage hole at the upper fracture surface. The ID surface of the retaining ring is visible in each image. In the upper image, the right arrow indicates the crack origin area and the left arrow indicates the location of an apparent beach mark; other possible beach marks are visible between the left and right arrows. The arrow in the lower image also indicates the location of the apparent crack origin.

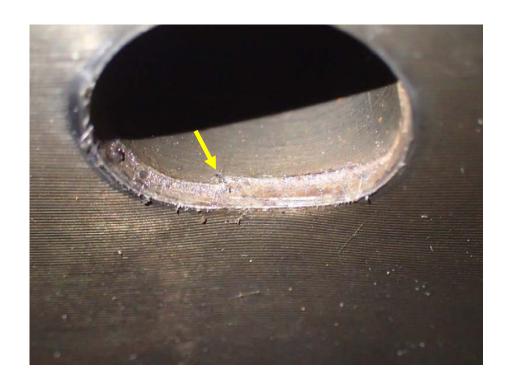
Figure 41. Views of a group of four cooling passage holes that were elongated (consistent with the opening or straightening of the retaining ring, and also exhibited indicates of mechanical damage at the hole ID surfaces near the ring ID surface.

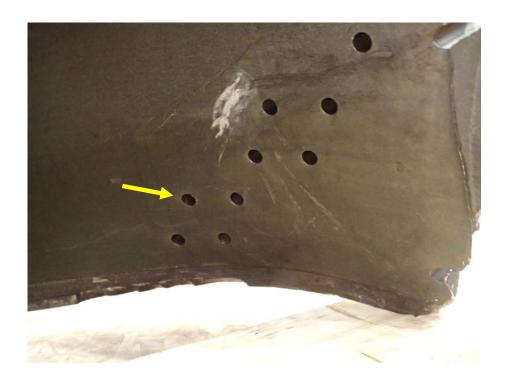
Figure 42. Close views of the interior of two of the elongated cooling passage holes in Figure 41. The arrows indicate the locations where internal surface damage is visible. Both of these locations also exhibited an angled featured with a small amount of piled up metal that was similar to that observed in the cooling passage at the crack origin area (arrows).

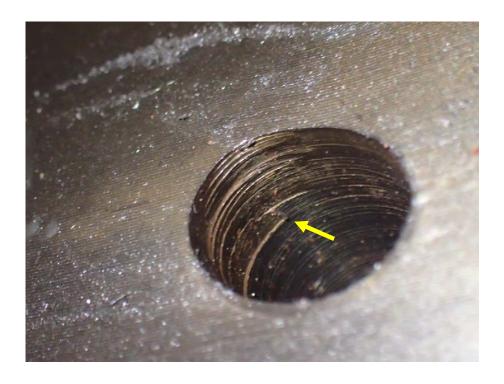
Figure 43. Additional views of a cooling passage hole with internal damage near the ring ID surface (arrow). The area shown is close to the upper fracture surface, which is toward the right in each image.

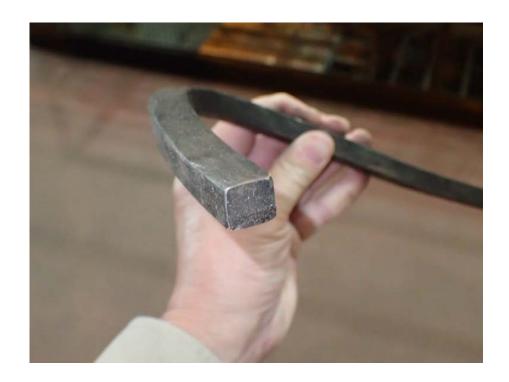
Figure 45. Views of the parts and fragments of material that appeared to be part of the ring retention snap ring and keys. The parts were deformed to various degrees and one of the ends of the snap ring was fractured.

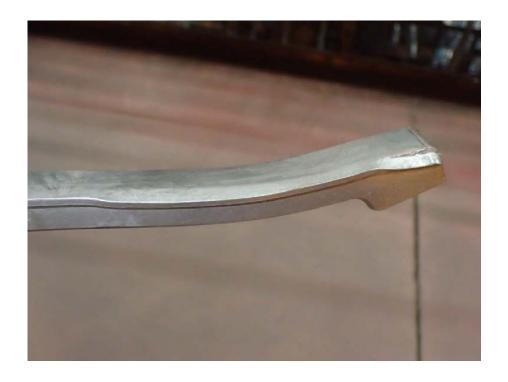
Figure 48. Close views of the other end of the snap ring shown in Figure 45. This end was damaged but not fractured, and the tool fitting has broken off at the location of the pins (visible in the upper image).

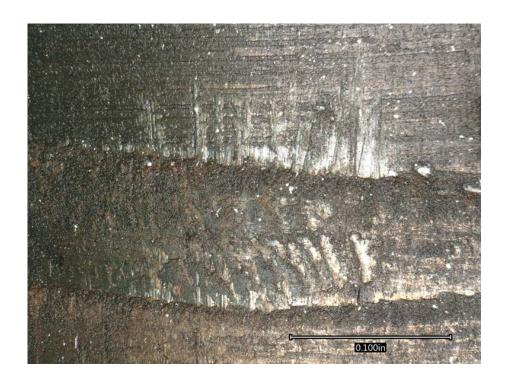
Figure 59. Digital microscope images of the central cooling passage and adjacent fracture surface, on the extracted section shown in Figure 58. Damage to the cooling passage surface is visible adjacent to the crack origin identified by the fracture surface texture (arrow).

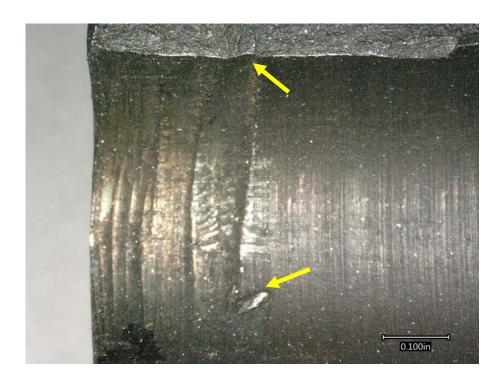
Figure 60. Additional close images of damage at the cooling passage surface. The lower image shows a close view of an angled feature with metal that has been piled up at the edge of the gouge.

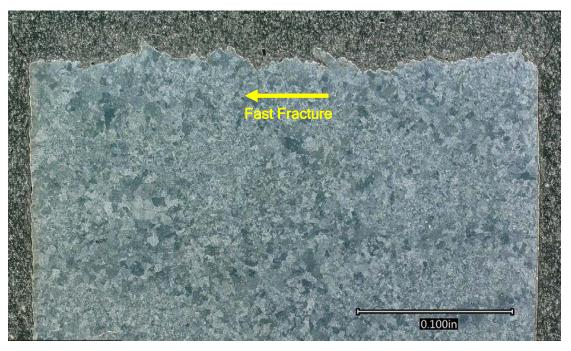
Figure 94. Digital microscope images of the prepared cross section on the left side of the upper image of Figure 91. The crack path was relatively straight and jagged in appearance. In these images, variations in the grain size are evident across the polished sample surface. (Etchant: Nital)
