**BEFORE THE OFFICE OF ADMINISTRATIVE HEARINGS
FOR THE
MINNESOTA PUBLIC UTILITIES COMMISSION
STATE OF MINNESOTA**

SURREBUTTAL TESTIMONY OF

TIMOTHY P. MURRAY

MD&A was contracted to perform the major overhaul to Xcel's, Sherburne County Generating Station unit # 3. The overhaul commenced on Oct 10, 2005 and was finished on 11/26/2005. Work was performed during 2 ten hour shifts, six days per week. Labor was supplied by MD&A Outage Services and consisted of 15 men per shift. Generator testing was performed by GE. All steam path recommendations and repairs were made and supervised by Steam Path Consultants. Outage machining services were performed by MD&A, including generator collector ring grinding. Outage support was supplied by Xcel Energy. Significant work performed this outage included the following:

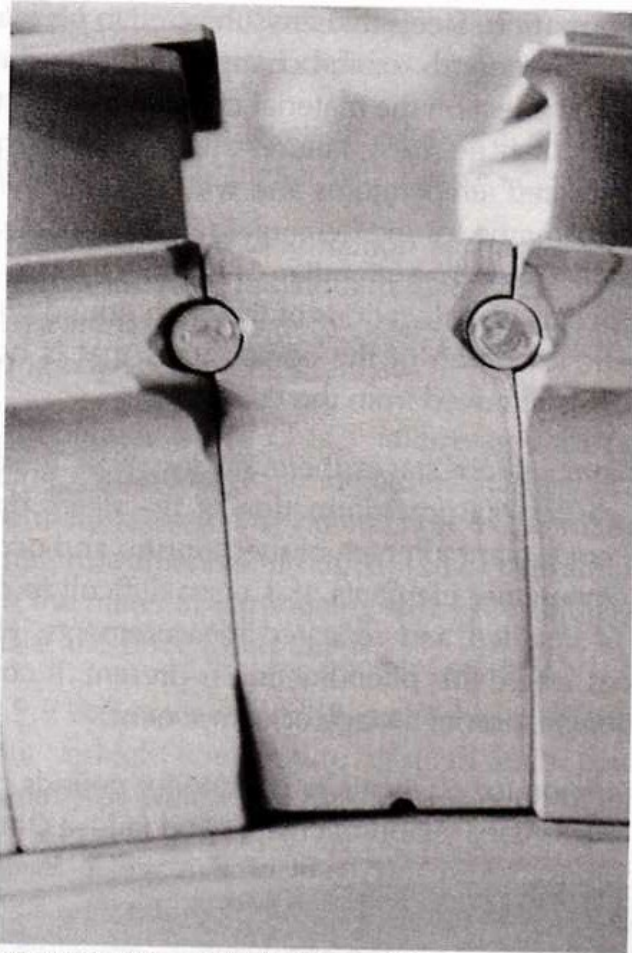
1 **Figure 1**

18
19 The problem, however, is that the notch block or notch blade is not directly
20 attached to the rotor wheel. As a result, load from this component (the notch block
21 or notch blade) is shared by the adjacent blades, which in turn create higher stresses
22 in the wheel dovetail at or near the notch opening. The presence of higher stresses
23 in this location on the rotor wheel can cause deformation of the rotor wheel
24 dovetail due to stress corrosion cracking (or other mechanisms) and causes the
25 notch block, notch blade and/or adjacent blades to move out of position and create
26 the gap or lift, which can be easily inspected (and measured) on tangentially loaded
27 blades.

20 **Fig. 1.9.10—The notch block from a high temperature stage**
21 **which has crept out radially under the influence of cen-**
22 **trifugal loading.**
