GE International, Inc.

DESCRIPTION	AMOUNT
SHERBURNE COUNTY GENERATING STATION BECKER, MN UNIT #3, TURBINE S/N 170X819 L-1 BUCKET UPGRADE, NON-DESTRUCTIVE ROTOR EXAMINATION, FIELD ENGINEERING SERVICES	1,300,000.00
<p>FIRM PRICE:</p> <p>MATERIAL PO PN613MM \$1,800,000.00 LABOR PO PN7053MS \$550,000.00</p> <p>*** SEPERATE INVOICE FOR TAX TO BE ISSUED AT COMPLETION OF WORK SCOPE ***</p>	
TO INVOICE FOR PAYMENT #2 UPON SHIPMENT OF BUCKETS	1,300,000.00

TECHNICAL INFORMATION LETTER

To inform users of need to inspect low pressure rotor wheel dovetails on steam turbines to detect possible Stress Corrosion Cracking.

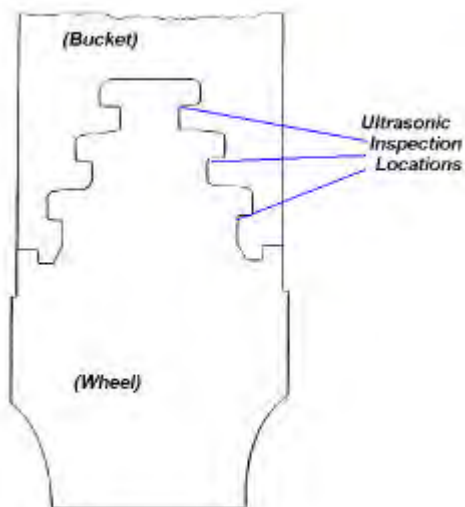
Figure 1. Tangential Dovetail

Over the past several years cases of intergranular Stress Corrosion Cracking (SCC) have been found in low pressure rotor dovetails of fossil steam turbine units with once through boilers. These rotors had been in service for extended periods. These incidents have involved both Tangential dovetails, figure 1.
And Finger dovetails, figure 2.

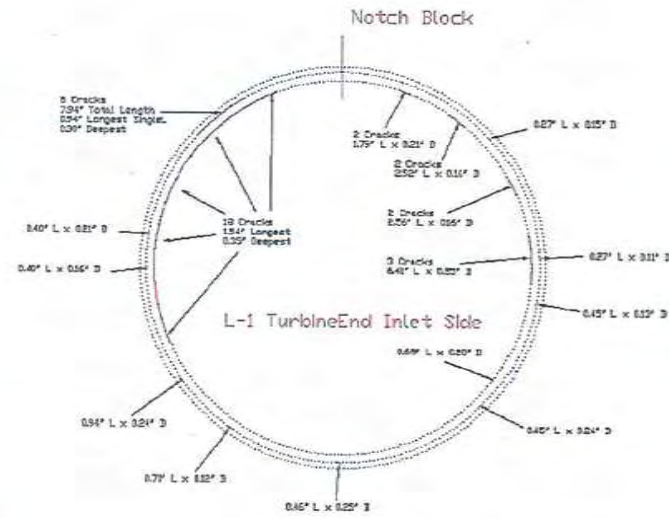
UNIT 1 – 2007 INSPECTION

- Cracking - all four wheels, all hooks
 - Unit 2 implications
 - Parallel paths to evaluate U1 and U2
 - Contacted vendors
 - GE, ReGENco, MD&A, SIA, Alstom, Turbine Masters, FOMIS (emergency request)
 - Multiple parallel paths to:
 - Verify WesDyne data
 - Investigate repair options (schedule, cost, service life)
 - Failure analysis U1 & U2
 - Gather U2 data (chemistry, operations, overspeeds, geometry, etc.)
 - Obtain industry data (FOMIS, vendors, other utilities)
- All agreed repair required, 0.375" cracks
- Alstom weld build-up selected
