List of Protocols
Sherco Unit No. 3 Root Cause Analysis

**Protocol for the Removal of the Damaged Rim (L-1) from the LP-B Rotor:
Sherburne County Generating Plant Unit 3 failure November 19, 2011
Becker, MN**

TEST PROTOCOL NO. 2**FOR SHERCO NO. 3 LP ROTOR-B FAILED L-1 RIM
ENGEL METALLURGICAL PROJECT 954-001**

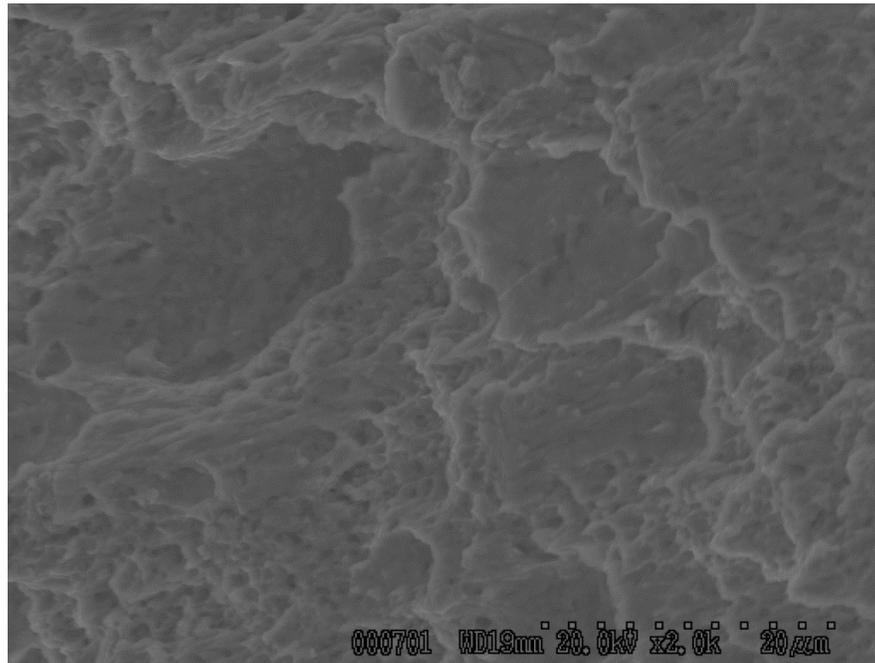
Fig. 329. Scanning electron microscope fractograph of generator shaft fracture subsegment "B", Area 2.

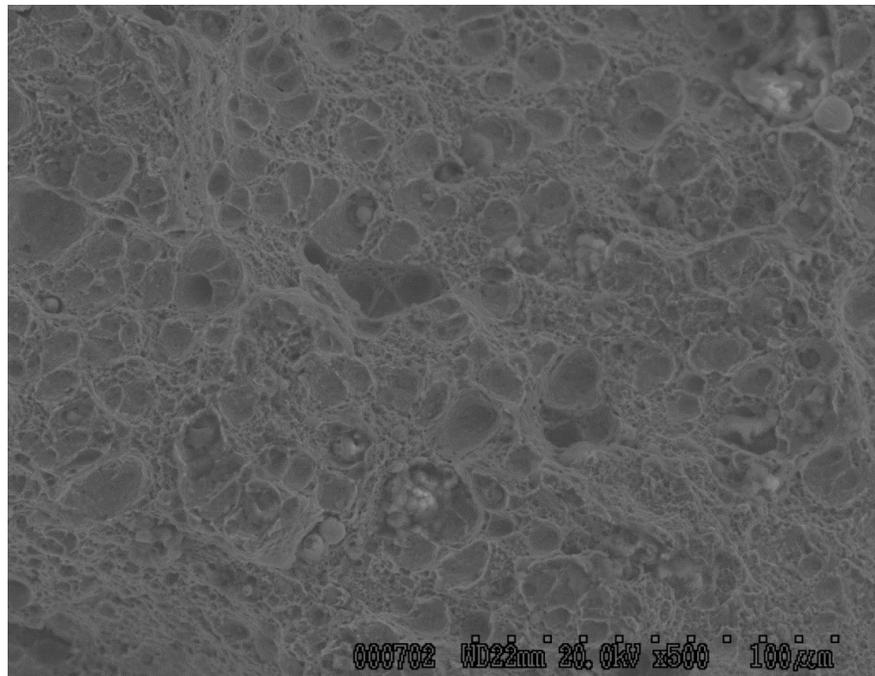
Fig. 330. Scanning electron microscope fractograph of generator shaft fracture subsegment "B", Area 3.

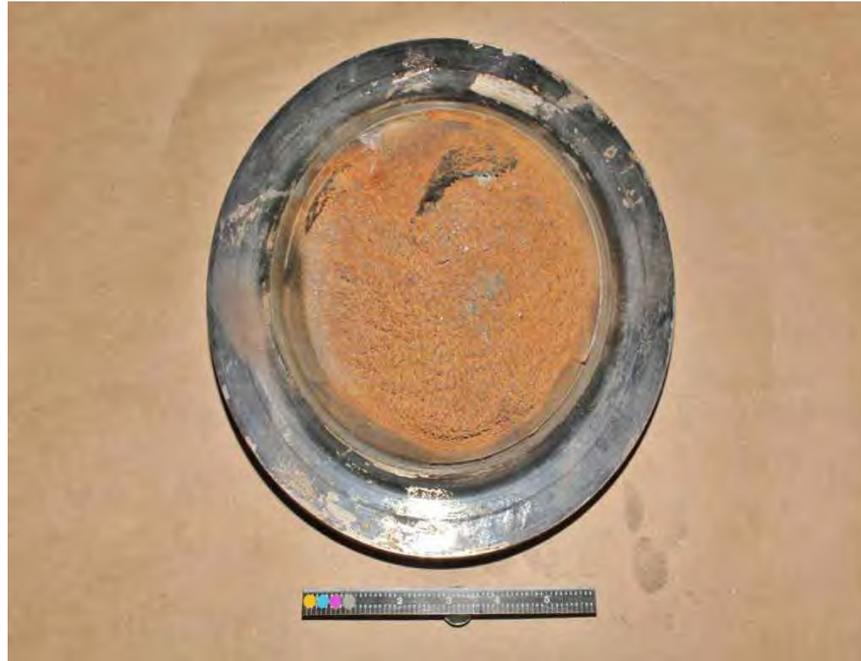
Fig 341. Close-up of fracture surface of exciter shaft fracture adjacent to the No. 11 bearing.

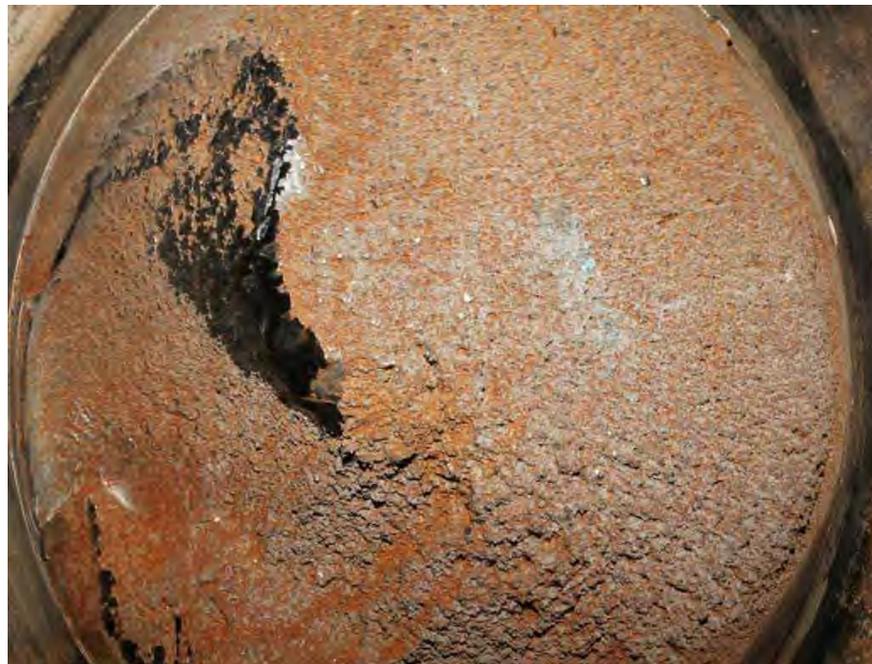
Fig. 342. Close-up of fracture surface of exciter shaft fracture adjacent to the No. 11 bearing

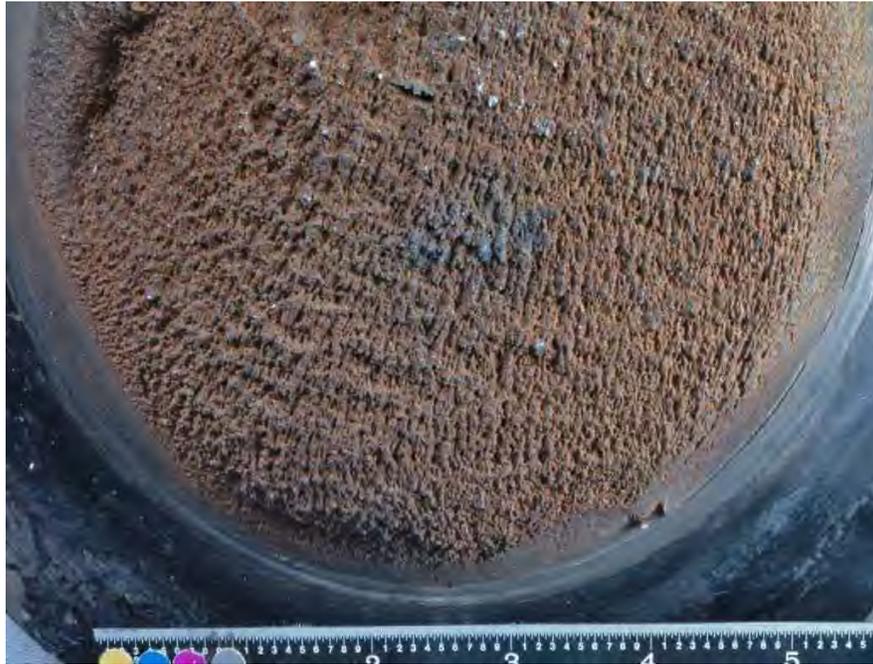
Fig. 343. Close-up of fracture surface of exciter shaft fracture adjacent to the No. 11 bearing

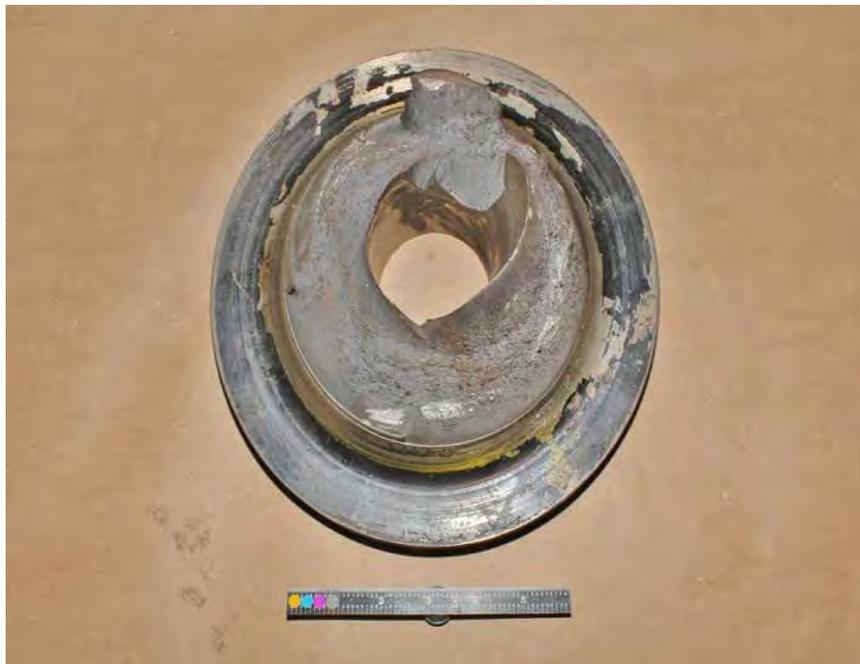
Fig. 344. Close-up of fracture surface of exciter shaft fracture adjacent to the No. 12 bearing.

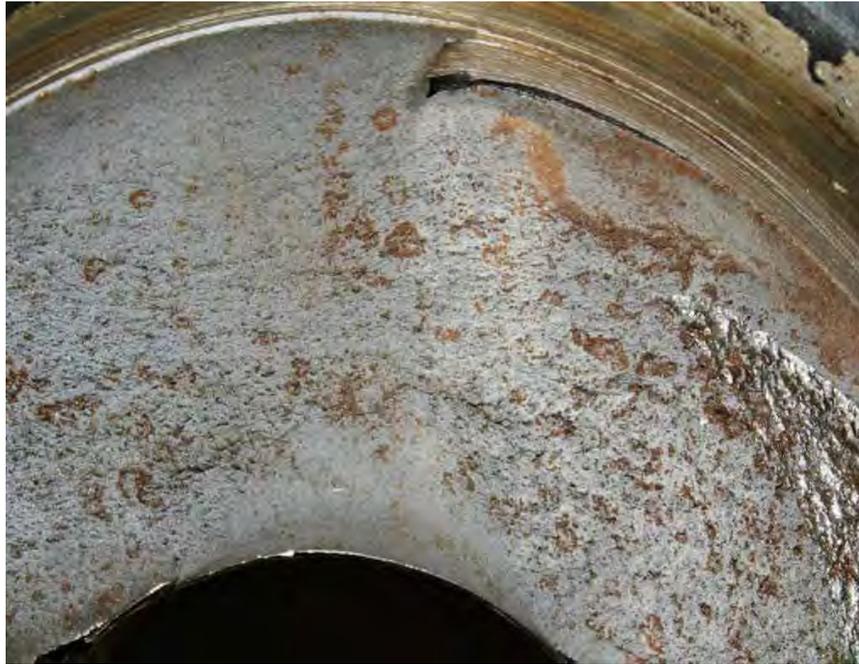
Fig. 347. Close-up of fracture surface of exciter shaft fracture adjacent to the No. 12 bearing.

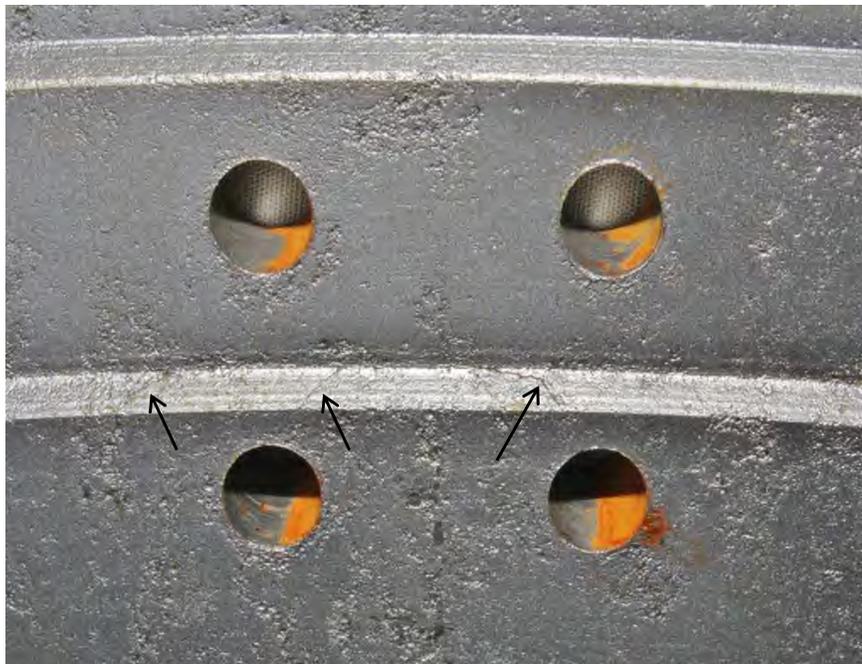
Fig. 383. Close-up photograph of turbine end L-1 finger pinned blade attachment from LP turbine "A" showing location of cracks (arrows).Pc "A2", side 2.

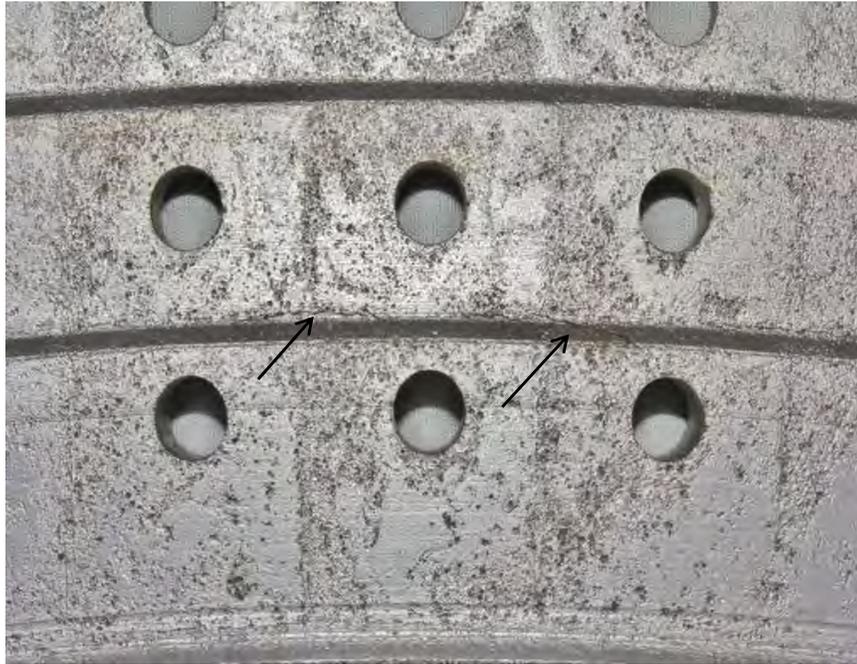
Fig. 384. Close-up photograph of turbine end L-1 finger pinned blade attachment from LP turbine "A" showing location of cracks (arrows).Pc "A3", side 1.

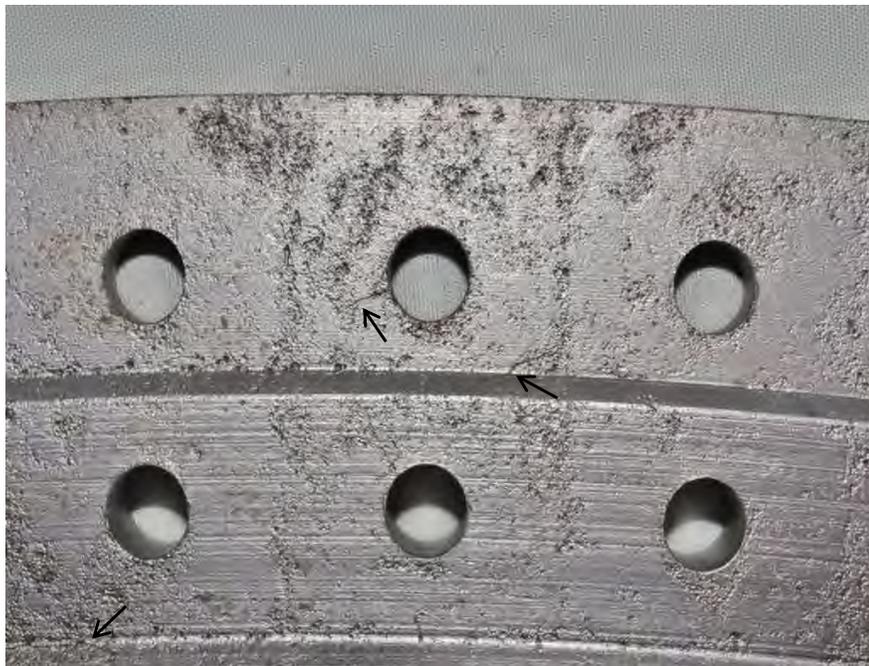
Fig. 385. Close-up photograph of turbine end L-1 finger pinned blade attachment from LP turbine "A" showing location of cracks (arrows).Pc "A3", side 2.

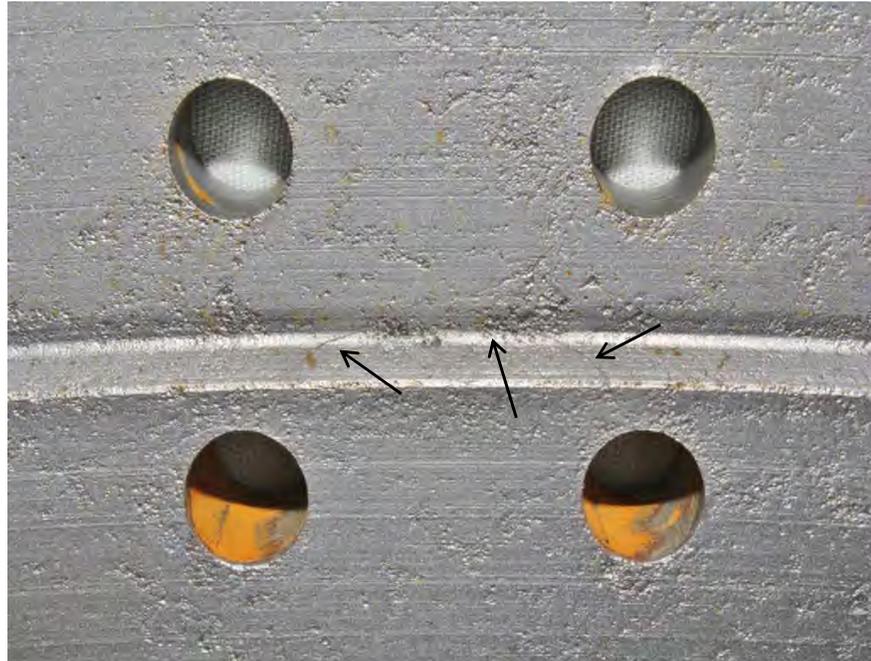
Fig 386. Close-up photograph of generator end L-1 finger pinned blade attachment from LP turbine "A" showing location of cracks (arrows). Pc "A2", side 1.

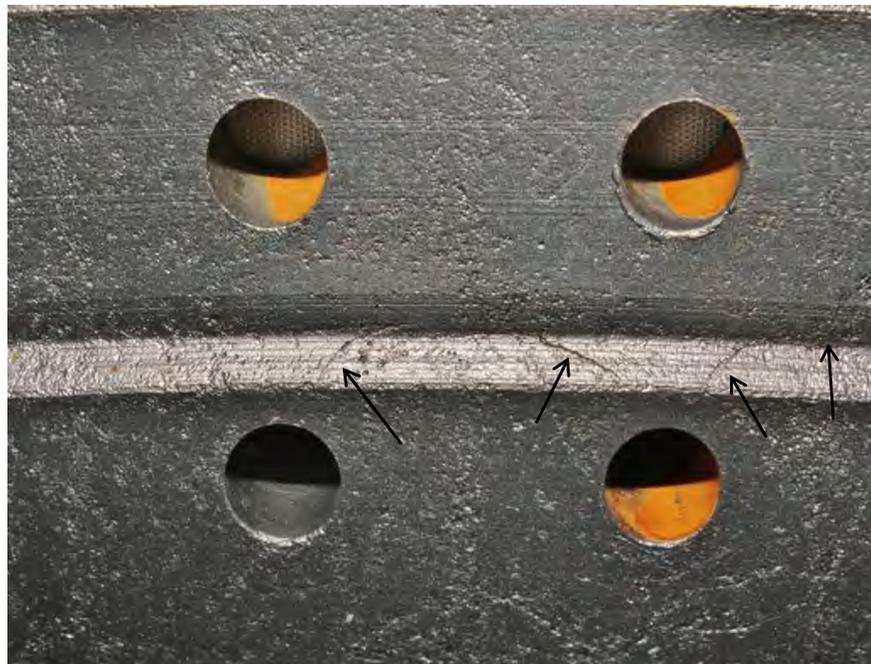
Fig. 387. Close-up photograph of generator end L-1 finger pinned blade attachment from LP turbine "A" showing location of cracks (arrows). Pc "A2", side 2.

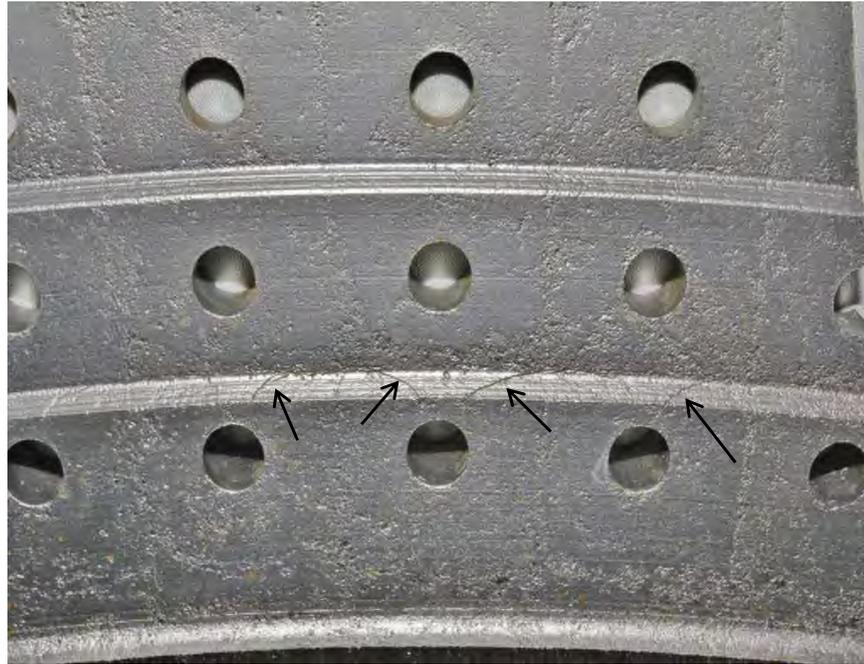
Fig. 388. Close-up photograph of generator end L-1 finger pinned blade attachment from LP turbine "A" showing location of cracks (arrows).Pc "A3", side 1.

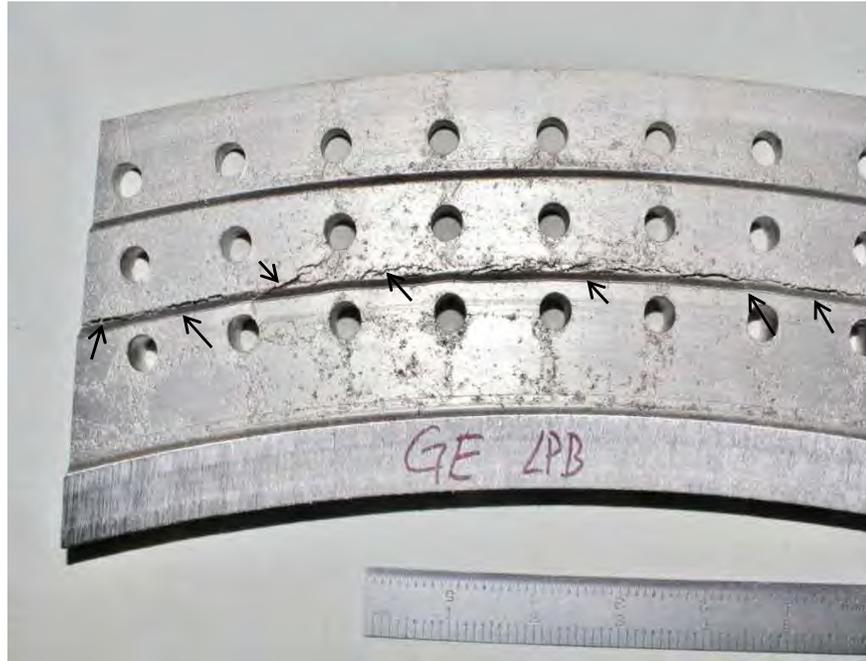
Fig. 390. Close-up photograph of generator end L-1 finger pinned blade attachment from LP turbine "B" showing location of cracks (arrows).Pc "A2", side 1.

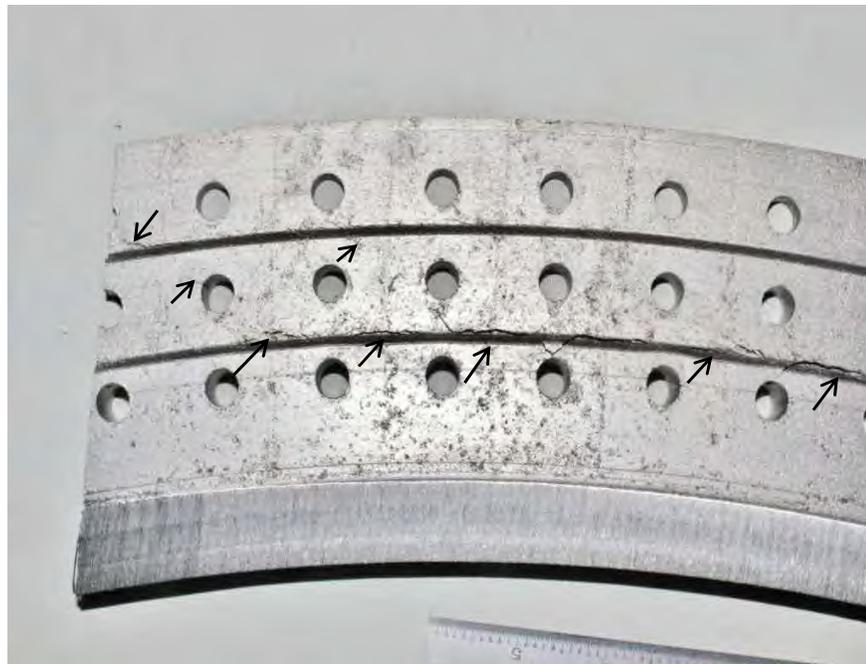
Fig. 391. Close-up photograph of generator end L-1 finger pinned blade attachment from LP turbine "B" showing location of cracks (arrows). Pc "A2", side 2.

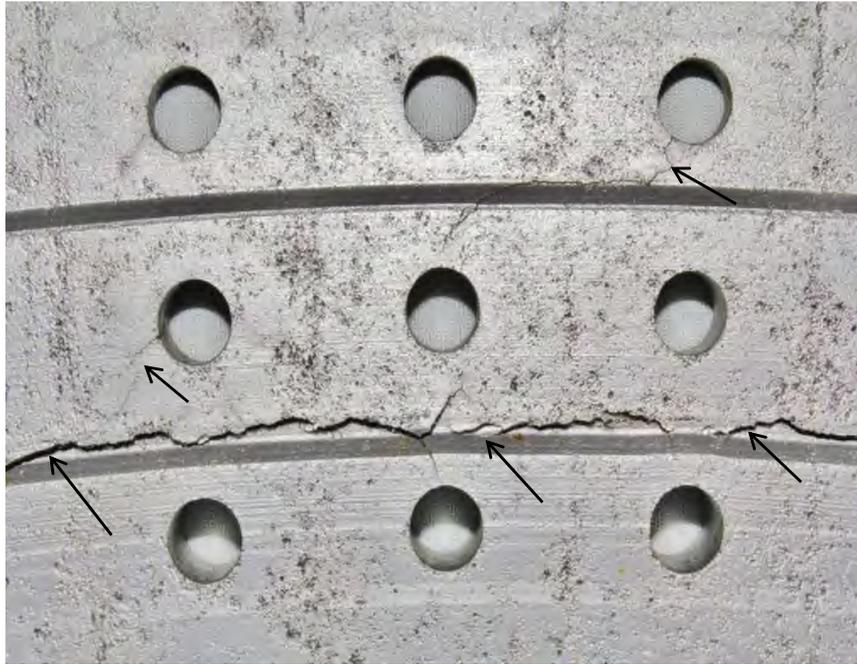
Fig. 392. Close-up photograph of generator end L-1 finger pinned blade attachment from LP turbine "B" showing location of cracks (arrows). Pc "A3", side 1.

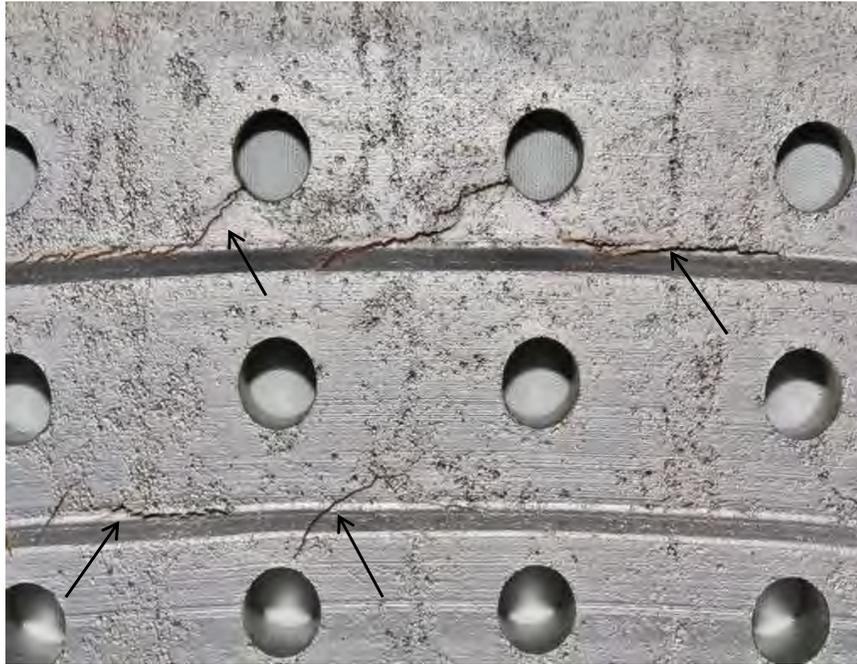
Fig. 394. Close-up photograph of generator end L-1 finger pinned blade attachment from LP turbine "B" showing location of cracks (arrows). Pc "A4", side 1.

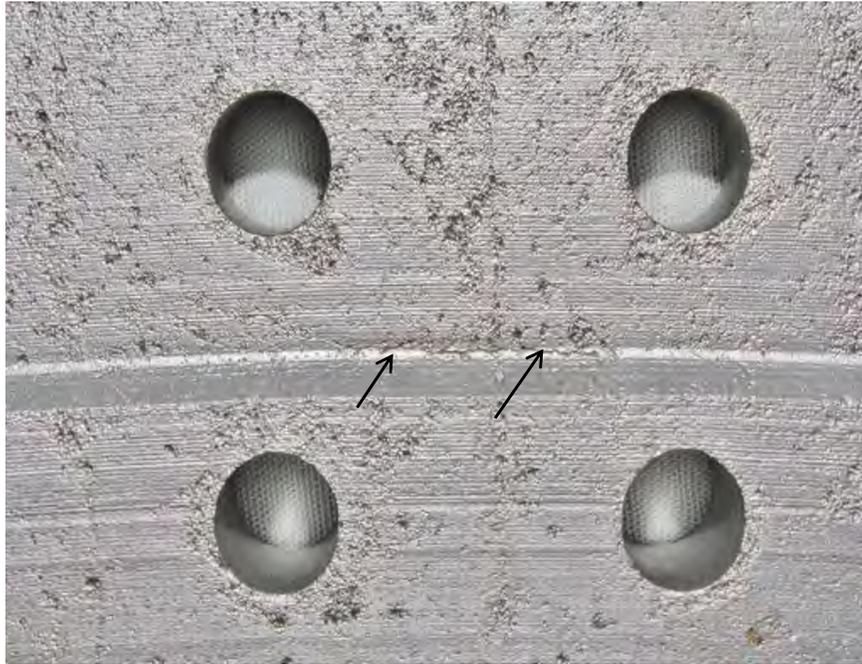
Fig. 396. Close-up photograph of generator end L-1 finger pinned blade attachment from LP turbine "B" showing location of cracks (arrows).Pc "A5", side 1.

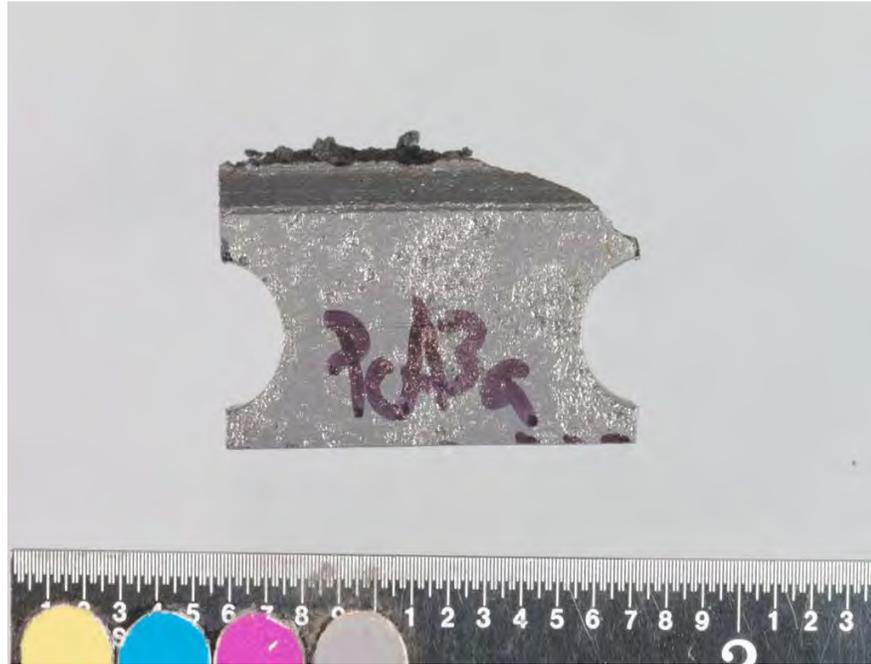
Fig. 398. Close-up photograph of subsegment A3a from LP turbine "A" containing a circumferential crack shown in Fig. 397.

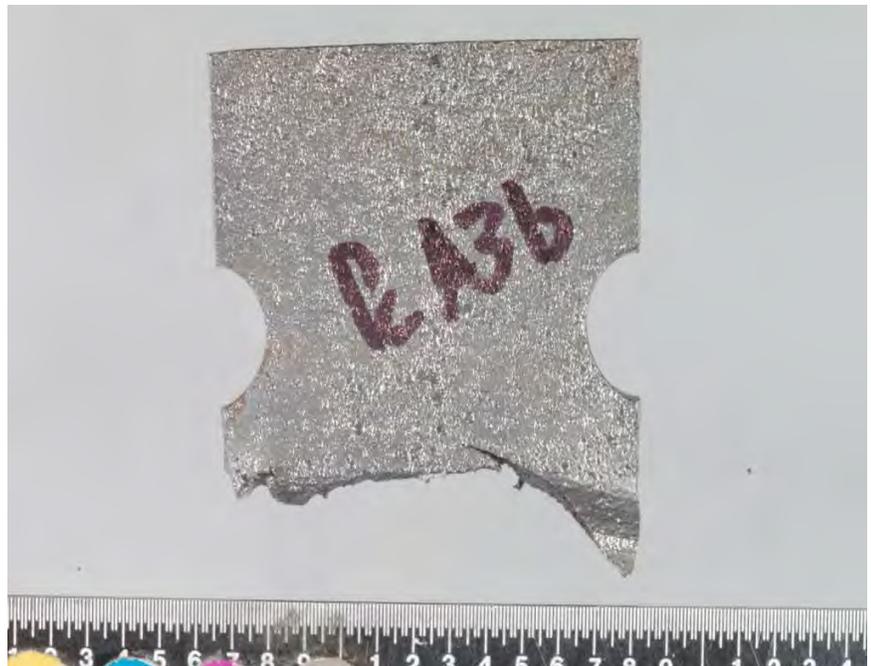
Fig. 399. Close-up photograph of subsegment A3b from LP turbine "A" containing a circumferential crack shown in Fig. 397.

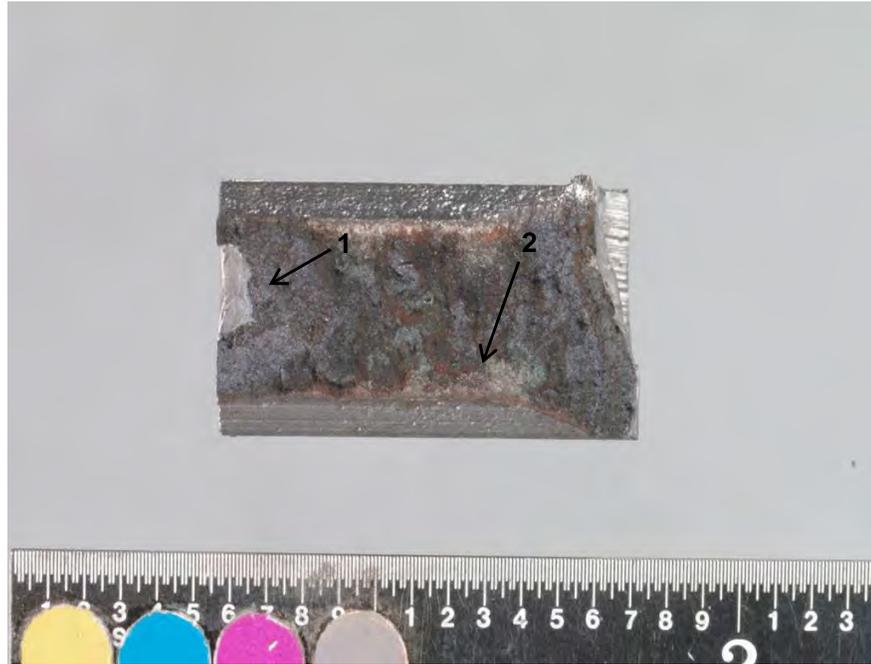
Fig. 400. Close-up photograph of crack surface from subsegment A3a shown in Fig. 398. Arrows show areas examined by scanning electron microscopy.

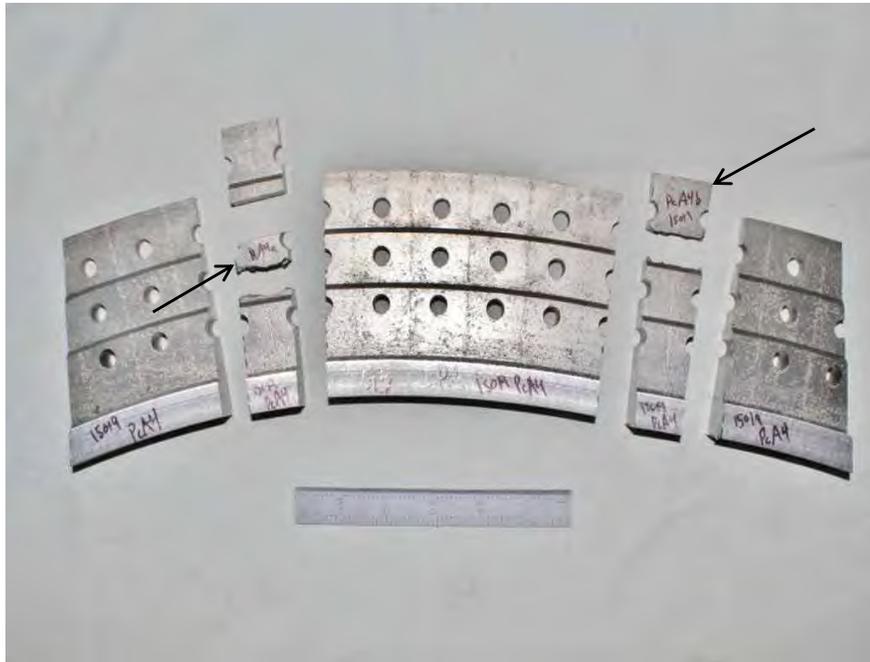
Fig. 403. Generator end finger pinned blade attachment, Pc A4, from LP turbine "A" showing sectioning of cracks (arrows) for further examination.

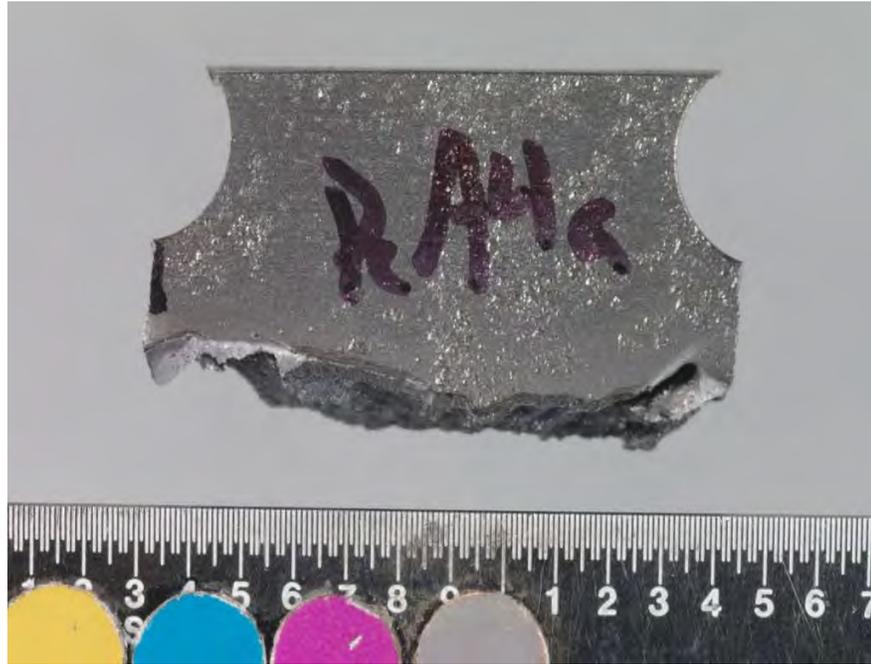
Fig. 404. Close-up photograph of subsegment A4a from LP turbine "A" containing a circumferential crack shown in Fig 403.

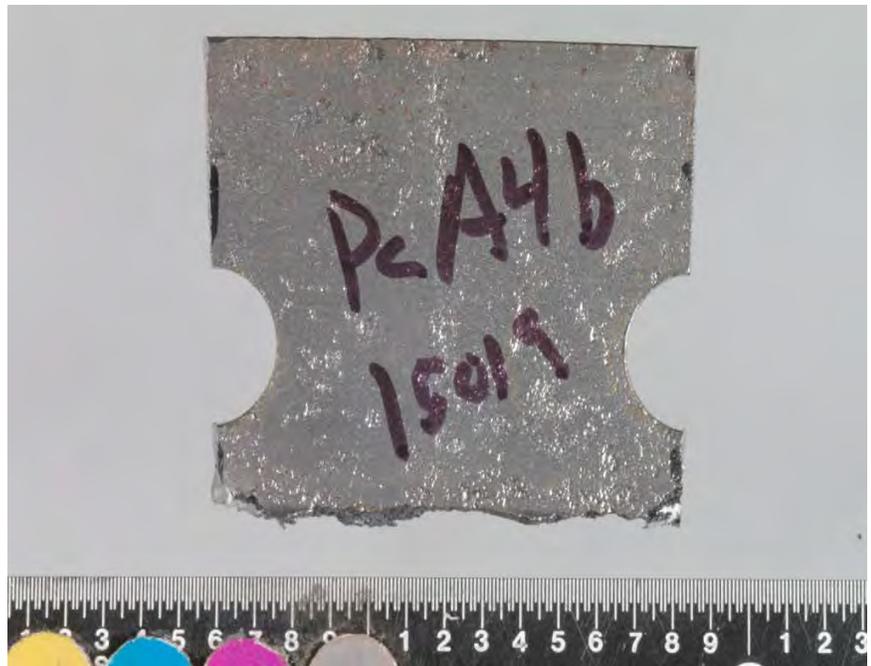
Fig. 405. Close-up photograph of subsegment A4b from LP turbine "A" containing a circumferential crack shown in Fig 403.

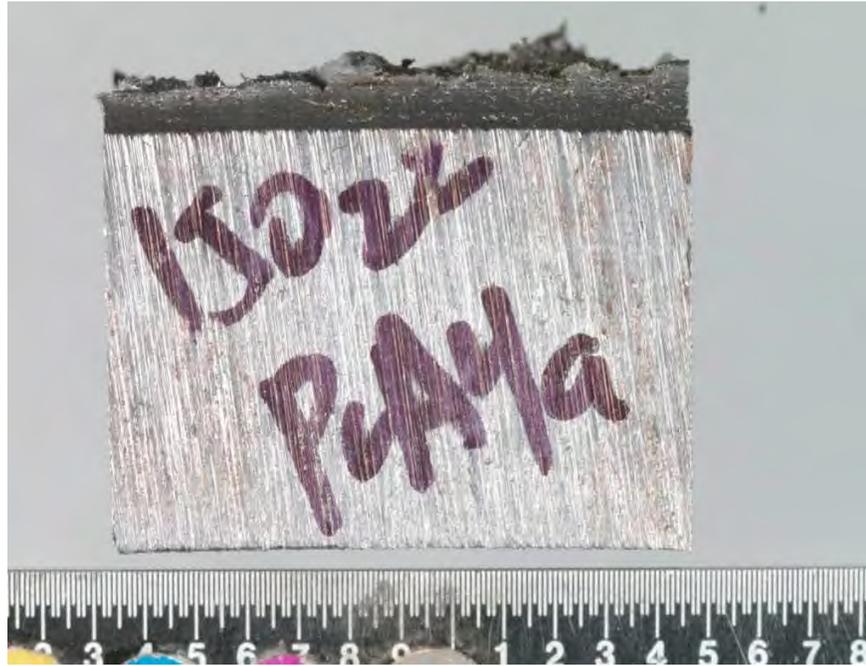
Fig. 410. Close-up photograph of subsegment A4a from LP turbine "B" containing circumferential crack shown in Fig 409.

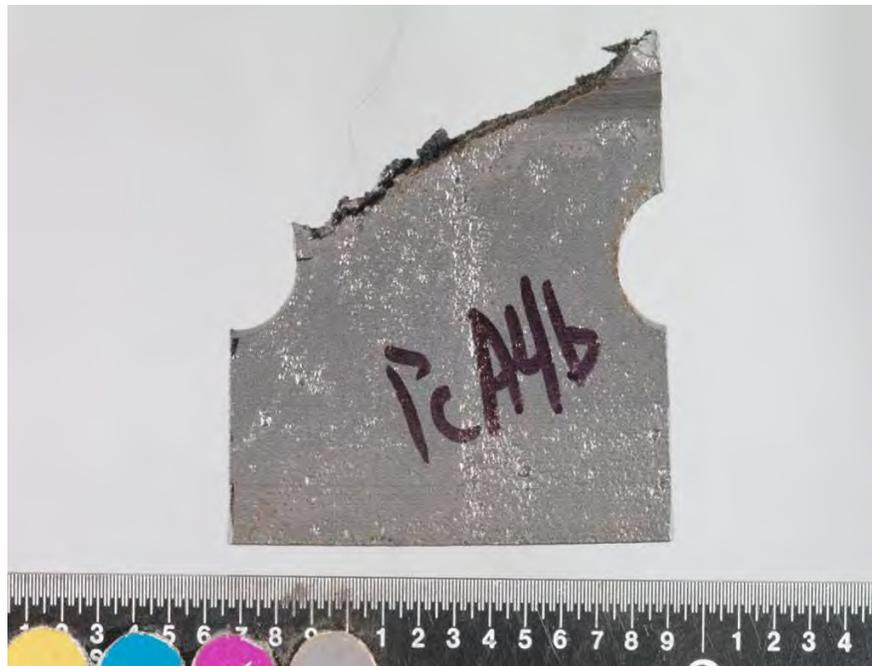
Fig. 411. Close-up photograph of subsegment A4b from LP turbine "B" containing a circumferential/radial crack shown in Fig 409.
