SHADOW FLICKER ASSESSMENT LAKE BENTON, MINNESOTA, USA

Report:
Document 2.0

Report Standard:
ASSESSMENT

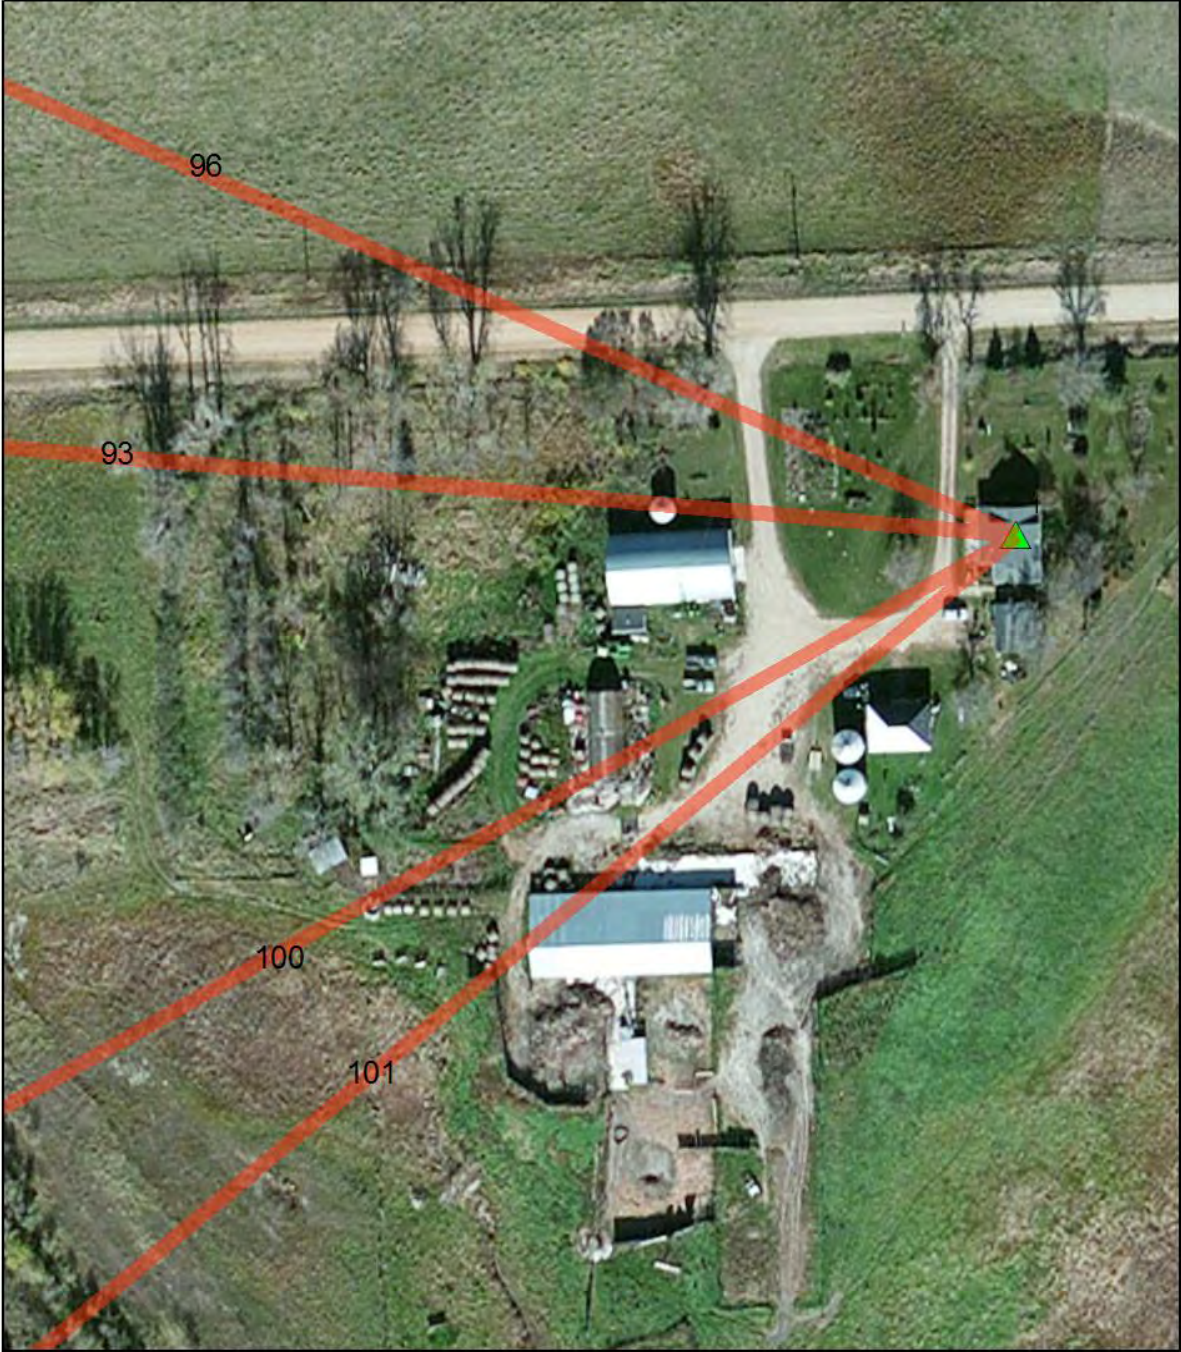
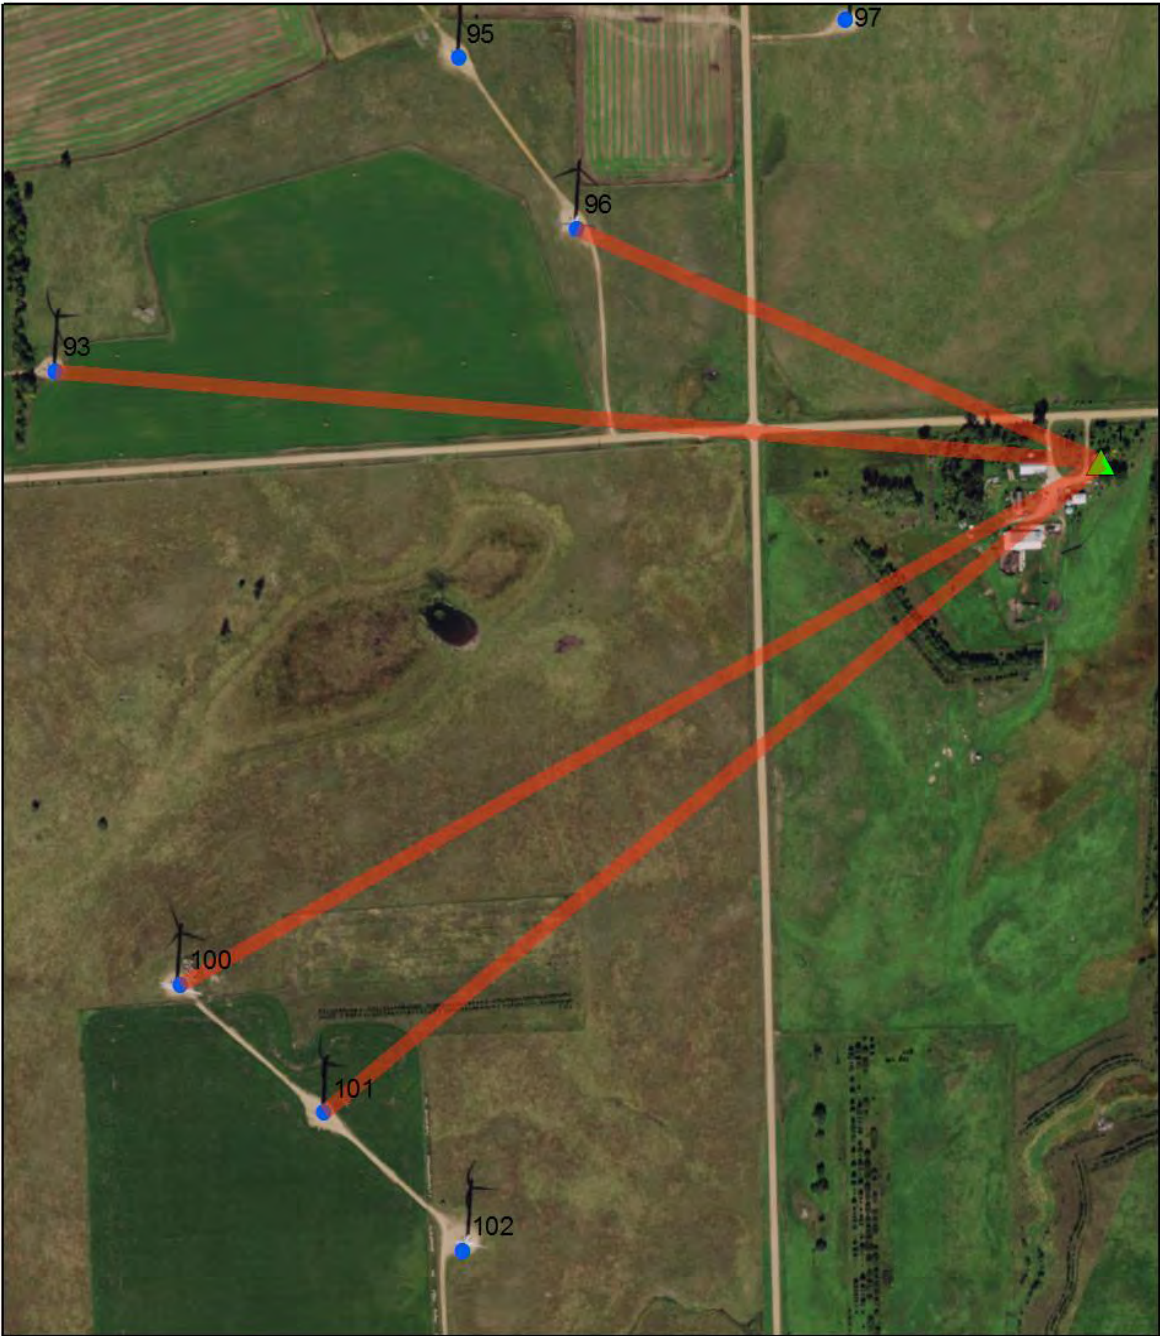
Figure 5. Receptor 1 Aerial Image with Line of Site from Turbines

Receptor 1: Obstructions mostly mitigate shadow flicker, with a range of 6 hours to 11 hours per year expected.

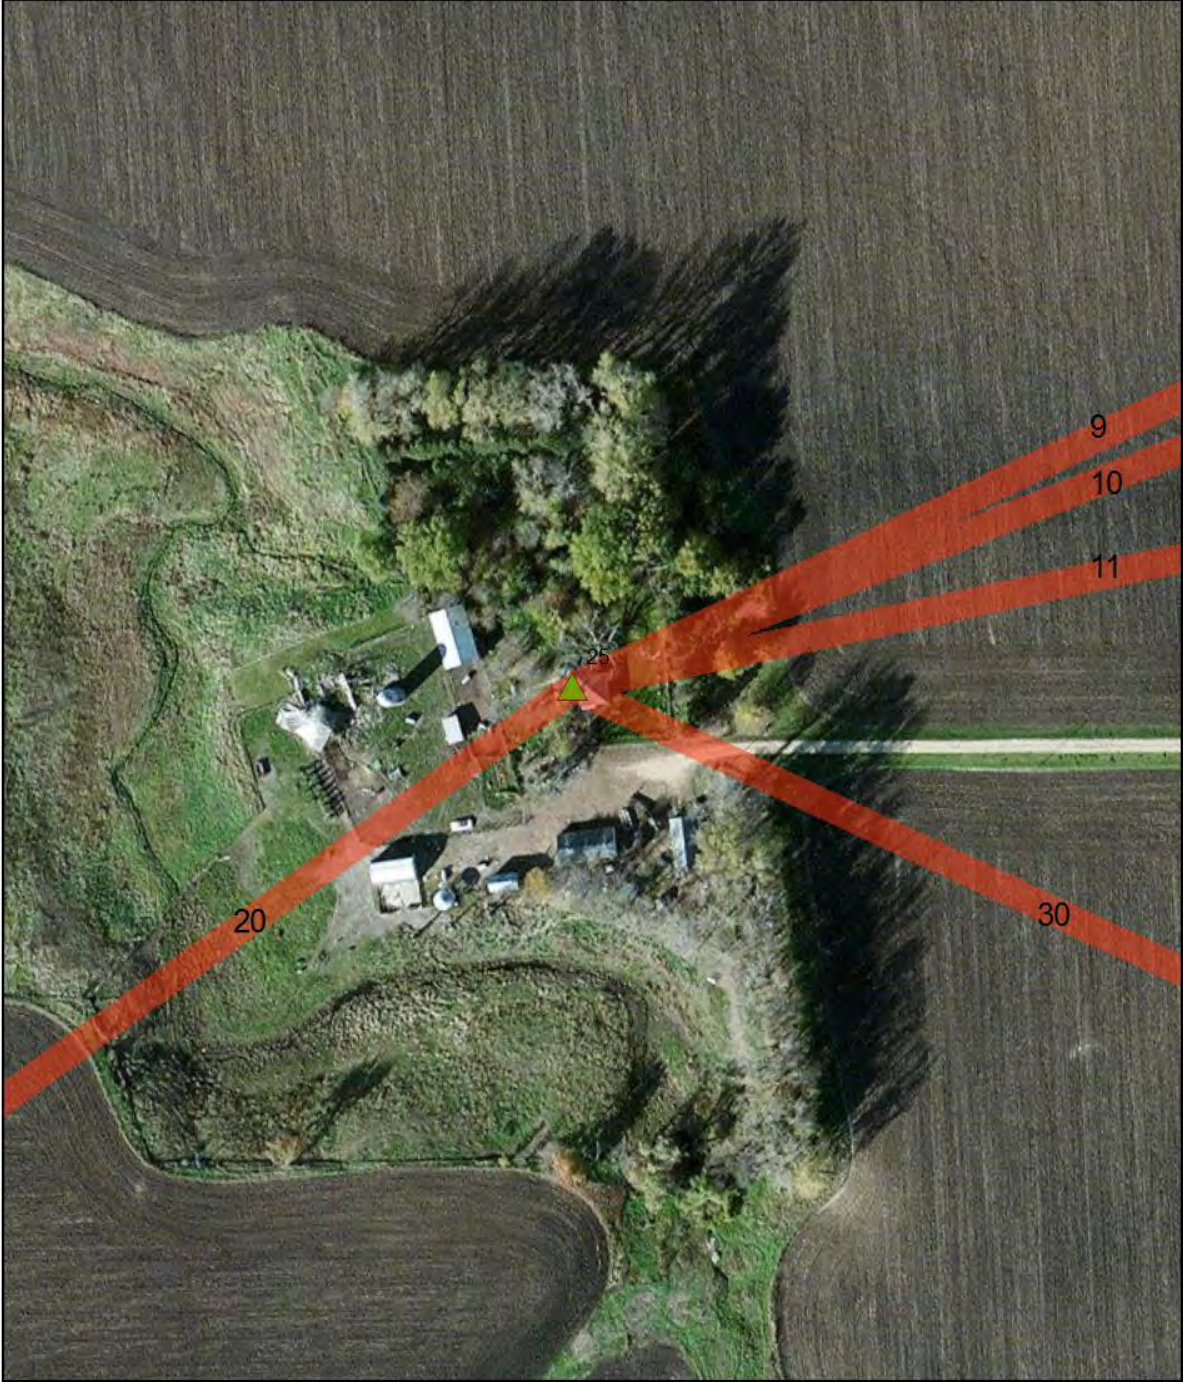
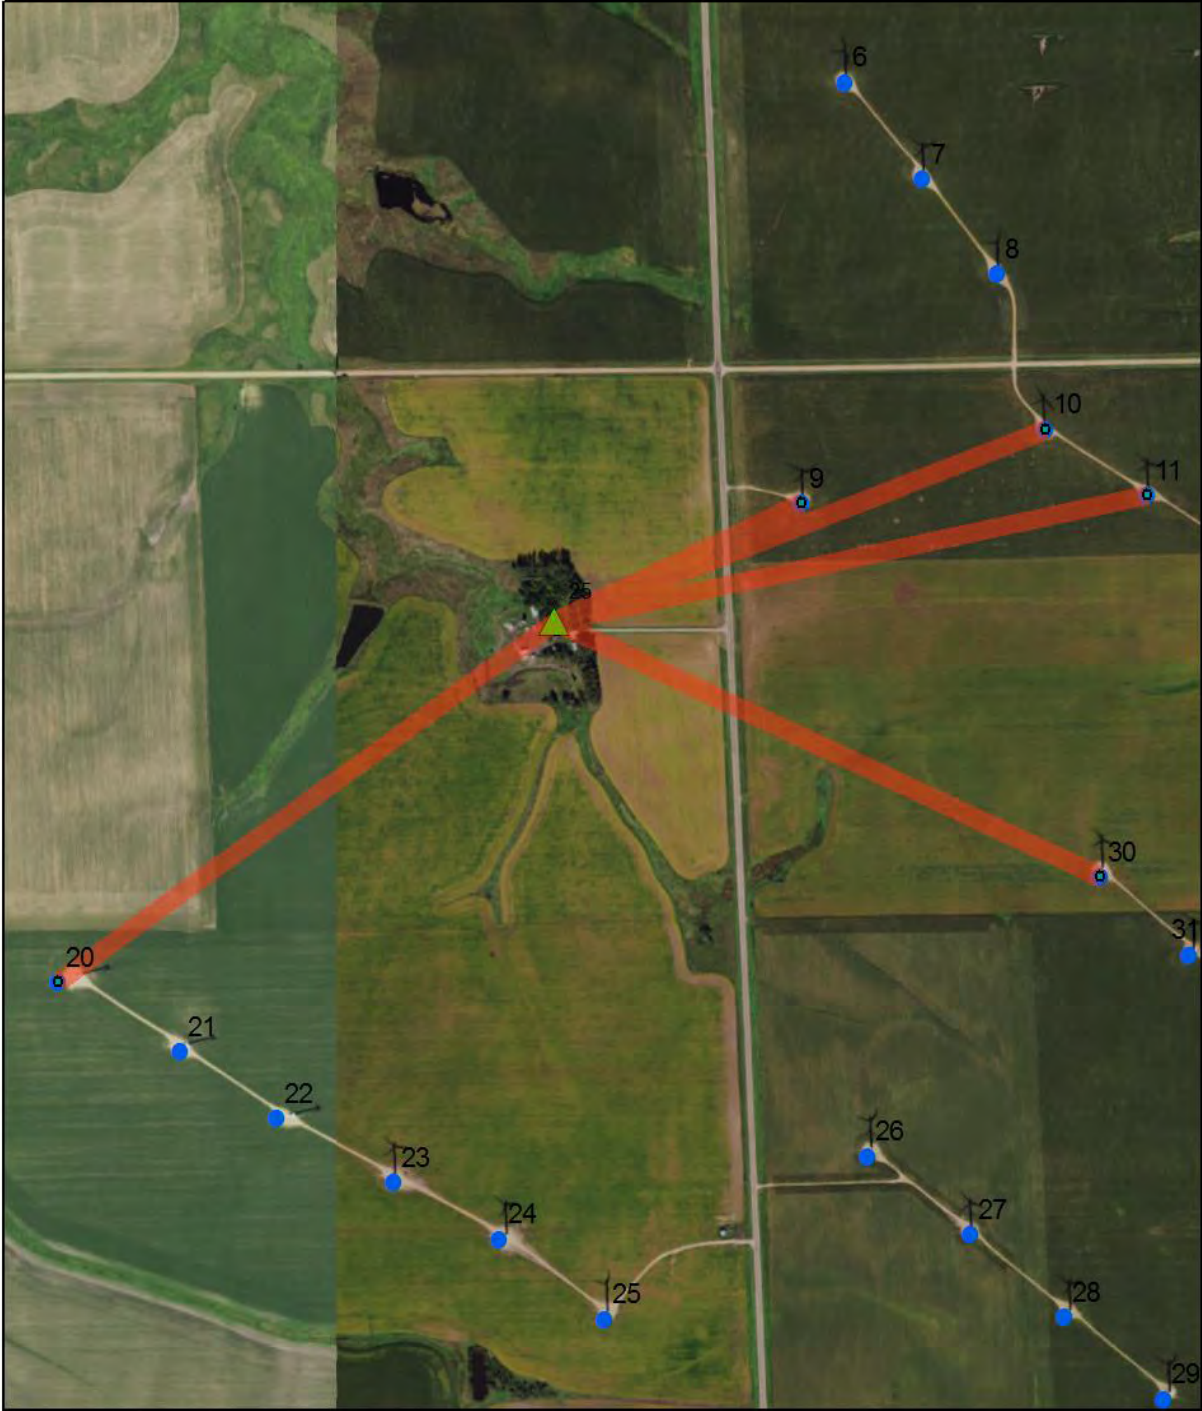
Figure 9. Receptor 25 Aerial Image with Line of Site from Turbines

Receptor 25: Obstructions mitigate shadow flicker, with a range of 1 to 2 hours per year expected.

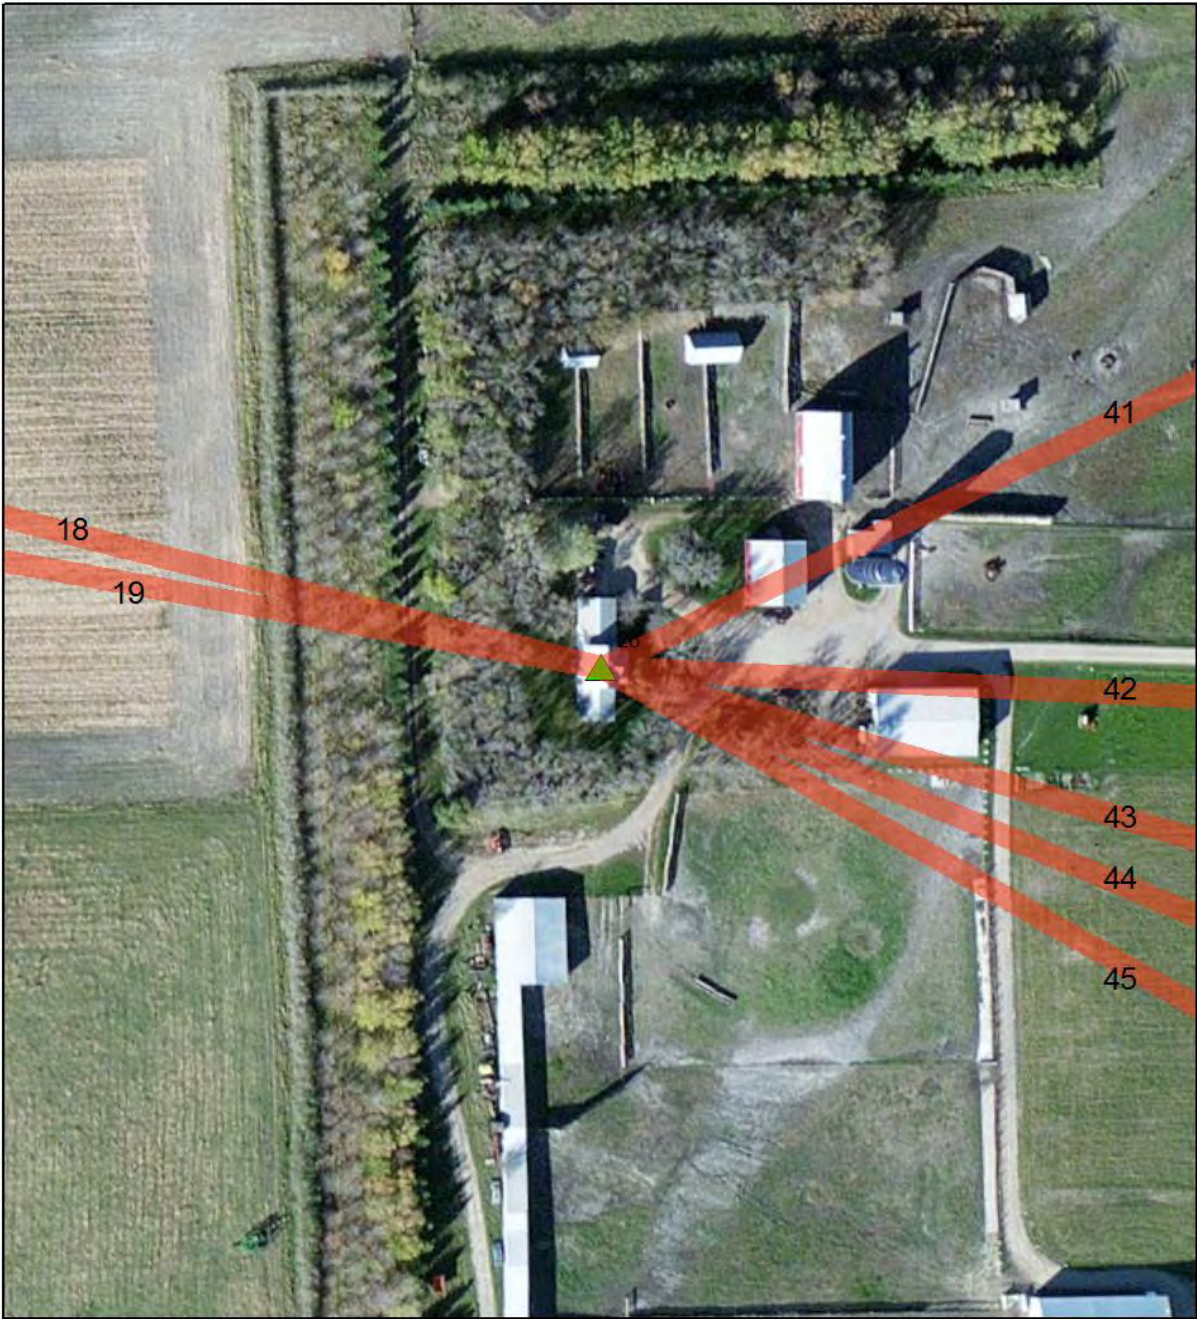
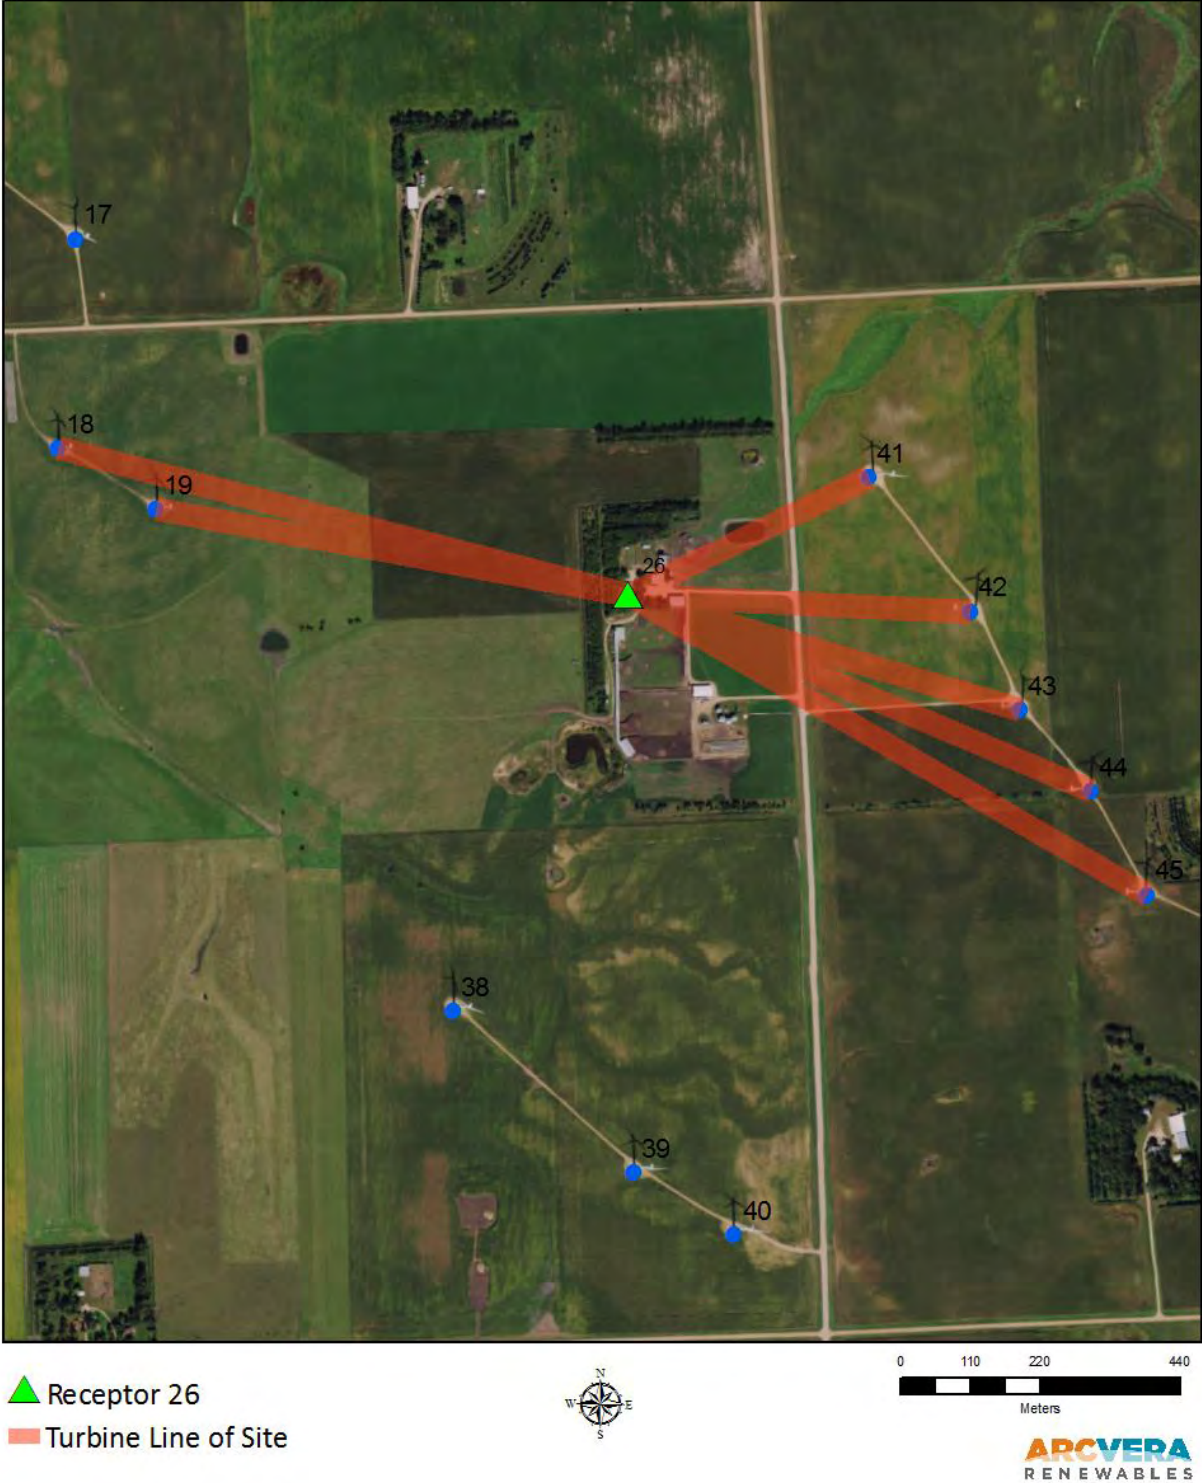
Figure 13. Receptor 26 Aerial Image with Line of Site from Turbines

Receptor 26: Obstructions mostly mitigate shadow flicker to about 5 hours per year, although northern windows could experience more shadow flicker with a range of 24 to 40 hours per year.

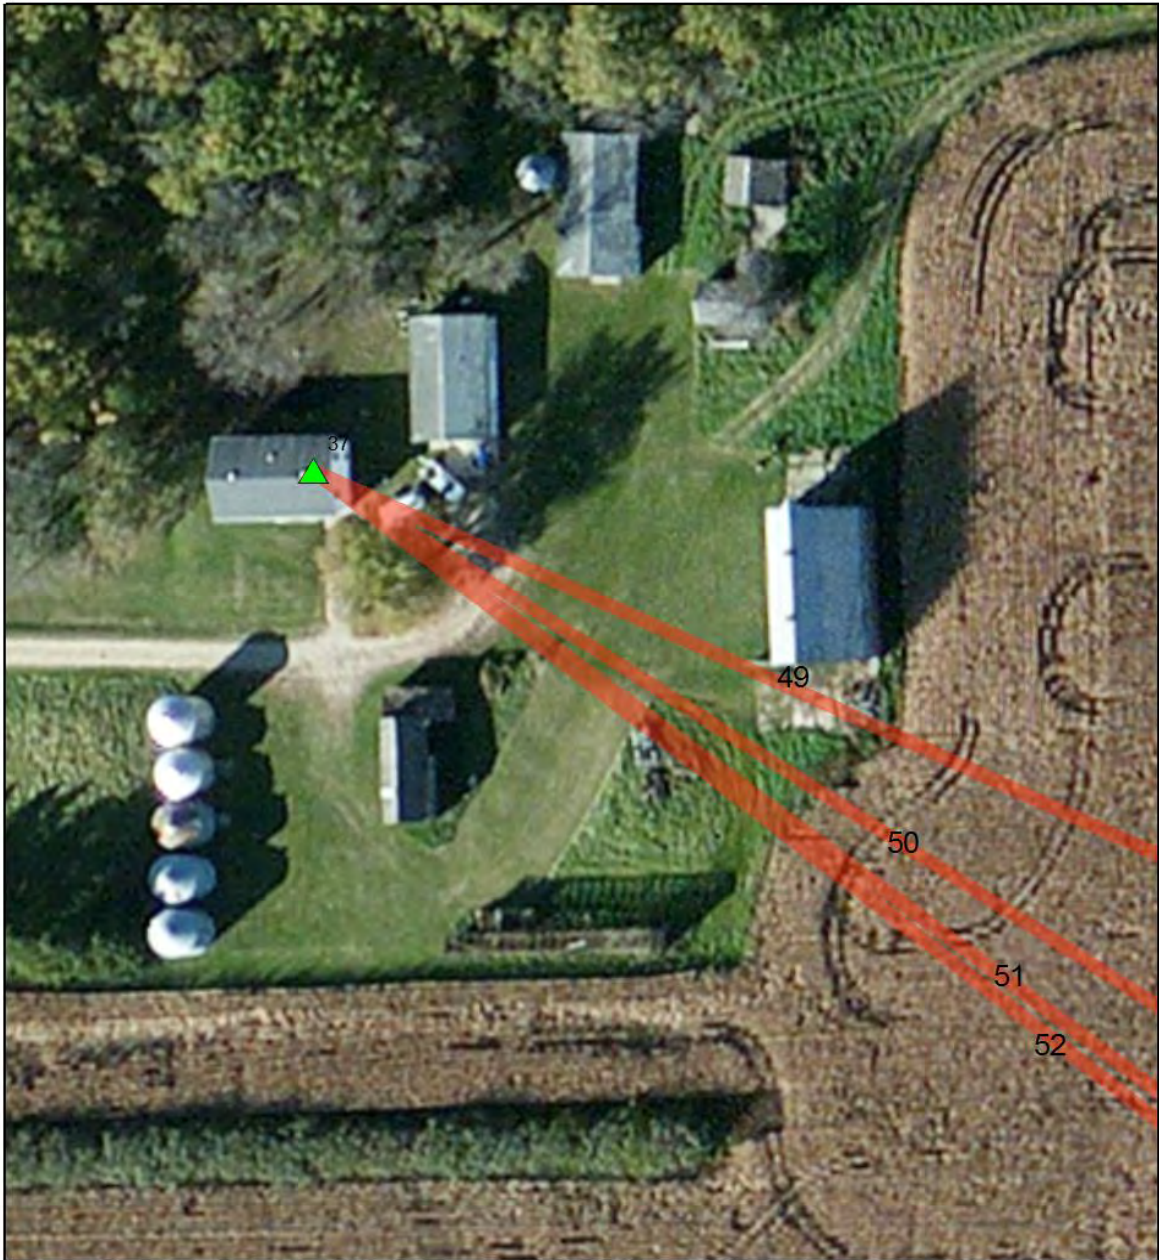
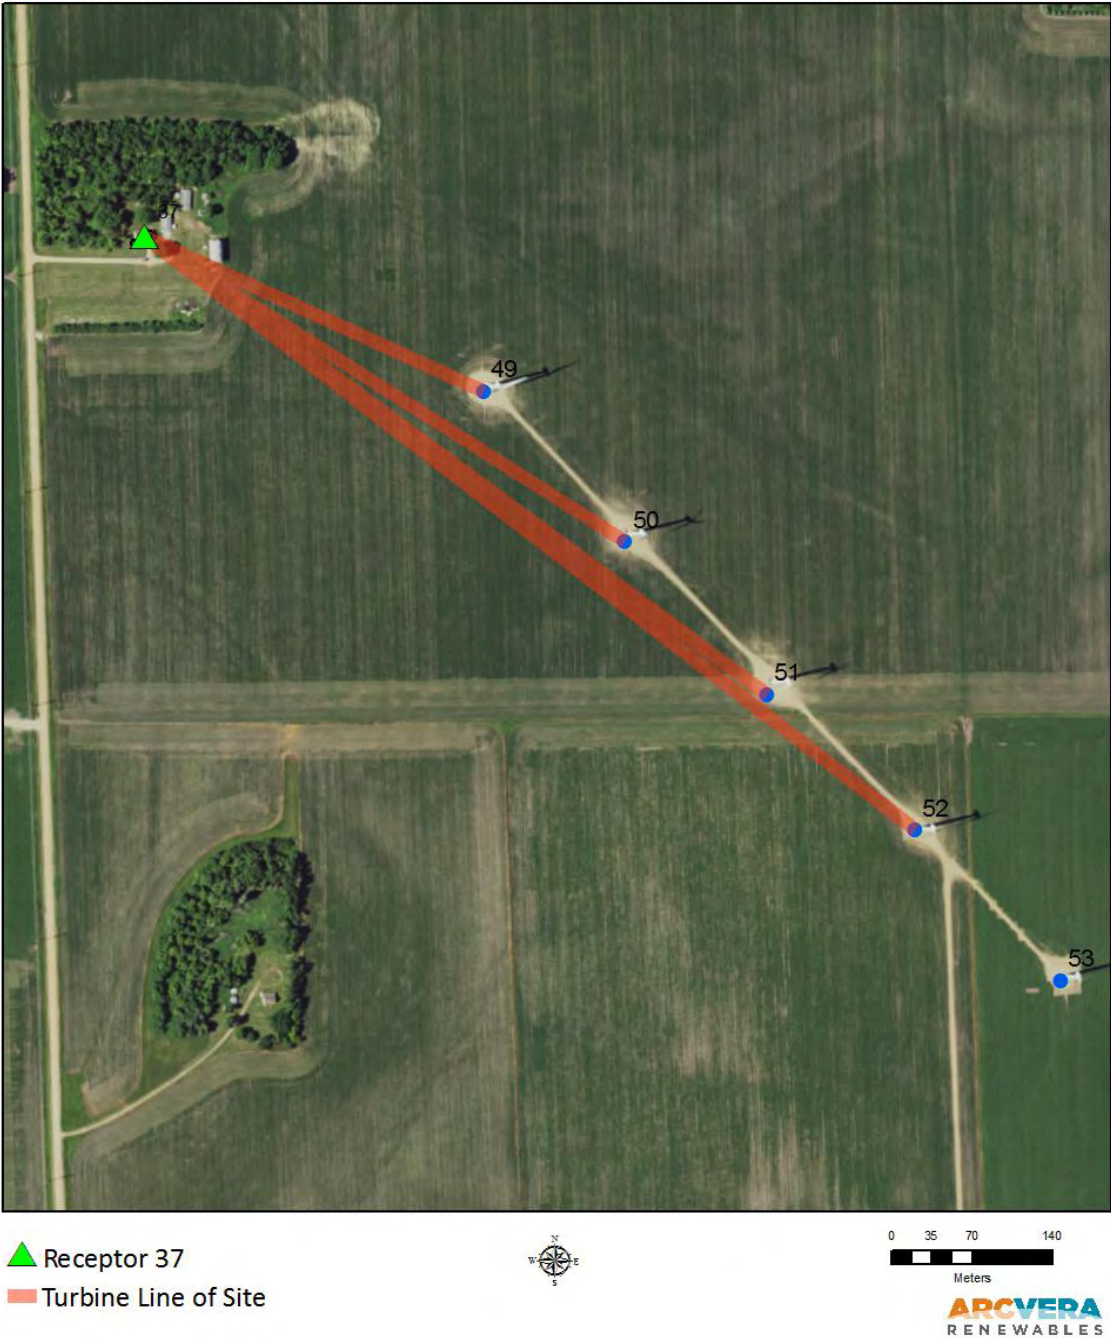
Figure 17. Receptor 37 Aerial Image with Line of Site from Turbines

Receptor 37: The lack of tree and building obstructions shows no mitigation of shadow flicker. Including cloud cover, the expected range of shadow flicker is expected to be within 26 to 40 hours per year.

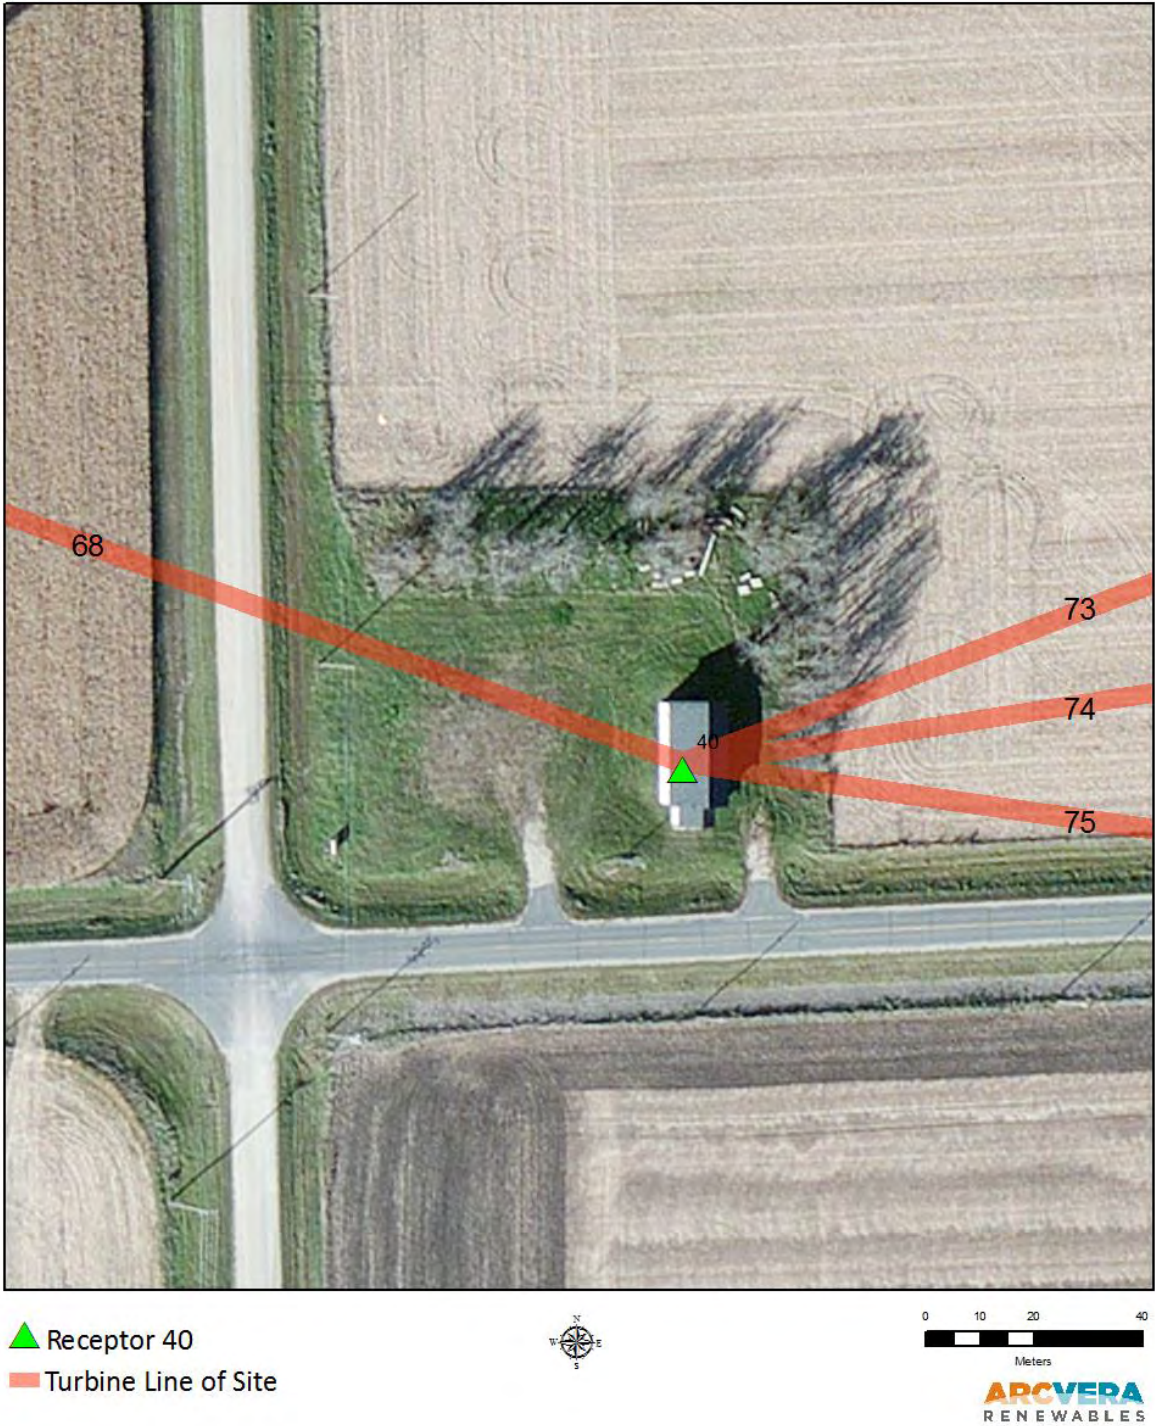
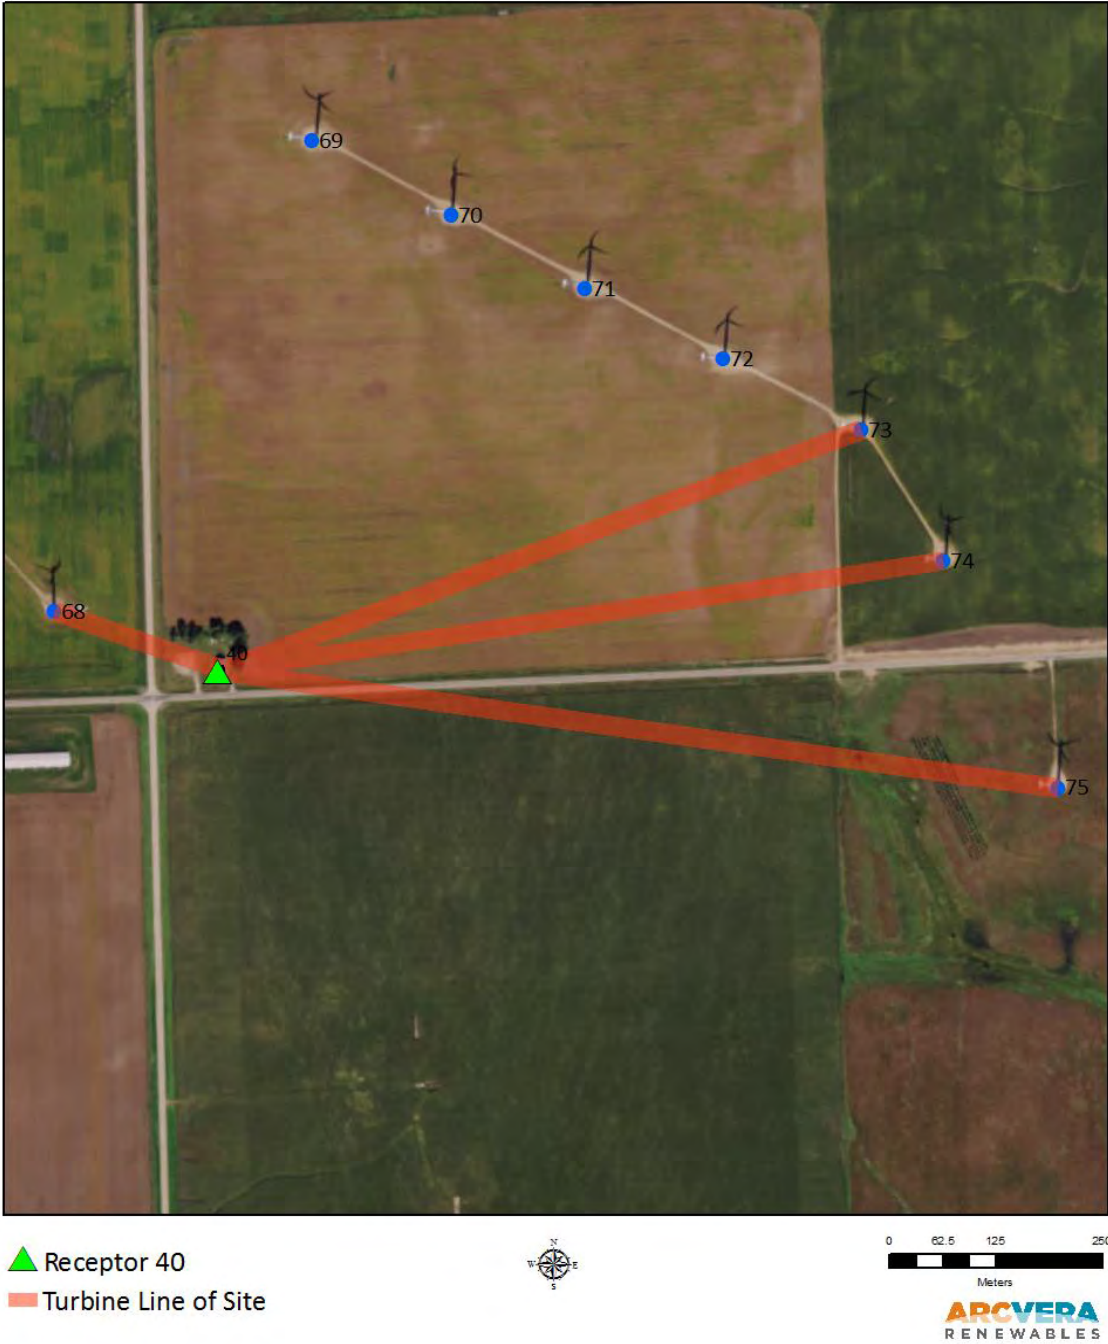
Figure 21. Receptor 40 Aerial Image with Line of Site from Turbines

Receptor 40: Receptor 40 is a town hall, and not occupied on a daily basis. There are no building obstructions. Deciduous trees to the north and west provide some blockage. Expected shadow flicker ranges from 37 to 47 hours per year.

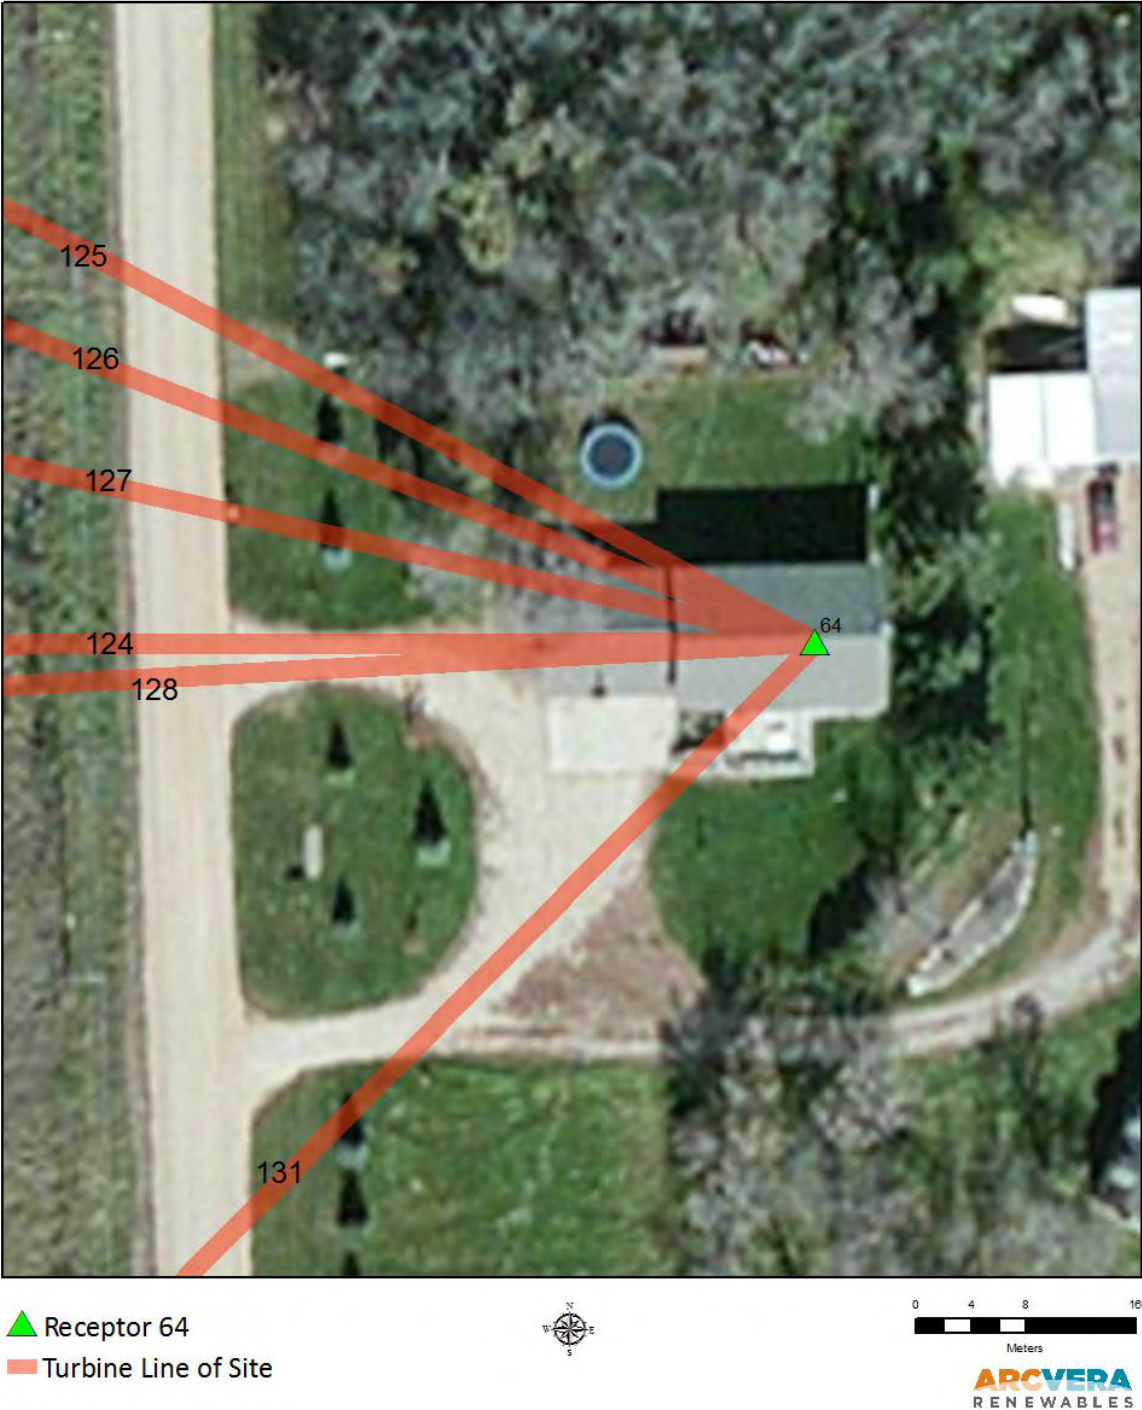
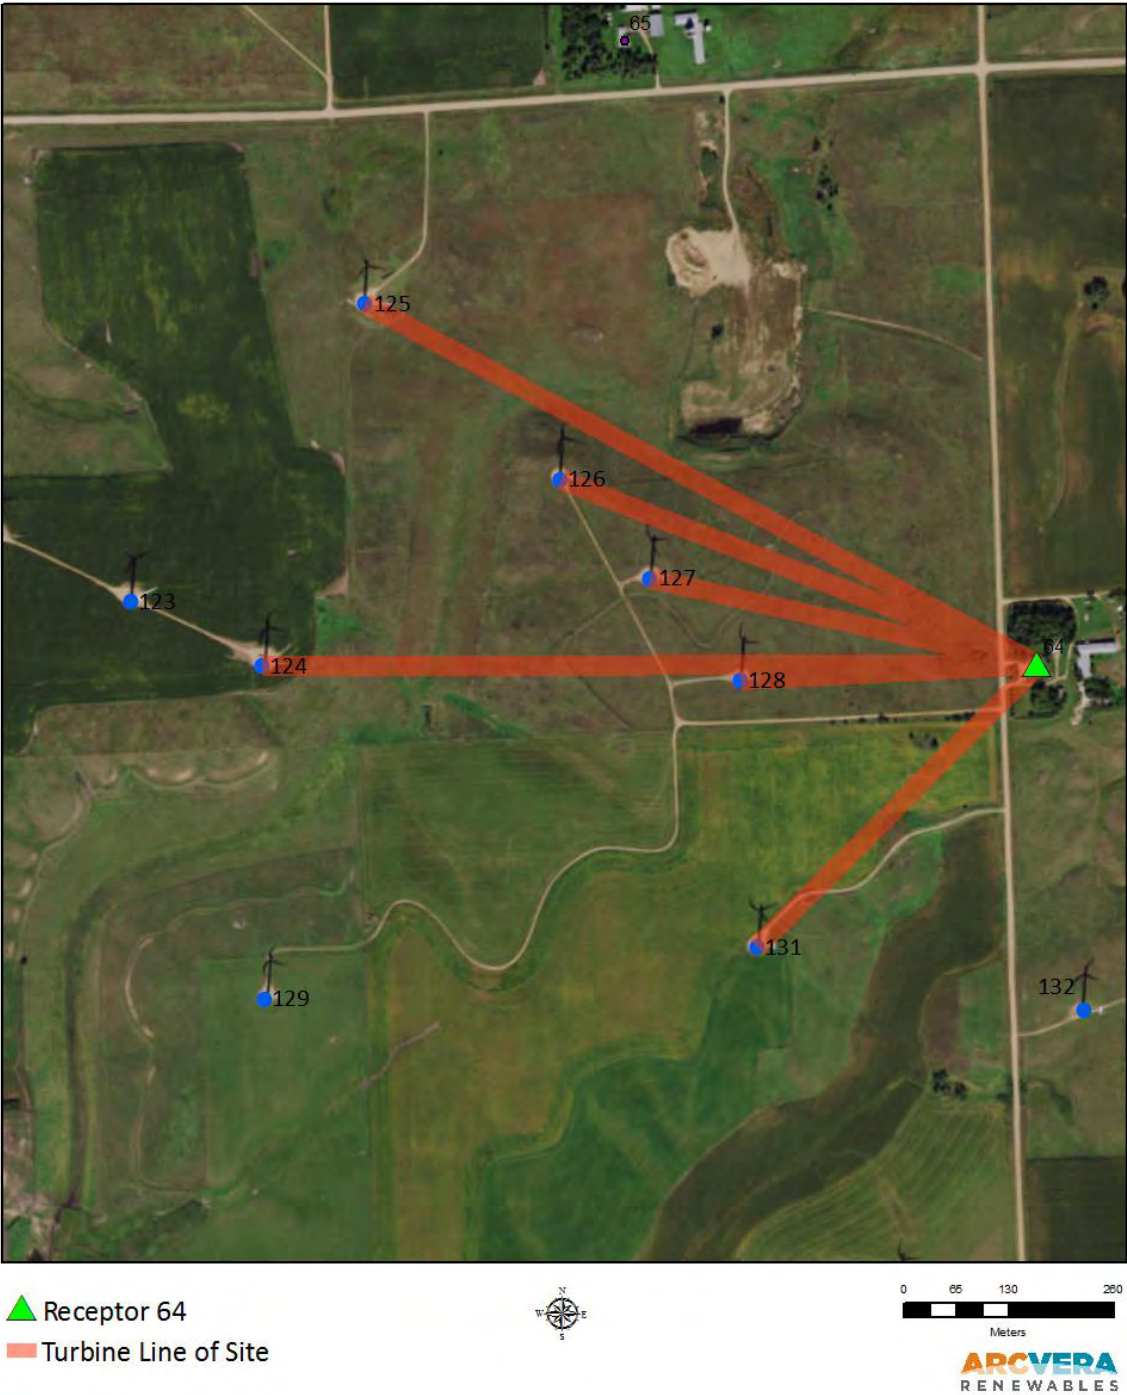
Figure 25. Receptor 64 Aerial Image with Line of Site from Turbines

Receptor 64: No buildings provide blockage for shadow flicker, and many of the trees in line with turbines are scattered. This results in high uncertainty for this receptor, with a range of 18 to 43 hours per year of shadow flicker.

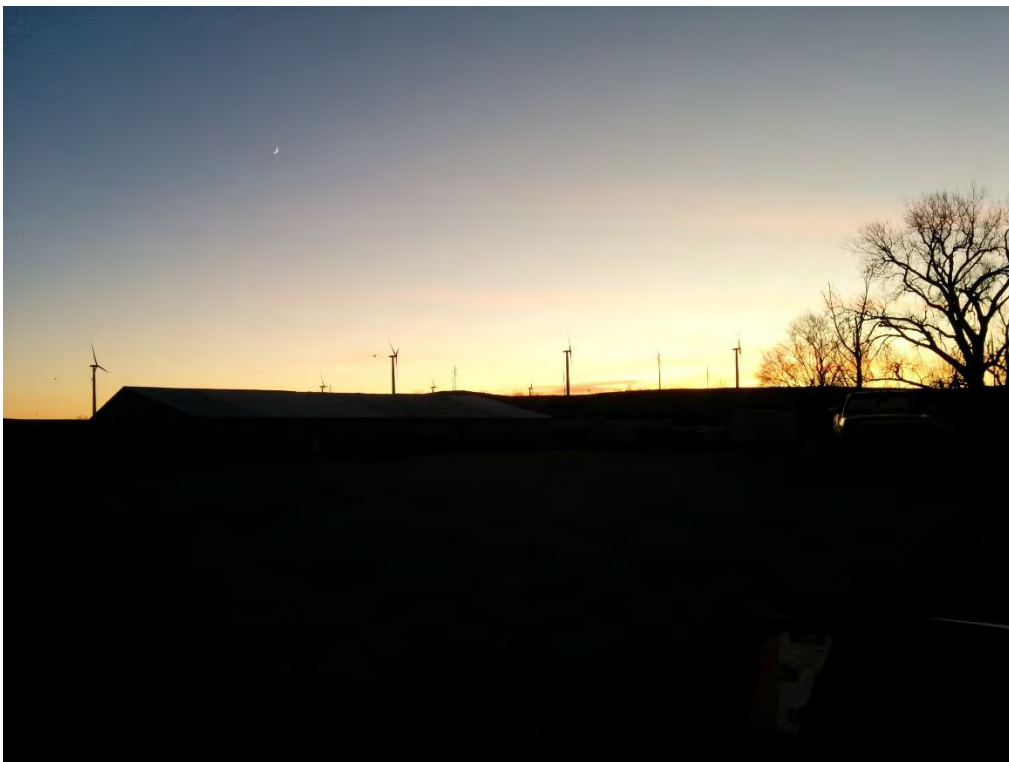
View from Receptor 1 from Driveway in line with Windows of Home

Photo from driveway has clear view inline with house of 100&101 - home base elev is much lower than turbine base. Trees on south removed to make way for expansion. Porch overhang is a good 4+ feet deep,

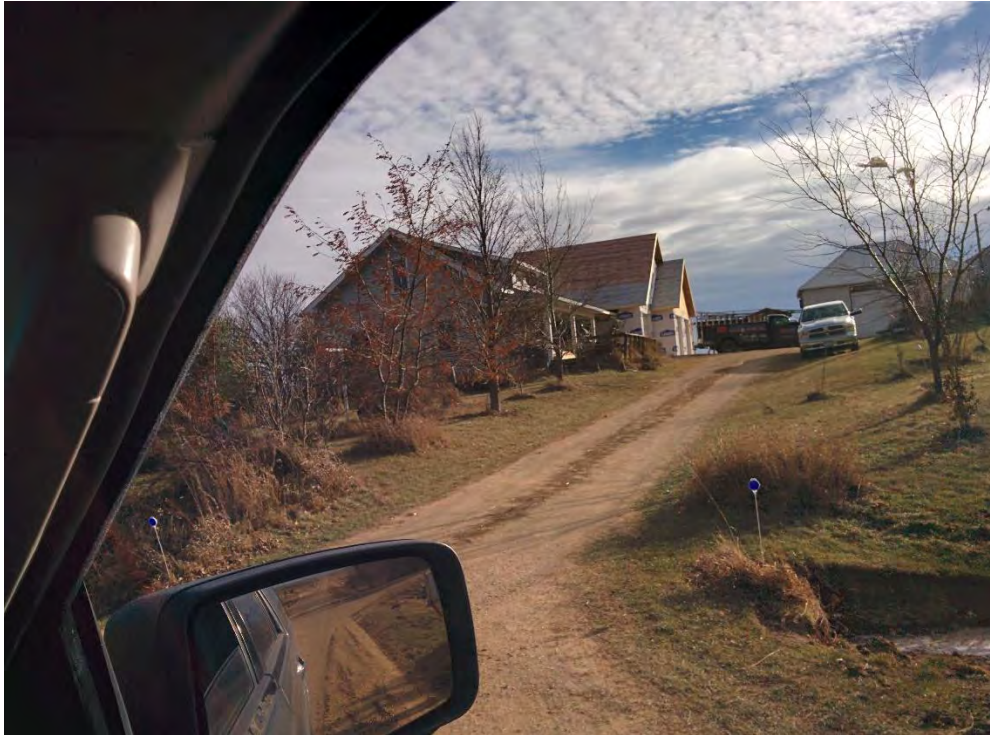
Looking up Driveway at Receptor 1

Expansion is underway, addition of a 3 car attached garage to south side of home, appears to double the area.

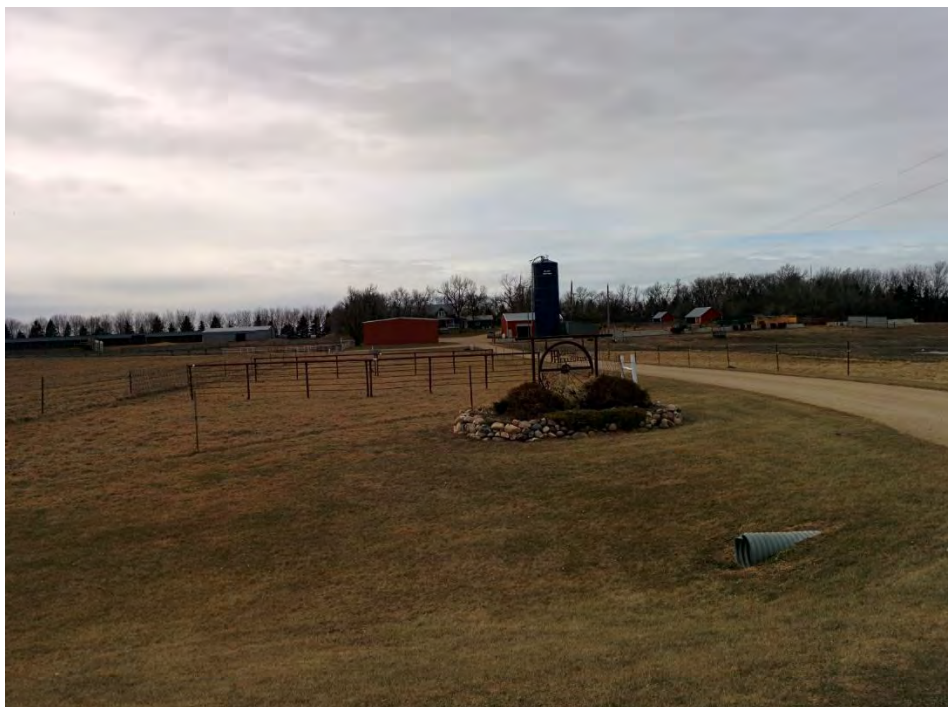
Facing Receptor 26 from Turbine 42 looking down driveway

Clear view of front door right down the driveway, some masking may fill in a bit with leaves, but it's a pretty clear view
