**FSA Slide Review: NAIP Imagery -  
October 2017  
Lemon Hill Solar Project  
Ranger Power  
Olmsted County, MN**

### Wetland Hydrology from Aerial Imagery – Recording Form

Project Name: Lemon Hill Solar Project

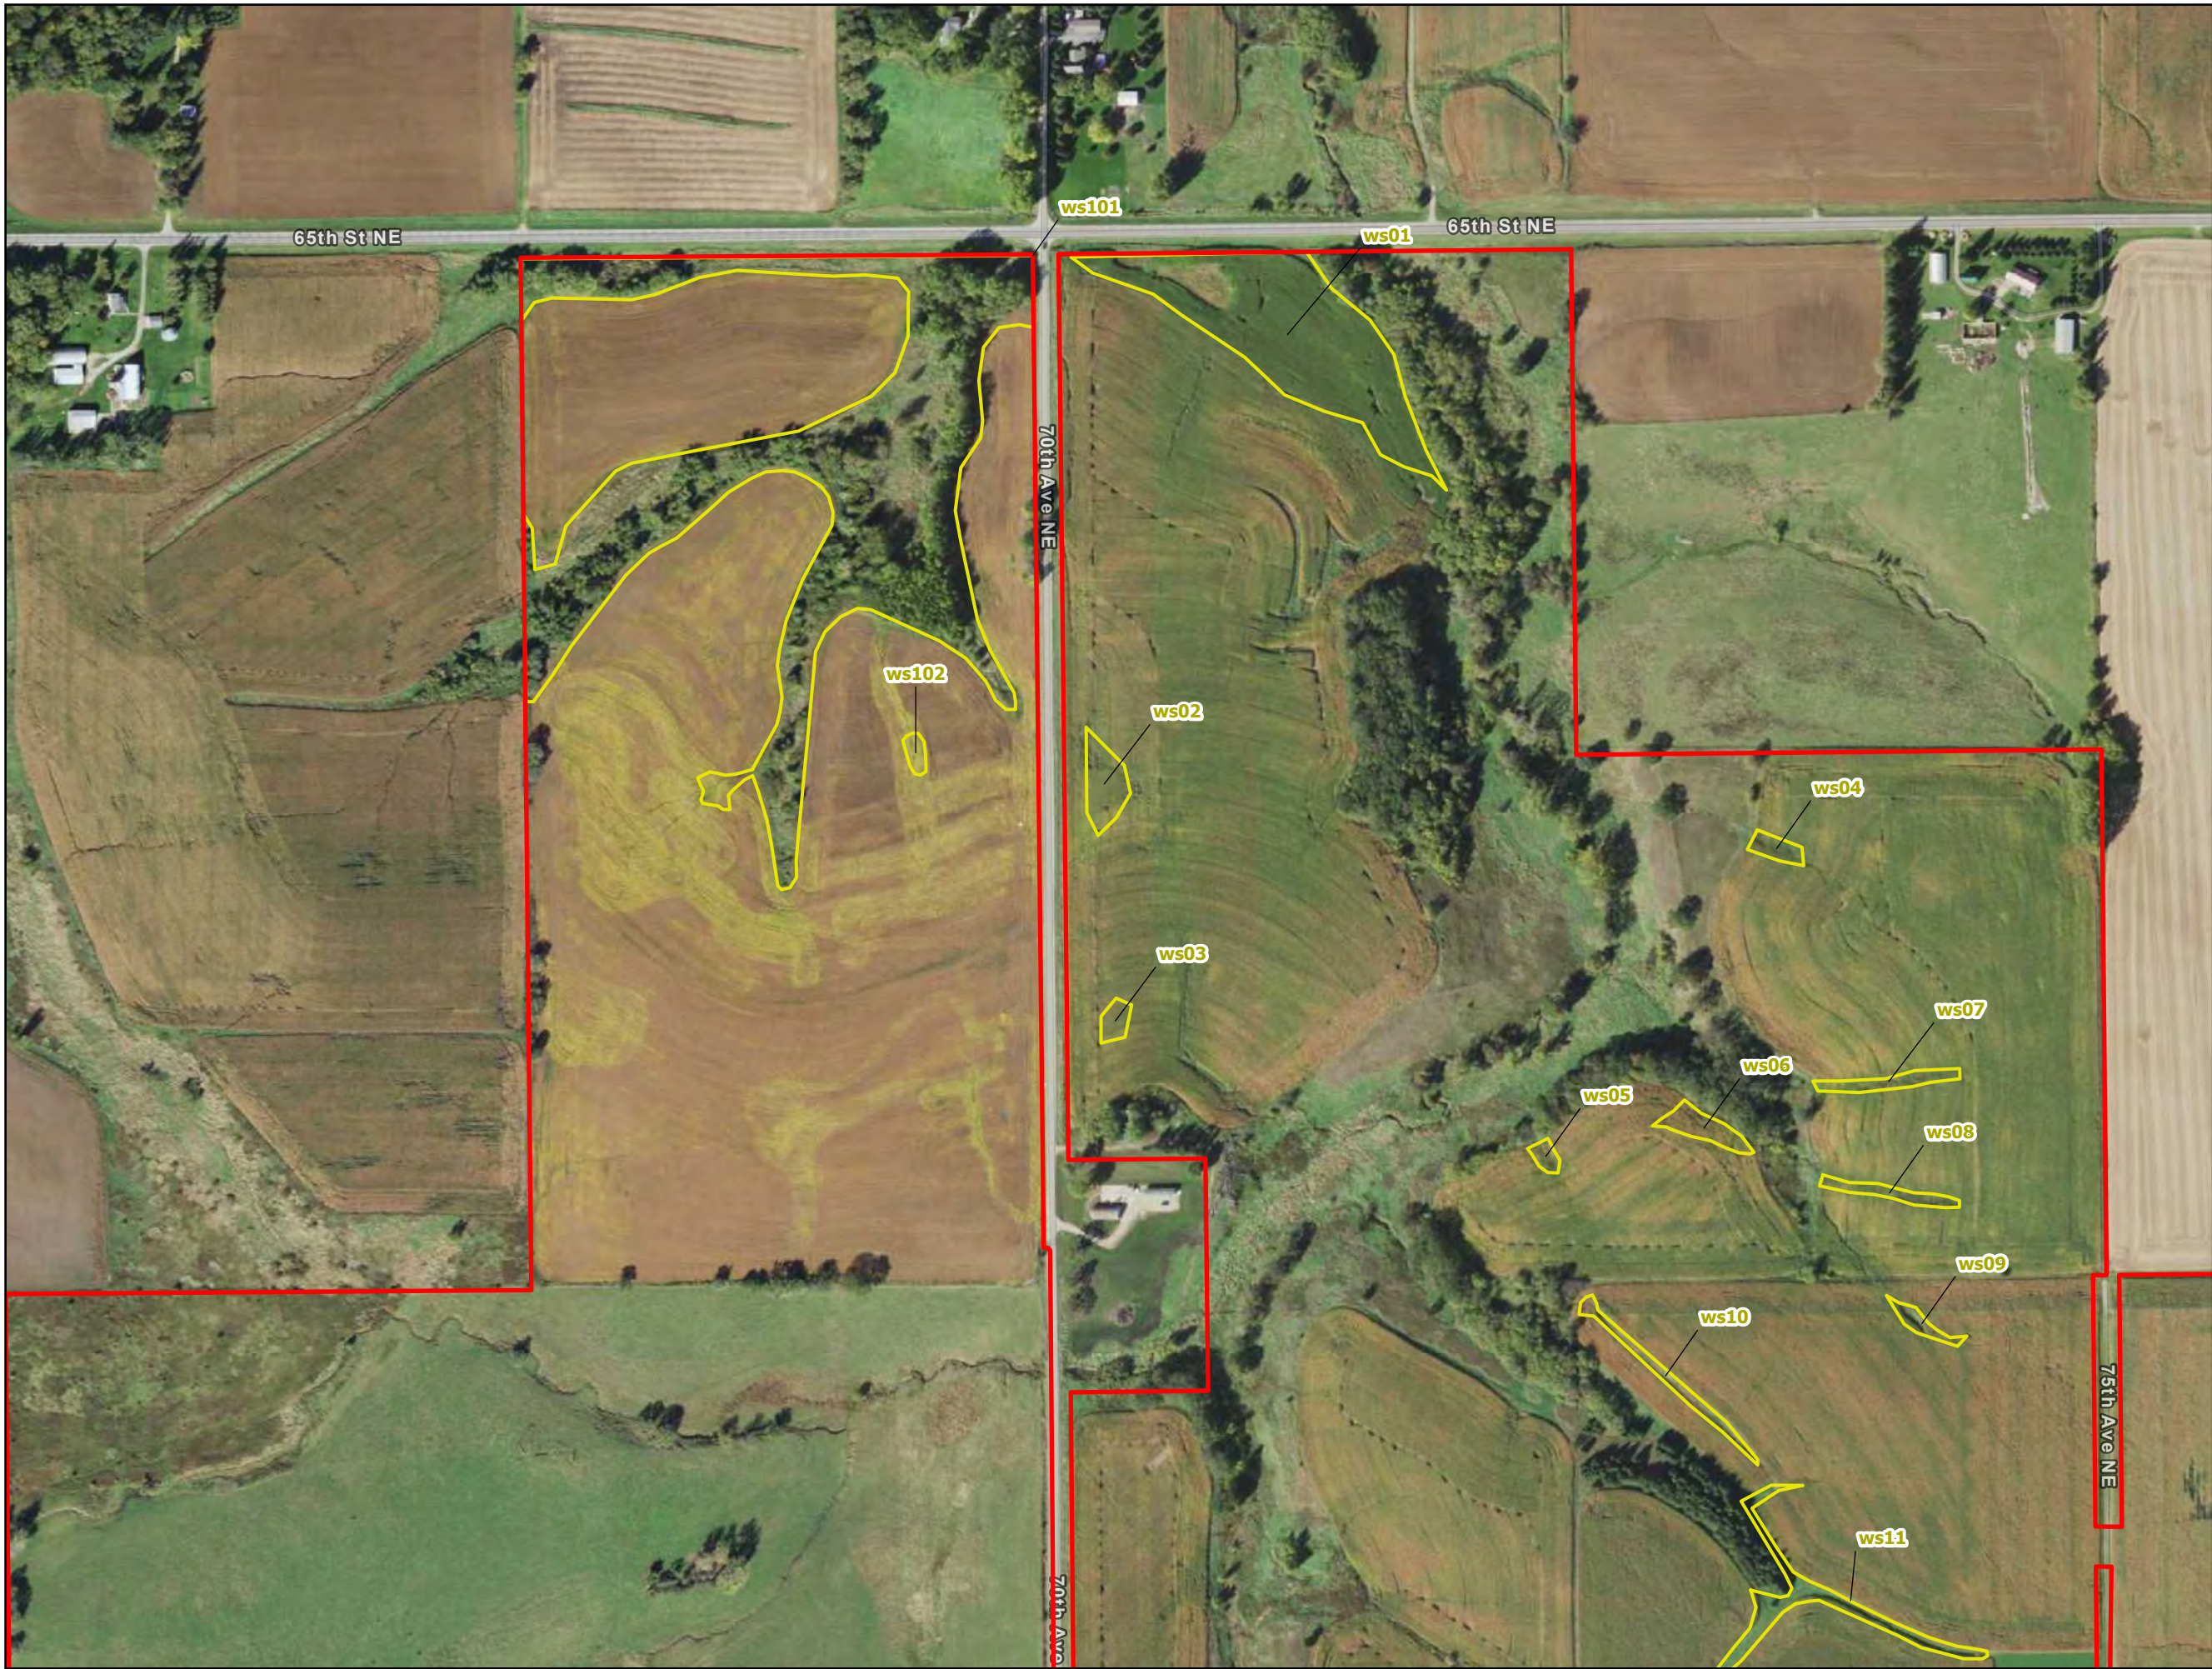
- Survey Area
- Wetness Signature

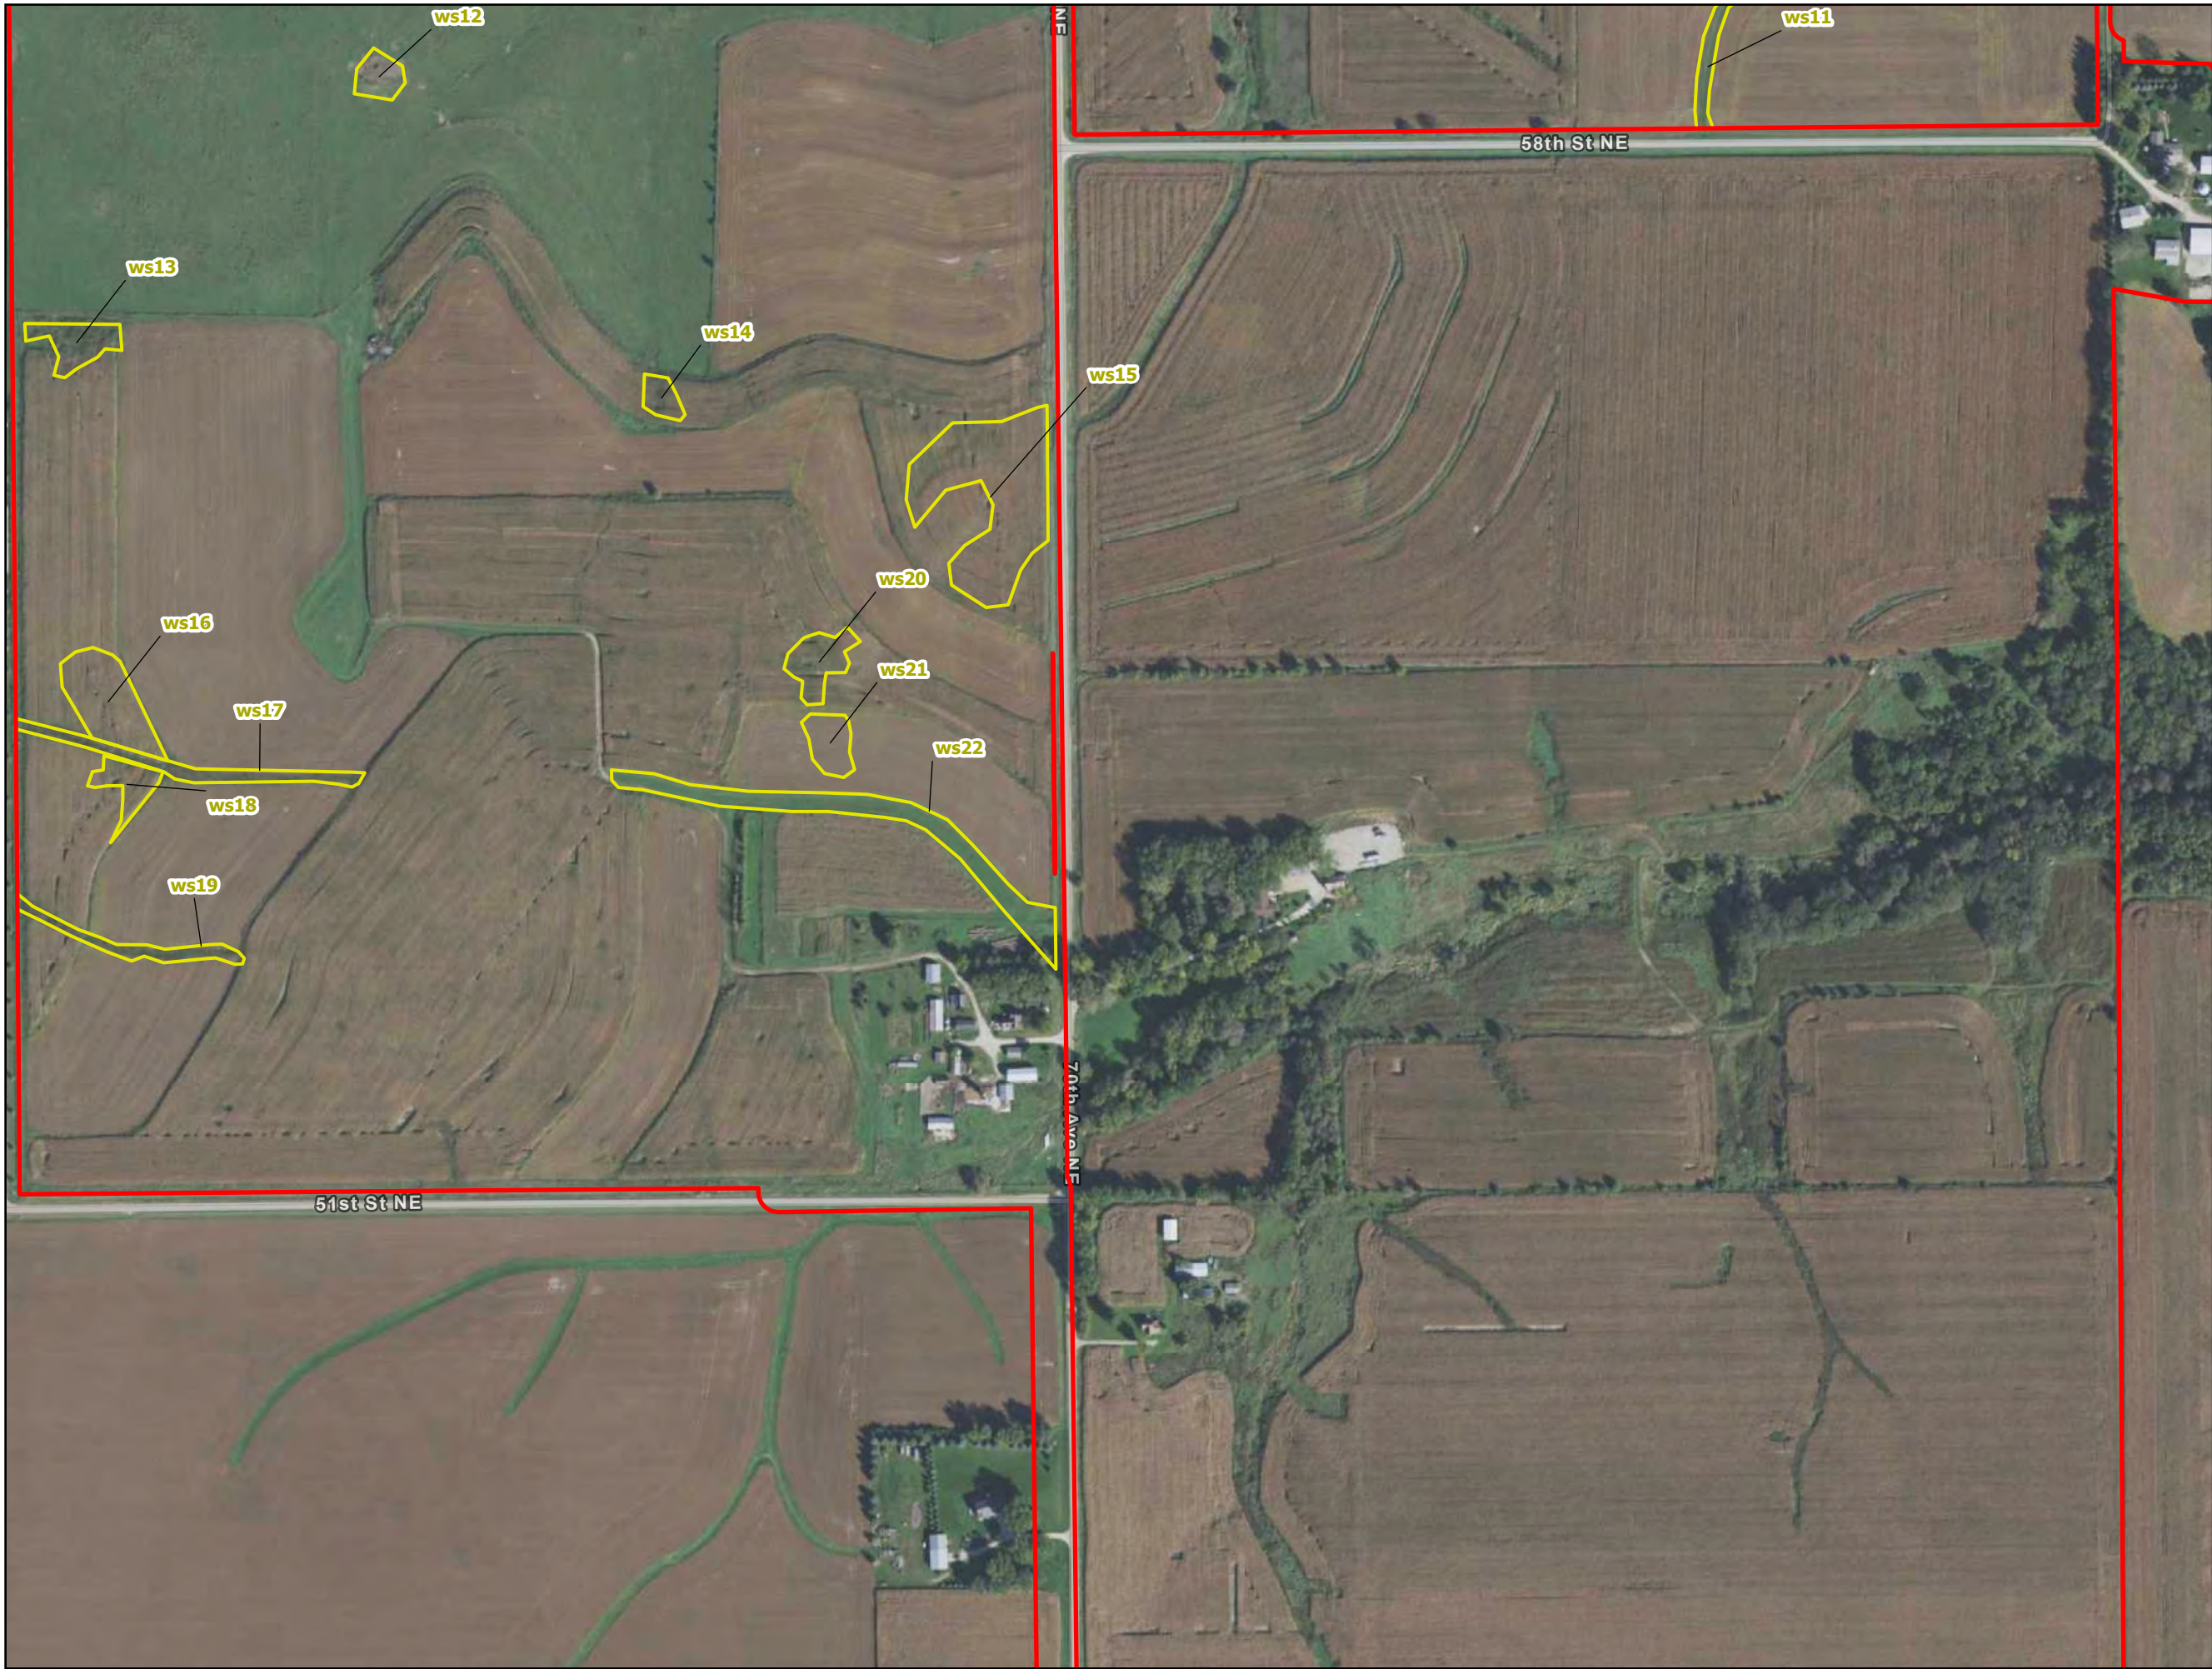
- Survey Area
- Wetness Signature

**FSA Slide Review: NAIP Imagery -  
October 2015  
Lemon Hill Solar Project  
Ranger Power  
Olmsted County, MN**

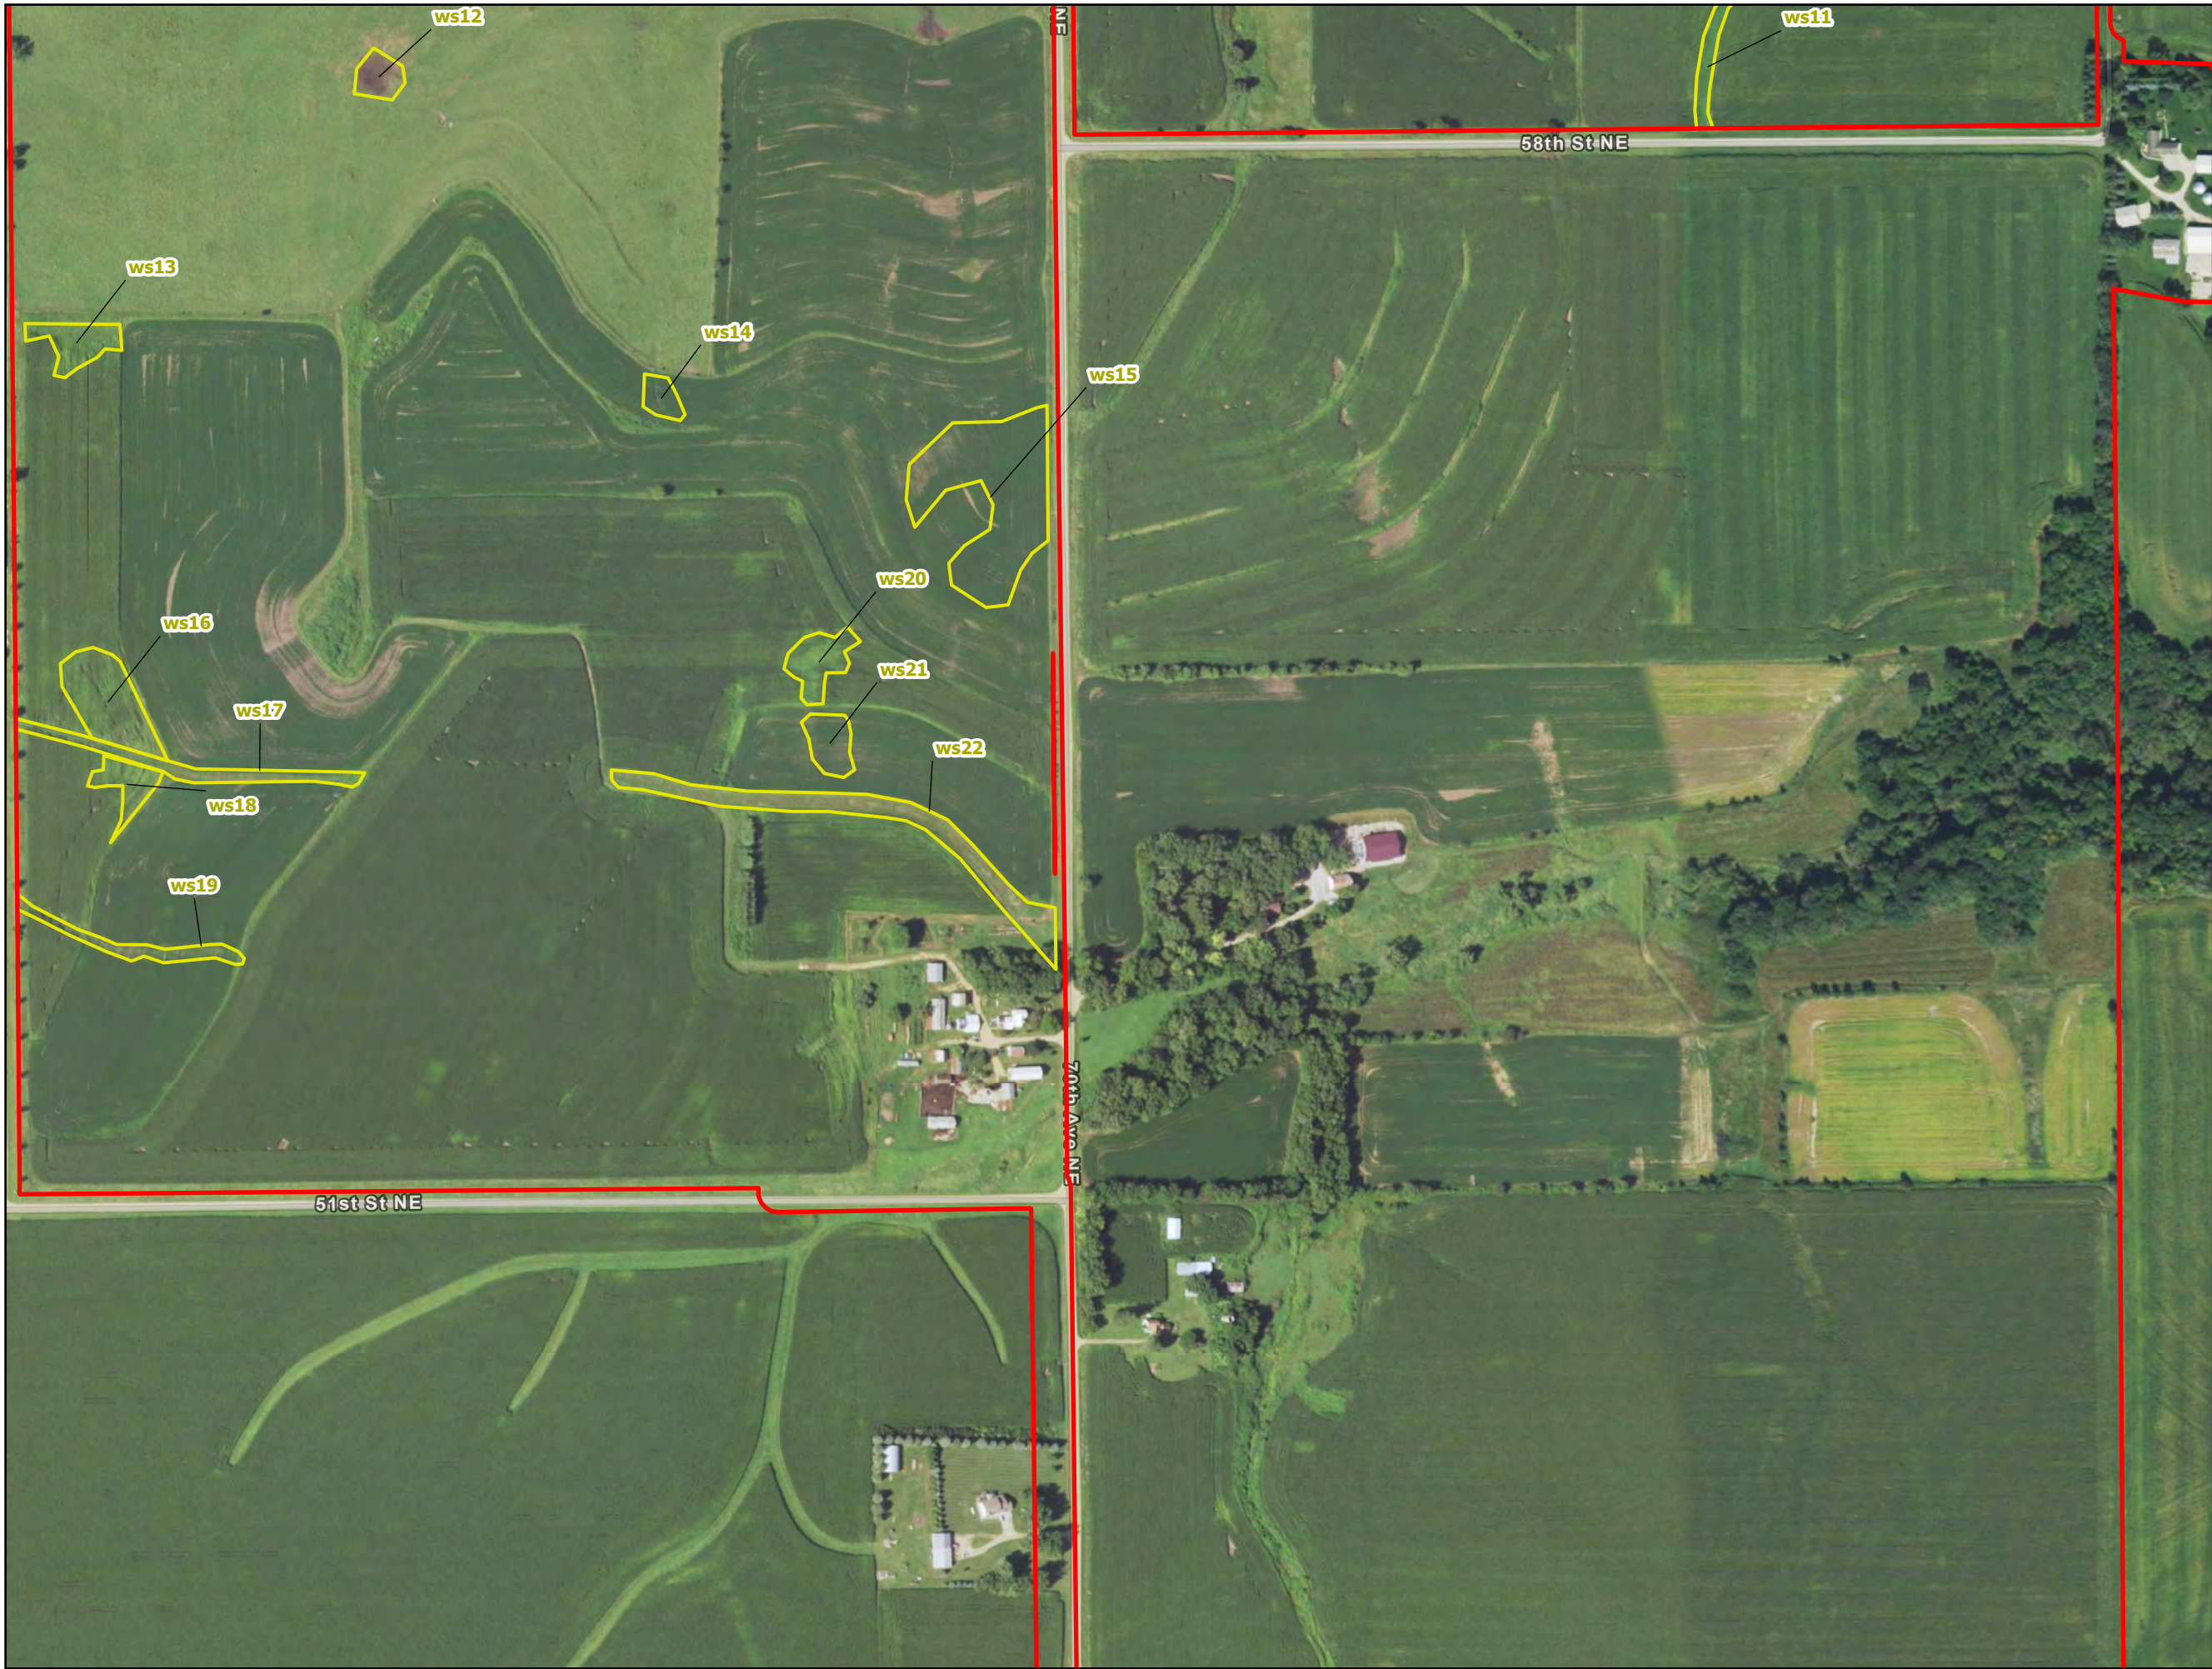
- Survey Area
- Wetness Signature

**FSA Slide Review: NAIP Imagery -  
August 2019  
Lemon Hill Solar Project  
Ranger Power  
Olmsted County, MN**
