Appendix H Wetland Delineation

Wetlands and Waters Survey

Elk Creek Solar Rock County, Minnesota

August 14, 2023

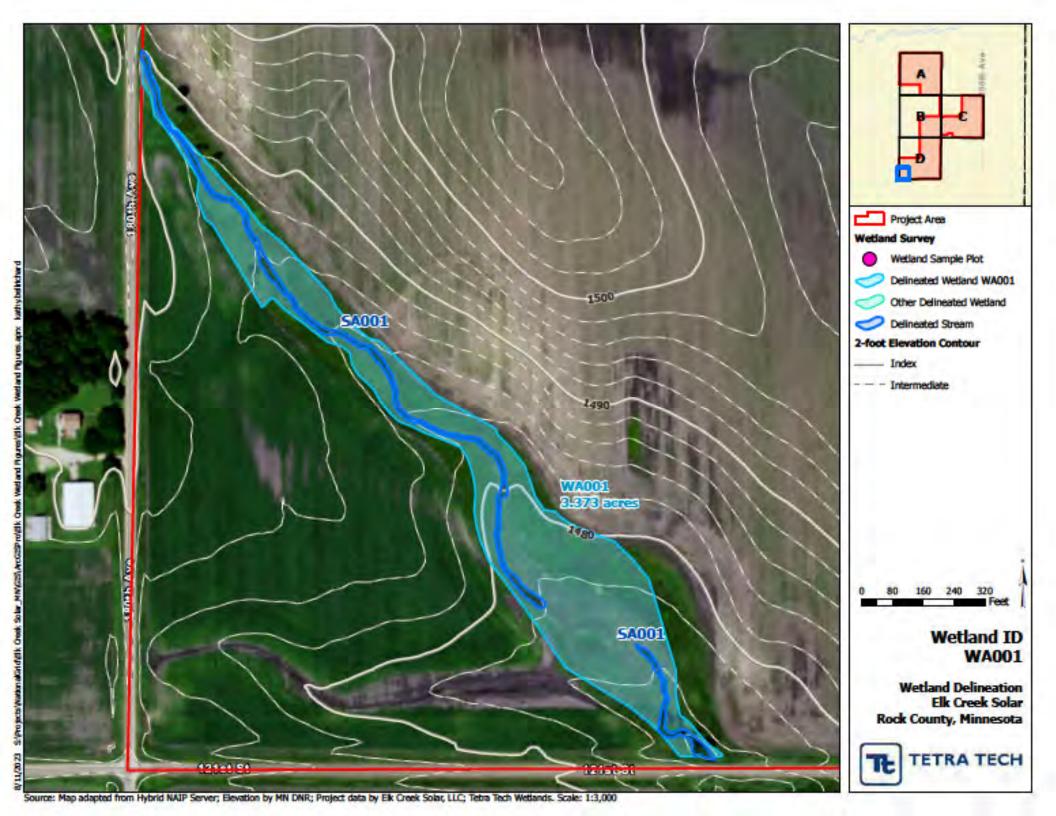
Overview of wetland WA001 and stream SA001.	
Direction: Southeast	Photo ID: f_photo-20230427-183819.jpg	Date: 04/27/2023
Project Name: Elk Creek Solar		Feature ID: WA001

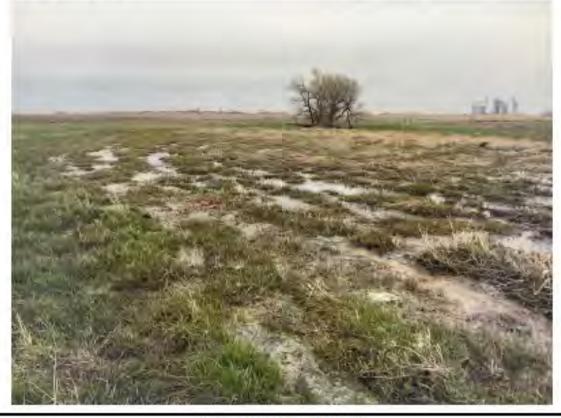
Overview of wetland WA001.				
Direction: Southeast	Photo ID: f_photo-20230427-190436.jpg	Date: 04/27/2023		
Project Name: Elk Creek Solar	7	Feature ID: WA001

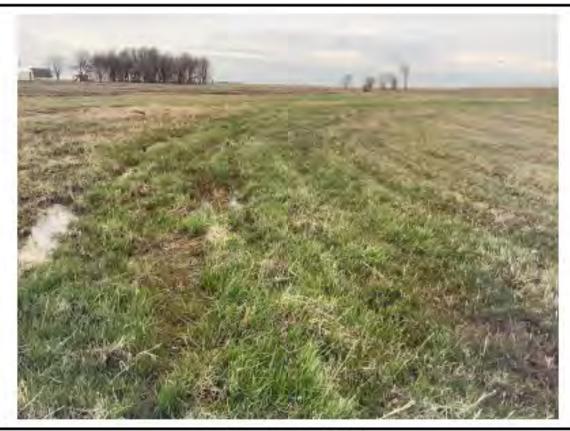
Overview of wetland WA001.				
Direction: Northwest	Photo ID: f_photo-20230427-190503.jpg	Date: 04/27/2023		
Project Name: Elk Creek Solar		Feature ID: WA001

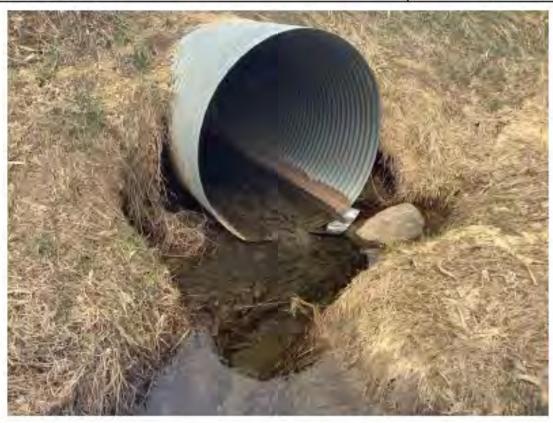
Upstream Photograph of SA001.			
Direction: Northwest	Photo ID:	Date: 04/27/2023	
Project Name: Elk Creek Solar		Feature ID: SA001

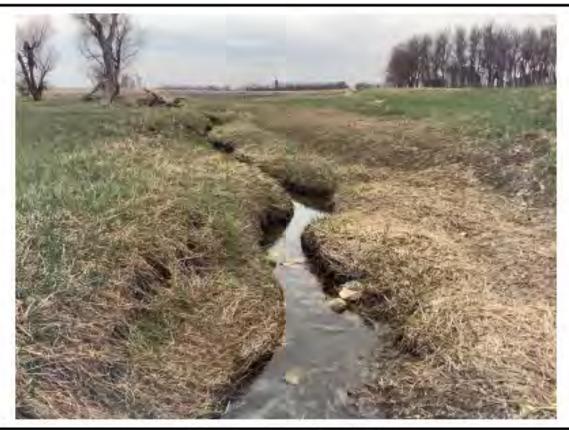
Downstream Photograph of SA001.				
Direction: Southeast	Photo ID:	Date: 04/27/2023		
Project Name: Elik Creek Solar		Feature ID: SA001

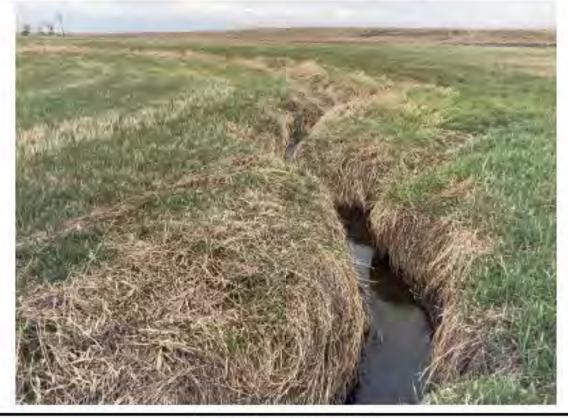
Upstream Photograph of SA001.			
Direction: North	Photo ID:	Date: 04/27/2023	
Project Name: Elk Creek Solar		Feature ID: SA001

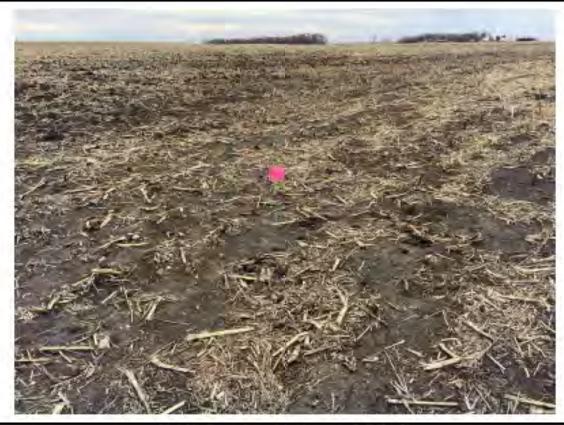
Overview of wetland sample point WA004A.				
Direction: Northwest	Photo ID: delin_photo-20230427-213510.jpg	Date: 04/27/2023			
Project Name: Elk Creek Sola		Feature ID: WA004

Wetland WA004 was delineated within a drainage swale in the Expansion Area. The wetland had been cultivated the previous season and no vegetation was present at the time of the survey. One hydric soil indicator (A12: Thick Dark Surface), and three secondary wetland hydrology indicators (B6: Surface Soil Cracks, C9: Saturation Visible on Aerial Imagery, and D2: Geomorphic Position) were observed at wetland sample point WA004A. No hydric soil indicators and only one secondary wetland hydrology indicator (D2: Geomorphic Position) were observed at upland sample point WA004B. Wetland determination data forms and photographs are provided in Appendix B

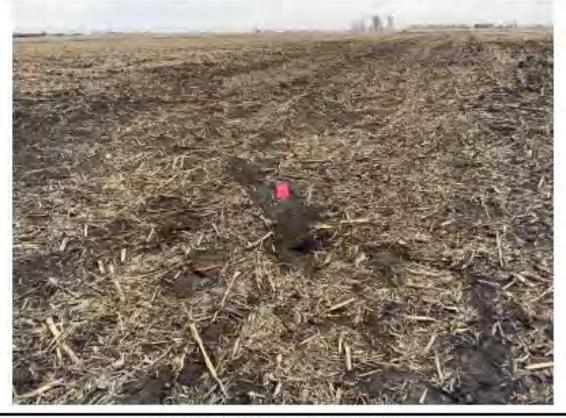
Overview of upland sample point WA004B.				
Direction: Southeast	Photo ID: delin_photo-20230427-212351.jpg	Date: 04/27/2023		
Project Name: Elk Creek Solar		Feature ID: WA004

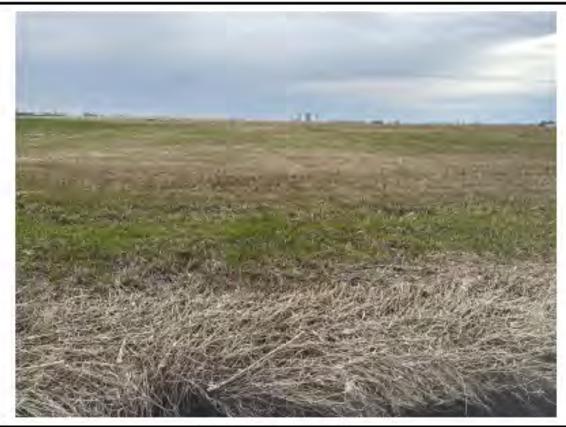
Overview of wetland WA005.				
Direction: South	Photo ID: f_photo-20230427-224901.jpg	Date: 04/27/2023			
Project Name: Elk Creek Sol.	ar	Feature ID: WA005

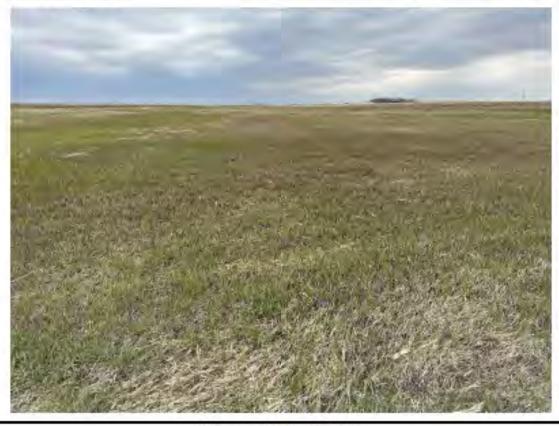
Overview of wetland WA005.				
Direction: North	Photo ID: f_photo-20230427-224922.jpg	Date: 04/27/2023		
Project Name: Elk Creek Sola		Feature ID: WA005

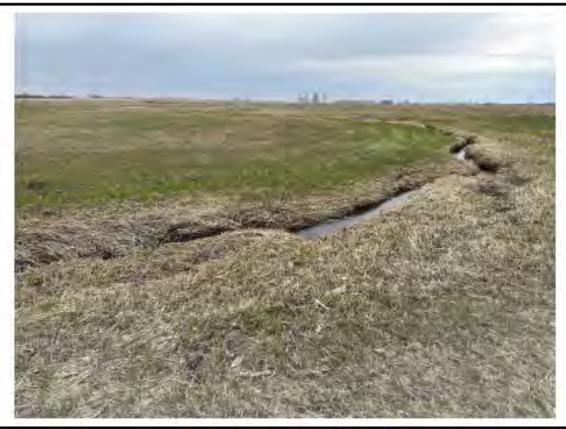
Overview of wetland WA005 and stream SA002.				
Direction: South	Photo ID: f_photo-20230427-225058.jpg	Date: 04/27/2023			
Project Name: Elk Creek Sola	ar .	Feature ID: WA005

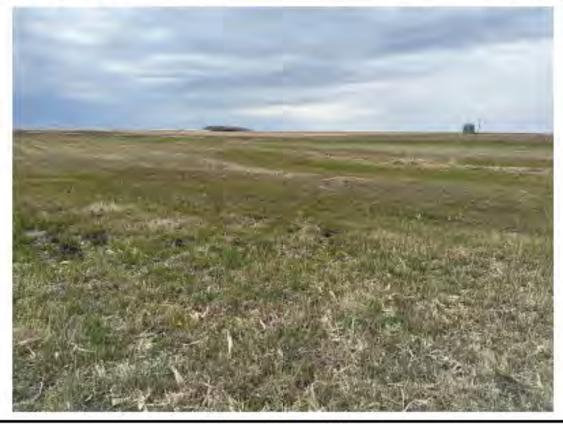
Overview of wetland WA005.				
Direction: Northeast	Photo ID: f_photo-20230427-225959.jpg	Date: 04/27/2023		
Project Name: Elk Creek Solar		Feature ID: WA005

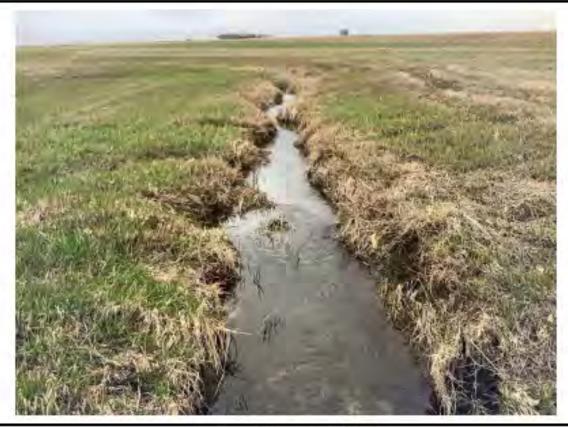
Upstream Photograph of SA002.					
Direction: Northeast	Photo ID:	Date: 04/27/2023				
Project Name: Elk Creek Solar		Feature ID: SA002

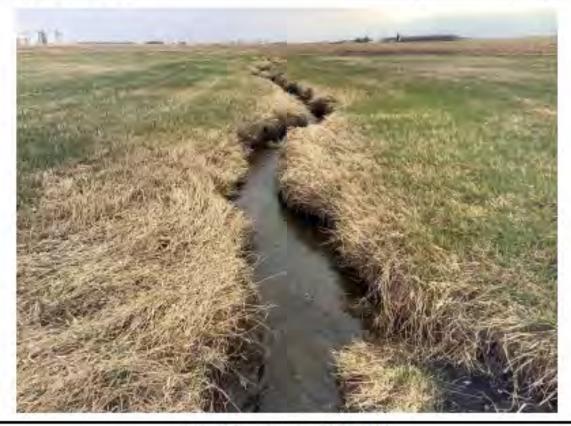
Downstream Photograph of SA002.				
Direction: Southwest	Photo ID:	Date: 04/27/2023		
Project Name: Elk Creek Solar		Feature ID: SA002

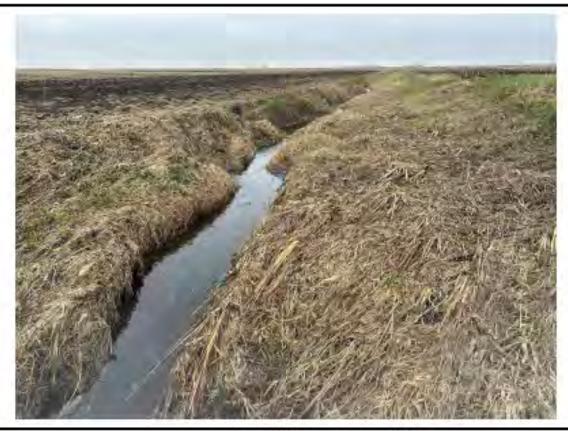
Overview of wetland WA009 and stream SA003.		
Direction: North	Photo ID: f_photo-20230428-123918.jpg	Date: 04/28/2023
Project Name: Elk Creek Solar		Feature ID: WA009

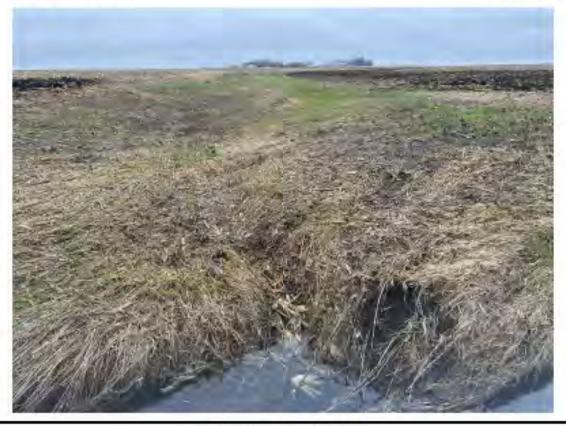
Overview of wetland WA009.		
Direction: West	Photo ID: f_photo-20230428-125606.jpg	Date: 04/28/2023
Project Name: Elk Creek Solar		Feature ID: WA009

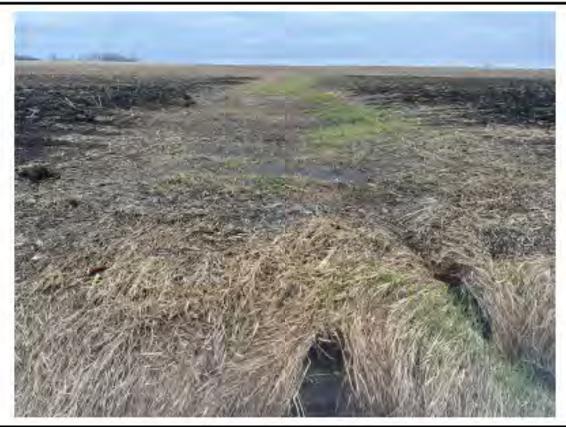
Overview of wetland WA009.		
Direction: West	Photo ID: f_photo-20230428-130804.jpg	Date: 04/28/2023
Project Name: Elk Creek Solar		Feature ID: WA009

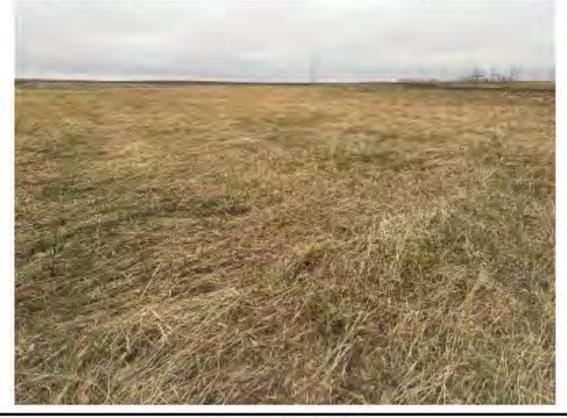
Overview of wetland WA009.		
Direction: Northeast	Photo ID: f_photo-20230428-131402.jpg	Date: 04/28/2023
Project Name: Elk Creek Solar		Feature ID: WA009

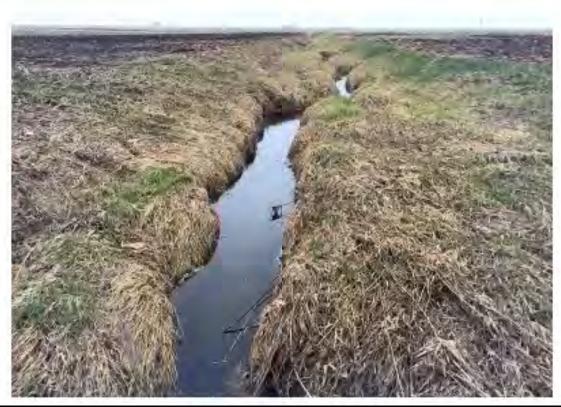
Upstream Photograph of SA003.		
Direction: North	Photo ID:	Date: 04/28/2023
Project Name: Elk Creek Solar		Feature ID: SA003

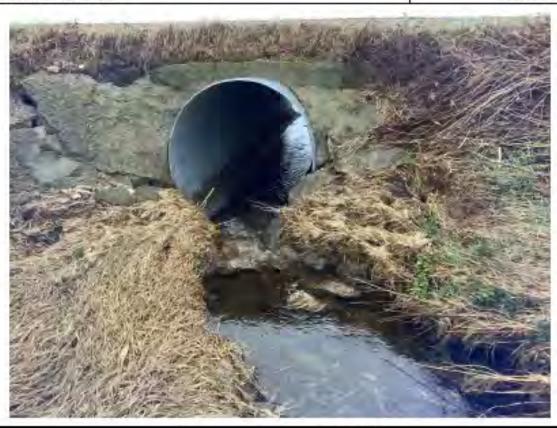
Downstream Photograph of SA003.		
Direction: Southeast	Photo ID:	Date: 04/28/2023
Project Name: Elk Creek Solar		Feature ID: SA003

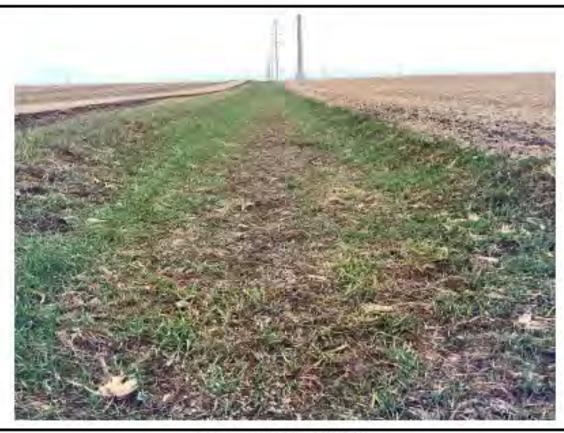
Overview of wetland WA012.		
Direction: North	Photo ID: f_photo-20230428-140653.jpg	Date: 04/28/2023
Project Name: Elk Creek Solar		Feature ID: WA012

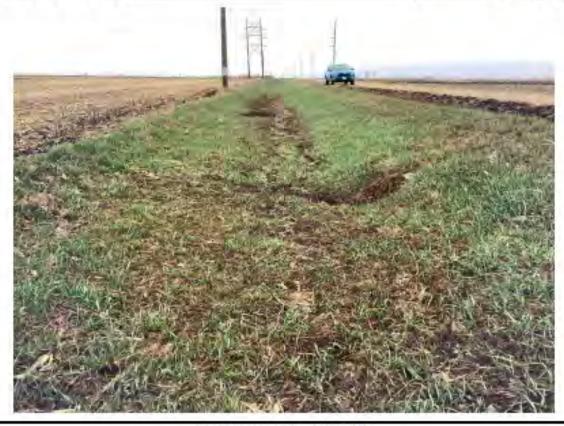
Overview of wetland WA012.		
Direction: South	Photo ID: f_photo-20230428-140708.jpg	Date: 04/28/2023
Project Name: Elk Creek Sola		Feature ID: WA012

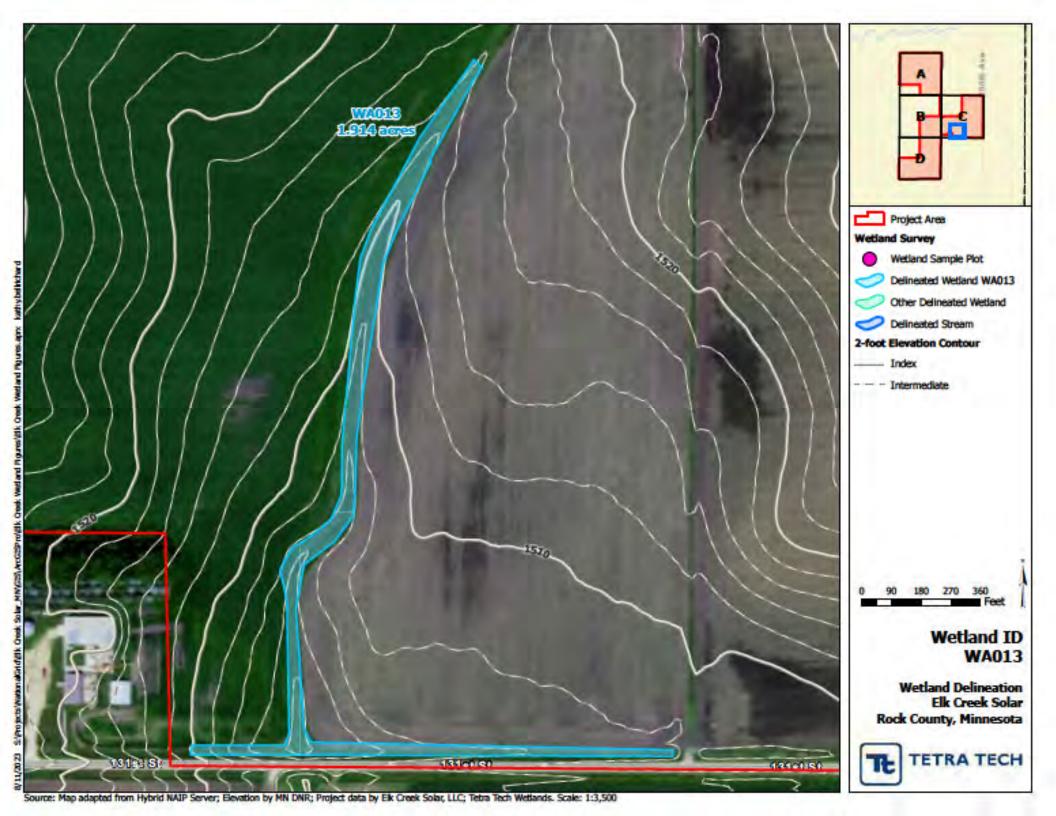
Overview of wetland WAD13.		
Direction: North	Photo ID: f_photo-20230428-143434.jpg	Date: 04/28/2023
Project Name: Elk Creek Solar		Feature ID: WA013

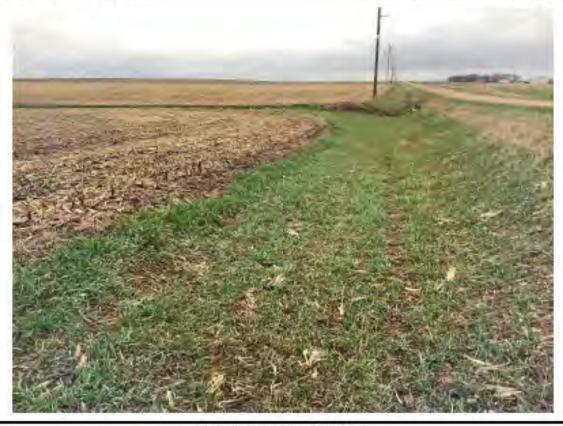
Overview of wetland WA013.		
Direction: East	Photo ID: f_photo-20230428-143912.jpg	Date: 04/28/2023
Project Name: Elk Creek Solar		Feature ID: WAD13
