**FSA Slide Review: NAIP Imagery -
October 2017
Lemon Hill Solar Project
Ranger Power
Olmsted County, MN**

Exhibit 1Field data sheet reference (if applicable): See attached crosswalk table**Wetland Hydrology from Aerial Imagery – Recording Form**

Project Name: Lemon Hill Solar Project

Date: 5/20/24 County: OlmstedInvestigator: Kyle Hanson Legal Description (T, R, S): T107N, R13W, S12**Summary Table**

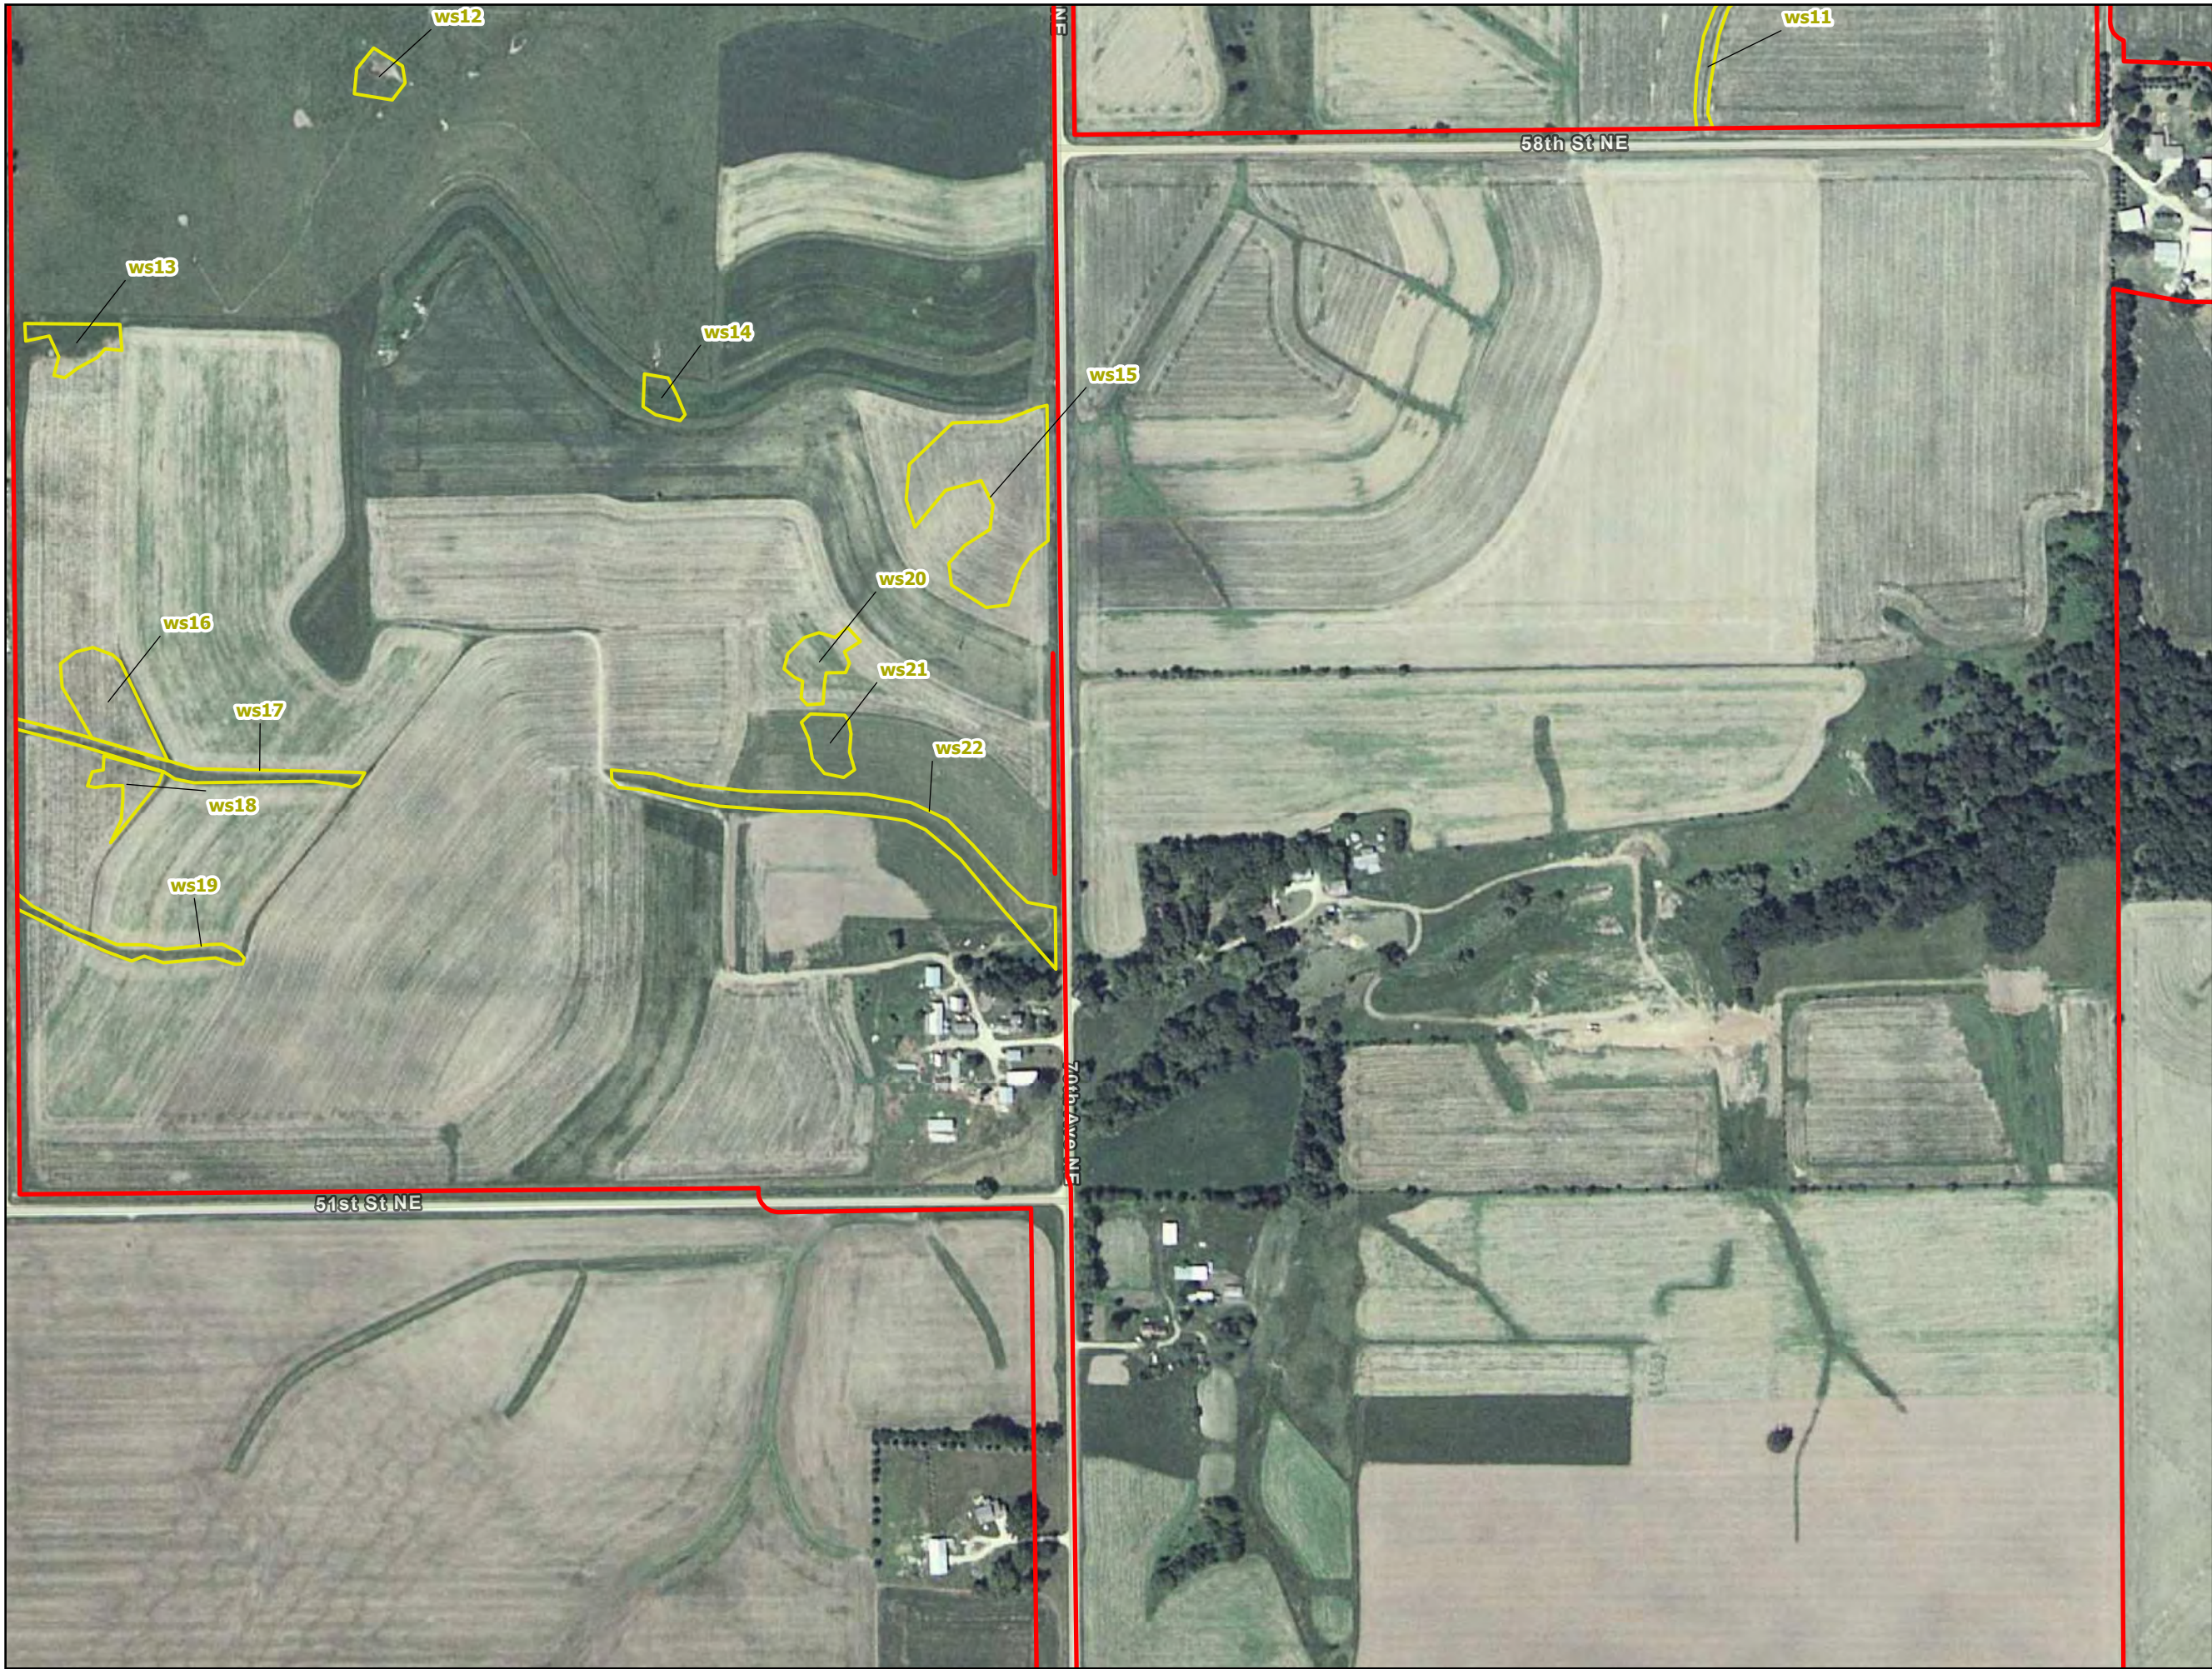
- Survey Area
- Wetness Signature

**FSA Slide Review: NAIP Imagery -
August 2009
Lemon Hill Solar Project
Ranger Power
Olmsted County, MN**

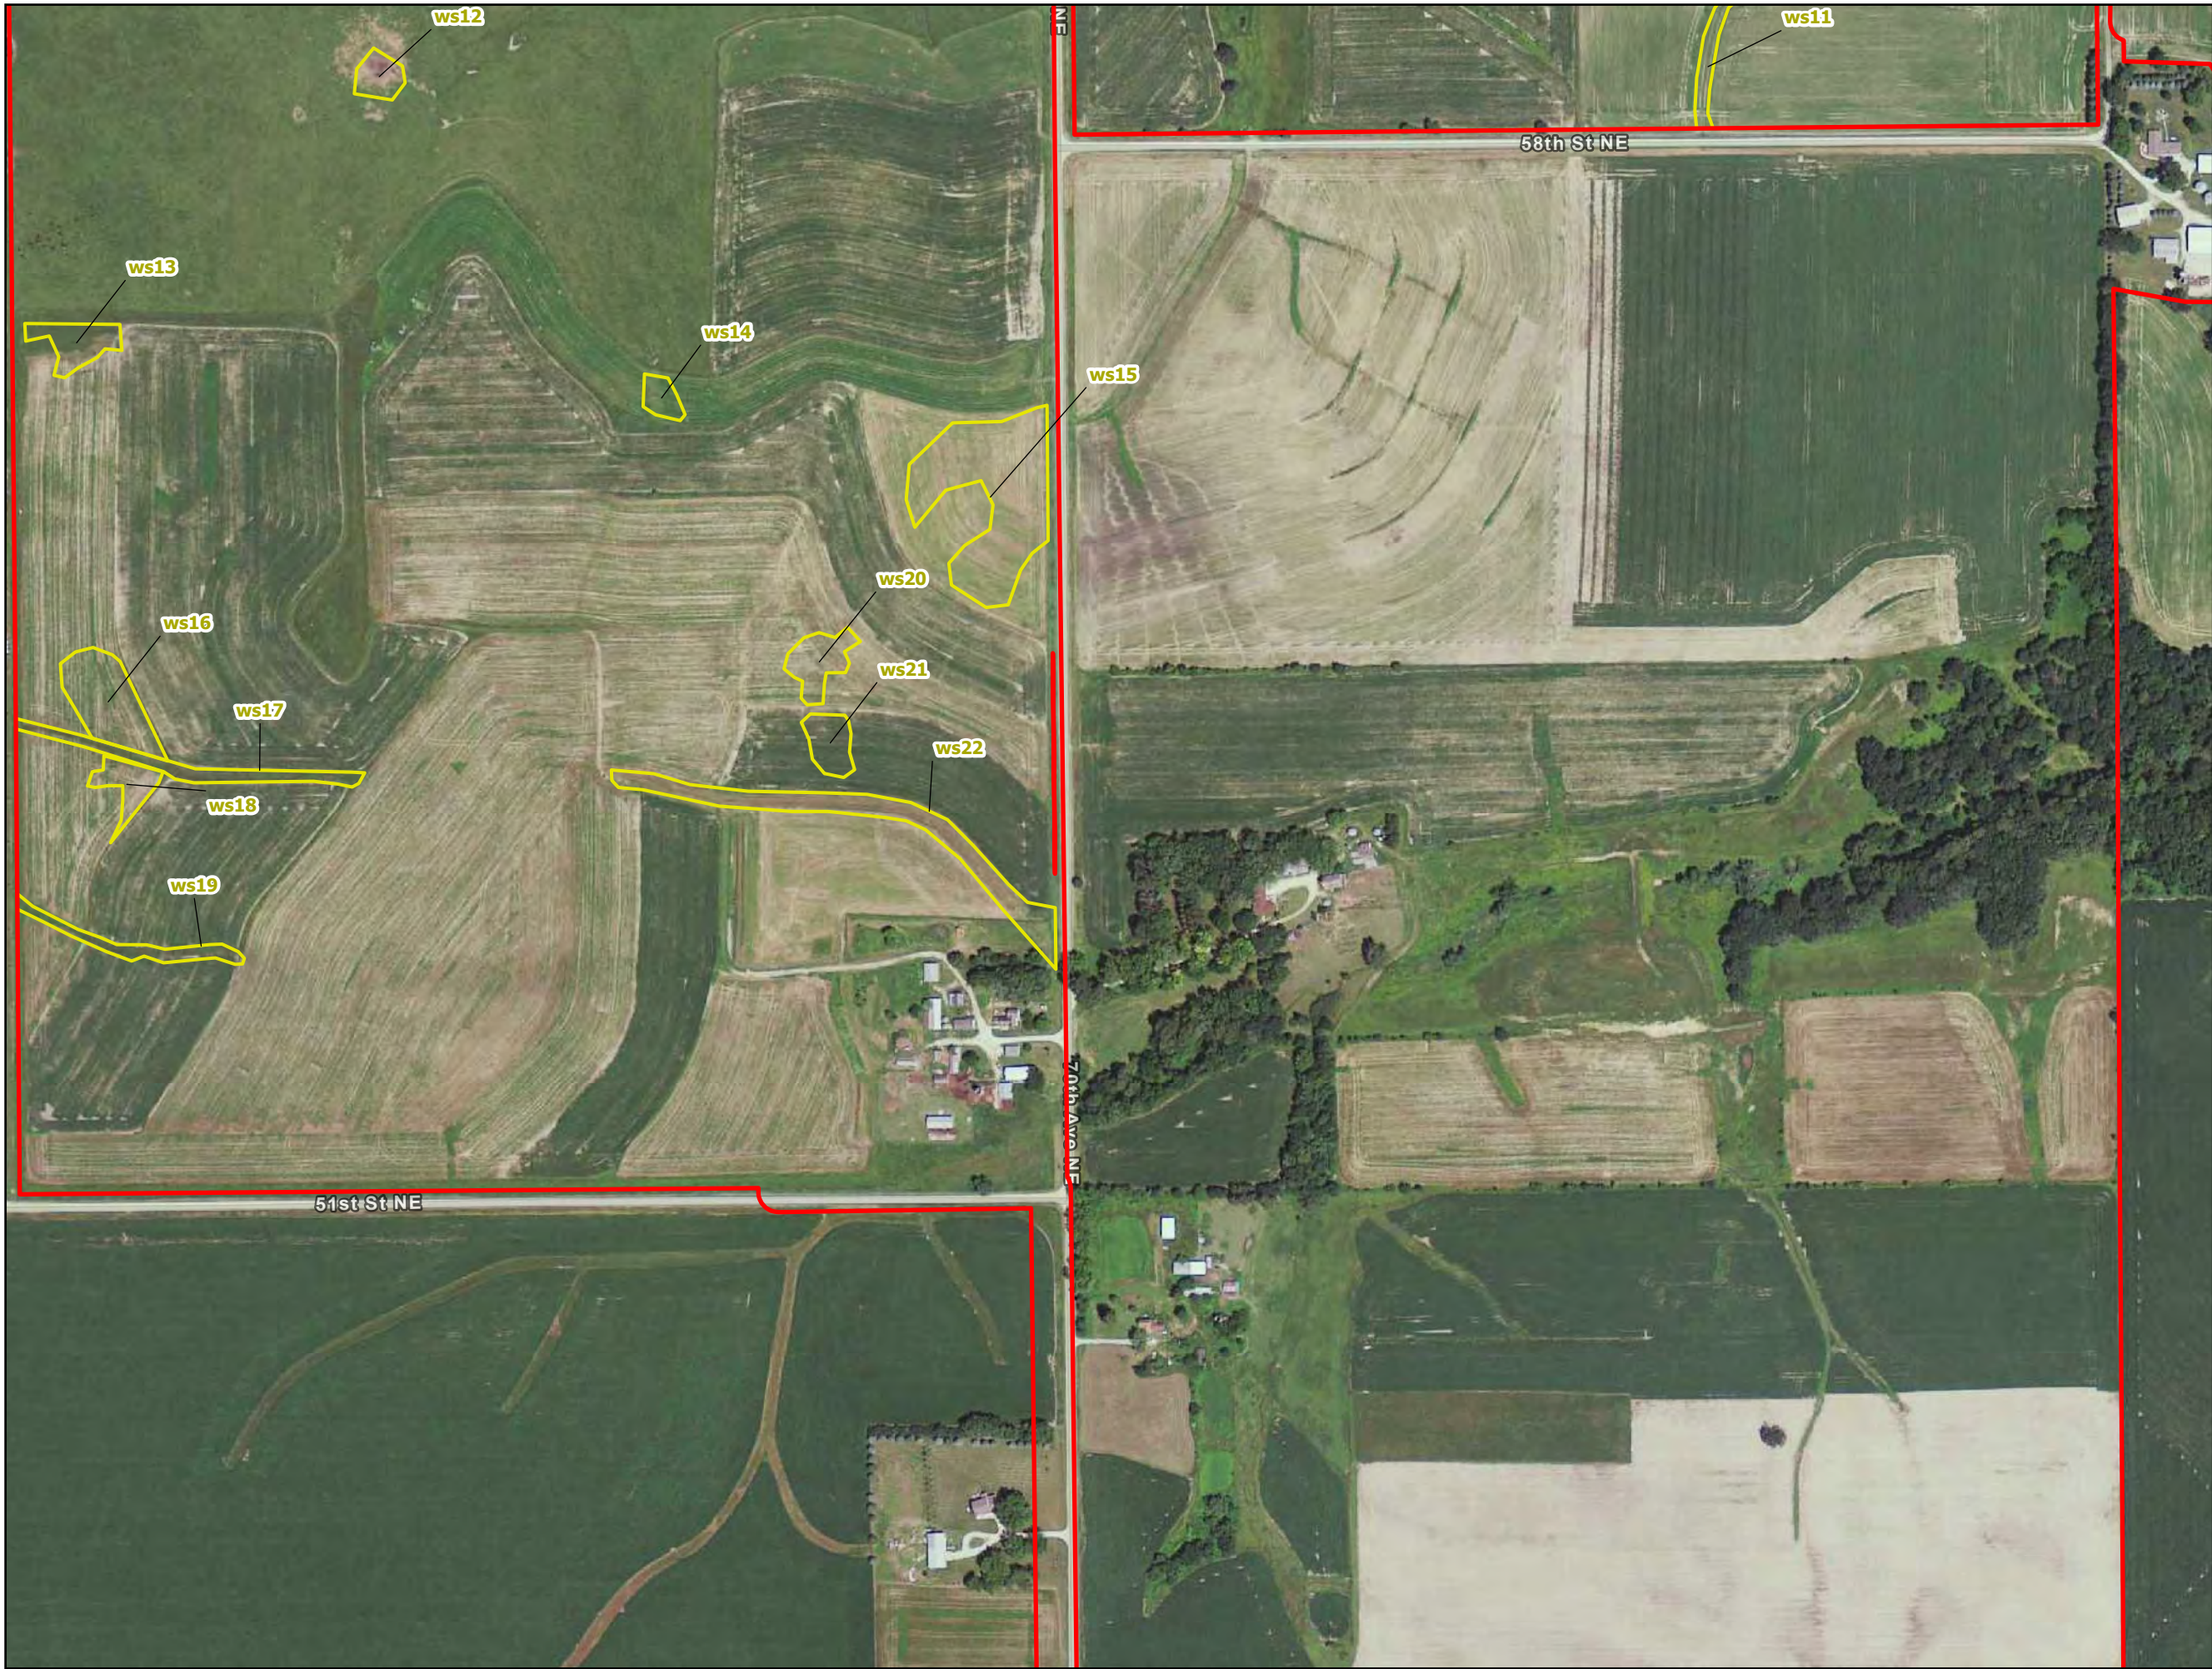
- Survey Area
- Wetness Signature

**FSA Slide Review: NAIP Imagery -
July 2010
Lemon Hill Solar Project
Ranger Power
Olmsted County, MN**

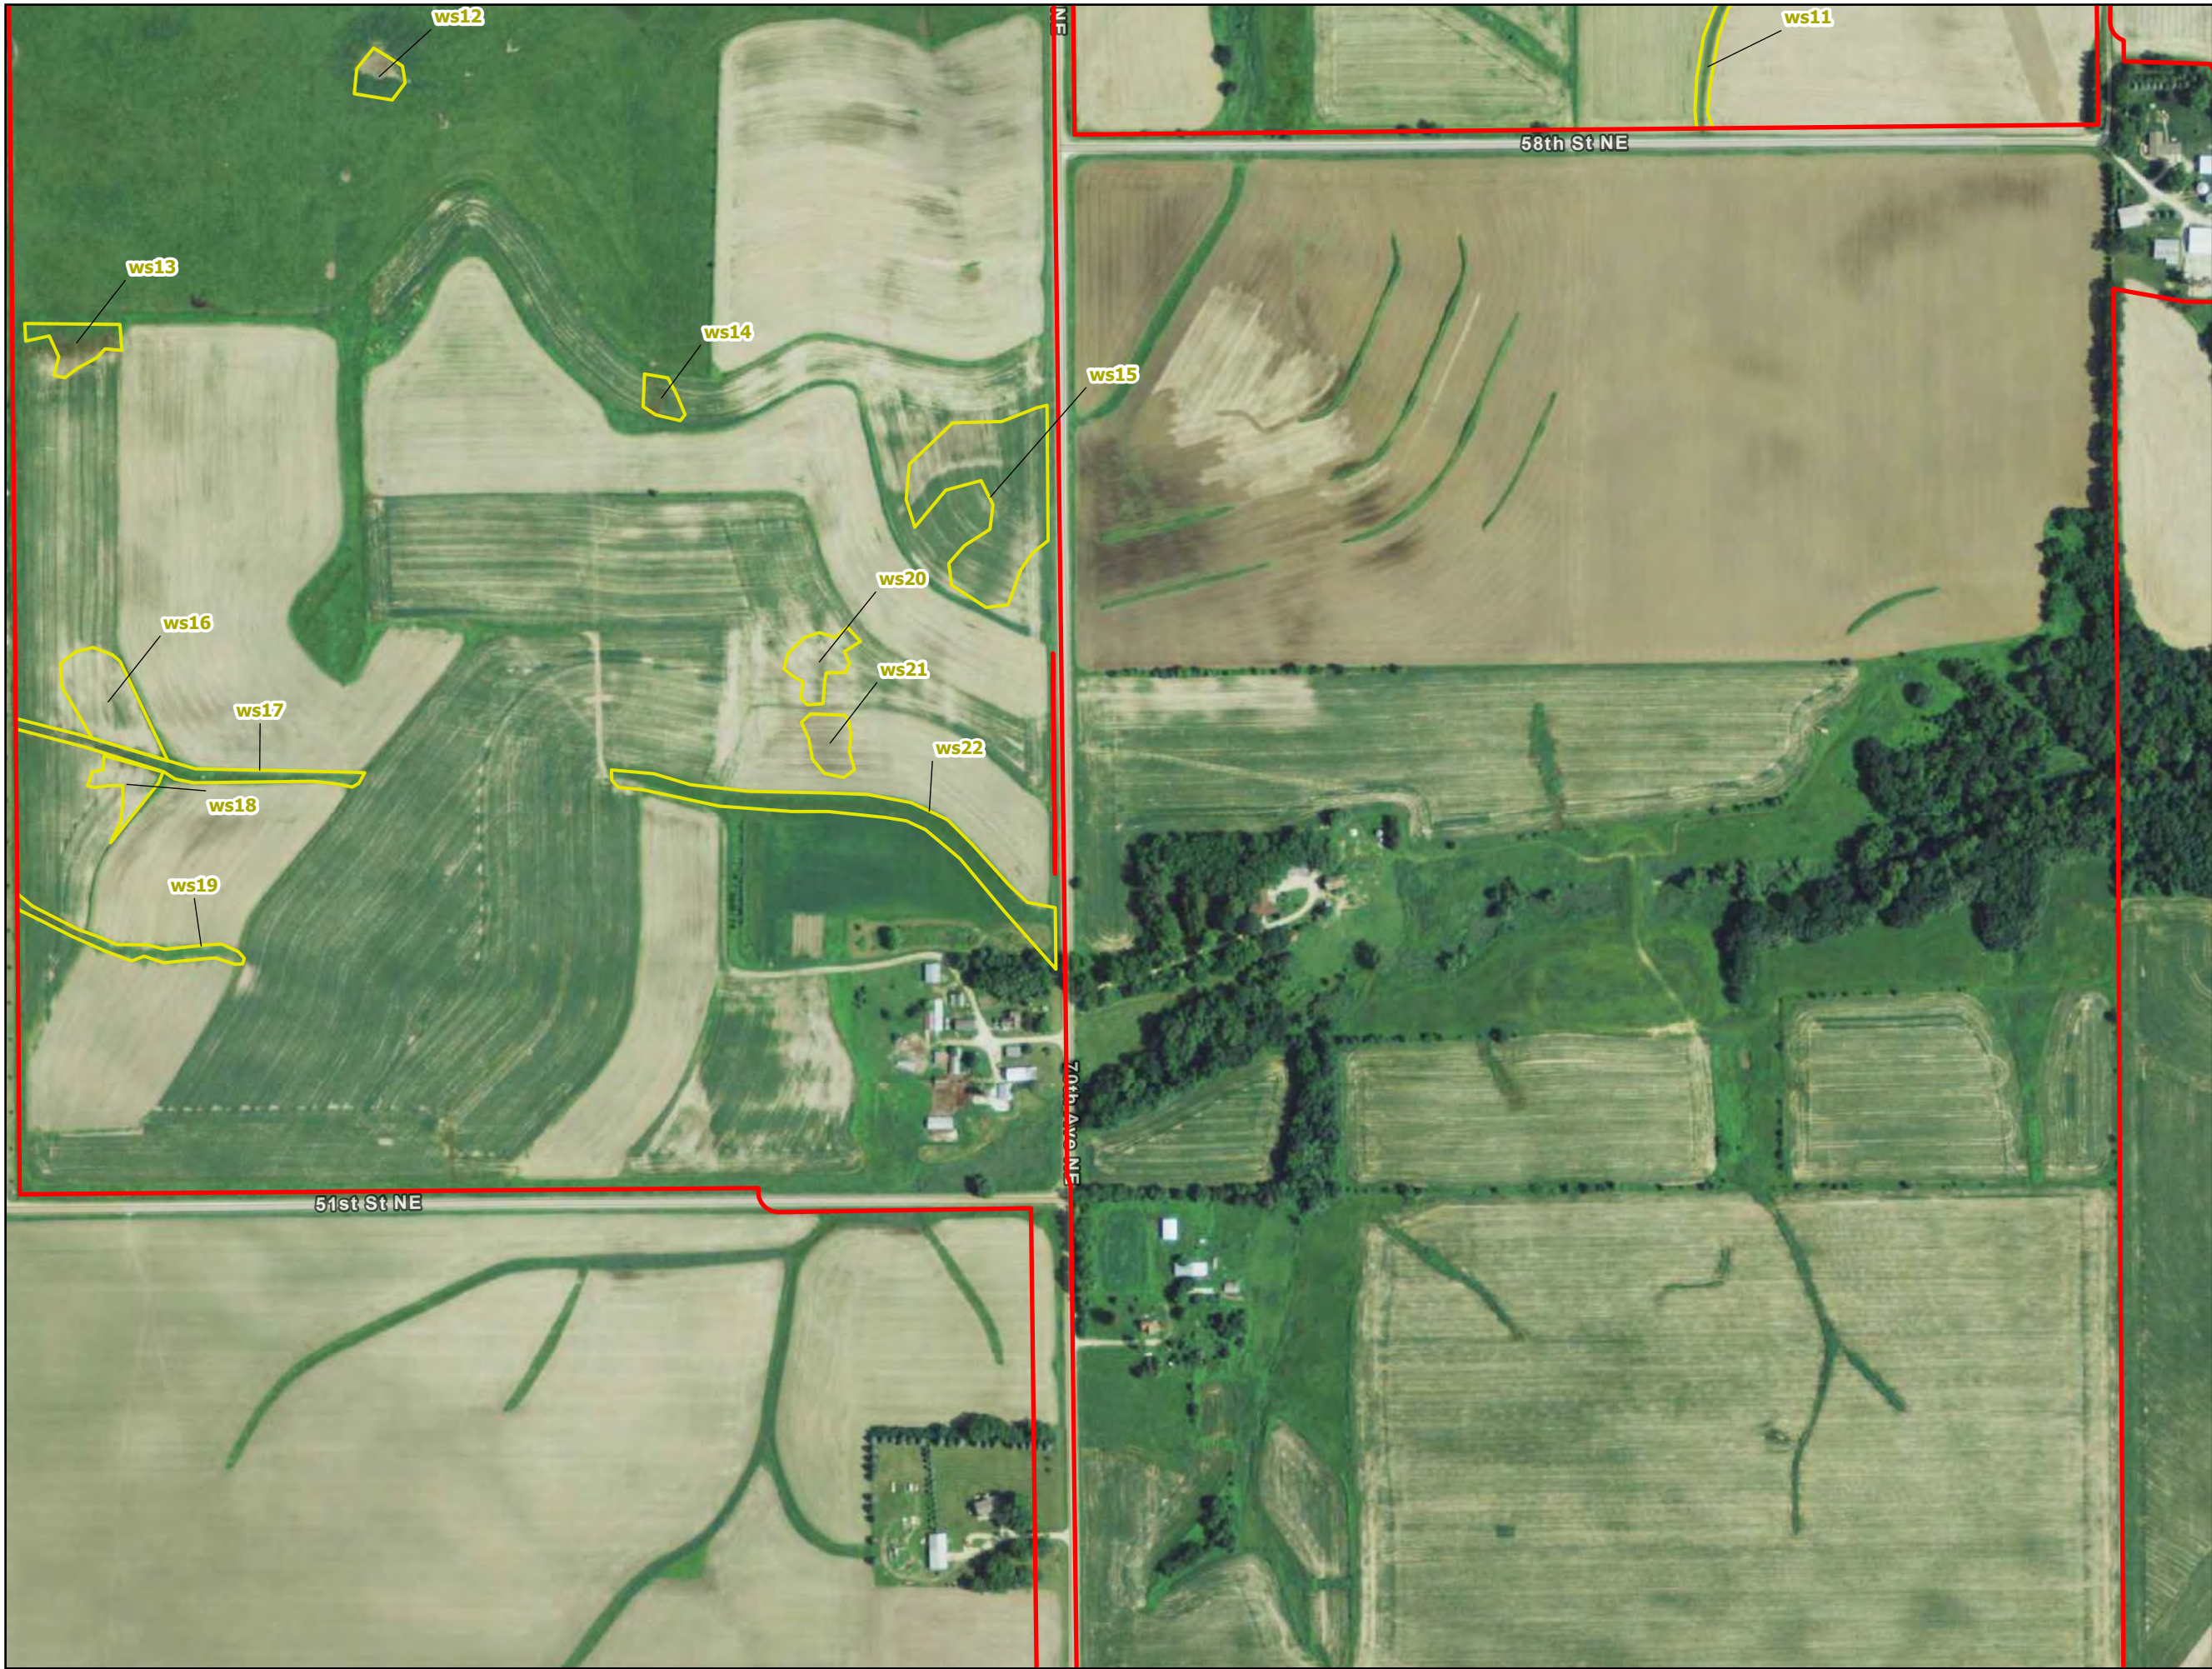
- Survey Area
- Wetness Signature

**FSA Slide Review: NAIP Imagery -
July 2013
Lemon Hill Solar Project
Ranger Power
Olmsted County, MN**

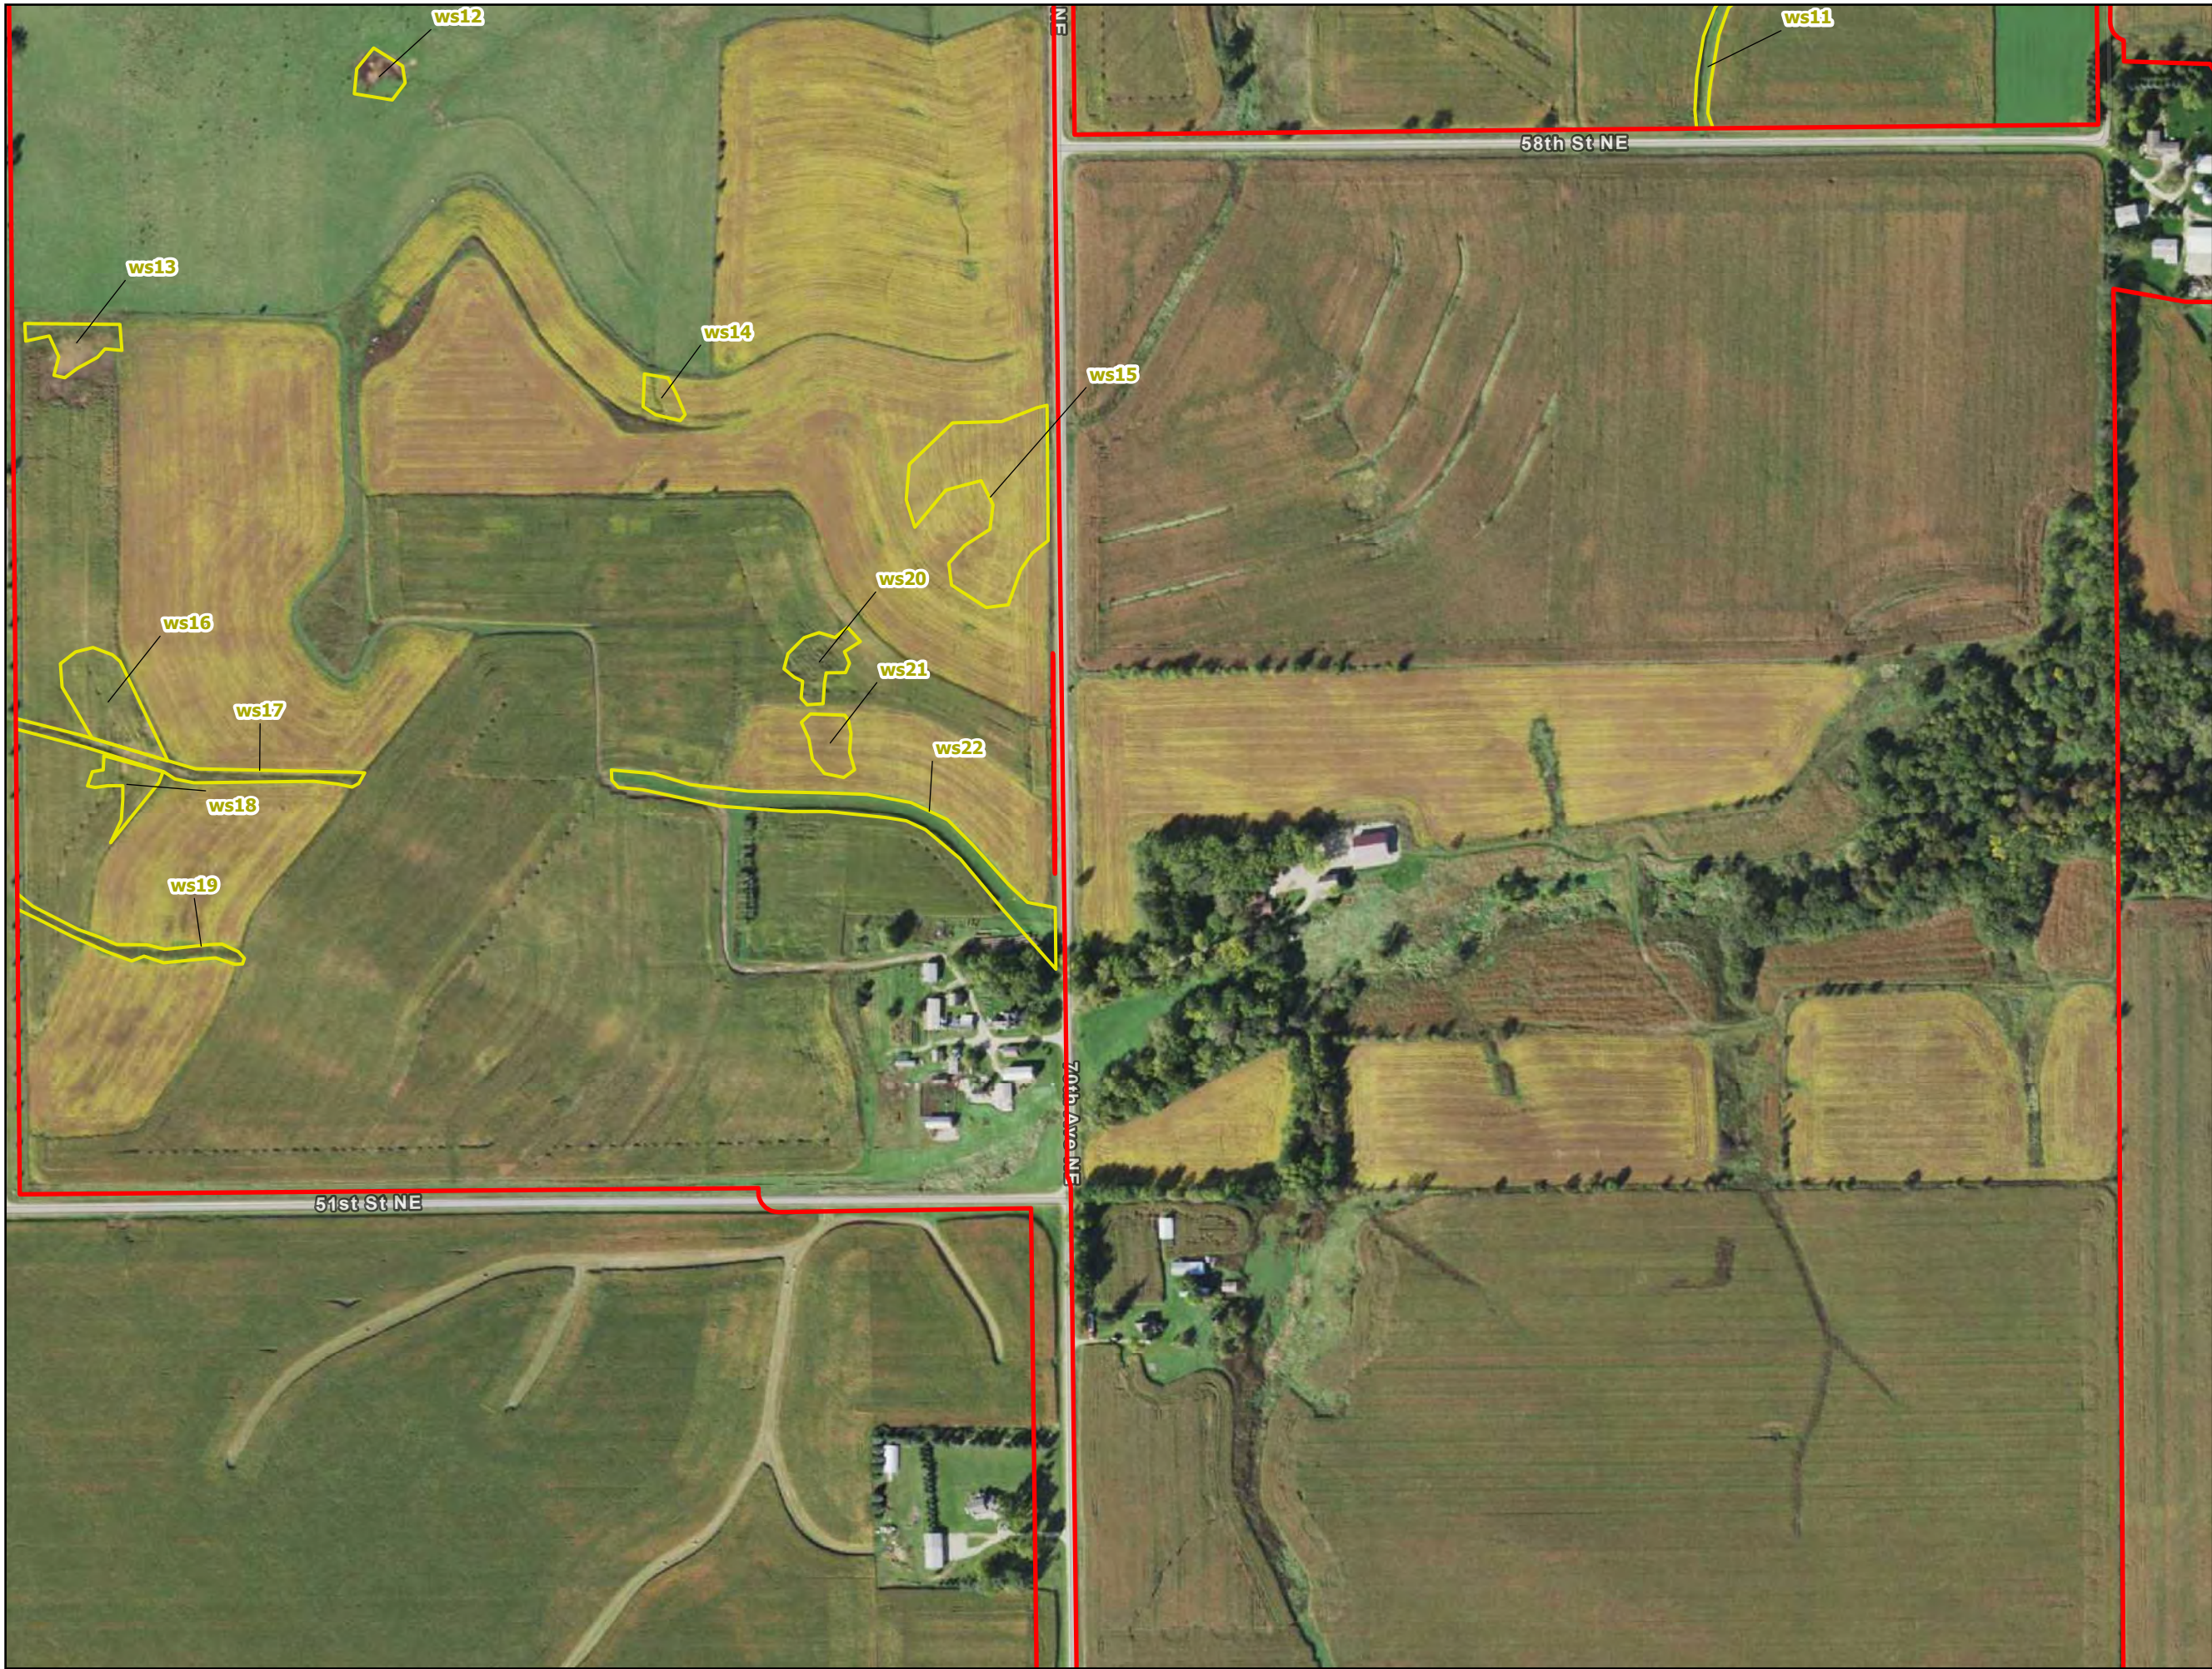
- Survey Area
- Wetness Signature

**FSA Slide Review: NAIP Imagery -
October 2017
Lemon Hill Solar Project
Ranger Power
Olmsted County, MN**

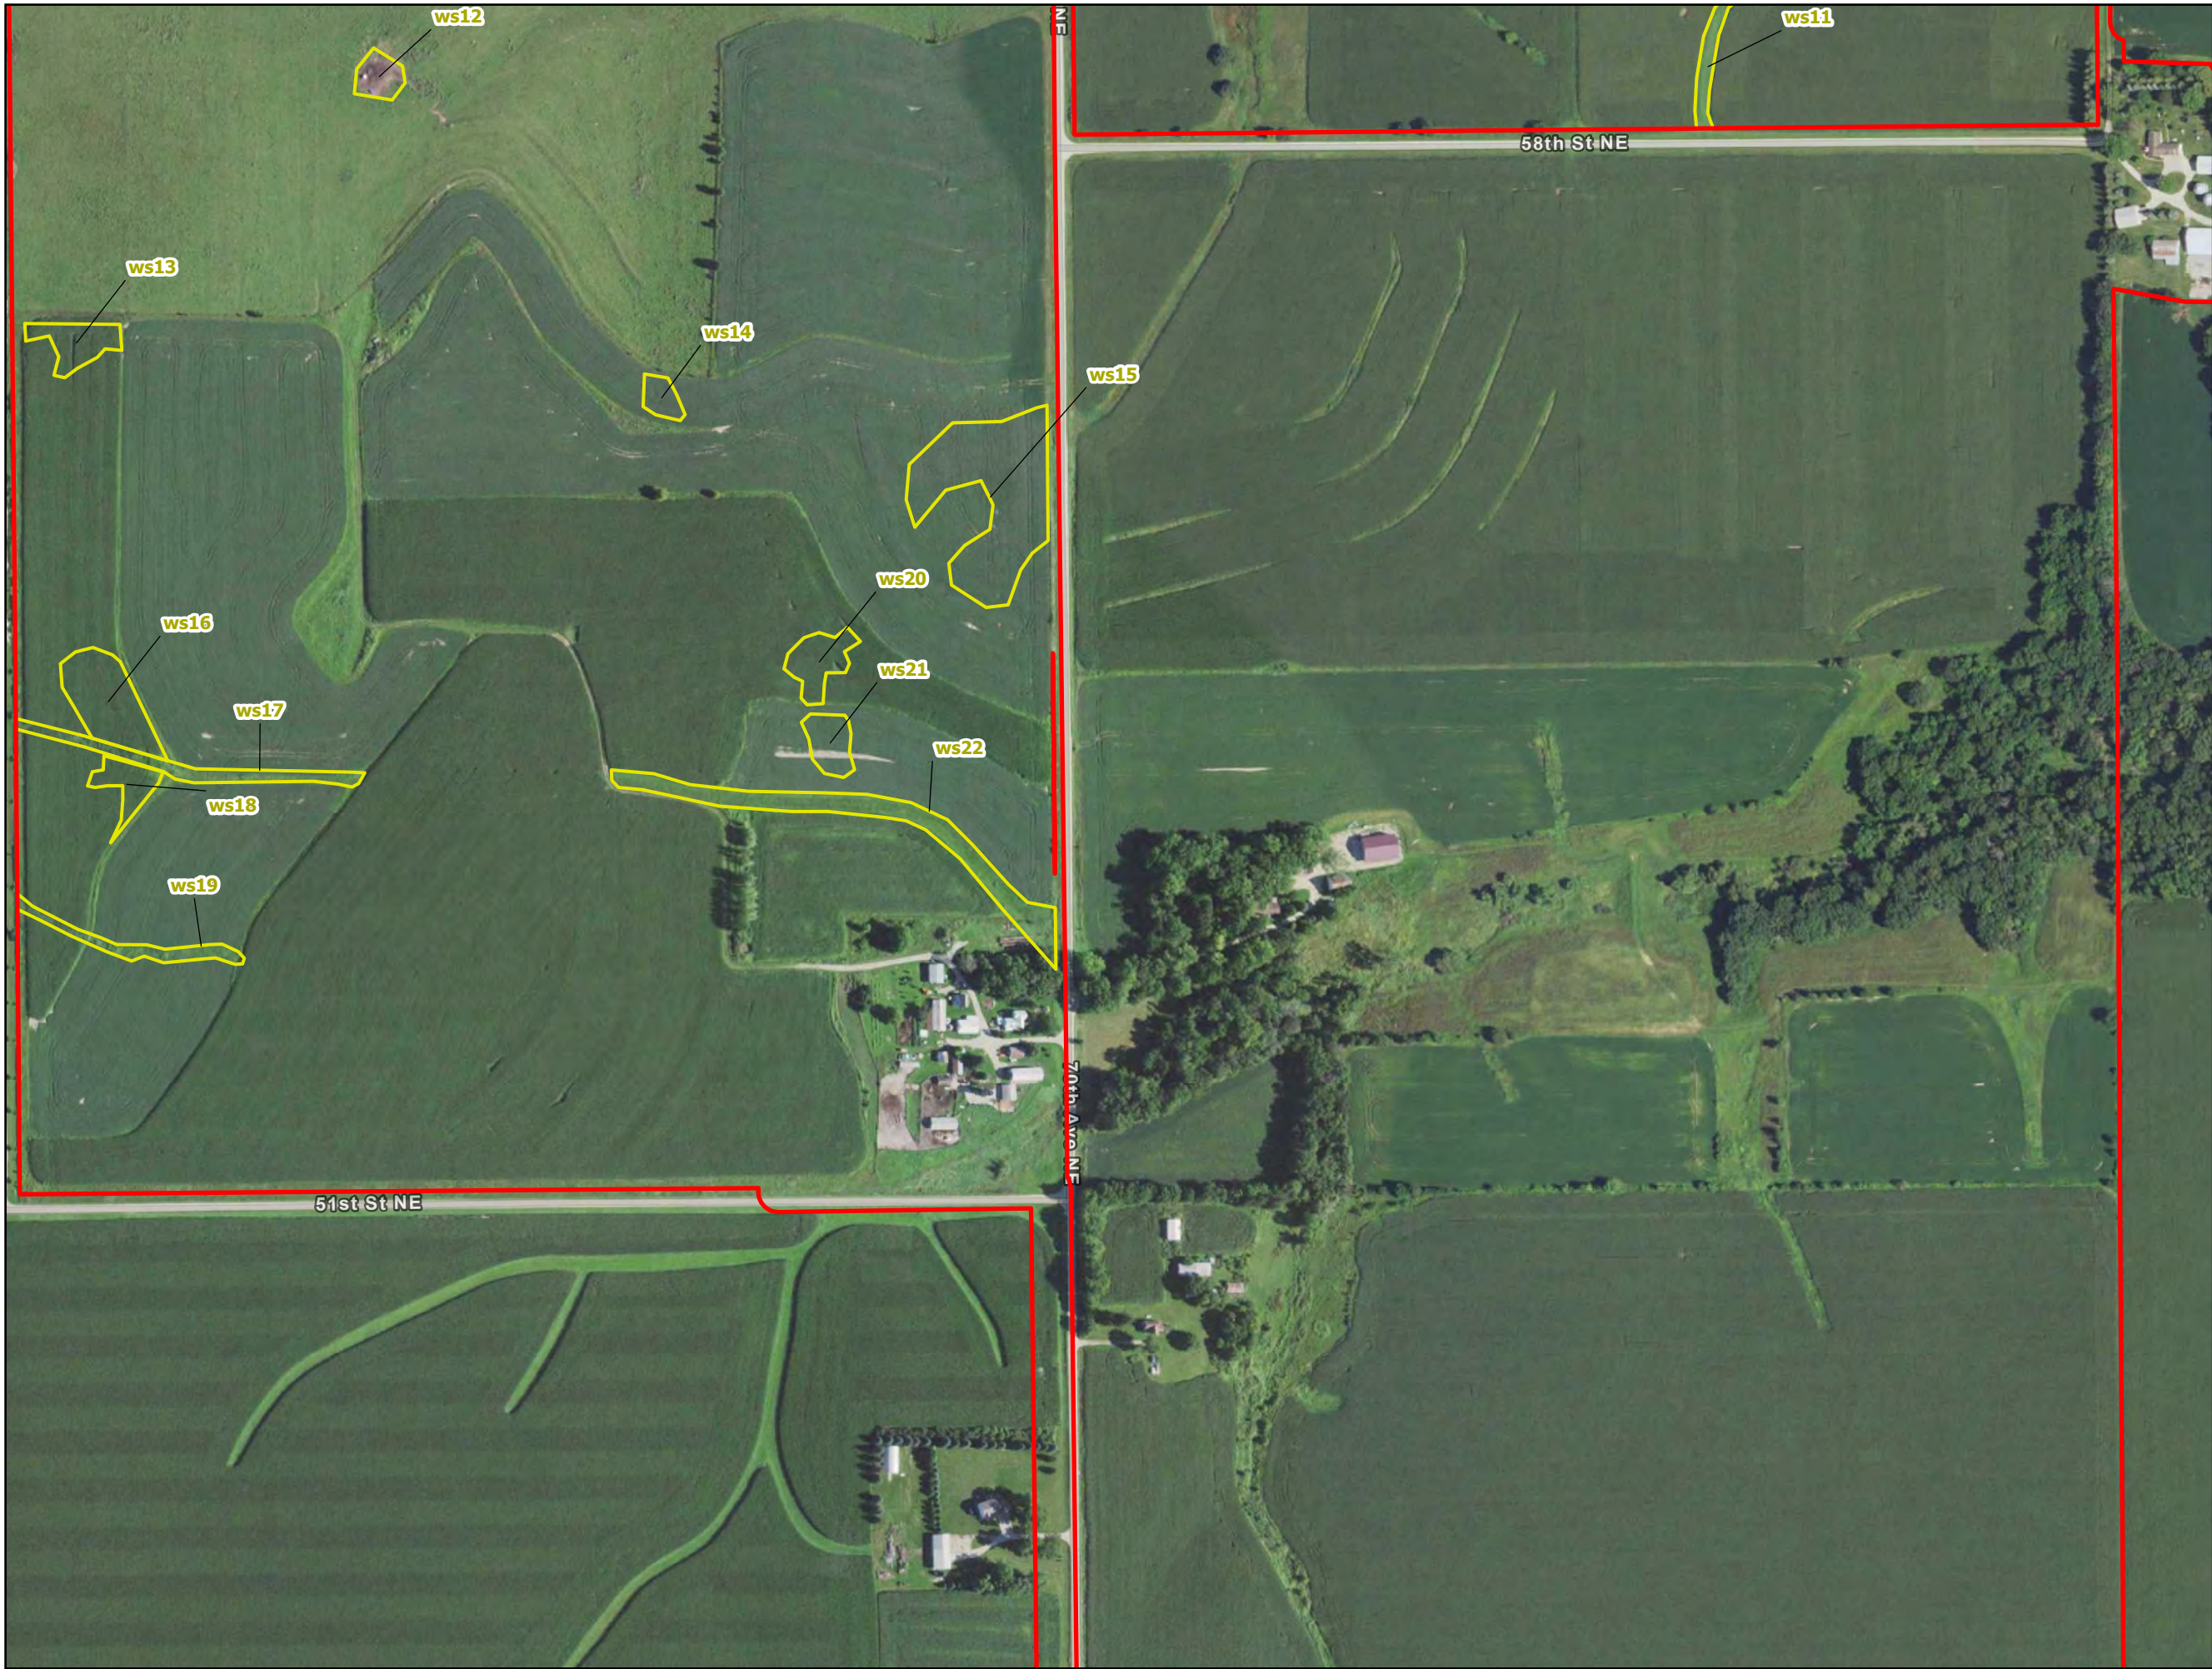
- Survey Area
- Wetness Signature

**FSA Slide Review: NAIP Imagery -
August 2021
Lemon Hill Solar Project
Ranger Power
Olmsted County, MN**

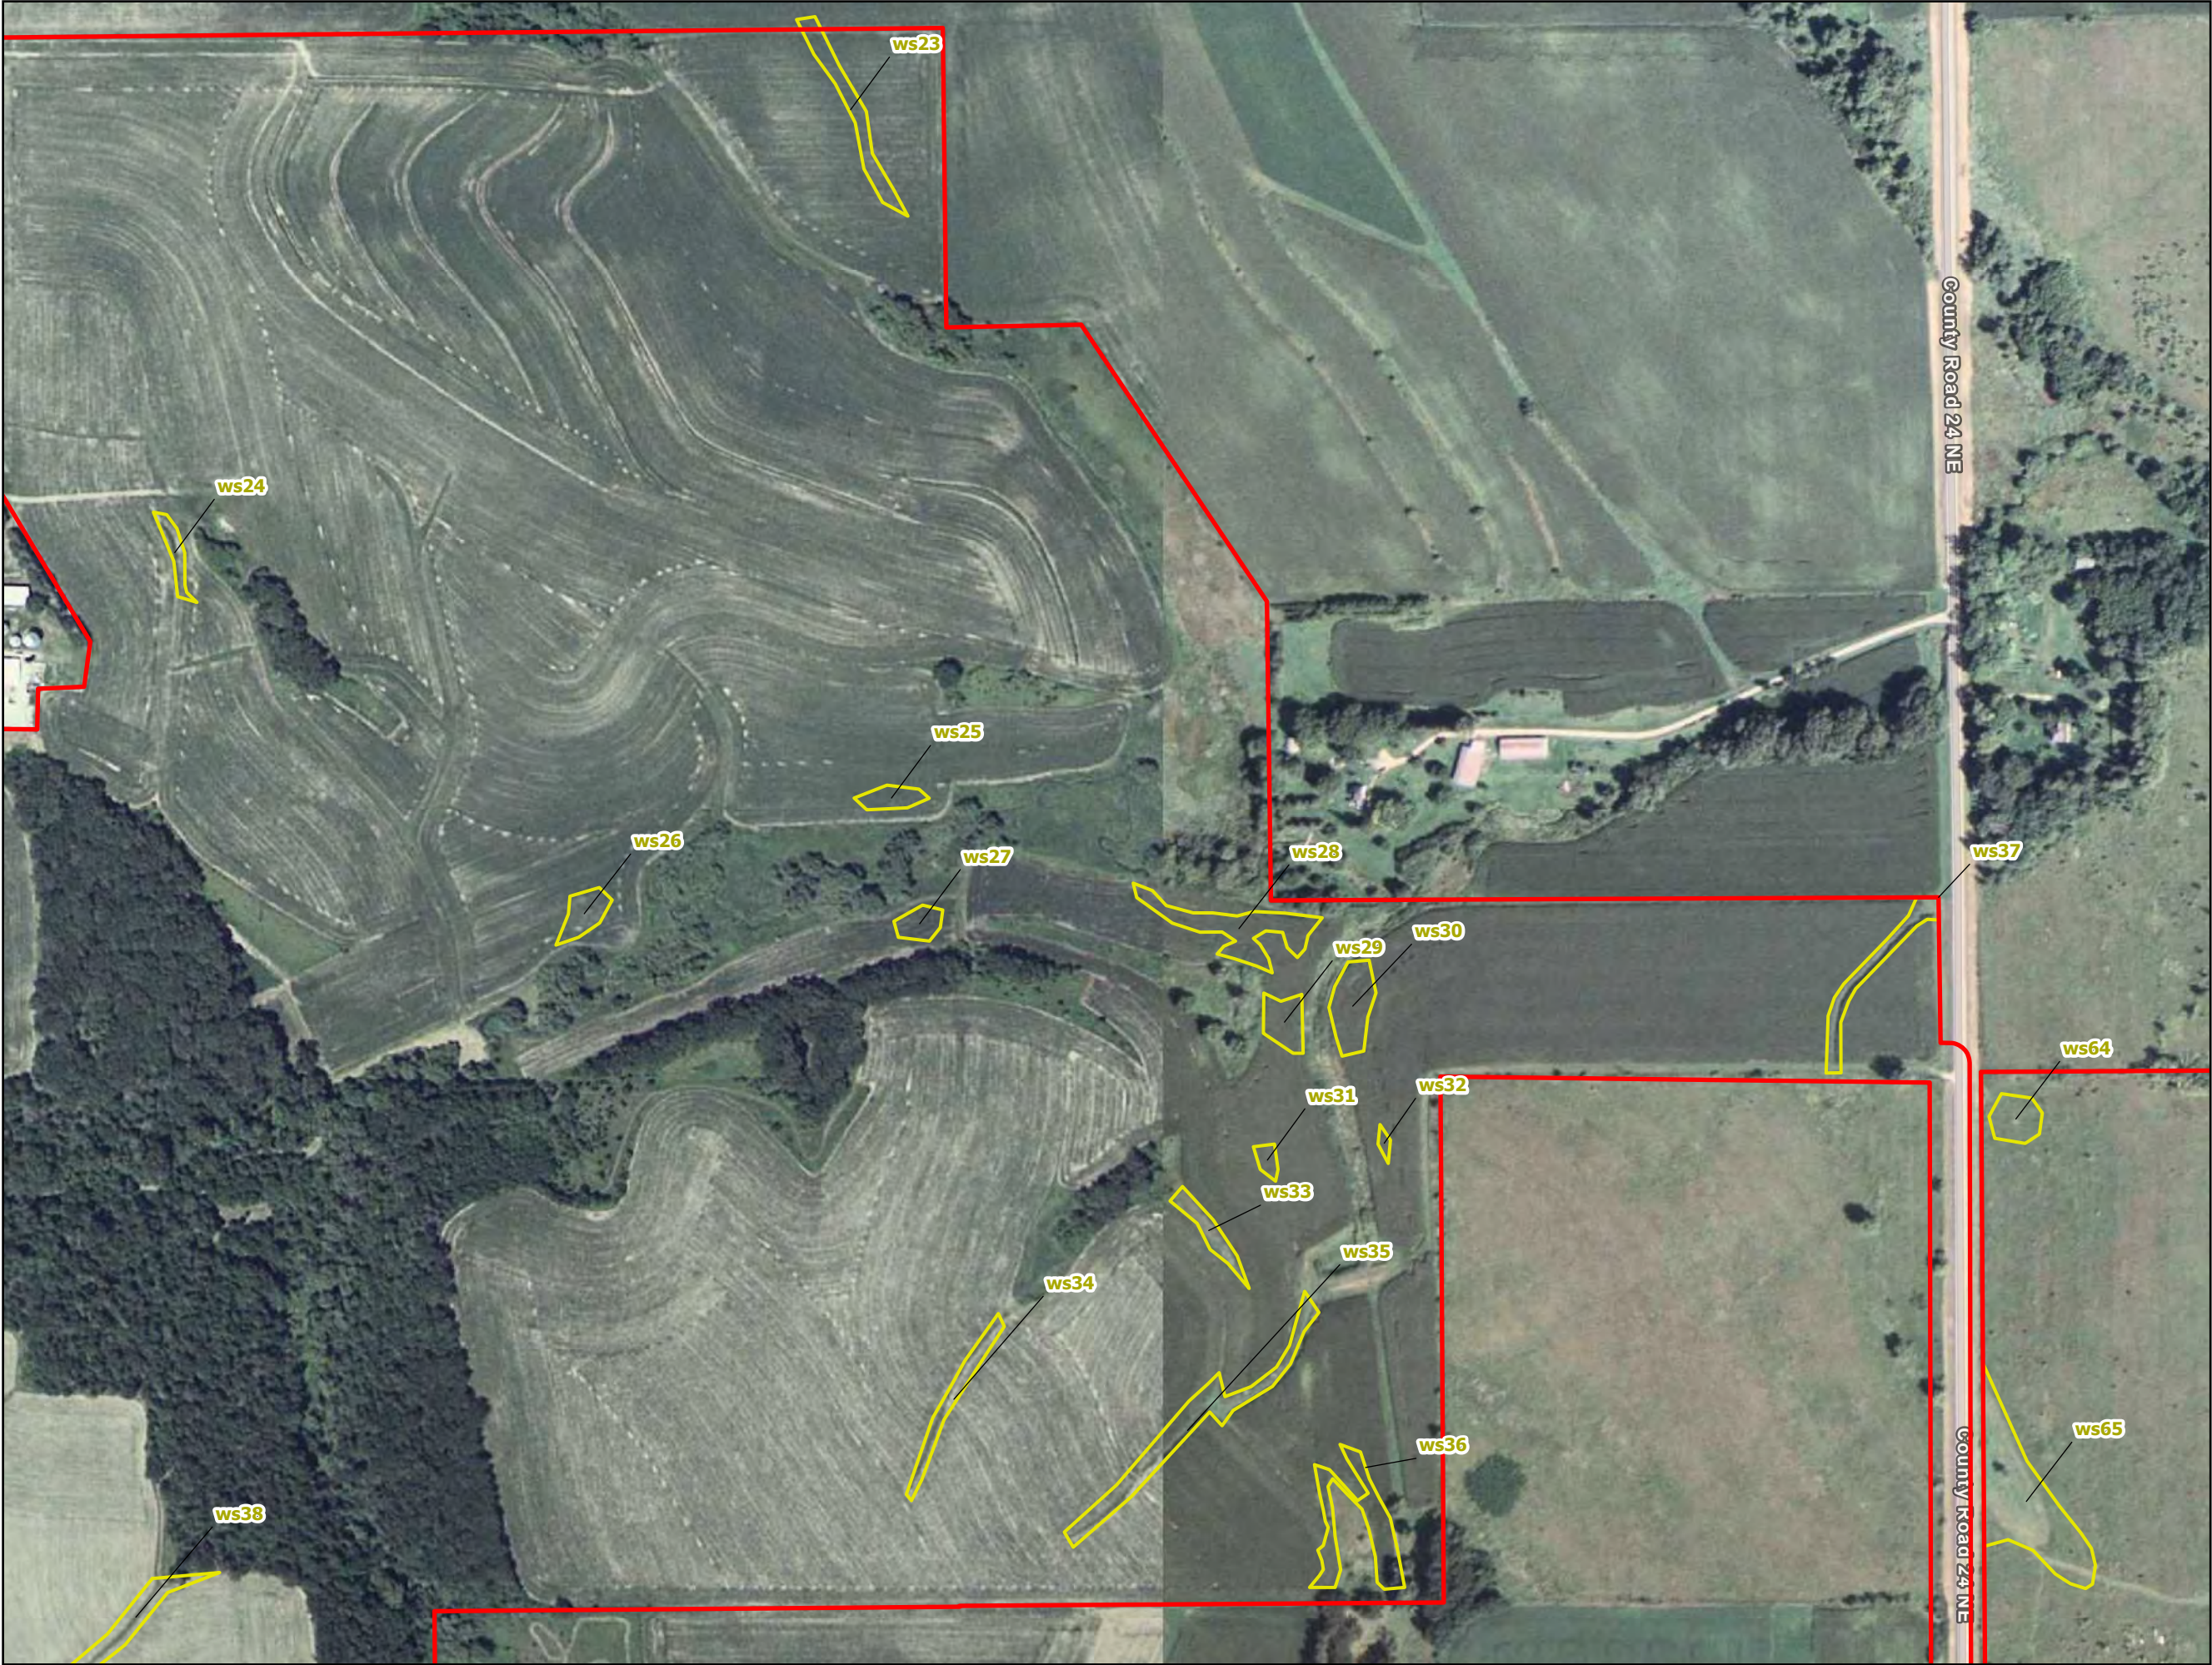
- Survey Area
- Wetness Signature

**FSA Slide Review: NAIP Imagery -
August 2009
Lemon Hill Solar Project
Ranger Power
Olmsted County, MN**
