**FSA Slide Review: NAIP Imagery -
October 2017
Lemon Hill Solar Project
Ranger Power
Olmsted County, MN**

Exhibit 1Field data sheet reference (if applicable): See attached crosswalk table**Wetland Hydrology from Aerial Imagery – Recording Form**

Project Name: Lemon Hill Solar Project

Date: 5/20/24 County: OlmstedInvestigator: Kyle Hanson Legal Description (T, R, S): T107N, R13W, S12**Summary Table**

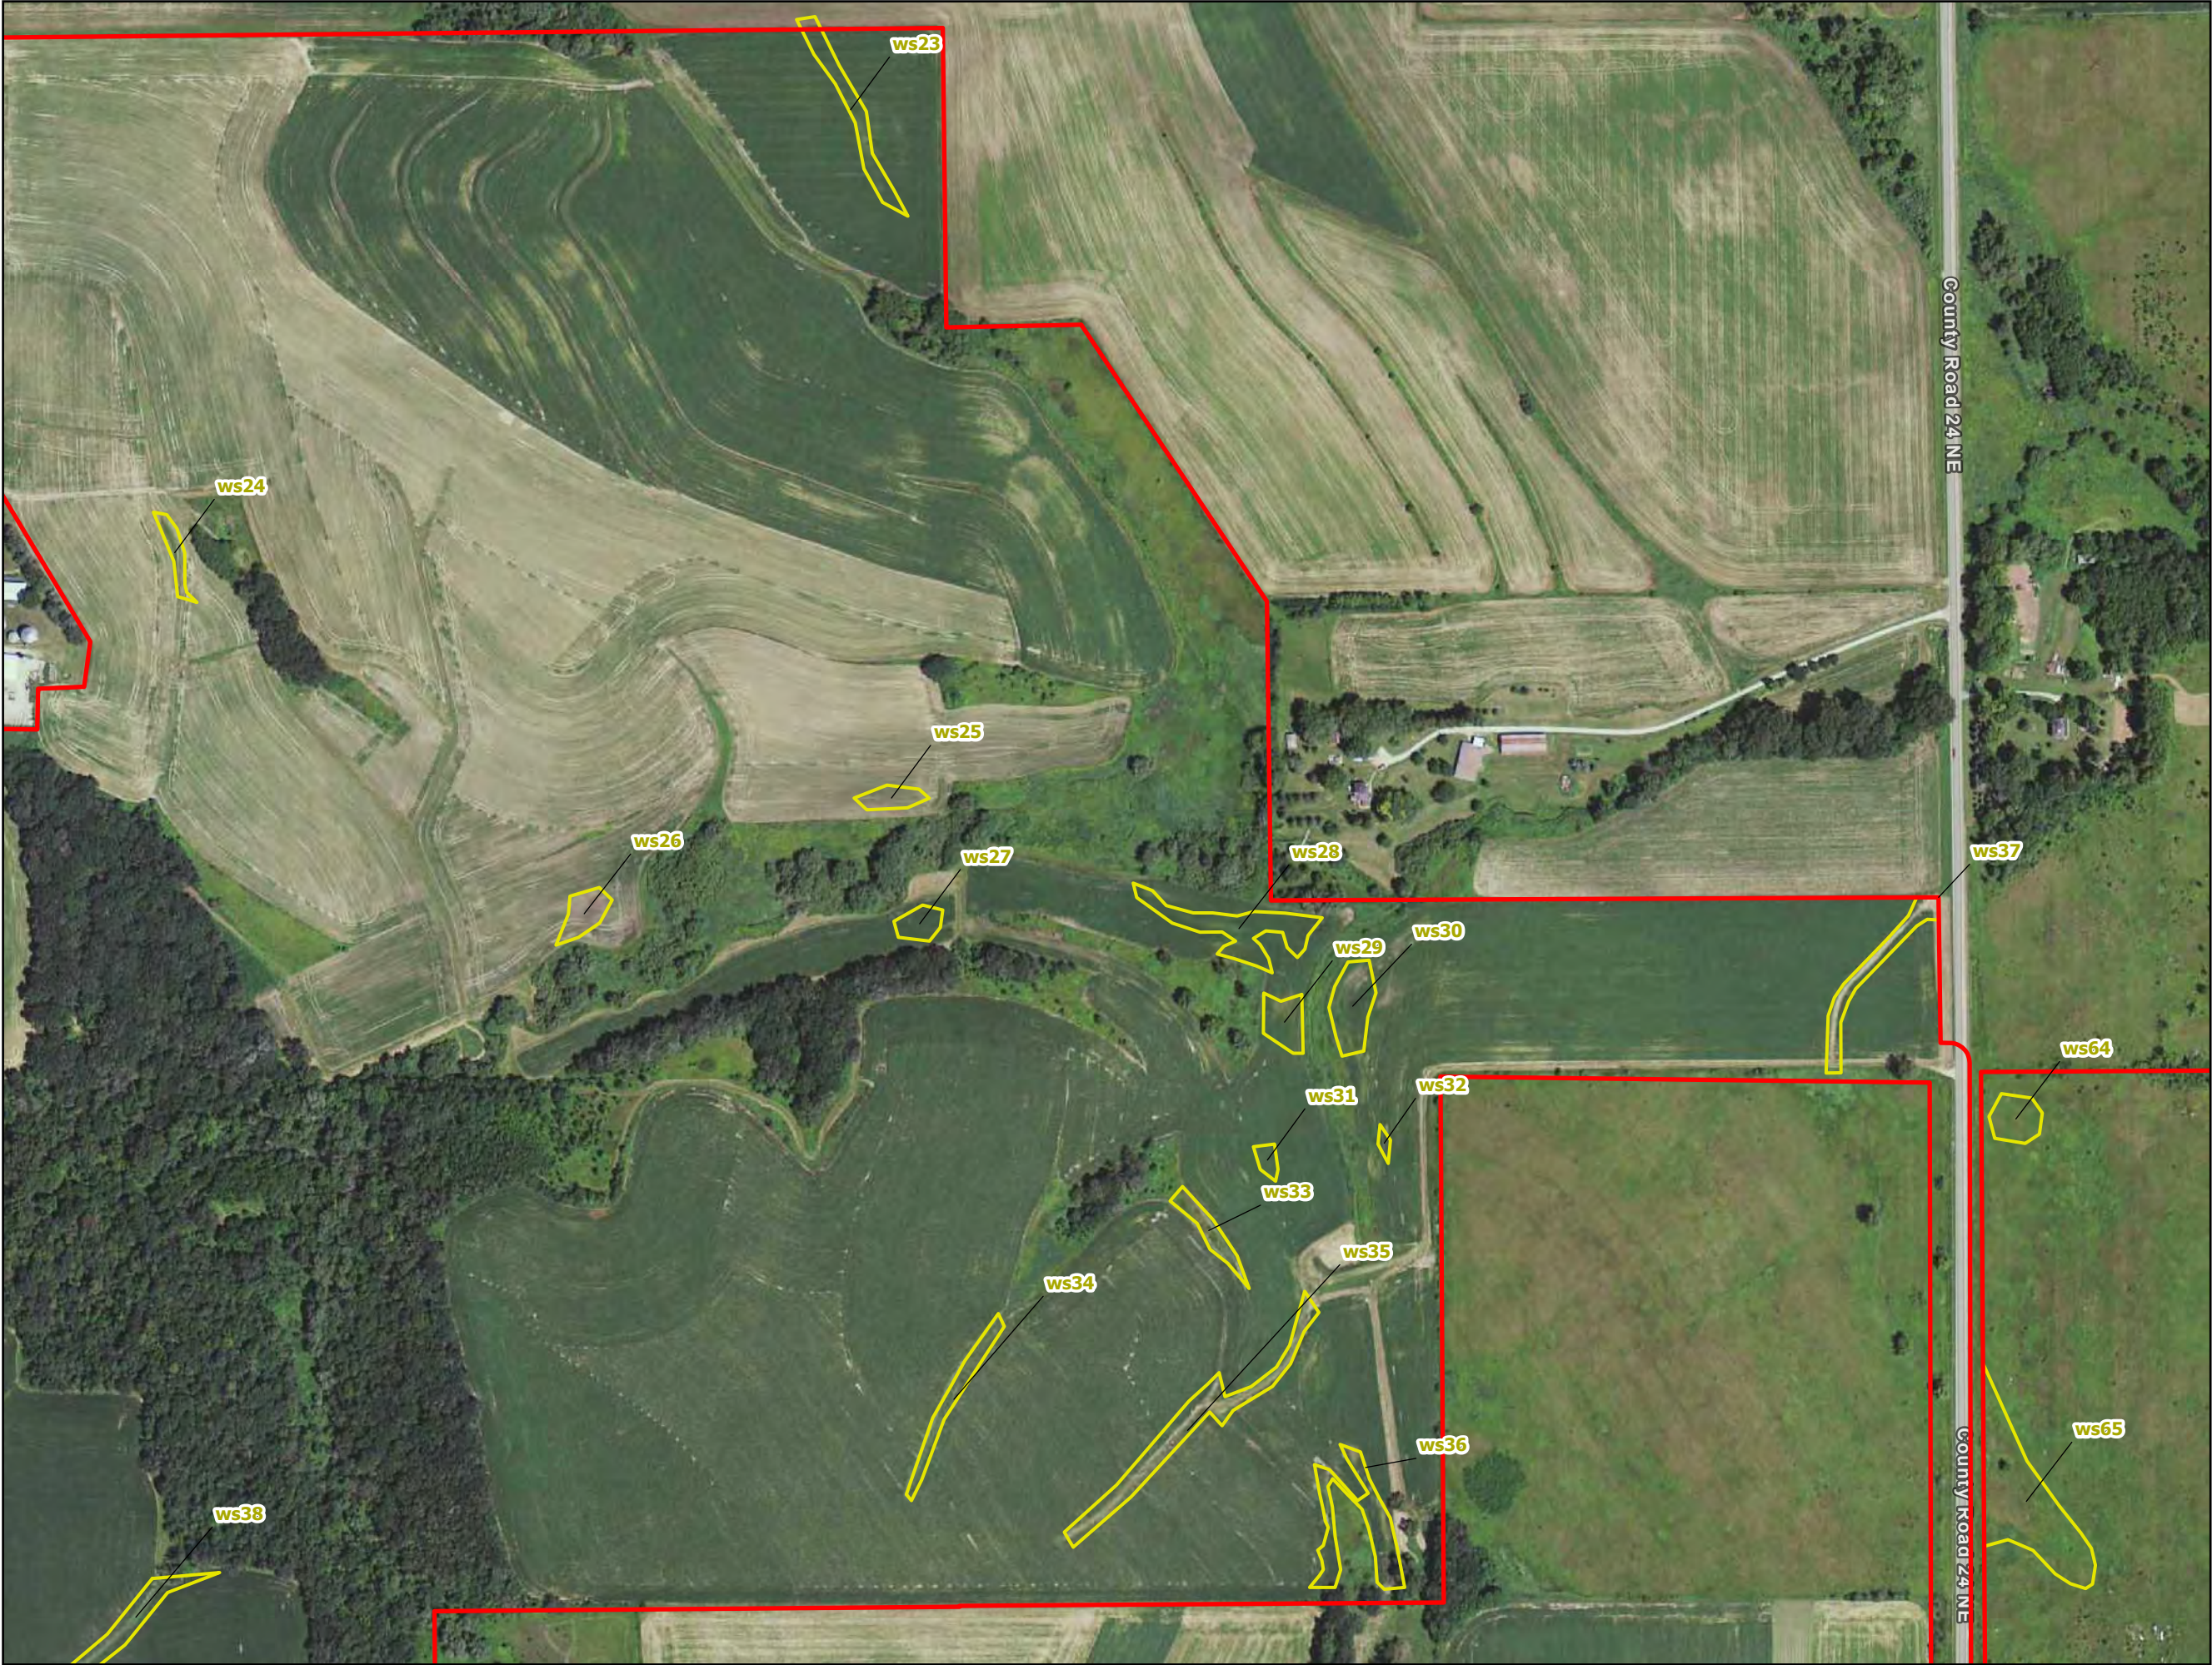
- Survey Area
- Wetness Signature

**FSA Slide Review: NAIP Imagery -
July 2010
Lemon Hill Solar Project
Ranger Power
Olmsted County, MN**

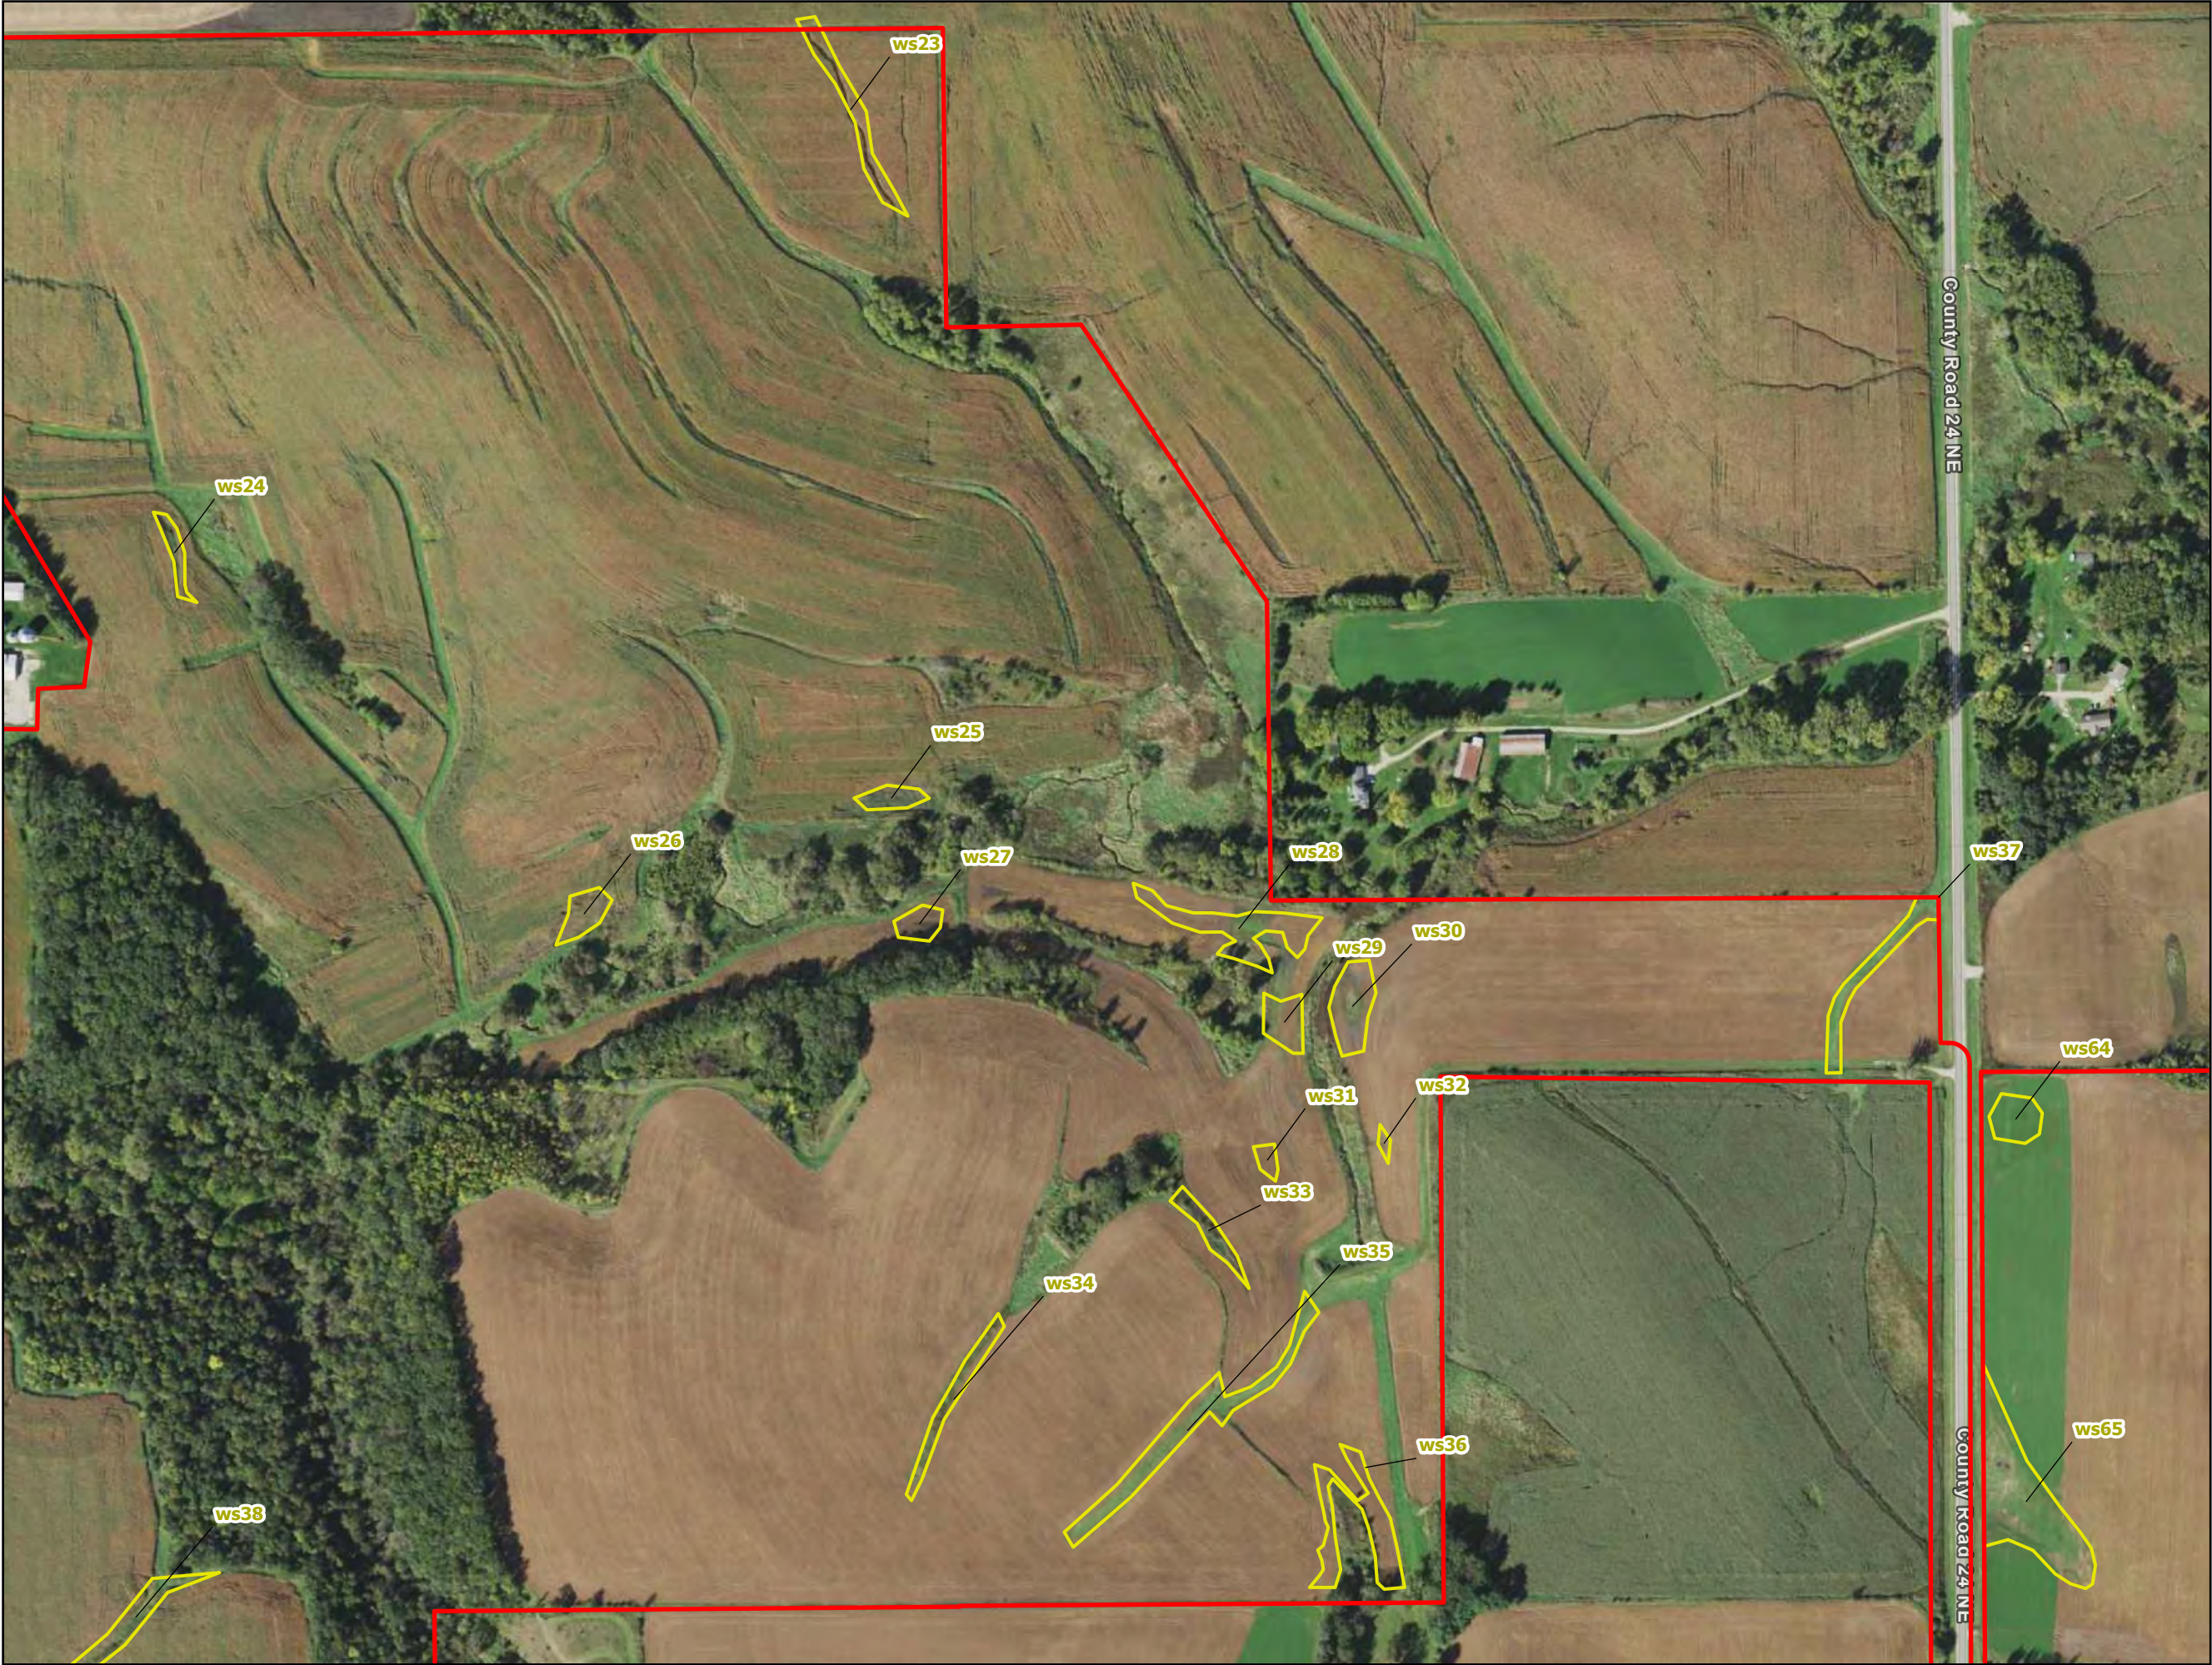
- Survey Area
- Wetness Signature

**FSA Slide Review: NAIP Imagery -
October 2017
Lemon Hill Solar Project
Ranger Power
Olmsted County, MN**

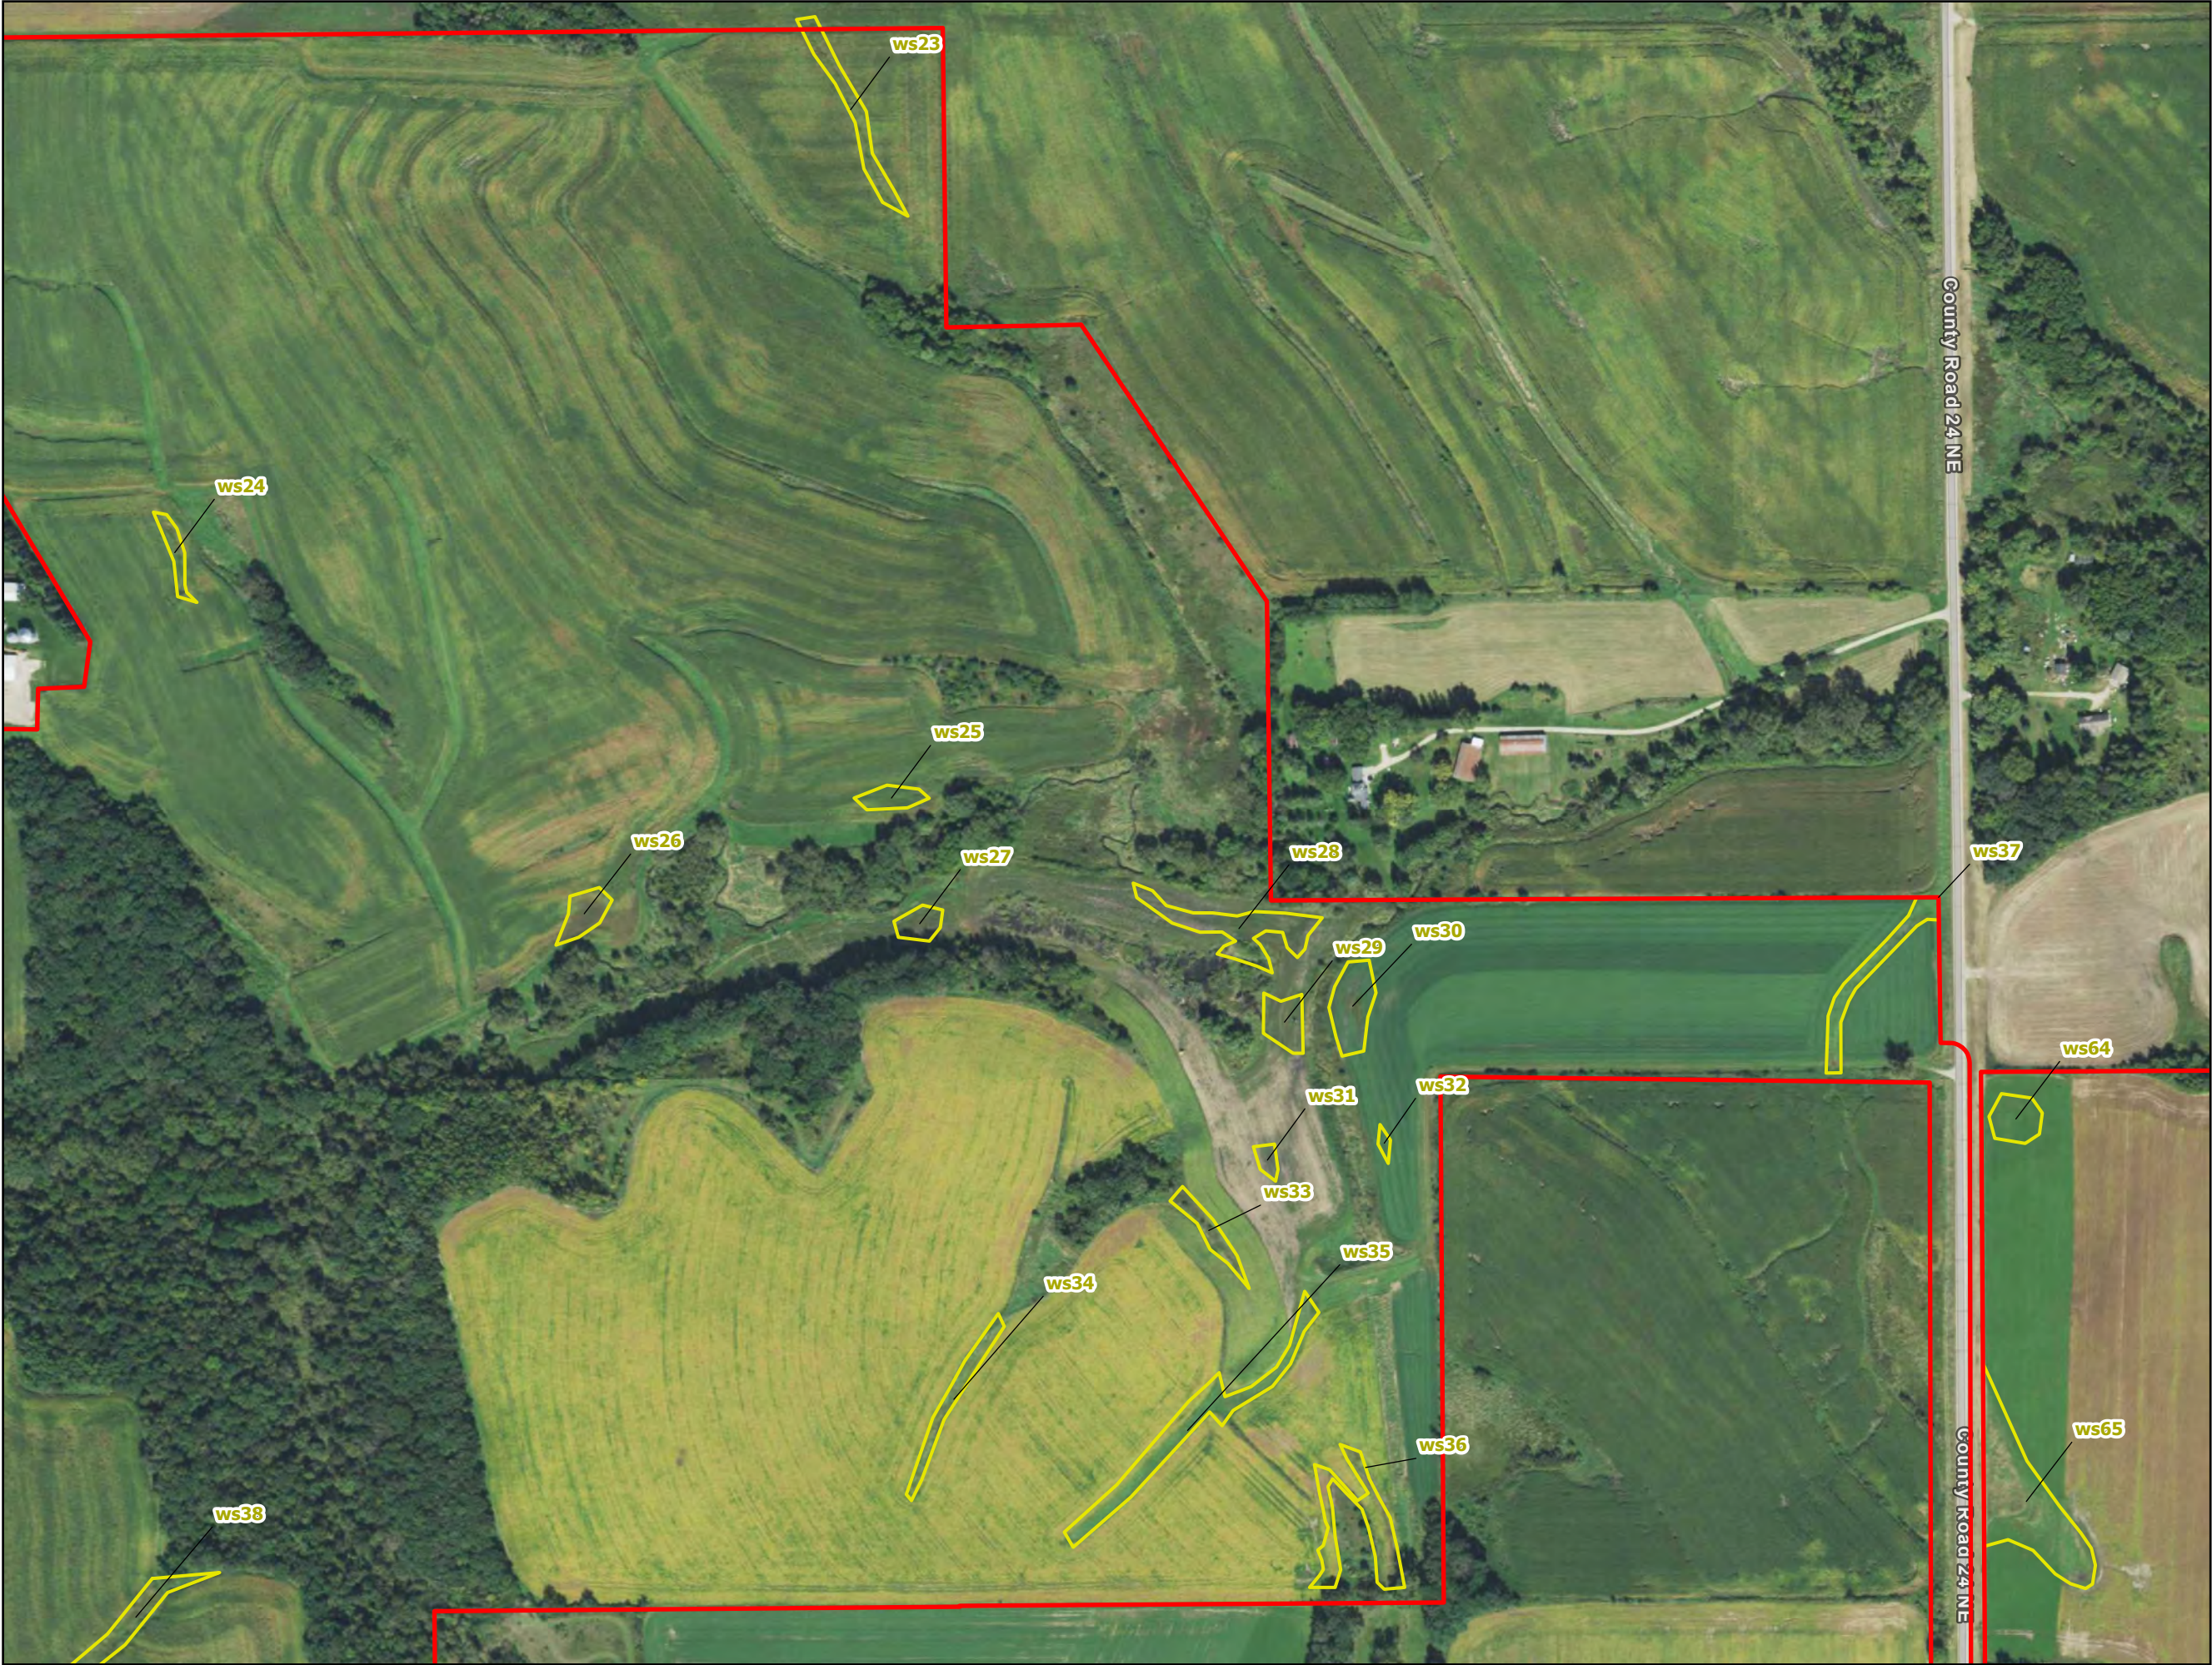
- Survey Area
- Wetness Signature

**FSA Slide Review: NAIP Imagery -
August 2019
Lemon Hill Solar Project
Ranger Power
Olmsted County, MN**

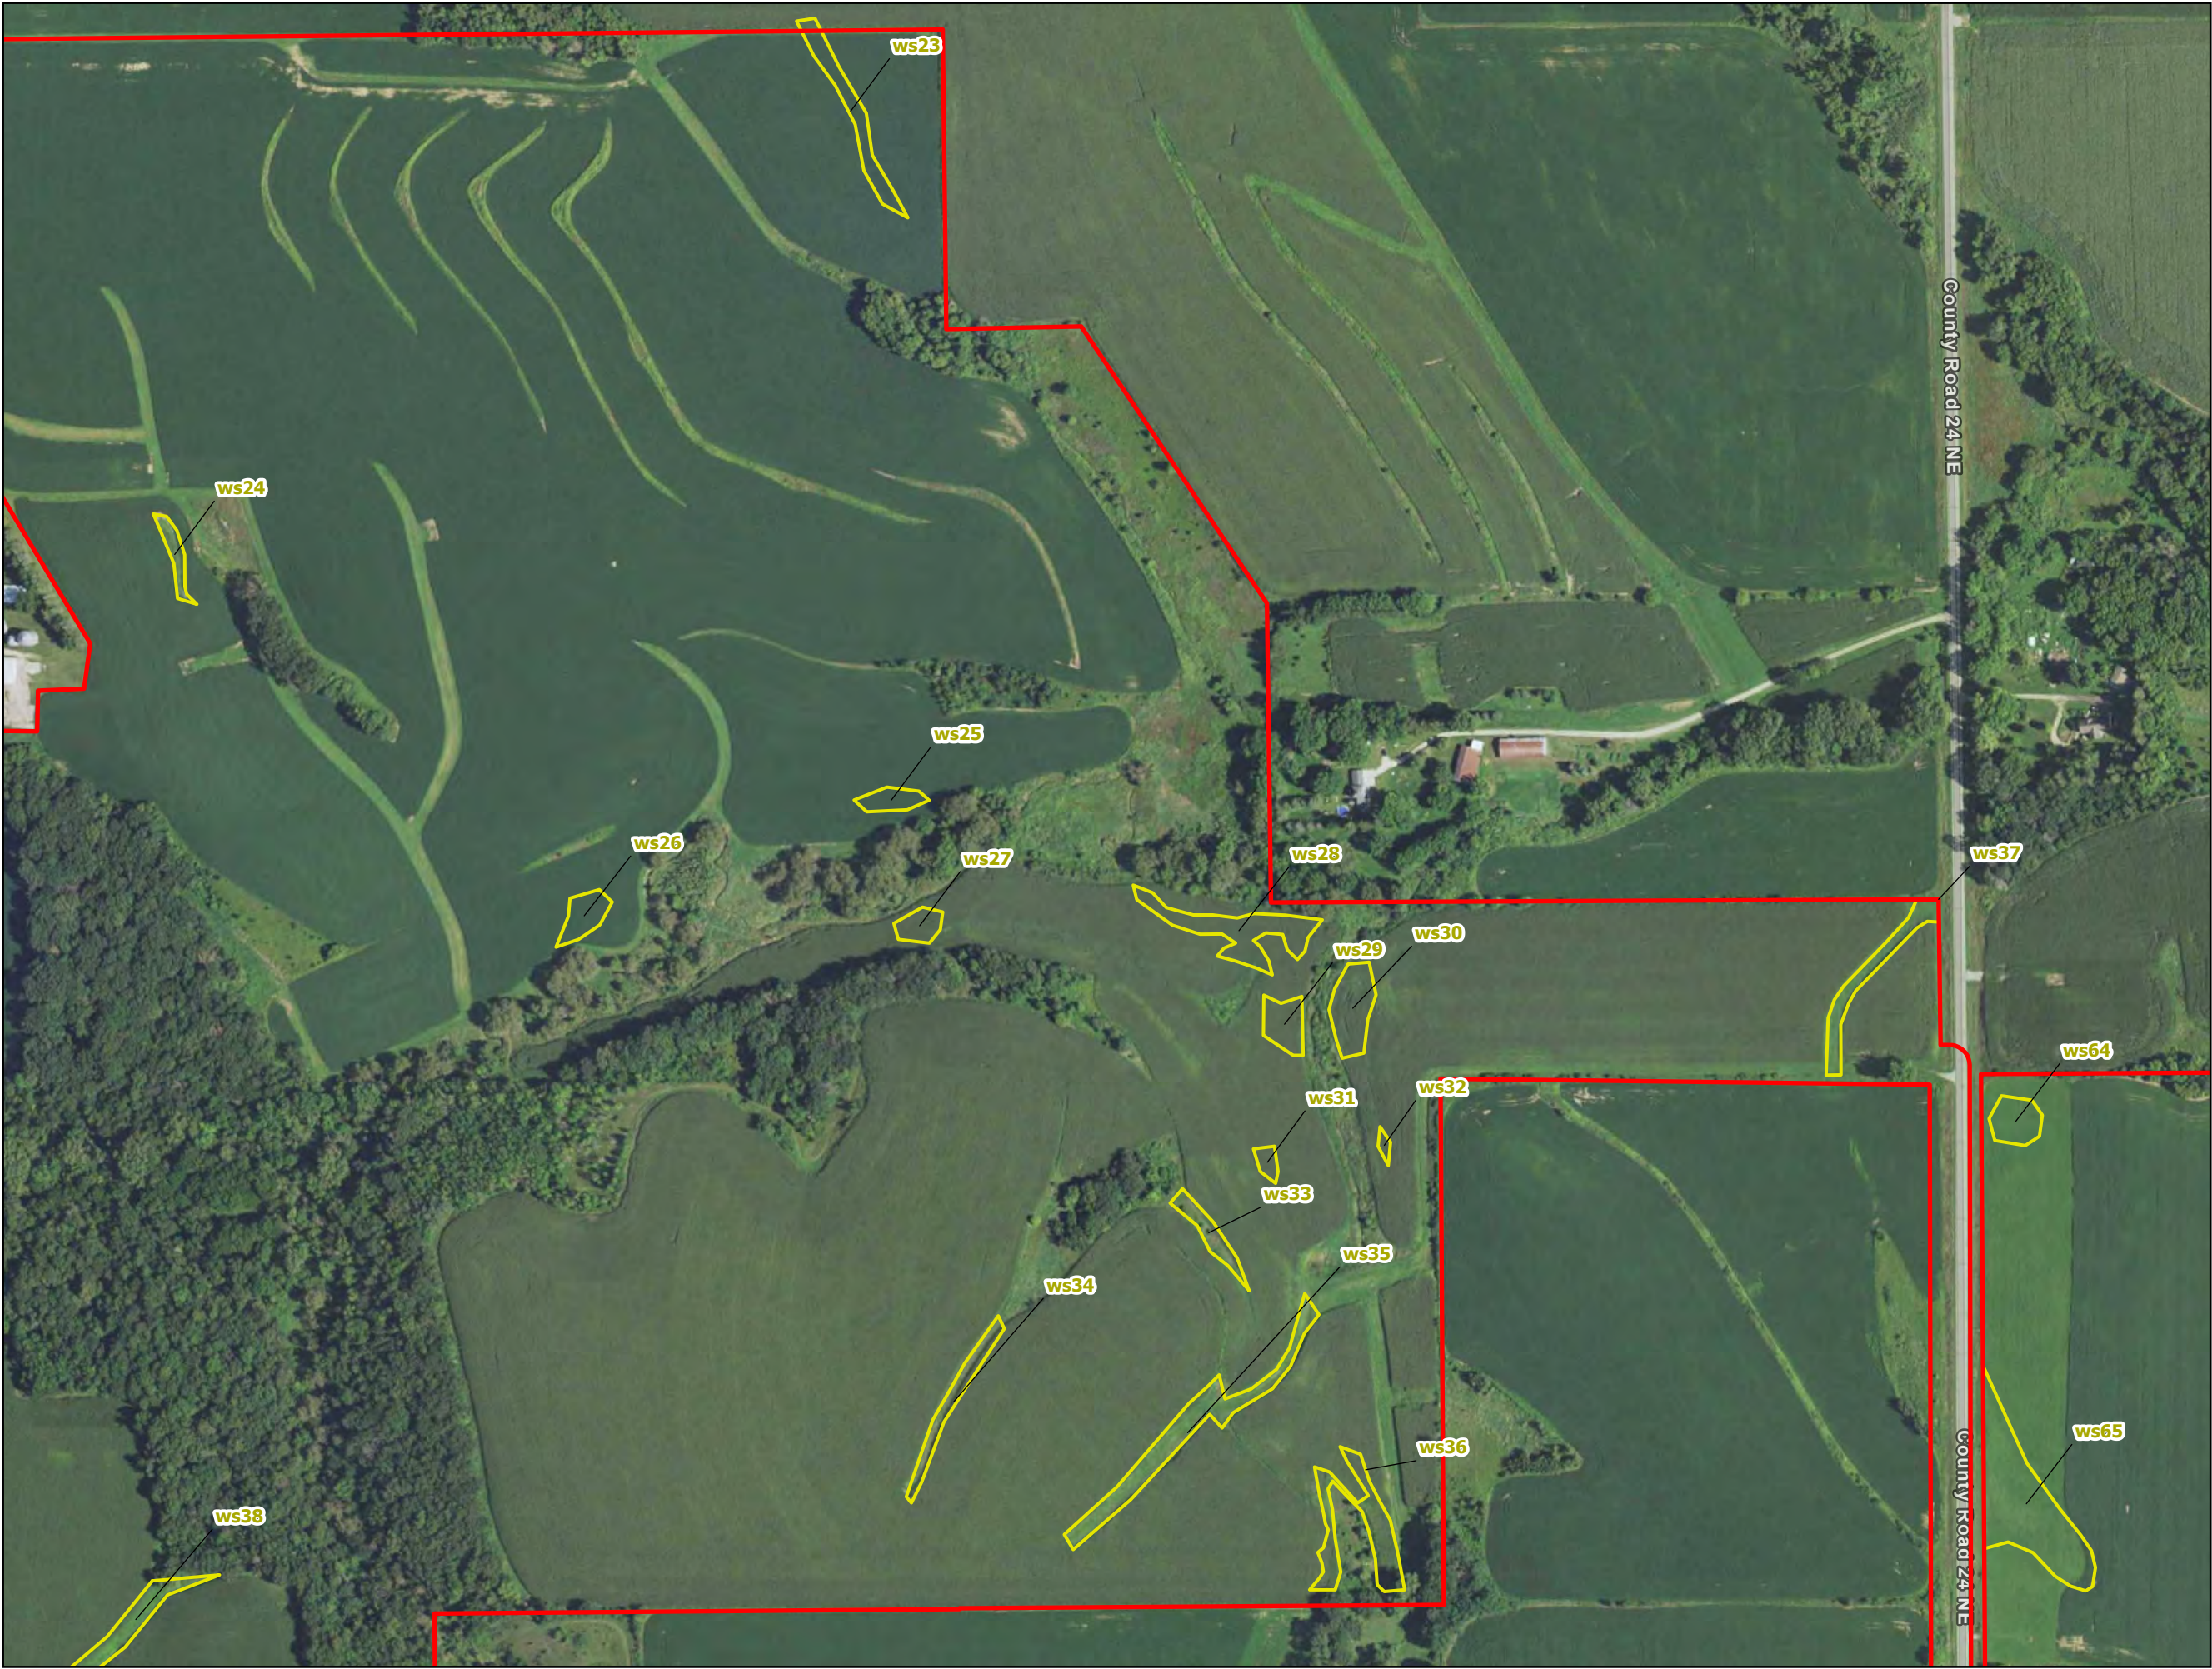
- Survey Area
- Wetness Signature

**FSA Slide Review: NAIP Imagery -
August 2021
Lemon Hill Solar Project
Ranger Power
Olmsted County, MN**

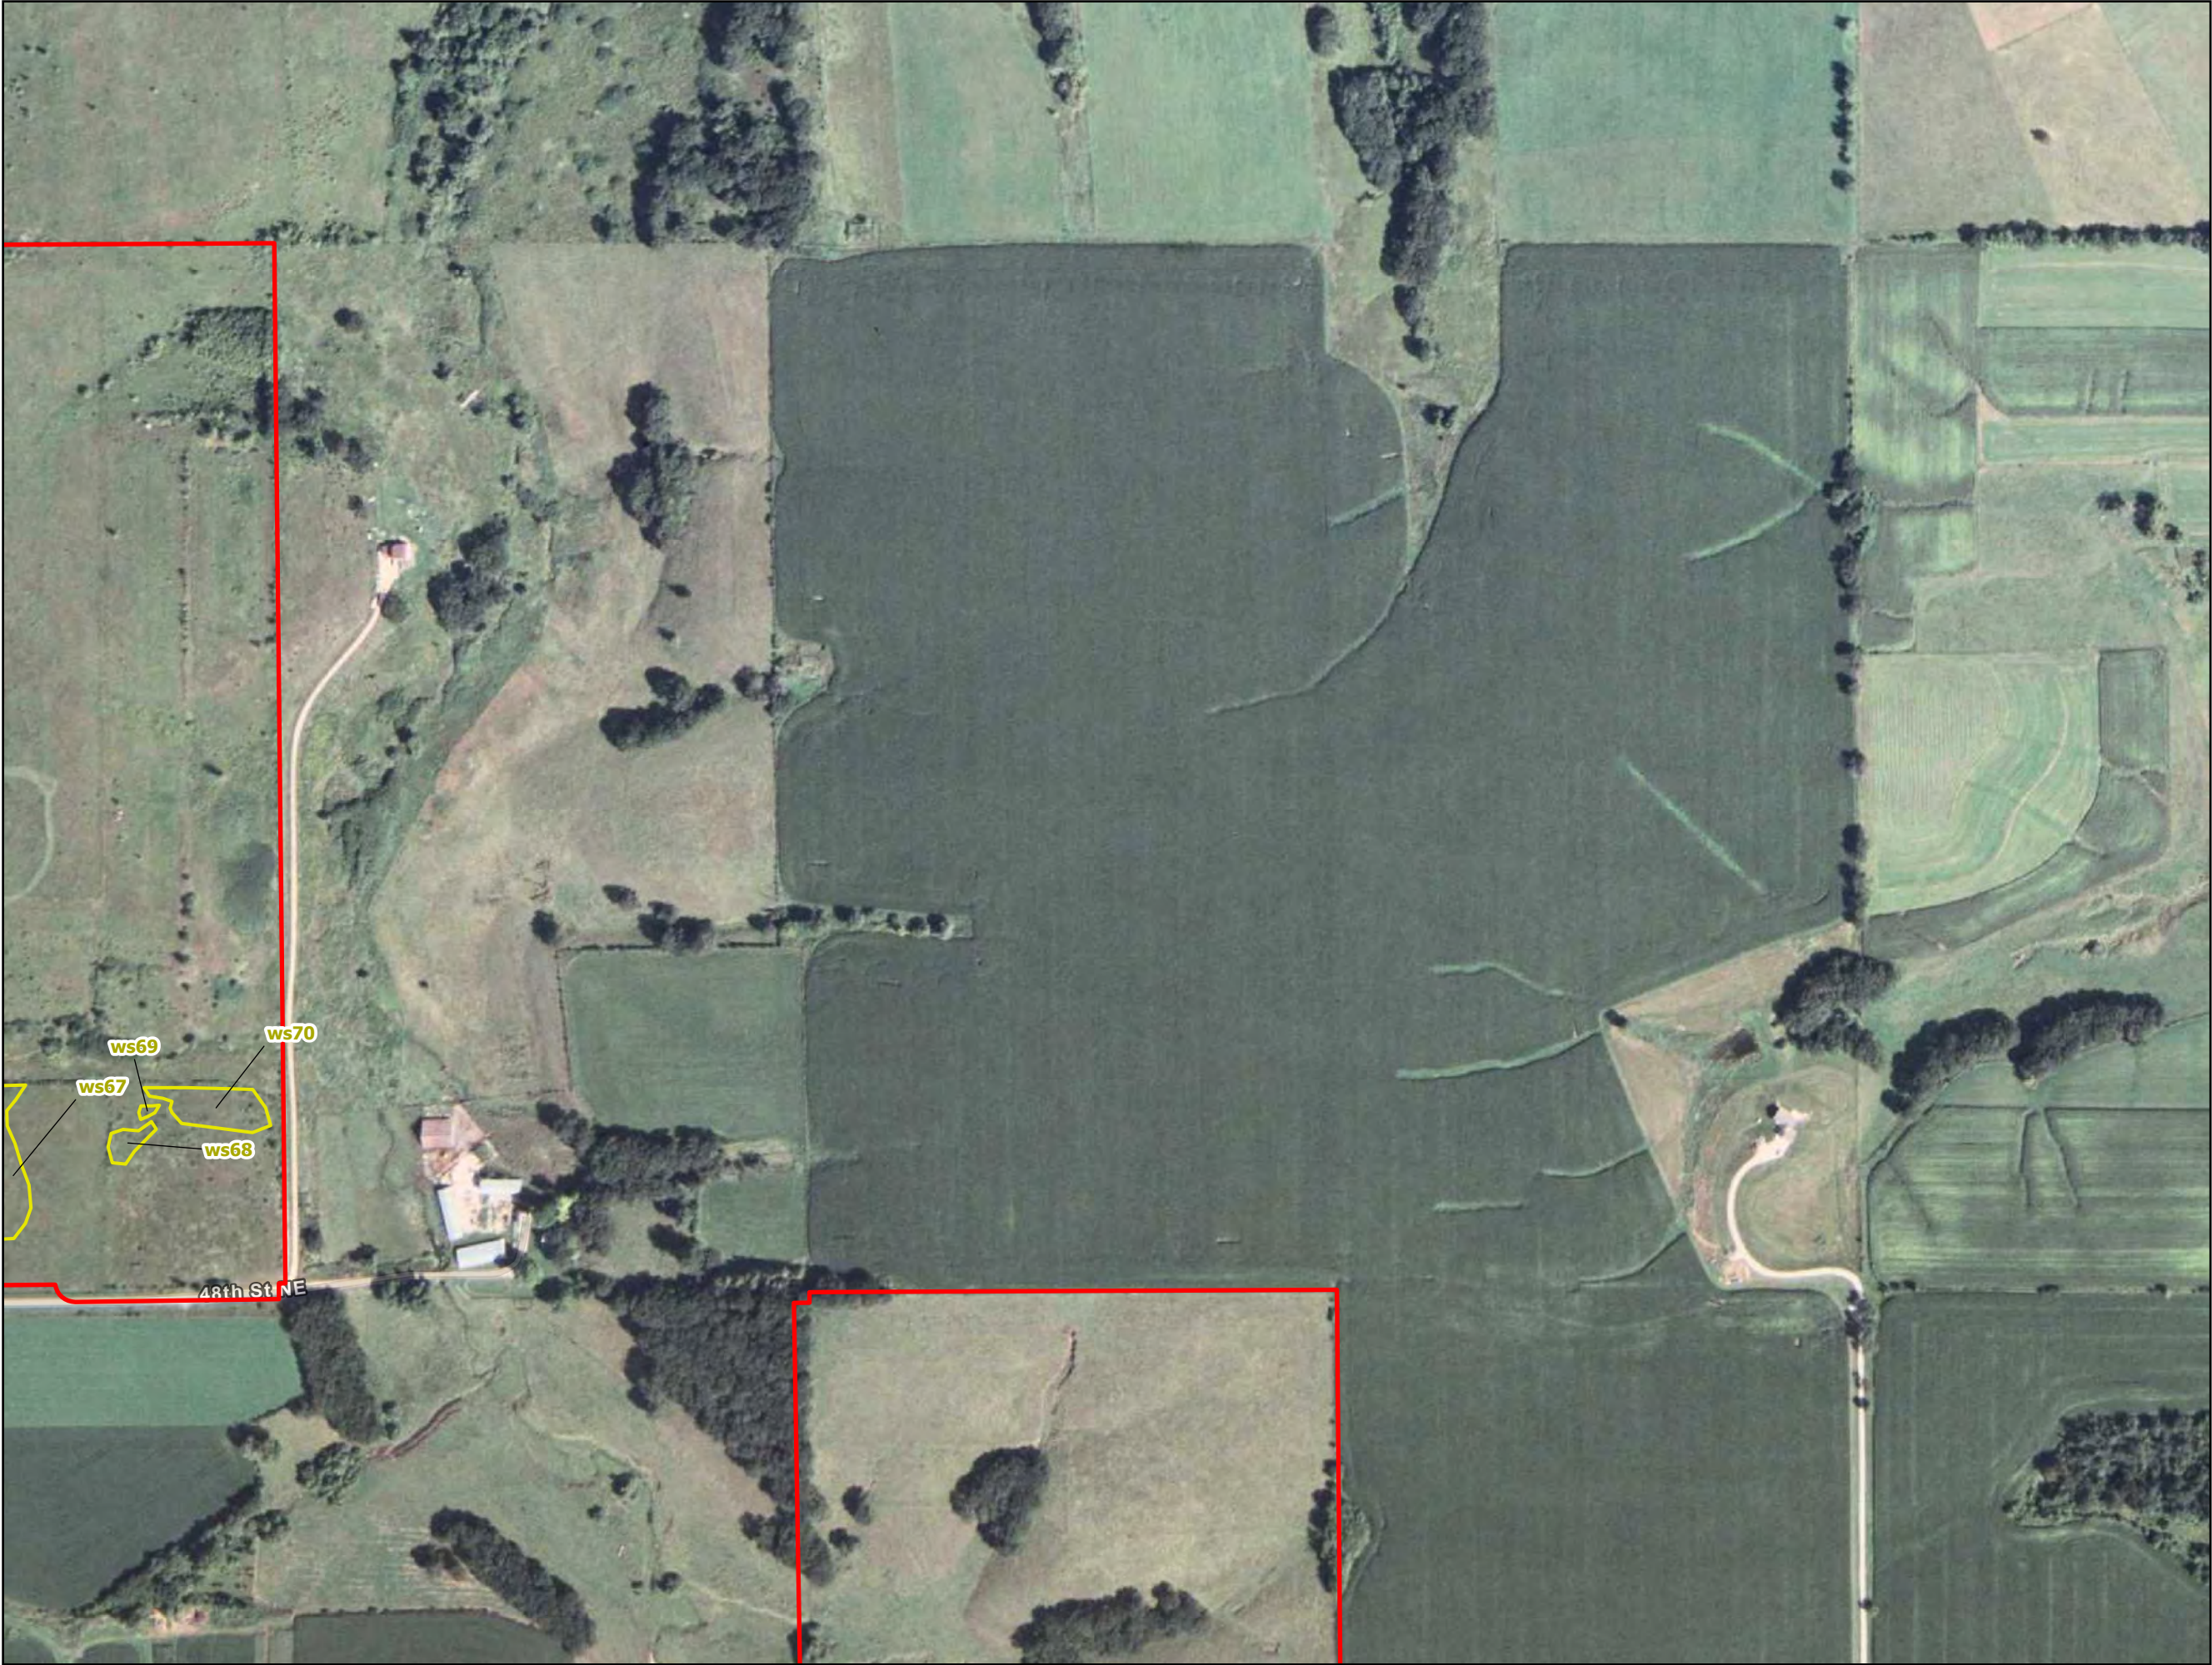
- Survey Area
- Wetness Signature

**FSA Slide Review: NAIP Imagery -
August 2009
Lemon Hill Solar Project
Ranger Power
Olmsted County, MN**

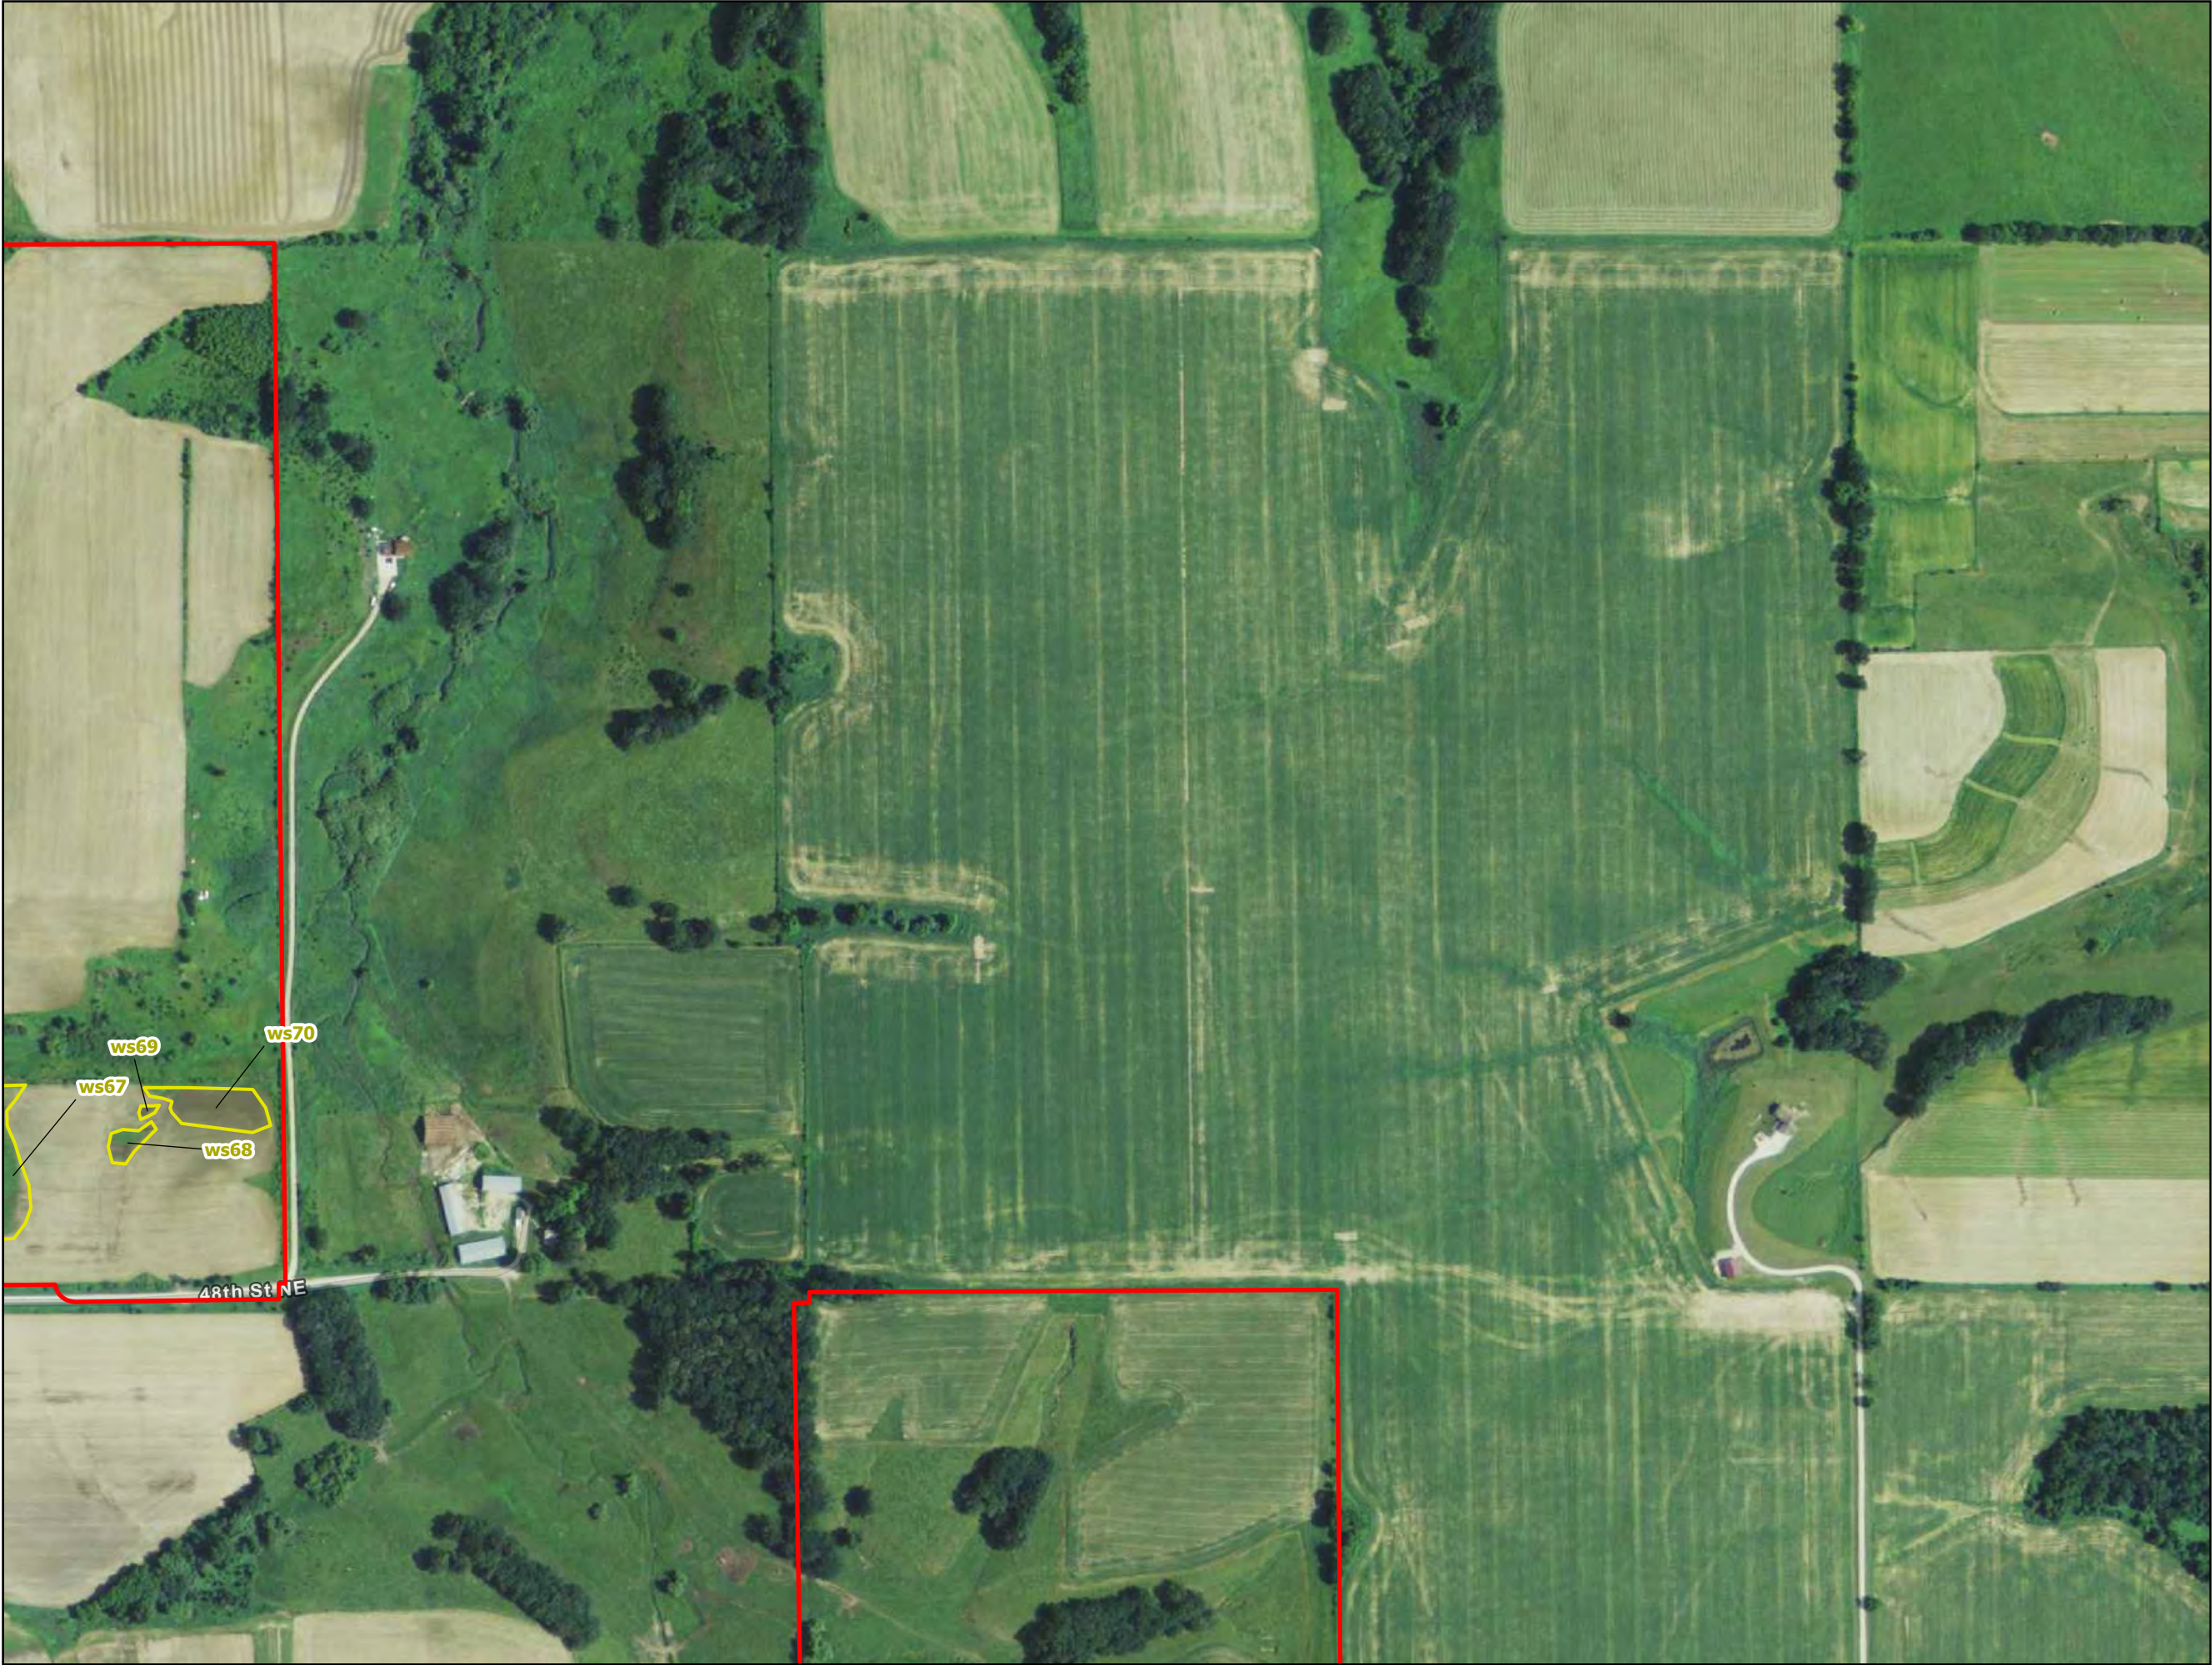
- Survey Area
- Wetness Signature

**FSA Slide Review: NAIP Imagery -
July 2013
Lemon Hill Solar Project
Ranger Power
Olmsted County, MN**
