**FSA Slide Review: NAIP Imagery -
October 2017
Lemon Hill Solar Project
Ranger Power
Olmsted County, MN**

Exhibit 1Field data sheet reference (if applicable): See attached crosswalk table**Wetland Hydrology from Aerial Imagery – Recording Form**

Project Name: Lemon Hill Solar Project

Date: 5/20/24 County: OlmstedInvestigator: Kyle Hanson Legal Description (T, R, S): T107N, R13W, S12**Summary Table**

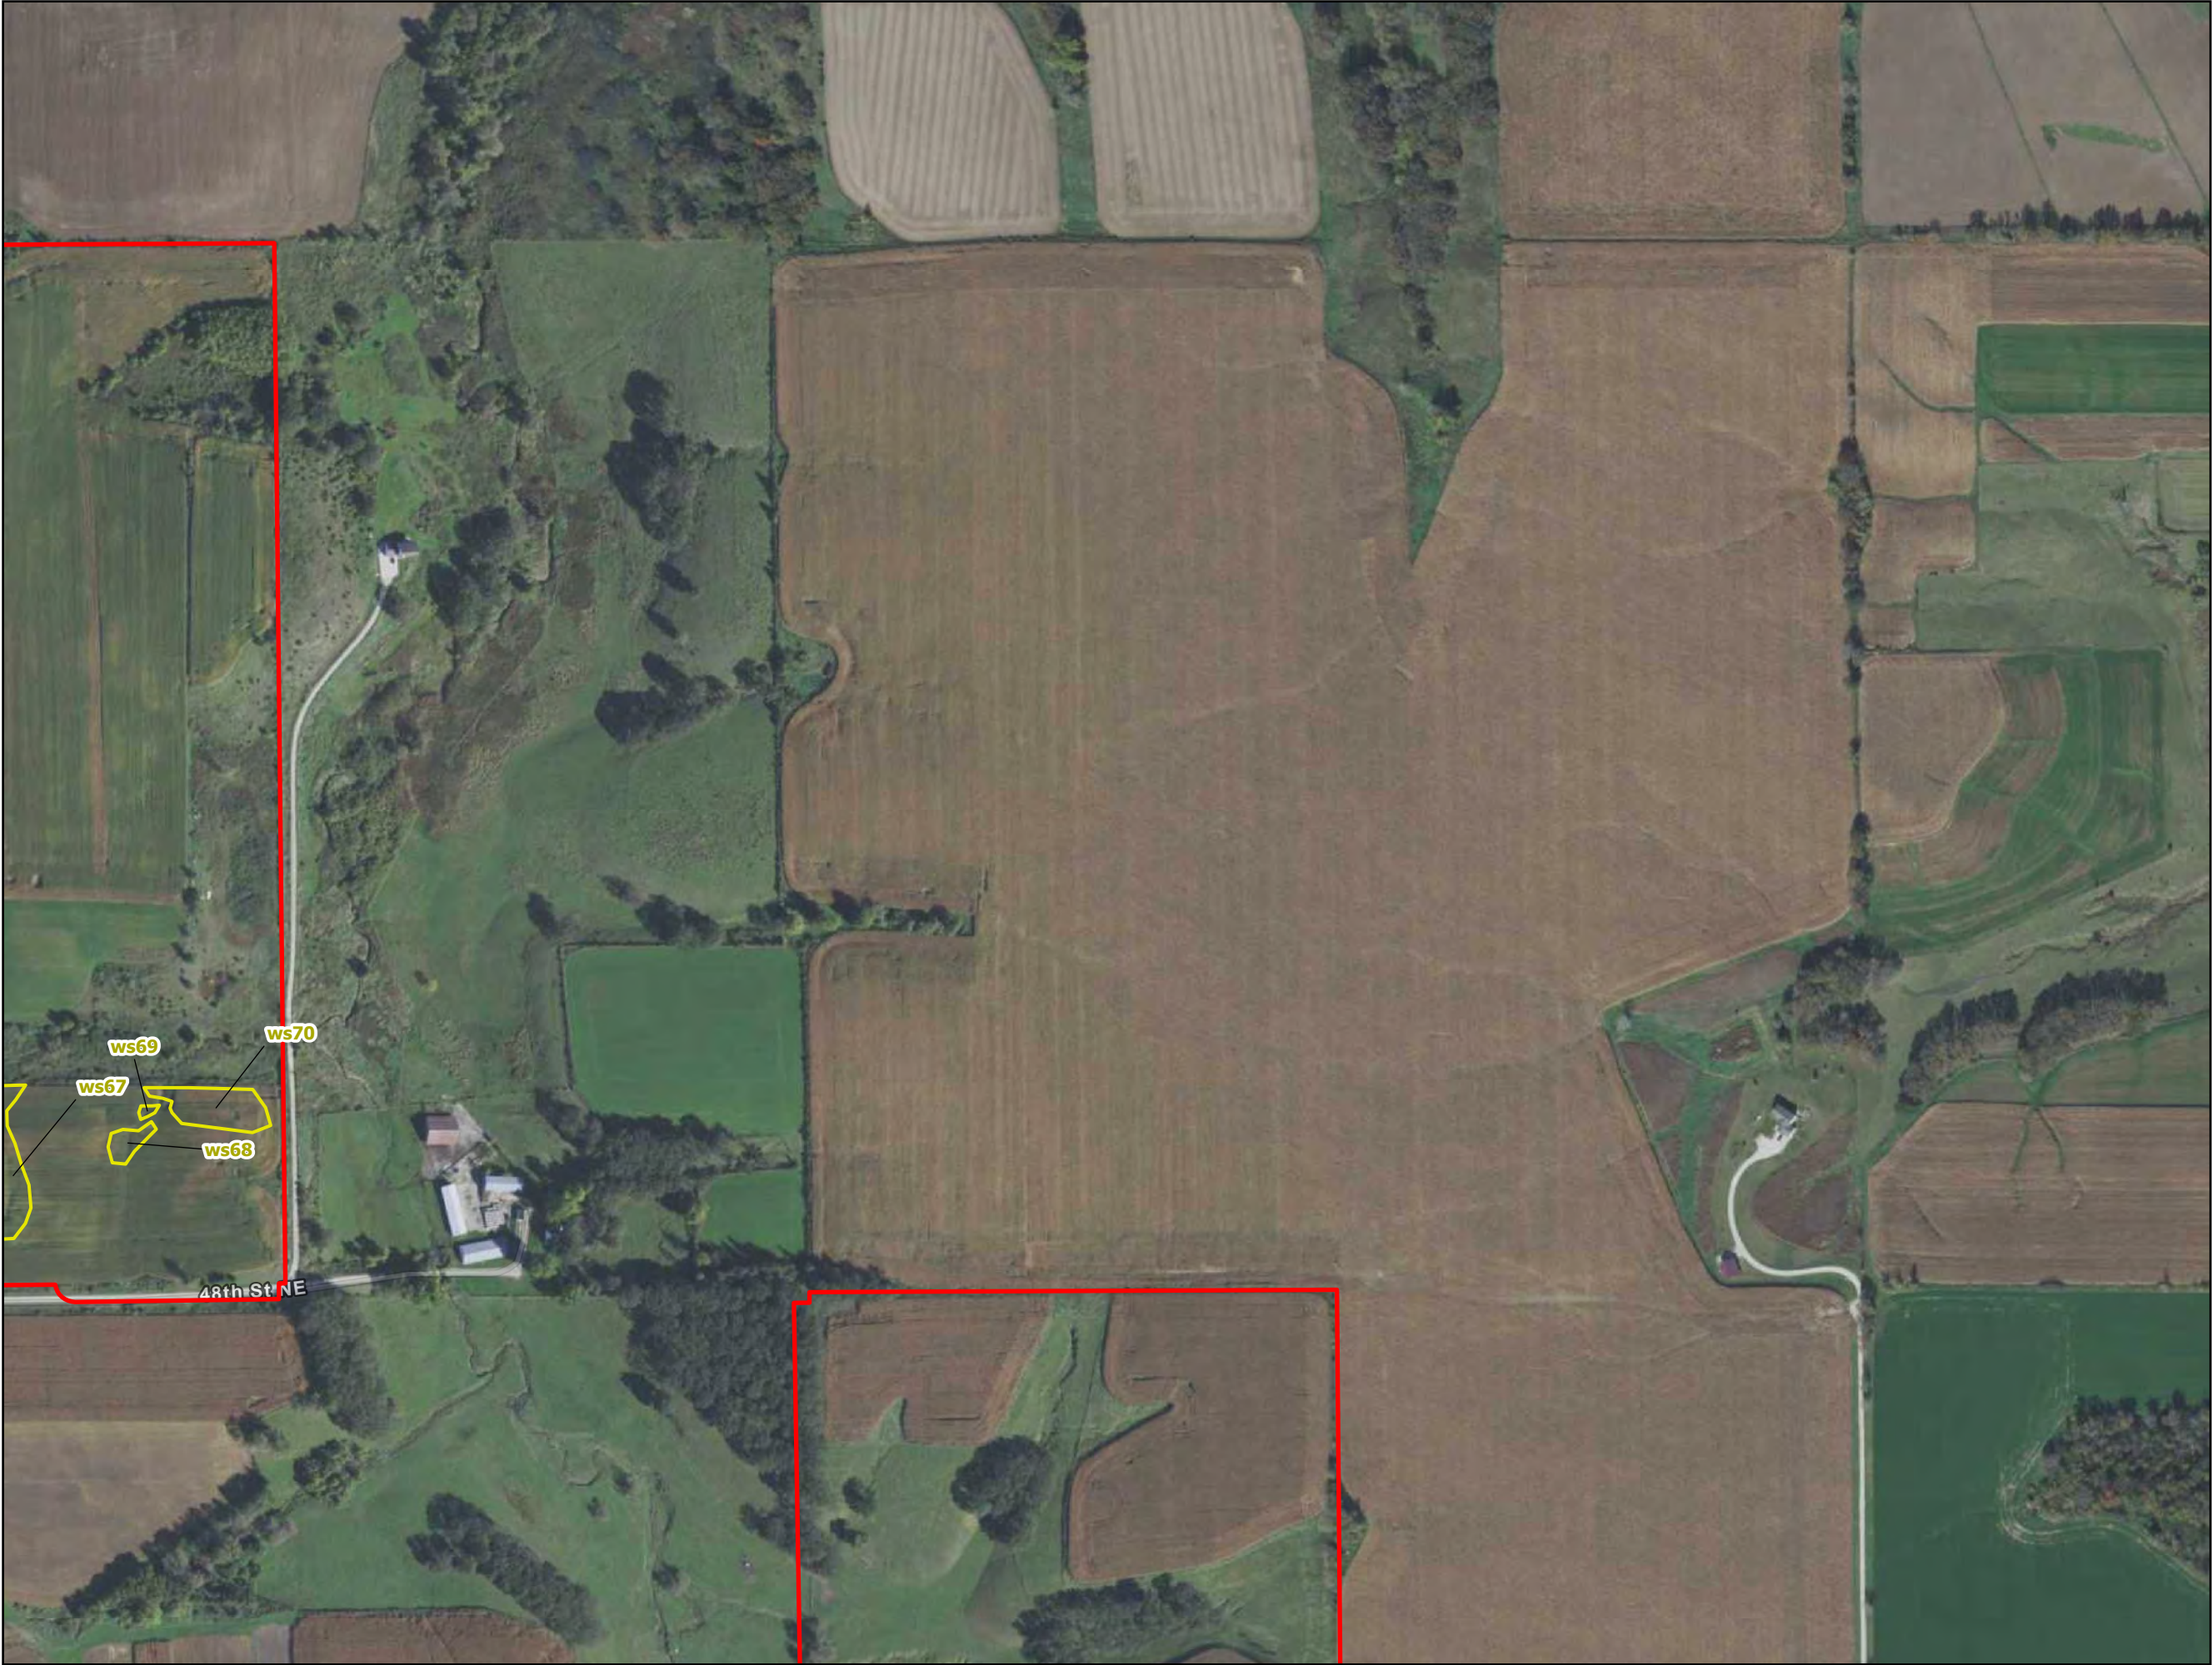
- Survey Area
- Wetness Signature

**FSA Slide Review: NAIP Imagery -
October 2015
Lemon Hill Solar Project
Ranger Power
Olmsted County, MN**

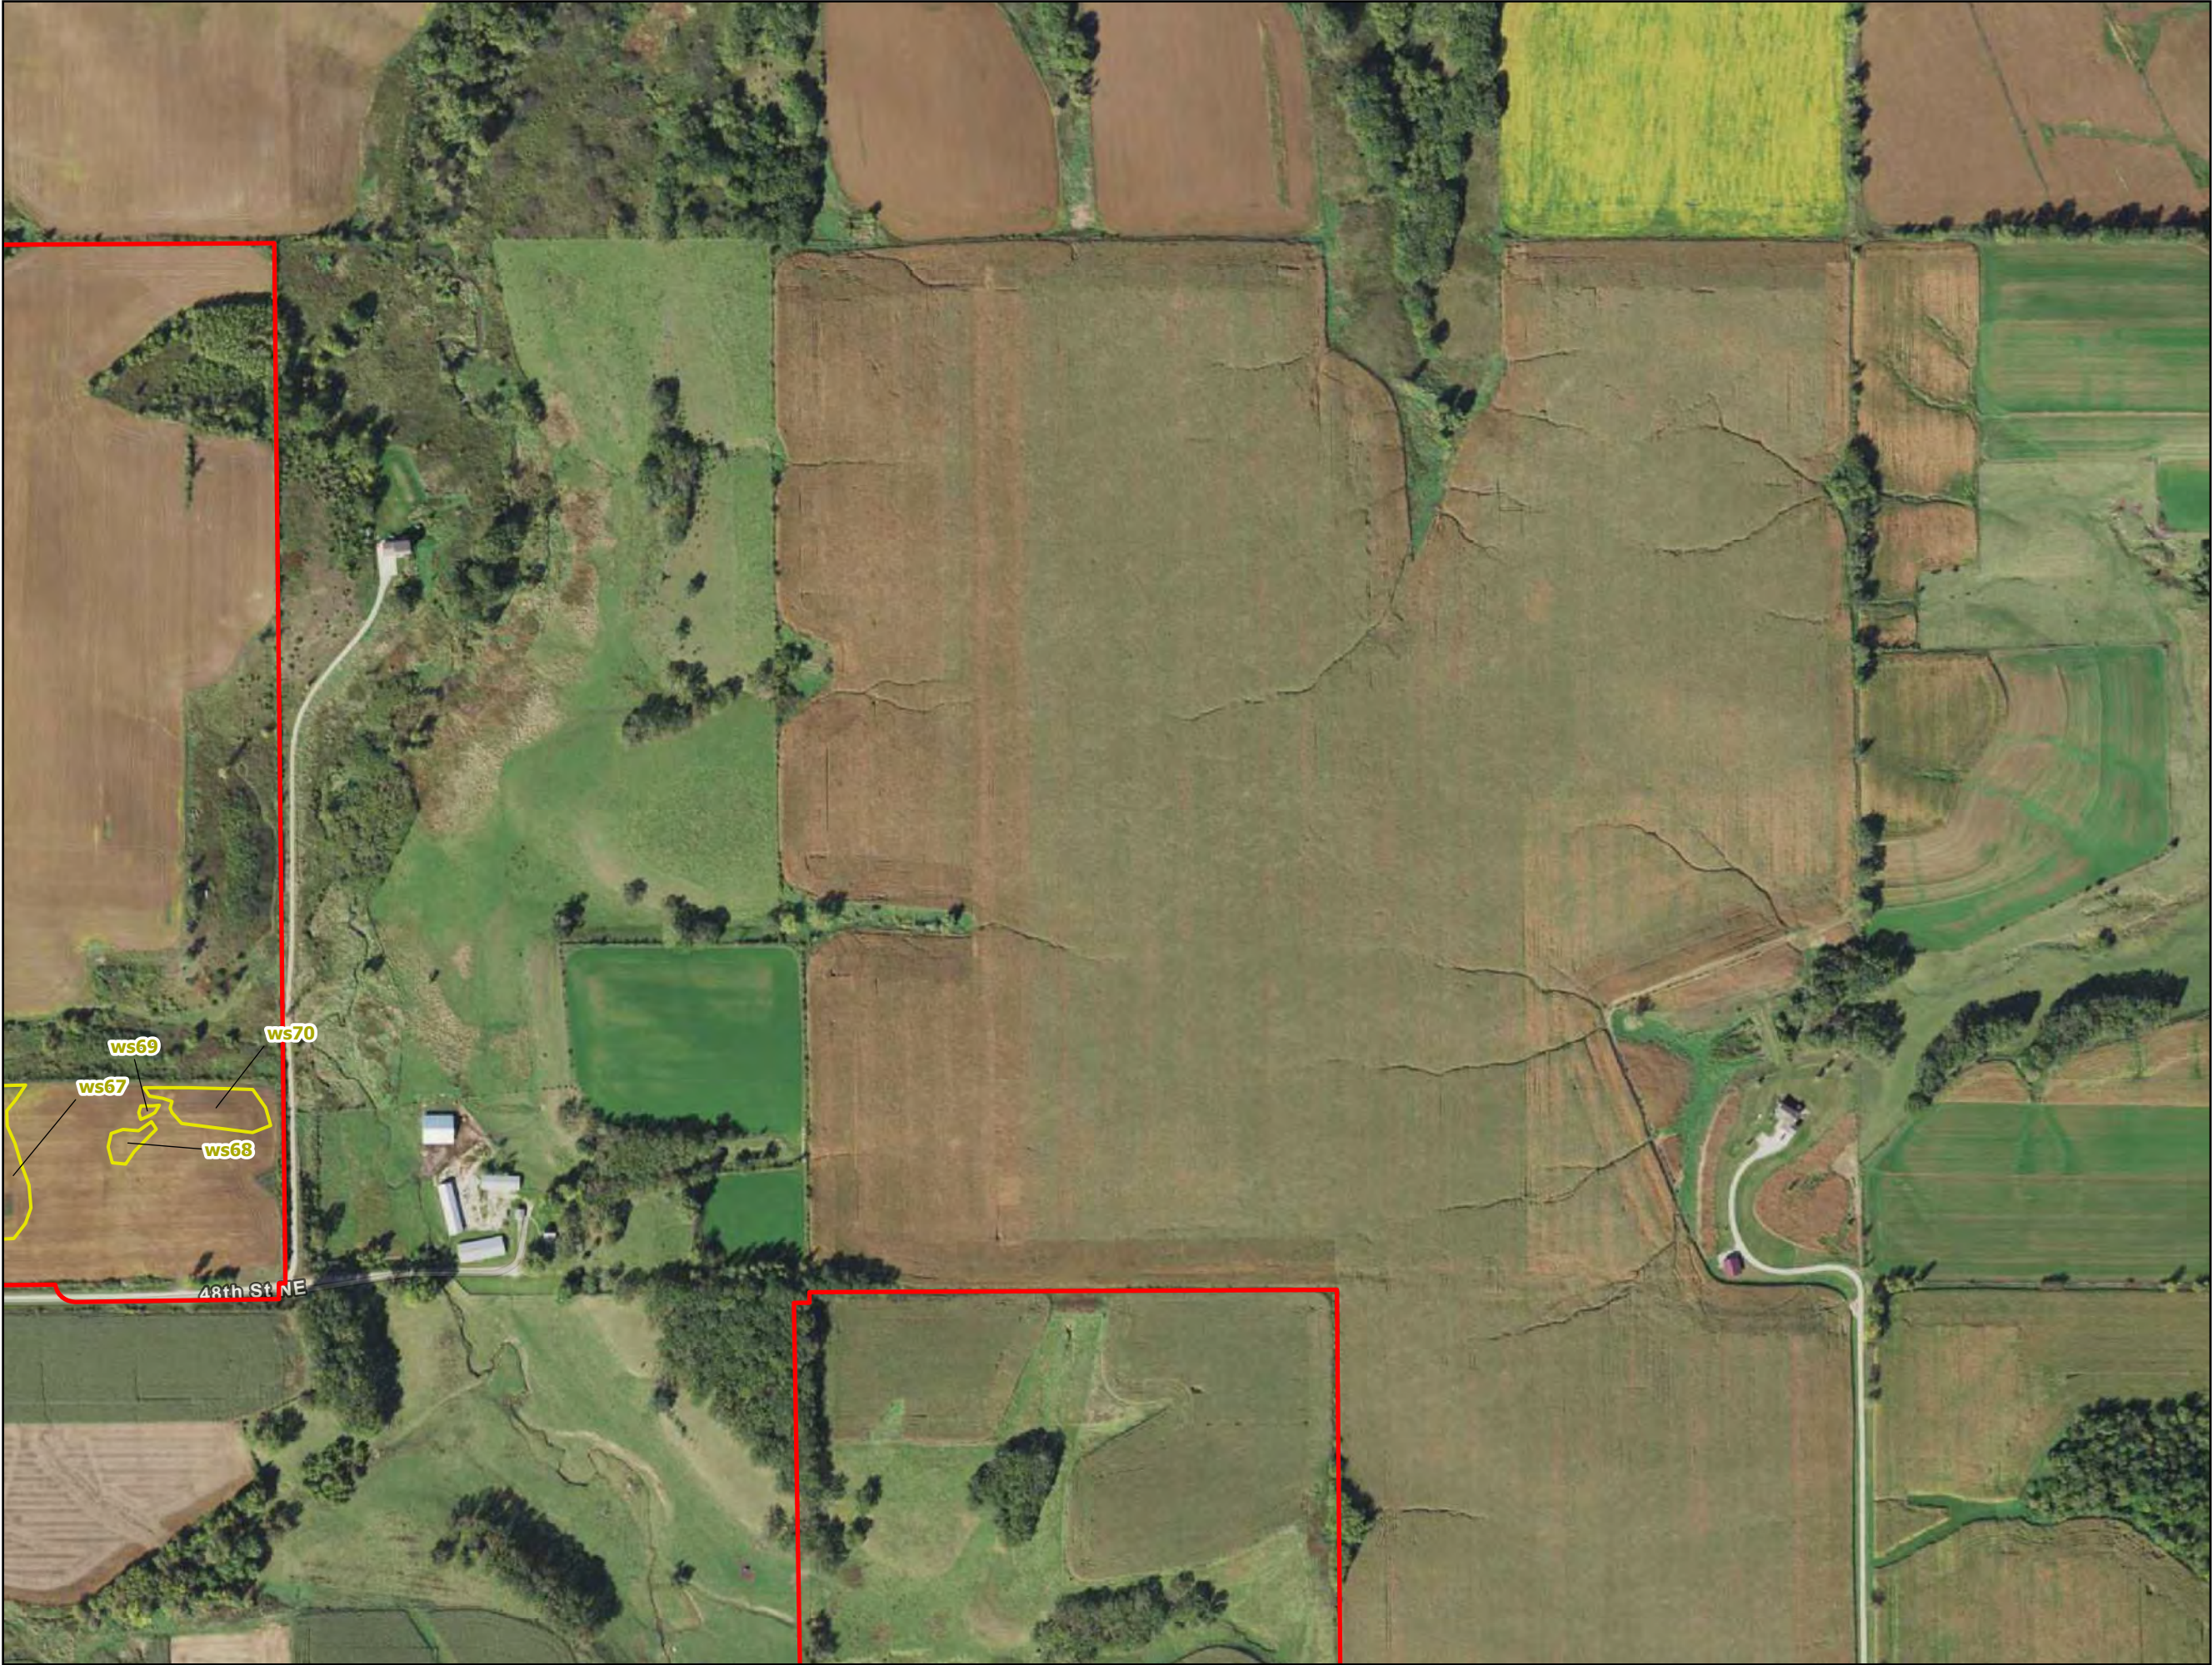
- Survey Area
- Wetness Signature

**FSA Slide Review: NAIP Imagery -
October 2017
Lemon Hill Solar Project
Ranger Power
Olmsted County, MN**

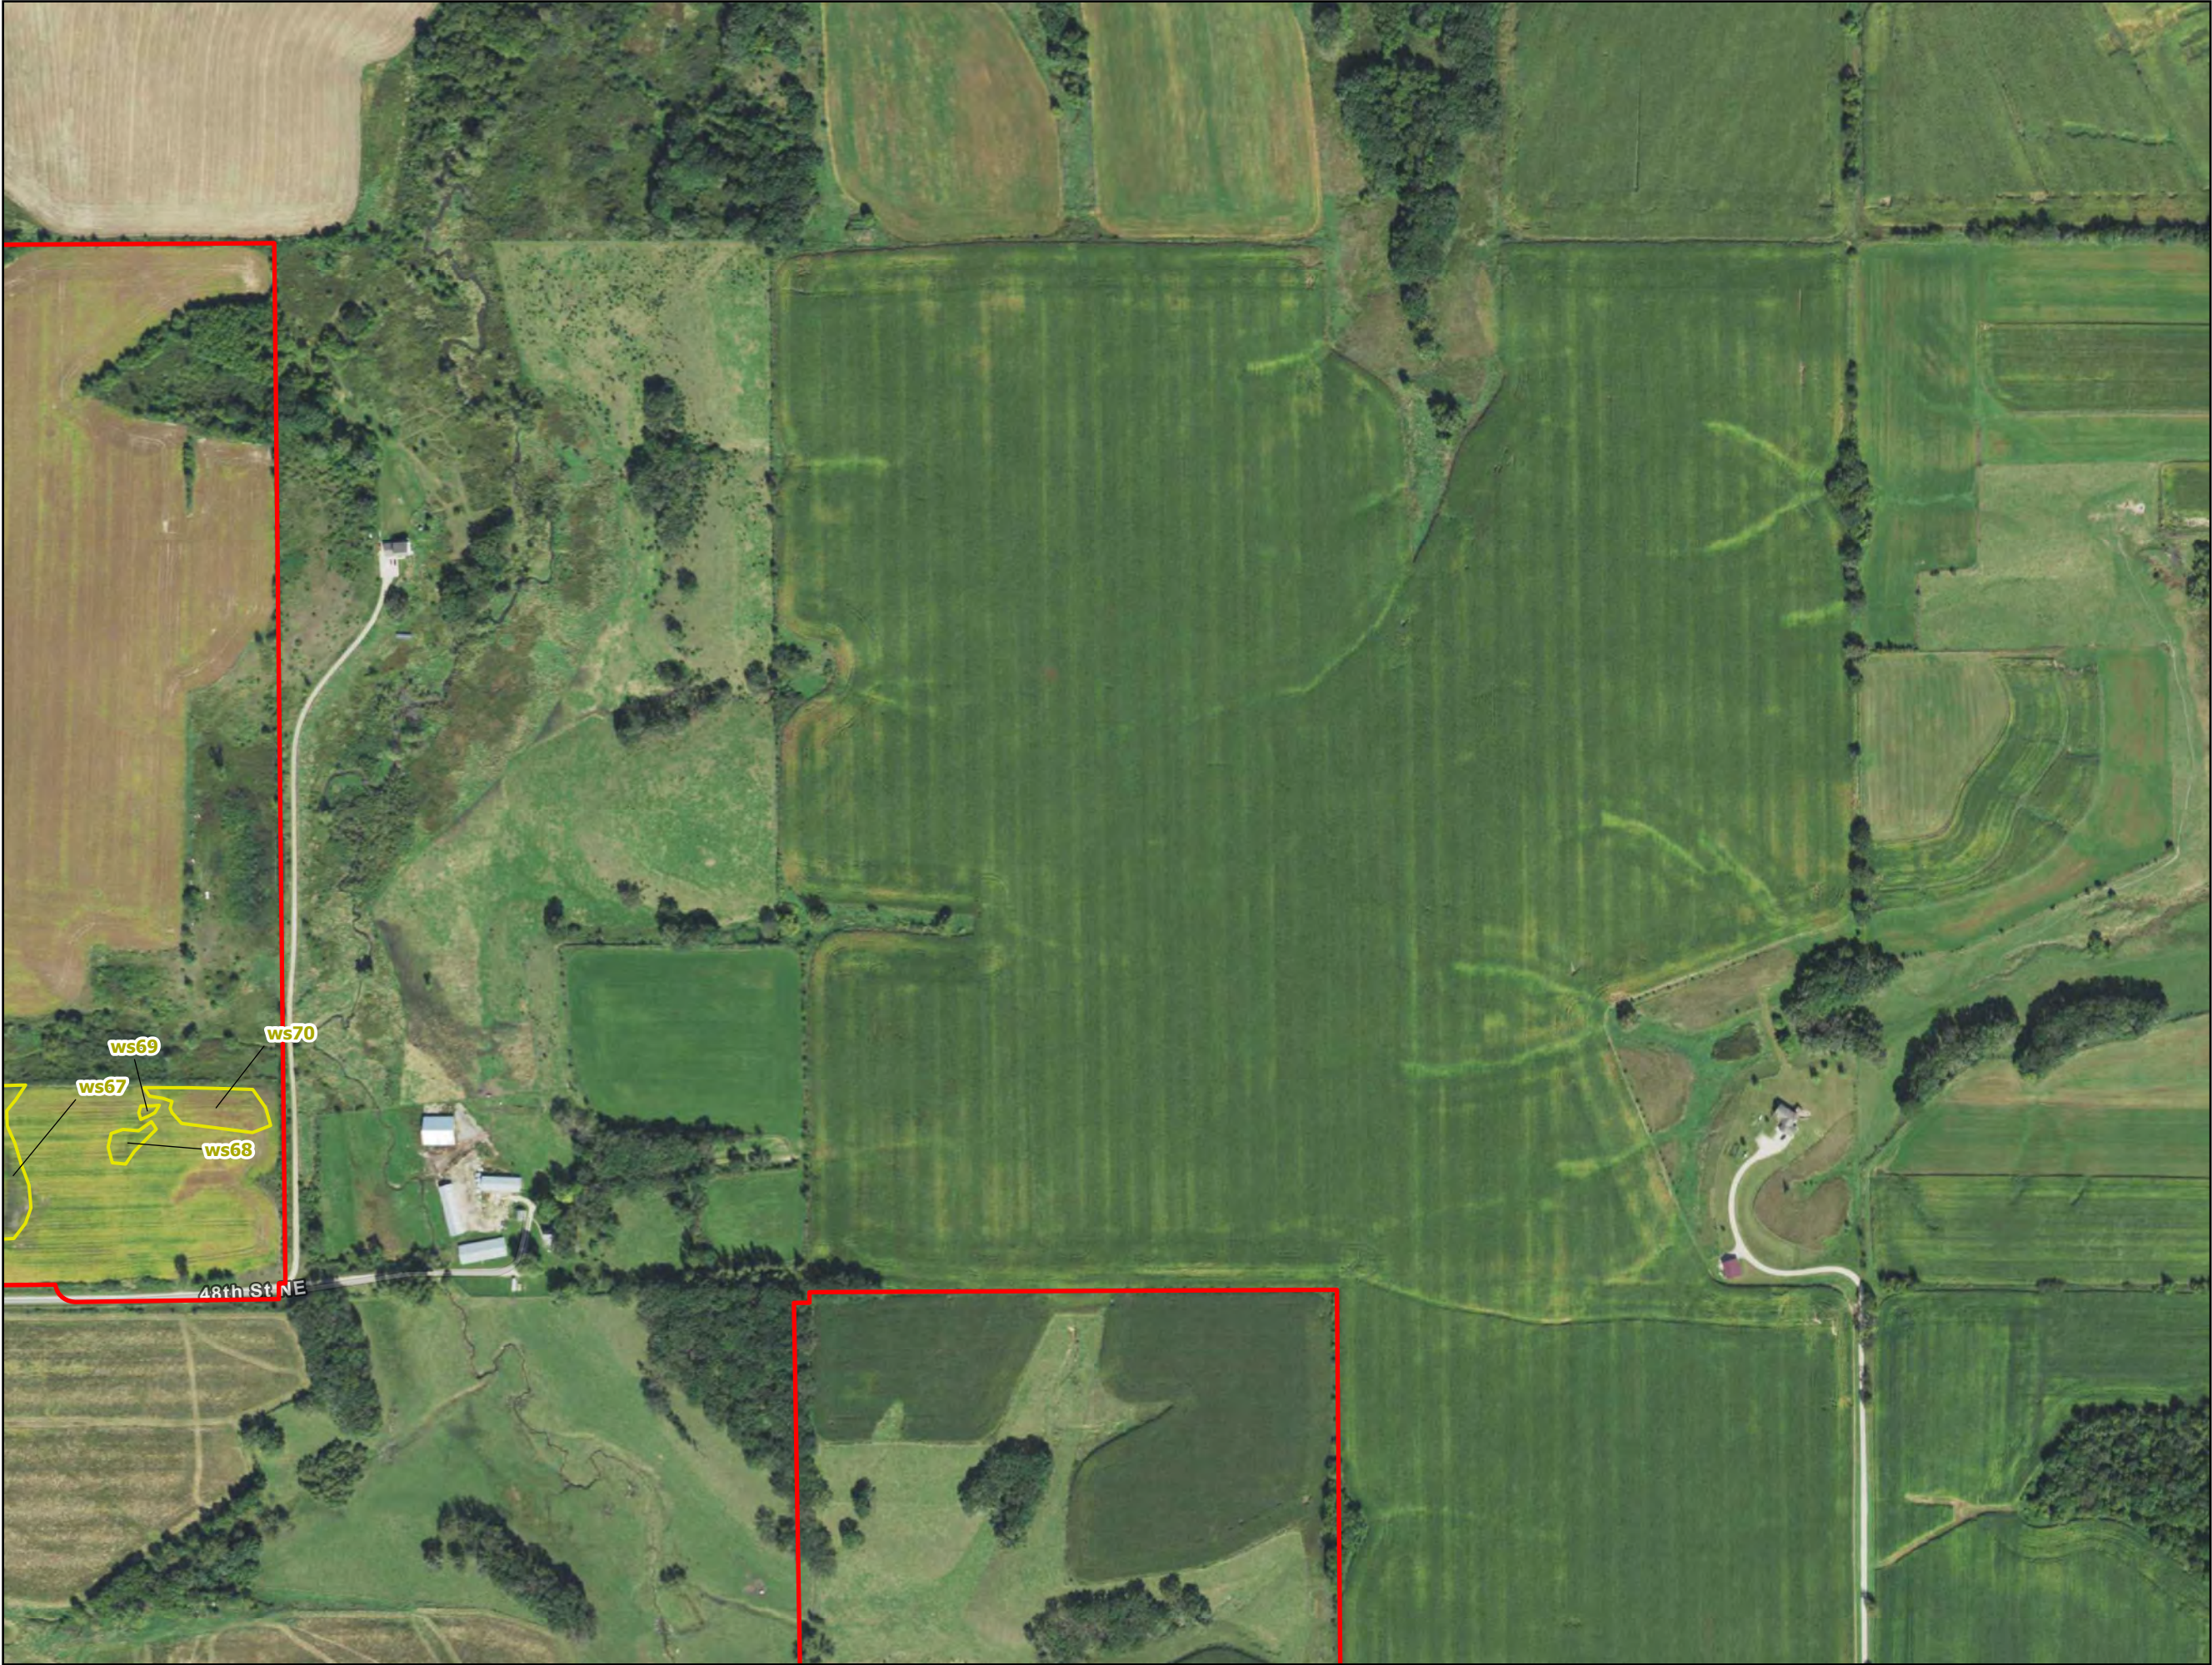
- Survey Area
- Wetness Signature

**FSA Slide Review: NAIP Imagery -
August 2019
Lemon Hill Solar Project
Ranger Power
Olmsted County, MN**

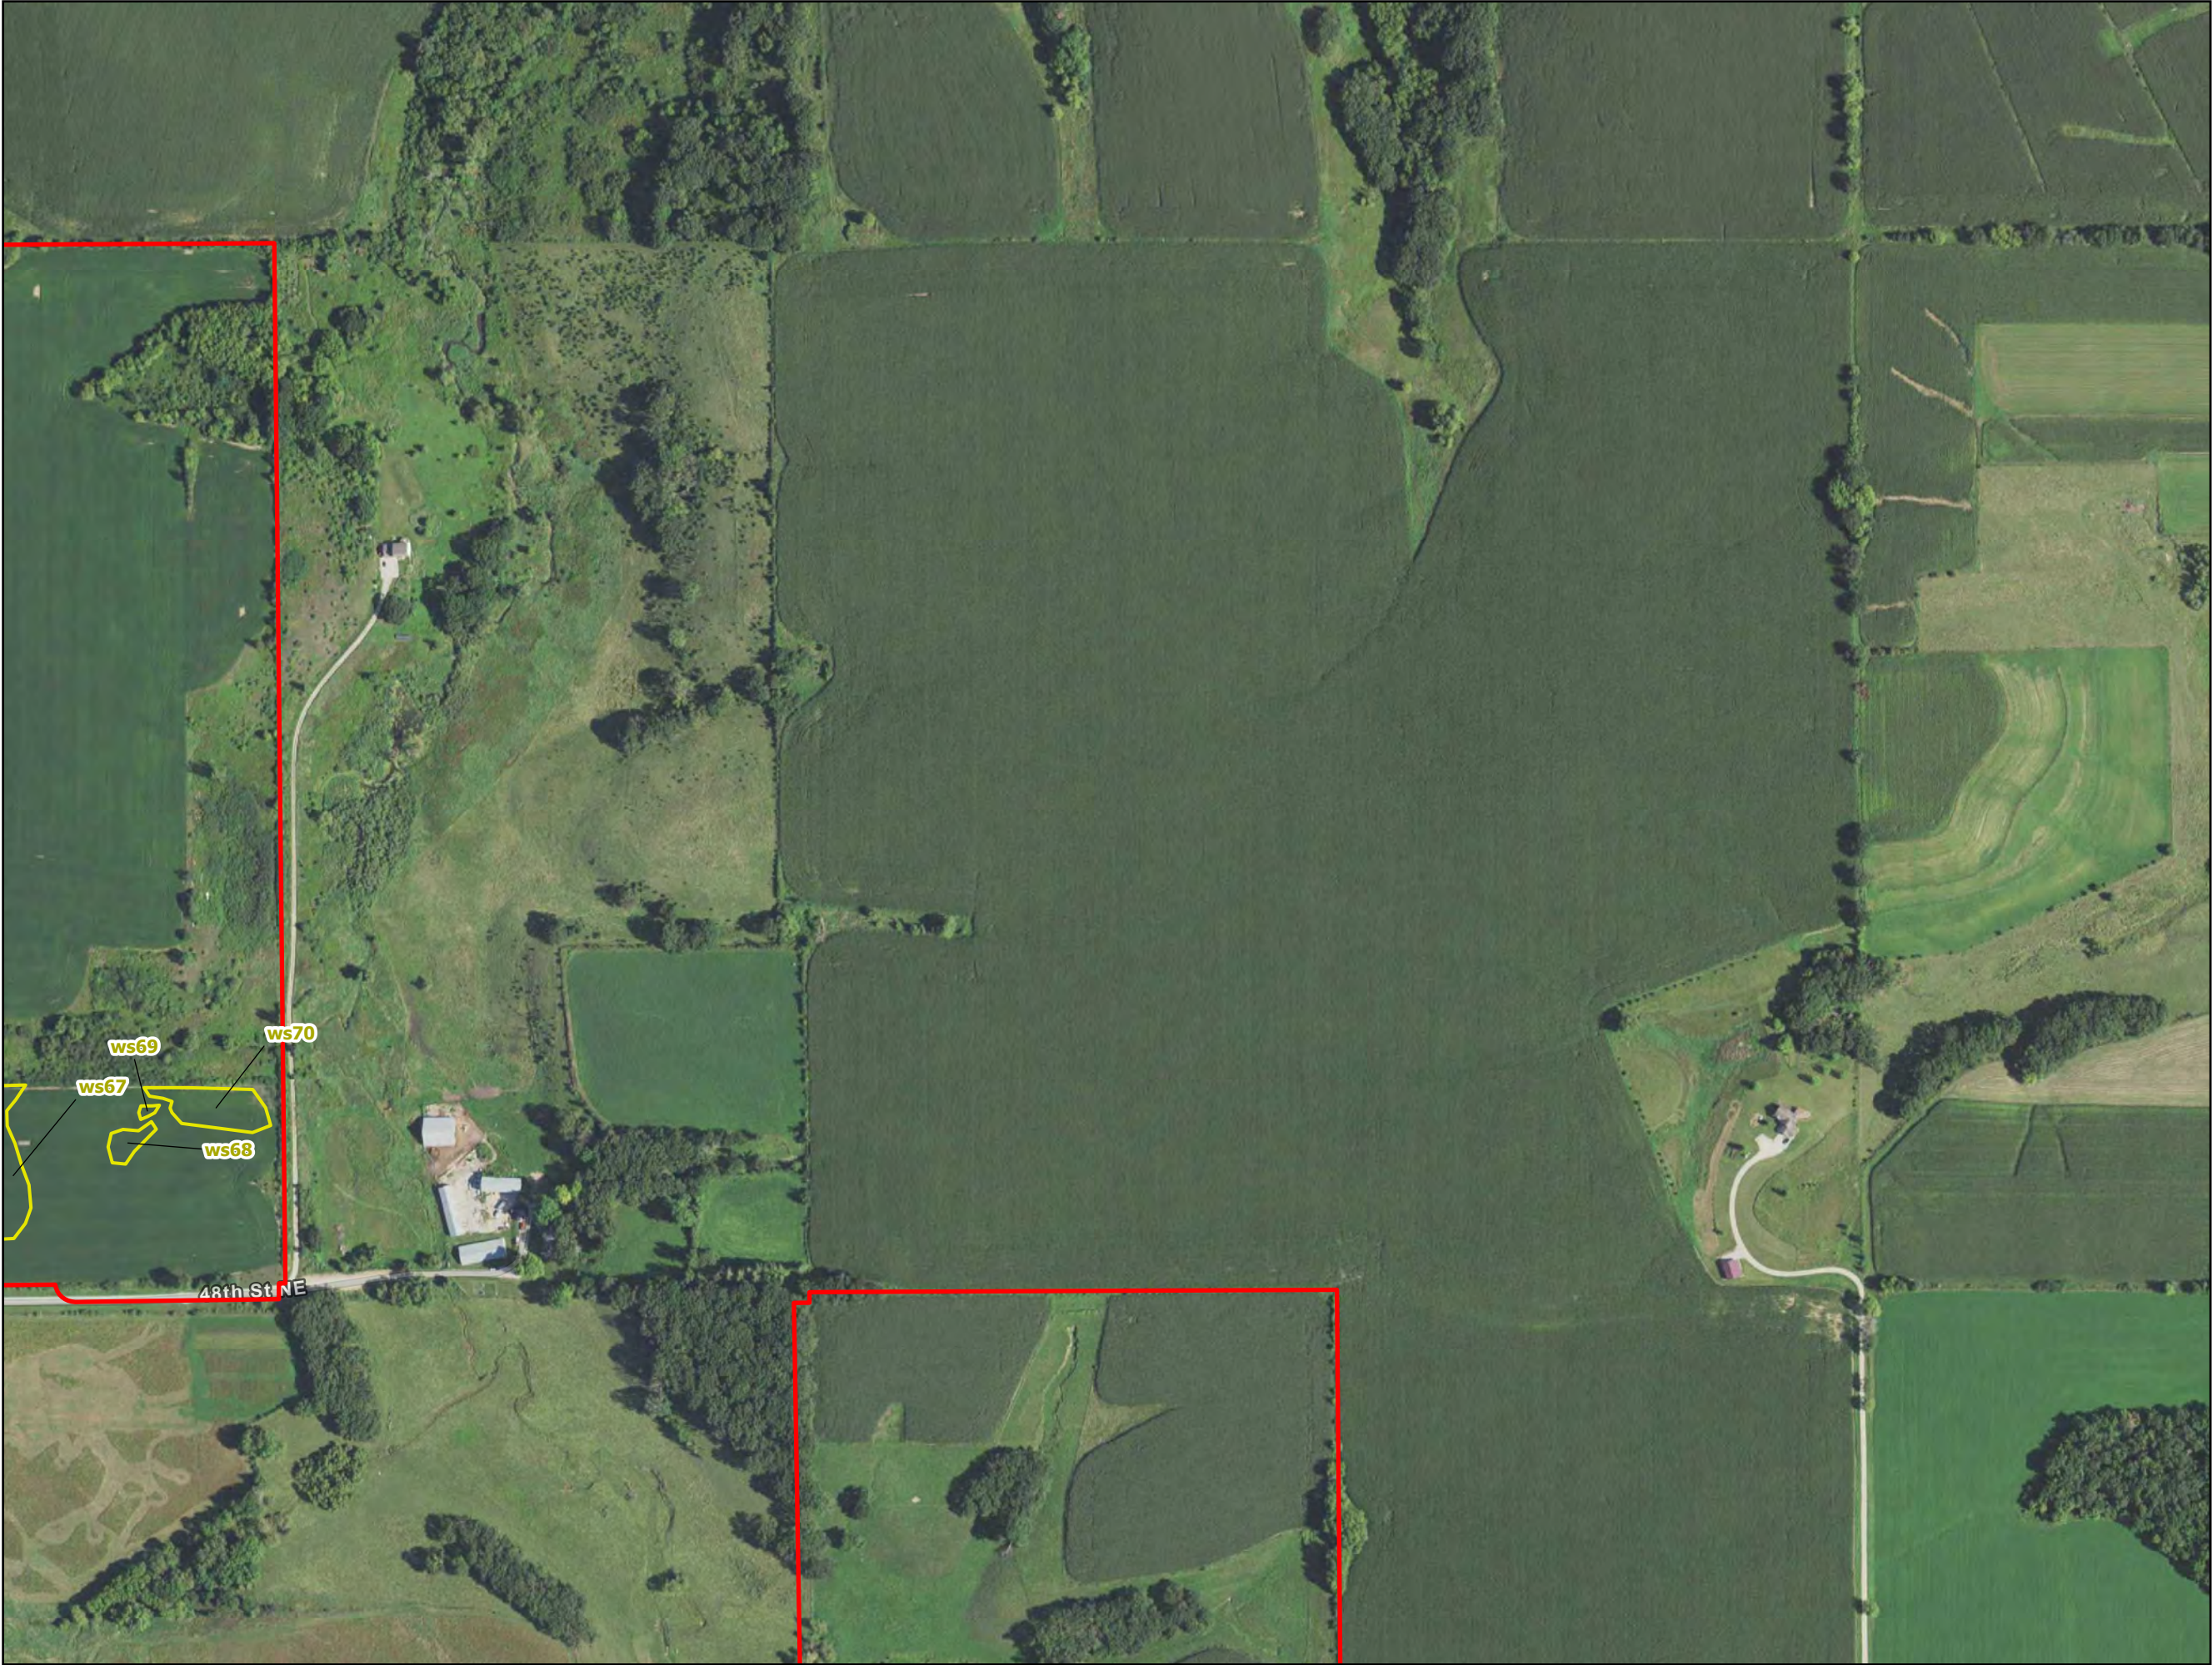
- Survey Area
- Wetness Signature

**FSA Slide Review: NAIP Imagery -
August 2021
Lemon Hill Solar Project
Ranger Power
Olmsted County, MN**

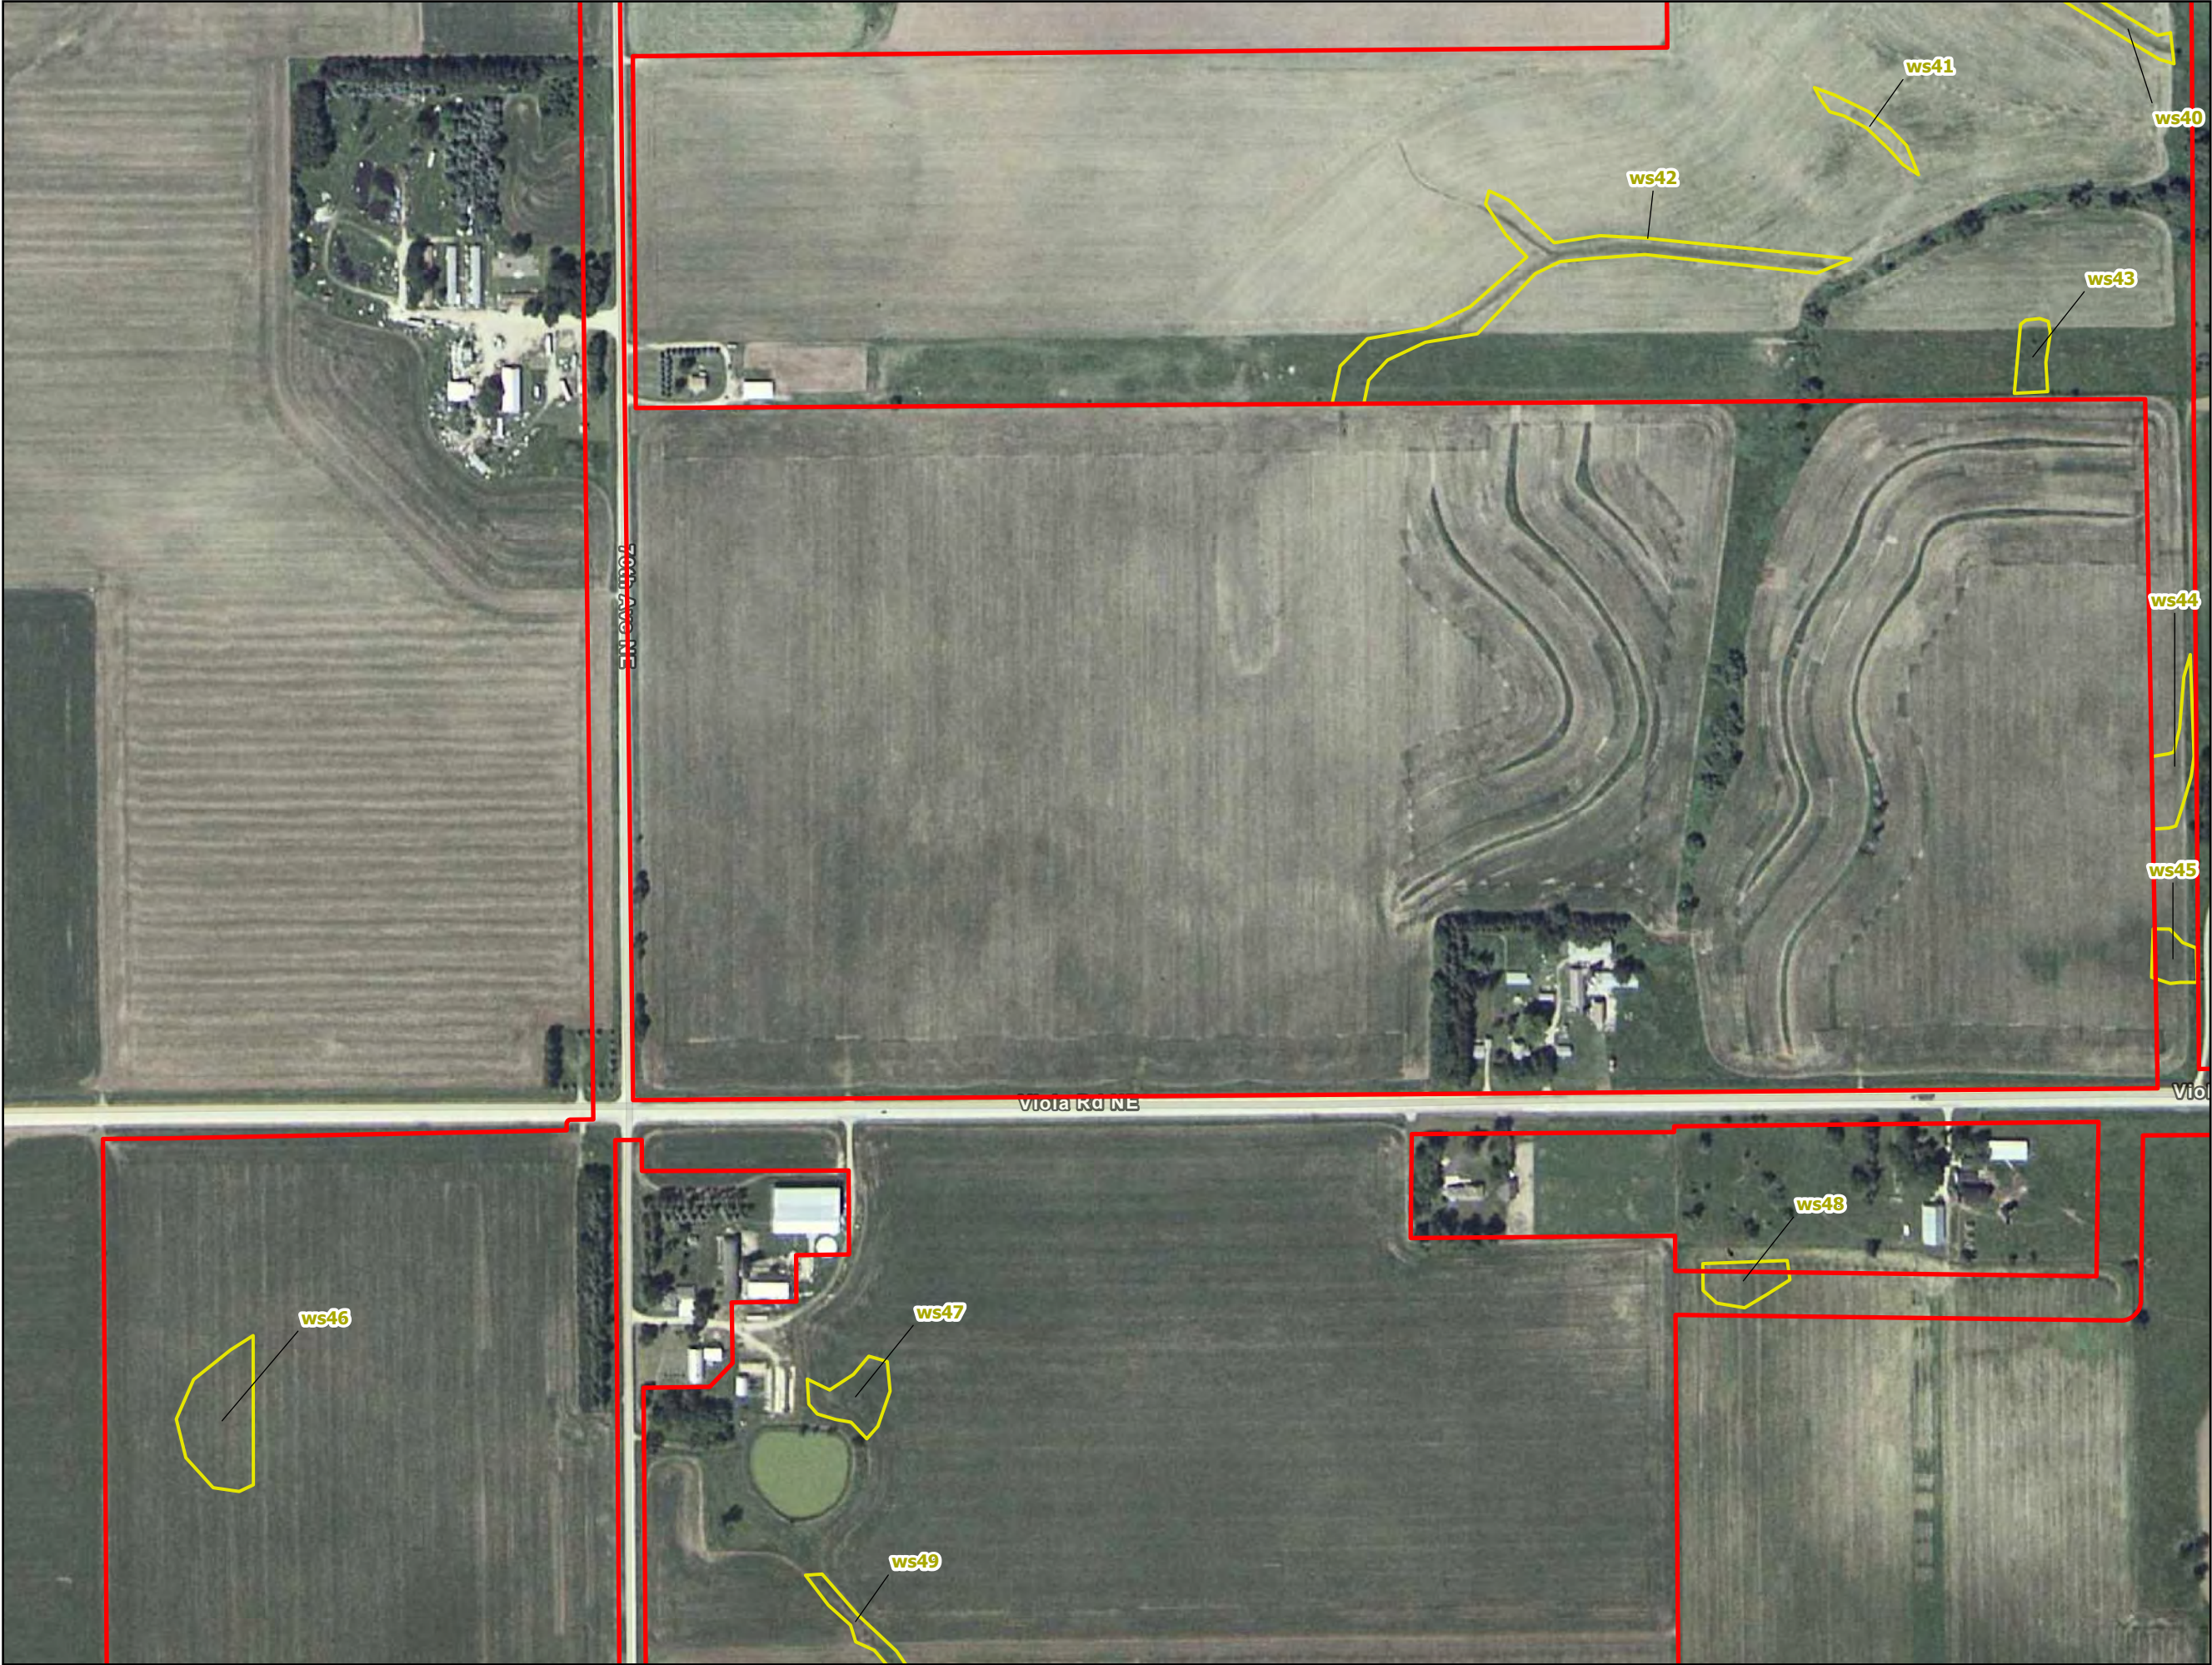
**FSA Slide Review: NAIP Imagery -
August 2009
Lemon Hill Solar Project
Ranger Power
Olmsted County, MN**

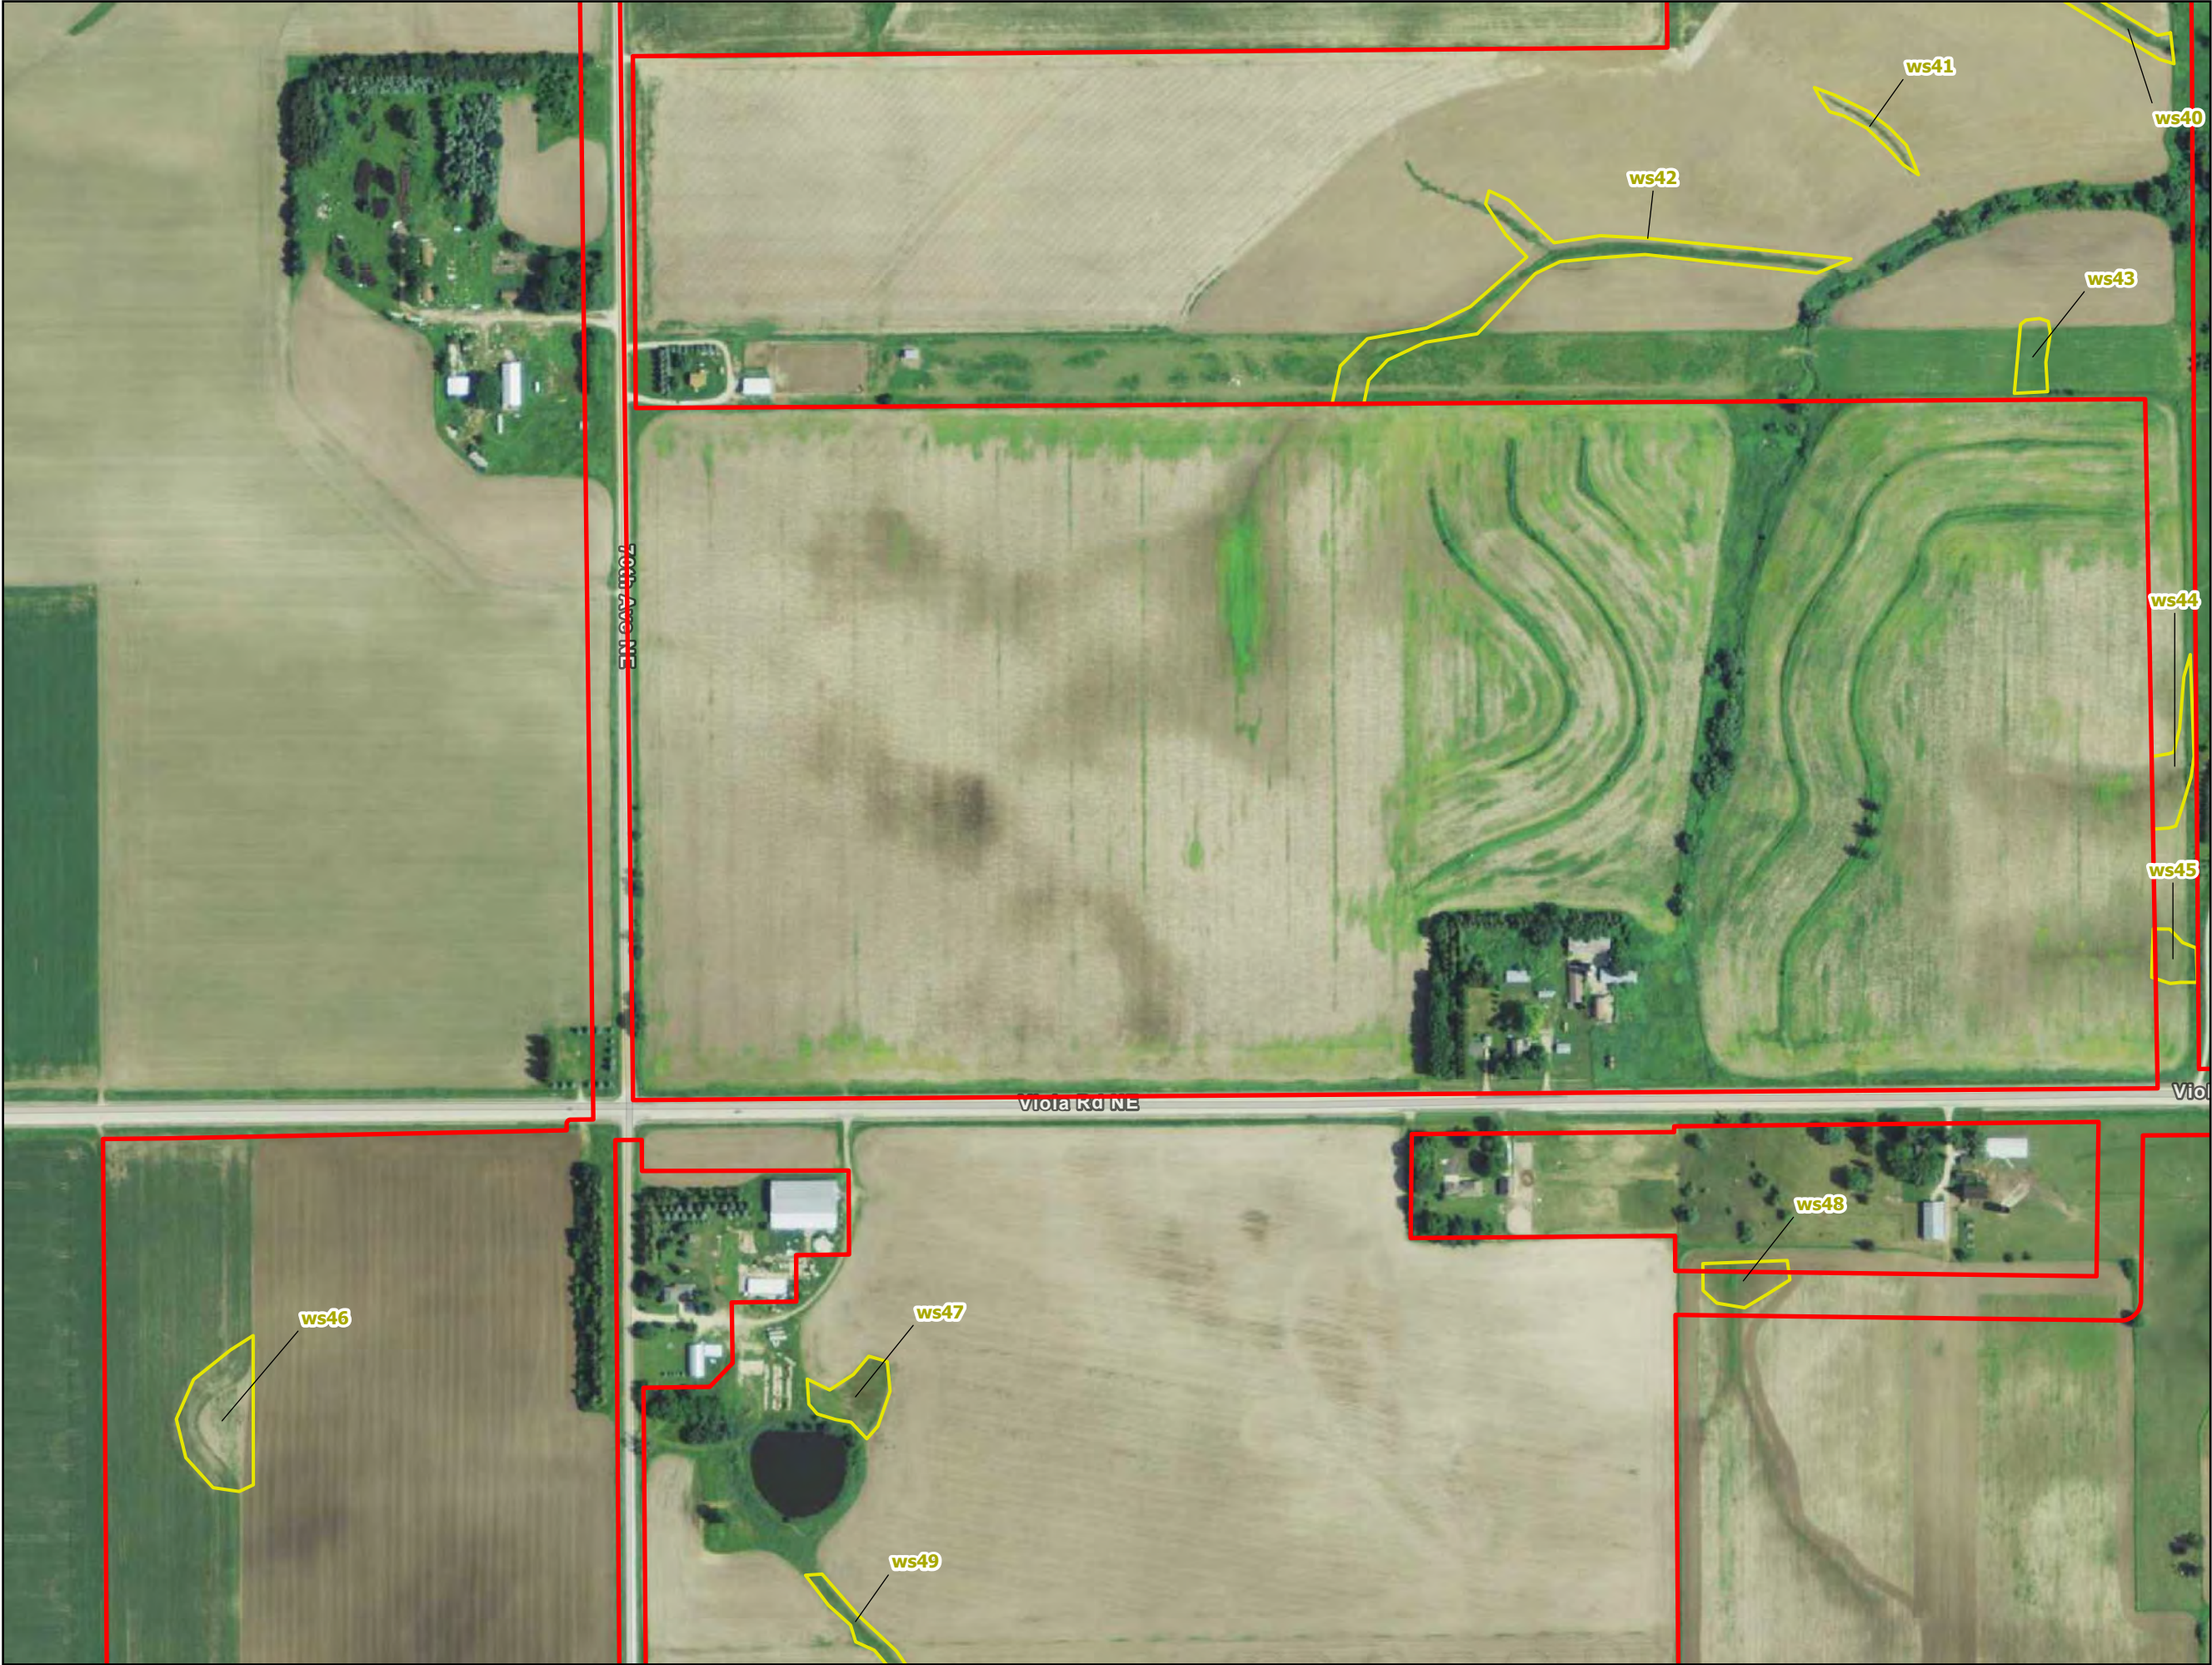
- Survey Area
- Wetness Signature

**FSA Slide Review: NAIP Imagery -
July 2013
Lemon Hill Solar Project
Ranger Power
Olmsted County, MN**
