**FSA Slide Review: NAIP Imagery -
October 2017
Lemon Hill Solar Project
Ranger Power
Olmsted County, MN**

Exhibit 1Field data sheet reference (if applicable): See attached crosswalk table**Wetland Hydrology from Aerial Imagery – Recording Form**

Project Name: Lemon Hill Solar Project

Date: 5/20/24 County: OlmstedInvestigator: Kyle Hanson Legal Description (T, R, S): T107N, R13W, S12**Summary Table**

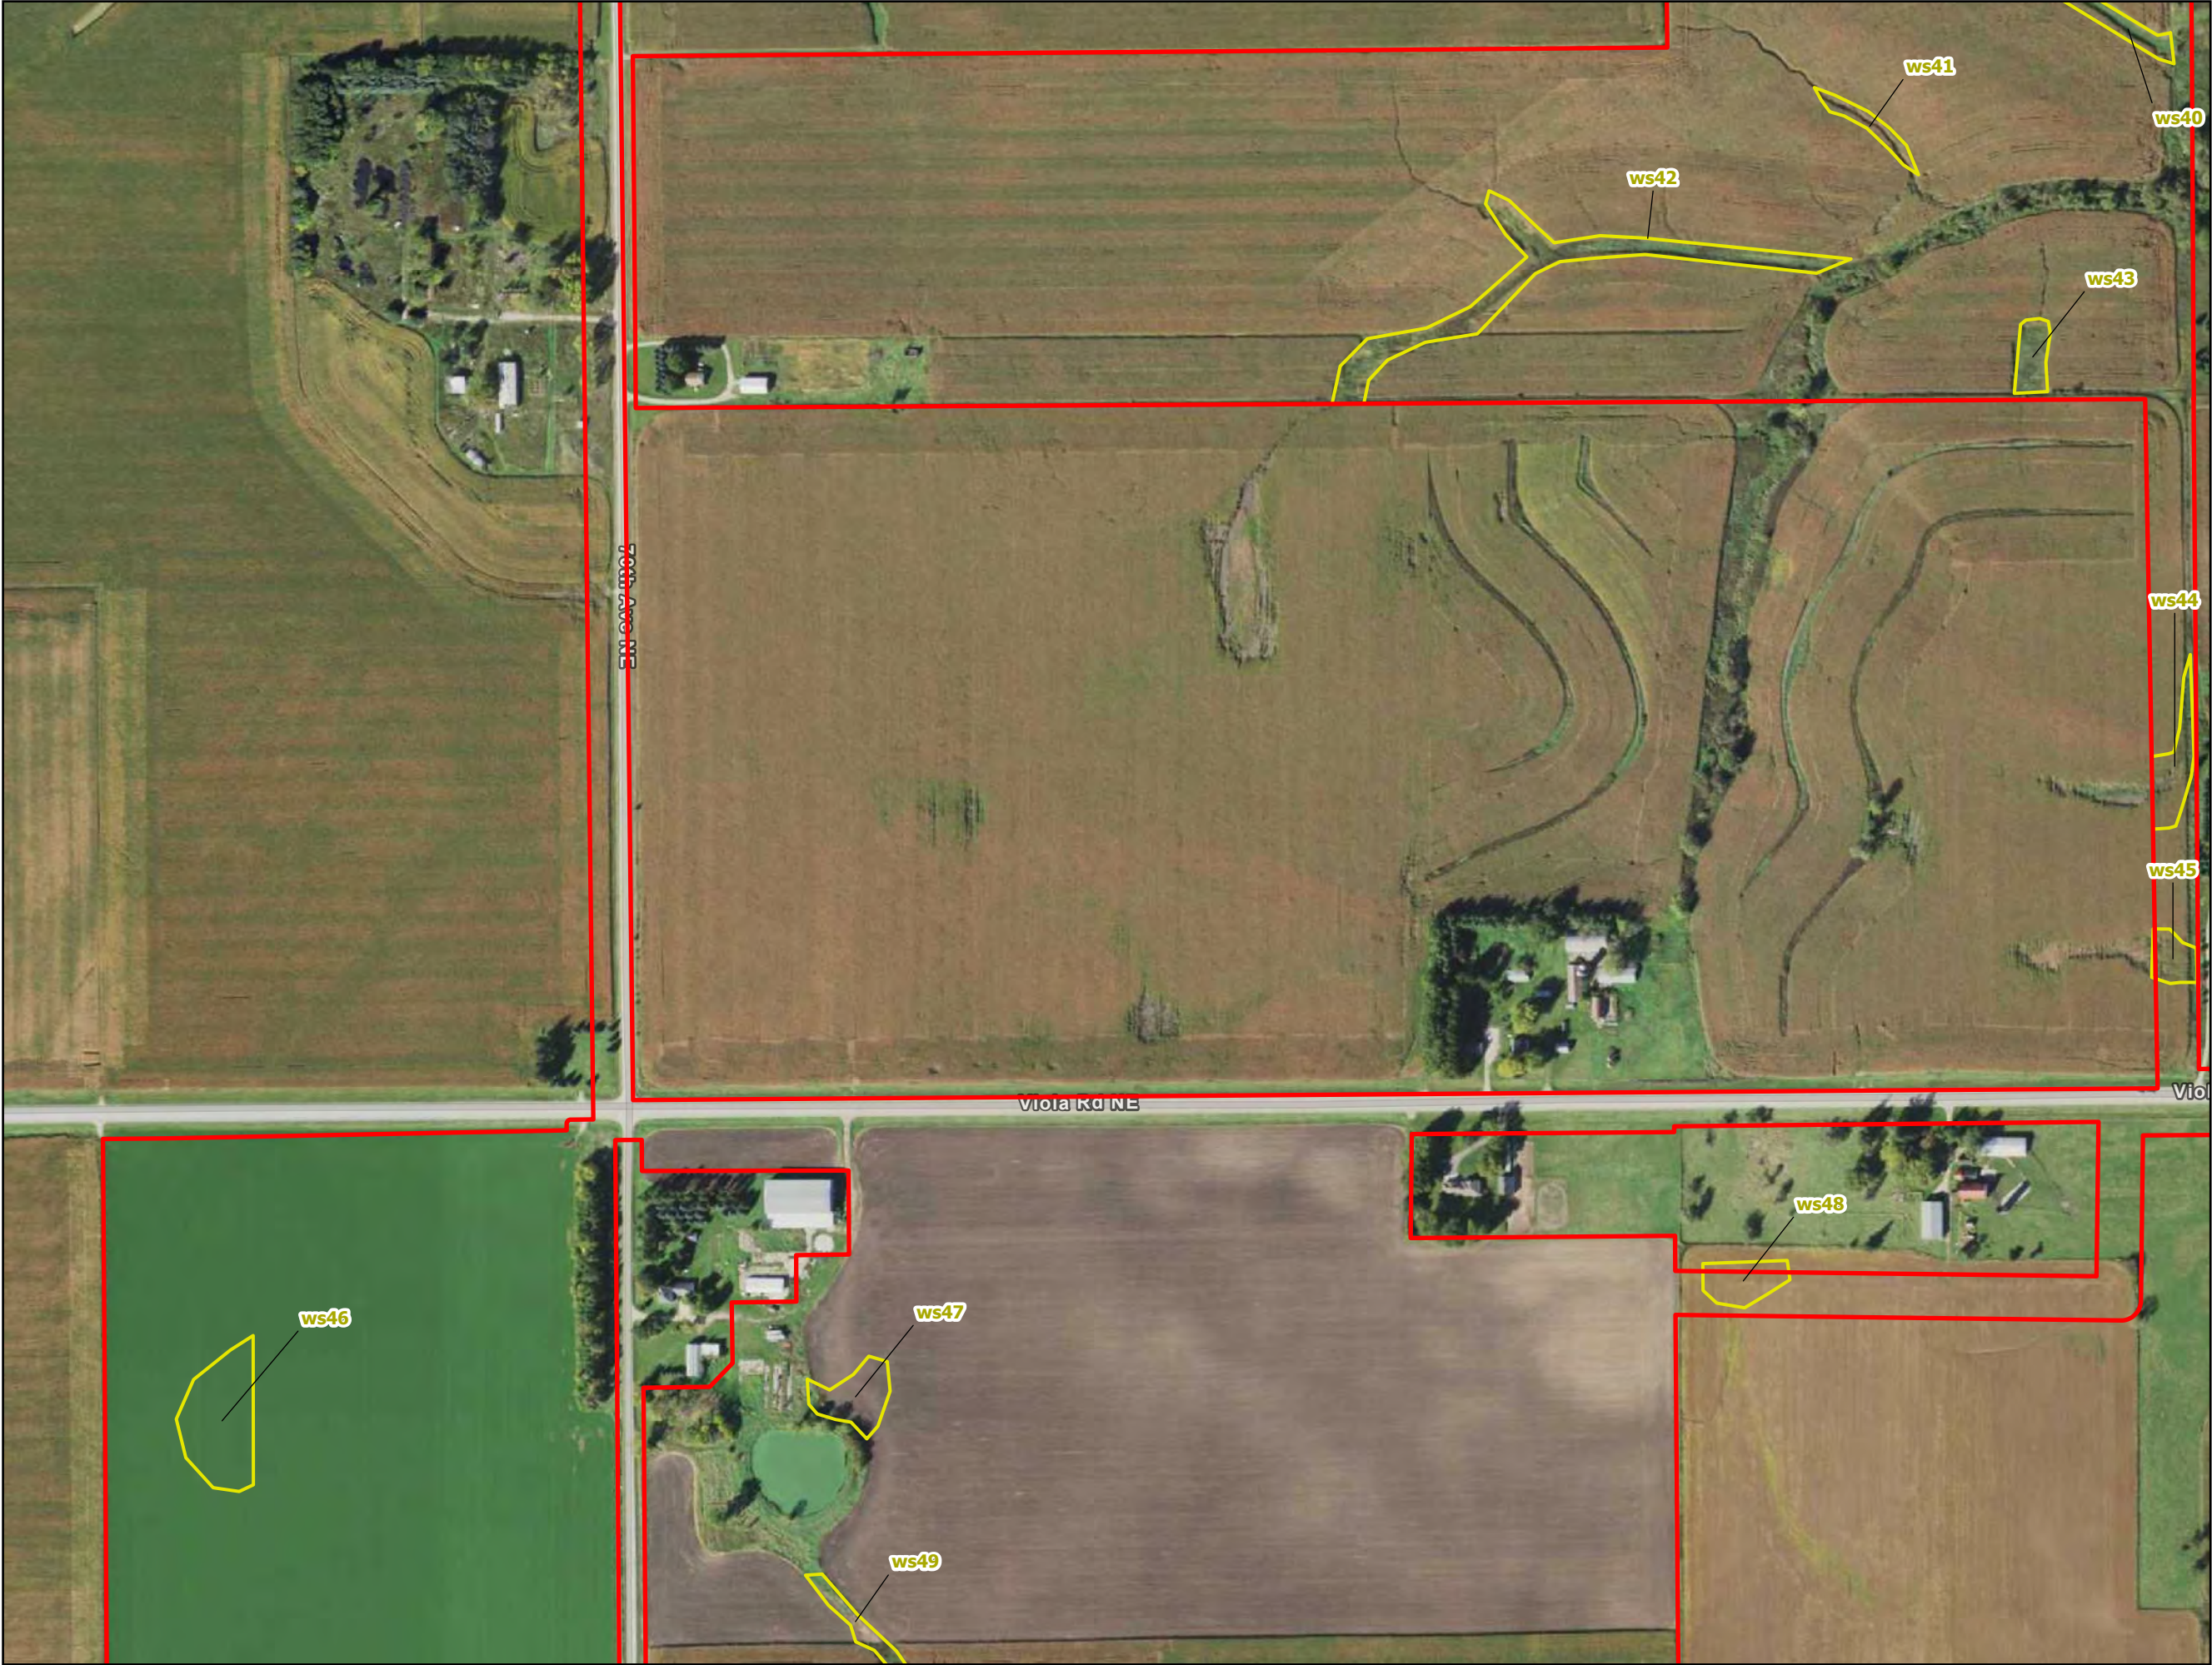
- Survey Area
- Wetness Signature

**FSA Slide Review: NAIP Imagery -
October 2017
Lemon Hill Solar Project
Ranger Power
Olmsted County, MN**

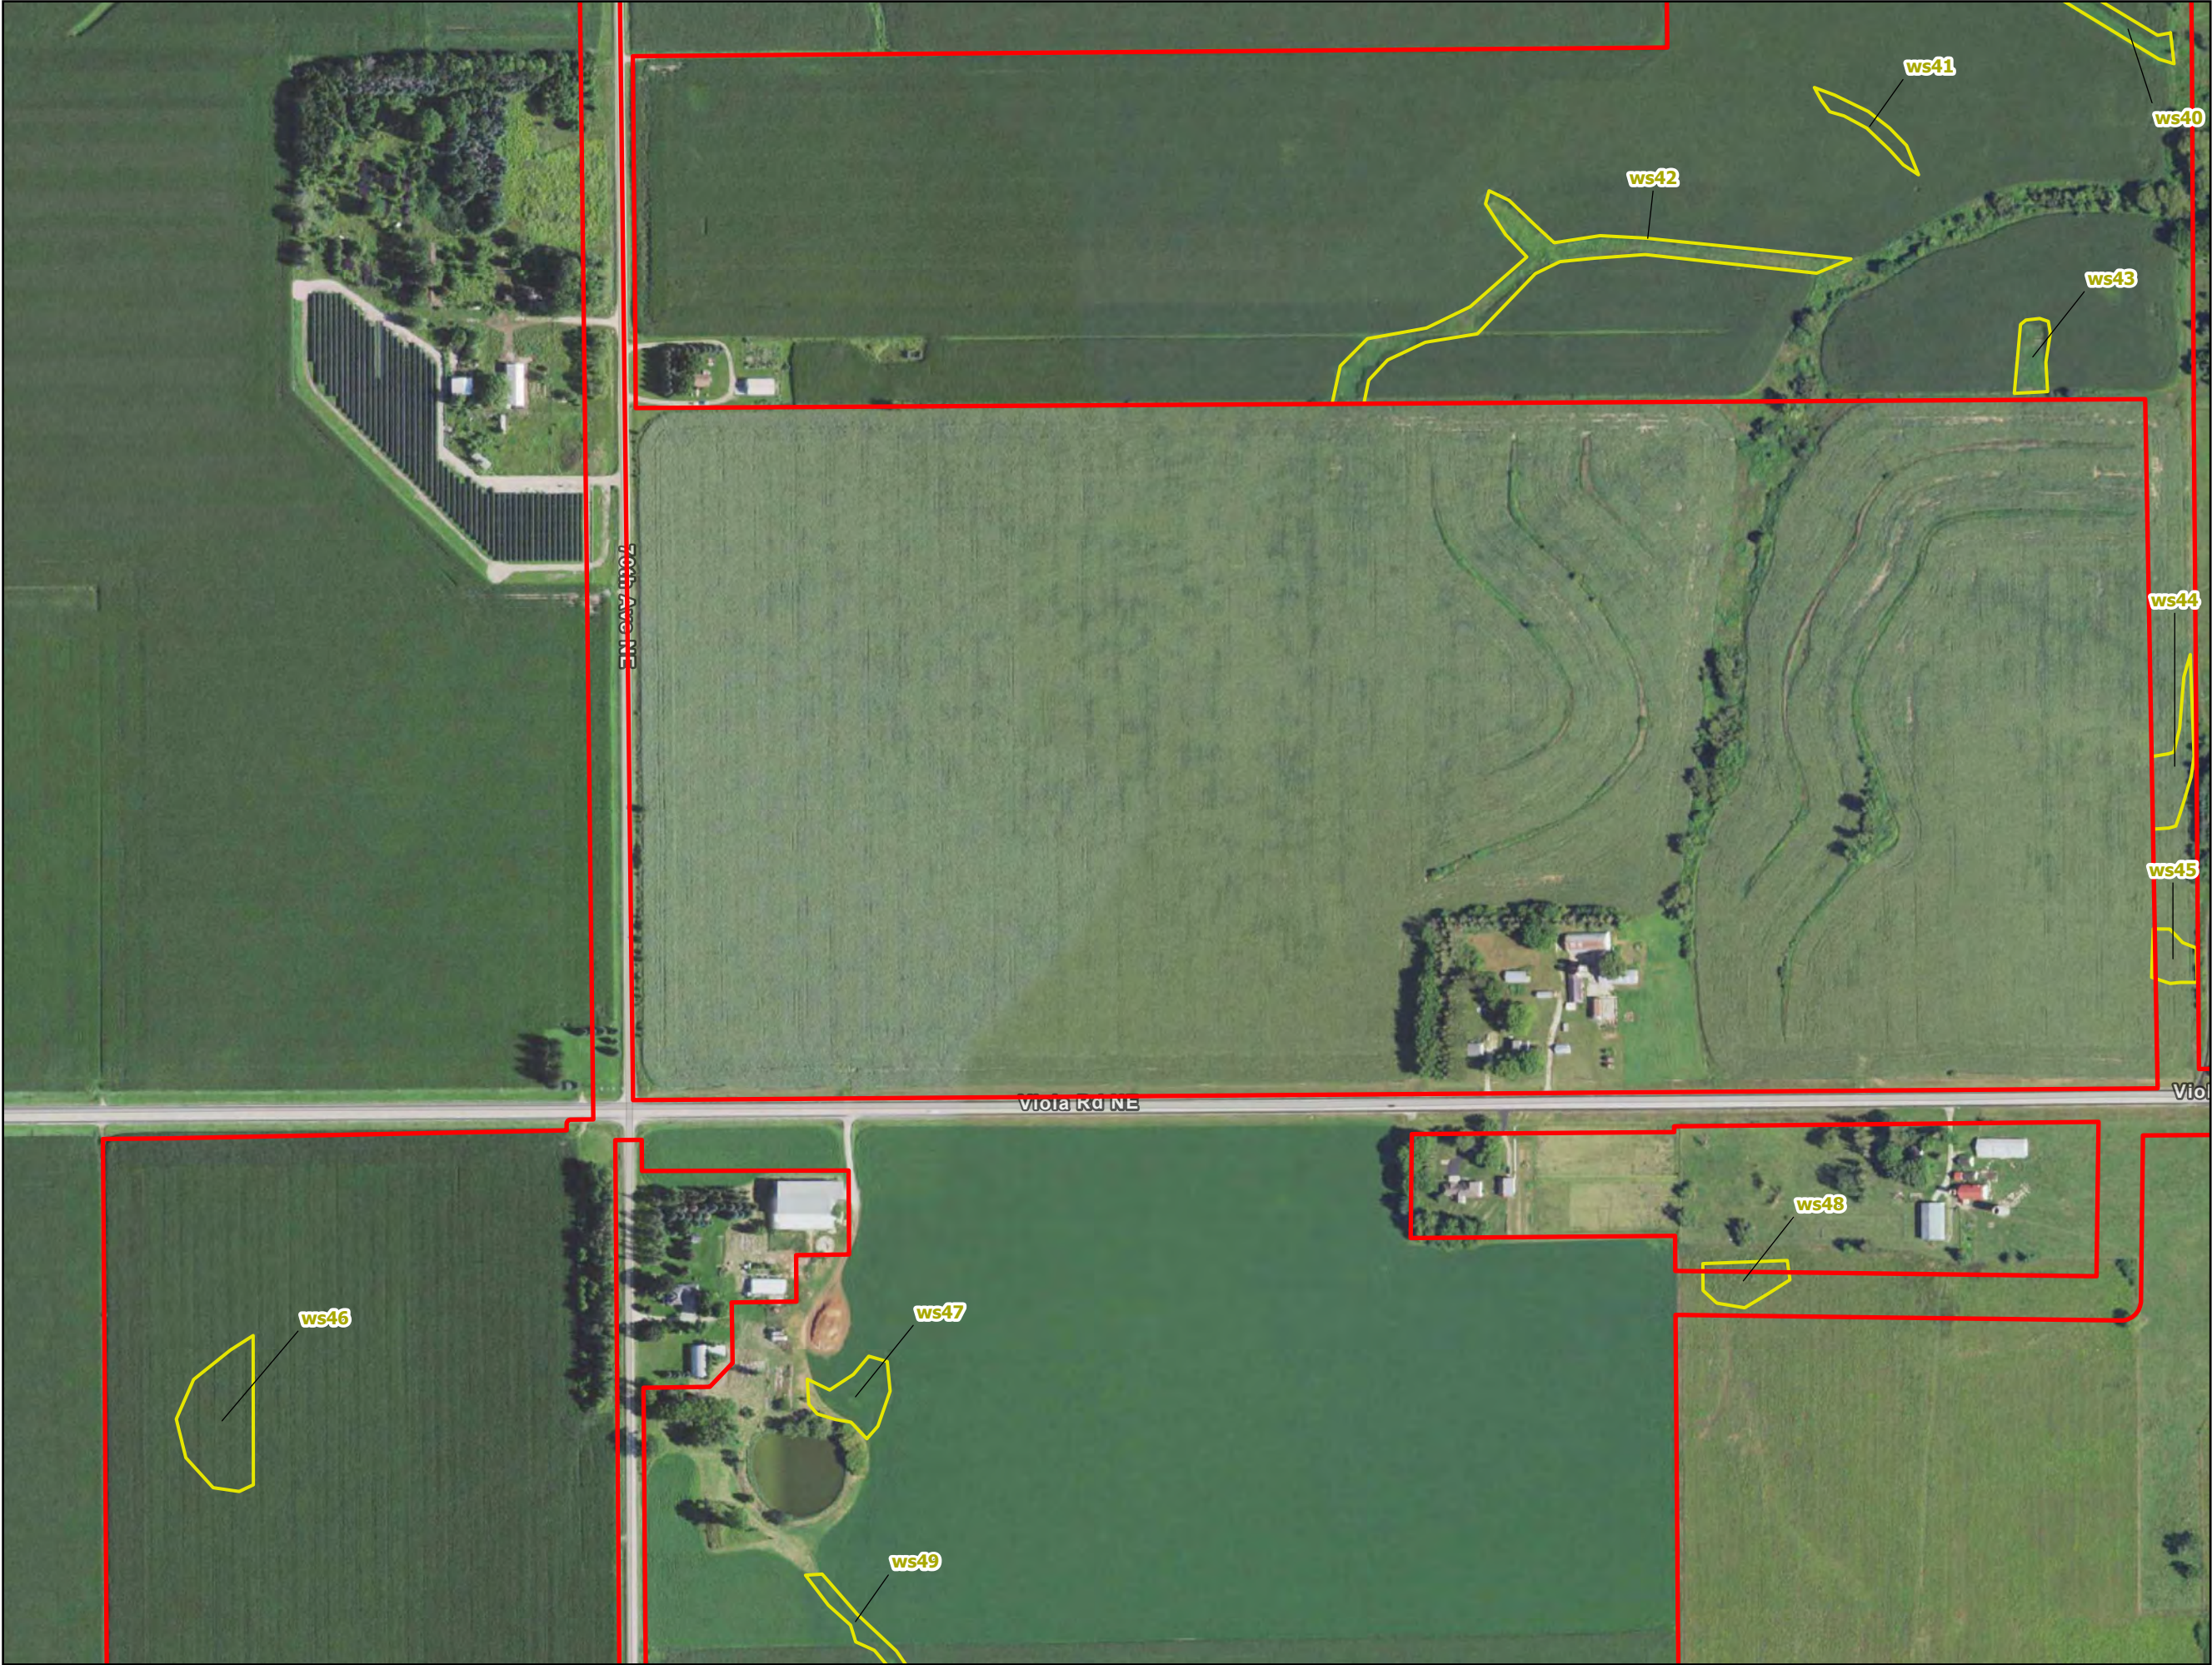
FSA Slide Review: NAIP Imagery -
August 2021
Lemon Hill Solar Project
Ranger Power
Olmsted County, MN

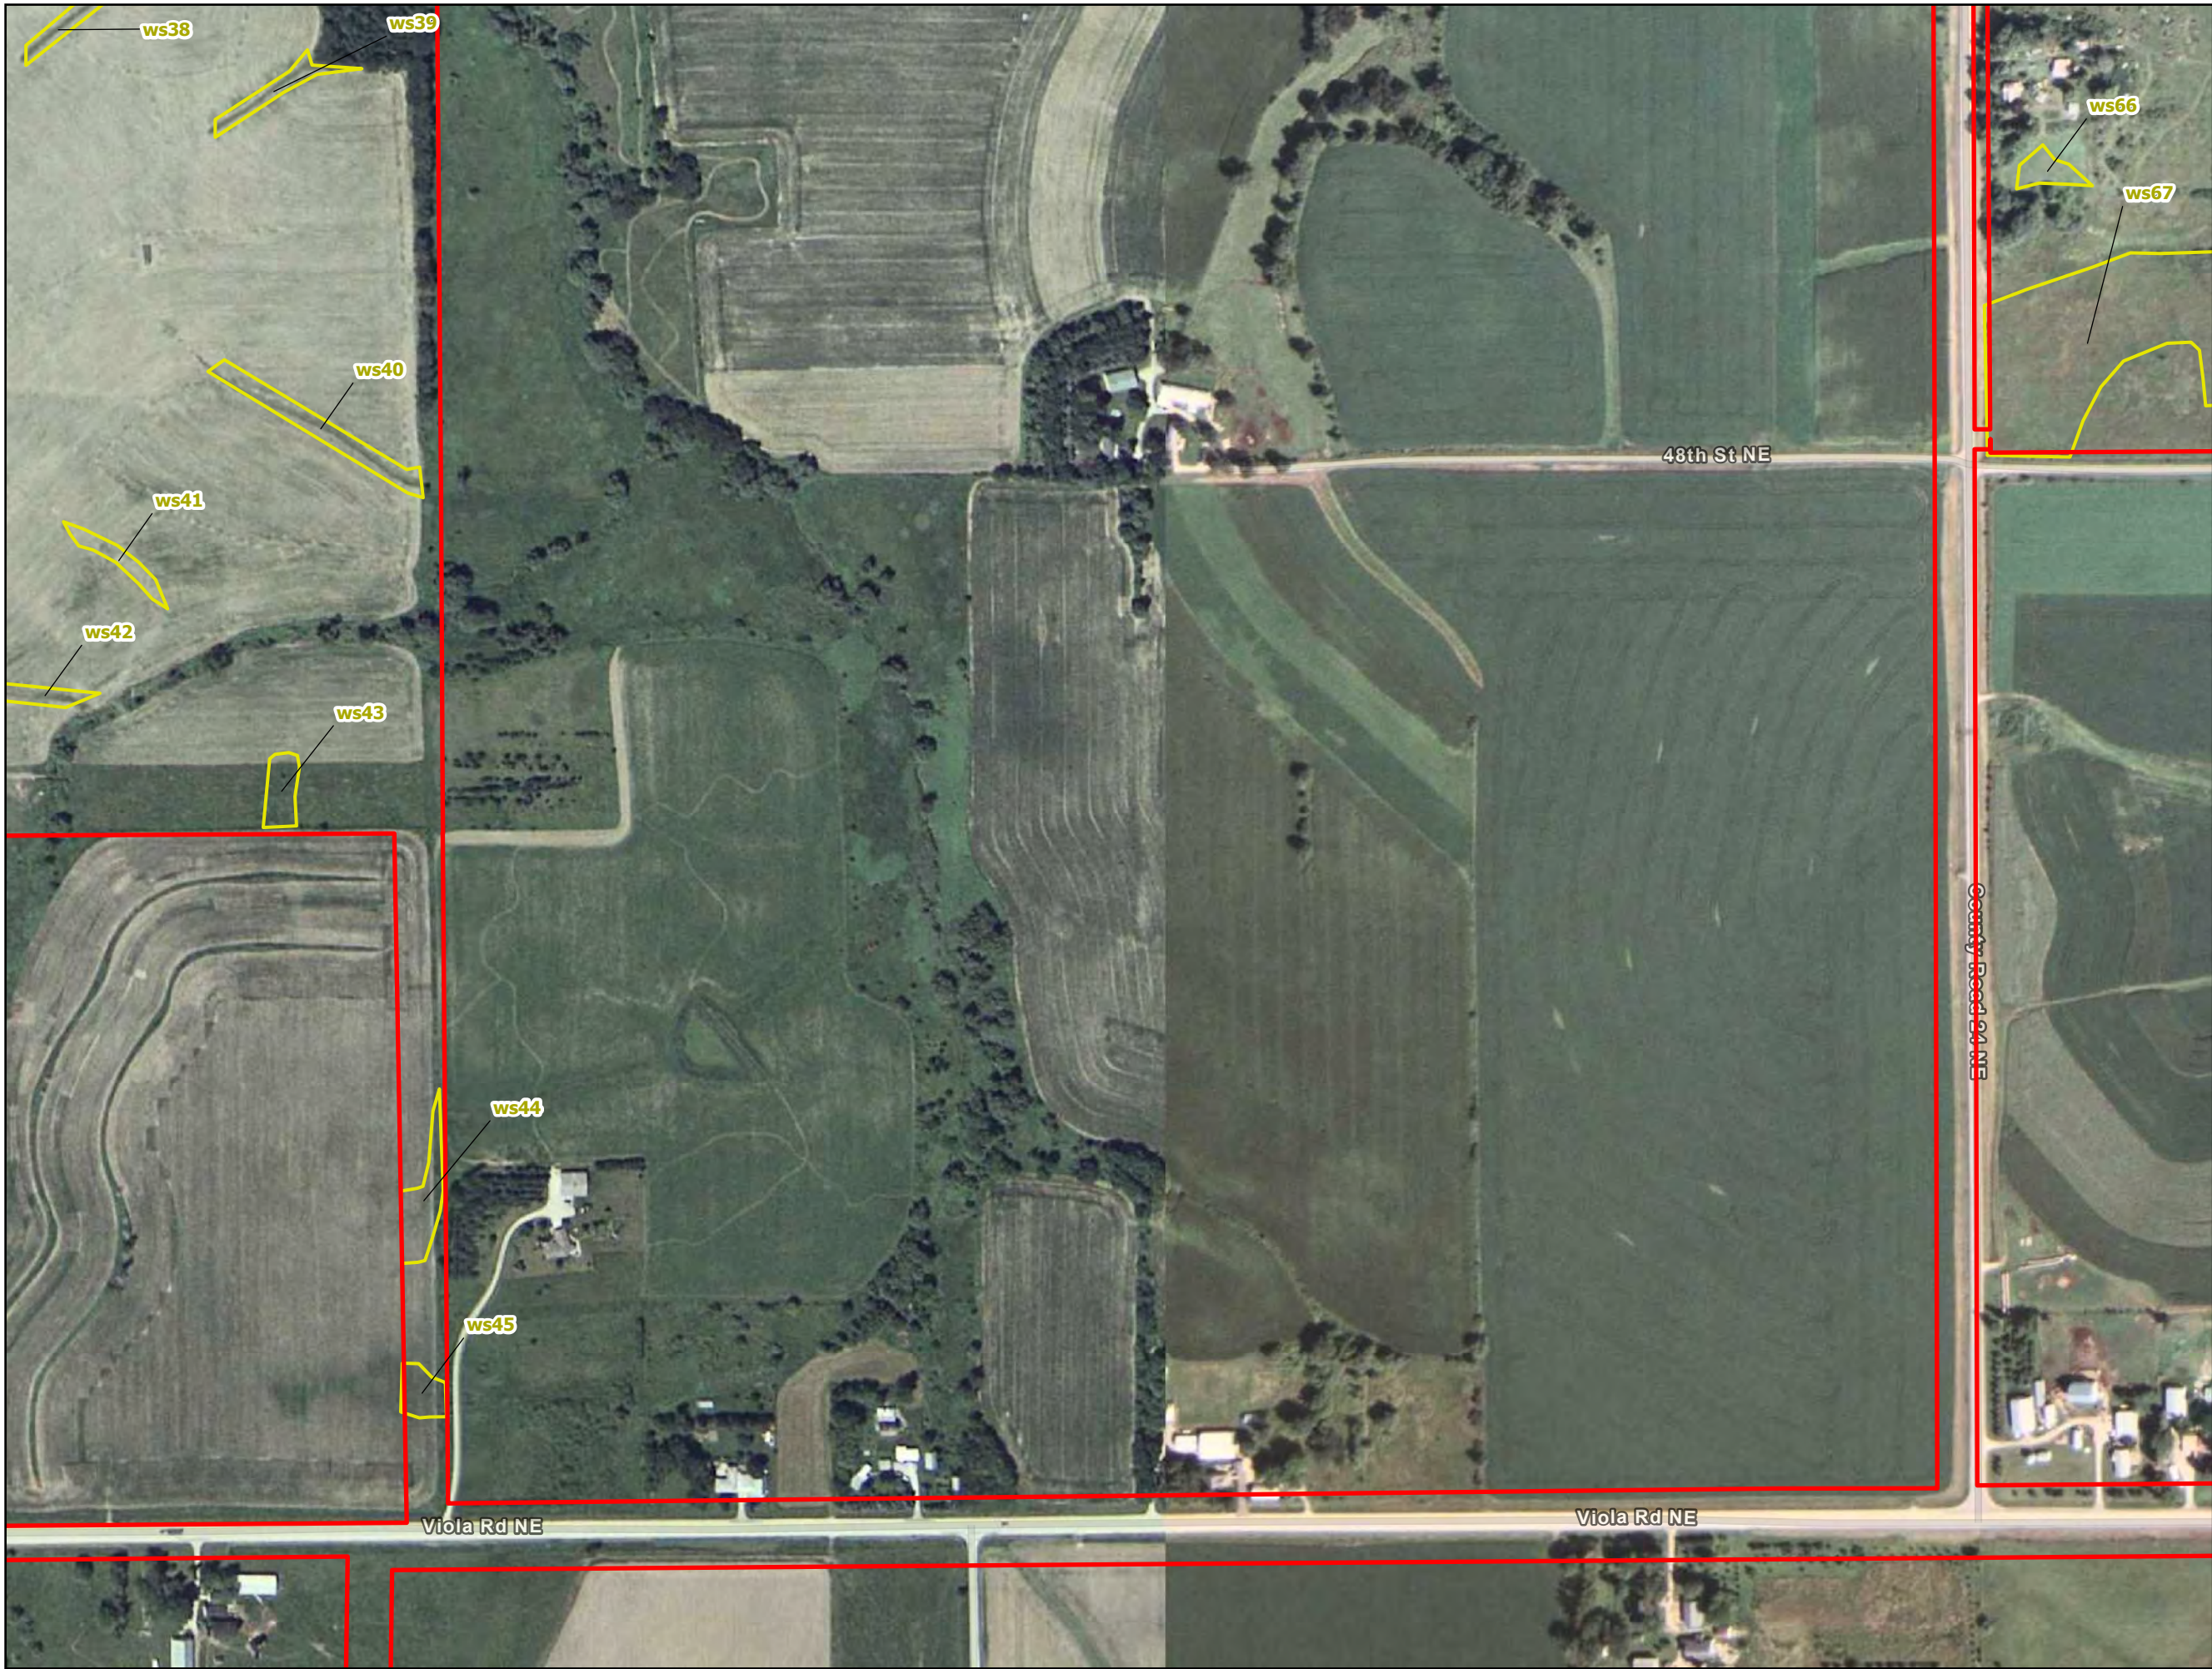
- Survey Area
- Wetness Signature

**FSA Slide Review: NAIP Imagery -
August 2009
Lemon Hill Solar Project
Ranger Power
Olmsted County, MN**

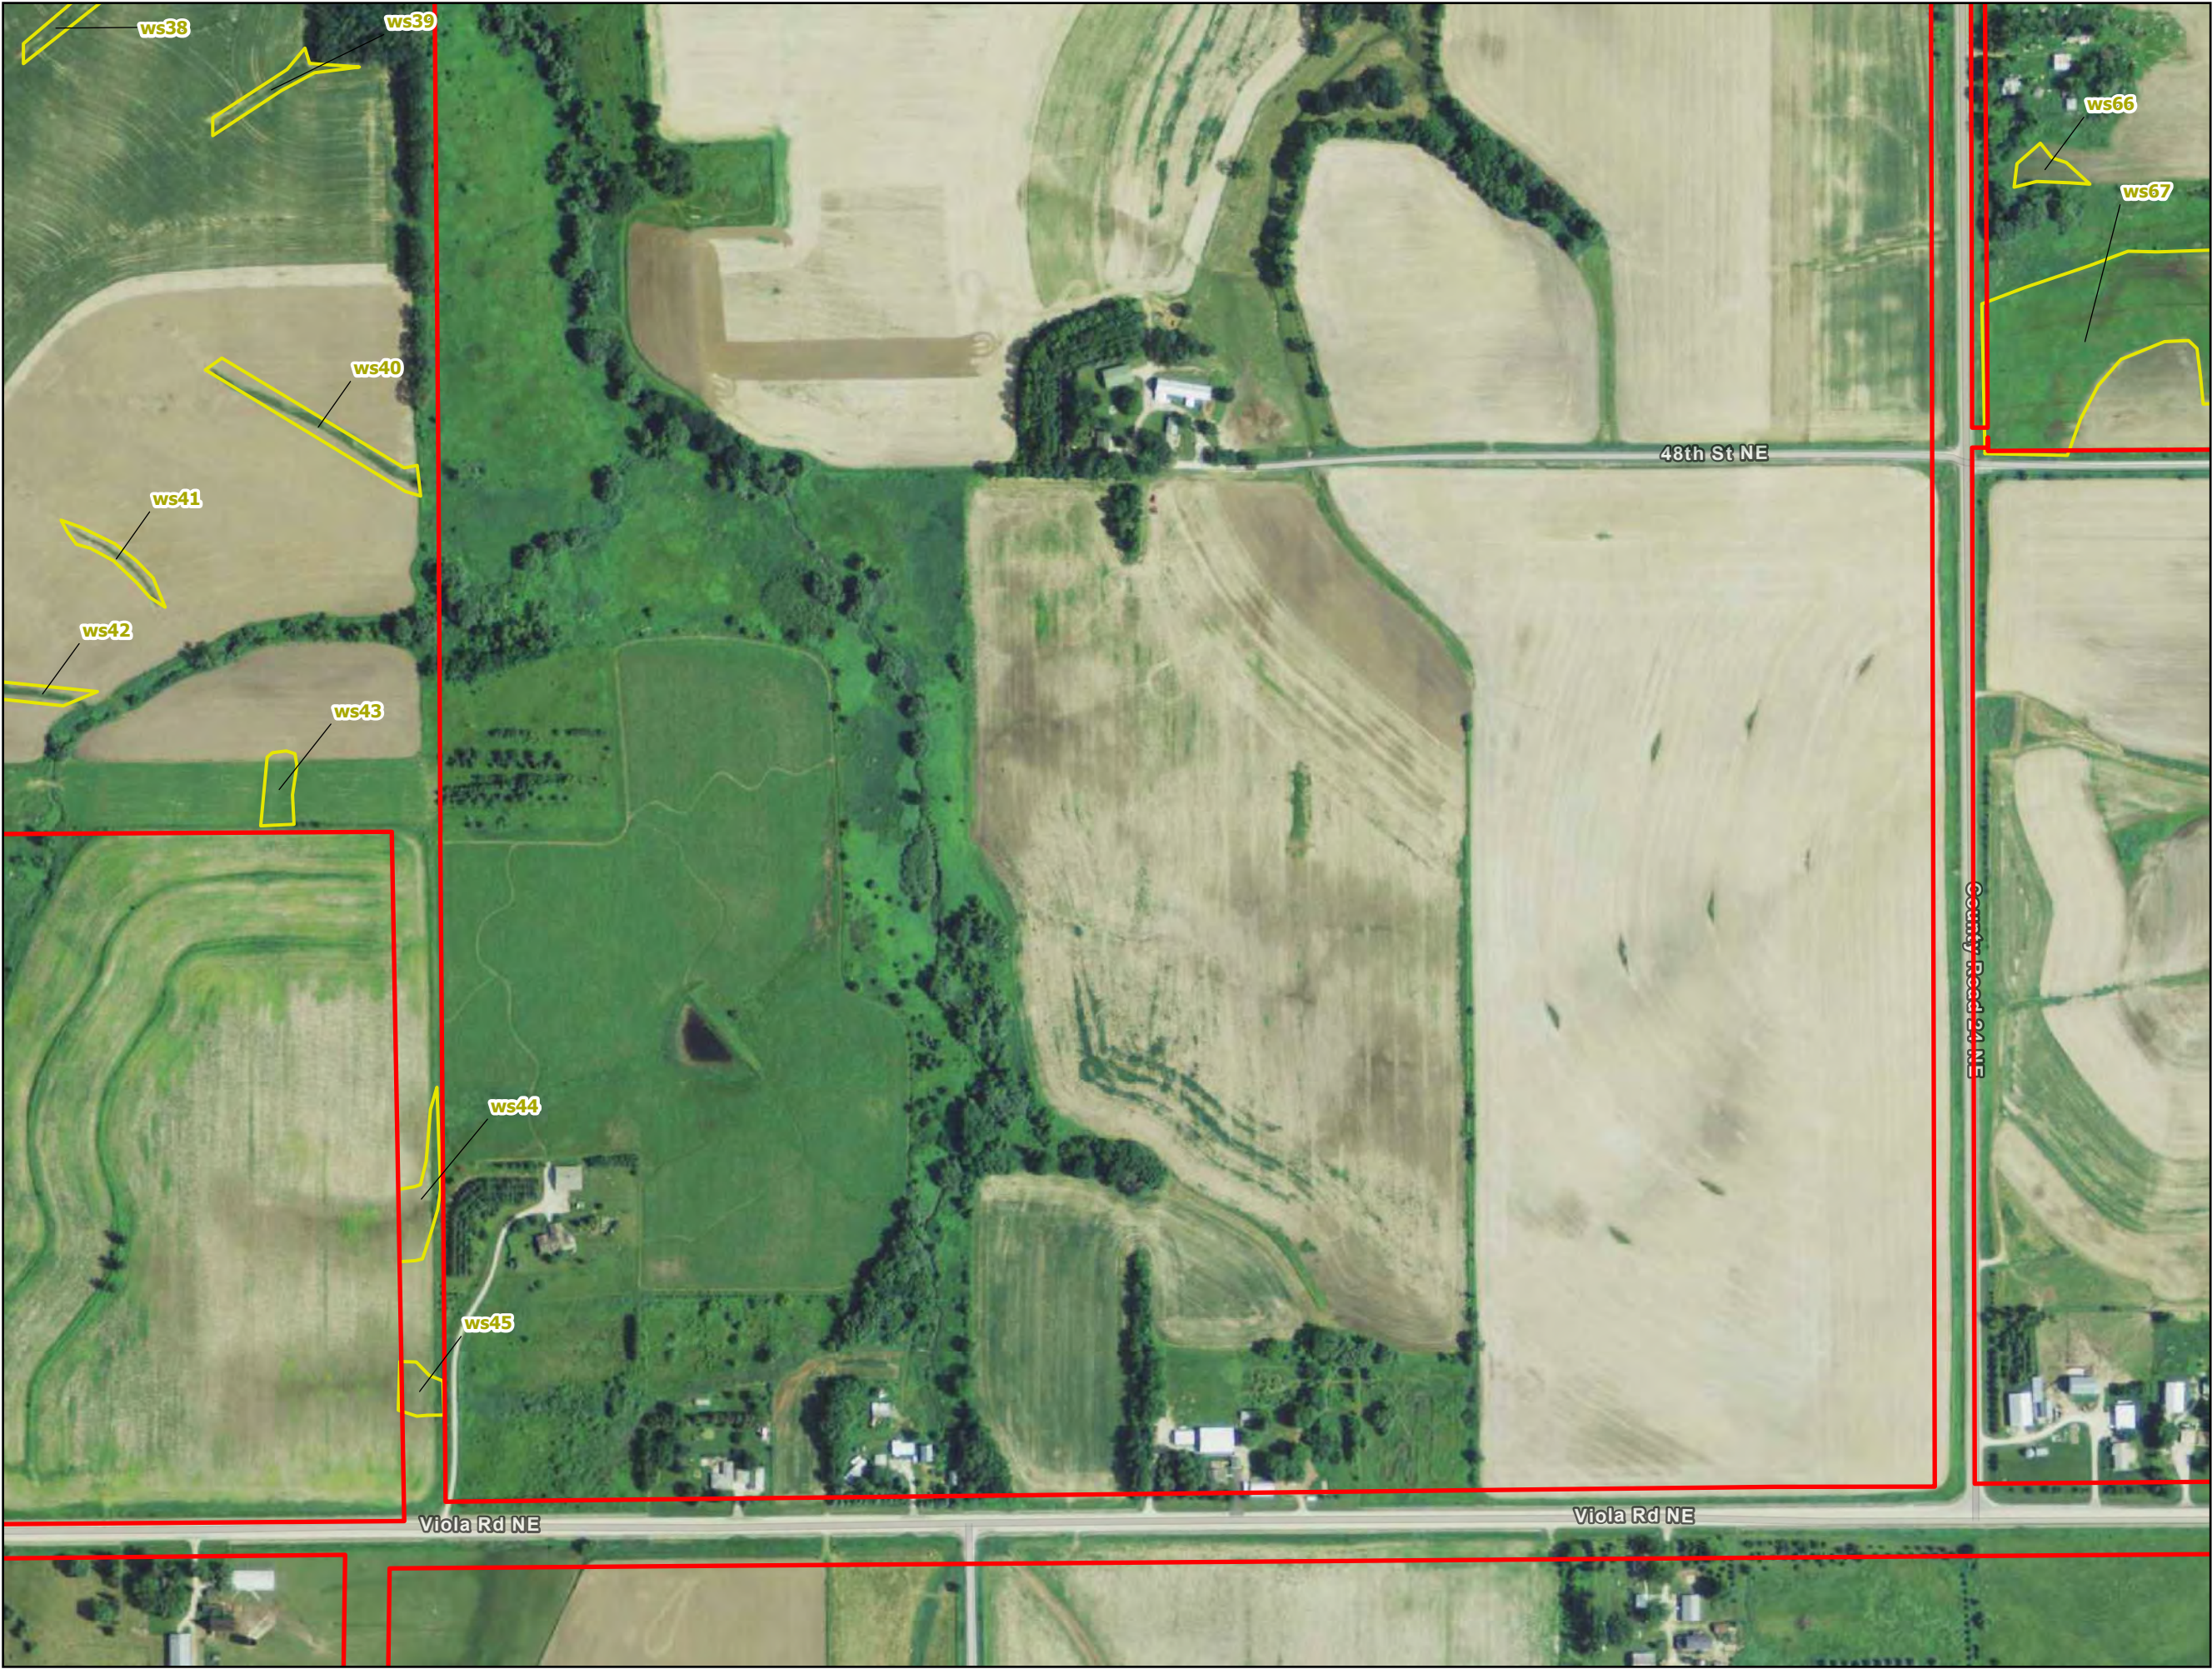
- Survey Area
- Wetness Signature

**FSA Slide Review: NAIP Imagery -
July 2013
Lemon Hill Solar Project
Ranger Power
Olmsted County, MN**

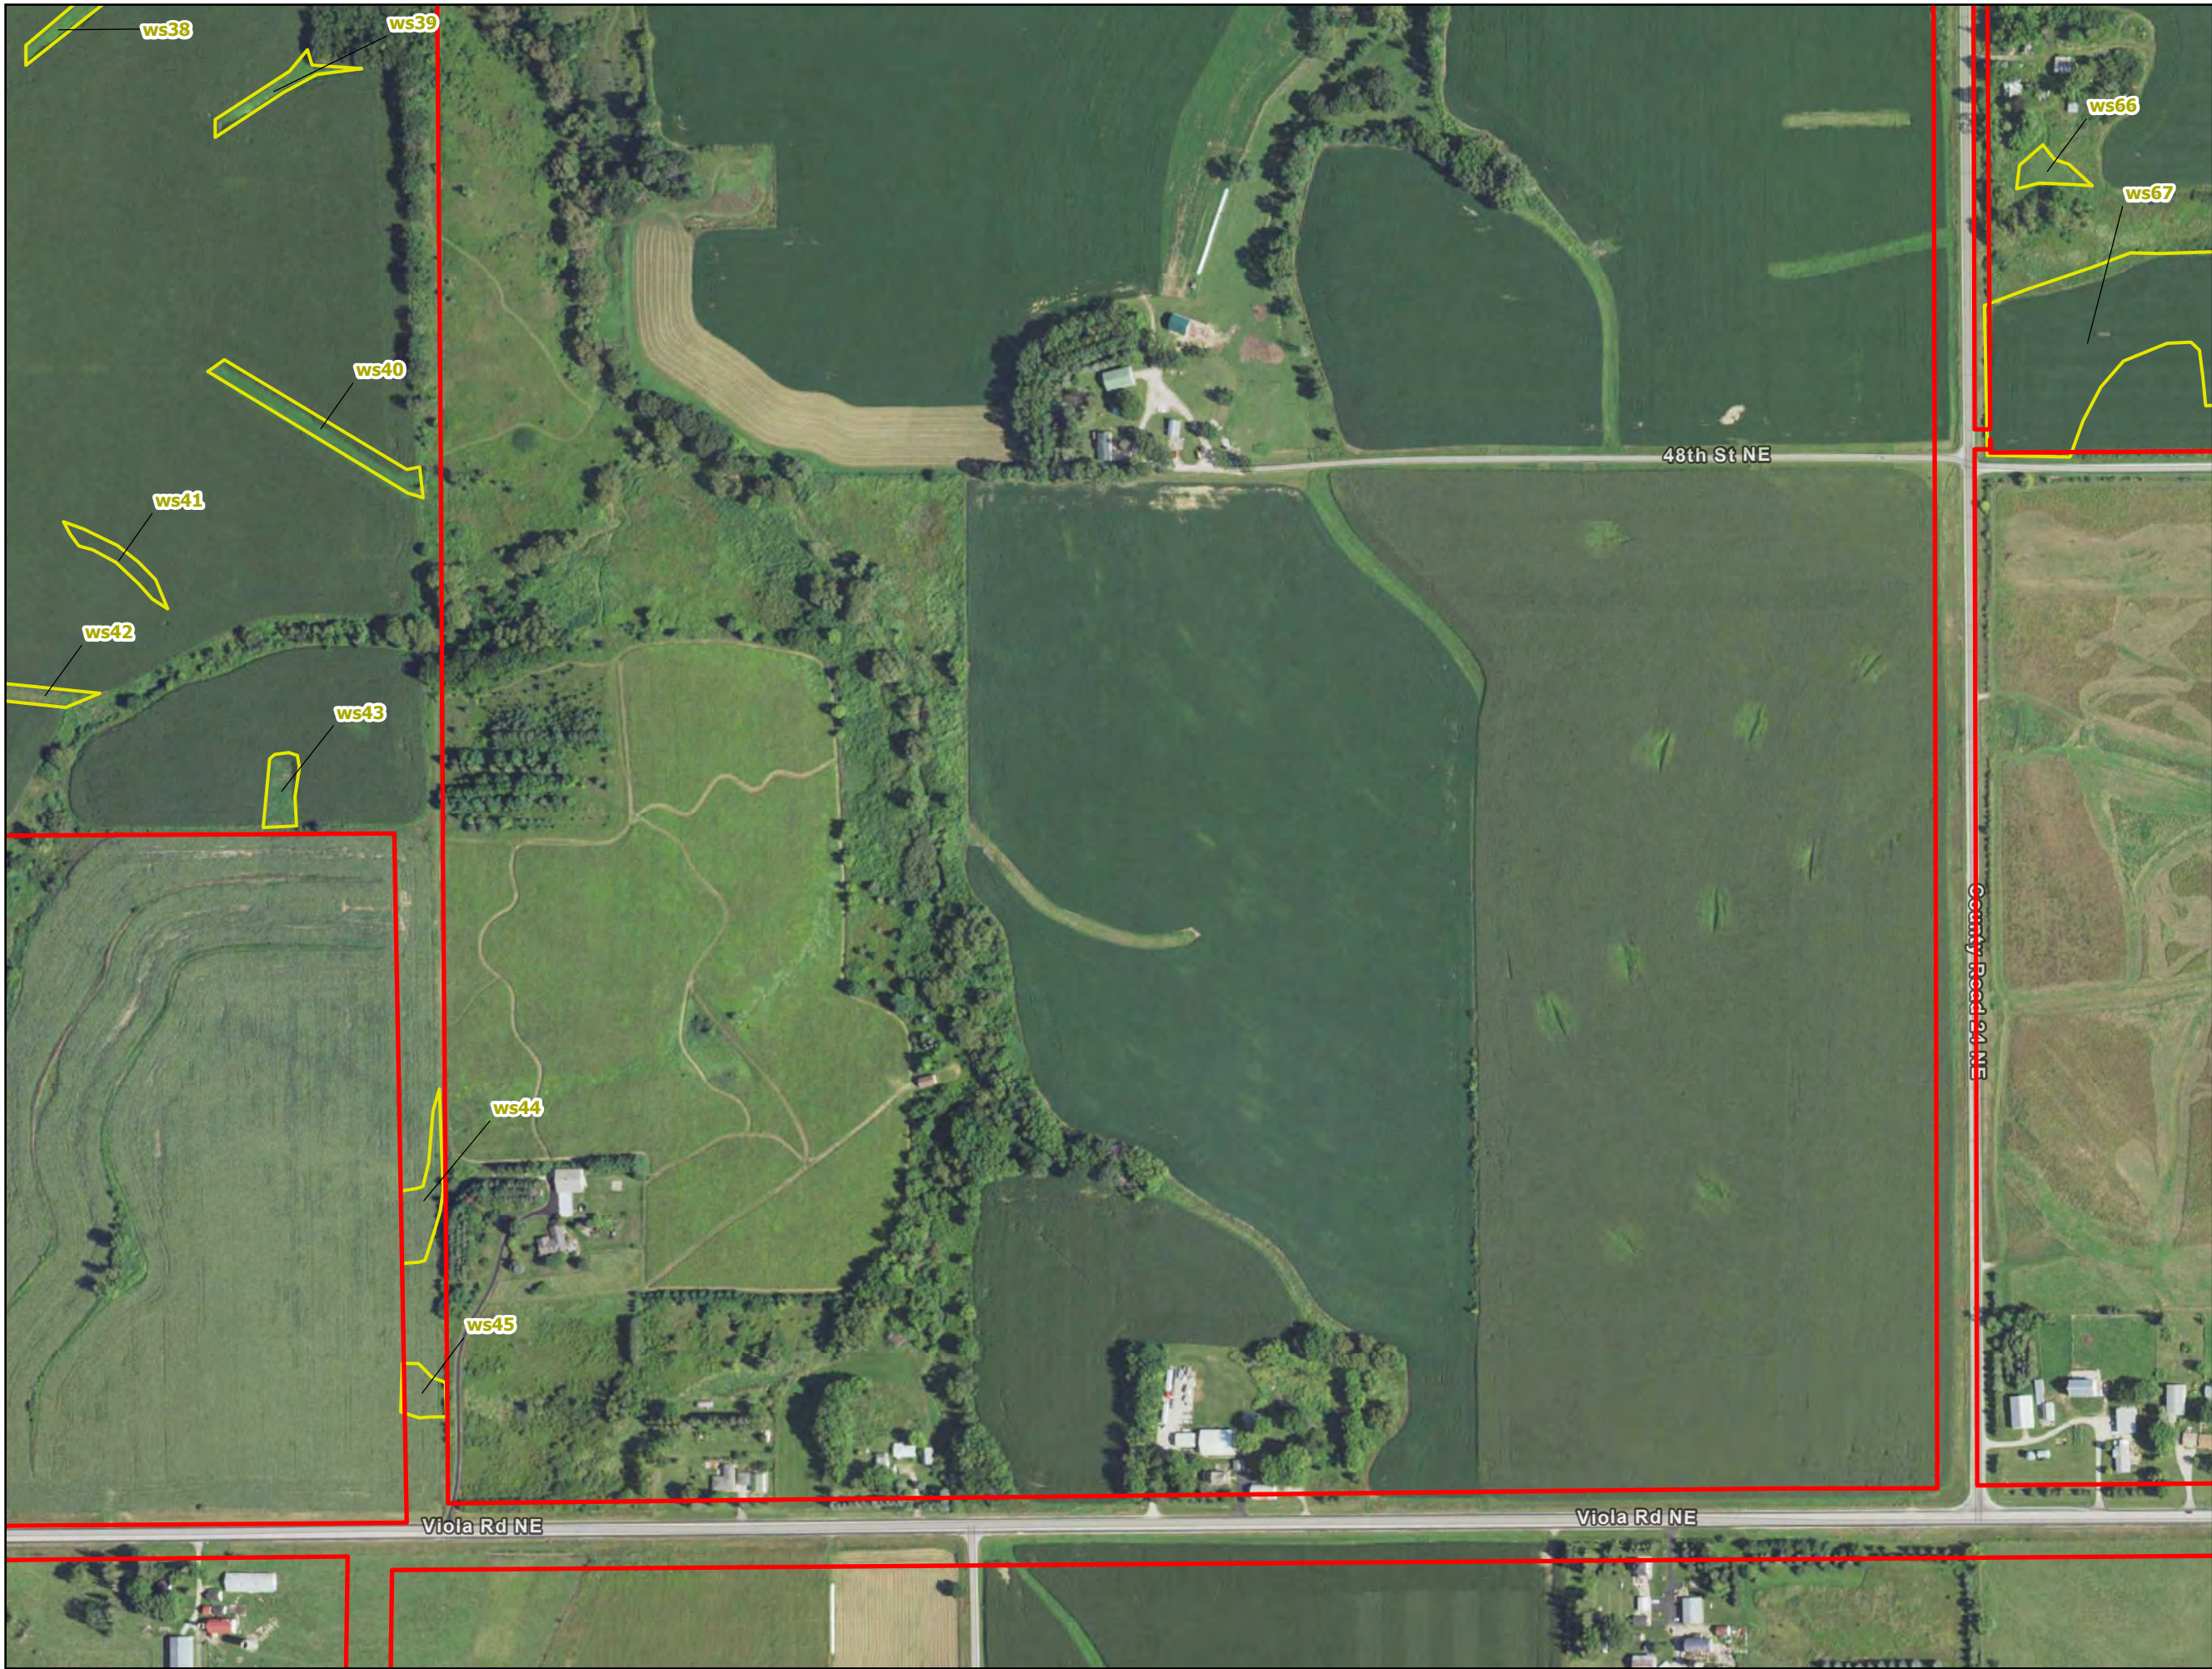
- Survey Area
- Wetness Signature

**FSA Slide Review: NAIP Imagery -
August 2021
Lemon Hill Solar Project
Ranger Power
Olmsted County, MN**

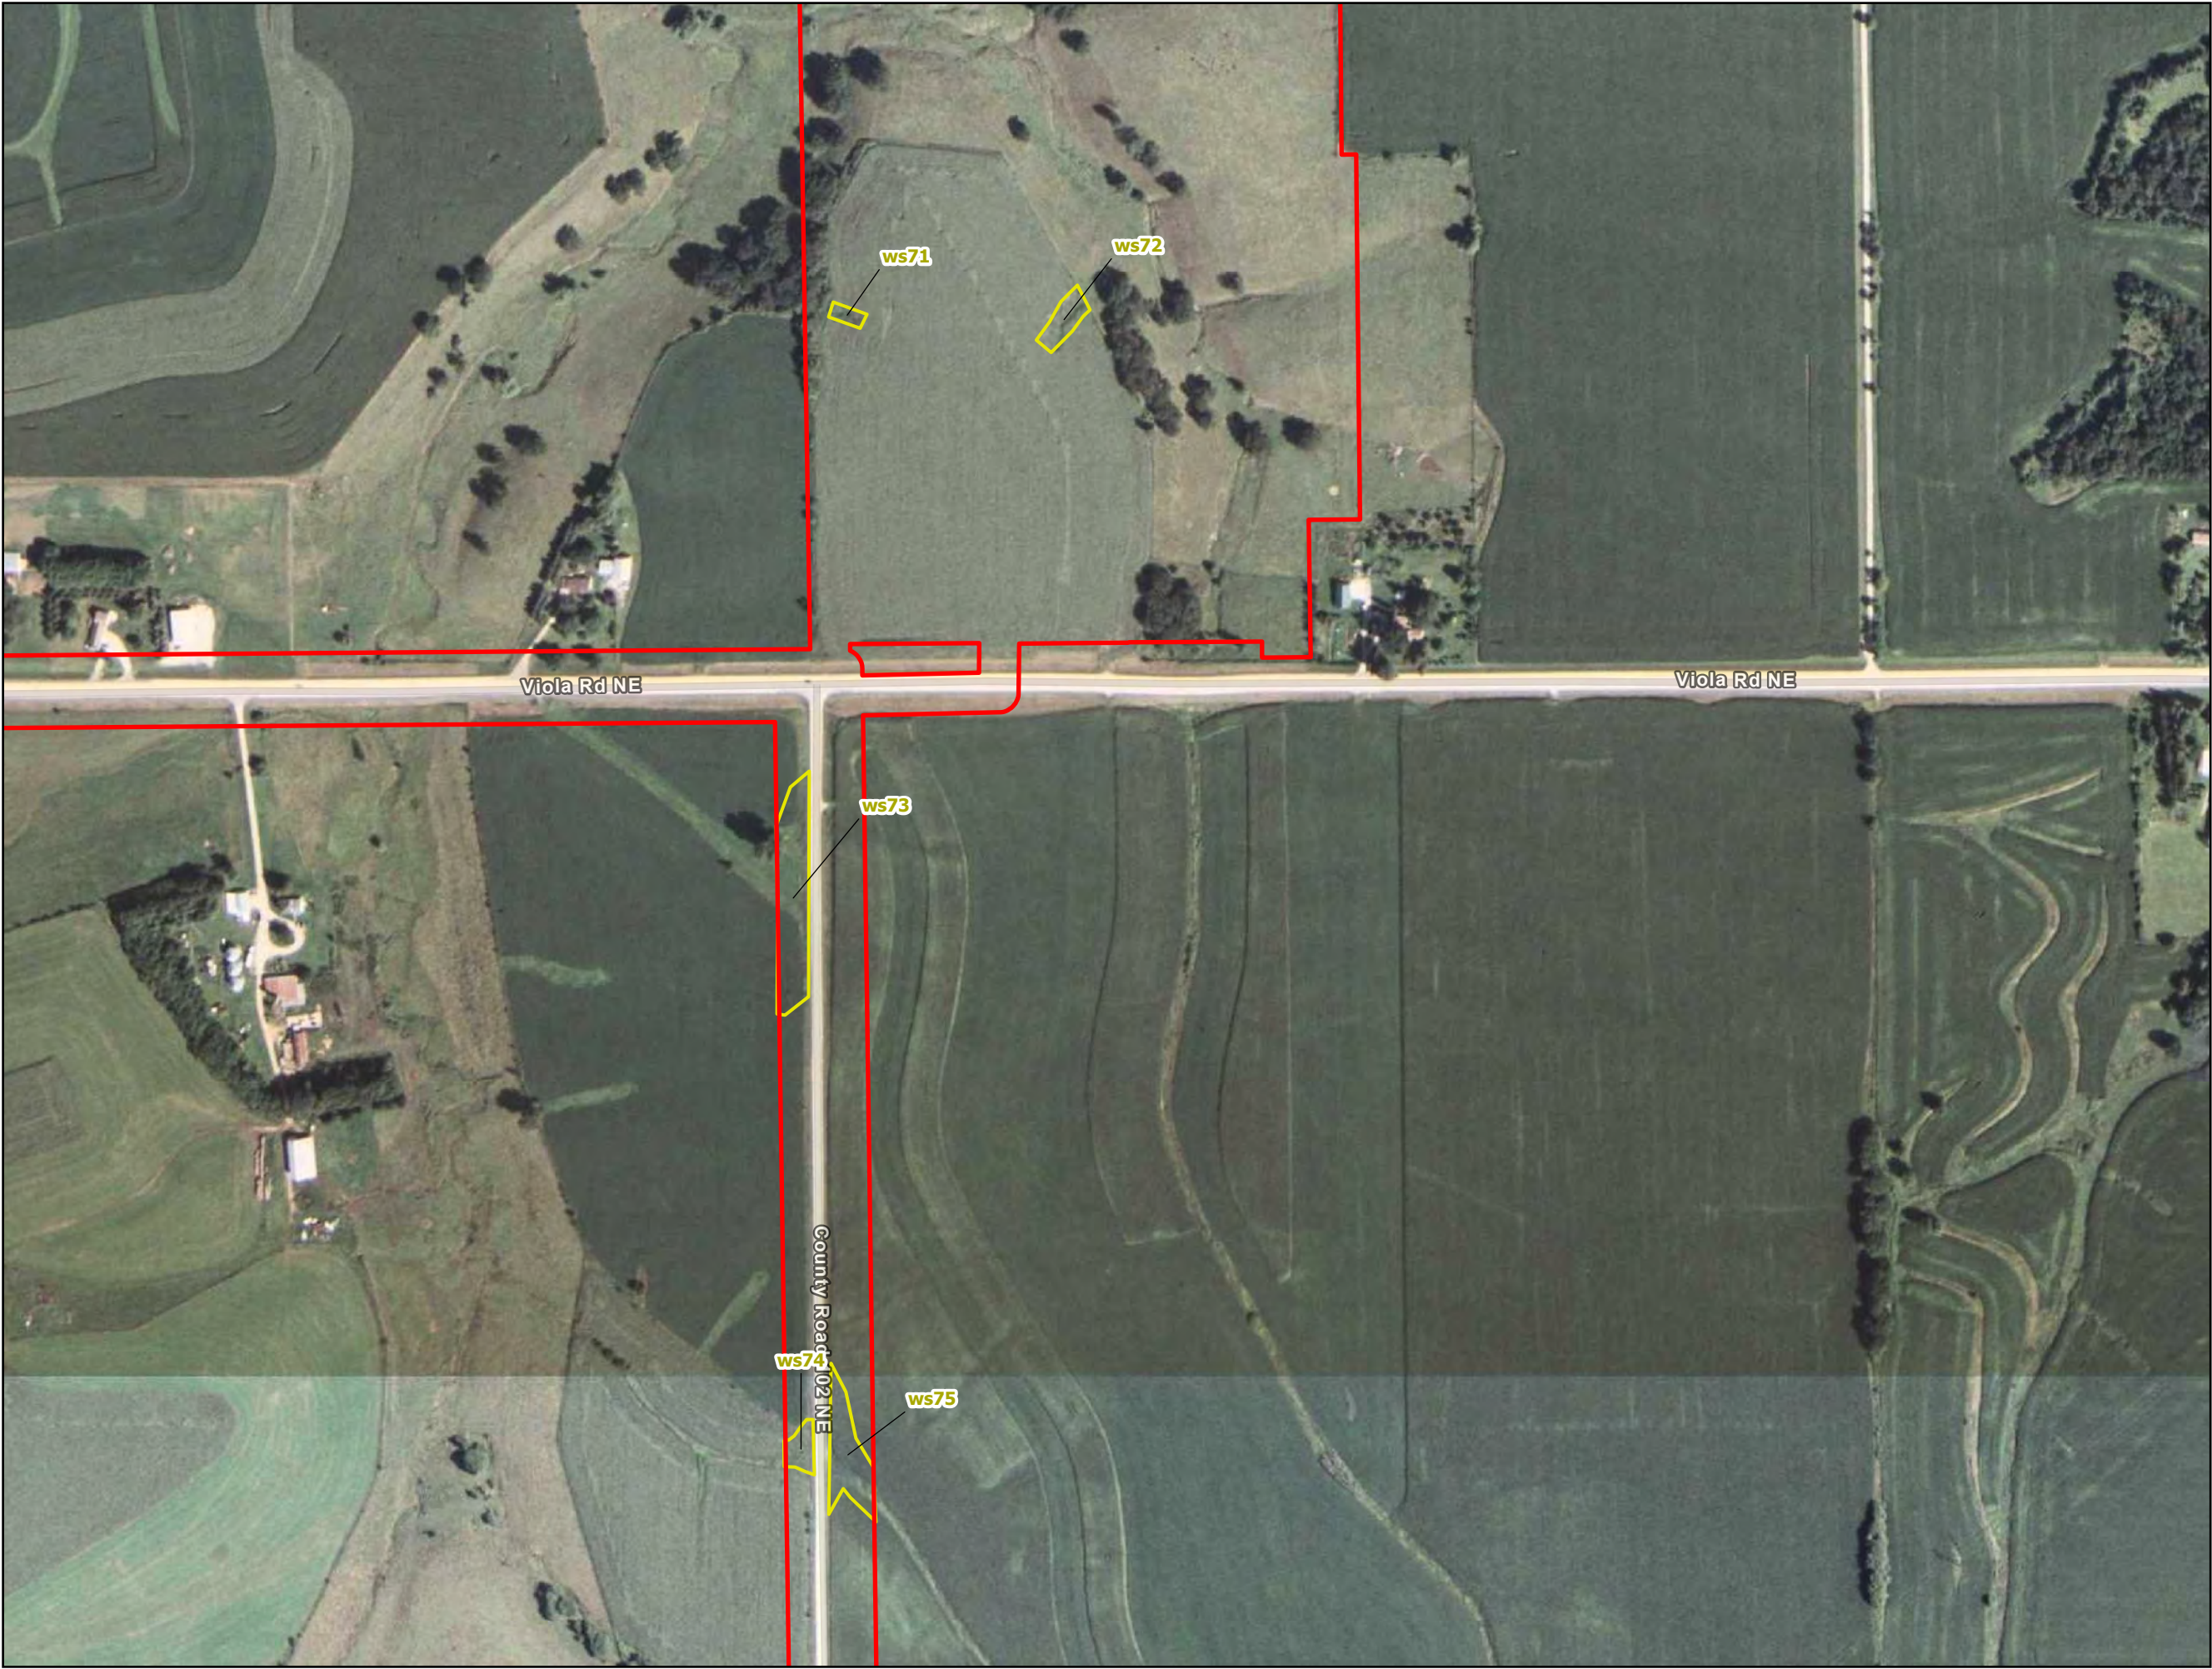
- Survey Area
- Wetness Signature

**FSA Slide Review: NAIP Imagery -
August 2009
Lemon Hill Solar Project
Ranger Power
Olmsted County, MN**
