**FSA Slide Review: NAIP Imagery -
October 2017
Lemon Hill Solar Project
Ranger Power
Olmsted County, MN**

Exhibit 1Field data sheet reference (if applicable): See attached crosswalk table**Wetland Hydrology from Aerial Imagery – Recording Form**

Project Name: Lemon Hill Solar Project

Date: 5/20/24 County: OlmstedInvestigator: Kyle Hanson Legal Description (T, R, S): T107N, R13W, S12**Summary Table**

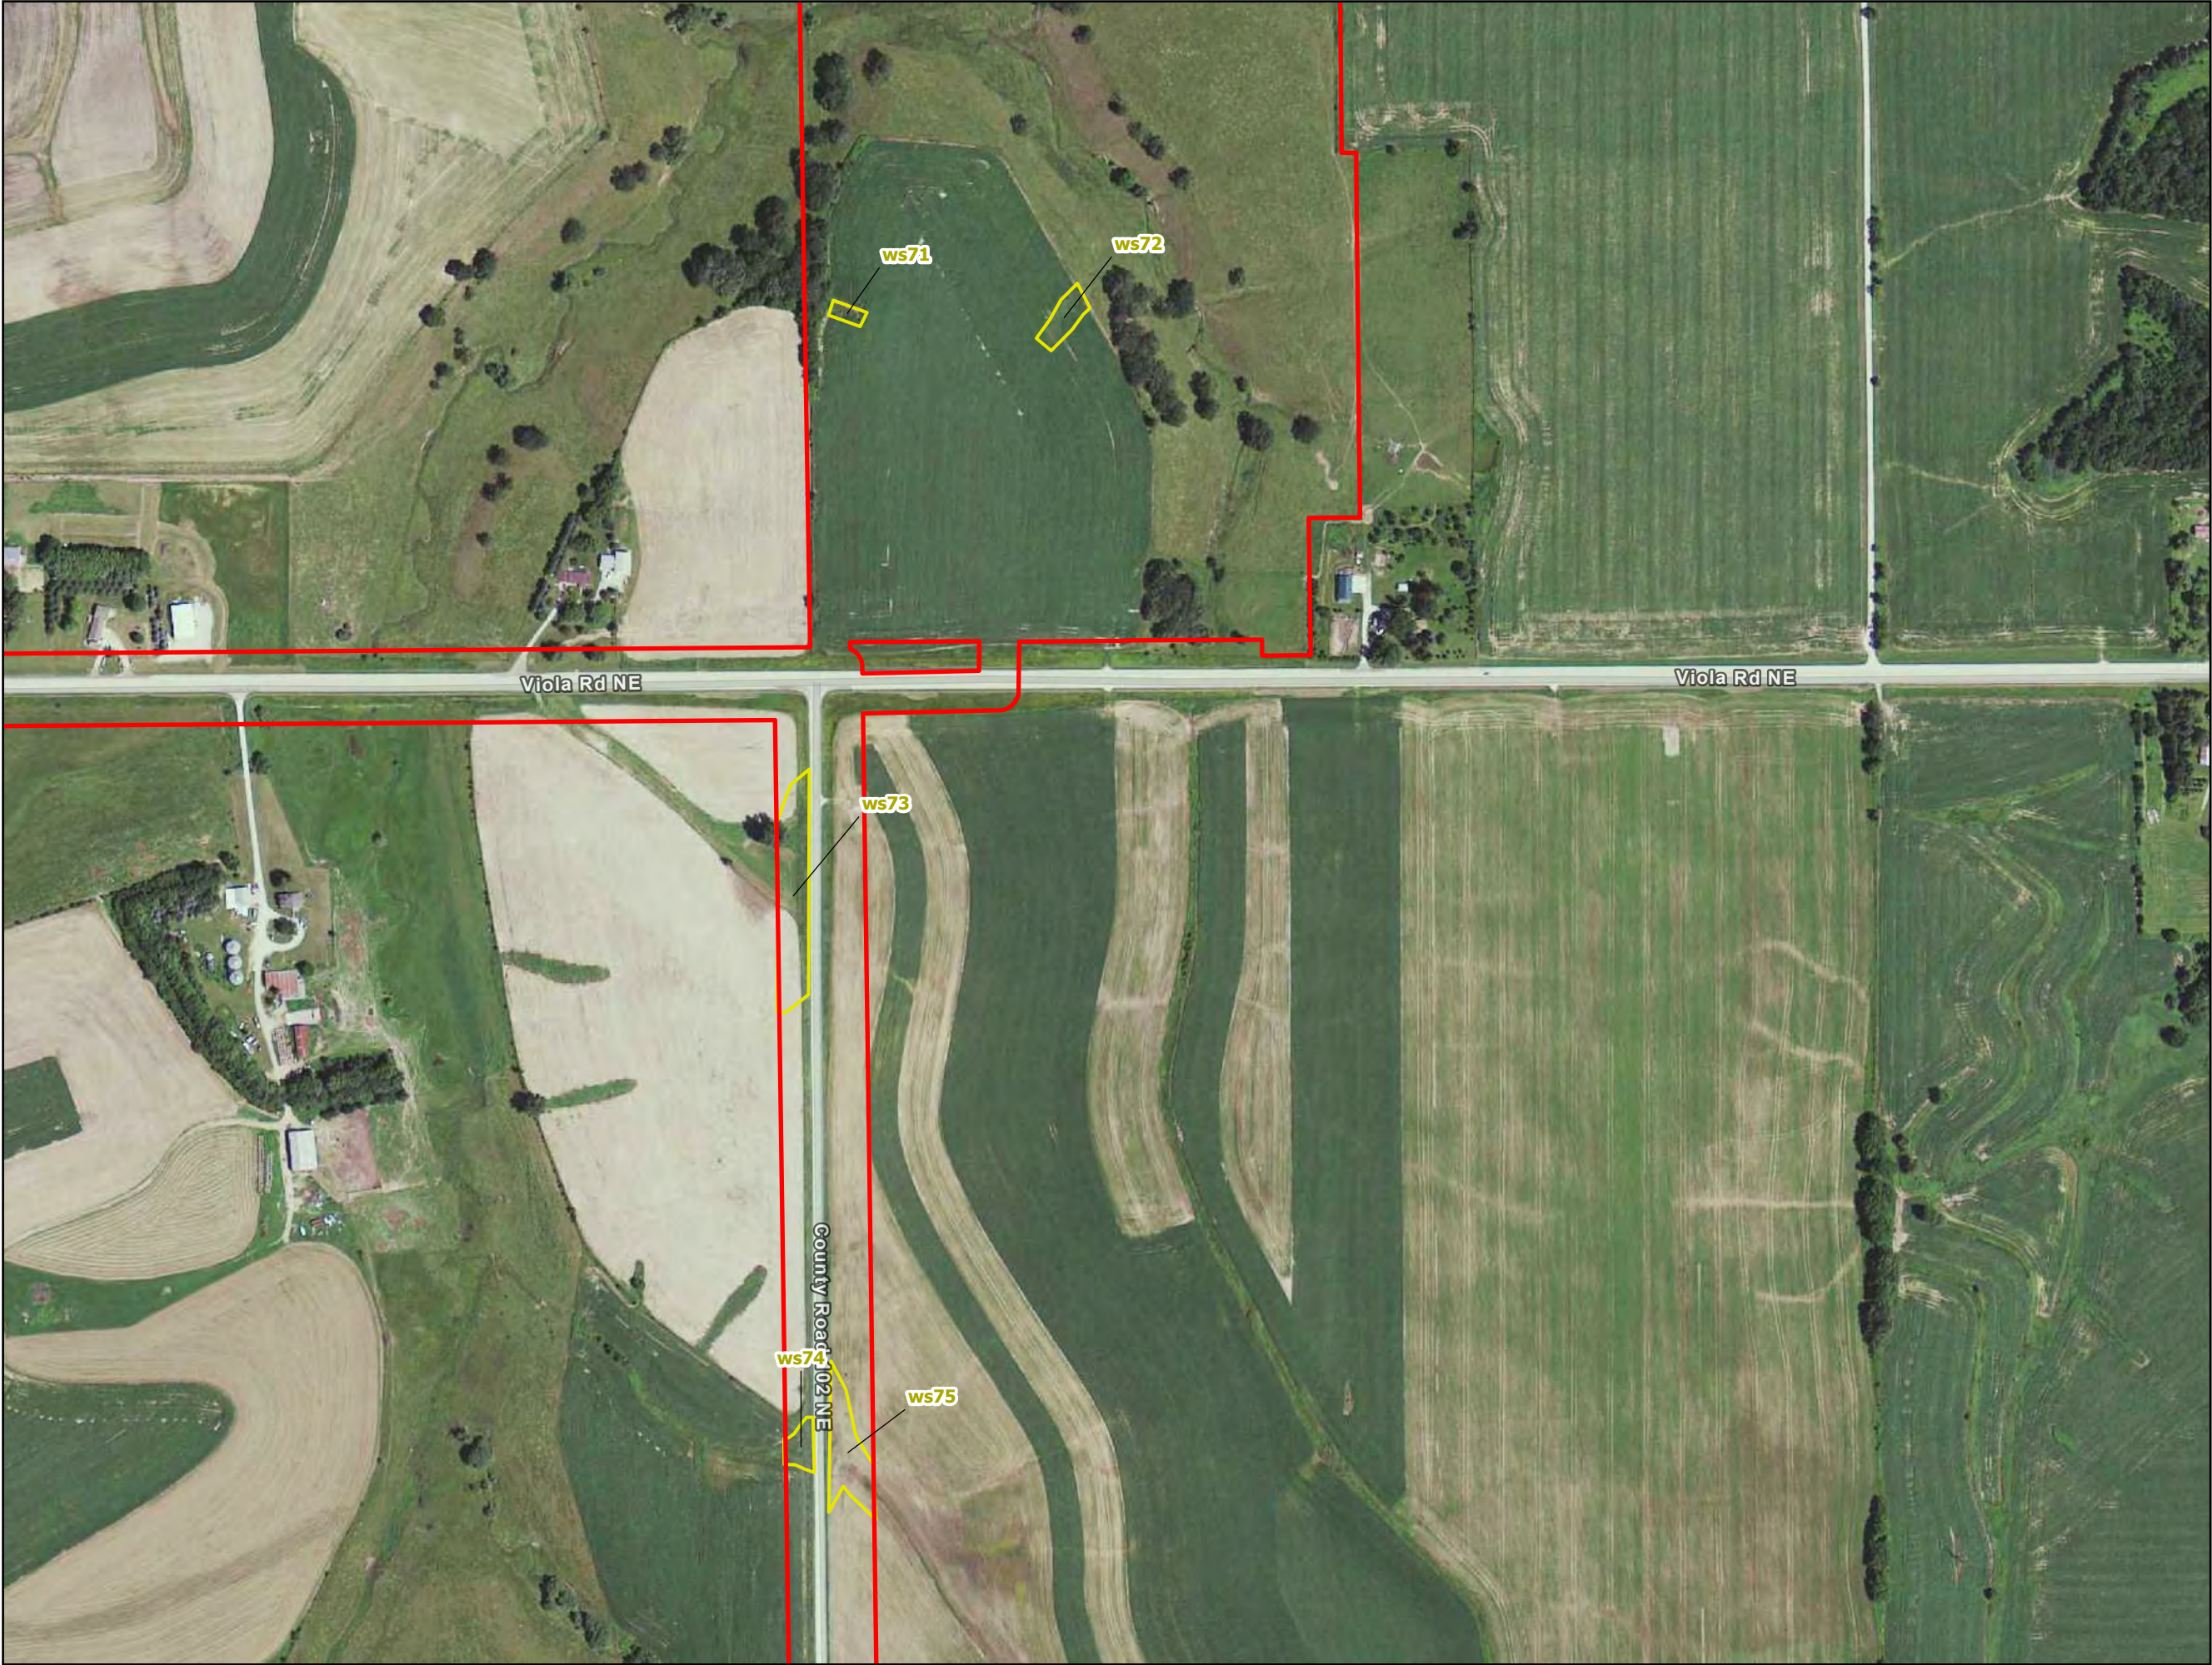
- Survey Area
- Wetness Signature

**FSA Slide Review: NAIP Imagery -
July 2010
Lemon Hill Solar Project
Ranger Power
Olmsted County, MN**

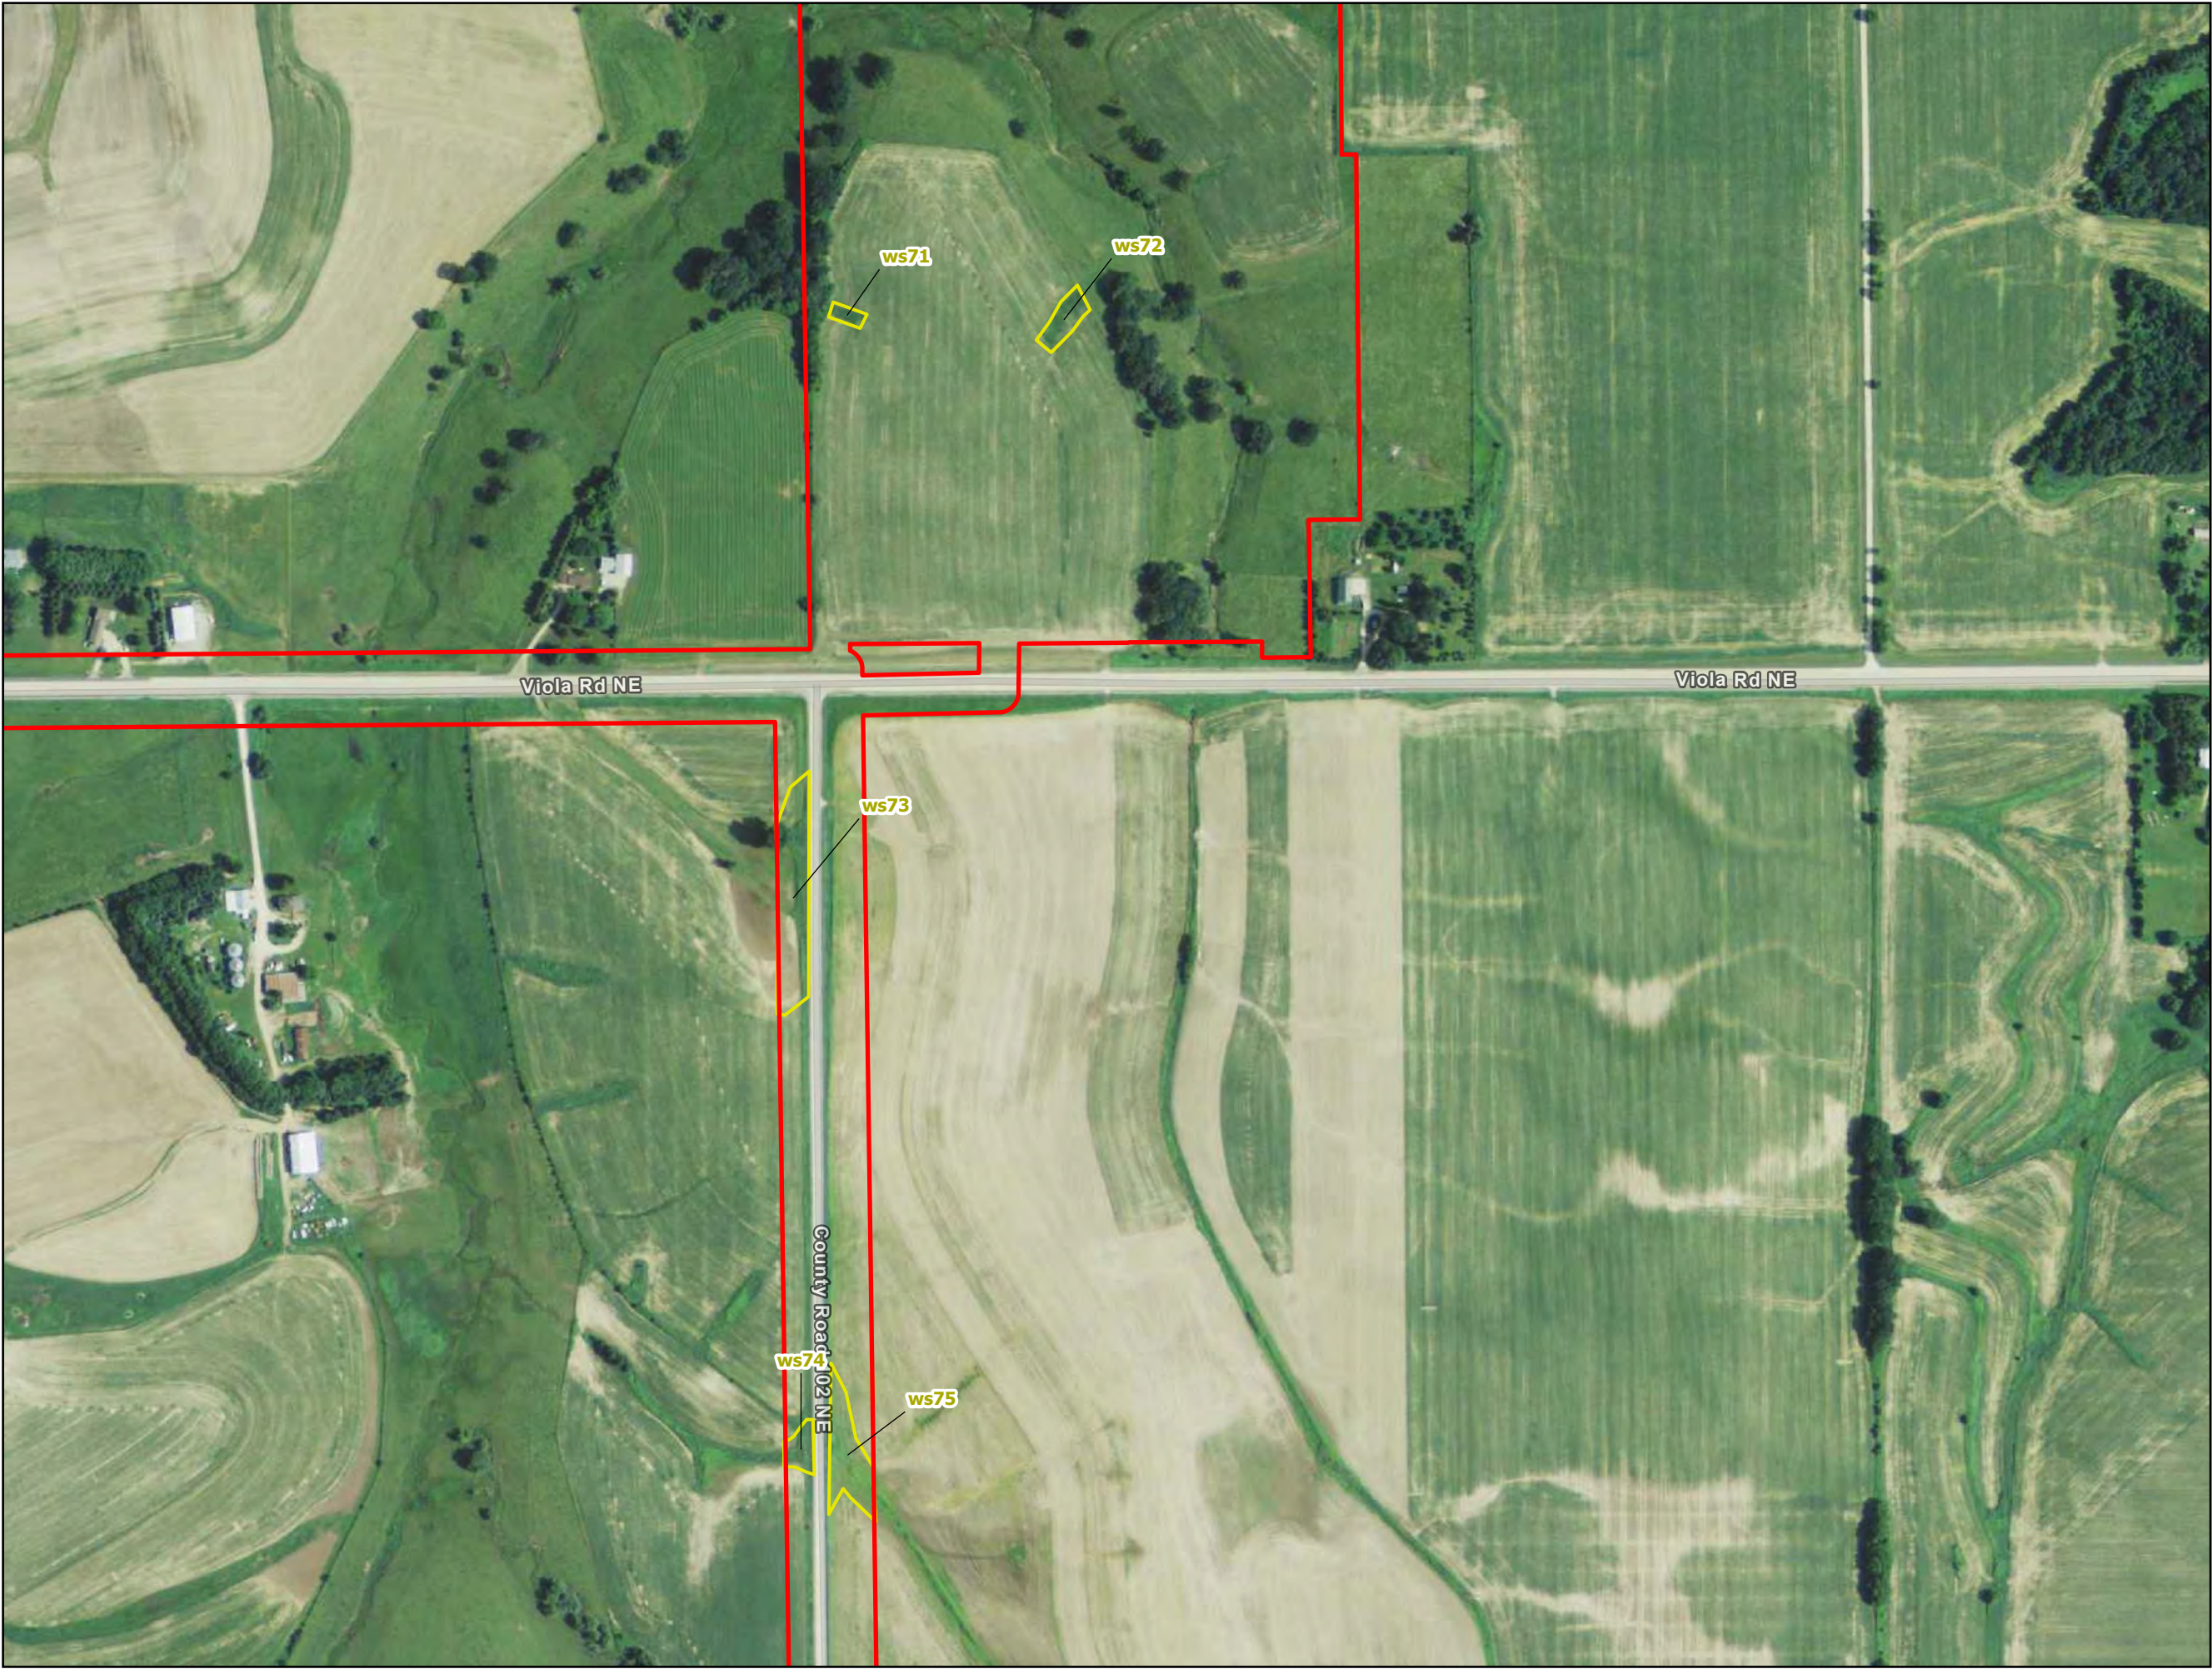
- Survey Area
- Wetness Signature

**FSA Slide Review: NAIP Imagery -
July 2013
Lemon Hill Solar Project
Ranger Power
Olmsted County, MN**

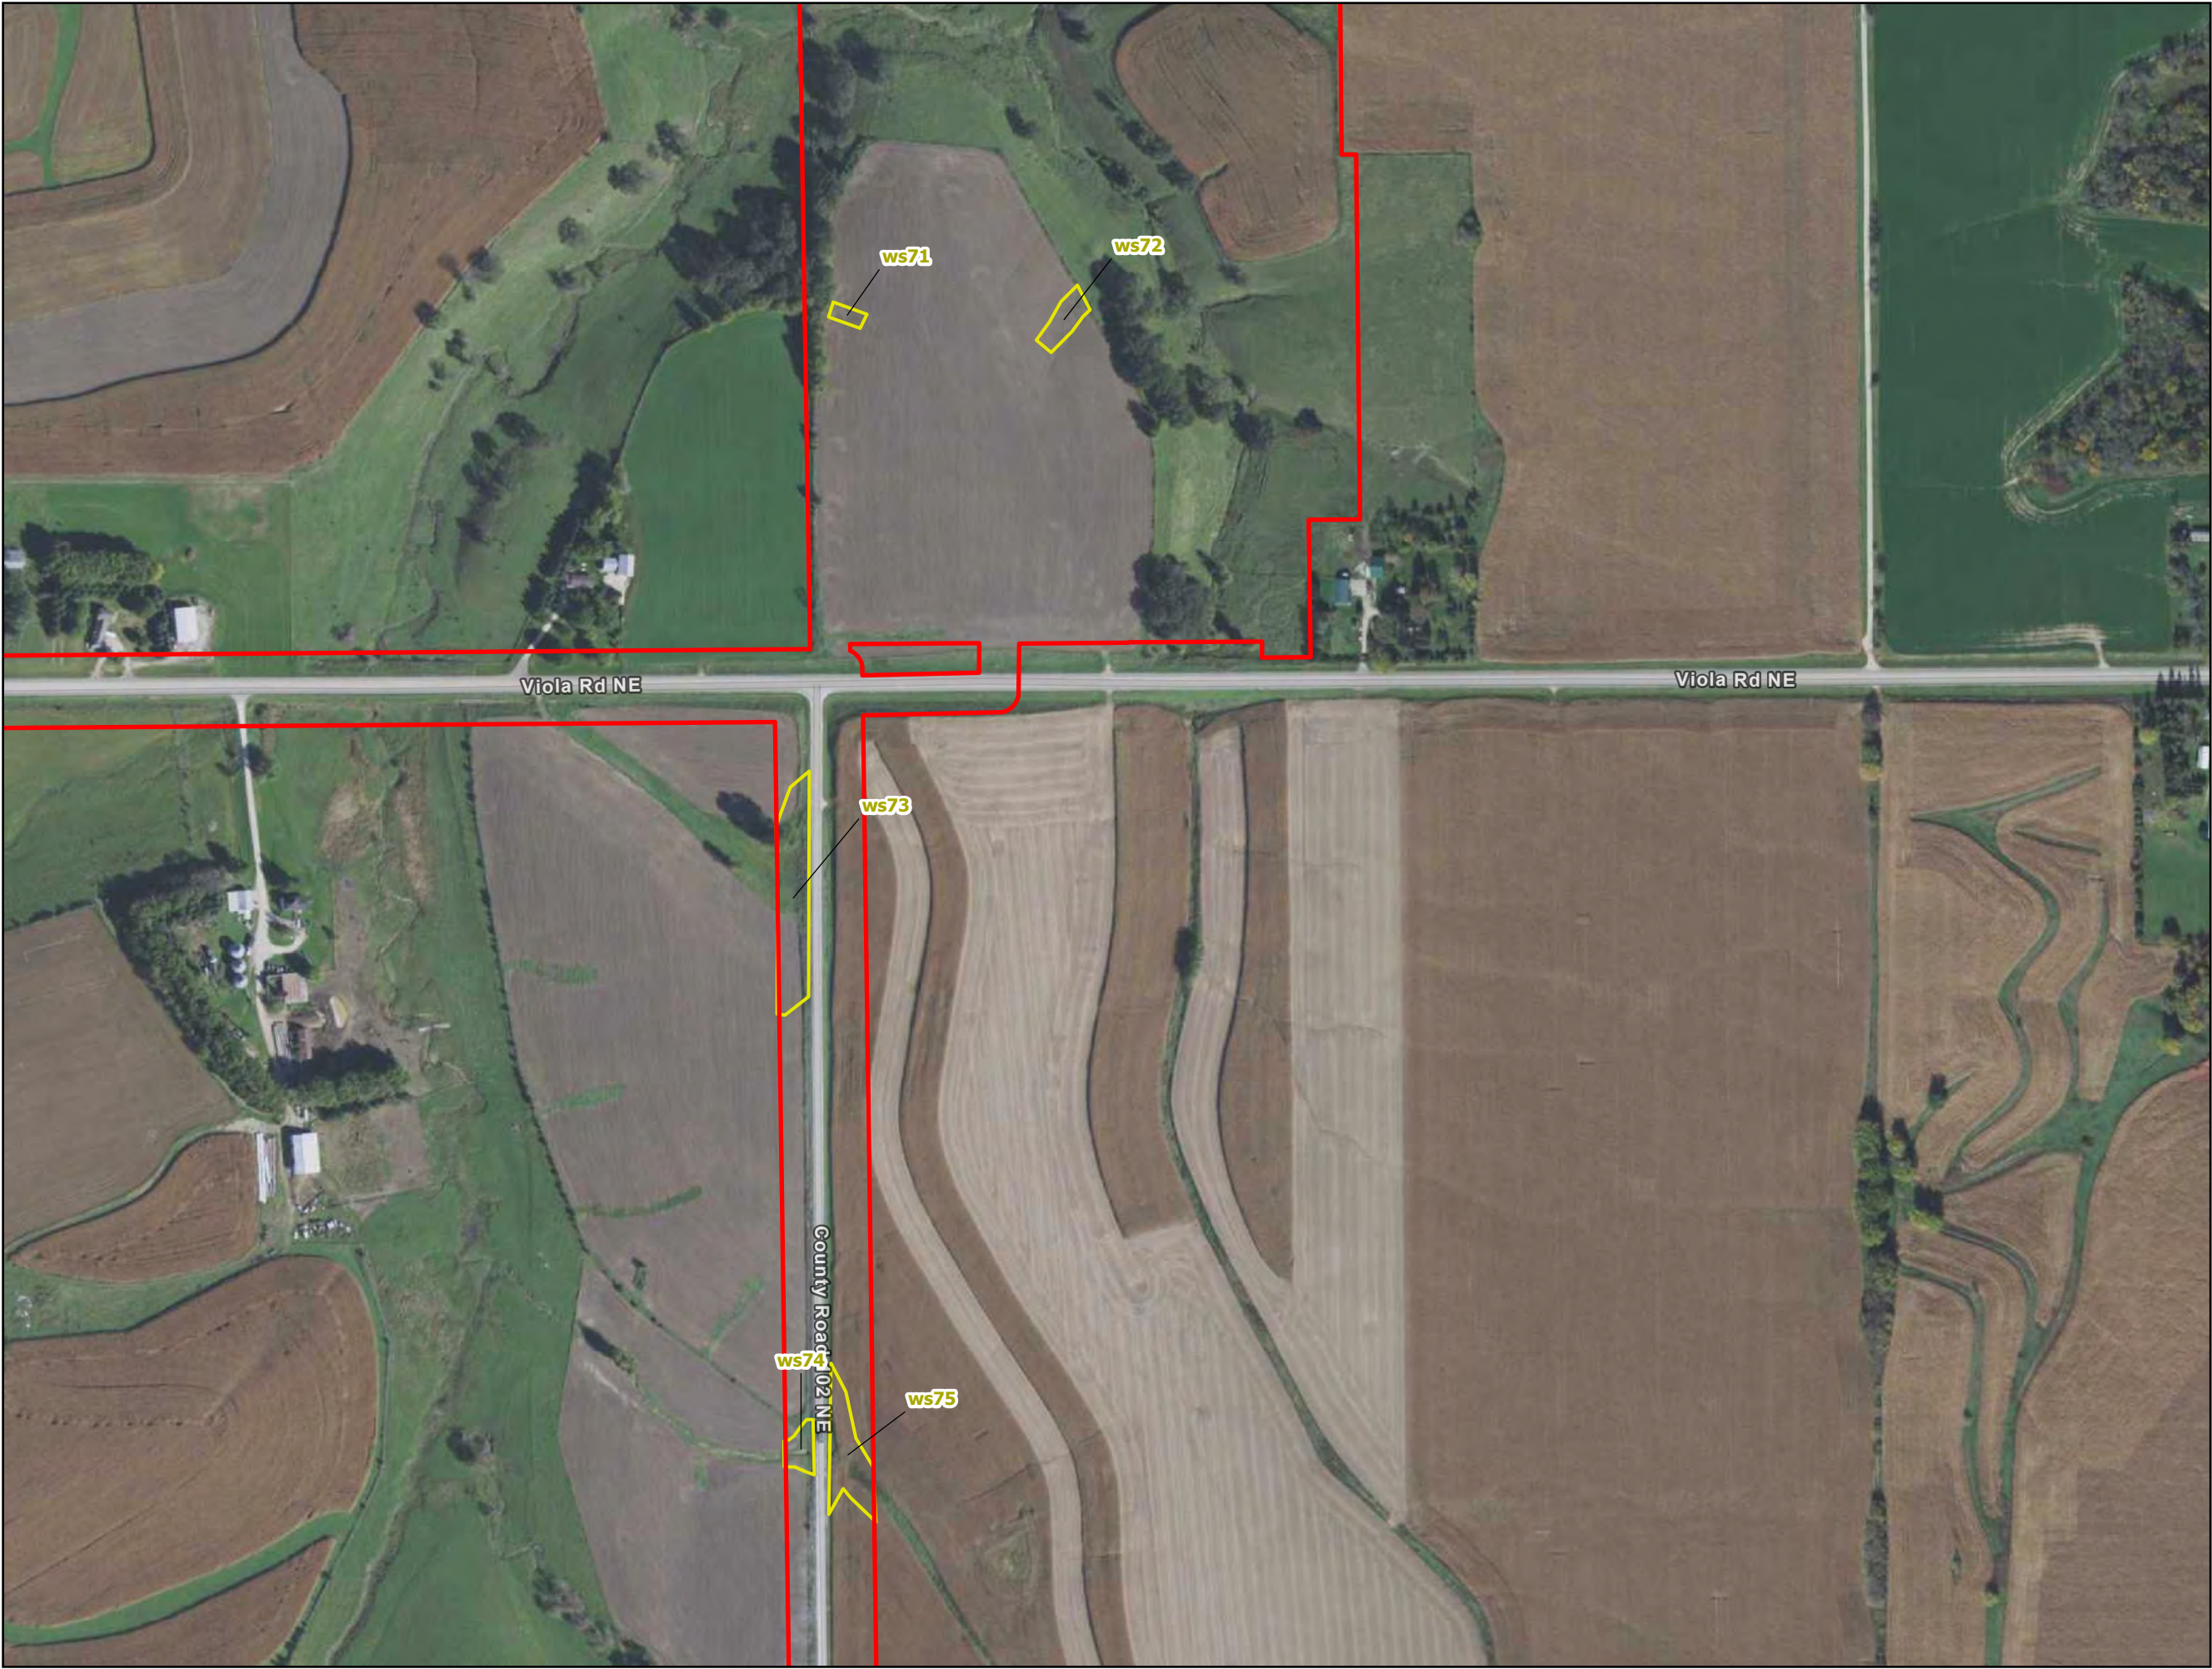
- Survey Area
- Wetness Signature

**FSA Slide Review: NAIP Imagery -
October 2015
Lemon Hill Solar Project
Ranger Power
Olmsted County, MN**

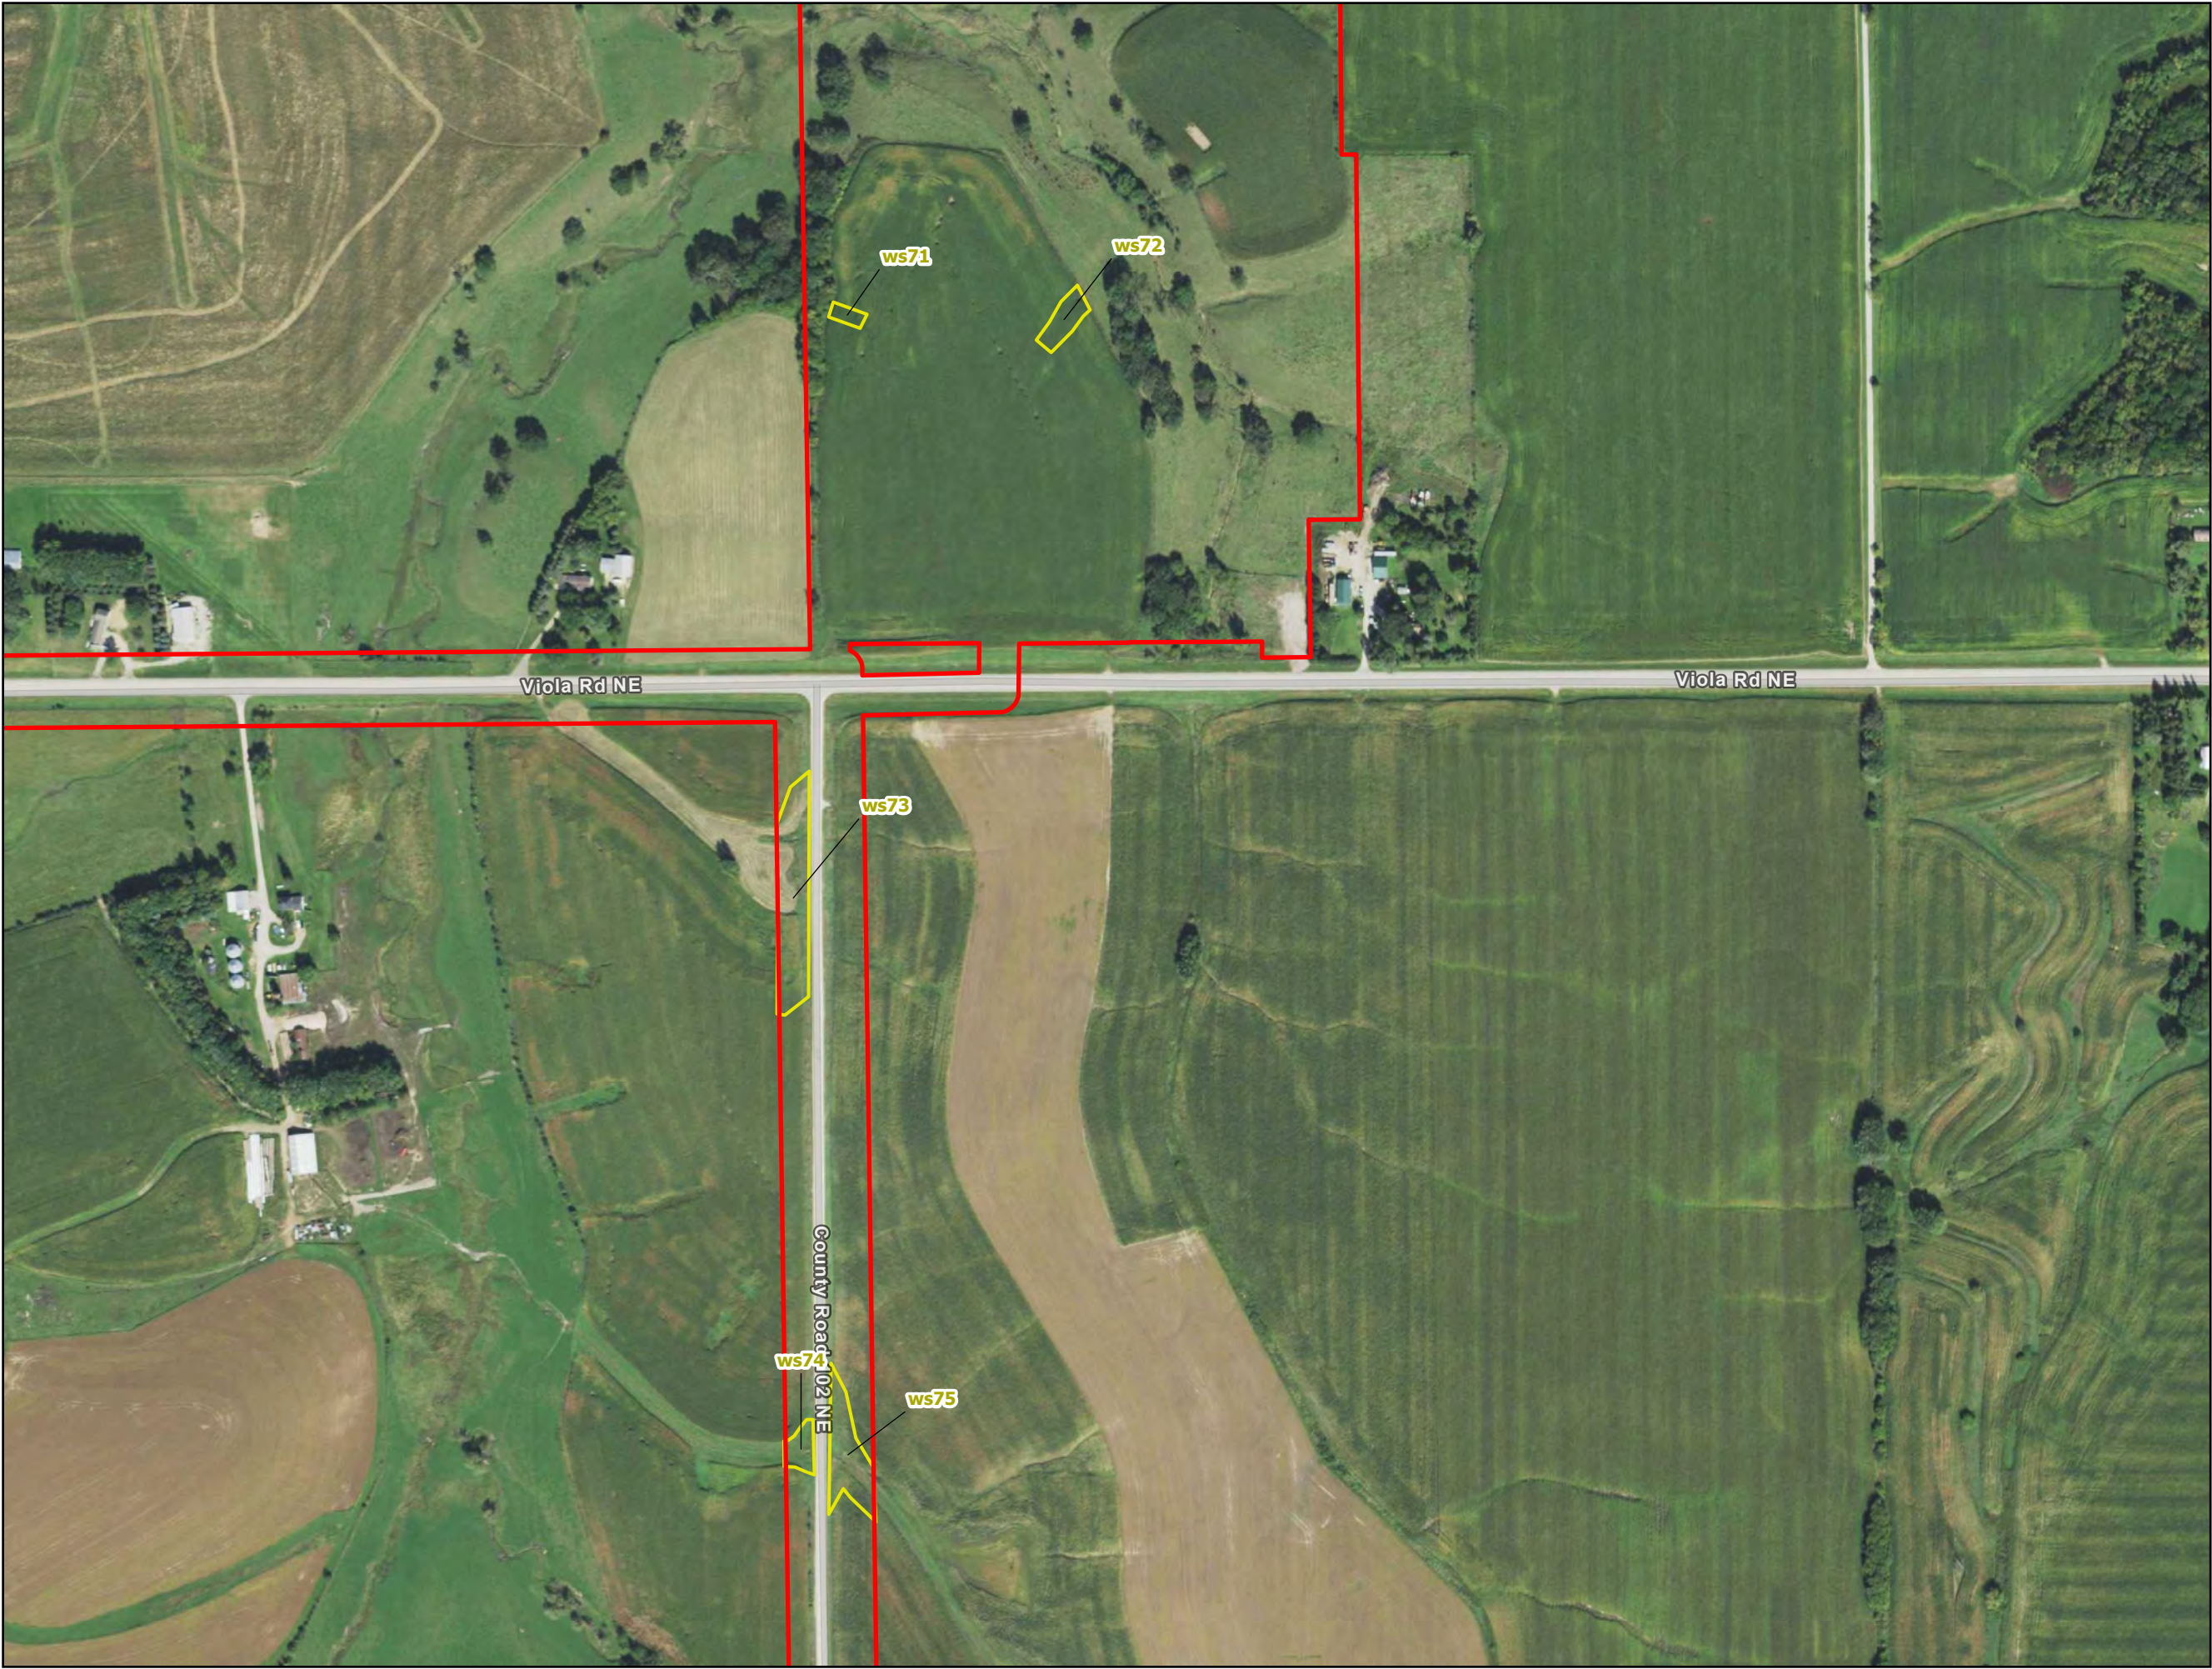
- Survey Area
- Wetness Signature

**FSA Slide Review: NAIP Imagery -
August 2019
Lemon Hill Solar Project
Ranger Power
Olmsted County, MN**

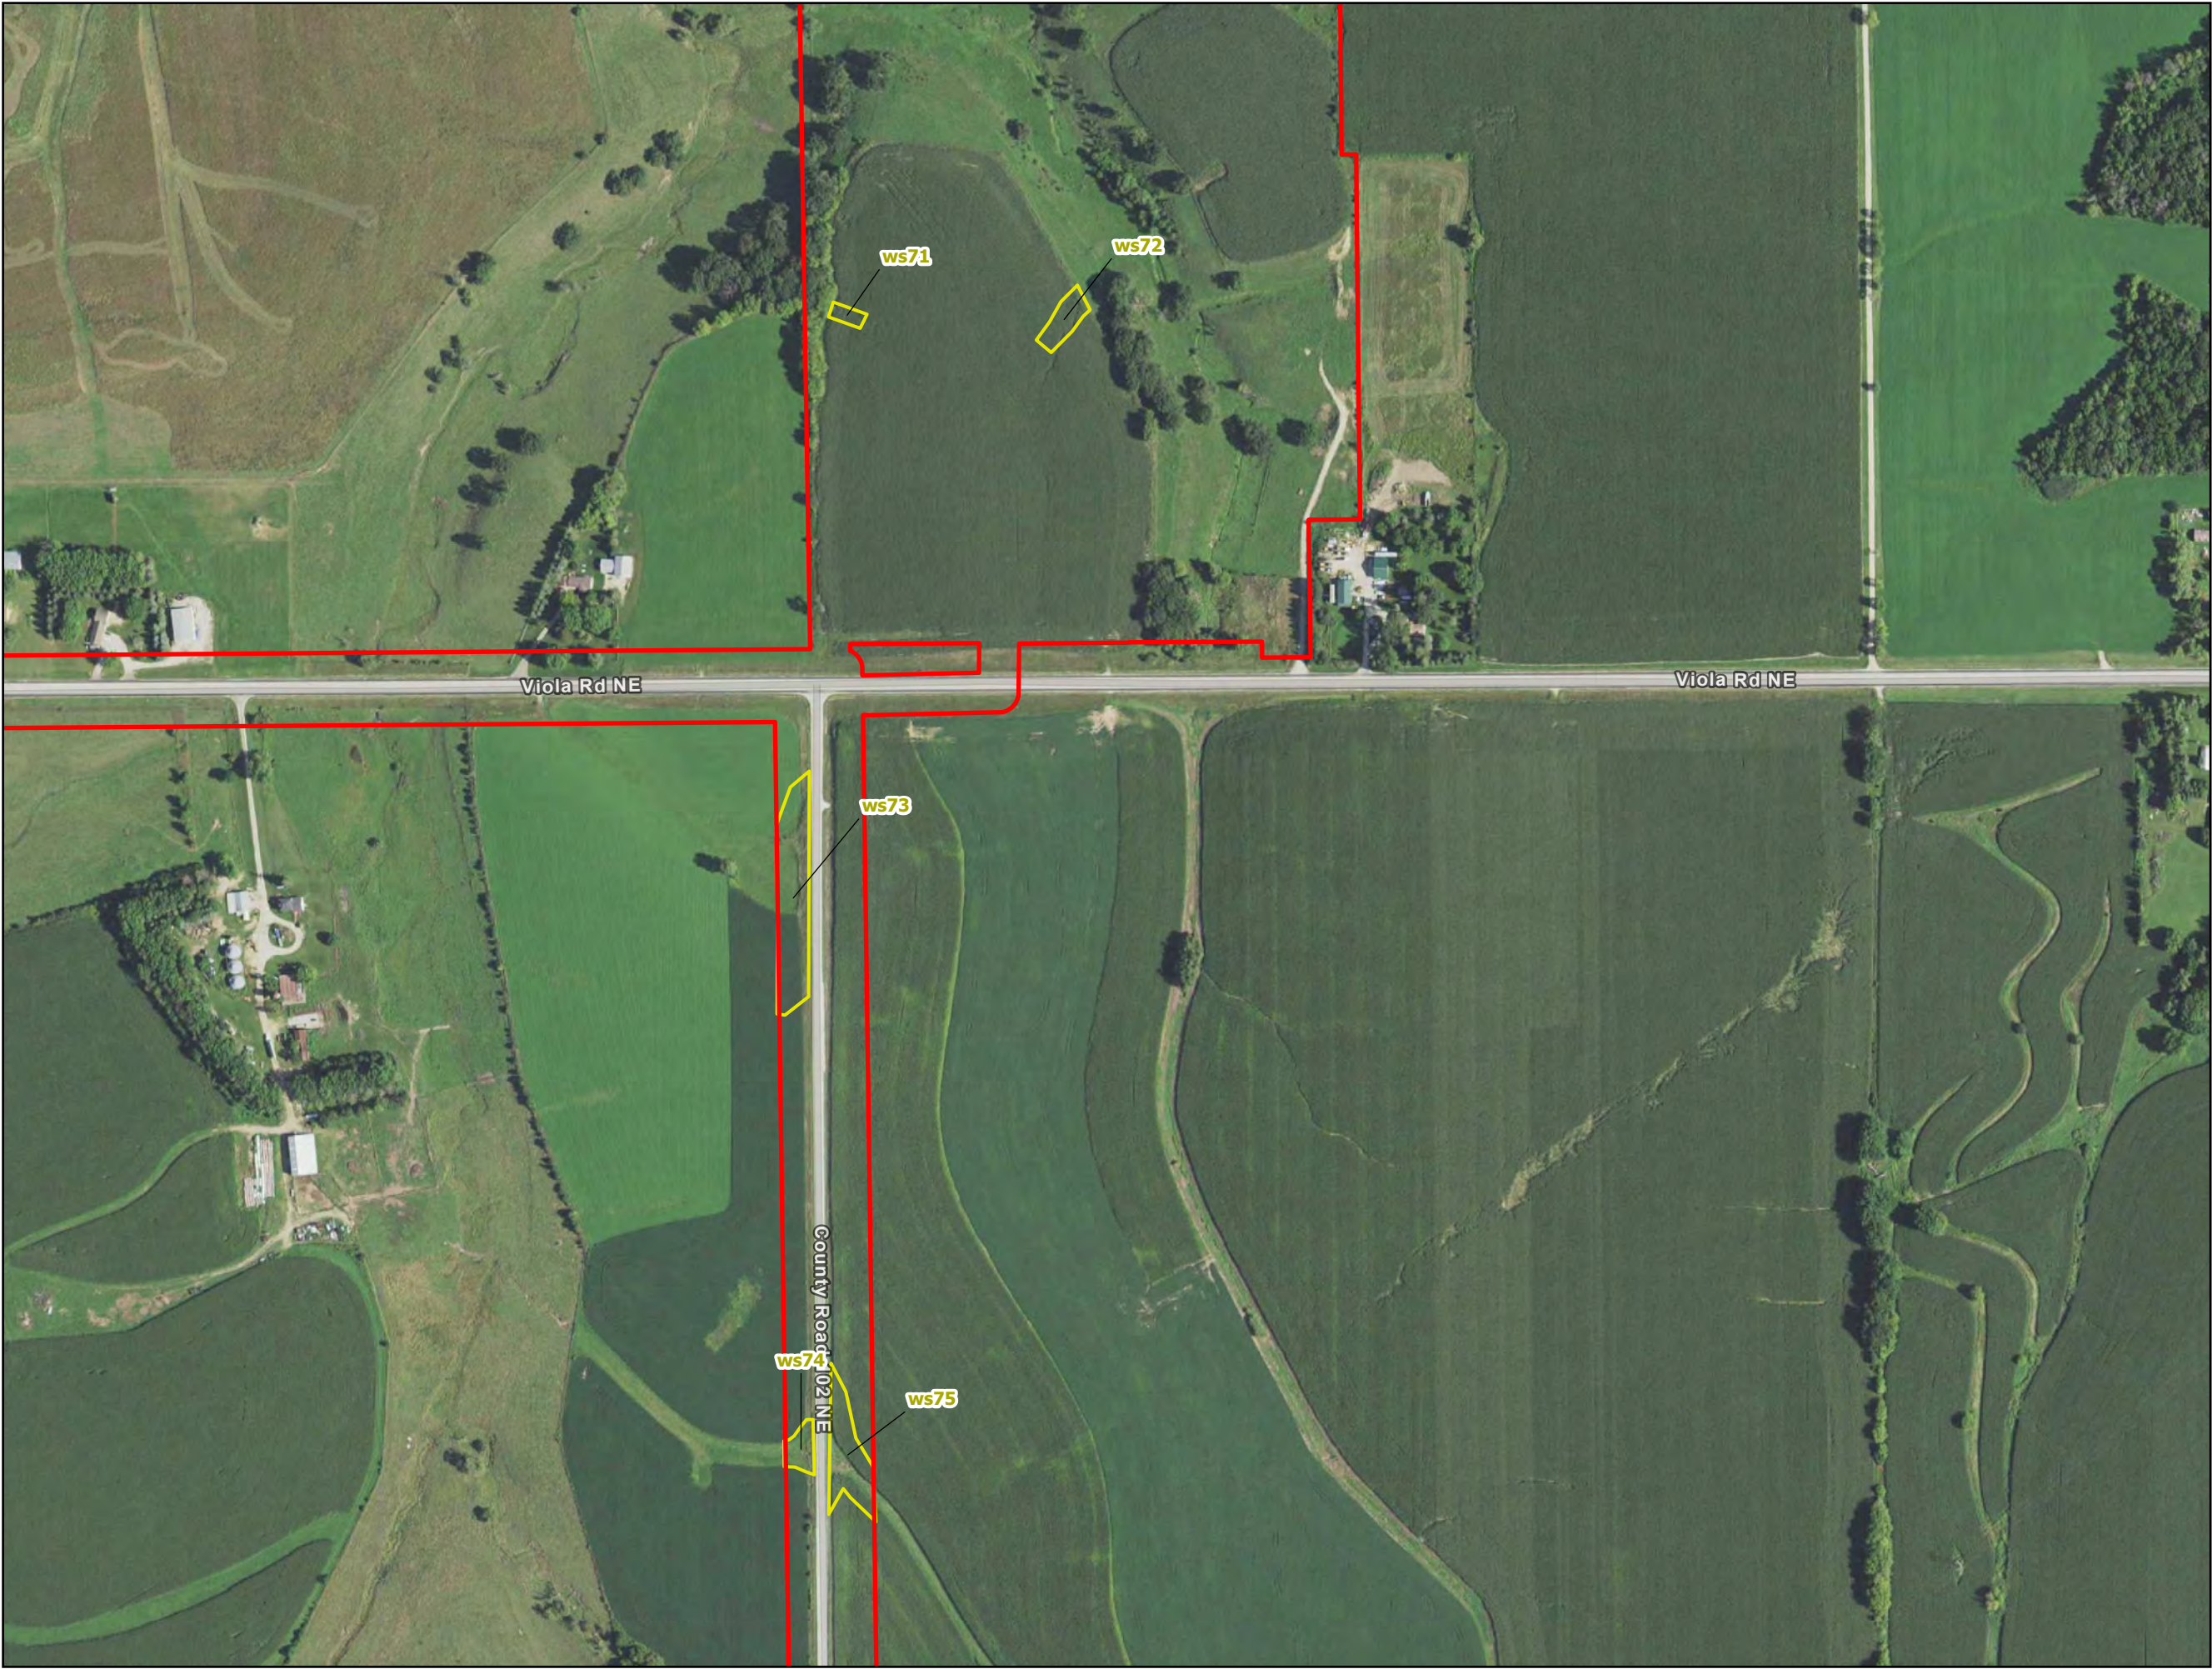
- Survey Area
- Wetness Signature

**FSA Slide Review: NAIP Imagery -
August 2021
Lemon Hill Solar Project
Ranger Power
Olmsted County, MN**

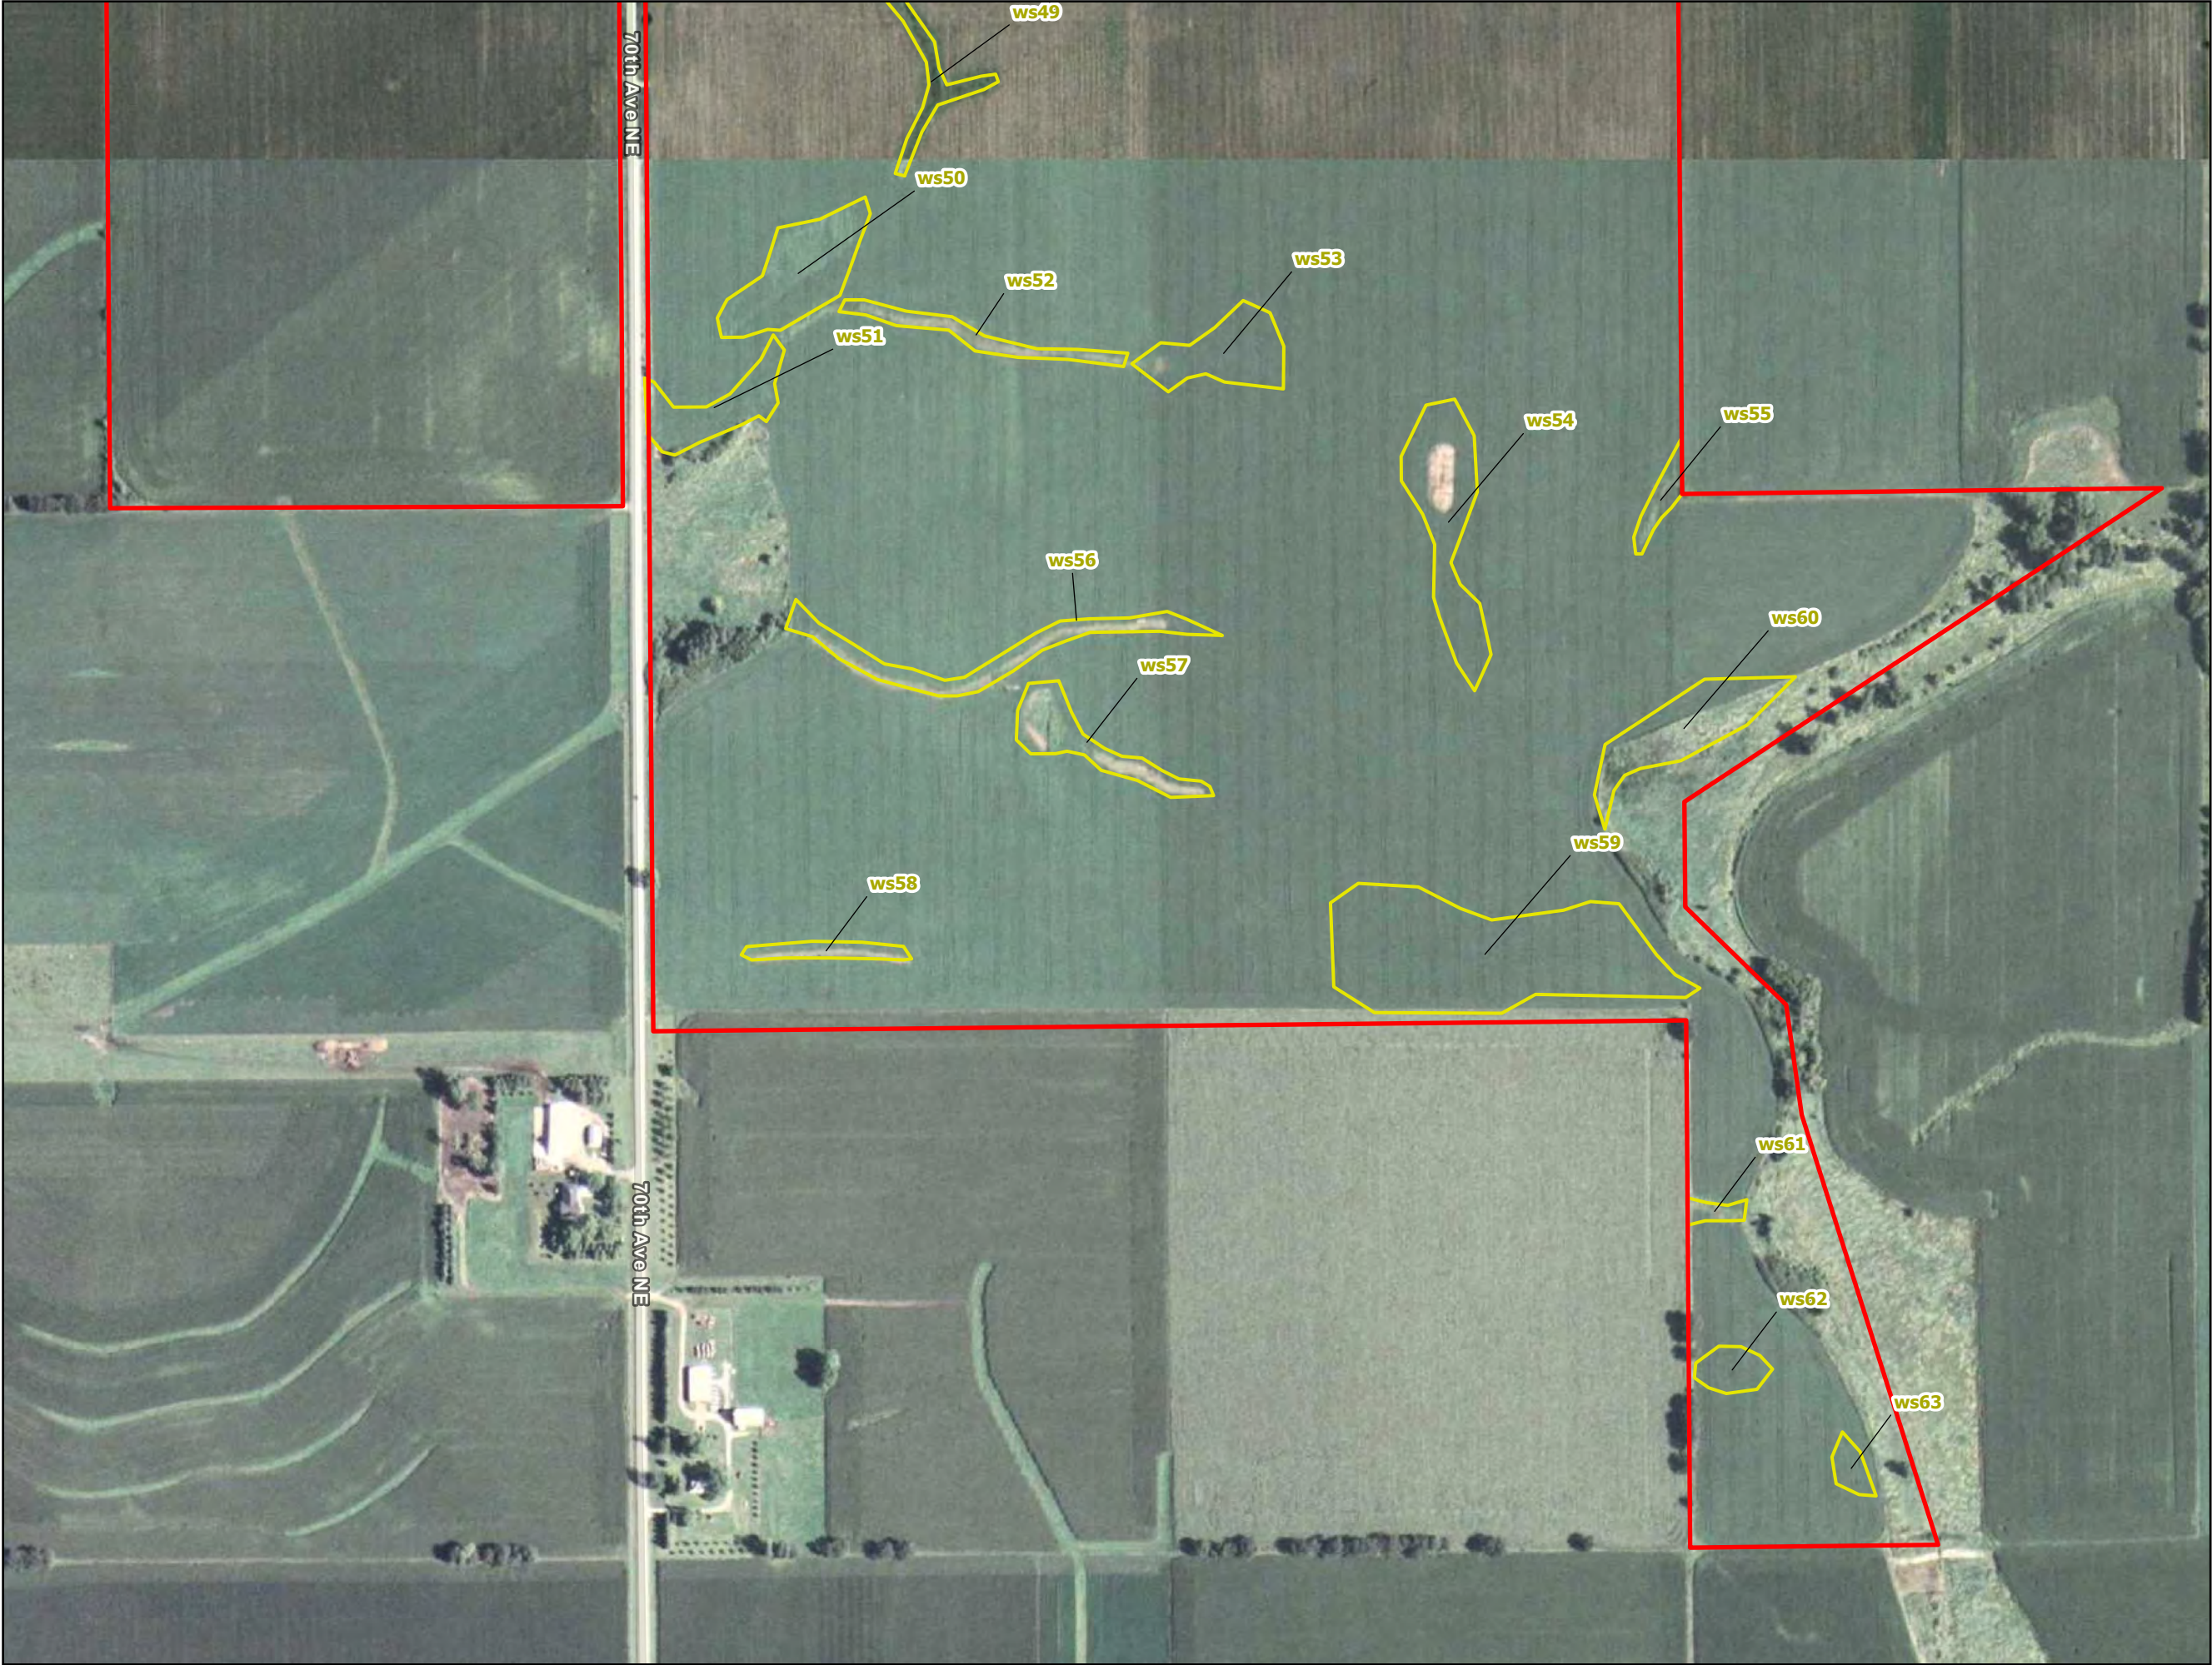
- Survey Area
- Wetness Signature

**FSA Slide Review: NAIP Imagery -
August 2009
Lemon Hill Solar Project
Ranger Power
Olmsted County, MN**
