**FSA Slide Review: NAIP Imagery -
October 2017
Lemon Hill Solar Project
Ranger Power
Olmsted County, MN**

Exhibit 1Field data sheet reference (if applicable): See attached crosswalk table**Wetland Hydrology from Aerial Imagery – Recording Form**

Project Name: Lemon Hill Solar Project

Date: 5/20/24 County: OlmstedInvestigator: Kyle Hanson Legal Description (T, R, S): T107N, R13W, S12**Summary Table**

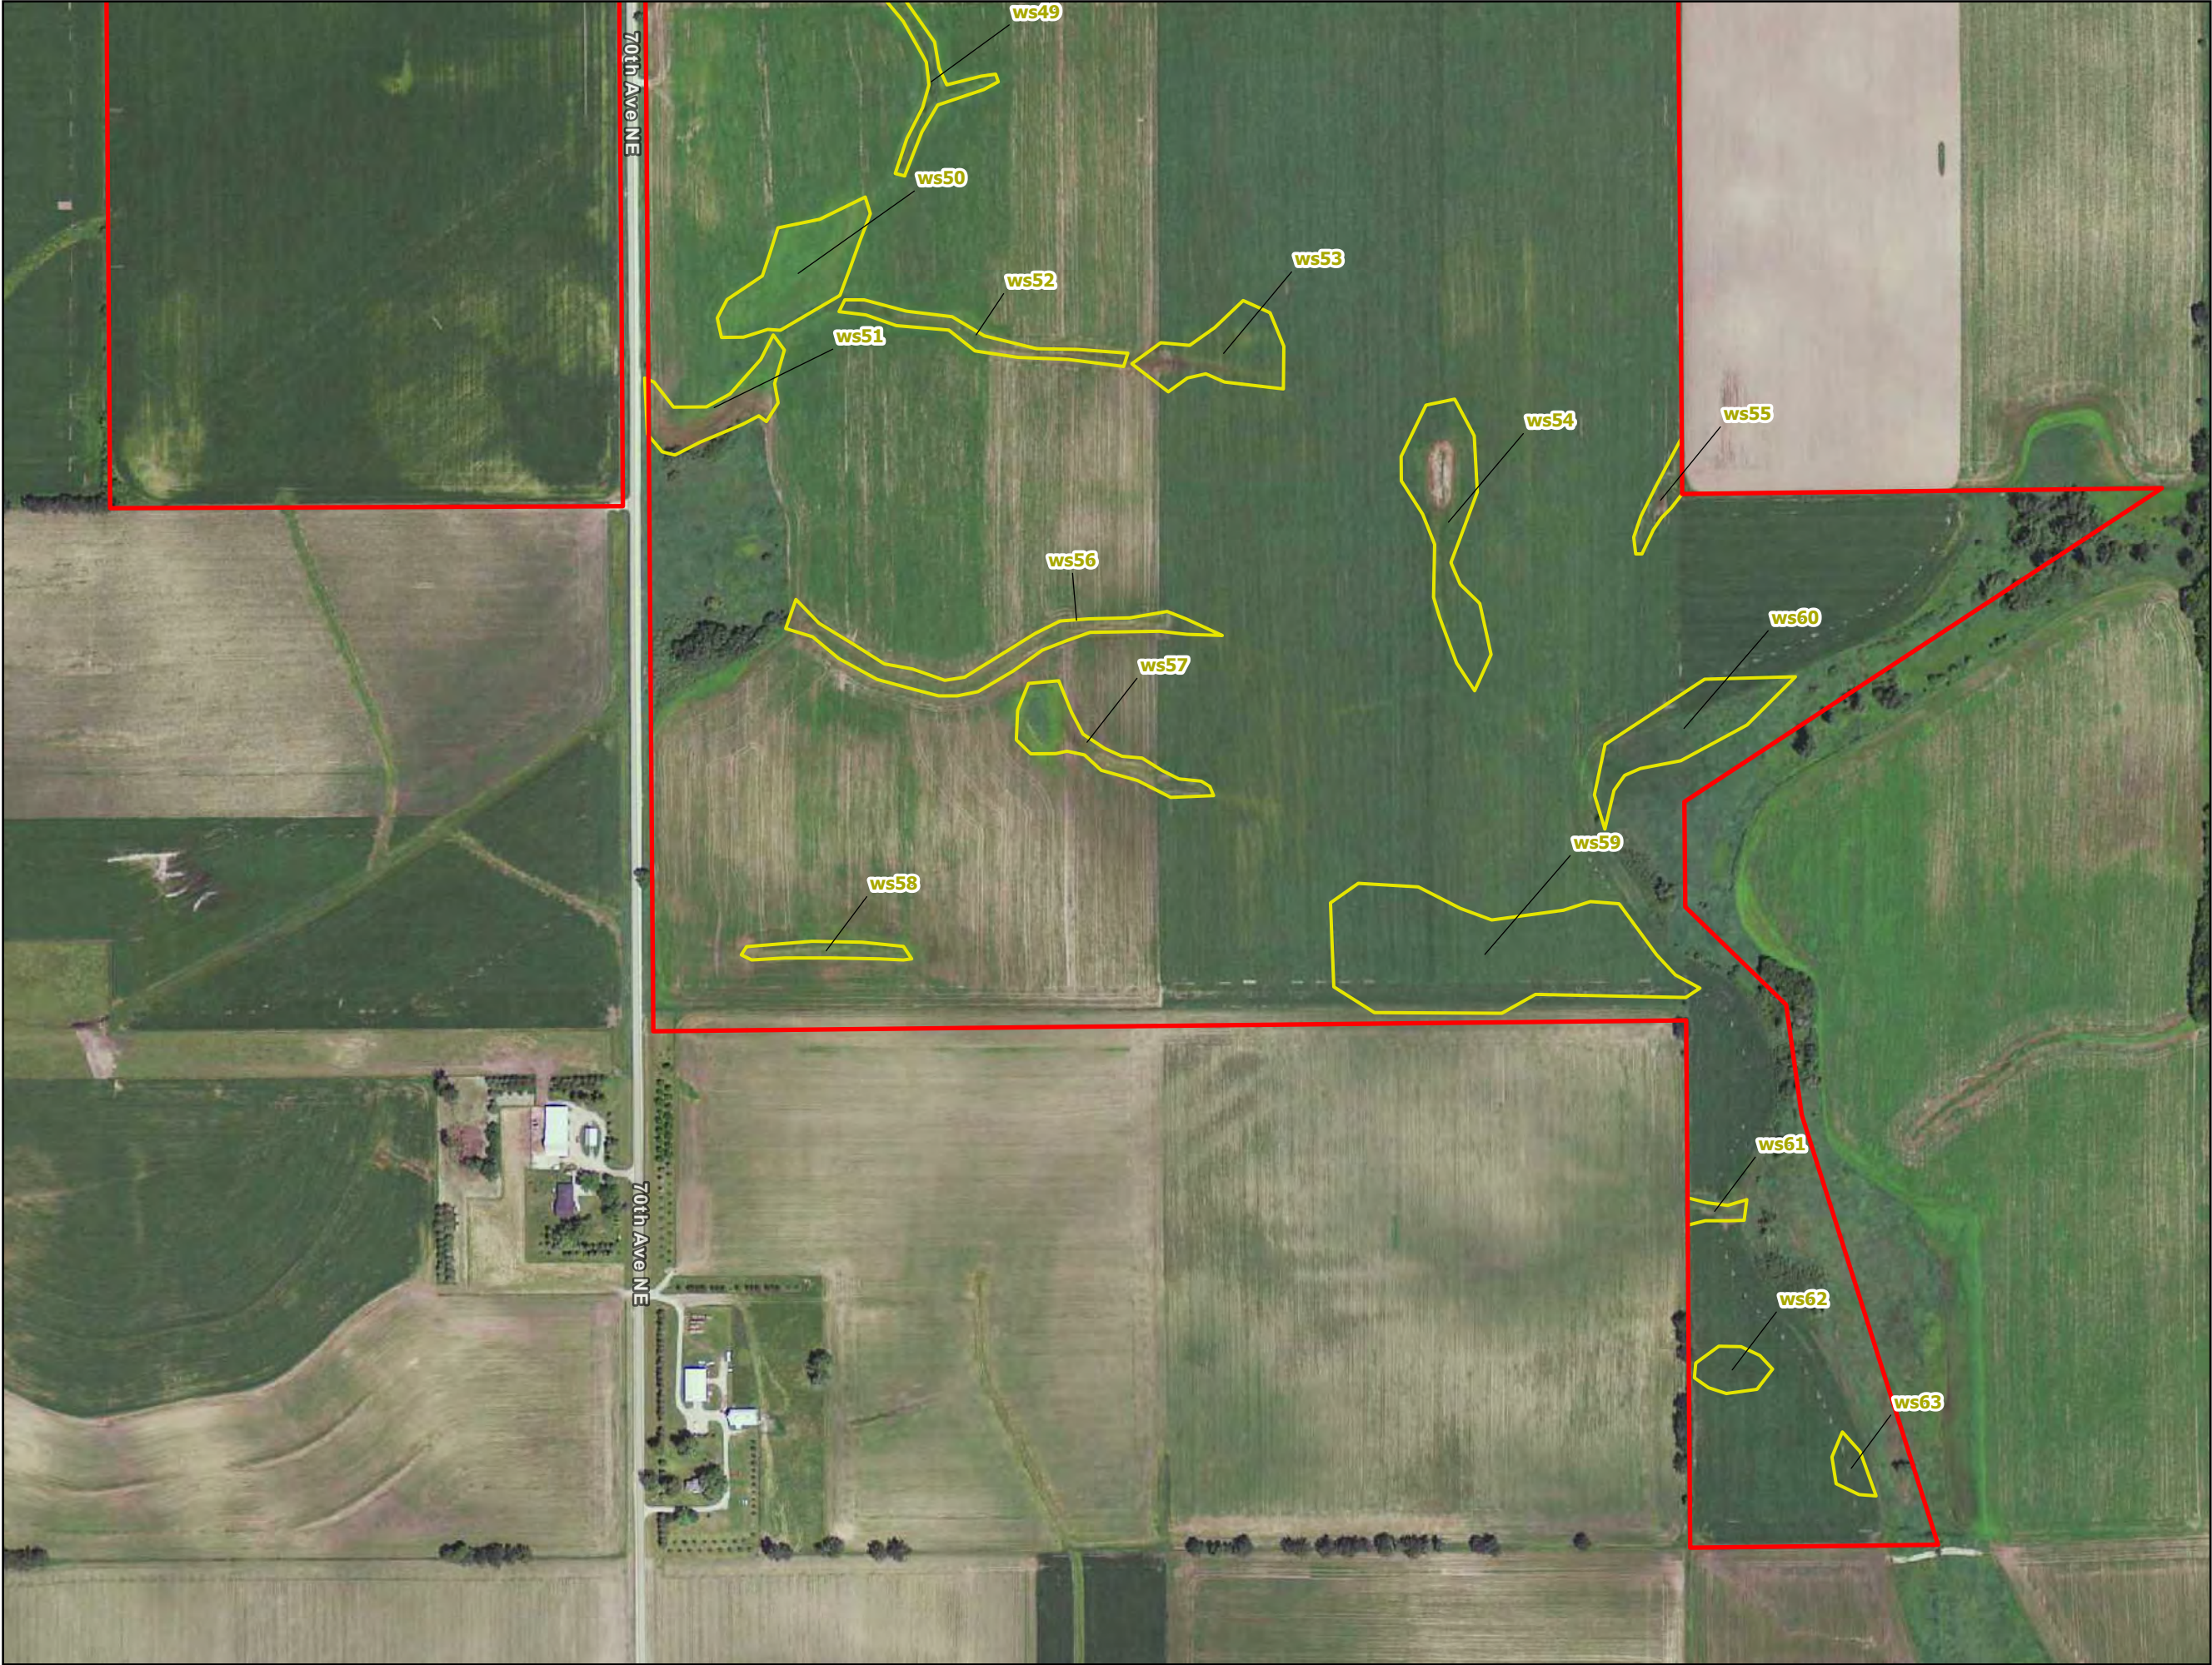
- Survey Area
- Wetness Signature

**FSA Slide Review: NAIP Imagery -
July 2010
Lemon Hill Solar Project
Ranger Power
Olmsted County, MN**

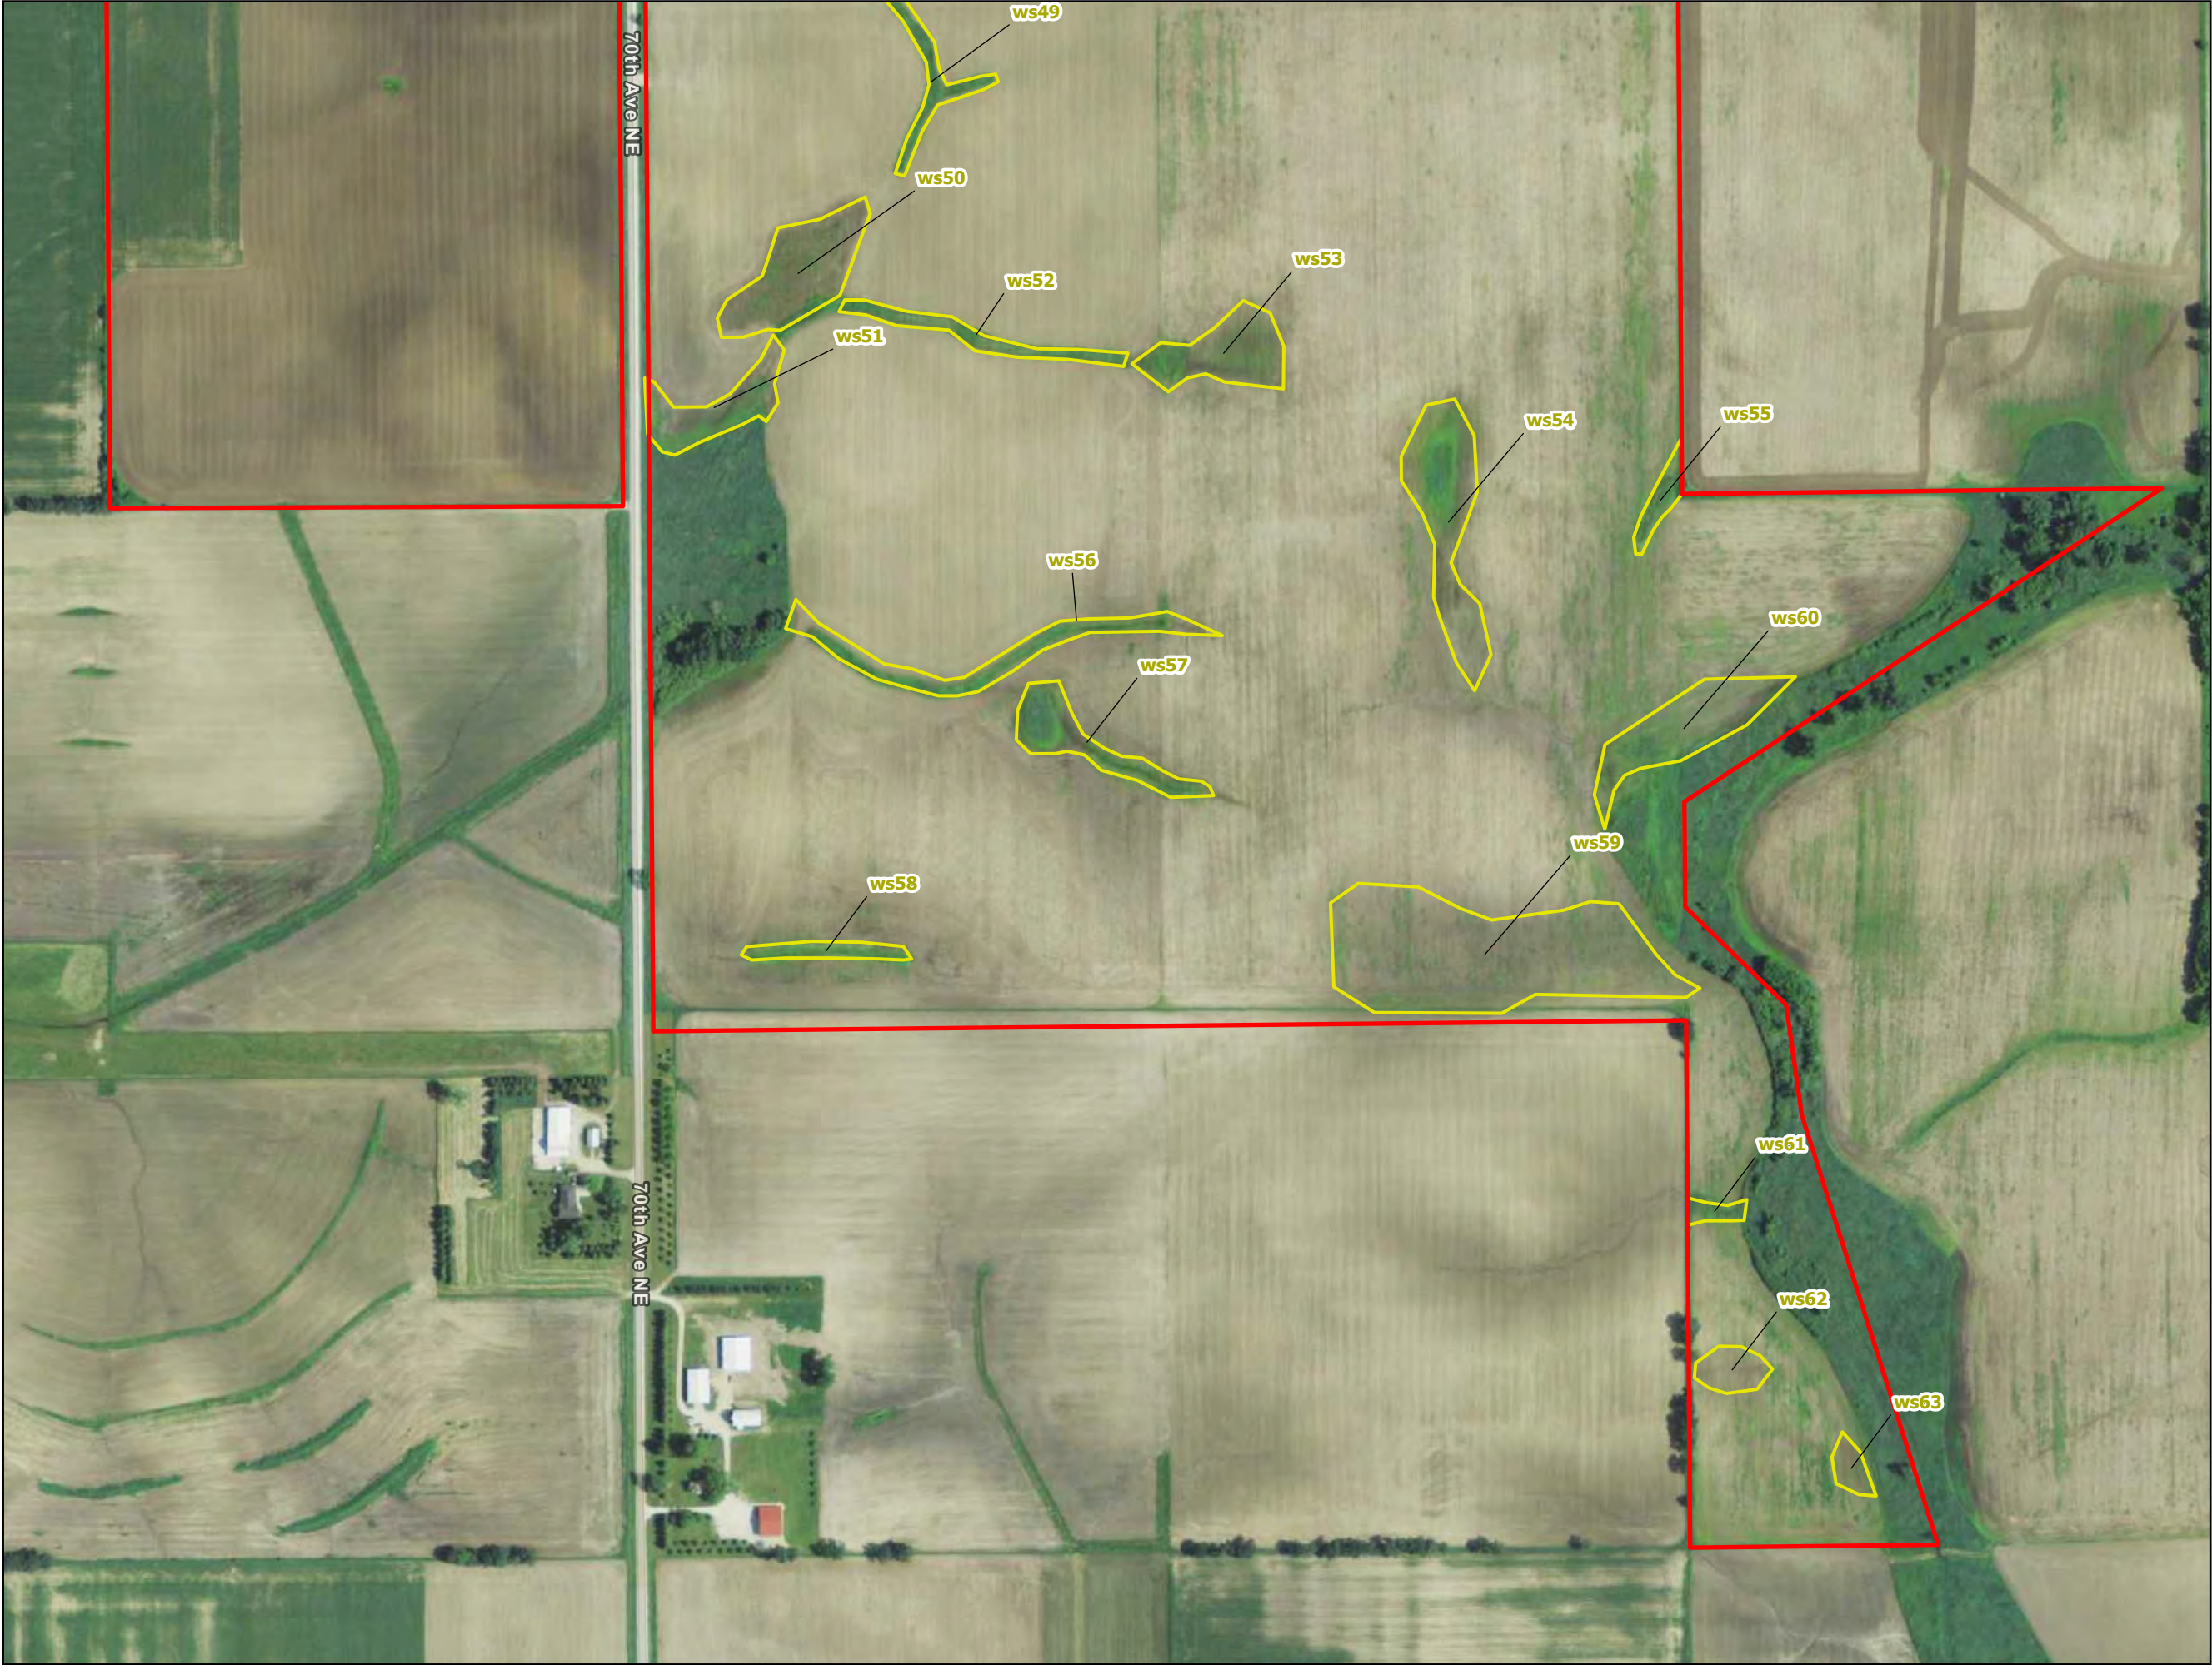
- Survey Area
- Wetness Signature

**FSA Slide Review: NAIP Imagery -
July 2013
Lemon Hill Solar Project
Ranger Power
Olmsted County, MN**

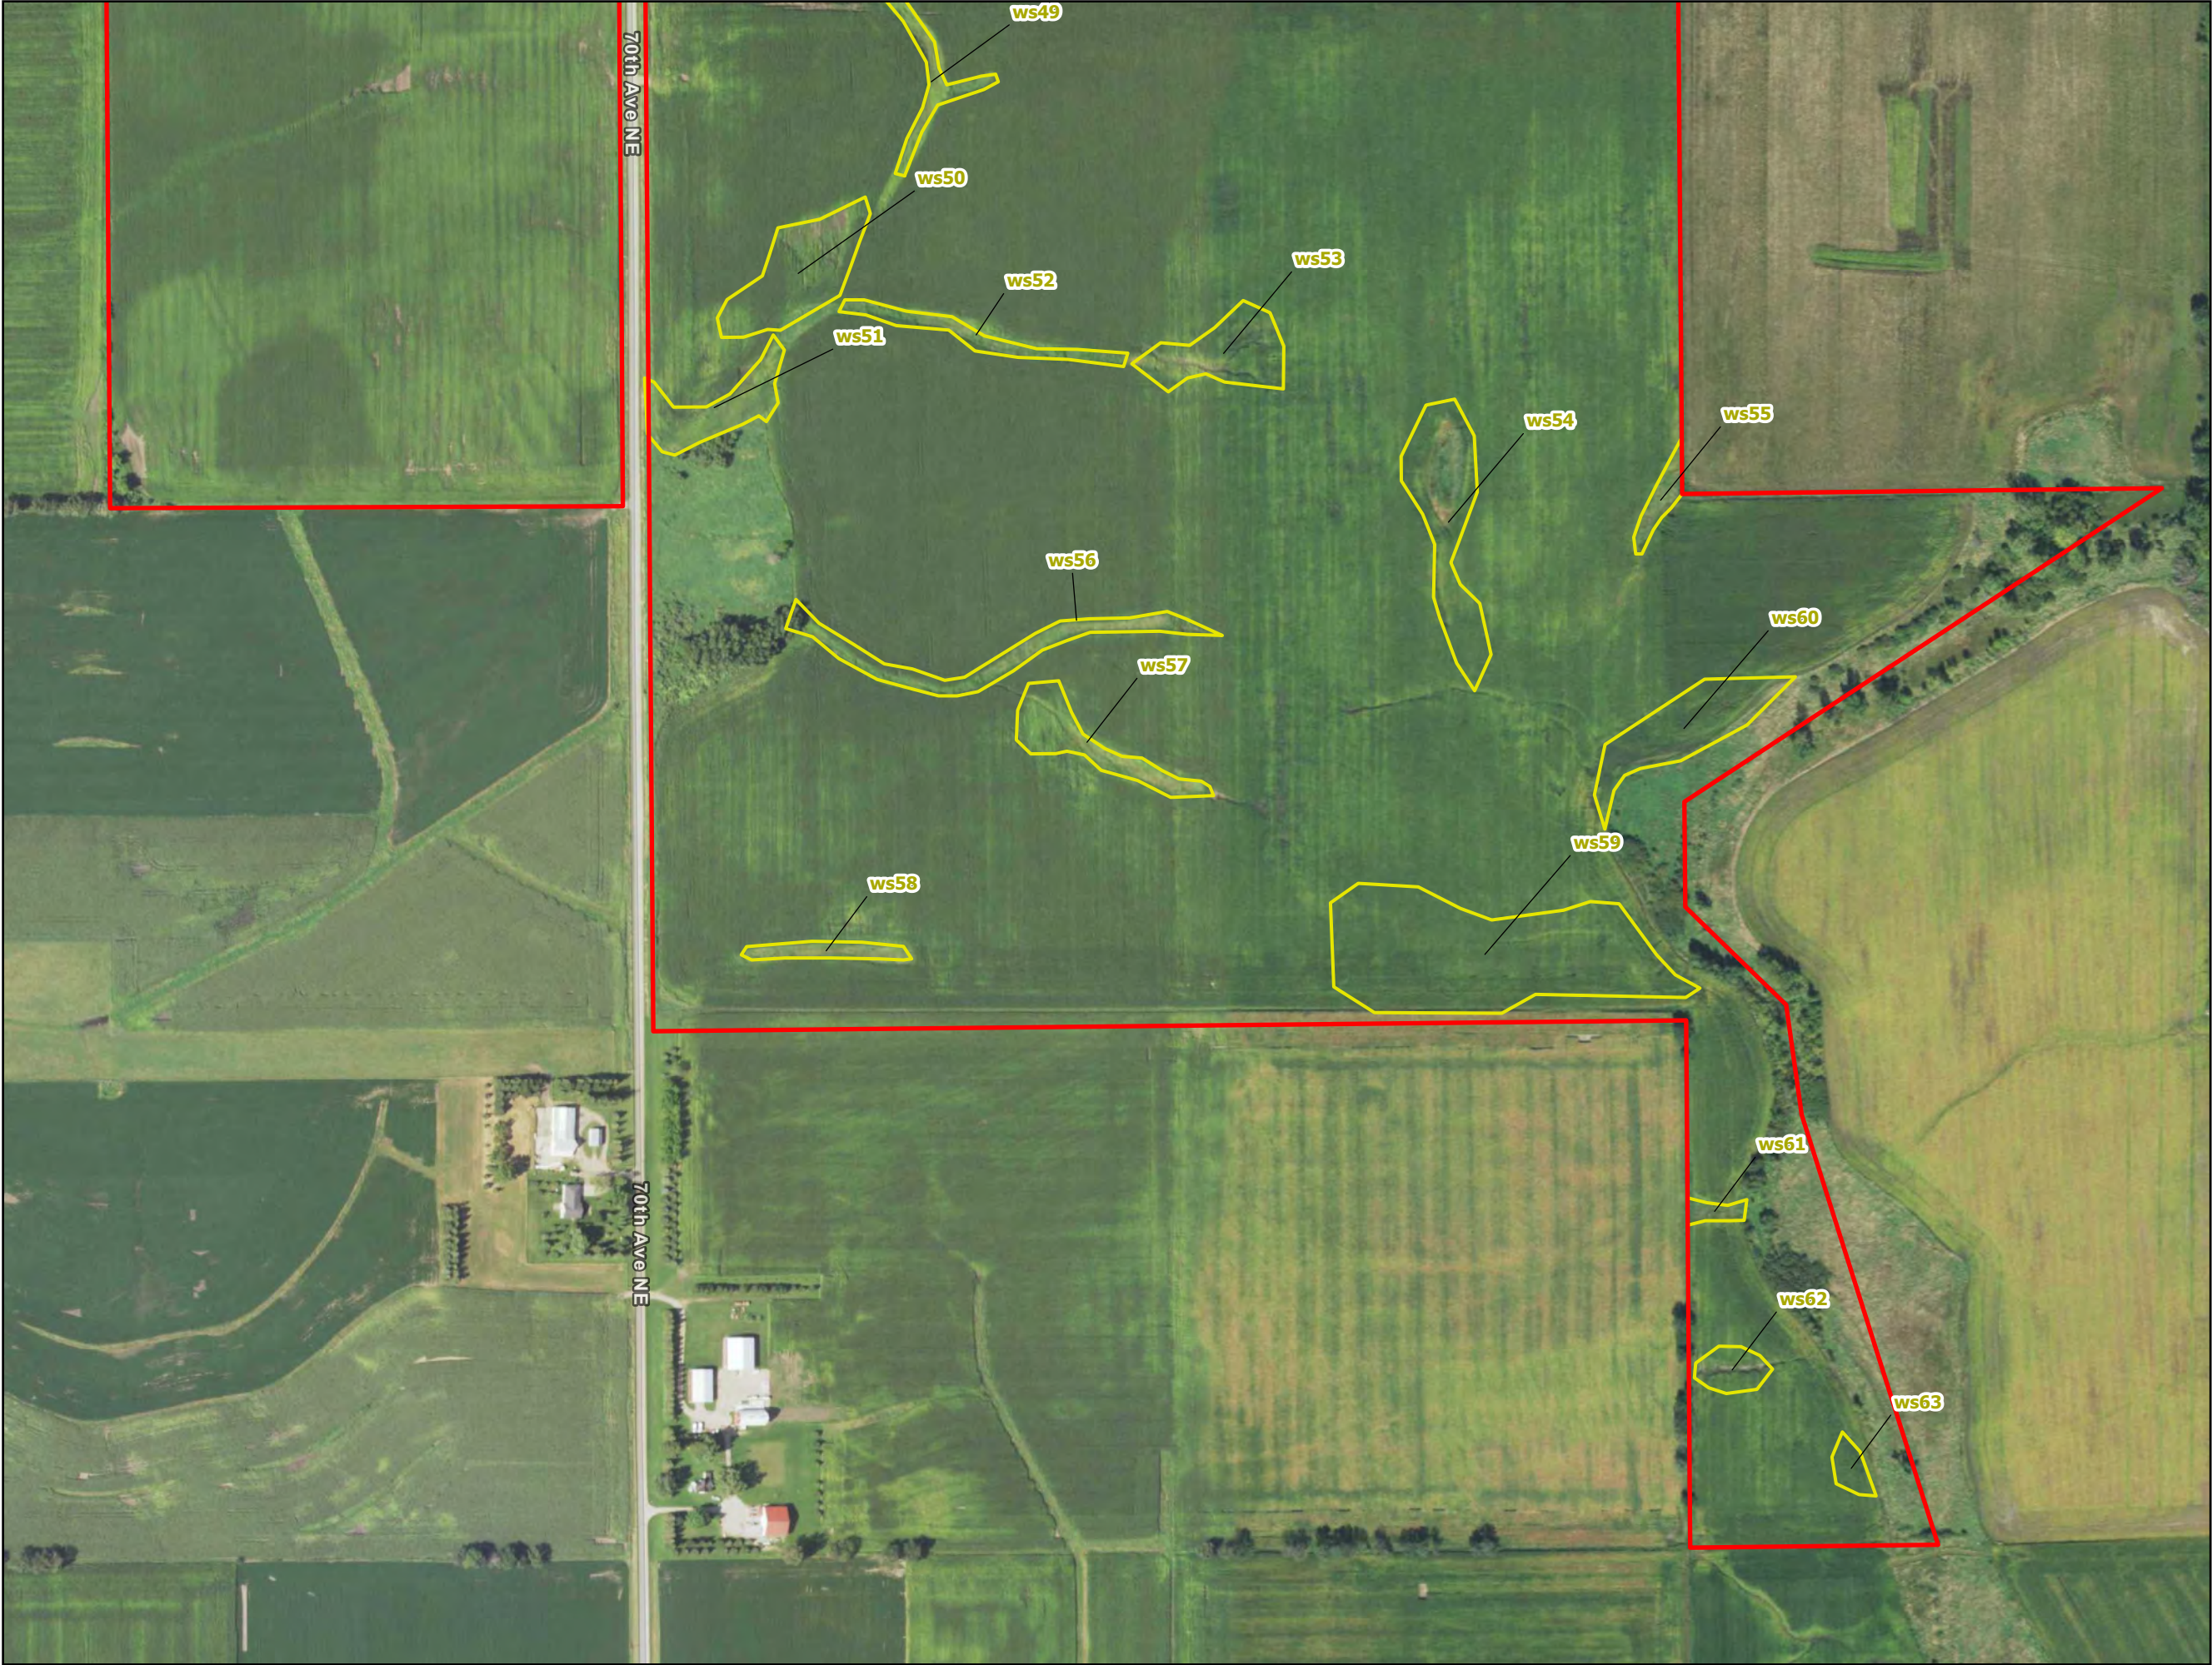
- Survey Area
- Wetness Signature

**FSA Slide Review: NAIP Imagery -
August 2019
Lemon Hill Solar Project
Ranger Power
Olmsted County, MN**

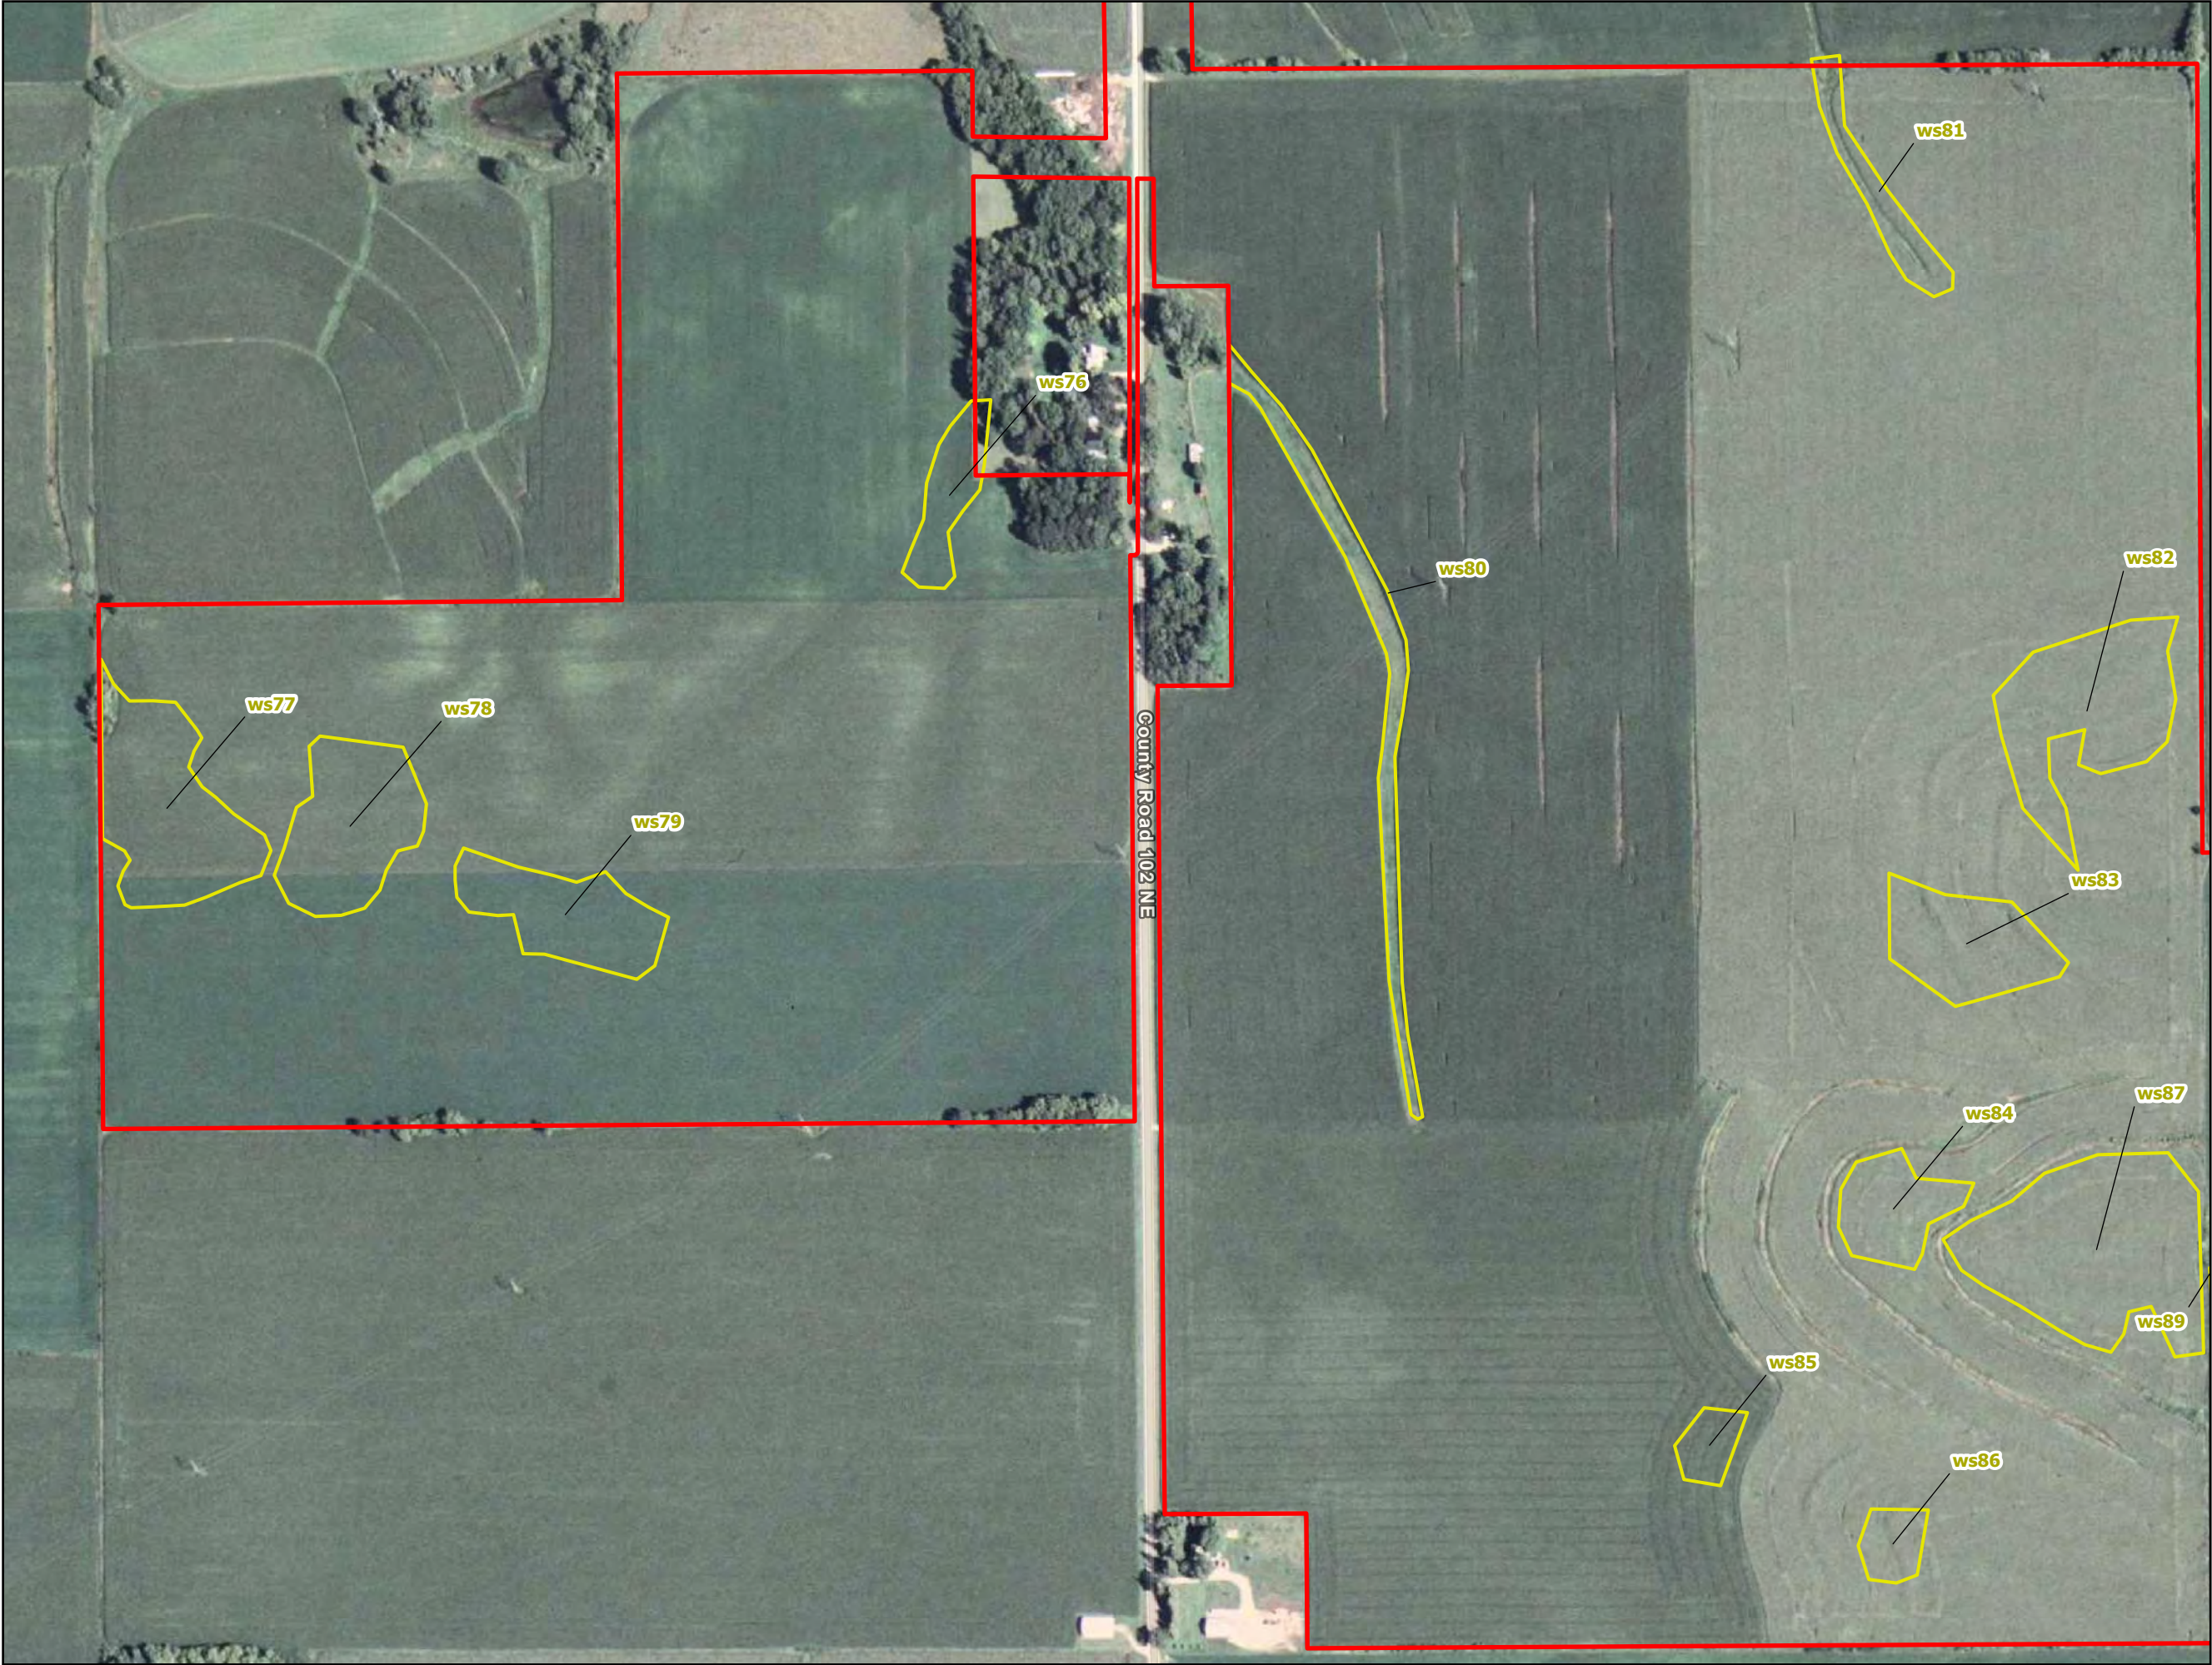
- Survey Area
- Wetness Signature

**FSA Slide Review: NAIP Imagery -
August 2009
Lemon Hill Solar Project
Ranger Power
Olmsted County, MN**

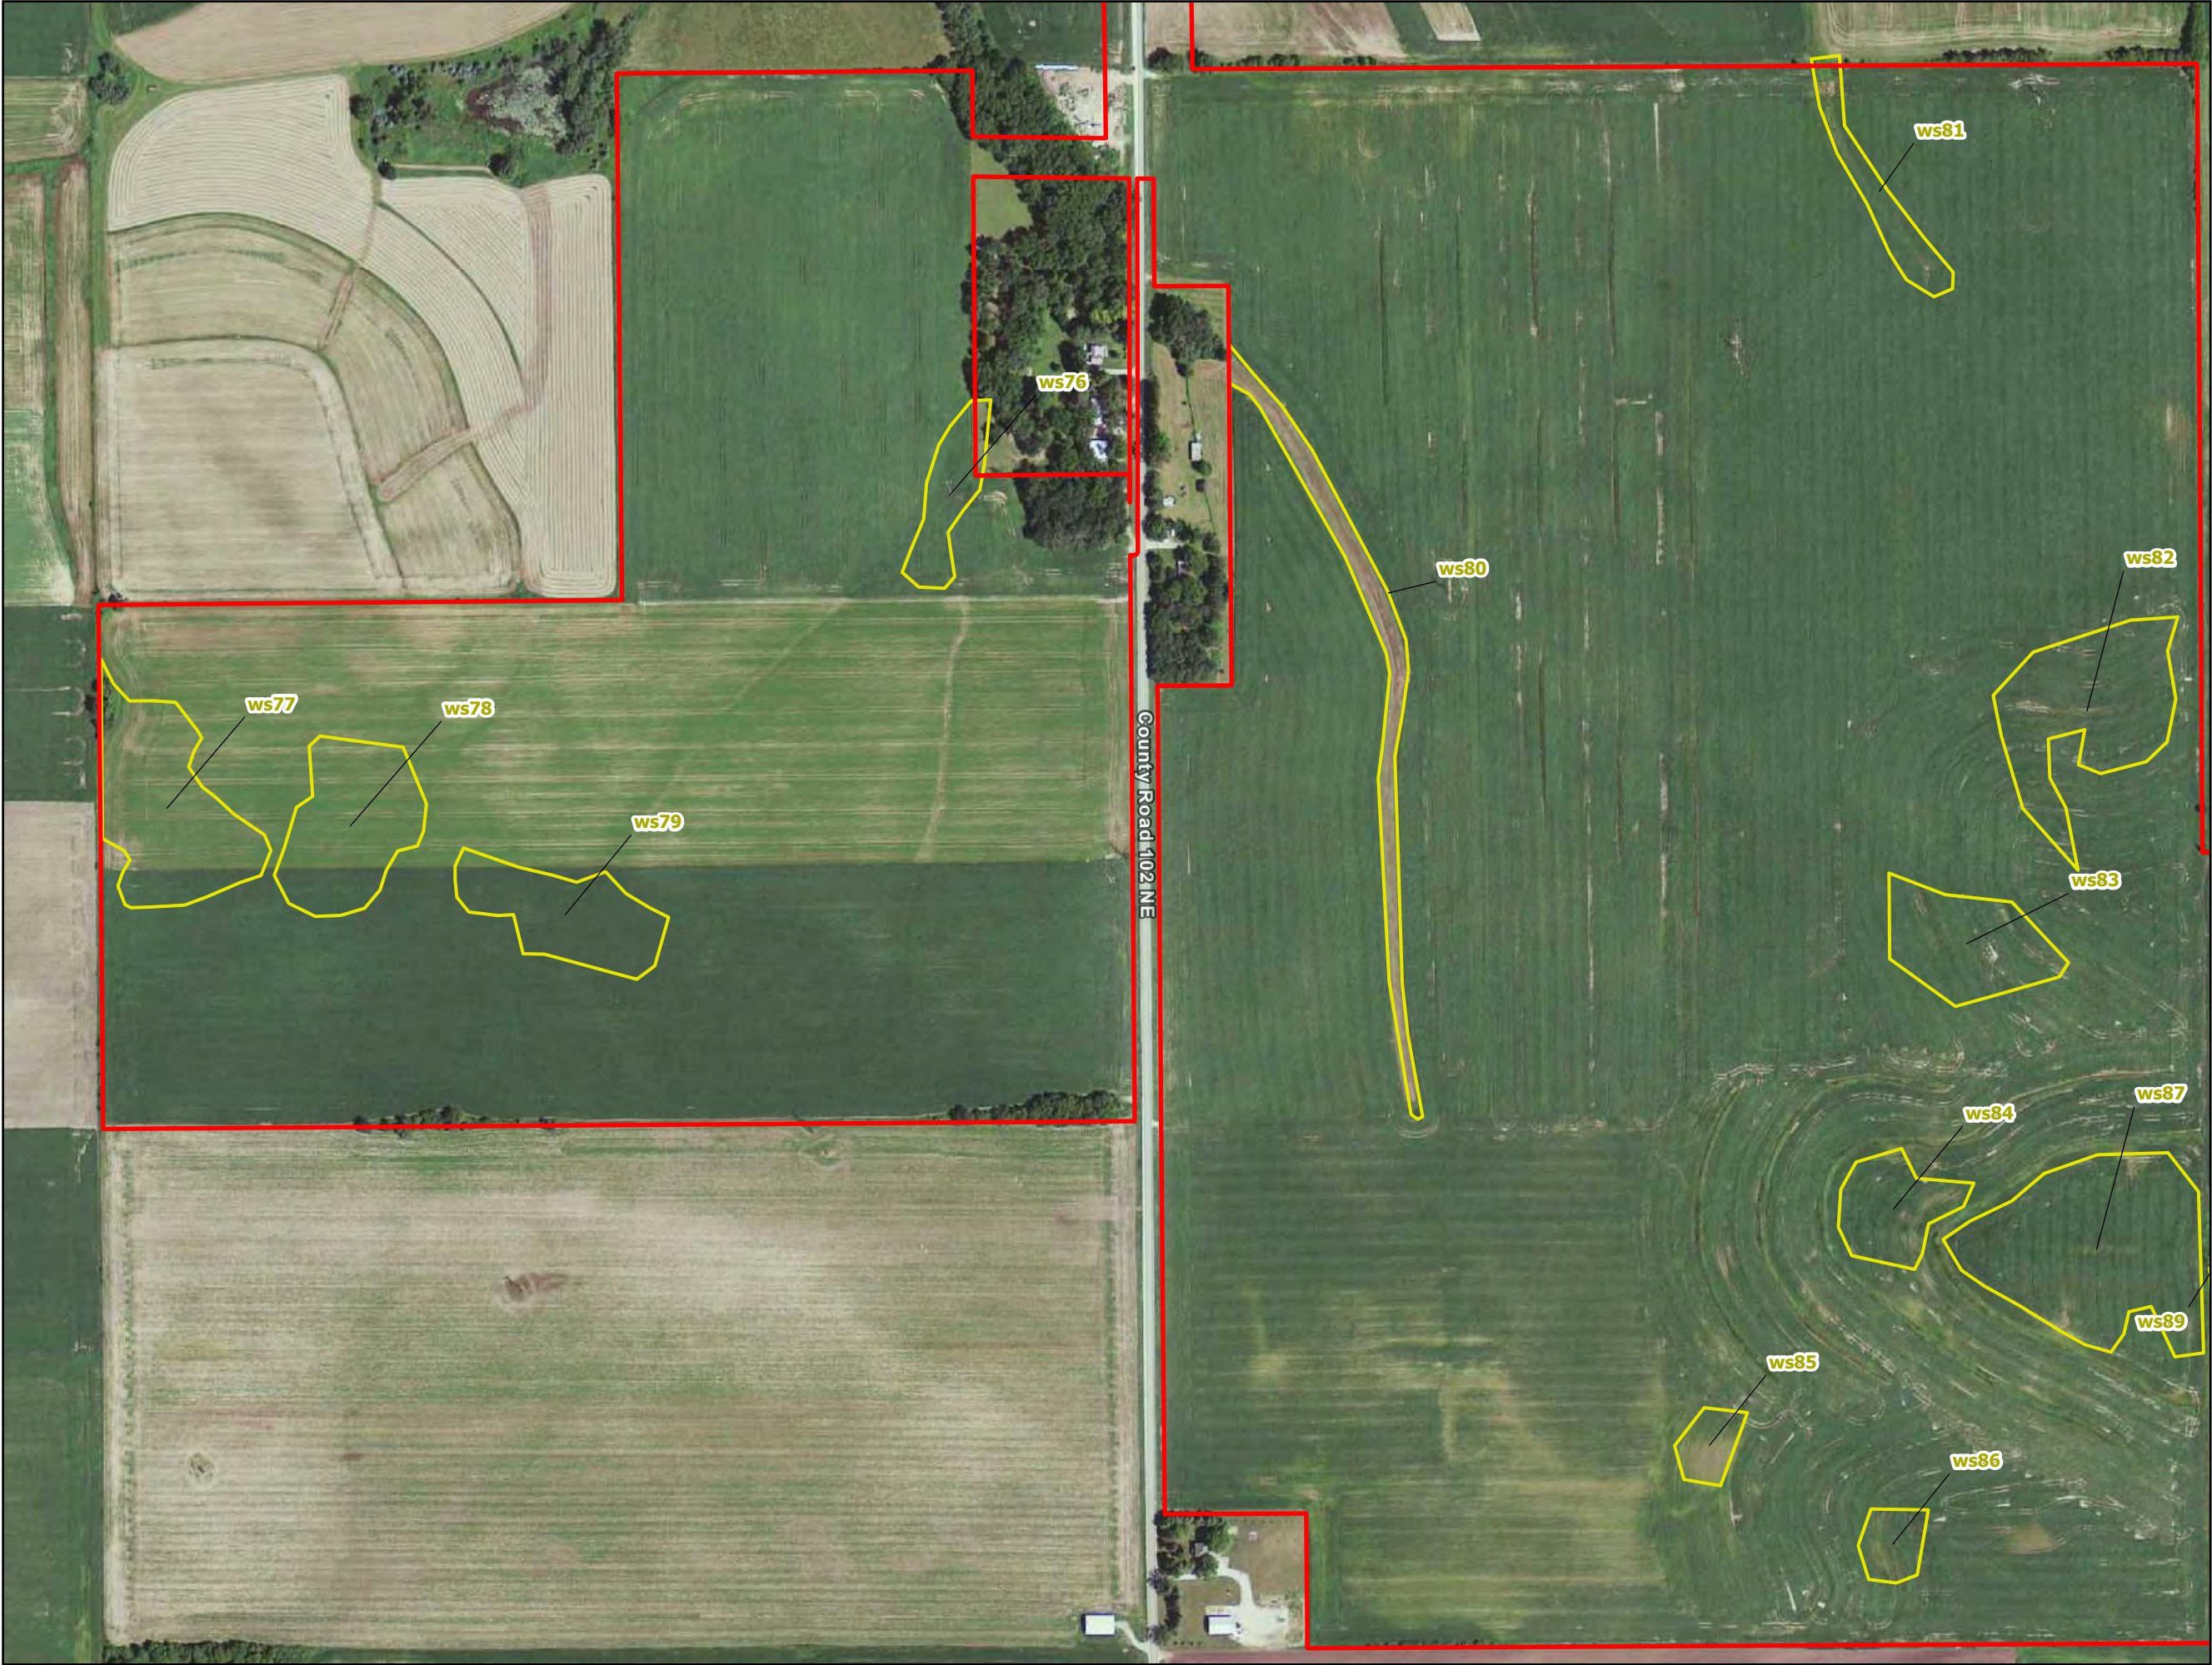
- Survey Area
- Wetness Signature

**FSA Slide Review: NAIP Imagery -
July 2010
Lemon Hill Solar Project
Ranger Power
Olmsted County, MN**

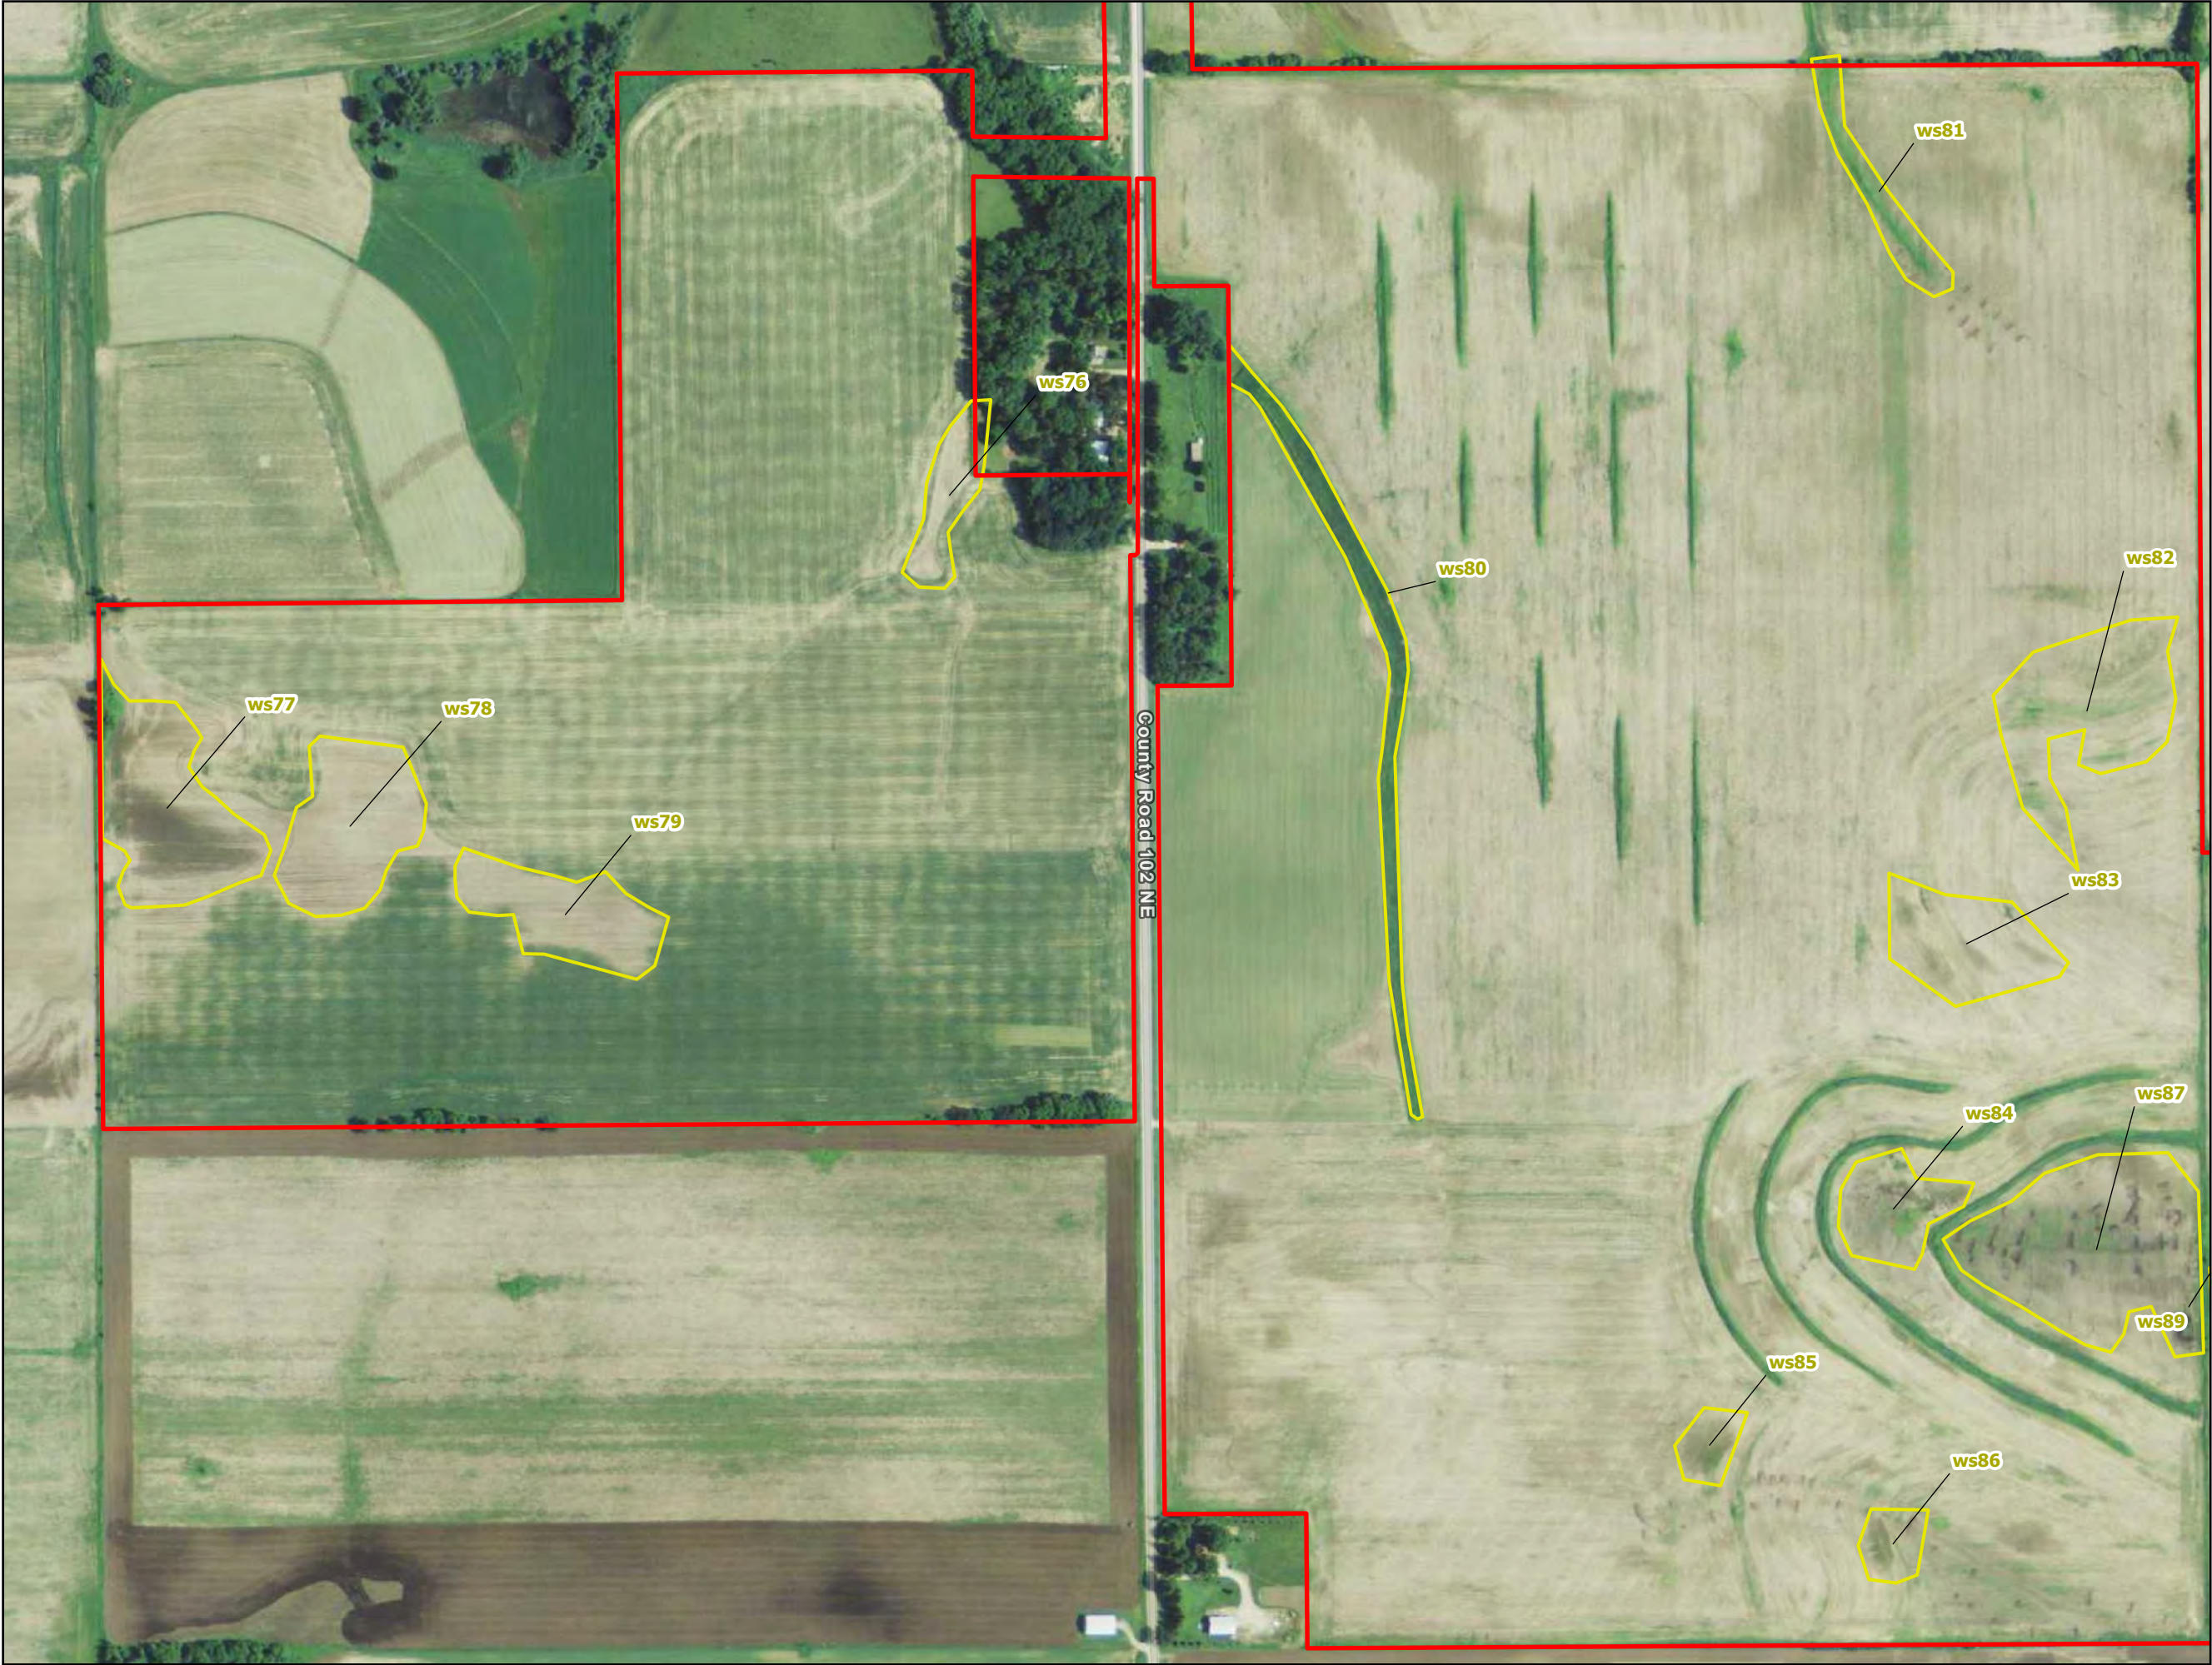
- Survey Area
- Wetness Signature

**FSA Slide Review: NAIP Imagery -
July 2013
Lemon Hill Solar Project
Ranger Power
Olmsted County, MN**
