**FSA Slide Review: NAIP Imagery -
October 2017
Lemon Hill Solar Project
Ranger Power
Olmsted County, MN**

Exhibit 1Field data sheet reference (if applicable): See attached crosswalk table**Wetland Hydrology from Aerial Imagery – Recording Form**

Project Name: Lemon Hill Solar Project

Date: 5/20/24 County: OlmstedInvestigator: Kyle Hanson Legal Description (T, R, S): T107N, R13W, S12**Summary Table**

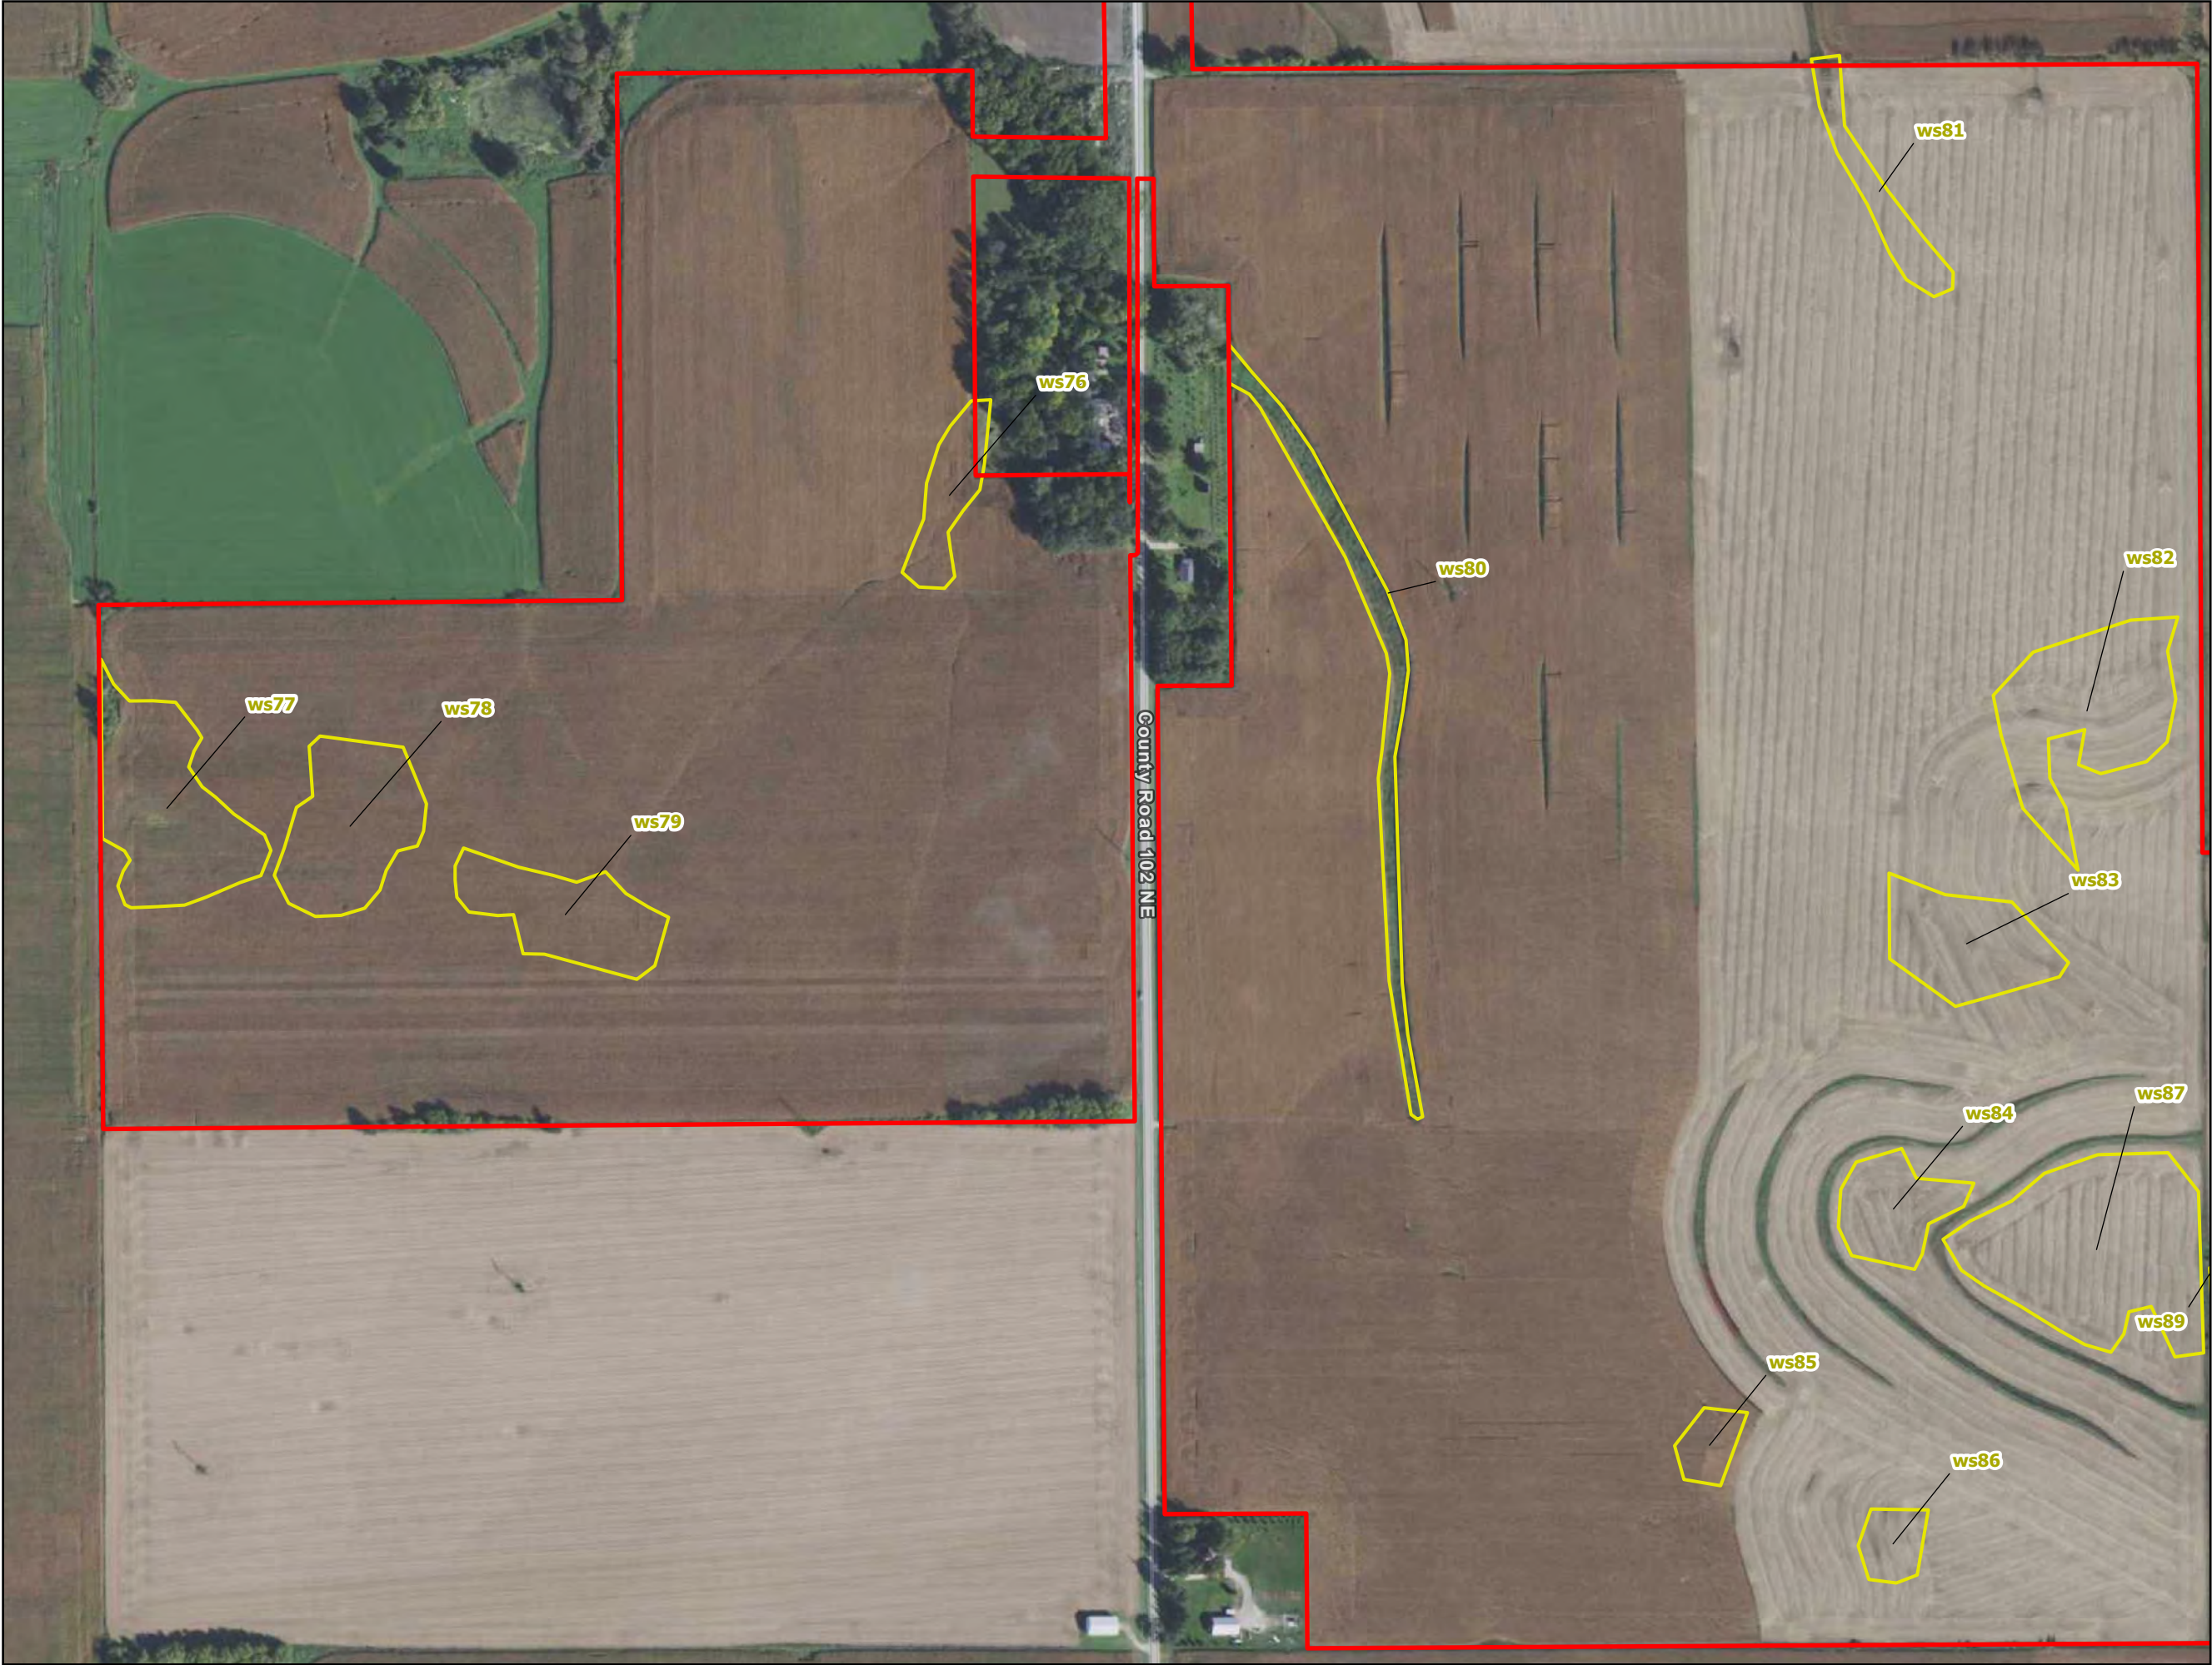
- Survey Area
- Wetness Signature

**FSA Slide Review: NAIP Imagery -
October 2015
Lemon Hill Solar Project
Ranger Power
Olmsted County, MN**

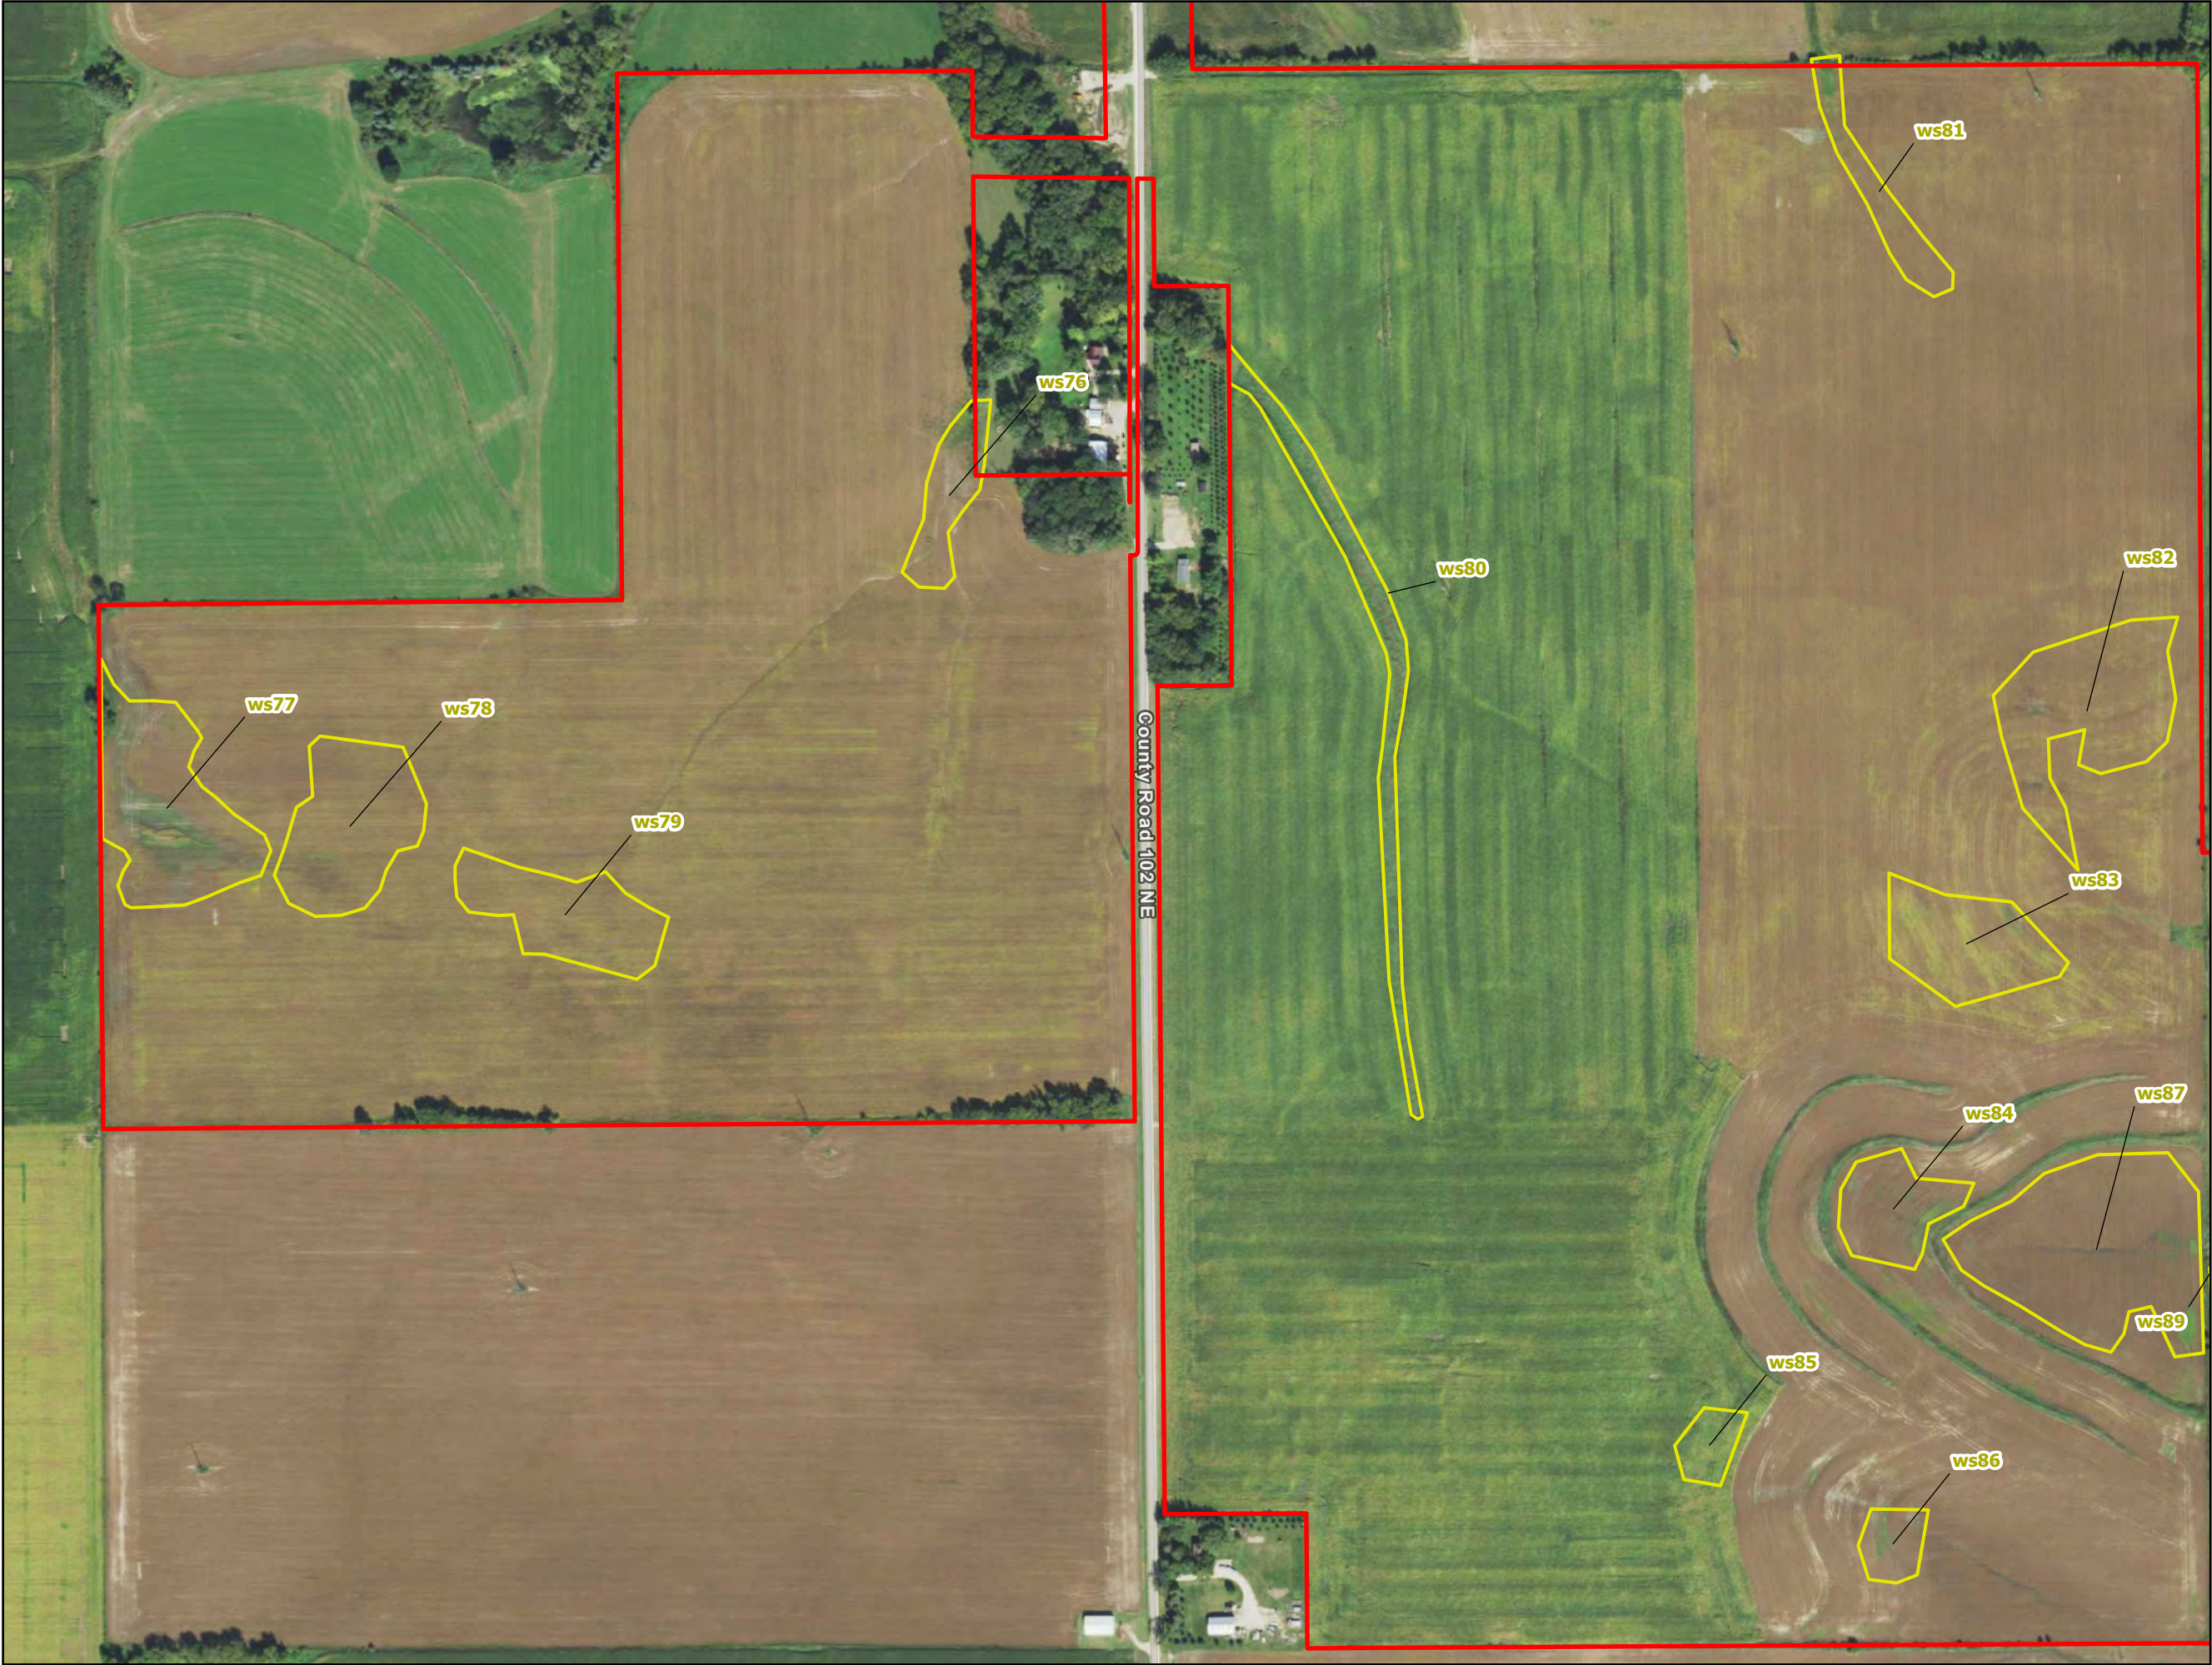
**FSA Slide Review: NAIP Imagery -
August 2019
Lemon Hill Solar Project
Ranger Power
Olmsted County, MN**

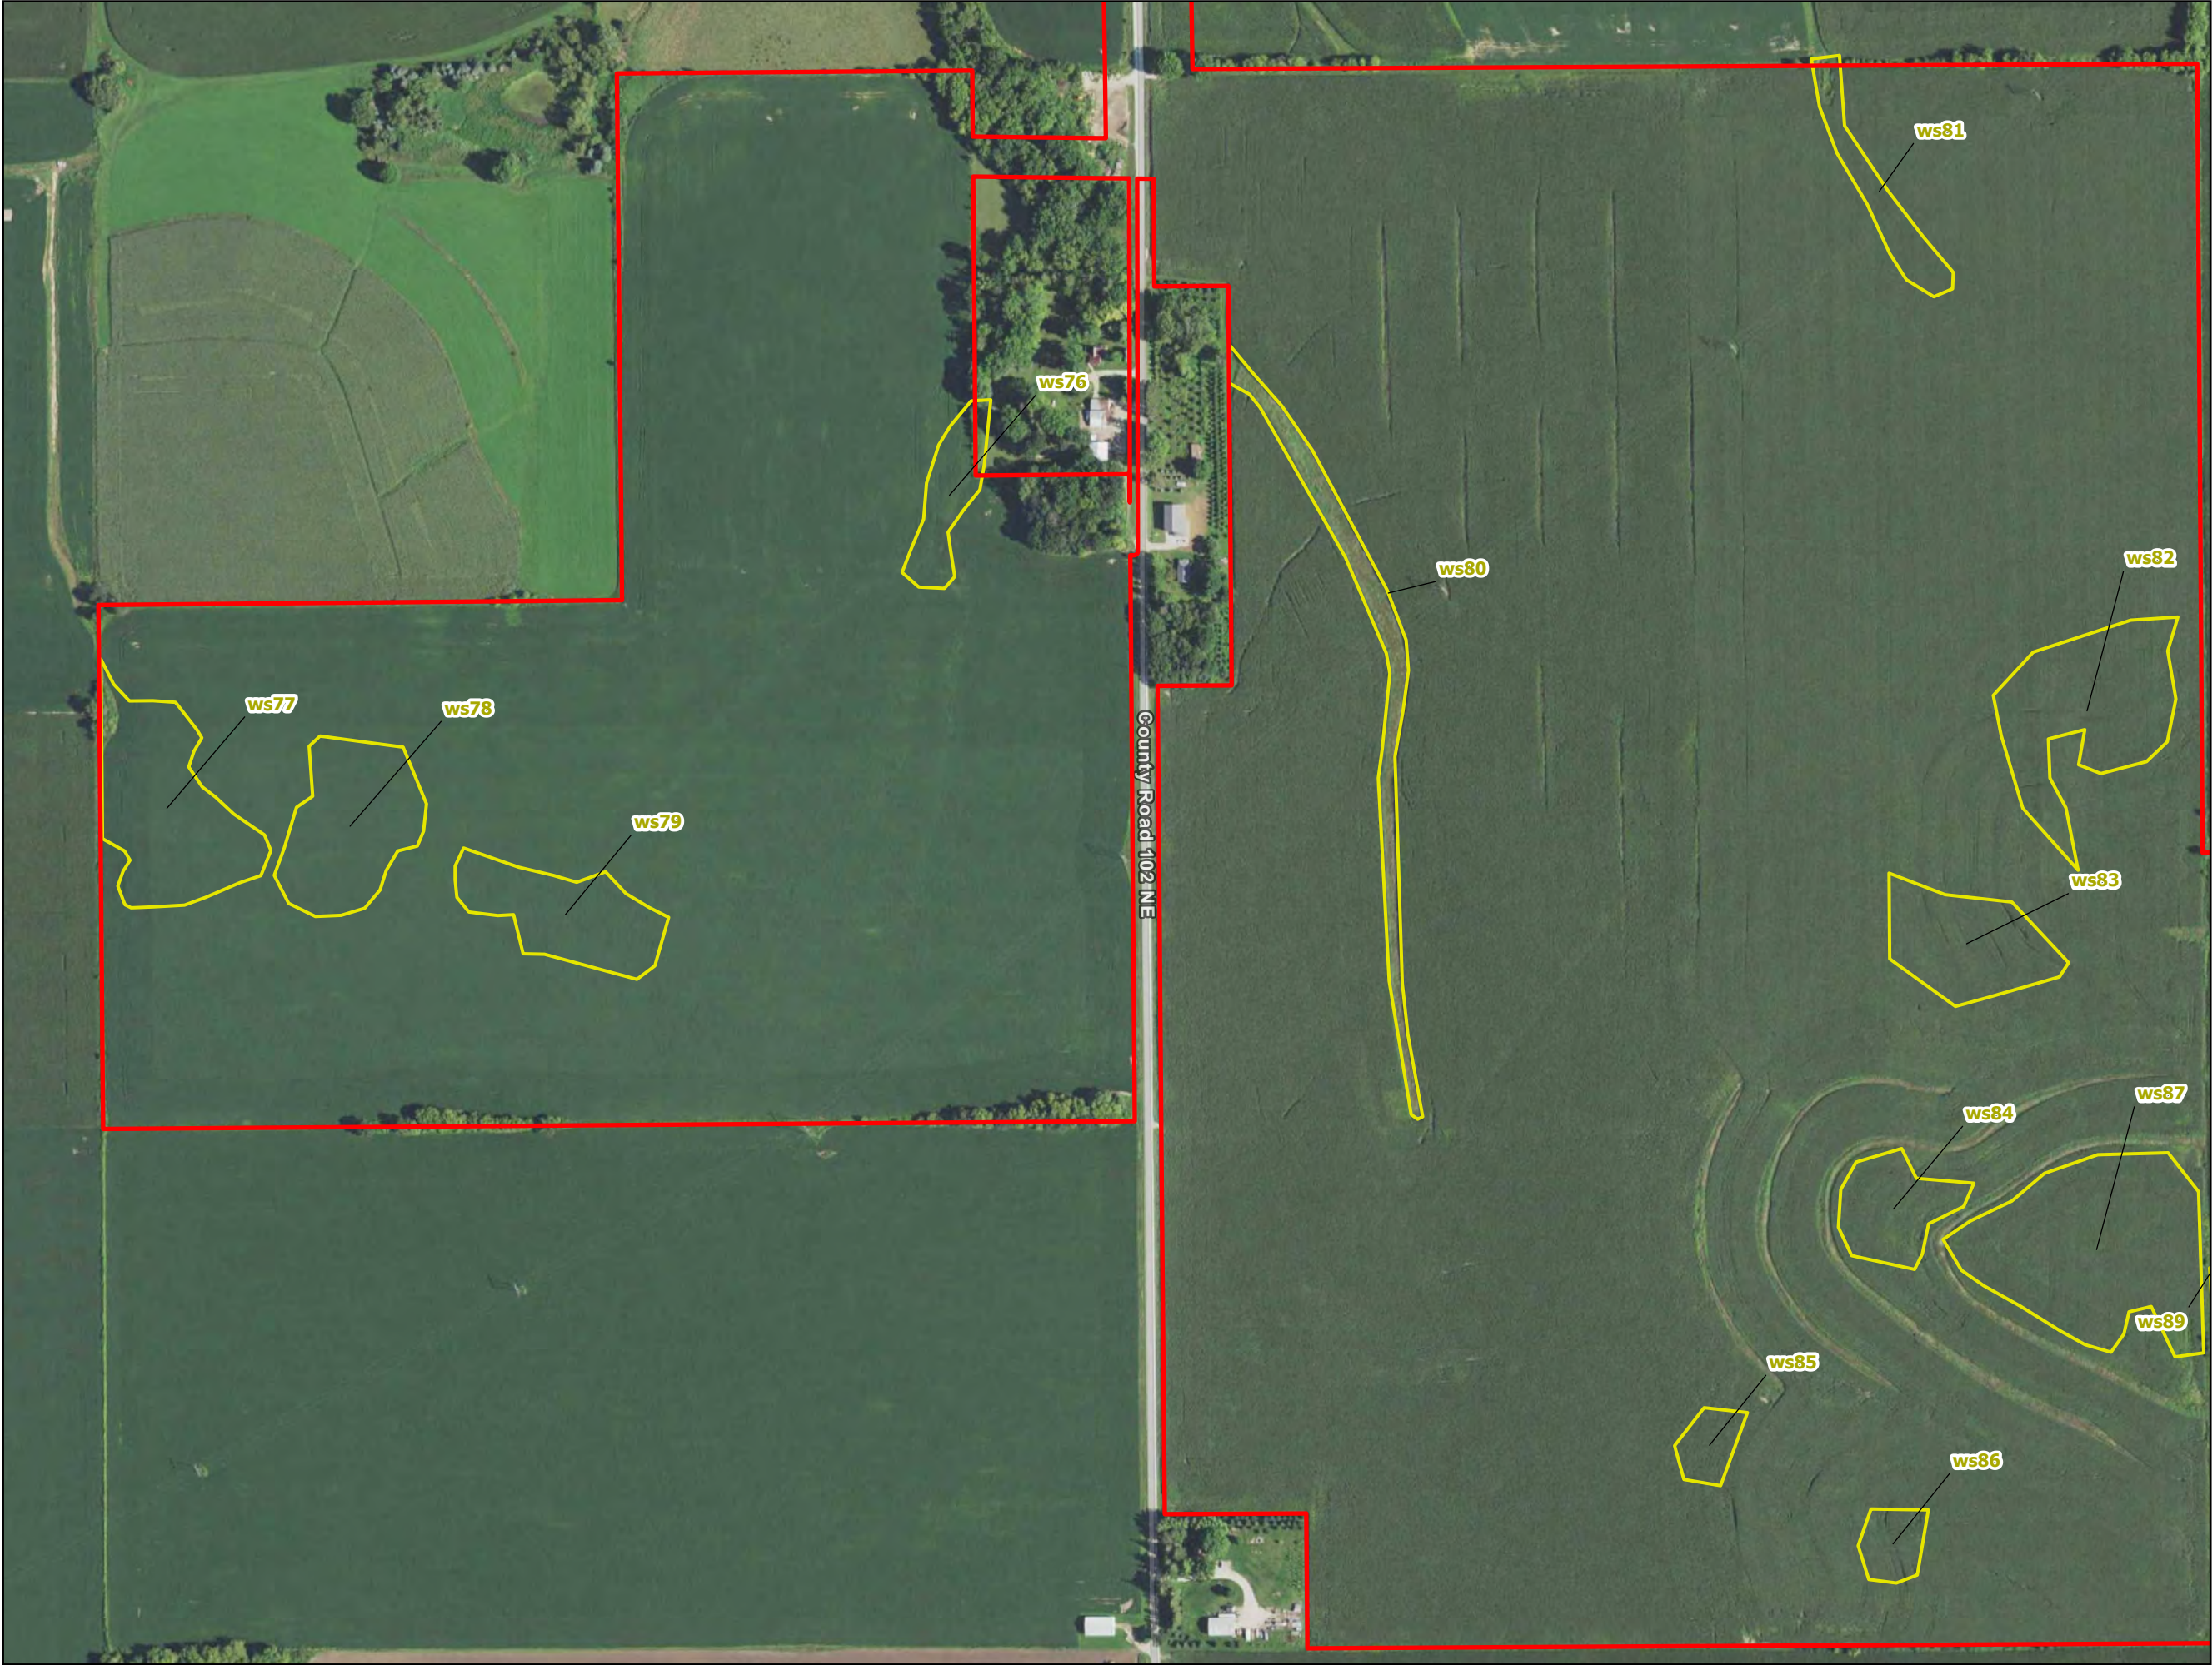
**FSA Slide Review: NAIP Imagery -
August 2021
Lemon Hill Solar Project
Ranger Power
Olmsted County, MN**

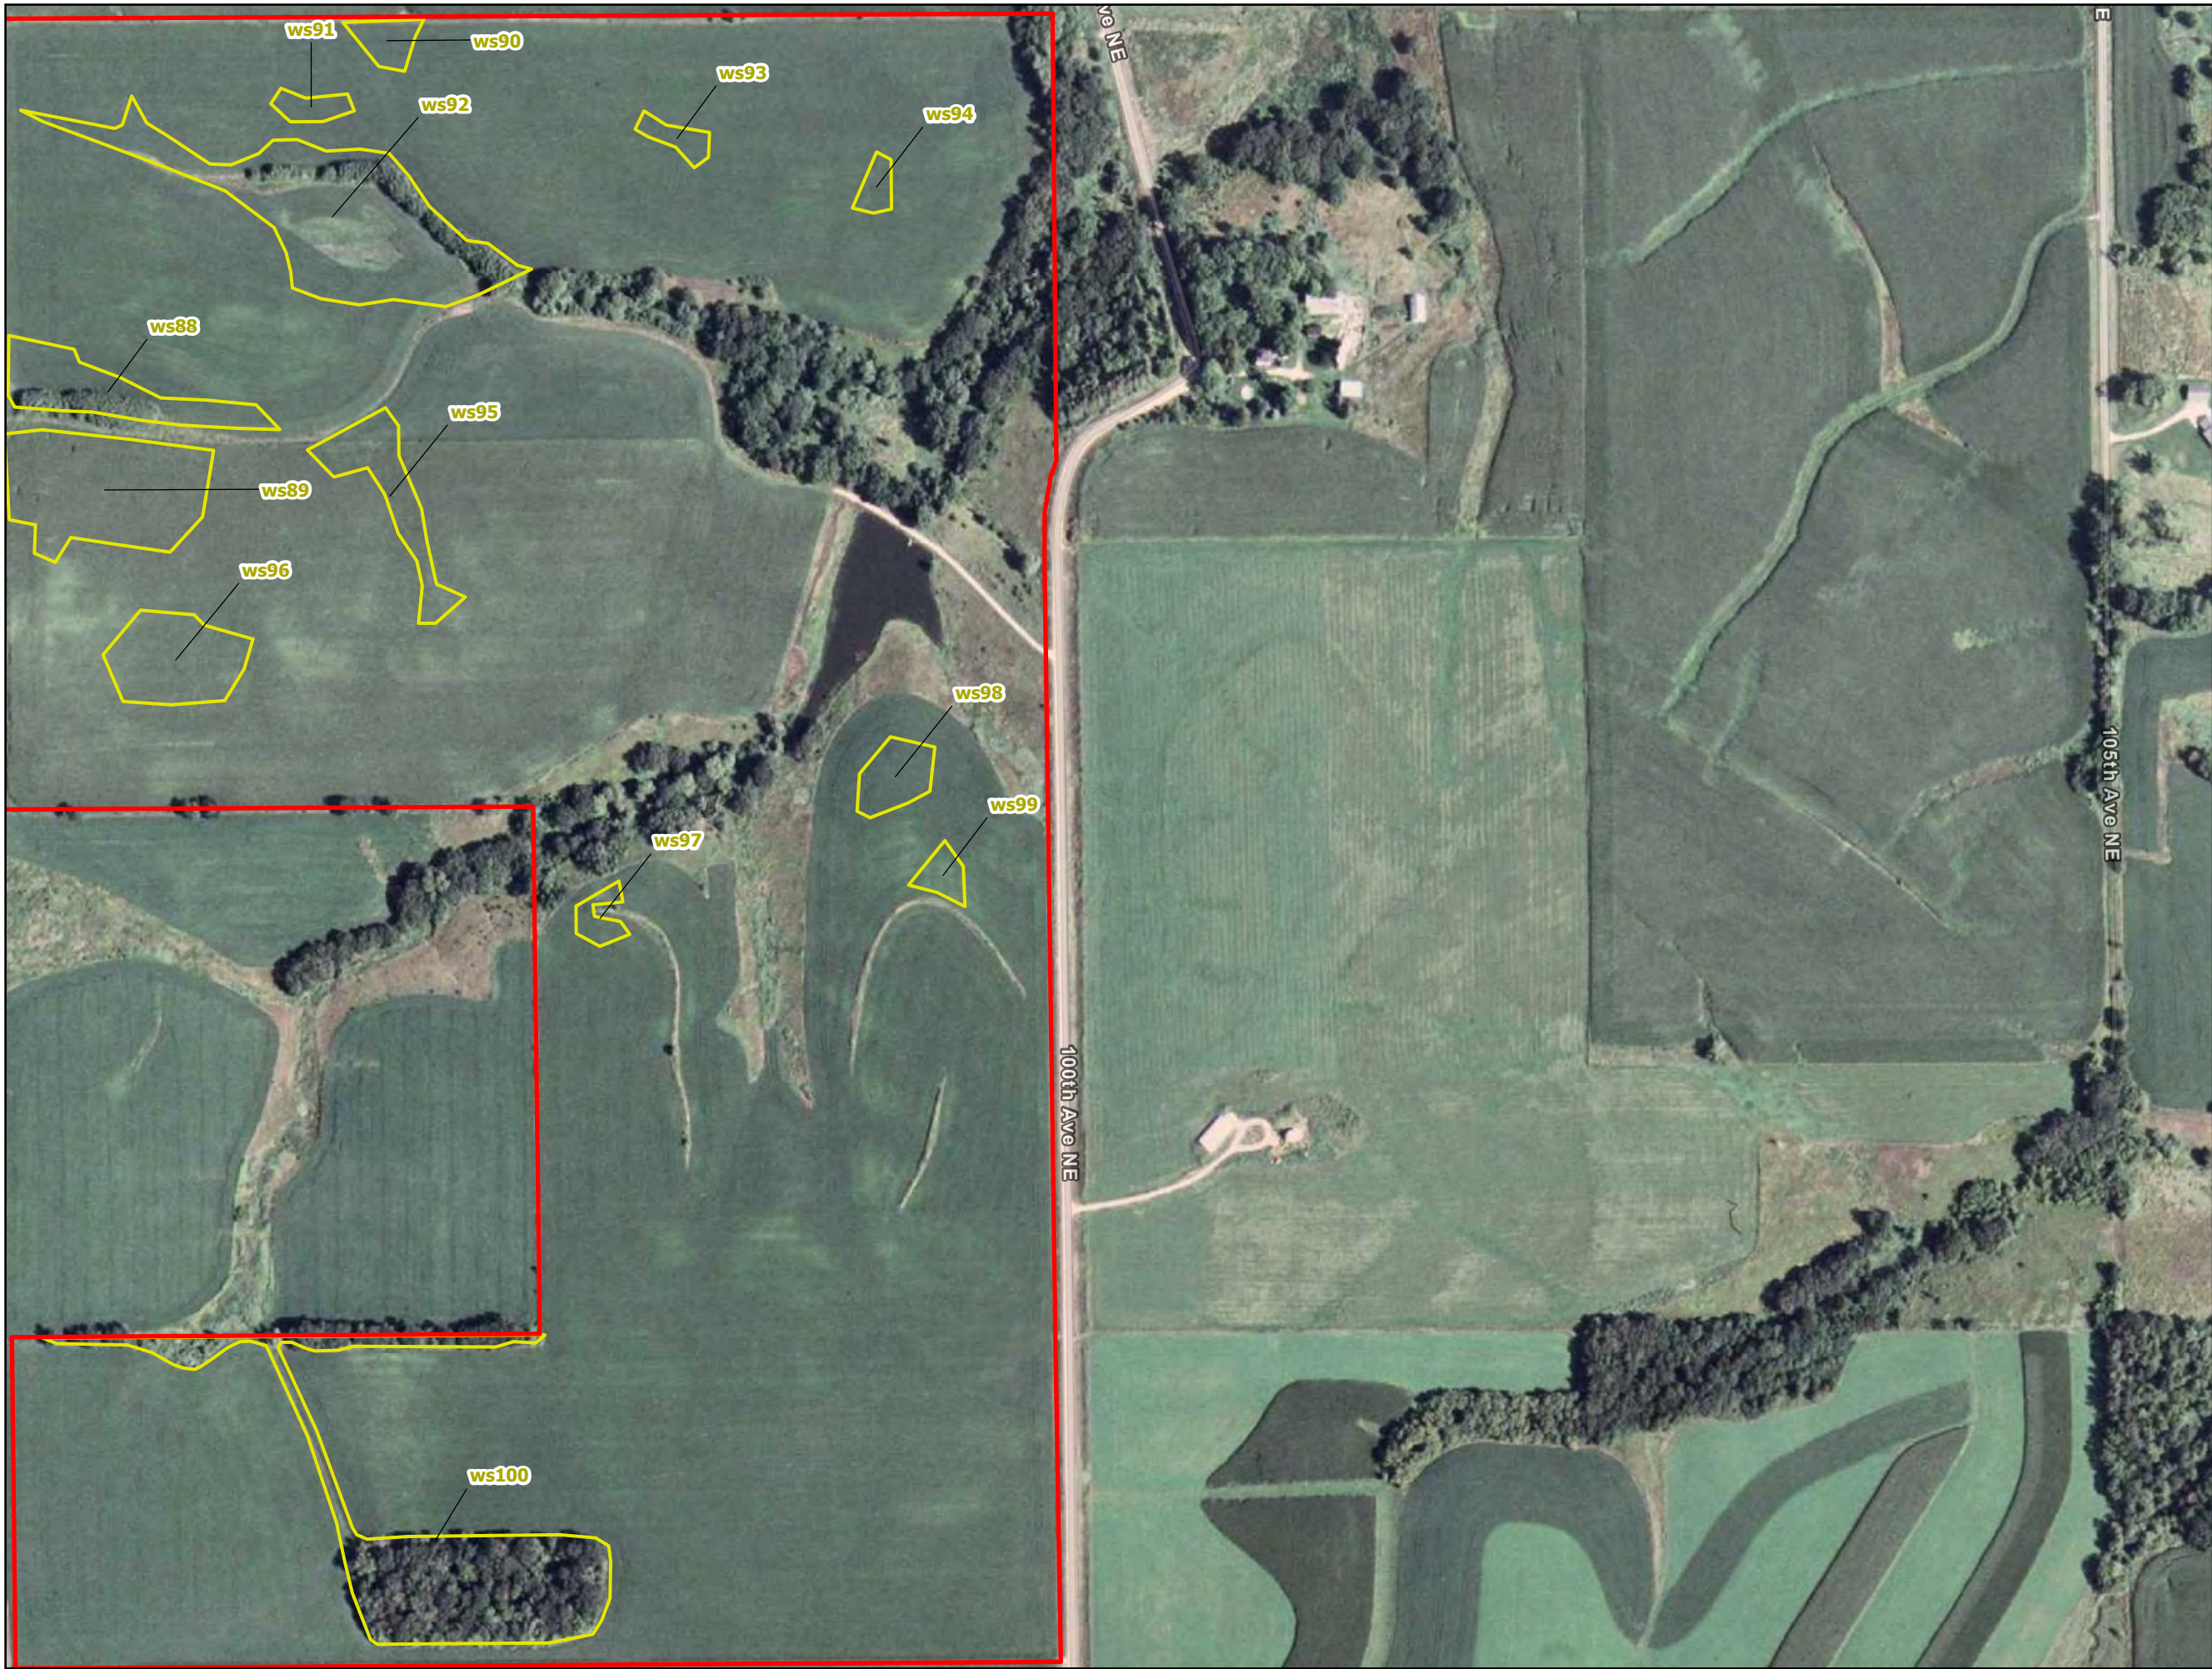
FSA Slide Review: NAIP Imagery -
August 2009
Lemon Hill Solar Project
Ranger Power
Olmsted County, MN

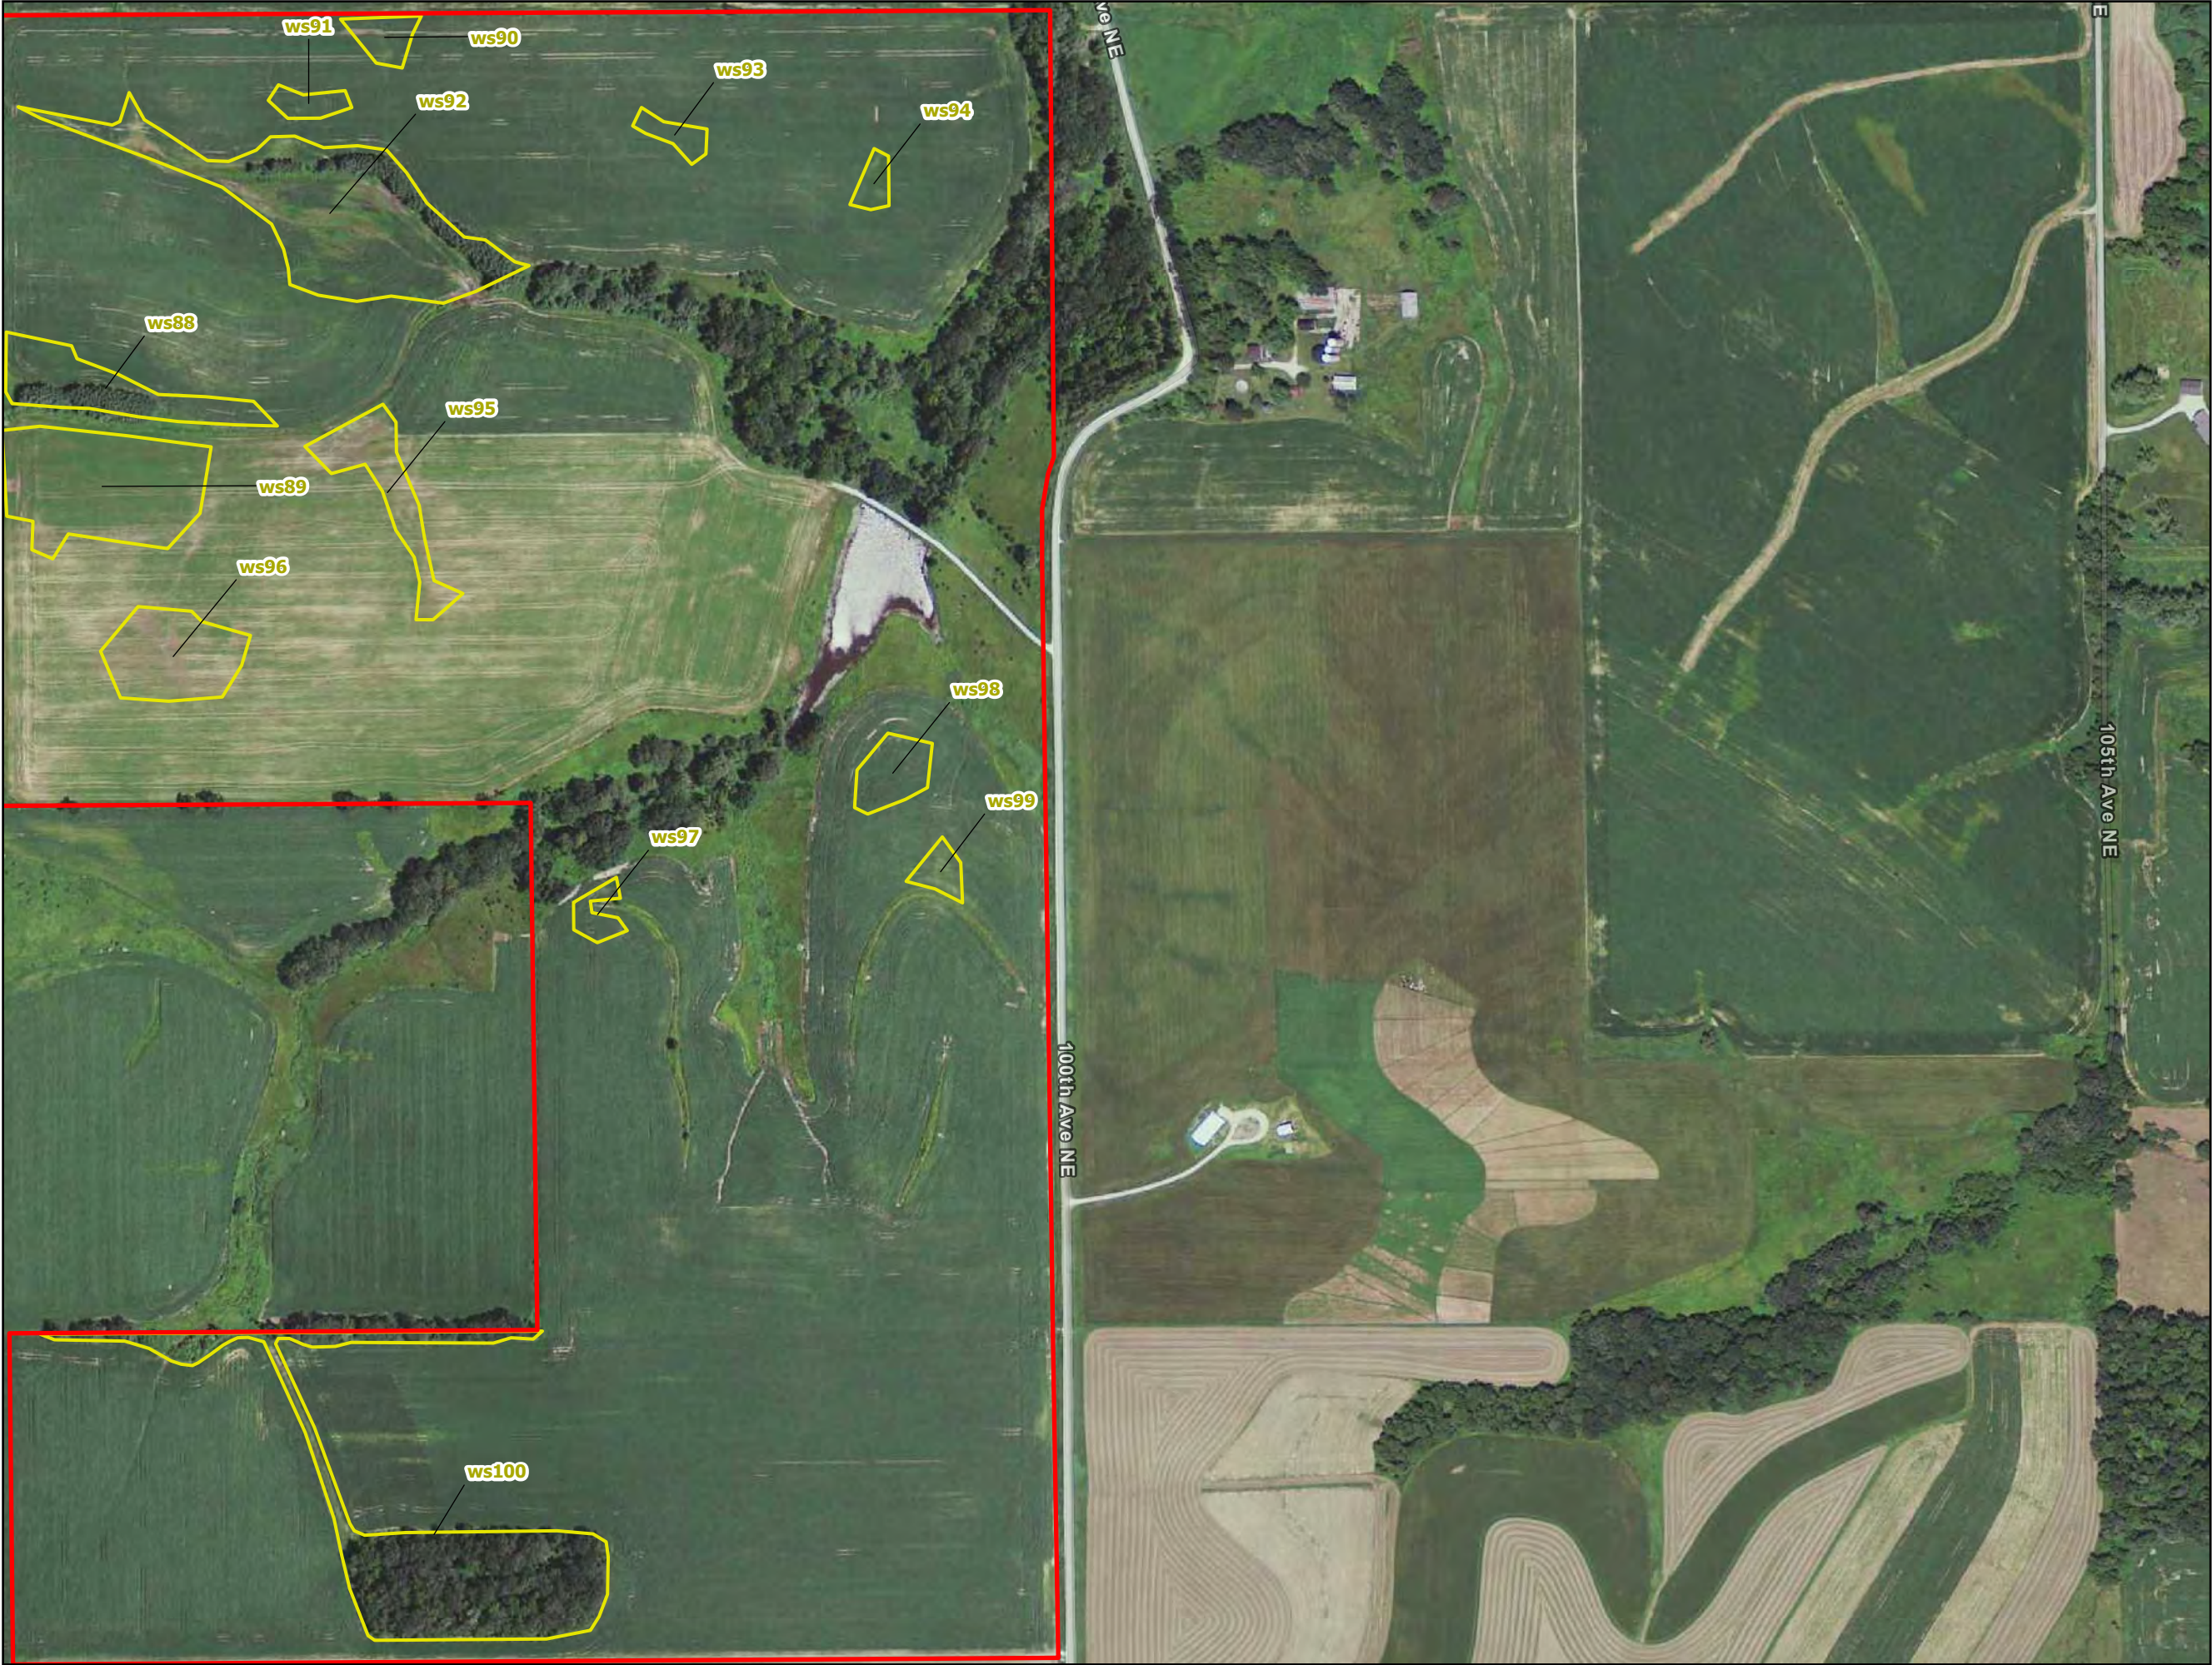
FSA Slide Review: NAIP Imagery -
July 2010
Lemon Hill Solar Project
Ranger Power
Olmsted County, MN

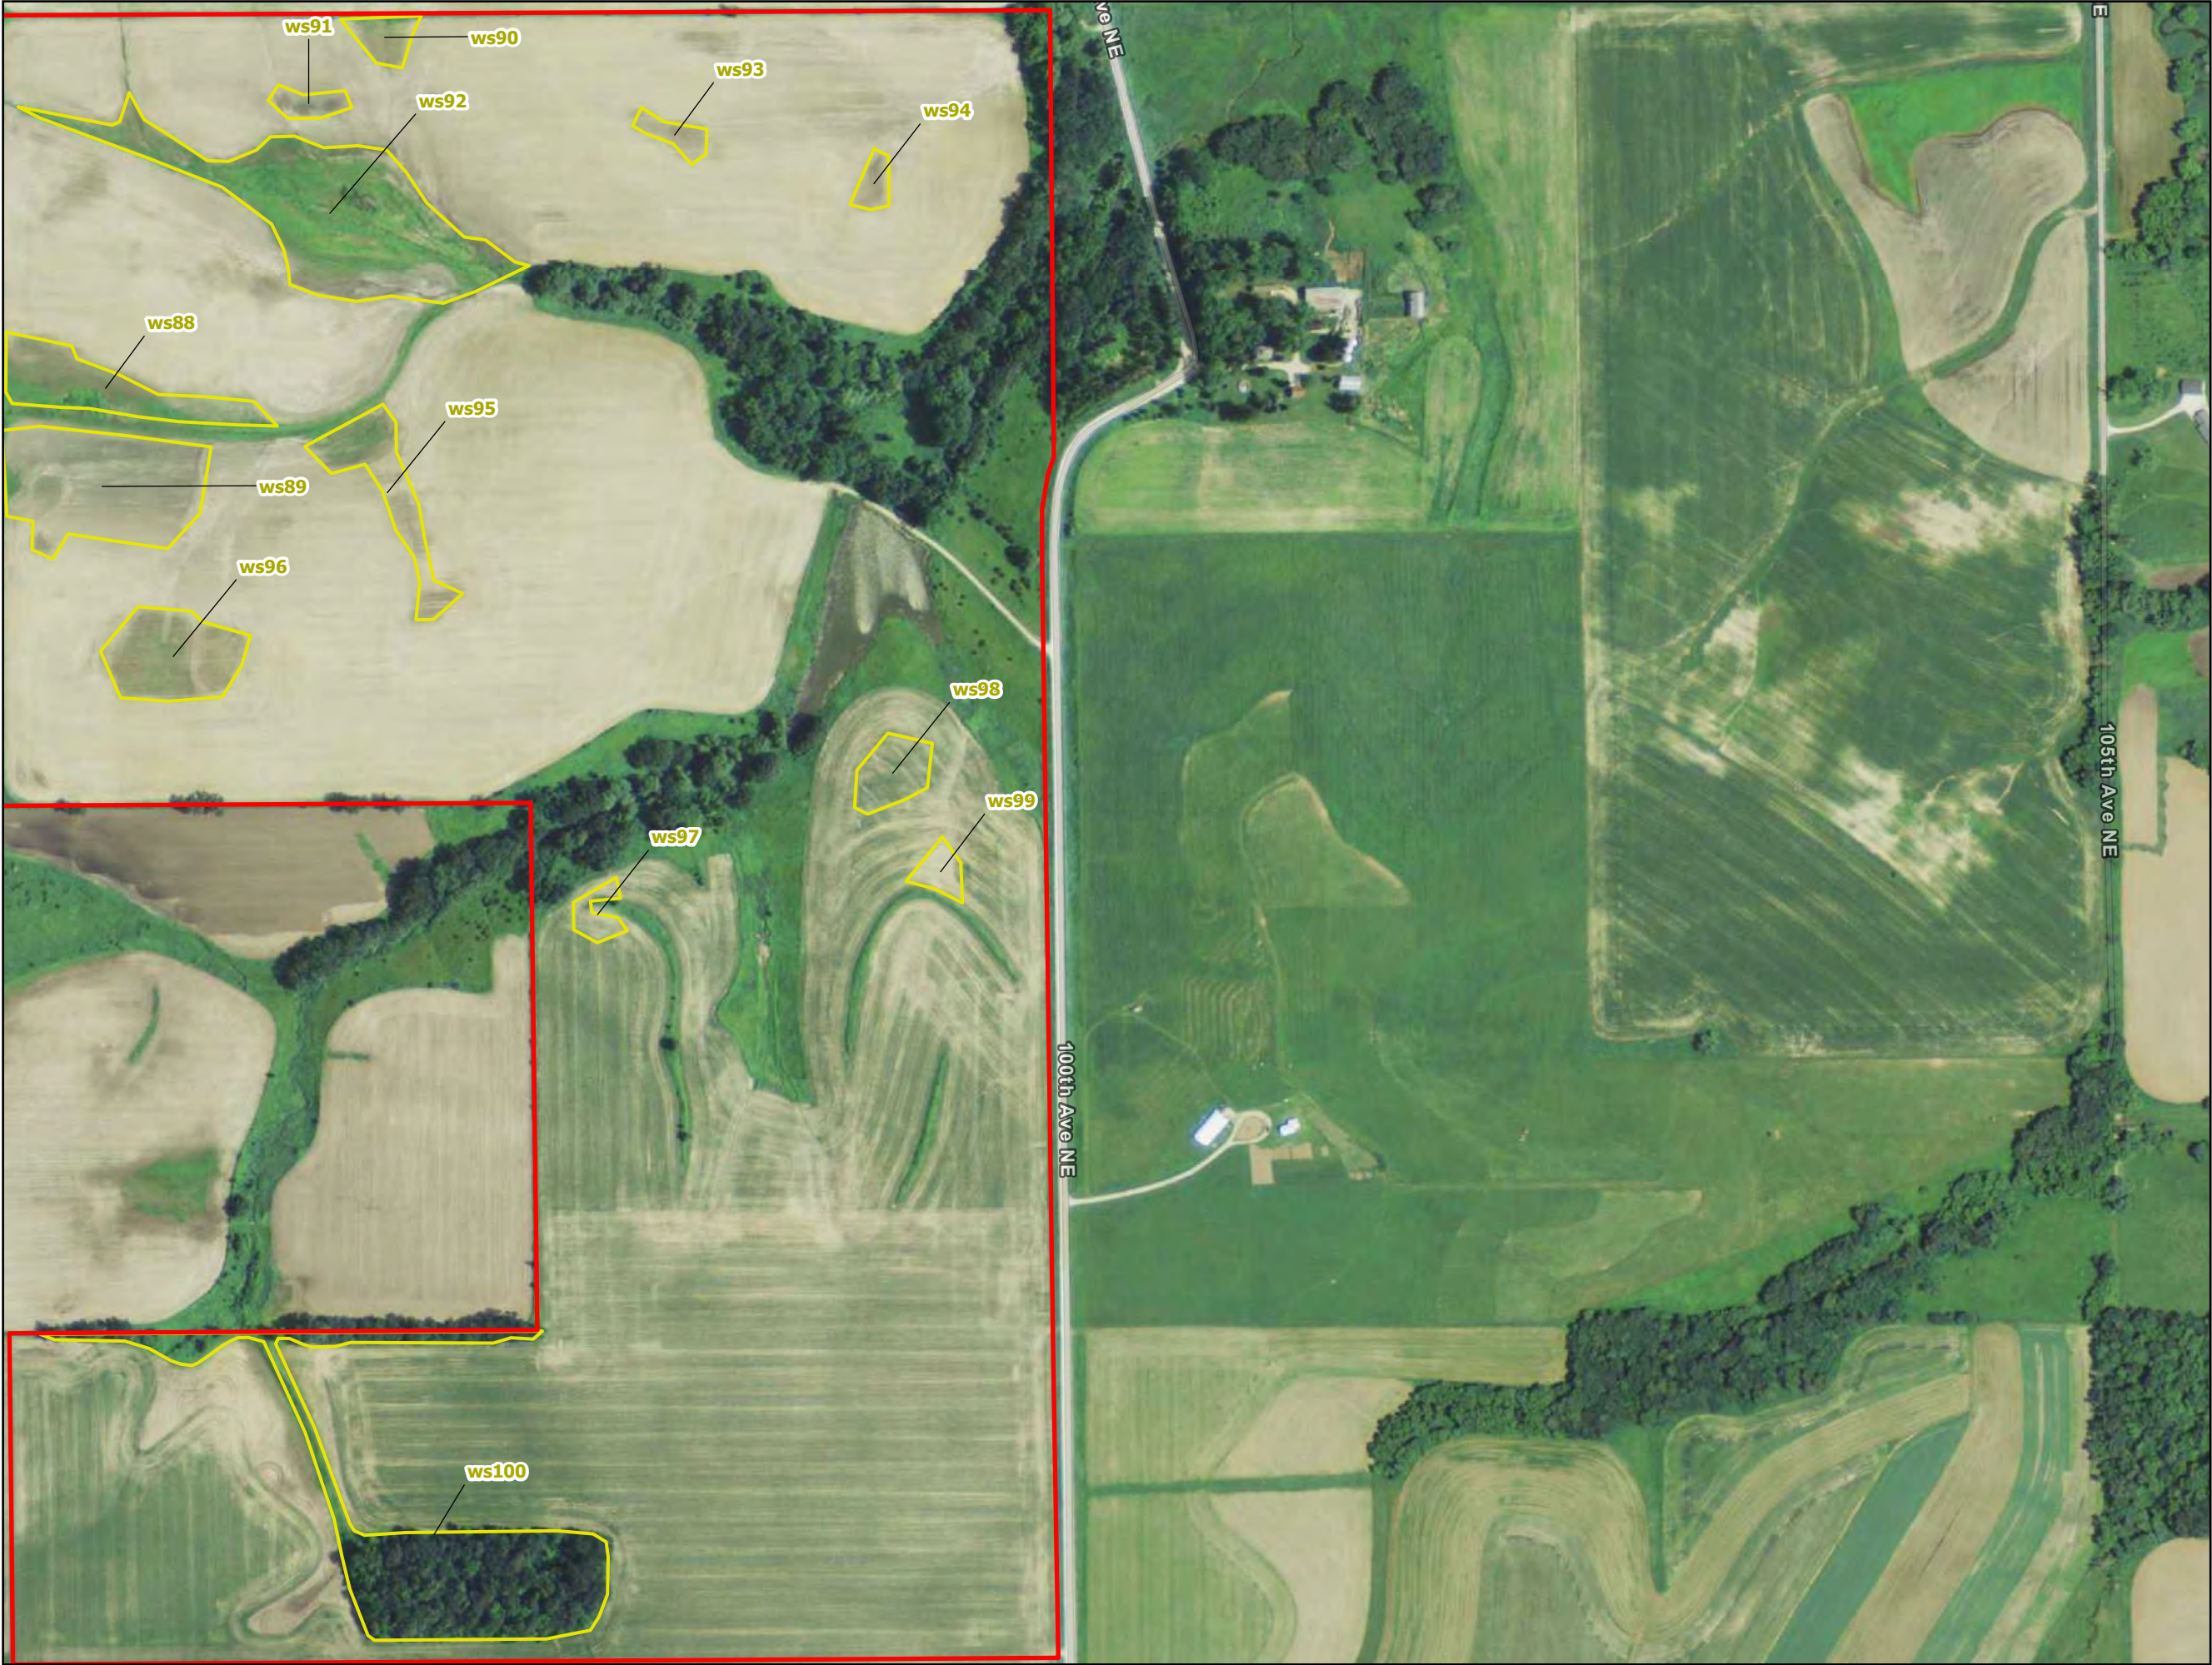
FSA Slide Review: NAIP Imagery -
July 2013
Lemon Hill Solar Project
Ranger Power
Olmsted County, MN
