**FSA Slide Review: NAIP Imagery -
October 2017
Lemon Hill Solar Project
Ranger Power
Olmsted County, MN**

Exhibit 1Field data sheet reference (if applicable): See attached crosswalk table**Wetland Hydrology from Aerial Imagery – Recording Form**

Project Name: Lemon Hill Solar Project

Date: 5/20/24 County: OlmstedInvestigator: Kyle Hanson Legal Description (T, R, S): T107N, R13W, S12**Summary Table**

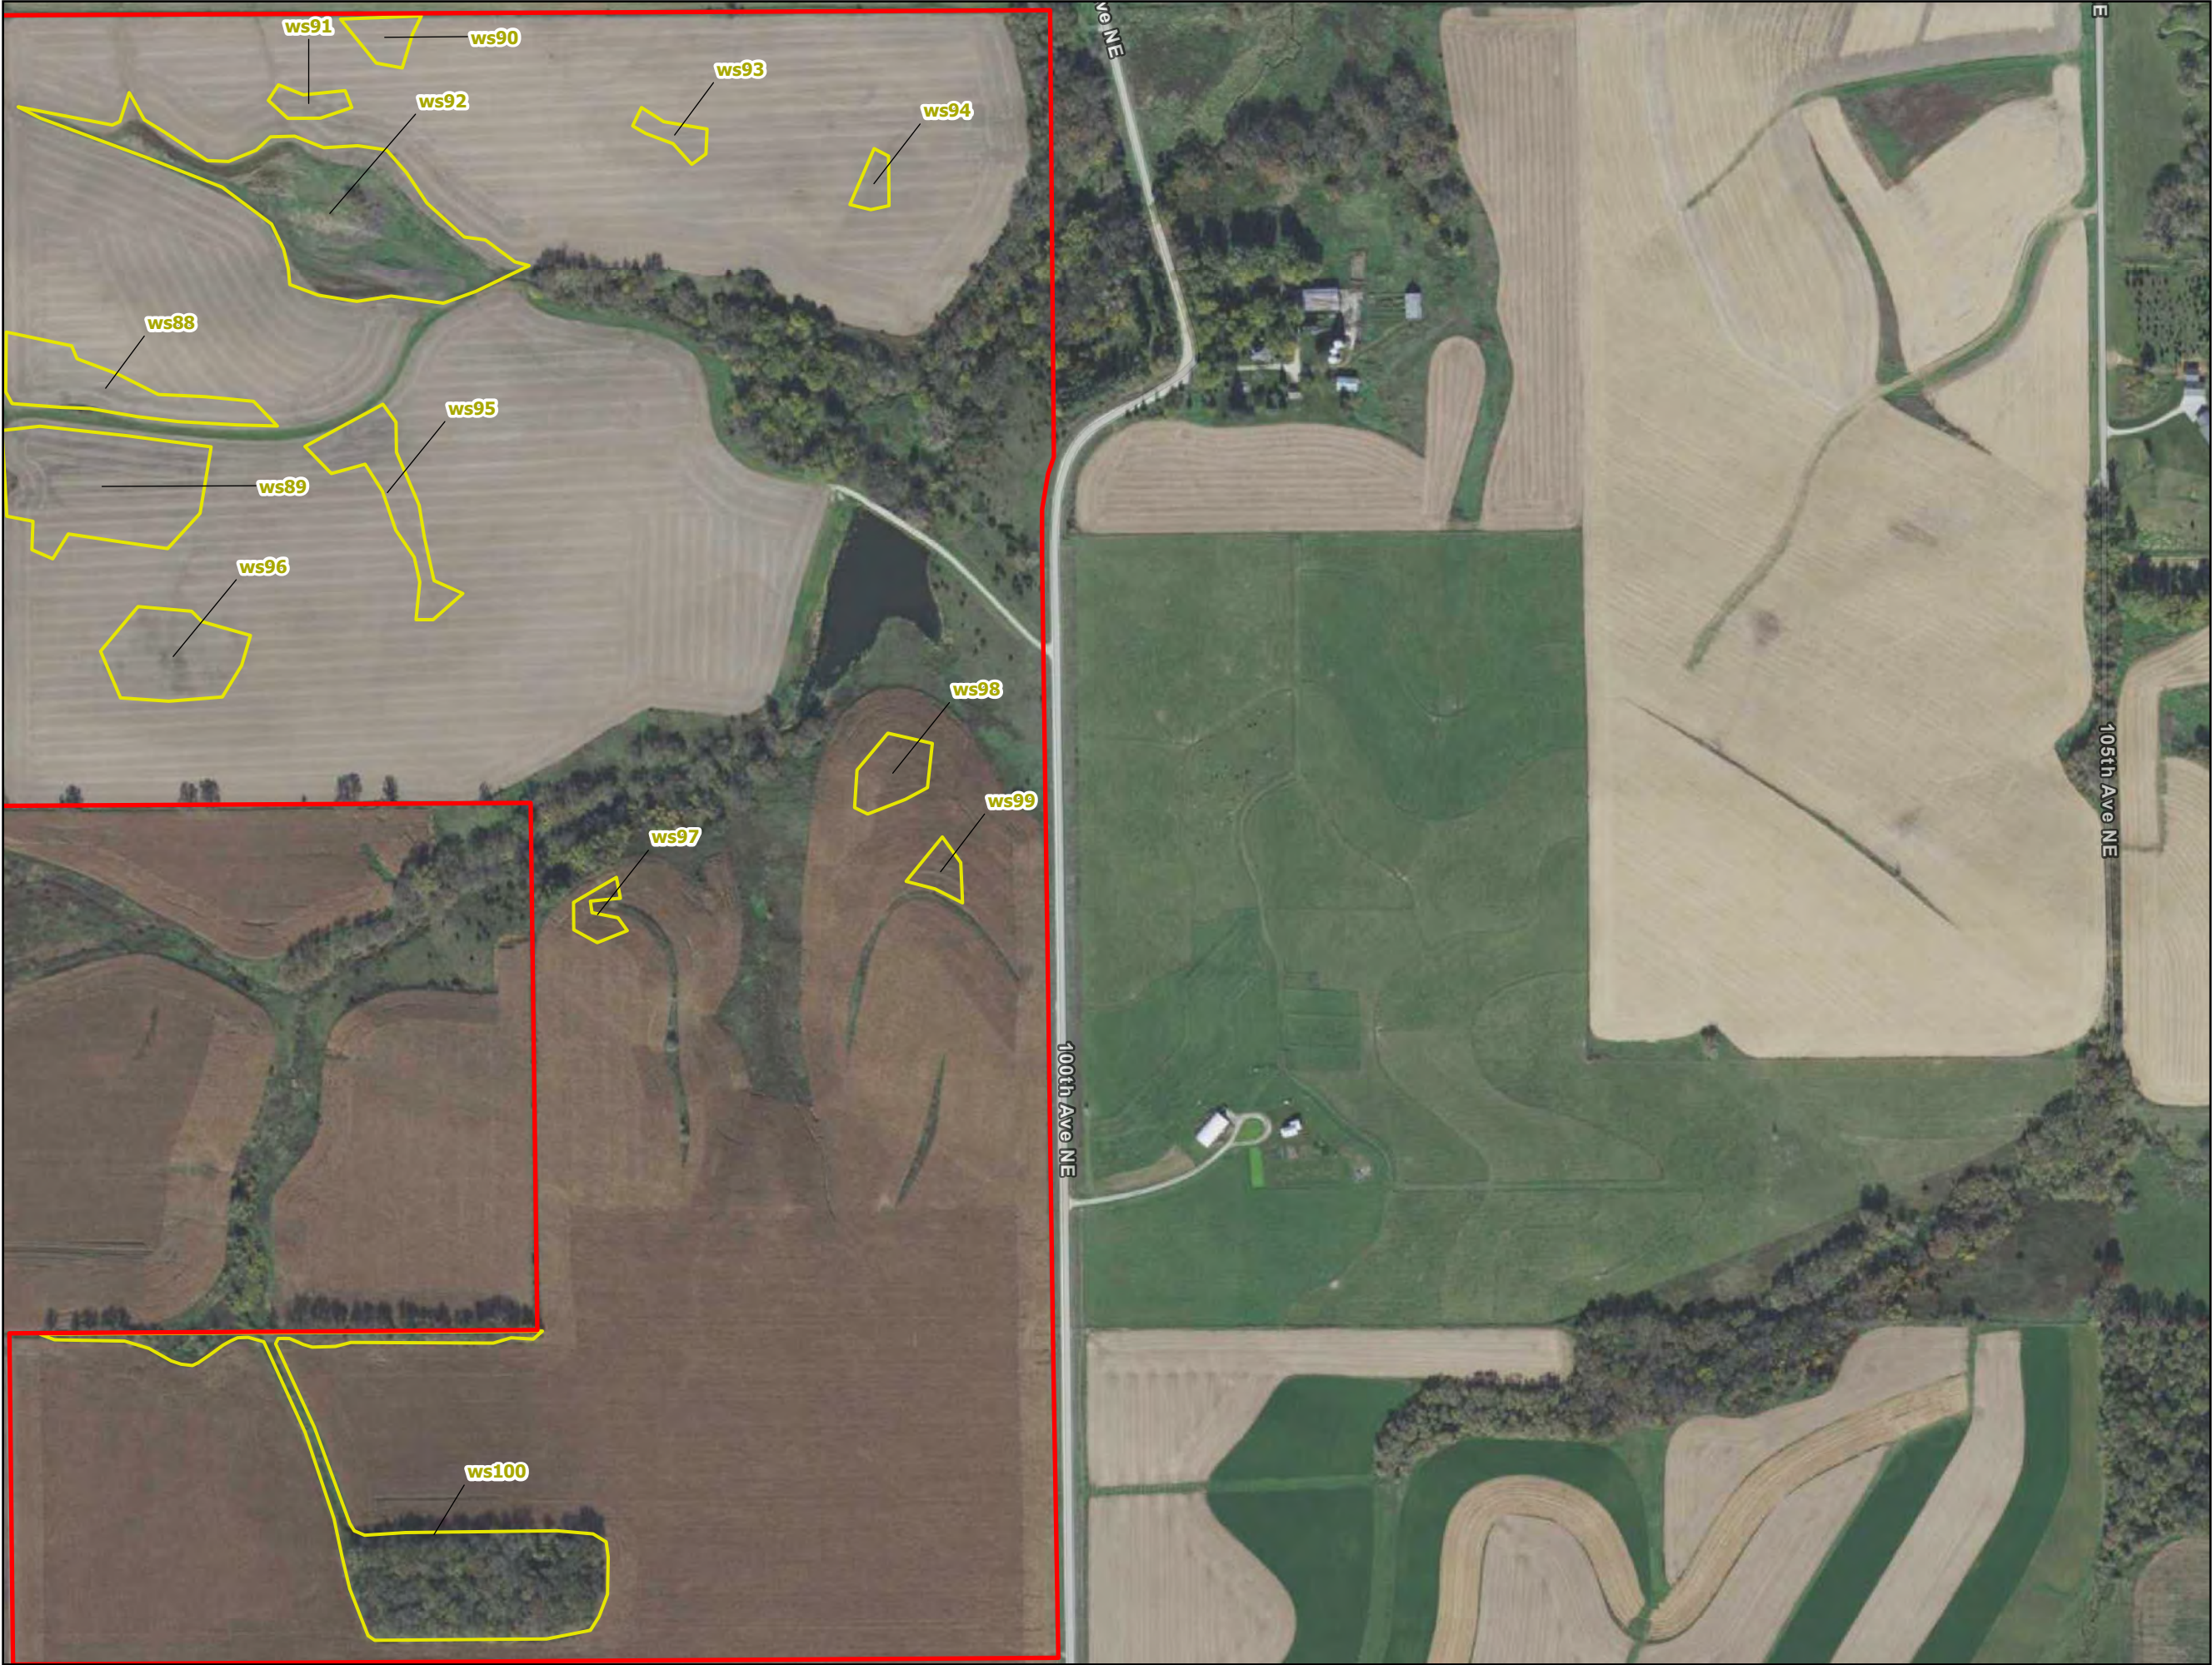
**FSA Slide Review: NAIP Imagery -
October 2015
Lemon Hill Solar Project
Ranger Power
Olmsted County, MN**

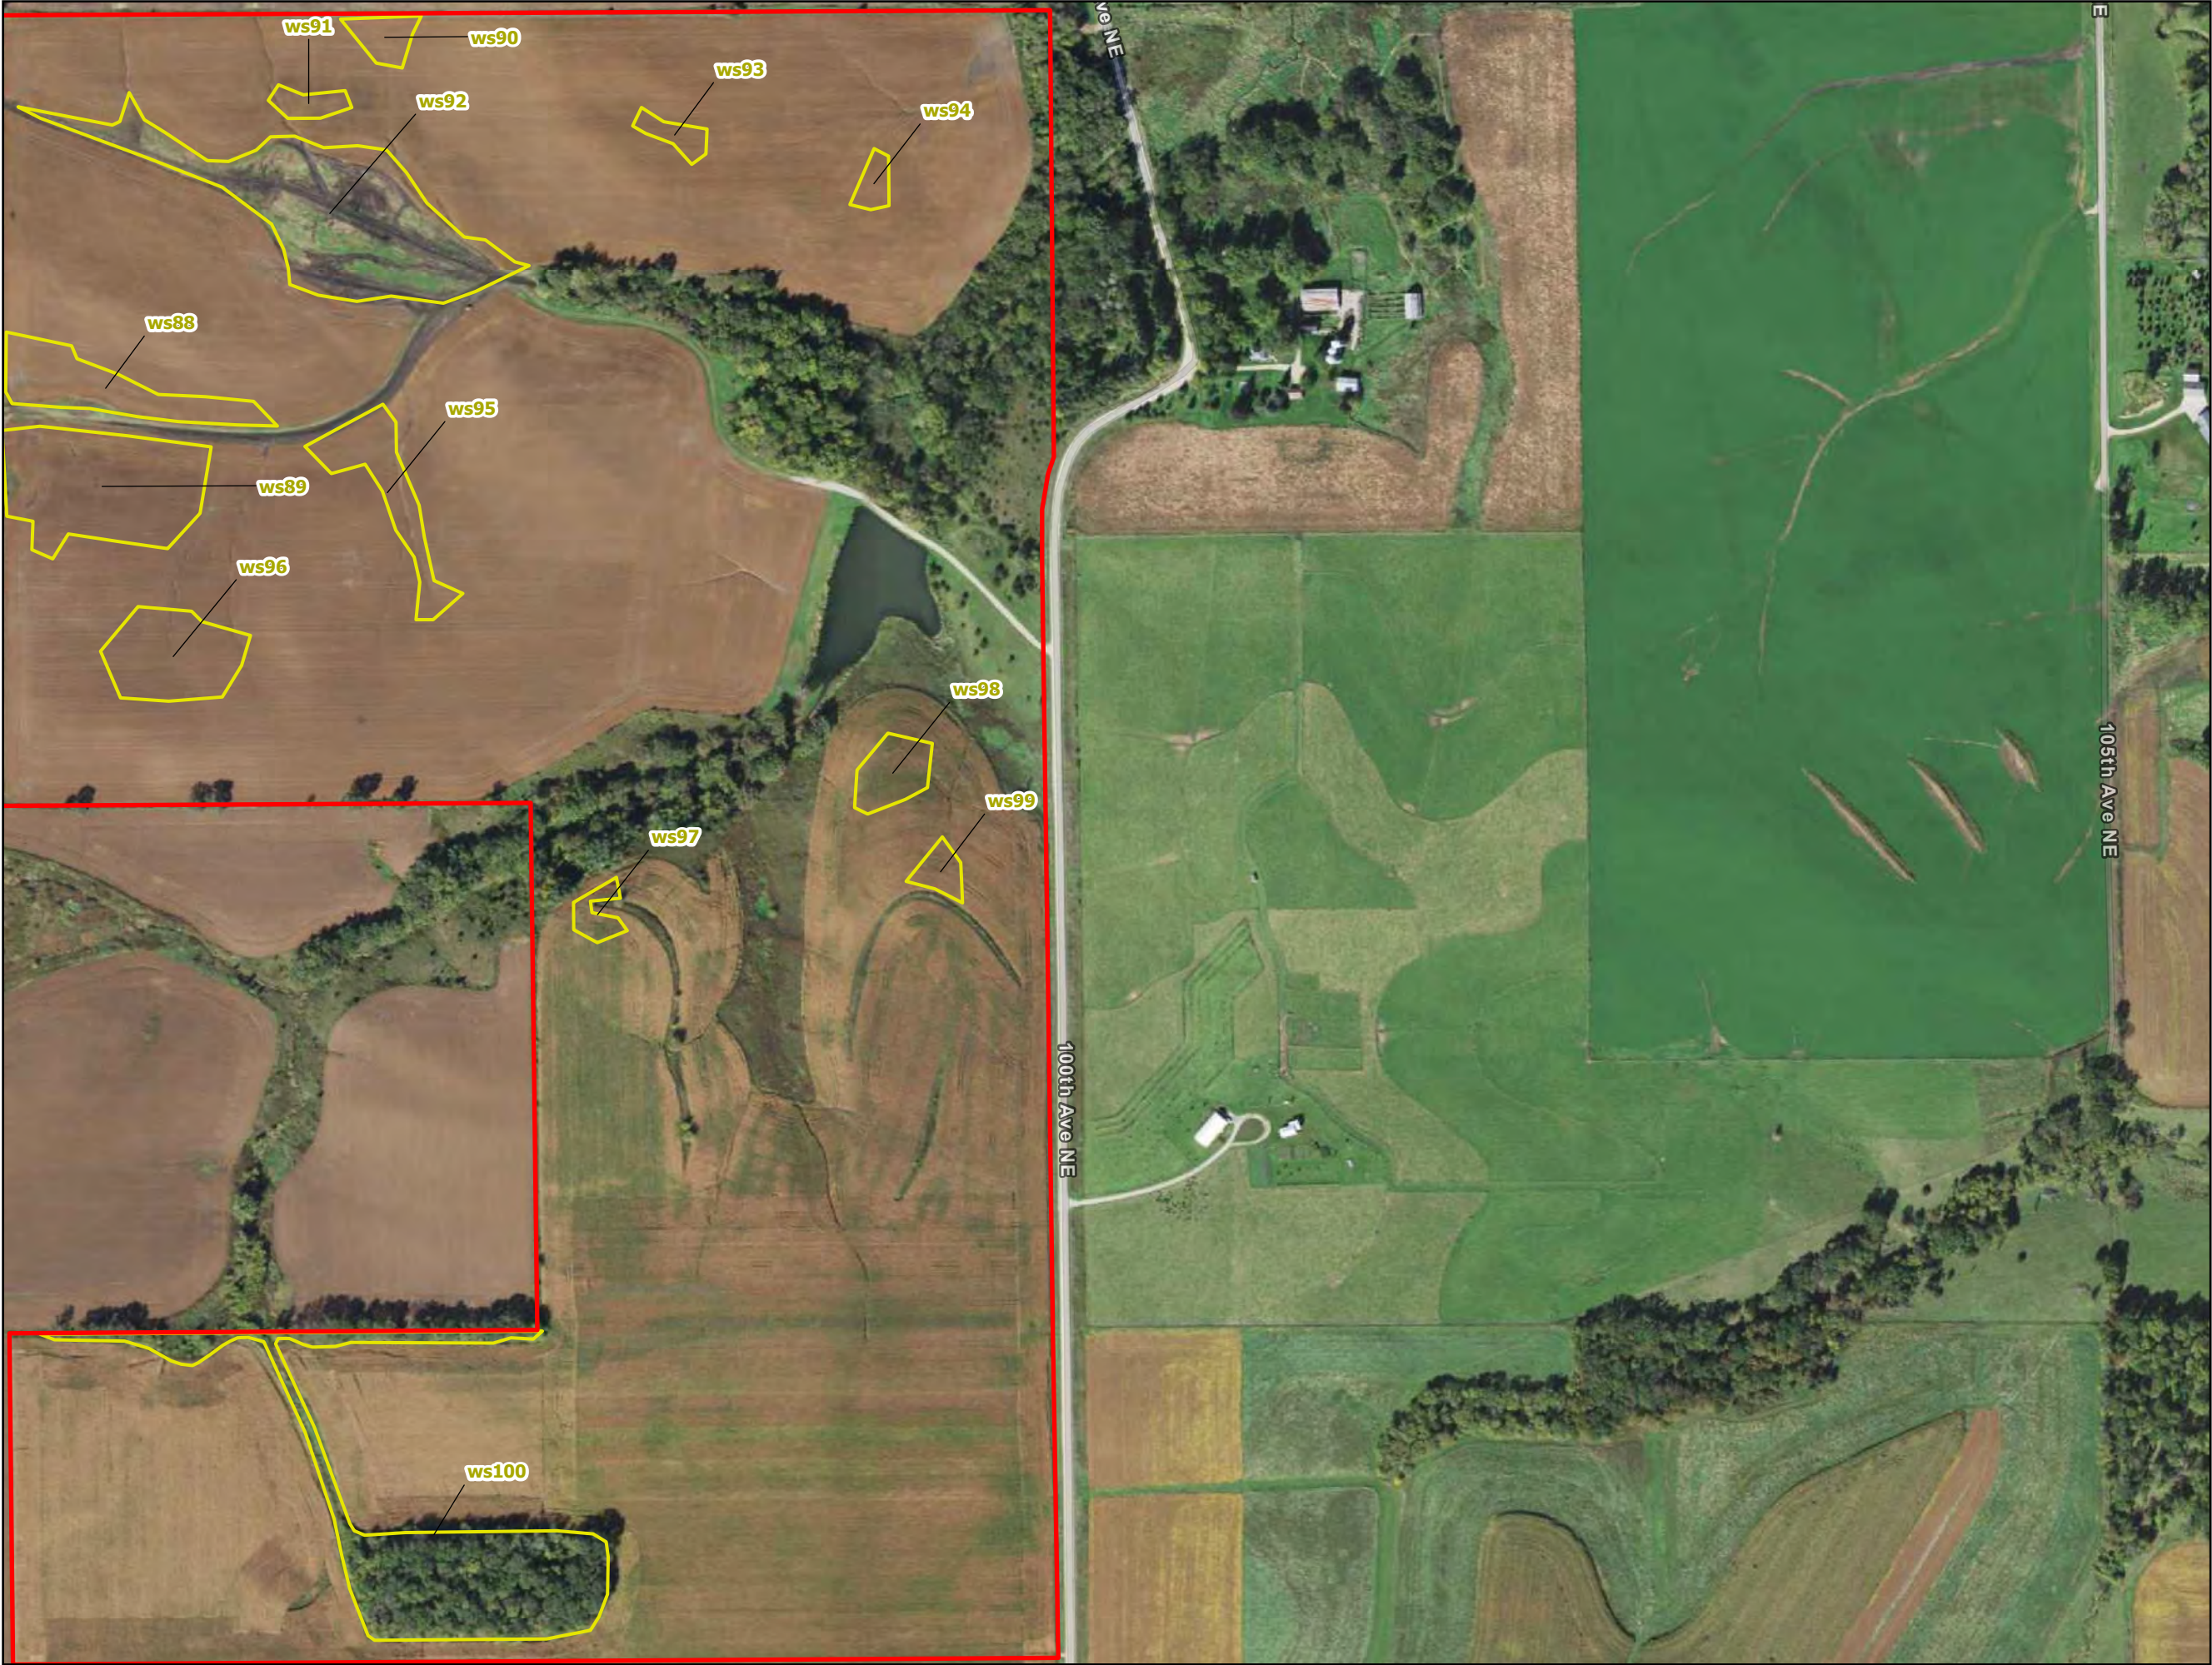
FSA Slide Review: NAIP Imagery -
October 2017
Lemon Hill Solar Project
Ranger Power
Olmsted County, MN

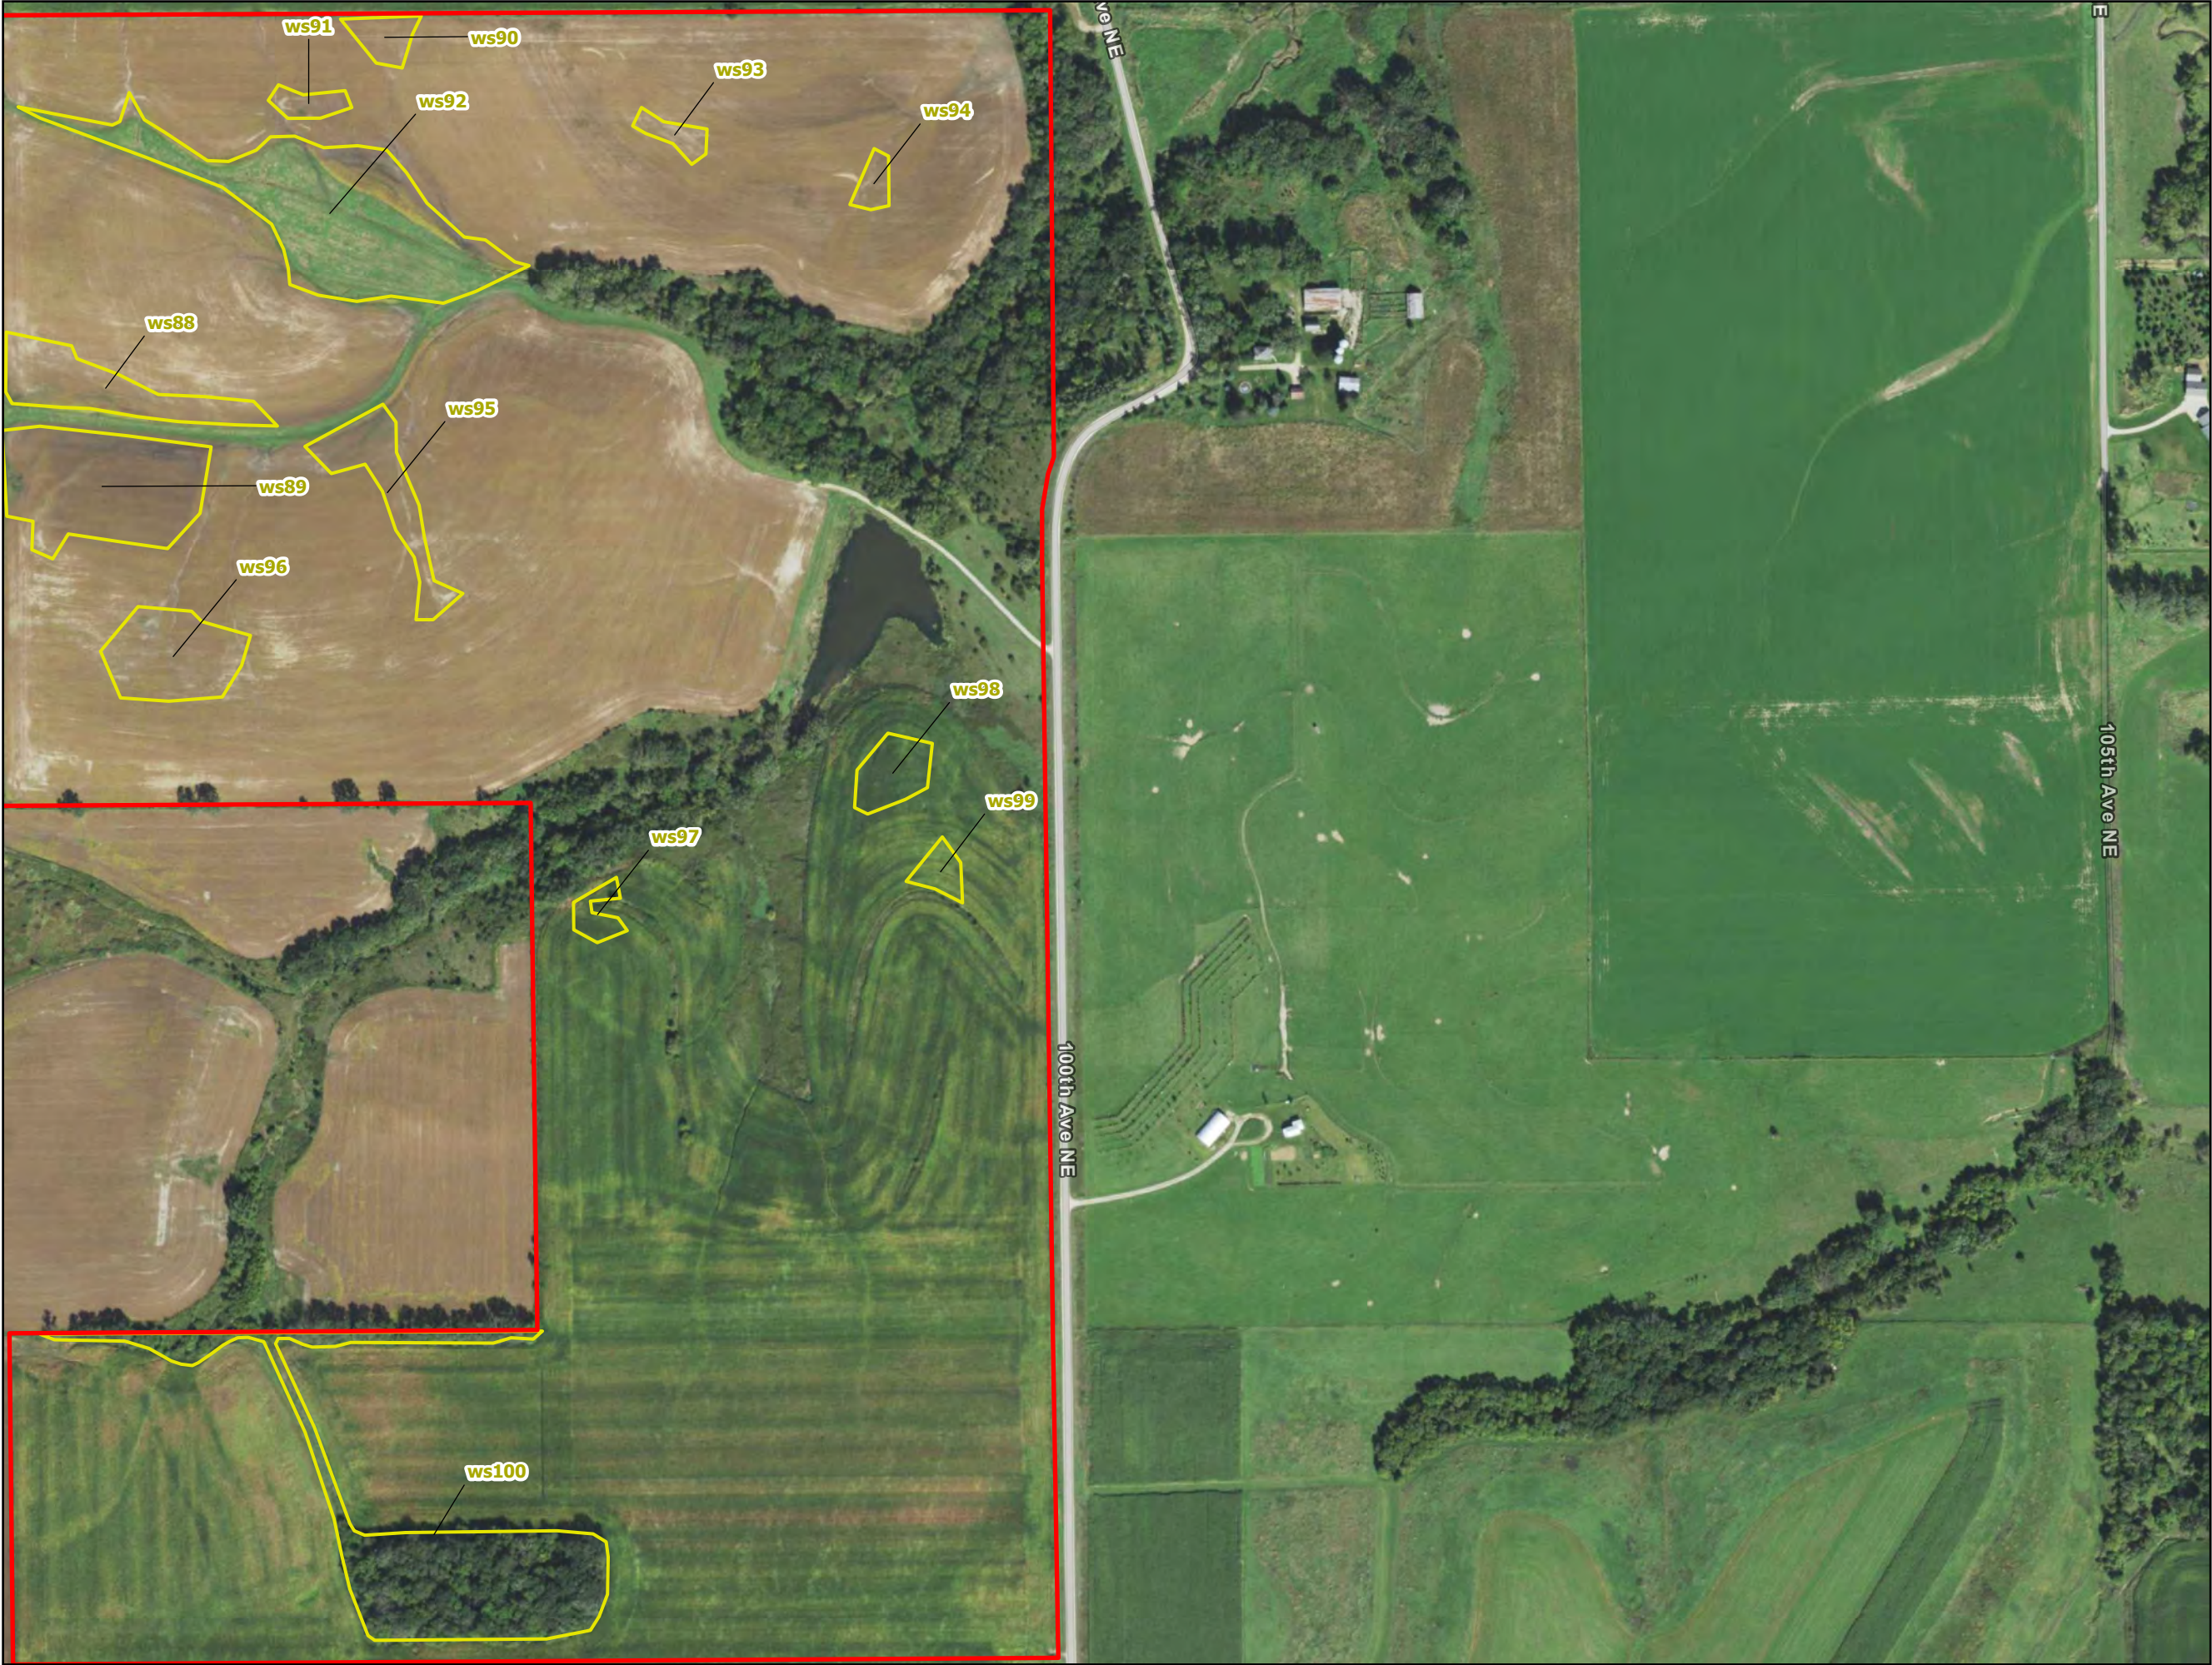
FSA Slide Review: NAIP Imagery -
August 2019
Lemon Hill Solar Project
Ranger Power
Olmsted County, MN

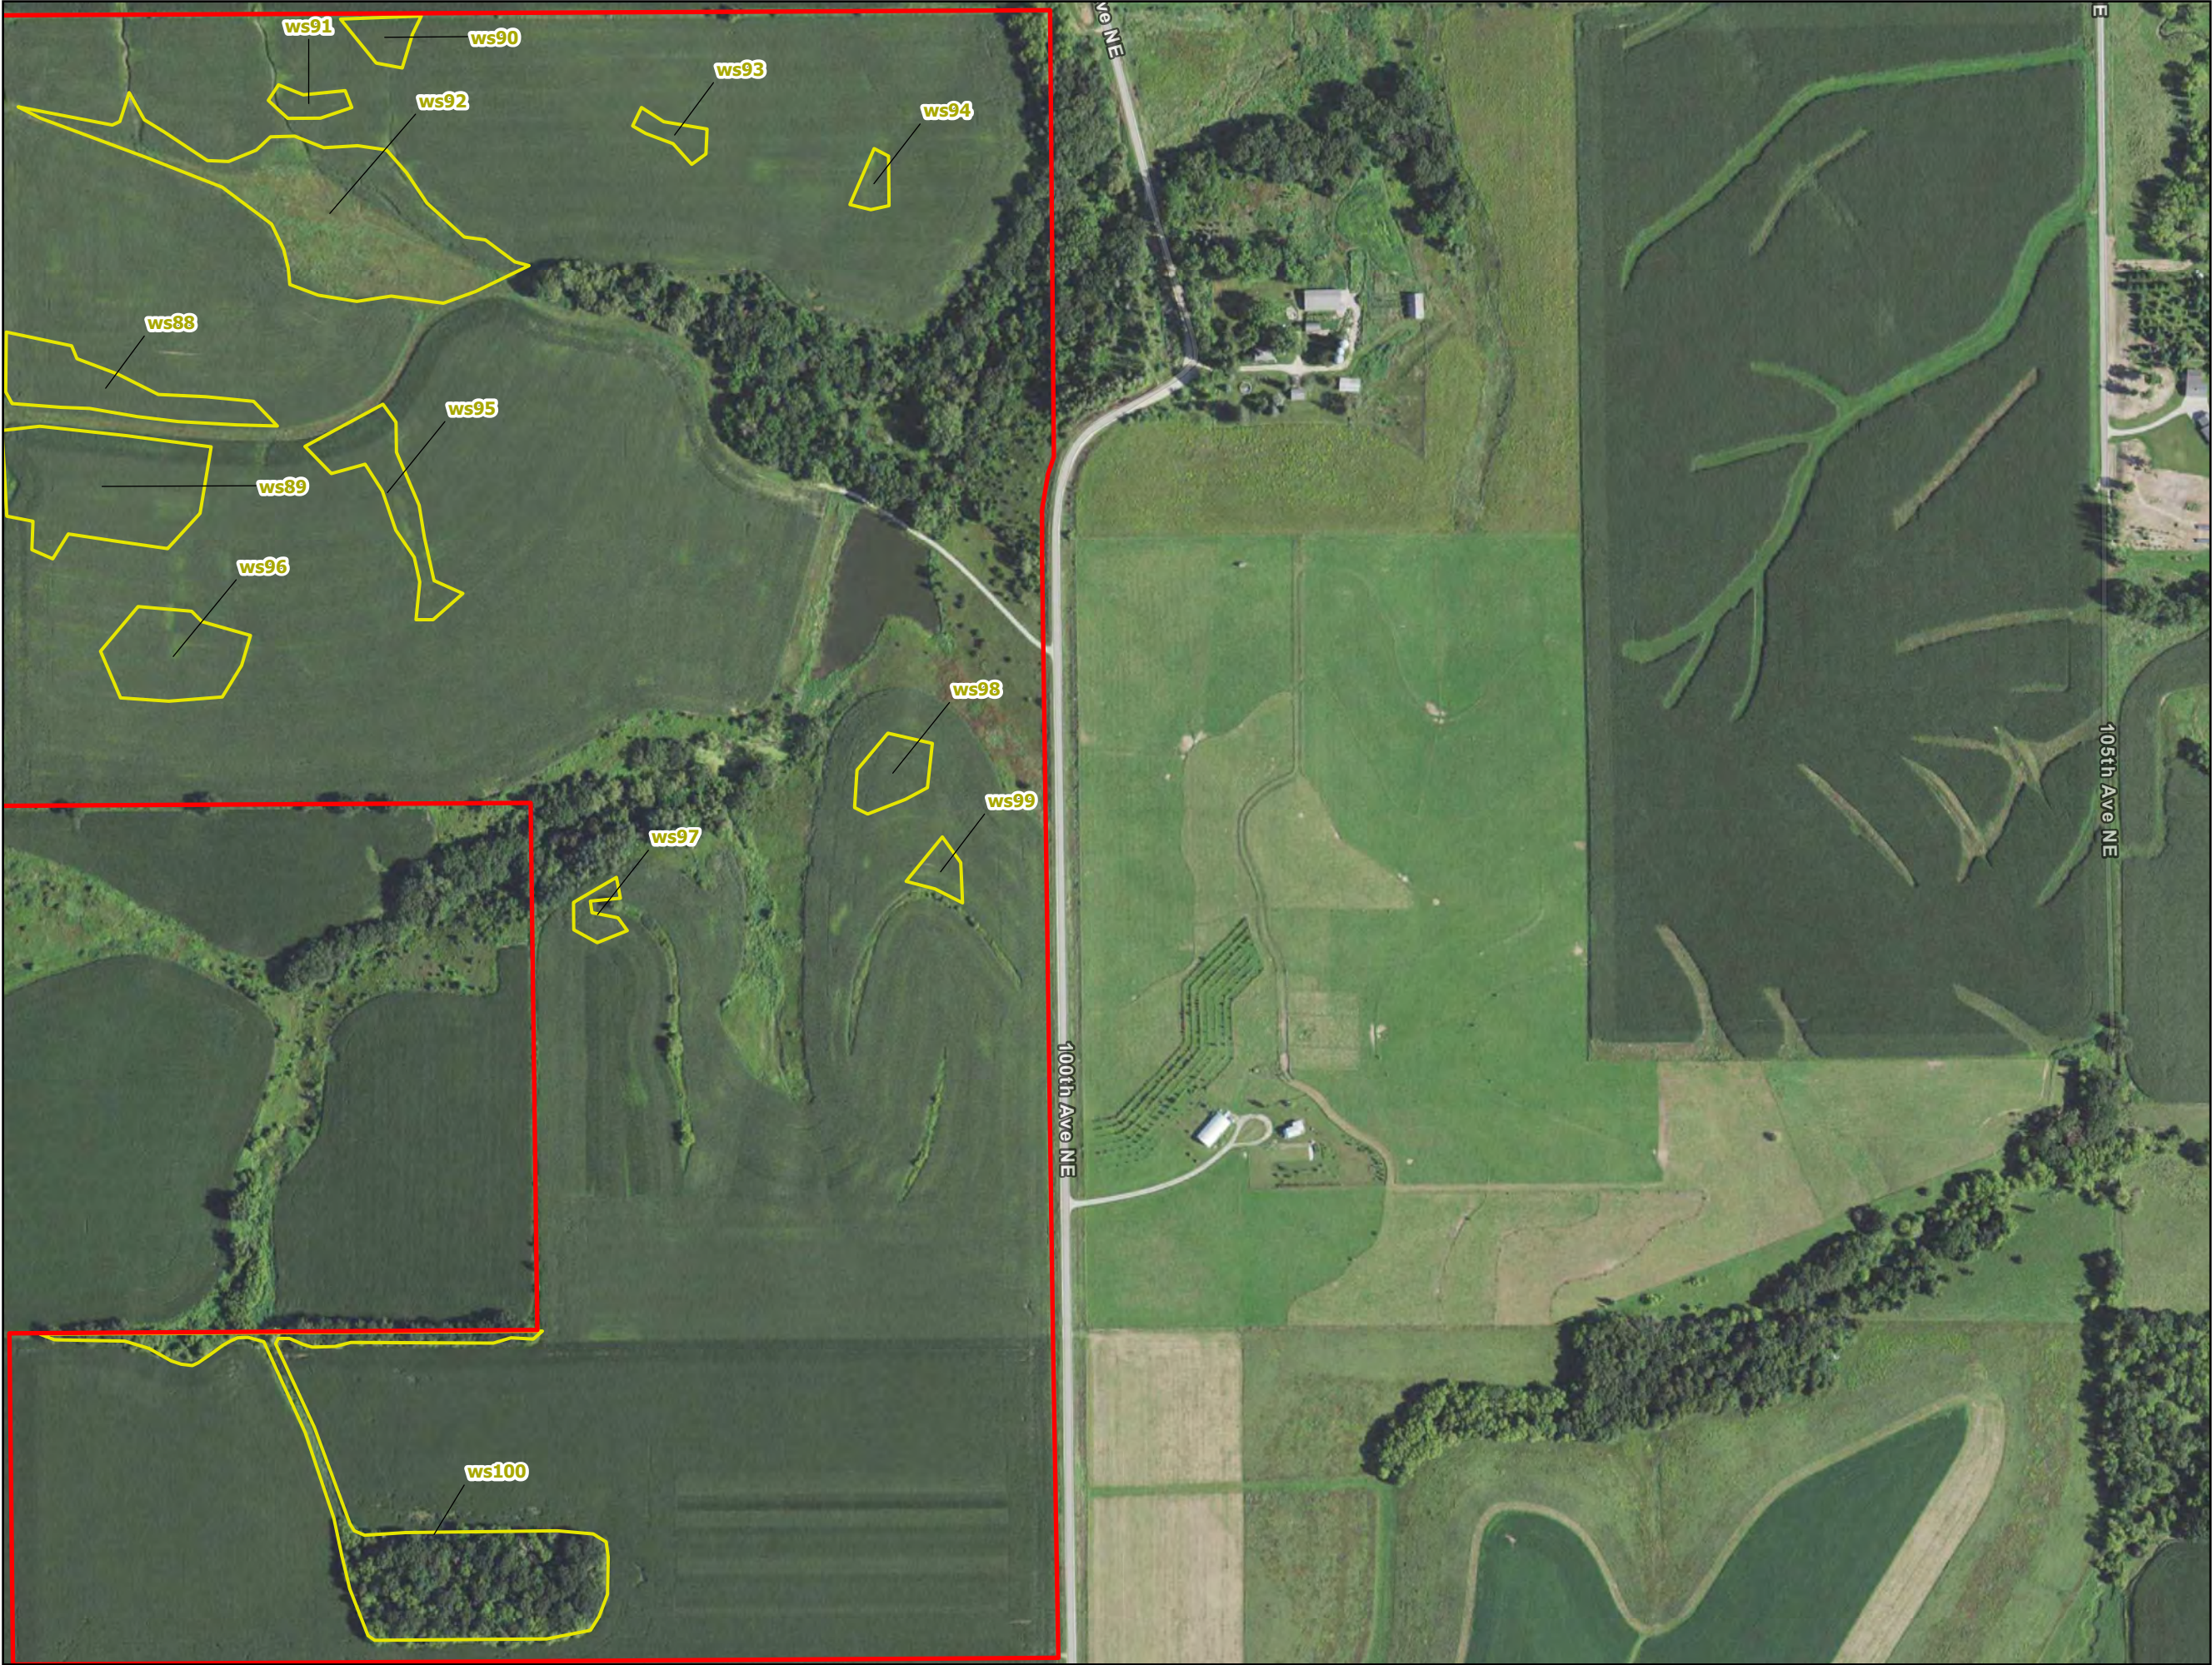
FSA Slide Review: NAIP Imagery -
August 2021
Lemon Hill Solar Project
Ranger Power
Olmsted County, MN
