Wetland Resources

Re: Wetland Delineation Report Midwater BESS, Shell Rock Township, Freeborn County

Westwood File 0046089.00

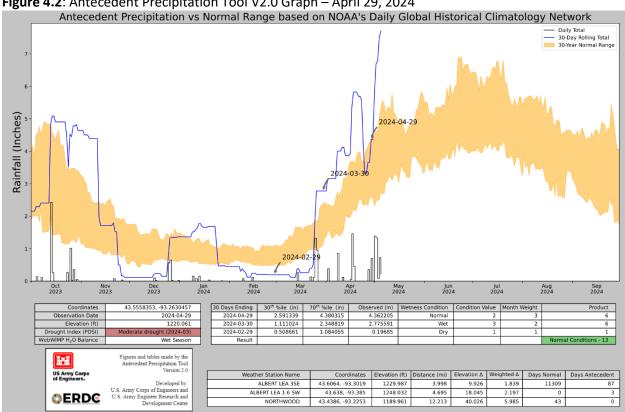
Figure 4.2: Antecedent Precipitation Tool V2.0 Graph – April 29, 2024

Antecedent precipitation data was evaluated for the 90 days prior to the site visit using the Antecedent Precipitation Tool (APT) developed by the USACE. Results from this data indicate antecedent precipitation was considered normal prior to the field review (Figure 4.2).

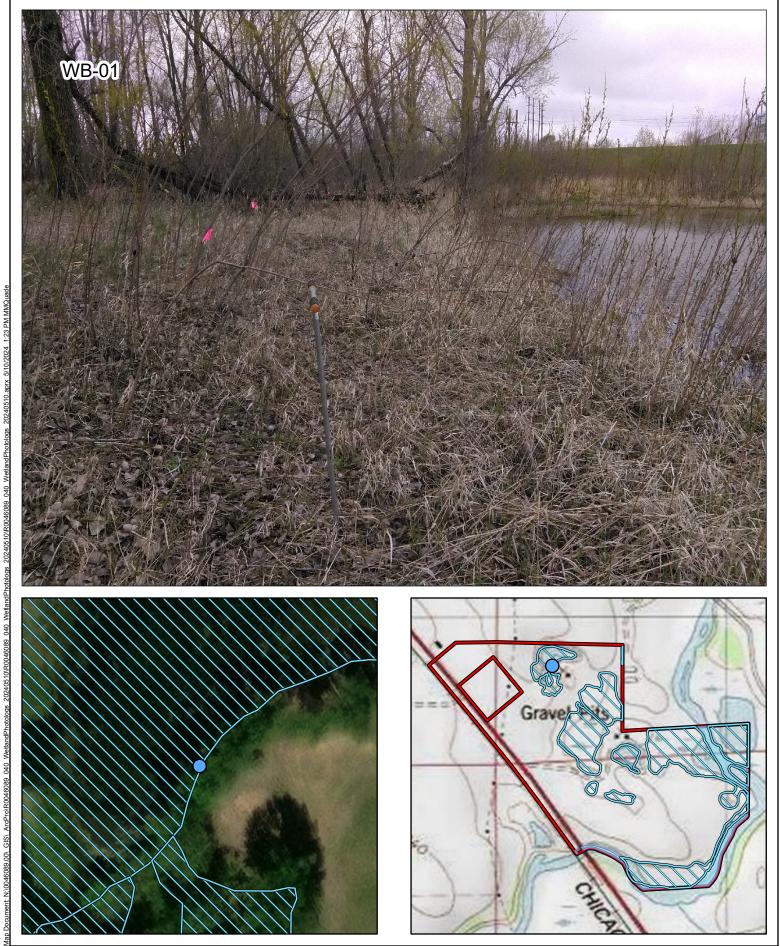
Midwater BESS Project Delineation Site Photograph

Project/Site: Midwater BESS	City/County: Freeborn County Sampling Date: 2024-04-29
Applicant/Owner: Spearmint Renewable Development	State: <u>Minnesota</u> Sampling Point: <u>WB-01-wet</u>
Investigator(s): <u>M. Stone, C. Gunn</u>	Section, Township, Range: sec 08 T101N R020W
Landform (hillslope, terrace, etc.): Toeslope	Local relief (concave, convex, none): <u>Concave</u>
Slope (%): <u>0-2</u> Lat: <u>43.560191</u>	Long: <u>-93.266967</u> Datum: <u>WGS84</u>
Soil Map Unit Name: Pits, sand and gravel	NWI classification: <u>PUBFx</u>
Are climatic / hydrologic conditions on the site typical for this time of ye	ear? Yes 🗹 No (If no, explain in Remarks.)
Are Vegetation, Soil, or Hydrology significantly	/ disturbed? Are "Normal Circumstances" present? Yes 🔽 No
Are Vegetation, Soil, or Hydrology naturally pr	oblematic? (If needed, explain any answers in Remarks.)
SUMMARY OF FINDINGS – Attach site map showing	g sampling point locations, transects, important features, etc.

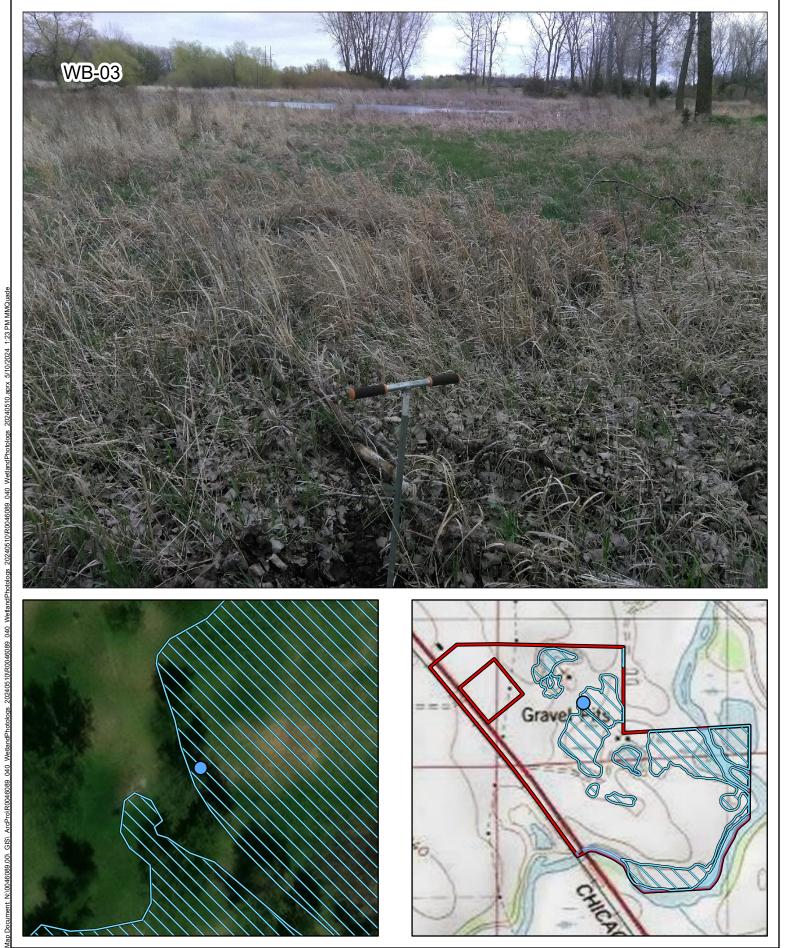
Midwater BESS Project Delineation Site Photograph

Project/Site: Midwater BESS	City/County: Freeborn County Sampling Date: 2024-04-29
Applicant/Owner: Spearmint Renewable Development	State: Minnesota Sampling Point: WB-03-wet
Investigator(s): <u>M. Stone, C. Gunn</u>	Section, Township, Range: sec 08 T101N R020W
Landform (hillslope, terrace, etc.): Depression	Local relief (concave, convex, none): Concave
Slope (%): 0-2 Lat: 43.559195	Long: <u>-93.265775</u> Datum: <u>WGS84</u>
Soil Map Unit Name: Pits, sand and gravel	NWI classification: PEM1A
Are climatic / hydrologic conditions on the site typical for this time of ye	ear? Yes 🗹 No (If no, explain in Remarks.)
Are Vegetation, Soil, or Hydrology significantly	/ disturbed? Are "Normal Circumstances" present? Yes No
Are Vegetation, Soil, or Hydrology naturally pr	oblematic? (If needed, explain any answers in Remarks.)
SUMMARY OF FINDINGS – Attach site map showing	g sampling point locations, transects, important features, etc.

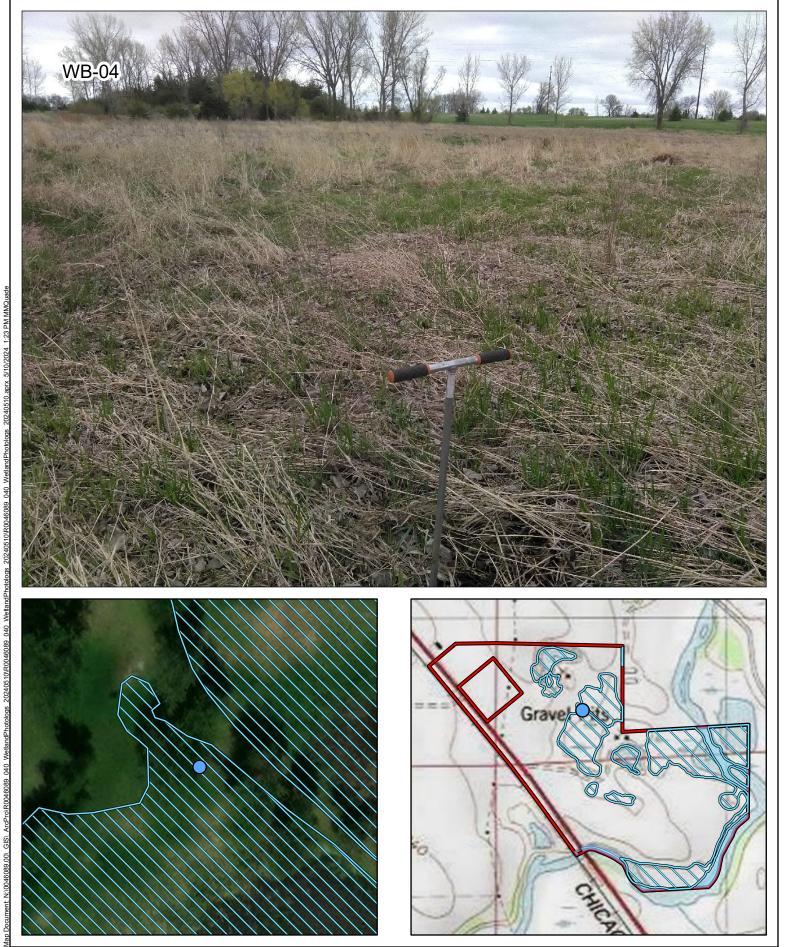
Midwater BESS Project Delineation Site Photograph

Project/Site: <u>Midwater BESS</u>			City/County: Fr	<u>eeborn County</u>	Sampling [Date: <u>2024</u>	-04-29
Applicant/Owner: Spearmint Rene	<u>wable Develo</u>	pment		State:	Minnesota Sampling Po	int: <u>WB-0</u>	4-wet
Investigator(s): M. Stone, C. Gunn			Section, Townsh	nip, Range: <u>sec 0</u>	8 T101N R020W		
Landform (hillslope, terrace, etc.): Dep	ression		Loca	l relief (concave, co	onvex, none): <u>Concave</u>)	
Slope (%): <u>0-2</u> Lat: <u>43.558</u>	956		_ Long: <u>-93.265</u>	764	Datum: <u>W</u>	GS84	
Soil Map Unit Name: Pits, sand and	gravel				NWI classification: PEN	/1A	
Are climatic / hydrologic conditions on th	ne site typical for	this time of y	vear?Yes 🖌	No (If no	, explain in Remarks.)		
Are Vegetation, Soil, or	Hydrology	_ significantl	y disturbed?	Are "Normal Circ	umstances" present? Ye	es 🖌	No
Are Vegetation, Soil, or	Hydrology	naturally p	roblematic?	(If needed, expla	in any answers in Remar	ks.)

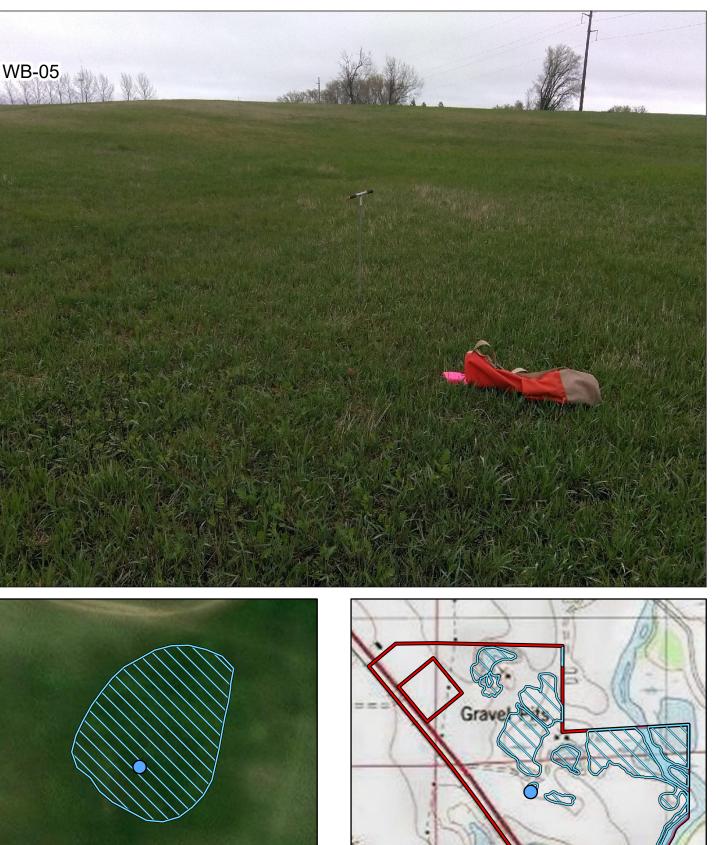
Midwater BESS Project Delineation Site Photograph

Project/Site: Midwater BESS	City/County: Freeborn County Sampling Date: 2024-04-29			
Applicant/Owner: Spearmint Renewable Development	State: Minnesota Sampling Point: WB-05-WET			
Investigator(s): M. Stone, C. Gunn	Section, Township, Range: <u>sec 17 T101N R020W</u>			
Landform (hillslope, terrace, etc.): Depression	Local relief (concave, convex, none): Concave			
Slope (%): 0-2 Lat: 43.556635	Long: -93.265435 Datum: WGS84			
Soil Map Unit Name: Estherville sandy loam, 6 to 12 percent	t slopes NWI classification: None			
Are climatic / hydrologic conditions on the site typical for this time of ye	ear? Yes 🗹 No (If no, explain in Remarks.)			
Are Vegetation, Soil, or Hydrology significantly	/ disturbed? Are "Normal Circumstances" present? Yes <u>v</u> No			
Are Vegetation, Soil, or Hydrology naturally pro	roblematic? (If needed, explain any answers in Remarks.)			
SUMMARY OF FINDINGS – Attach site map showing	sampling point locations, transects, important features, etc.

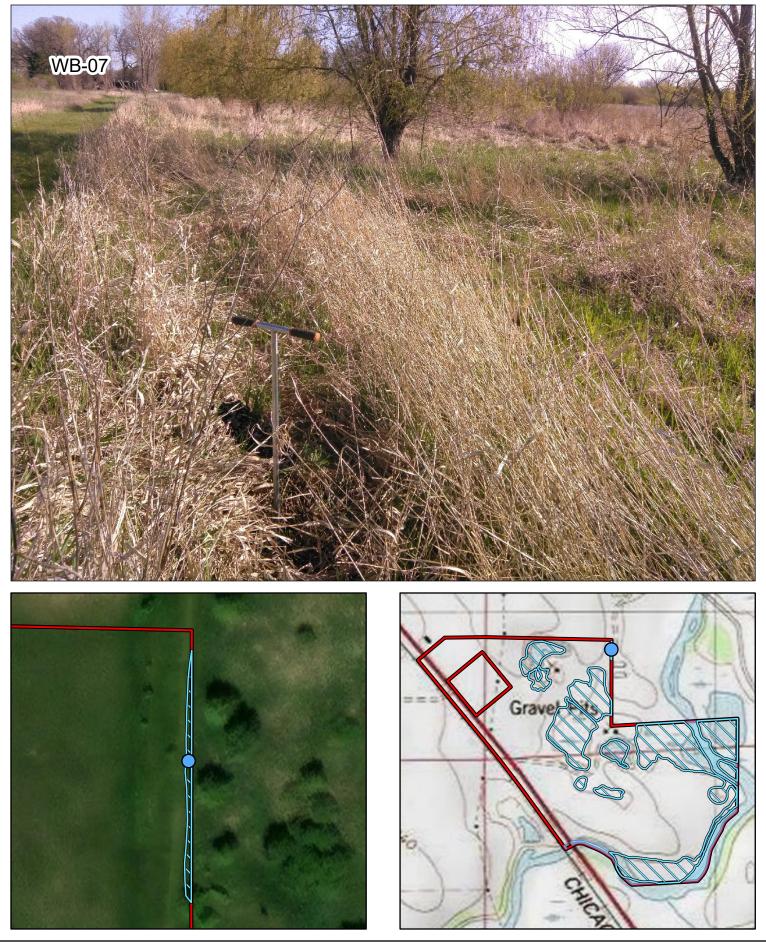
Midwater BESS Project Delineation Site Photograph

Project/Site: Midwater BESS	City/County: Freeborn County	Sampling Date: 2024-04-30
Applicant/Owner: Spearmint Renewable Development	State: <u>Mi</u>	innesota Sampling Point: WB-07-wet
Investigator(s): M. Stone	Section, Township, Range: <u>Sec 08</u>	T101N R020W
Landform (hillslope, terrace, etc.): Depression	Local relief (concave, con	vex, none): <u>Concave</u>
Slope (%): <u>0-2</u> Lat: <u>43.560501</u>	Long: <u>-93.264208</u>	Datum: <u>WGS84</u>
Soil Map Unit Name: Aquents and Histosols, ponded	N	WI classification: <u>None</u>
Are climatic / hydrologic conditions on the site typical for this time	of year? Yes No (If no, e	explain in Remarks.)
Are Vegetation, Soil, or Hydrology signific	antly disturbed? Are "Normal Circun	nstances" present? Yes 🔽 No
Are Vegetation, Soil, or Hydrology natura	lly problematic? (If needed, explain	any answers in Remarks.)
SUMMARY OF FINDINGS – Attach site map show	ving sampling point locations, t	ransects, important features, etc.

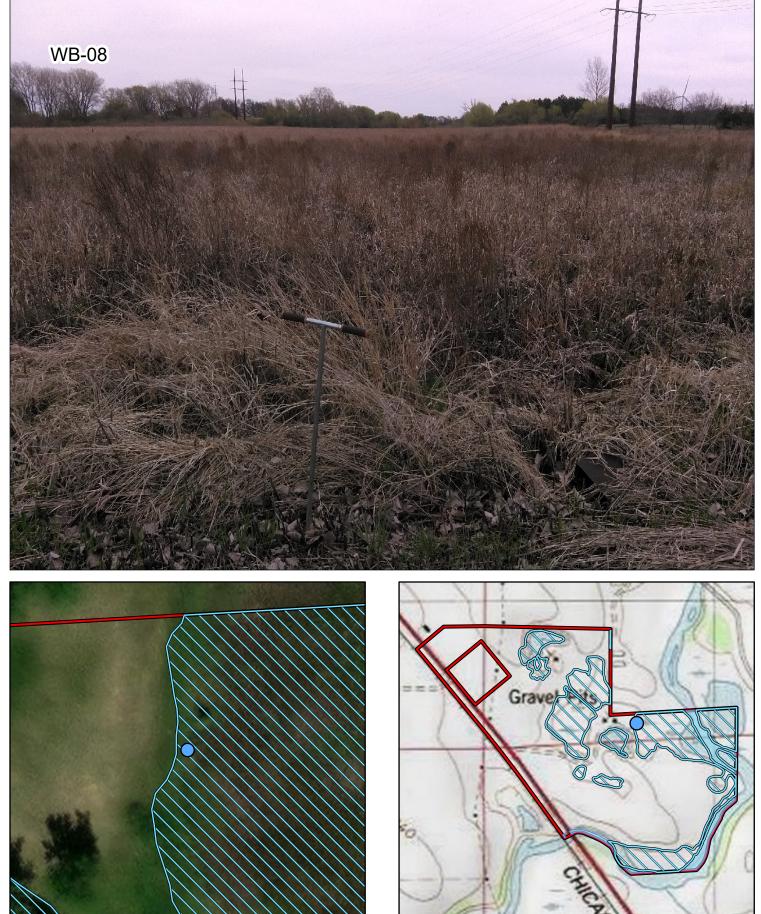
Midwater BESS Project Delineation Site Photograph

Project/Site: Midwater BESS	City/County: Freeborn County	Sampling Date: 2024-04-30
Applicant/Owner: Spearmint Renewable Development	State: Minr	nesota Sampling Point: WB-08-wet
Investigator(s): M. Stone	Section, Township, Range: <u>Sec 08 T</u>	101N R020W
Landform (hillslope, terrace, etc.): Depression	Local relief (concave, conve	x, none): <u>Concave</u>
Slope (%): <u>0-2</u> Lat: <u>43.558105</u>	Long: -93.263211	Datum: WGS84
Soil Map Unit Name: Muskego soils, 0 to 1 percent slope	NW	classification: <u>None</u>
Are climatic / hydrologic conditions on the site typical for this time of	of year? Yes 🖌 No (If no, exp	plain in Remarks.)
Are Vegetation, Soil, or Hydrology significa	Intly disturbed? Are "Normal Circums	tances" present? Yes 🖌 No
Are Vegetation, Soil, or Hydrology naturally	y problematic? (If needed, explain ar	ny answers in Remarks.)
SUMMARY OF FINDINGS – Attach site map show	ing sampling point locations, tra	nsects, important features, etc.

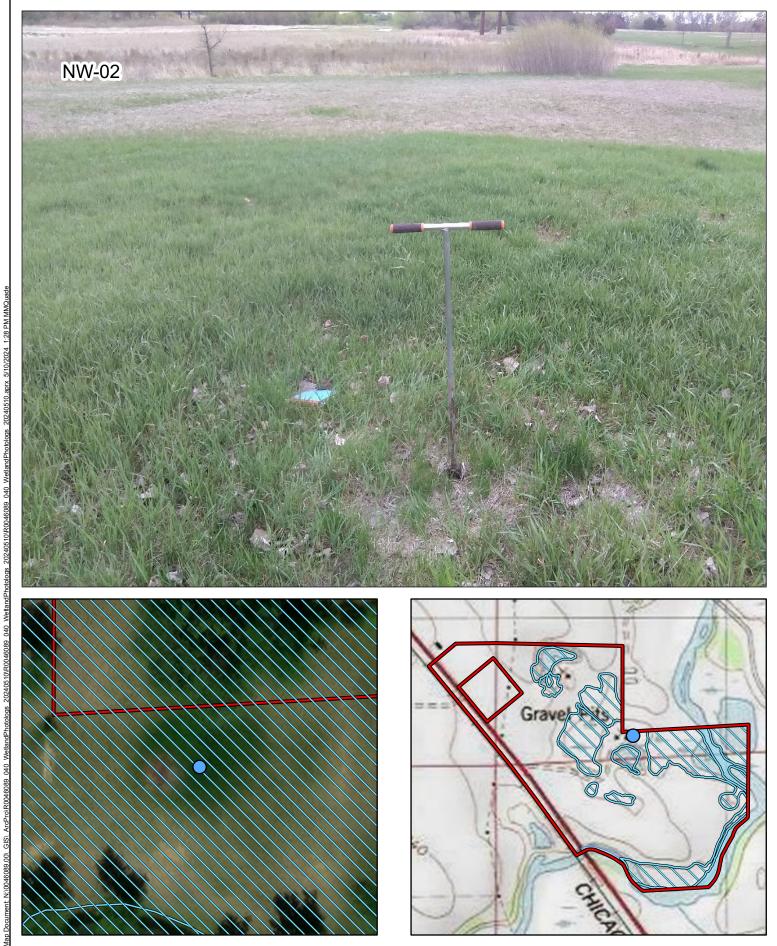
Midwater BESS Project Delineation Site Photograph

Project/Site: Midwater BESS		City/County: Freeborn County Sampling Date: 2024-04						
Applicant/Owner: Spearmint Renewab	le Development	State: Minnesota Sampling Point: NW-02						
Investigator(s): M. Stone, C. Gunn		Section, Township, Range: <u>sec 08 T101N R020W</u>						
Landform (hillslope, terrace, etc.): Rise		Local relief (concave, convex, none): <u>Convex</u>						
Slope (%): <u>0-2</u> Lat: <u>43.558246</u>		Long: <u>-93.263813</u>	Datum: WGS84					
Soil Map Unit Name: Pits, sand and gra	vel		NWI classification: None					
Are climatic / hydrologic conditions on the sit	e typical for this time of ye	ear? Yes 🖌 No (If	no, explain in Remarks.)					
Are Vegetation, Soil, or Hydr	ology significantly	disturbed? Are "Normal C	ircumstances" present? Yes 🖌 No					
Are Vegetation, Soil, or Hydr	ology naturally pr	oblematic? (If needed, exp	plain any answers in Remarks.)					
SUMMARY OF FINDINGS – Attach site map showing sampling point locations, transects, important features, etc.

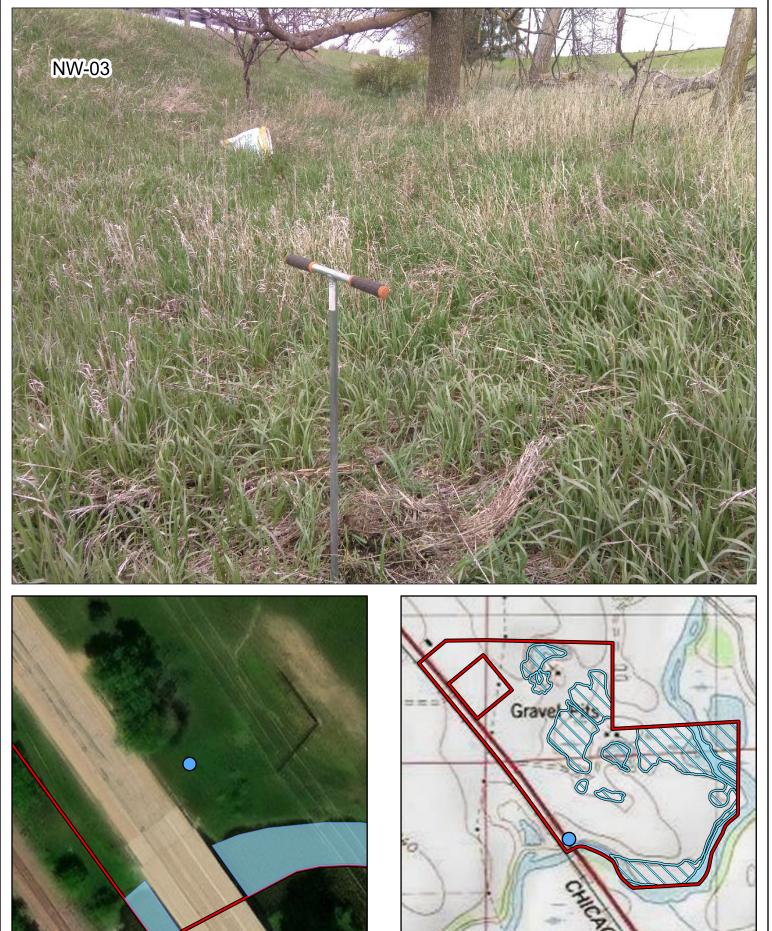
Midwater BESS Project Delineation Site Photograph

Project/Site: Midwater BESS	City/County: Freeborn Co	unty Sampling Date: 2024-04-30						
Applicant/Owner: Spearmint Renewable Developme	ntSf	tate: <u>Minnesota</u> Sampling Point: <u>NW-03</u>						
Investigator(s): <u>M. Stone</u>	Section, Township, Range: <u>S</u>	ec 17 T101N R020W						
Landform (hillslope, terrace, etc.): Ditch	Local relief (conca	ve, convex, none): <u>Concave</u>						
Slope (%): <u>0-2</u> Lat: <u>43.555223</u>	Long: <u>-93.265921</u>	Datum: WGS84						
Soil Map Unit Name: Kalmarville loam, frequently floo	ded	NWI classification: None						
Are climatic / hydrologic conditions on the site typical for this time of year? Yes <u>V</u> No (If no, explain in Remarks.)								
Are Vegetation, Soil, or Hydrology sign	ificantly disturbed? Are "Norma	I Circumstances" present? Yes No						
Are Vegetation, Soil, or Hydrology natu	rally problematic? (If needed,	explain any answers in Remarks.)

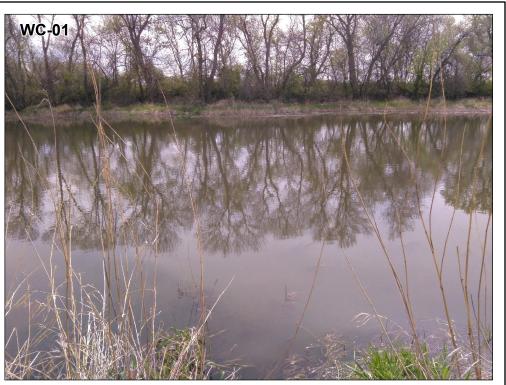
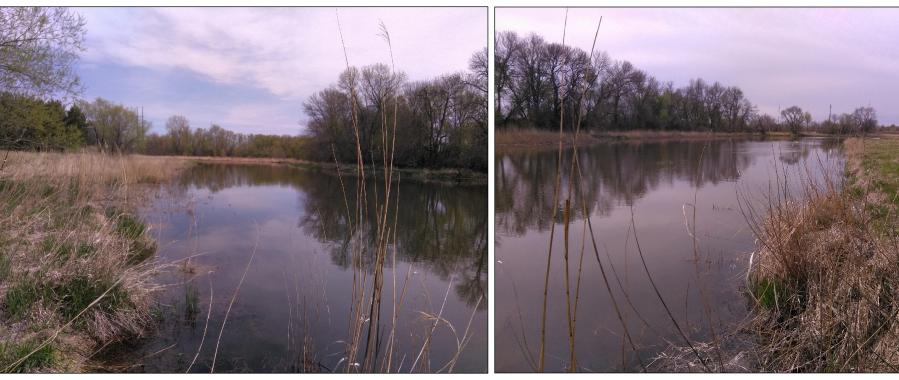
Midwater BESS Project Watercourse Data Form

Attributes	
Feature ID	WC-01	
Defined Bed & Bank	Yes	
Mapped on NHD	Yes	
Mapped on NWI	Yes	
Investigator		
Flow Characteristics	Perennial	
Direction of the Flow	S	
Water Width at Observation Point (ft)	50	
Water Depth at Observation Point (ft)	15	
Left Bank Height (ft) - Looking Downstream	3	
Right Bank Height (ft) - Looking Downstream	4	
OHWM Width (ft)	50+	
OHWM Height (ft from Substrate)	12	
Evidence of Scour or Erosion	Yes	
OHWM Criteria	Bed and banks	
Pools, Riffles, Runs Present?	Riffles	
Substrate	Clay

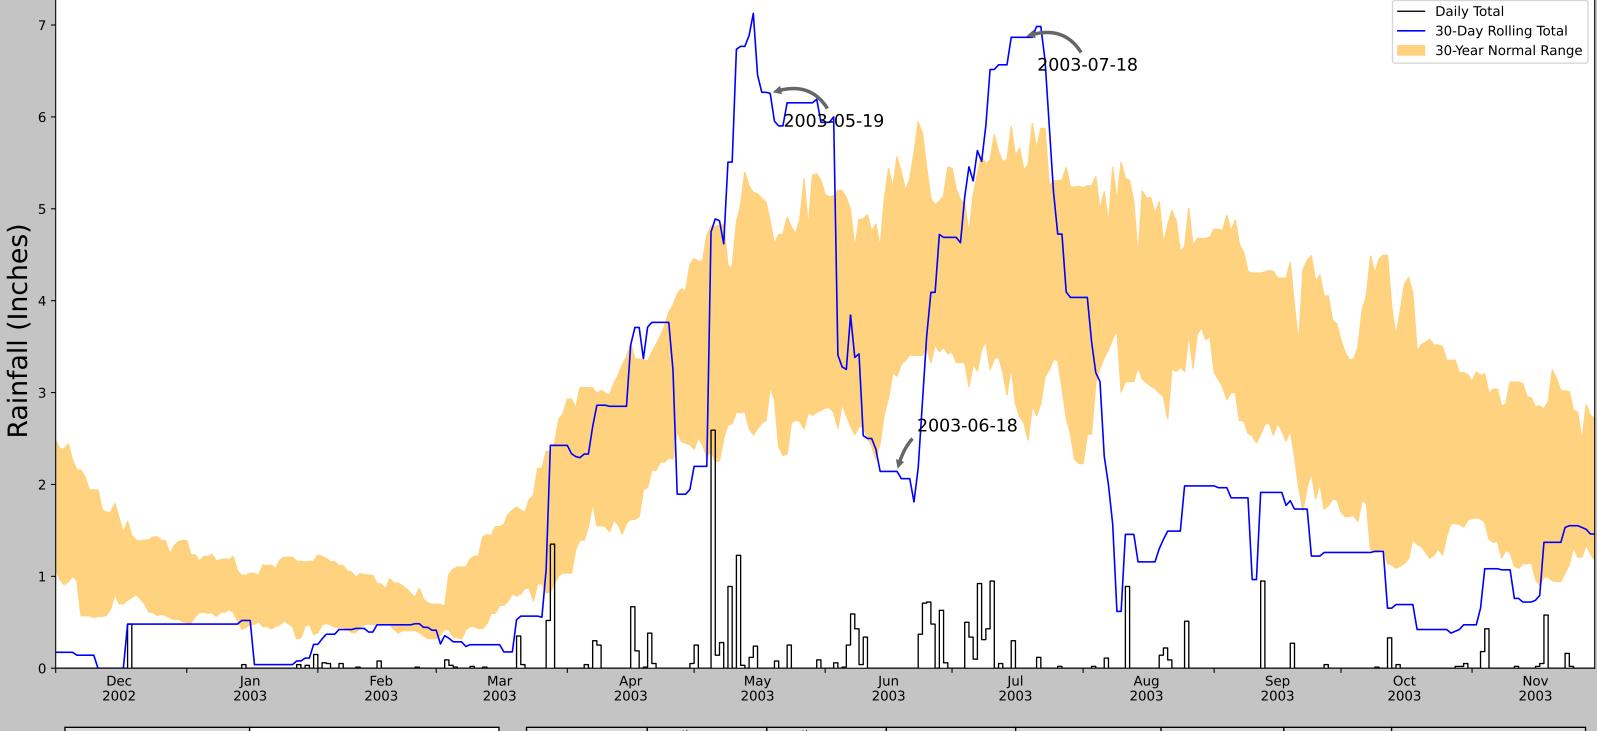
Coordinates	43.5556353, -93.2642970
Observation Date	2003-07-18
Elevation (ft)	1225.833
Drought Index (PDSI)	Normal
WebWIMP H_2O Balance	Dry Season

30 Days Ending	30 th %ile (in)	70 th %ile (in)	Observed (in)	Wetness Condition	Condition Value	Month Weight	Product
2003-07-18	2.67126	5.419685	6.866142	Wet	3	3	9
2003-06-18	3.179921	5.565748	2.141732	Dry	1	2	2
2003-05-19	3.059843	4.861024	6.255906	Wet	3	1	3
Result							Normal Conditions - 14

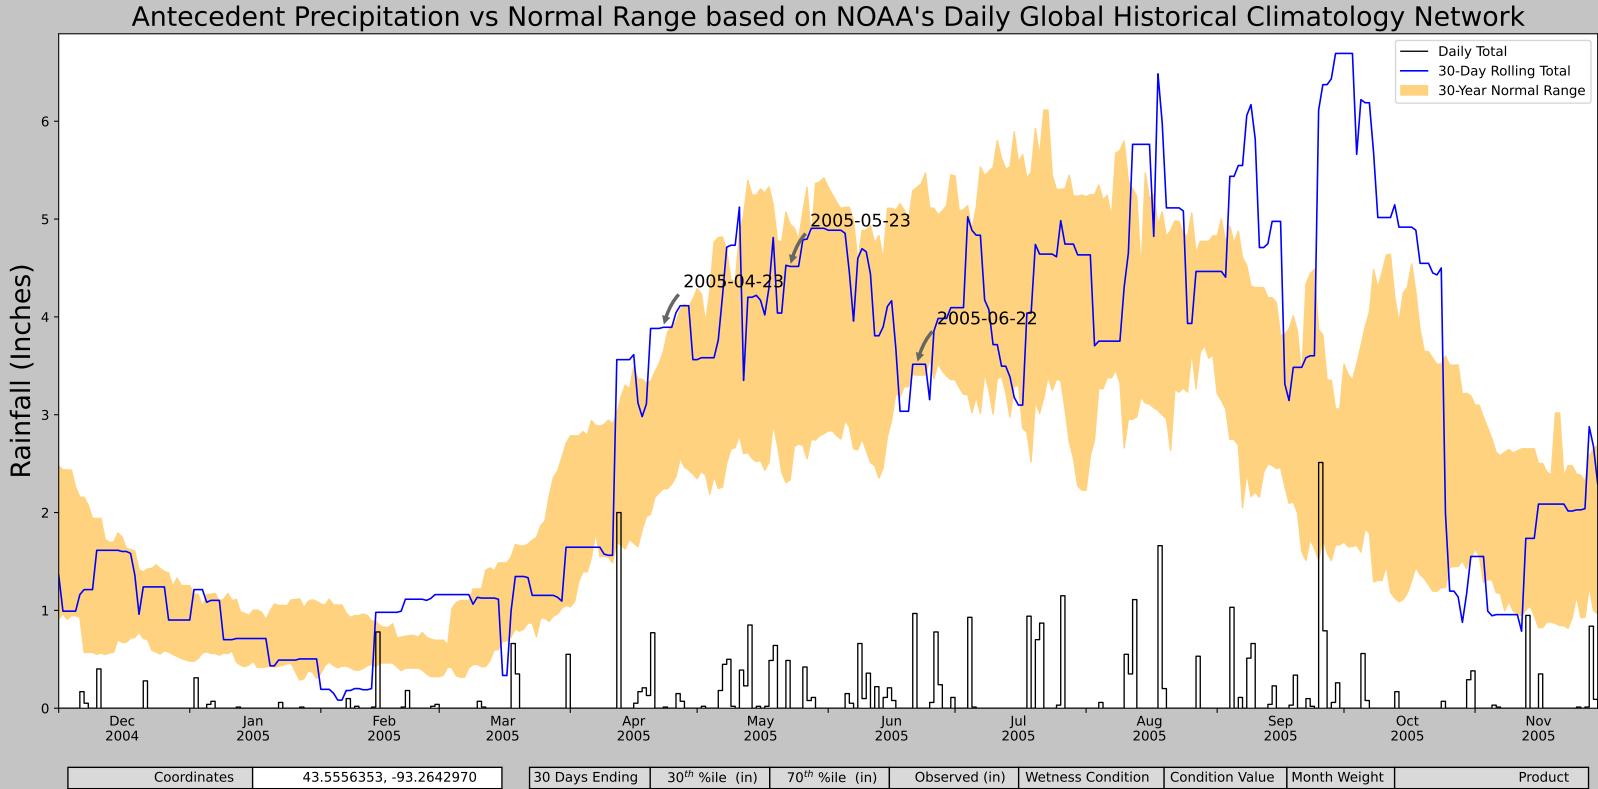
Coordinates	43.5556353, -93.2642970
Observation Date	2005-06-22
Elevation (ft)	1225.833
Drought Index (PDSI)	Severe wetness
WebWIMP H ₂ O Balance	Dry Season

30 Days Ending	30 th %ile (in)	70 th %ile (in)	Observed (in)	Wetness Condition	Condition Value	Month Weight	Product
2005-06-22	3.404331	5.325197	3.515748	Normal	2	3	6
2005-05-23	2.333465	4.948425	4.515748	Normal	2	2	4
2005-04-23	2.243701	3.645276	3.893701	Wet	3	1	3
Result							Normal Conditions - 13

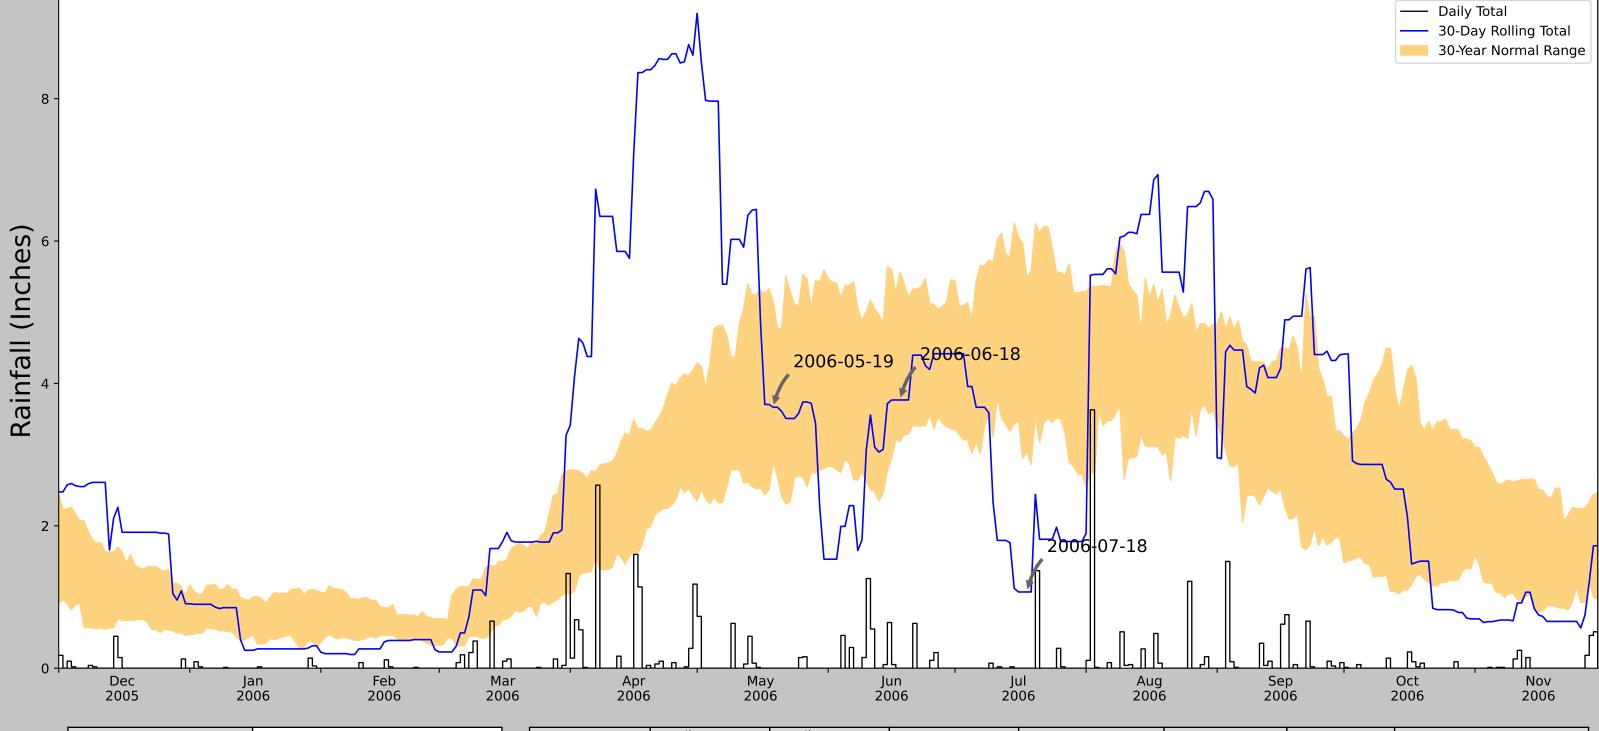
Coordinates	43.5556353, -93.2642970
Observation Date	2006-07-18
Elevation (ft)	1225.833
Drought Index (PDSI)	Mild drought
WebWIMP H ₂ O Balance	Dry Season

30 Days Ending	30 th %ile (in)	70 th %ile (in)	Observed (in)	Wetness Condition	Condition Value	Month Weight	Product
2006-07-18	3.038583	5.481496	1.070866	Dry	1	3	3
2006-06-18	3.179921	5.565748	3.767717	Normal	2	2	4
2006-05-19	2.901575	5.151181	3.665354	Normal	2	1	2
Result							Drier than Normal - 9

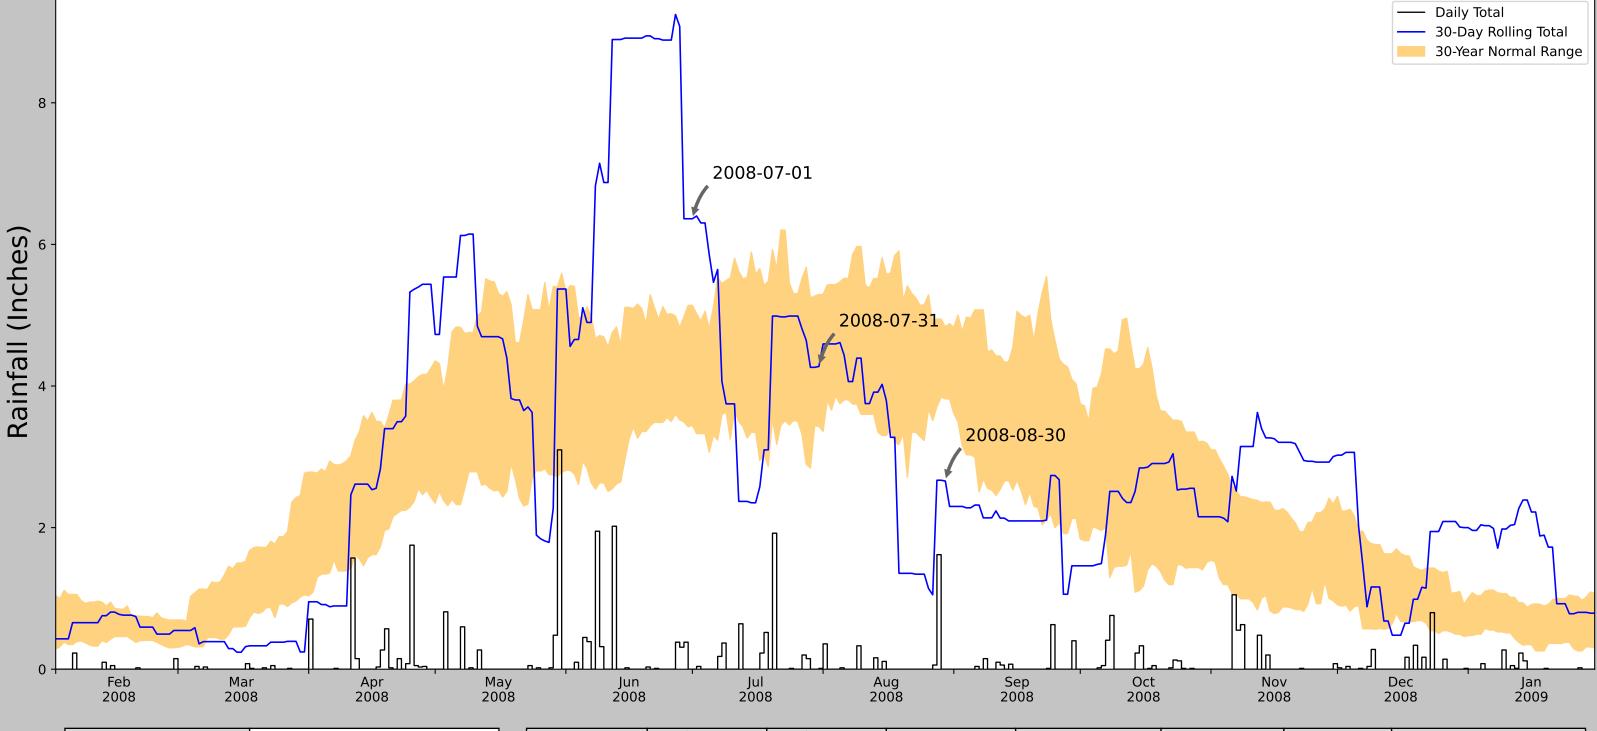
Coordinates	43.5556353, -93.2642970
Observation Date	2008-08-30
Elevation (ft)	1225.833
Drought Index (PDSI)	Incipient drought
WebWIMP H ₂ O Balance	Dry Season

30 Days Ending	30 th %ile (in)	70 th %ile (in)	Observed (in)	Wetness Condition	Condition Value	Month Weight	Product
2008-08-30	3.817717	4.837008	2.65748	Dry	1	3	3
2008-07-31	3.433465	5.29252	4.275591	Normal	2	2	4
2008-07-01	3.445276	5.138583	6.362205	Wet	3	1	3
Result							Normal Conditions - 10

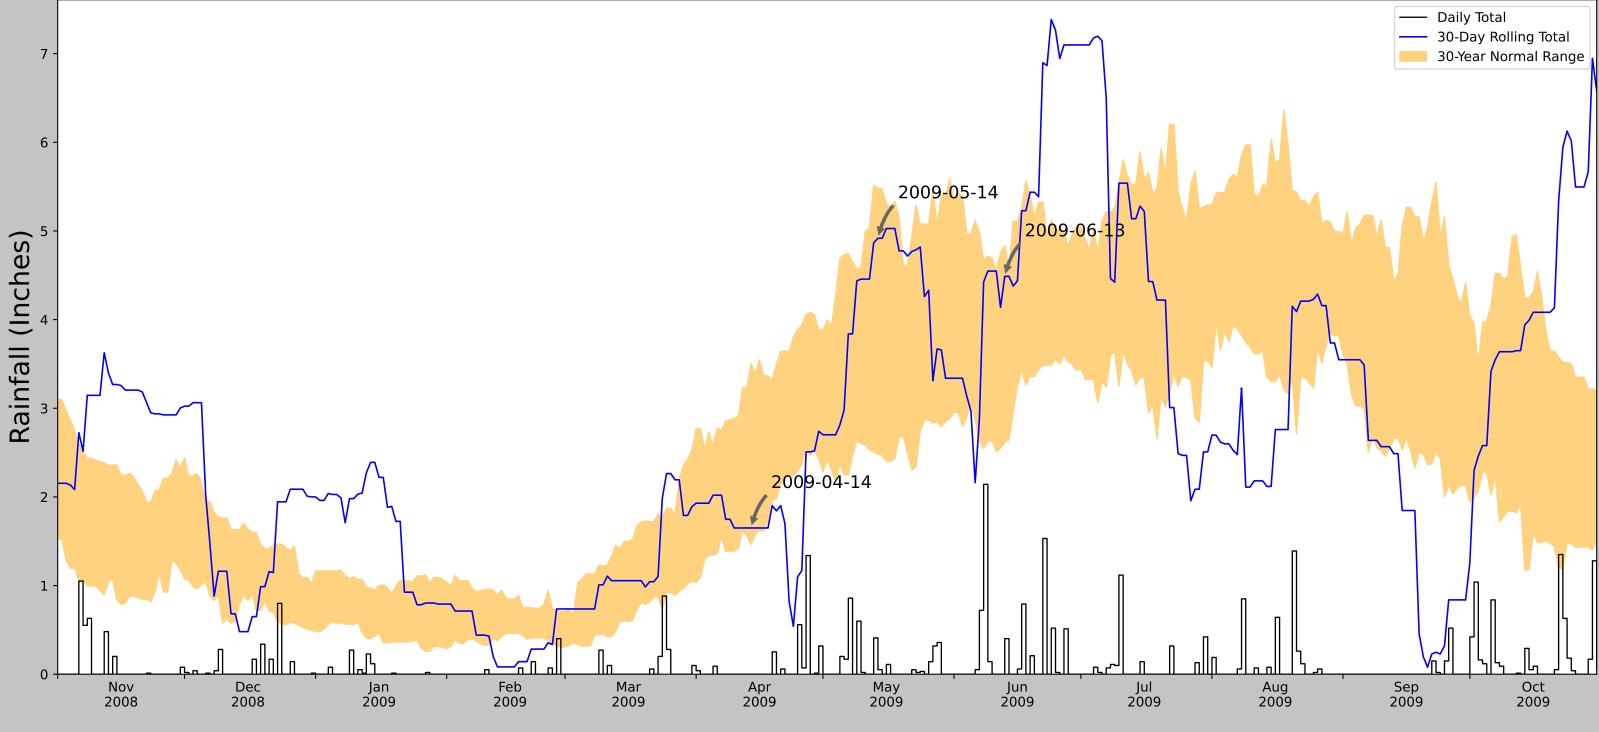
Coordinates	43.5556353, -93.2642970
Observation Date	2009-06-13
Elevation (ft)	1225.833
Drought Index (PDSI)	Mild drought
WebWIMP H ₂ O Balance	Dry Season

30 Days Ending	30 th %ile(in)	70 th %ile (in)	Observed (in)	Wetness Condition	Condition Value	Month Weight	Product
2009-06-13	2.616142	4.833465	4.488189	Normal	2	3	6
2009-05-14	2.484252	5.481496	4.917323	Normal	2	2	4
2009-04-14	1.460236	3.505118	1.649606	Normal	2	1	2
Result							Normal Conditions - 12

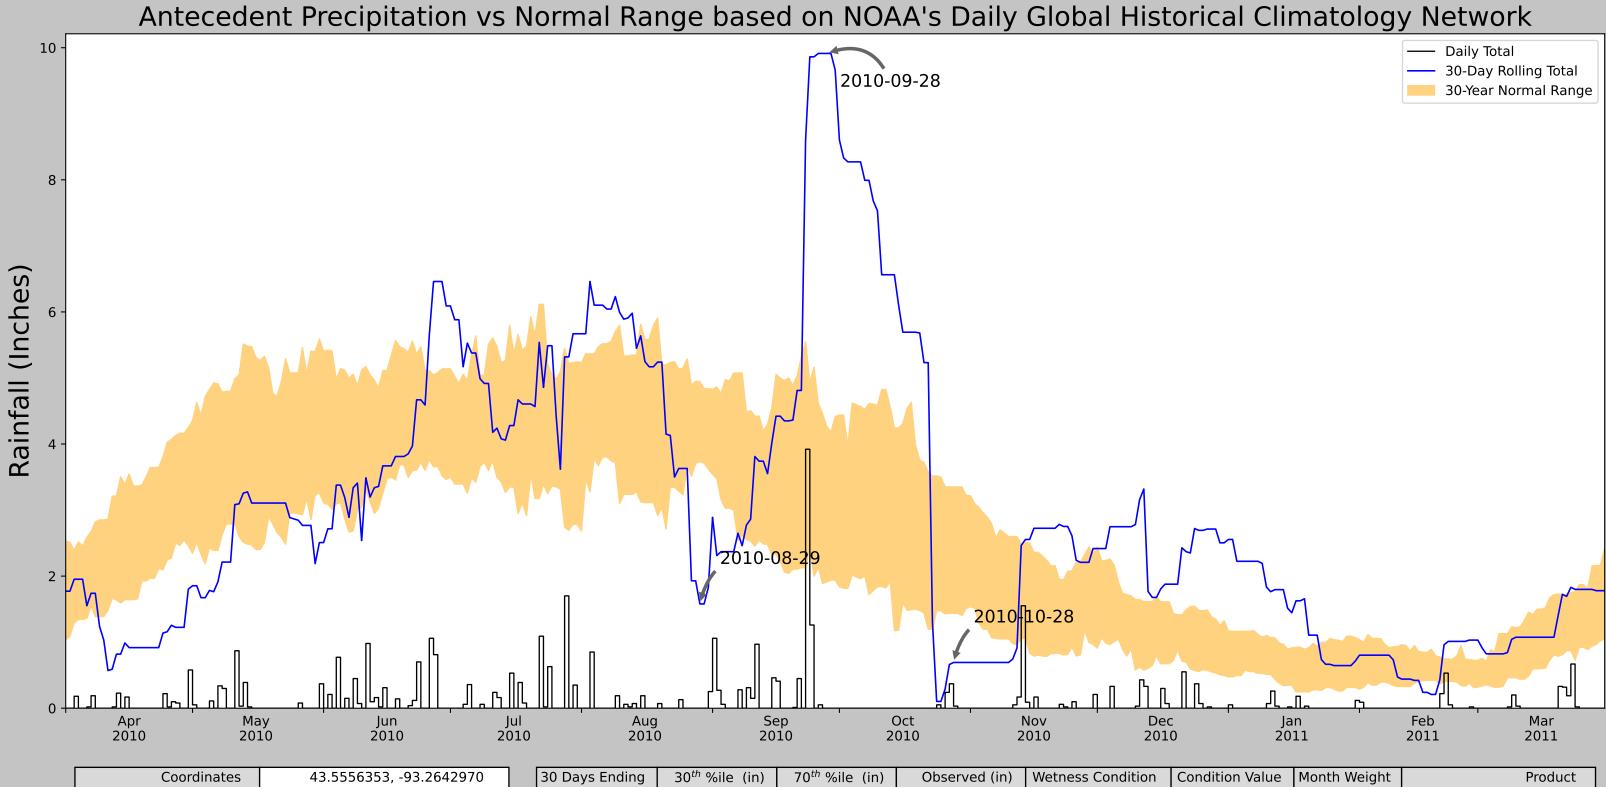
Coordinates	43.5556353, -93.2642970
Observation Date	2010-10-28
Elevation (ft)	1225.833
Drought Index (PDSI)	Extreme wetness
WebWIMP H ₂ O Balance	Wet Season

30 Days Ending	30 th %ile (in)	70 th %ile (in)	Observed (in)	Wetness Condition	Condition Value	Month Weight	Product
2010-10-28	1.436221	3.350394	0.692913	Dry	1	3	3
2010-09-28	1.911811	4.267717	9.913386	Wet	3	2	6
2010-08-29	3.735039	4.943701	1.57874	Dry	1	1	1
Result							Normal Conditions - 10

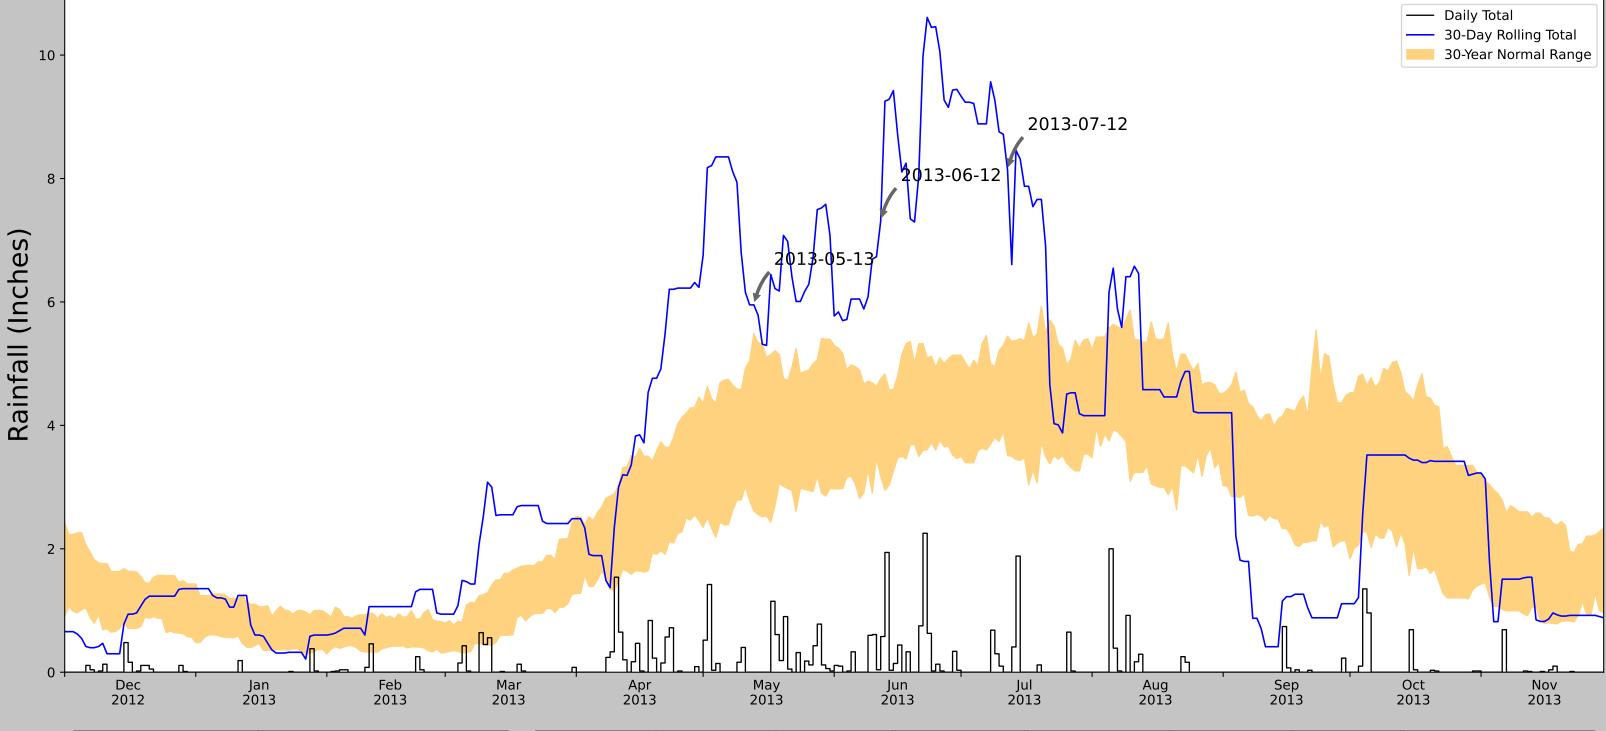
Coordinates	43.5556353, -93.2642970
Observation Date	2013-07-12
Elevation (ft)	1225.833
Drought Index (PDSI)	Normal
WebWIMP H_2O Balance	Dry Season

30 Days Ending	30 th %ile (in)	70 th %ile (in)	Observed (in)	Wetness Condition	Condition Value	Month Weight	Product
2013-07-12	3.509843	5.445669	8.137796	Wet	3	3	9
2013-06-12	3.179134	4.755118	7.311024	Wet	3	2	6
2013-05-13	2.612205	5.486221	5.952756	Wet	3	1	3
Result							Wetter than Normal - 18

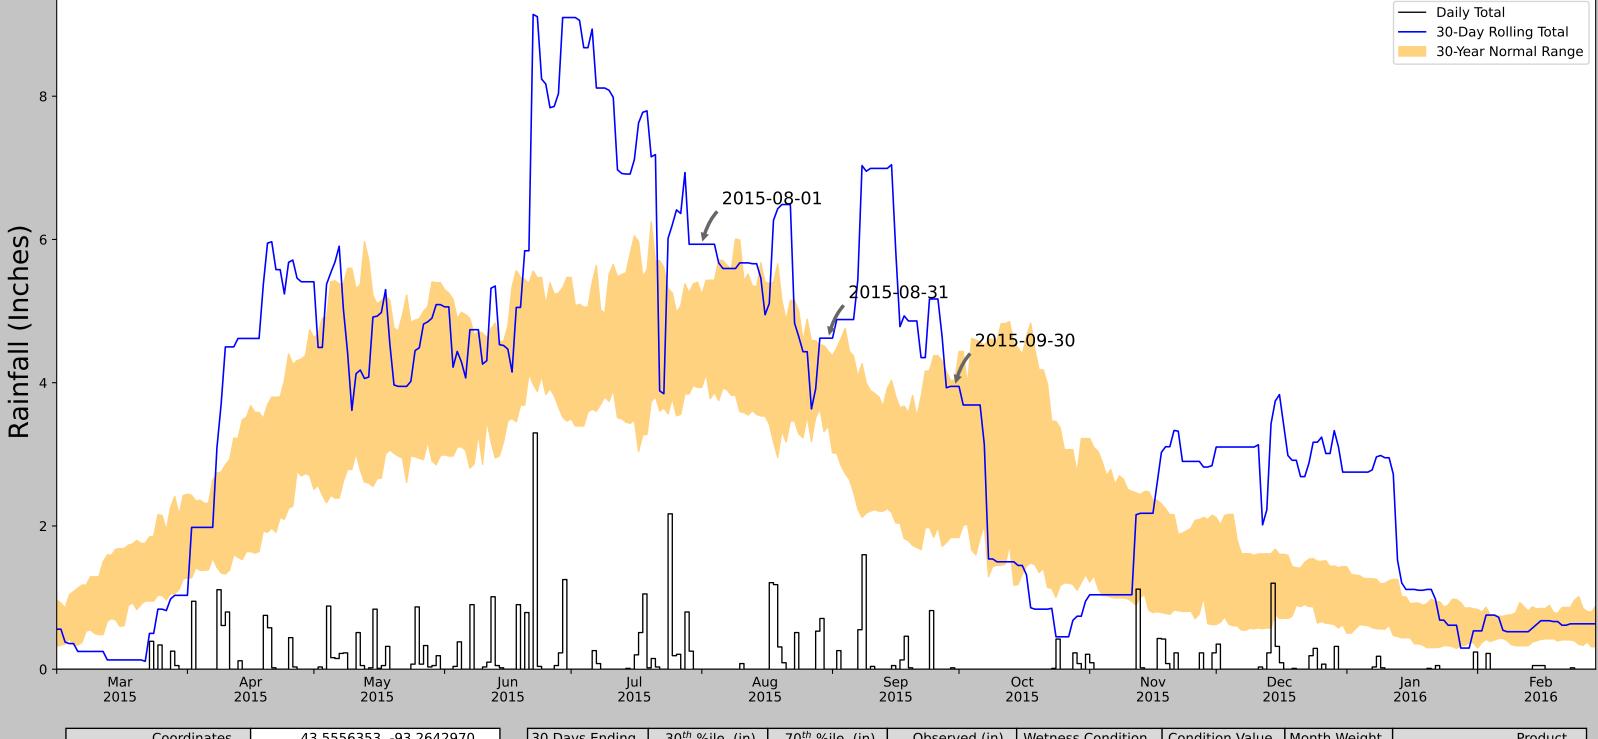
Coordinates	43.5556353, -93.2642970
Observation Date	2015-09-30
Elevation (ft)	1225.833
Drought Index (PDSI)	Moderate wetness
WebWIMP H ₂ O Balance	Wet Season

30 Days Ending	30 th %ile (in)	70 th %ile (in)	Observed (in)	Wetness Condition	Condition Value	Month Weight	Product
2015-09-30	1.838583	4.032284	3.948819	Normal	2	3	6
2015-08-31	3.399606	4.44252	4.622047	Wet	3	2	6
2015-08-01	3.933858	5.230709	5.933071	Wet	3	1	3
Result							Wetter than Normal - 15

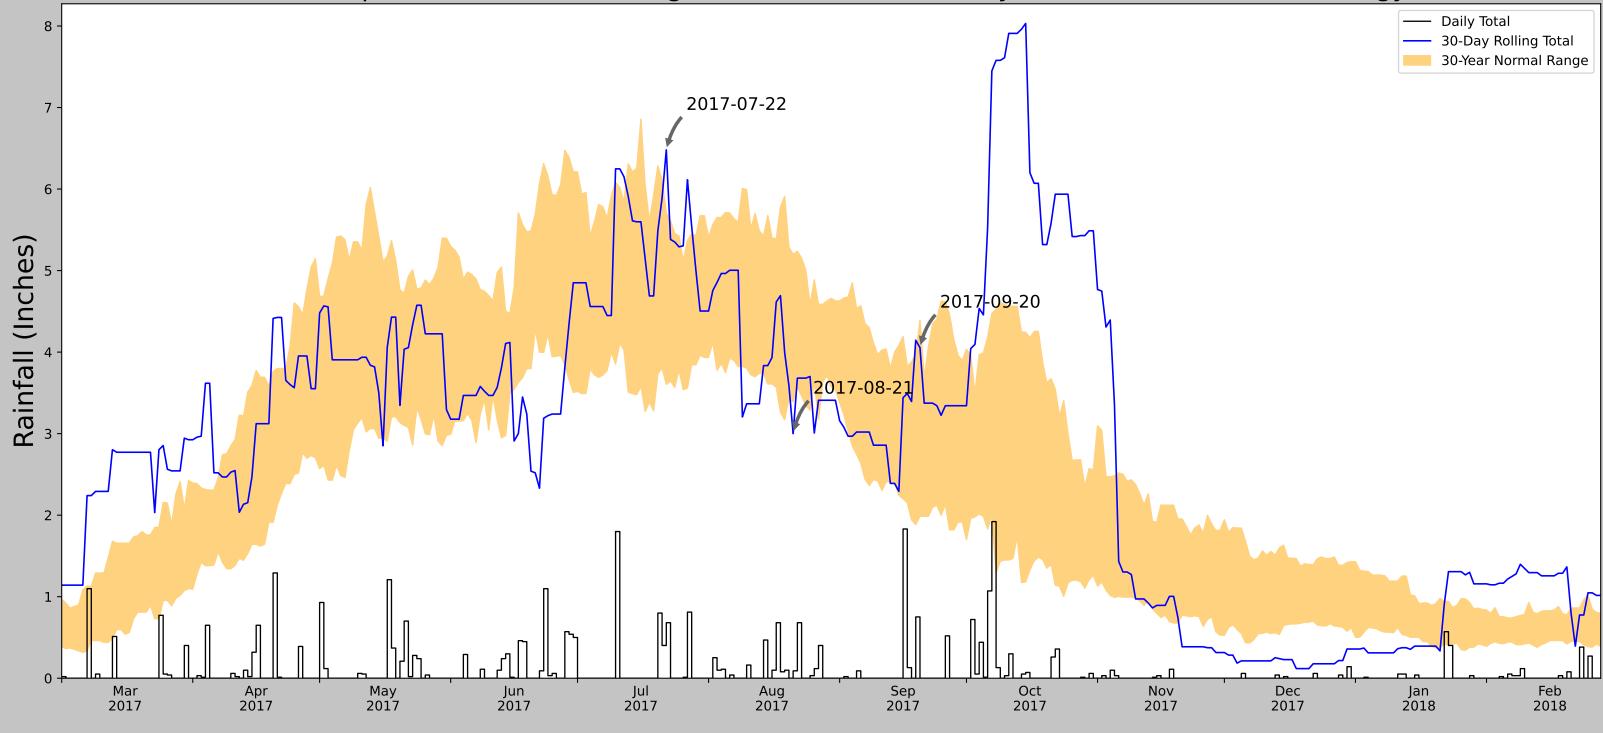
Coordinates	43.5556353, -93.2642970
Observation Date	2017-09-20
Elevation (ft)	1225.833
Drought Index (PDSI)	Severe wetness
WebWIMP H ₂ O Balance	Wet Season

30 Days Ending	30 th %ile (in)	70 th %ile (in)	Observed (in)	Wetness Condition	Condition Value	Month Weight	Product
2017-09-20	1.985827	4.392914	4.055118	Normal	2	3	6
2017-08-21	3.392913	5.196851	3.0	Dry	1	2	2
2017-07-22	3.604331	5.705906	6.480315	Wet	3	1	3
Result							Normal Conditions - 11

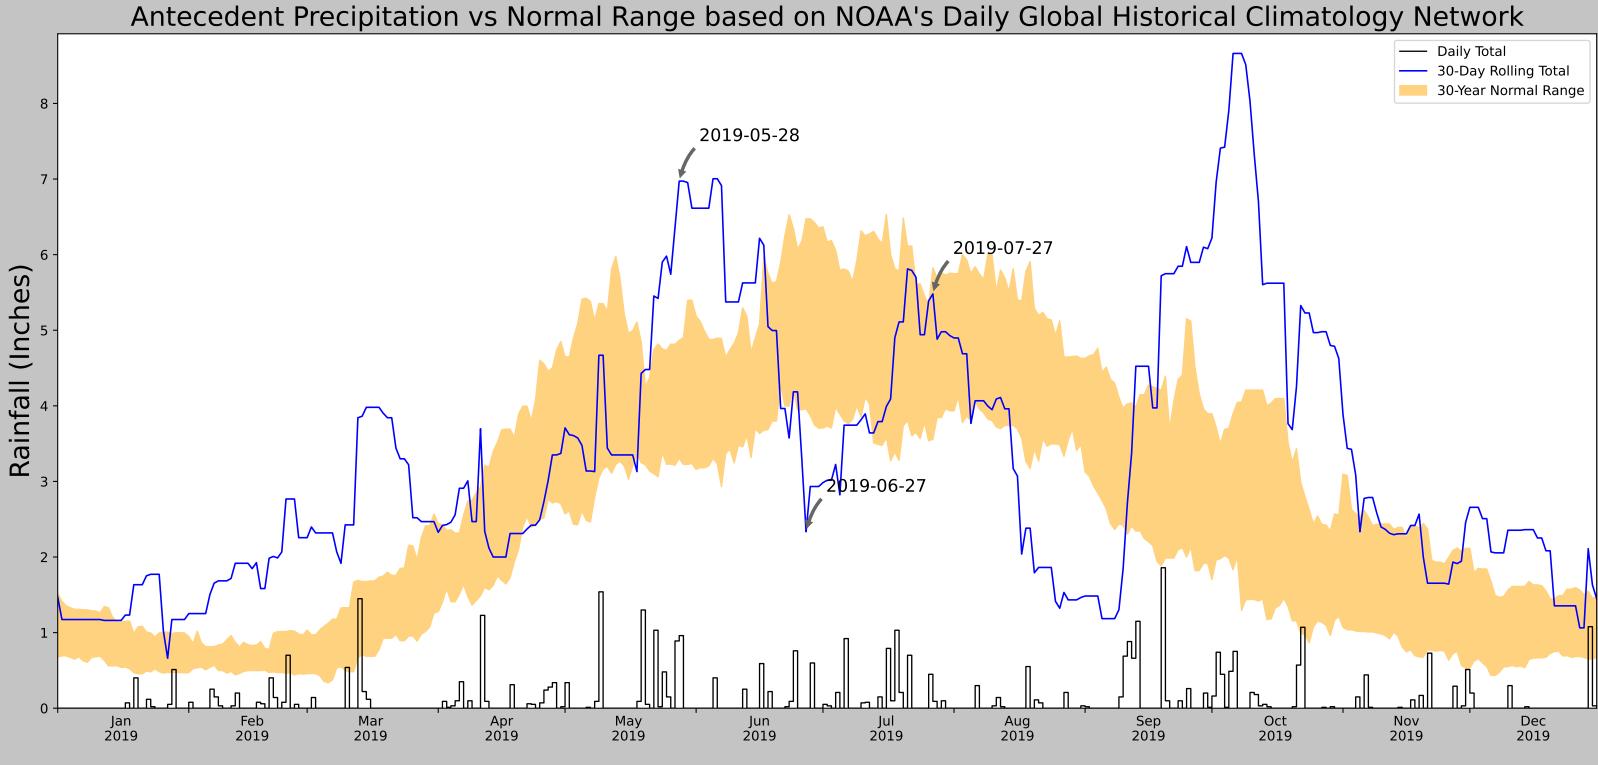
Coordinates	43.5556353, -93.2642970
Observation Date	2019-07-27
Elevation (ft)	1225.833
Drought Index (PDSI)	Extreme wetness
WebWIMP H_2O Balance	Dry Season

30 Days Ending	30 th %ile (in)	70 th %ile (in)	Observed (in)	Wetness Condition	Condition Value	Month Weight	Product
2019-07-27	3.557874	5.826772	5.480315	Normal	2	3	6
2019-06-27	3.959449	6.474803	2.334646	Dry	1	2	2
2019-05-28	3.305512	4.866929	6.972441	Wet	3	1	3
Result							Normal Conditions - 11
