Wetland Resources

Re: Wetland Delineation Report Midwater BESS, Shell Rock Township, Freeborn County

Westwood File 0046089.00

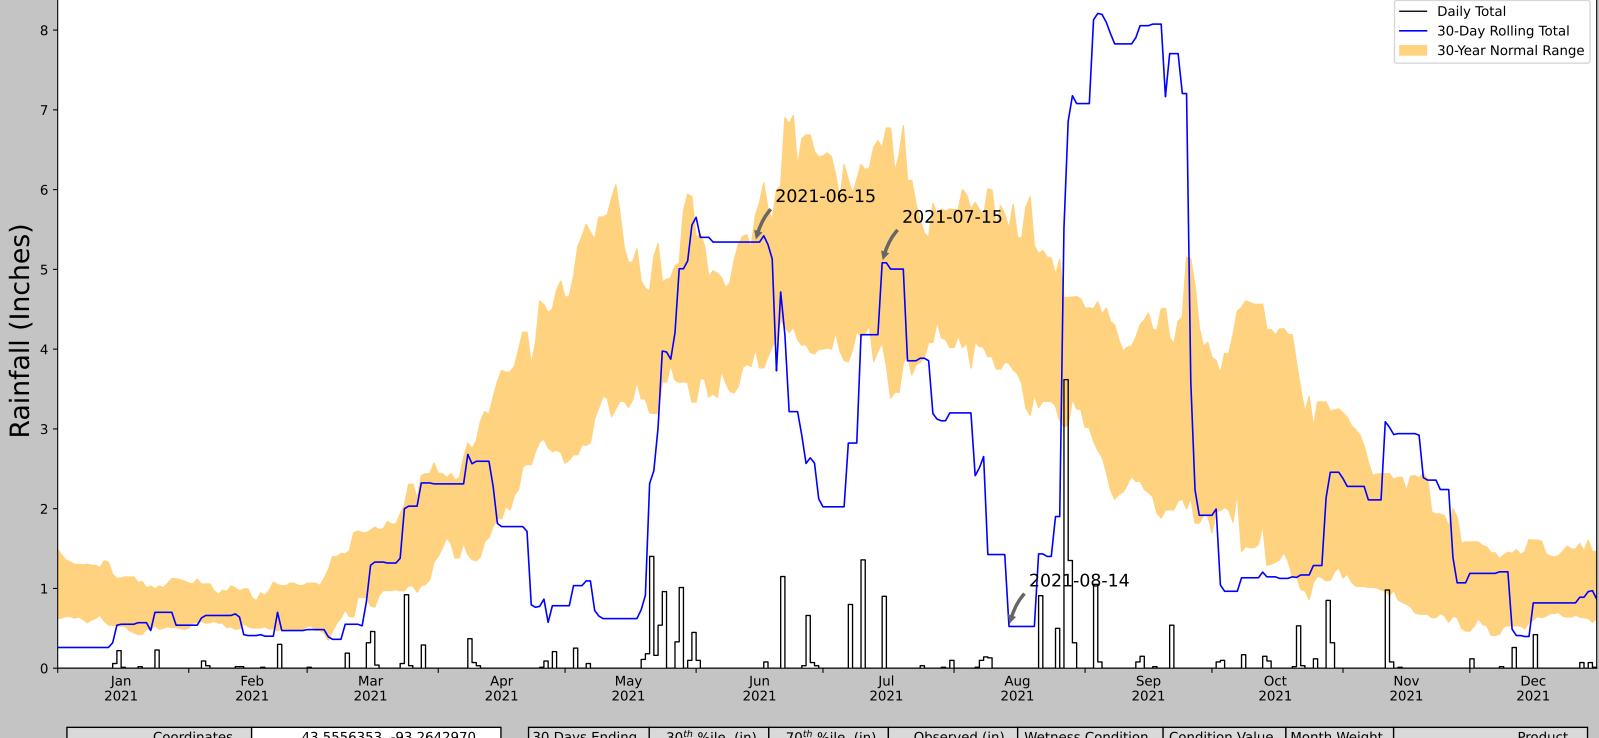
Coordinates	43.5556353, -93.2642970
Observation Date	2021-08-14
Elevation (ft)	1225.833
Drought Index (PDSI)	Mild drought
WebWIMP H ₂ O Balance	Dry Season

30 Days Ending	30 th %ile (in)	70 th %ile (in)	Observed (in)	Wetness Condition	Condition Value	Month Weight	Product
2021-08-14	3.822835	5.512599	0.523622	Dry	1	3	3
2021-07-15	4.075197	6.52126	5.082677	Normal	2	2	4
2021-06-15	4.002362	5.675591	5.34252	Normal	2	1	2
Result							Drier than Normal - 9

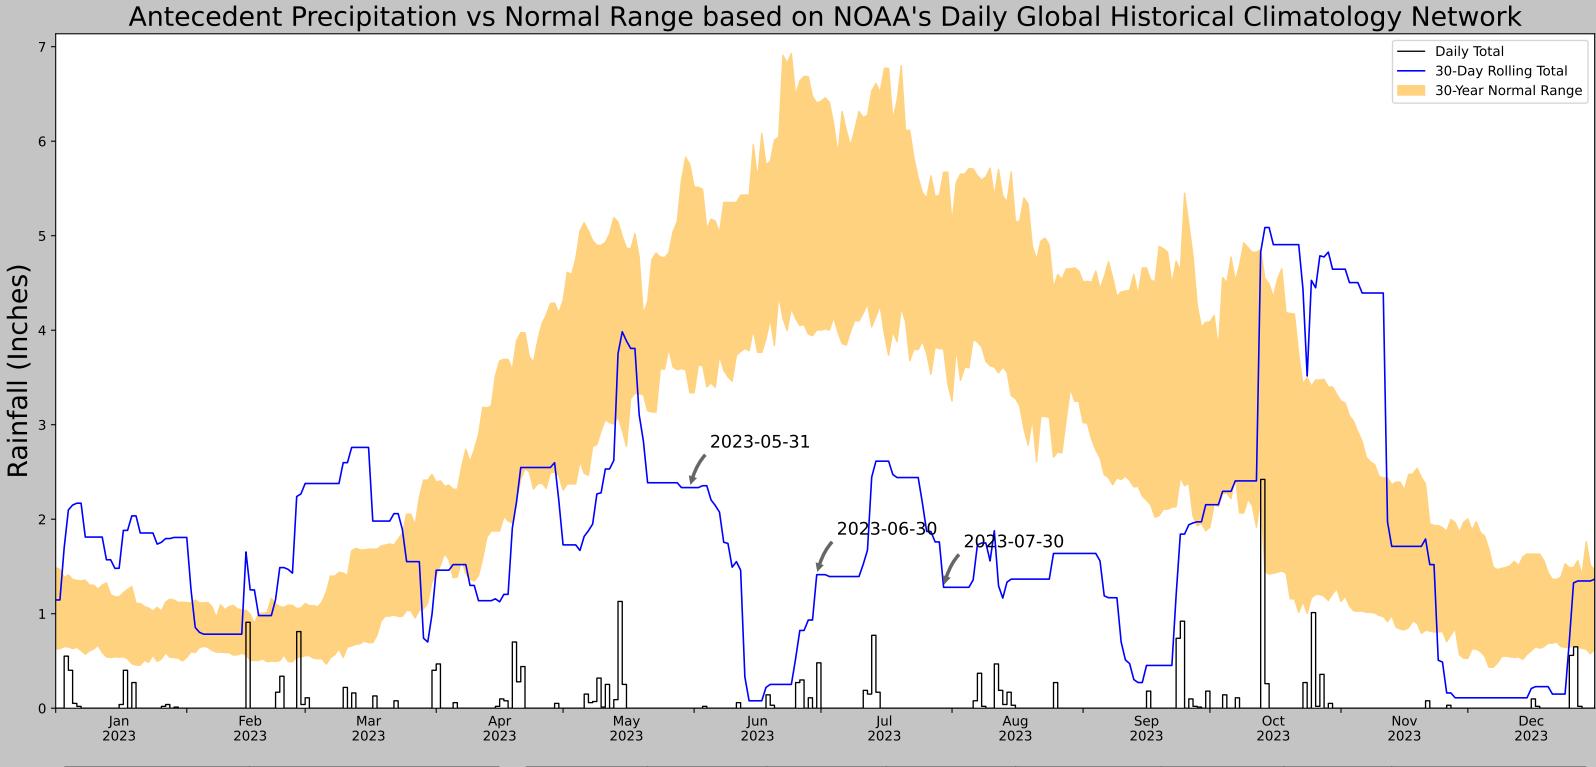
Coordinates	43.5556353, -93.2642970
Observation Date	2023-07-30
Elevation (ft)	1225.833
Drought Index (PDSI)	Mild drought
WebWIMP H ₂ O Balance	Dry Season

30 Days Ending	30 th %ile(in)	70 th %ile (in)	Observed (in)	Wetness Condition	Condition Value	Month Weight	Product
2023-07-30	3.800788	5.672835	1.279528	Dry	1	3	3
2023-06-30	4.001181	6.405906	1.413386	Dry	1	2	2
2023-05-31	3.337402	5.753543	2.334646	Dry	1	1	1
Result							Drier than Normal - 6
