# WETLAND DETERMINATION DATA FORM - Midwest Region

Project/Site: Summit Lake Solar City/County: Nobles Sampling Date: 10/12/2022  
 Applicant/Owner: Summit Lake Solar, LLC State: Minnesota Sampling Point: NWA034A  
 Investigator(s): Susan Mayer Section, Township, Range: Sec.24 T103N R41W  
 Landform (hillslope, terrace, etc.): Broad Depression Local relief (concave, convex, none): Concave  
 Slope (%): 0 Lat: 43.71448 Long: -95.69457 Datum: WGS84  
 Soil Map Unit Name: Clarion loam, 2 to 6 percent slopes NWI Classification: None

## Summit Lake Solar Project Expansion Nobles County, Minnesota

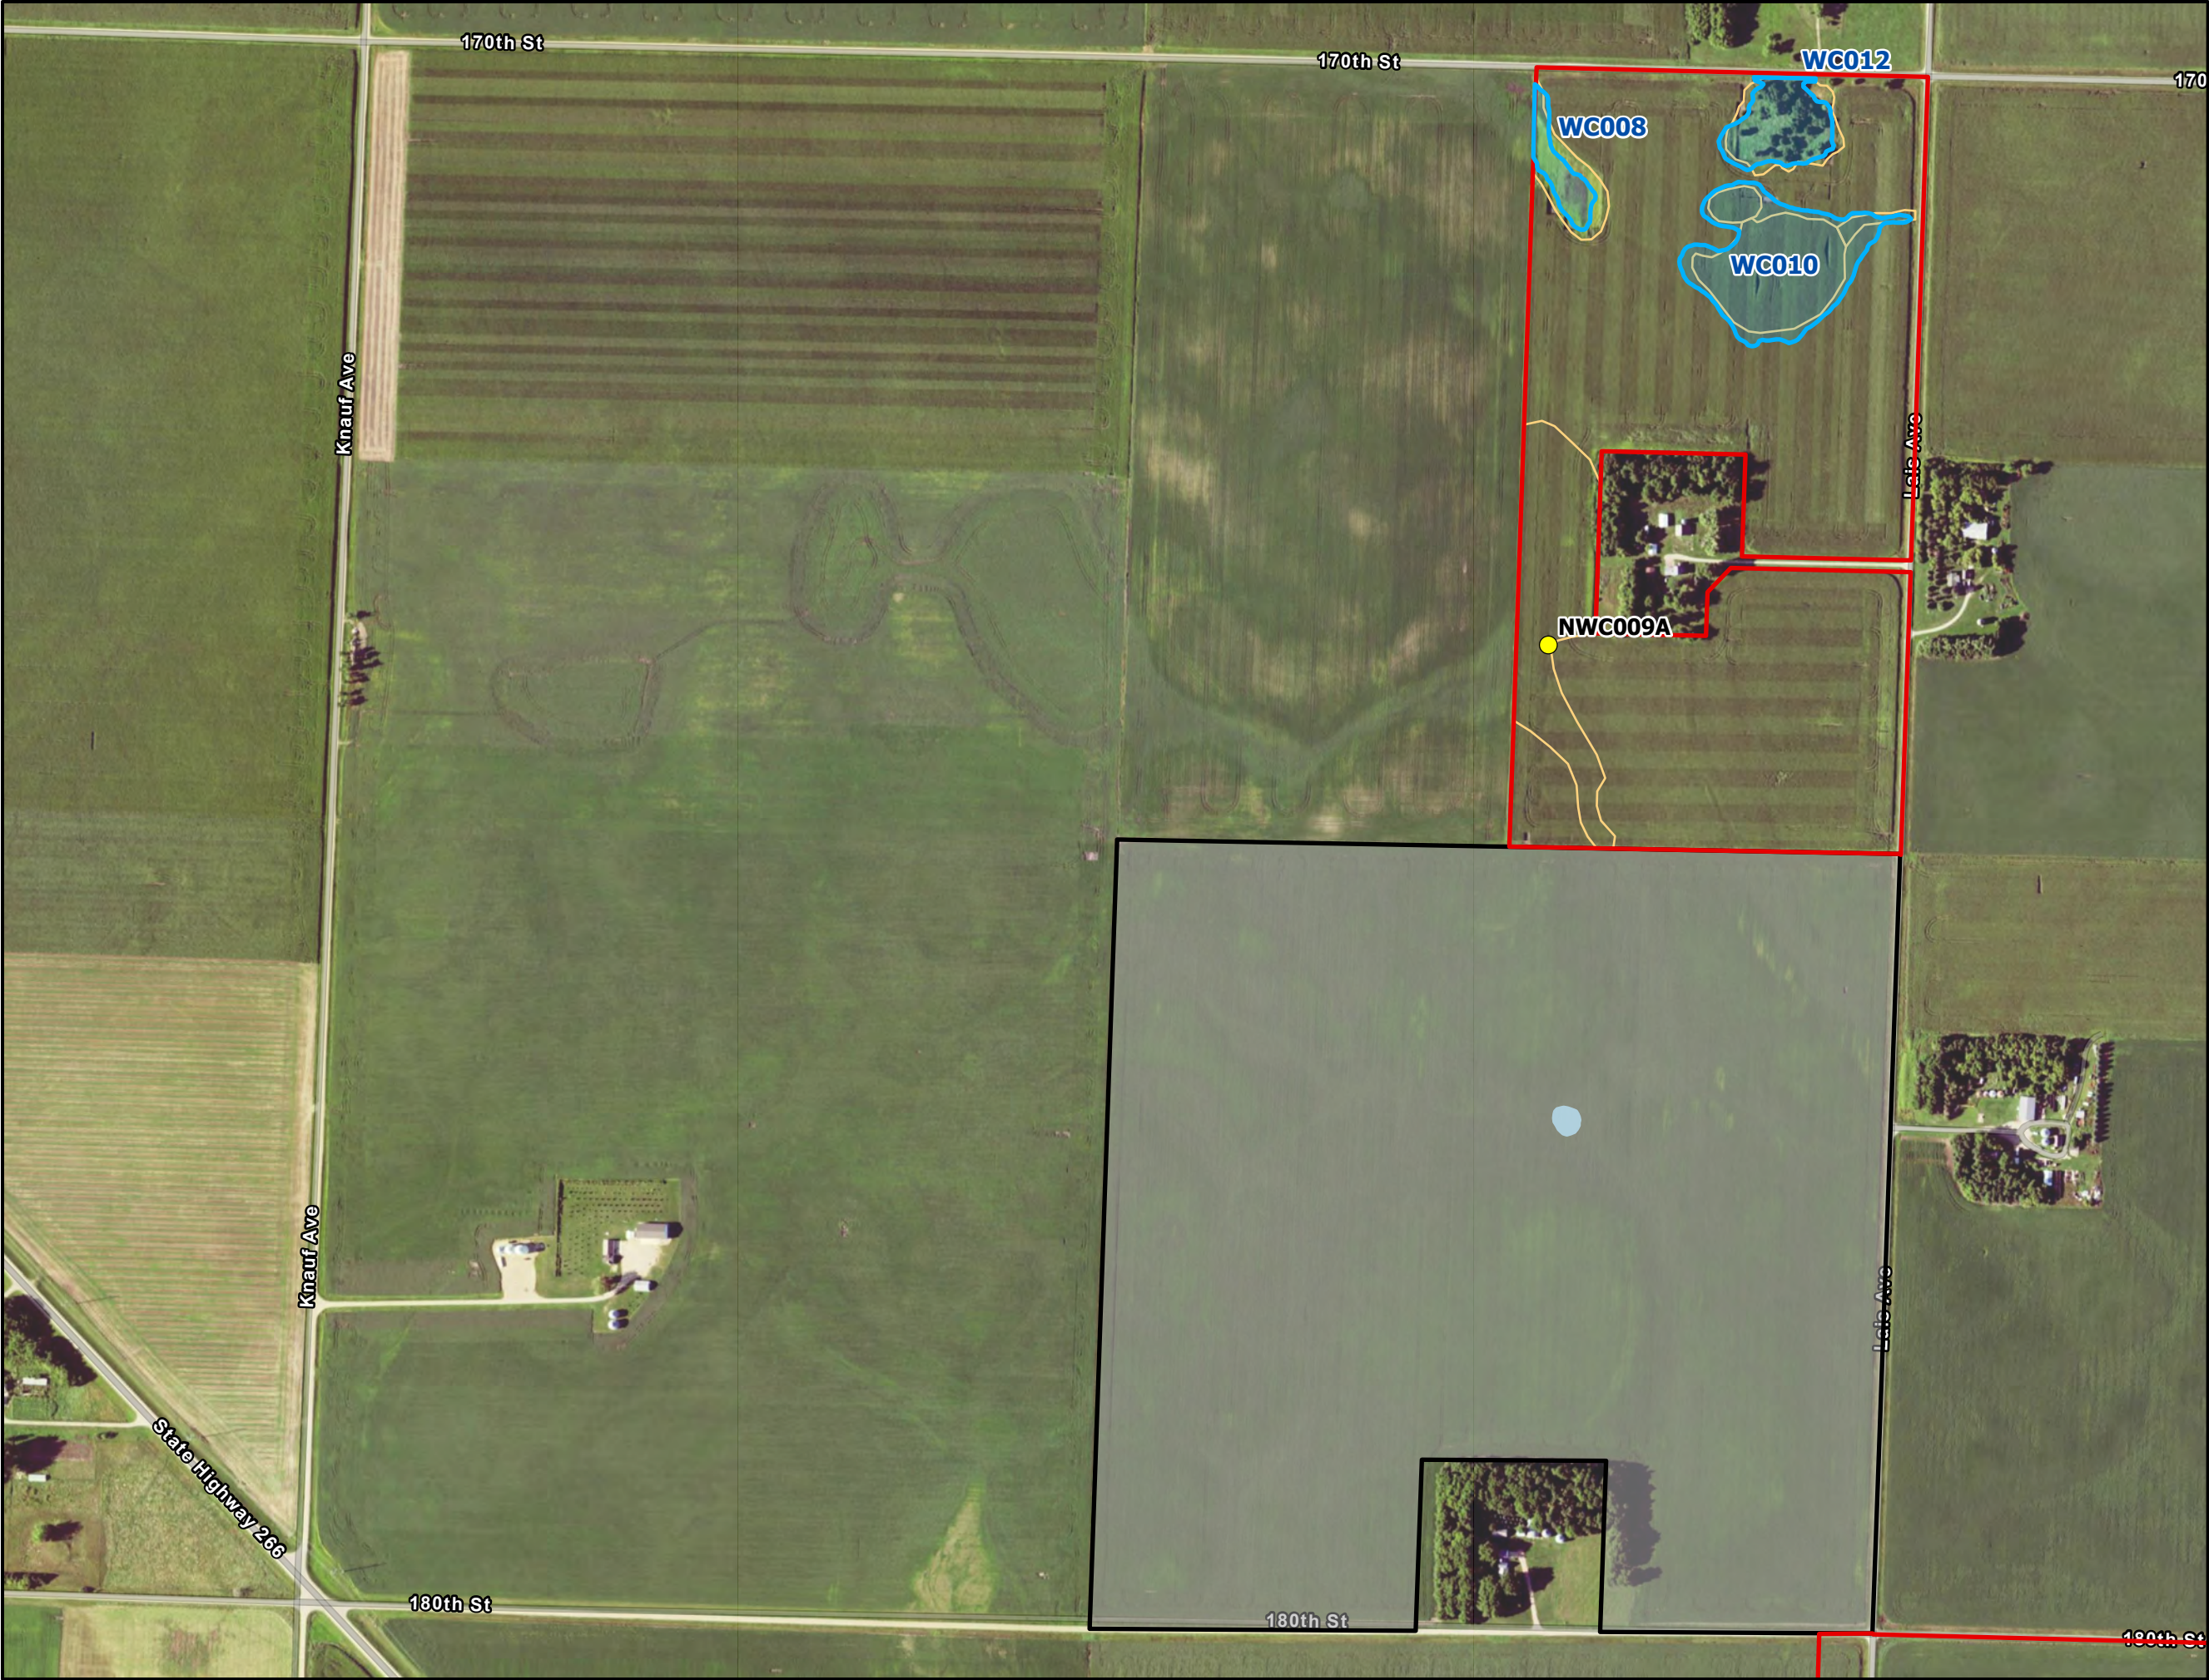
9/24/2024 kathy.bellrichard S:\Projects\NationalGrid\Summit Lake Solar MN\GIS\ArcGISPro\SummitLake\_WetlandReport\_20230411\SummitLake\_WetlandReport\_20240821.aprx Figure 4 Survey Results

- Expansion Area (408 acres)
- Initial Area (1,582 acres)
- Non-Wetland Sample Point
- Delineated Wetland
- Previously Delineated Wetland
- Desktop Potential Wetlands and Waters

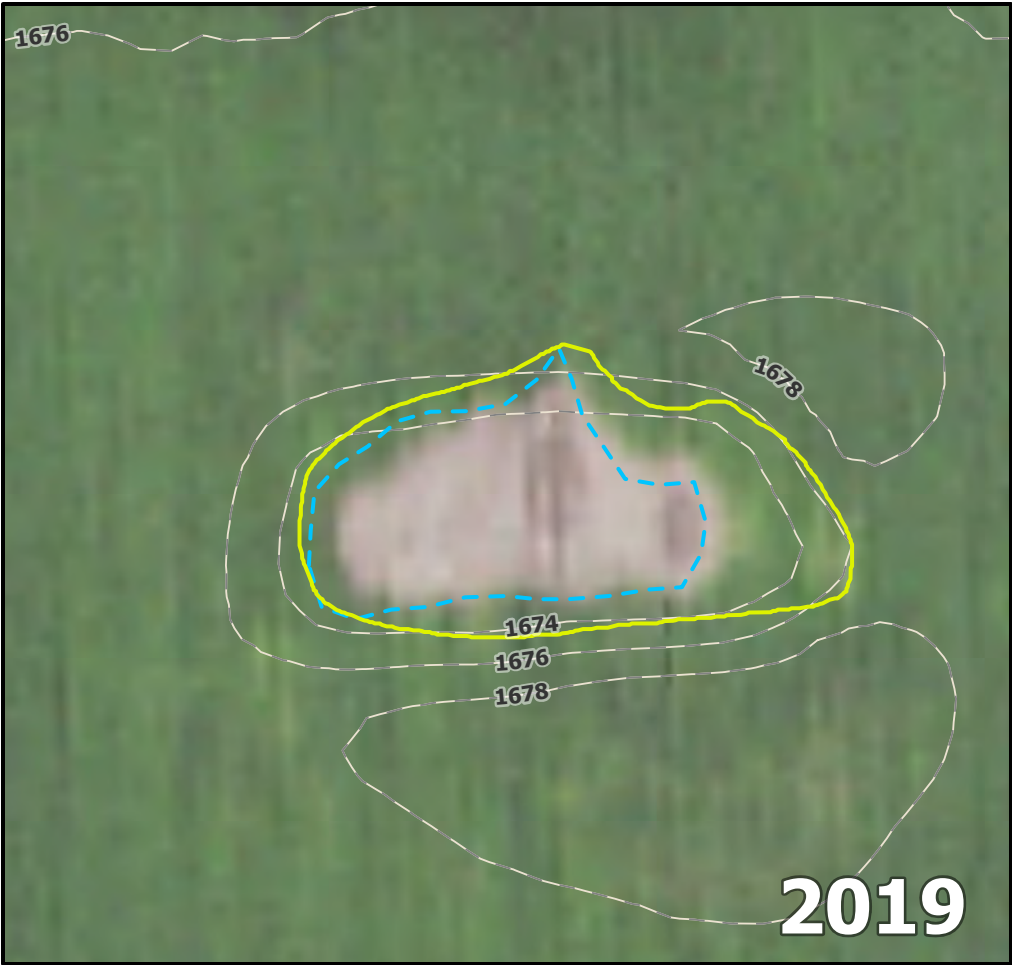
Feature ID: WC007

- Expansion Area
- Aerial Photo Signature Boundary
- Field Delineated Wetland Boundary
