STEEL/CONCRETE POLES

Steel/Concrete Pole Construction Worldwide

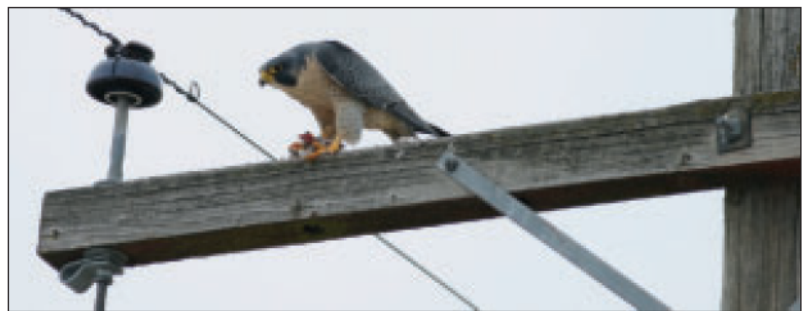
FIGURE 6.1: Peregrine falcon with prey on distribution pole.

Power line structures in relatively treeless areas have made millions of kilometers of suitable habitat available to perch-hunting raptors (Olendoff et al. 1980). Power poles offer raptors an expansive view of the surrounding terrain while they inconspicuously watch for prey below (see Figure 4.9). Perch-hunting also allows raptors to

conserve energy by minimizing flight activity (Figure 6.1). Ospreys (*Pandion haliaetus*) readily perch-hunt from power poles that have been placed near treeless wetlands or other water bodies.

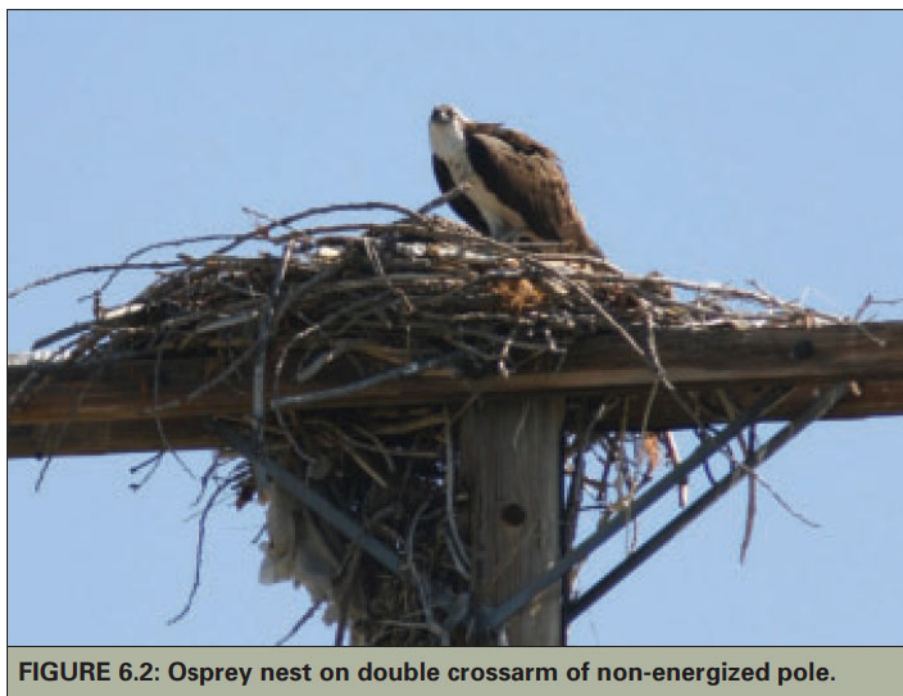
FIGURE 6.2: Osprey nest on double crossarm of non-energized pole.

Casual observation attests, and many studies have documented, that raptors nest on distribution and transmission structures (see Table 6.1). Although most species that nest on power line structures inhabit open, arid areas, one notable exception is the osprey (Figure 6.2). Ospreys use utility structures for nesting more than any other North American raptor. They typically select poles that are located near or over waters where fish are abundant. To protect ospreys and the power system, nest platforms have been installed on or near transmission towers and distribution poles so nest material and excrement will not contaminate lines. In addition, power poles that are left standing when lines are decommissioned can provide both nest and perch sites. During an 11-year period in Michigan, an average of 55% of the osprey platforms available were occupied (Postupalsky 1978). On Lake Huron in Canada, 82% of artificial platforms were occupied within one year of installation (Ewins 1996). In 1995, nearly 46% of osprey nests studied in Finland ($n=951$) were located on artificial structures and, in southern Finland, up to 90% of occupied nests ($n=79$) were on artificial platforms (Saurola 1997).

as this provides more support for nests (Figure 6.3). The configuration of two poles supporting four paired sets of crossarms was most often used by raptors in New Mexico (Brubaker et al. 2003). Double dead-end and dead-end distribution poles (see Figures 5.15, 5.16, 6.2, 6.23, 6.24, 6.25, and 6.26 for examples) are the distribution configurations most commonly used by osprey and some other raptors throughout North America.

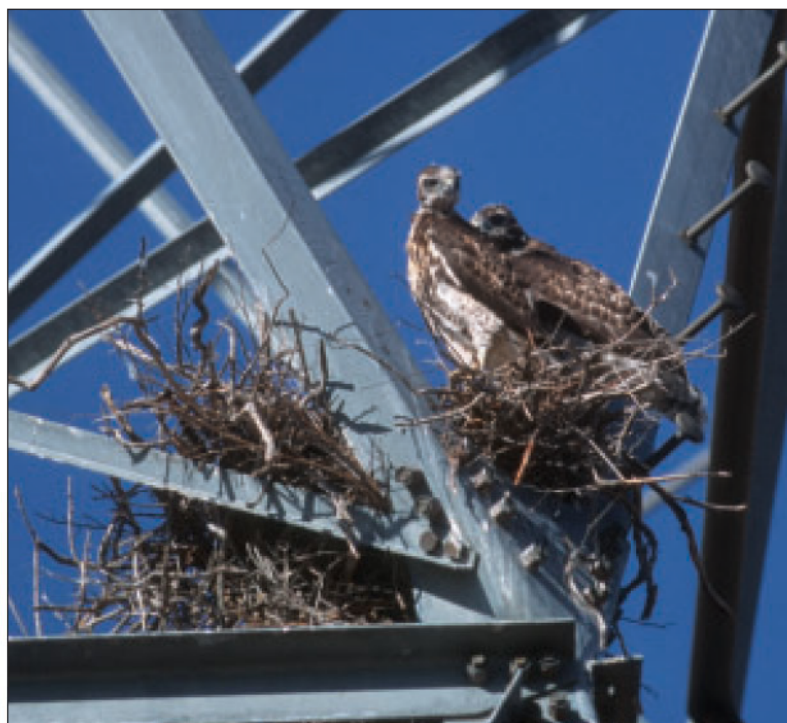
FIGURE 6.3: Red-tailed hawk nest on steel lattice transmission tower.

Nest location on a power structure can vary by species and structure type. On natural substrates, ospreys typically nest on the flat tops of dead trees and broken tops of live trees. Likewise, on power structures, ospreys prefer the upper portions of transmission towers or the tops of distribution poles. Red-tailed, Swainson's (*Buteo swainsoni*), and ferruginous hawks (*B. regalis*) generally prefer nest heights that are relatively high, moderate, and low, respectively. Tower sections where steel lattice-work is relatively dense are generally preferred,
