## **Wetland Delineation Reports**

# Wetlands and Waters Survey

**Lake Charlotte Solar  
Martin County, Minnesota**

**June 16, 2023**

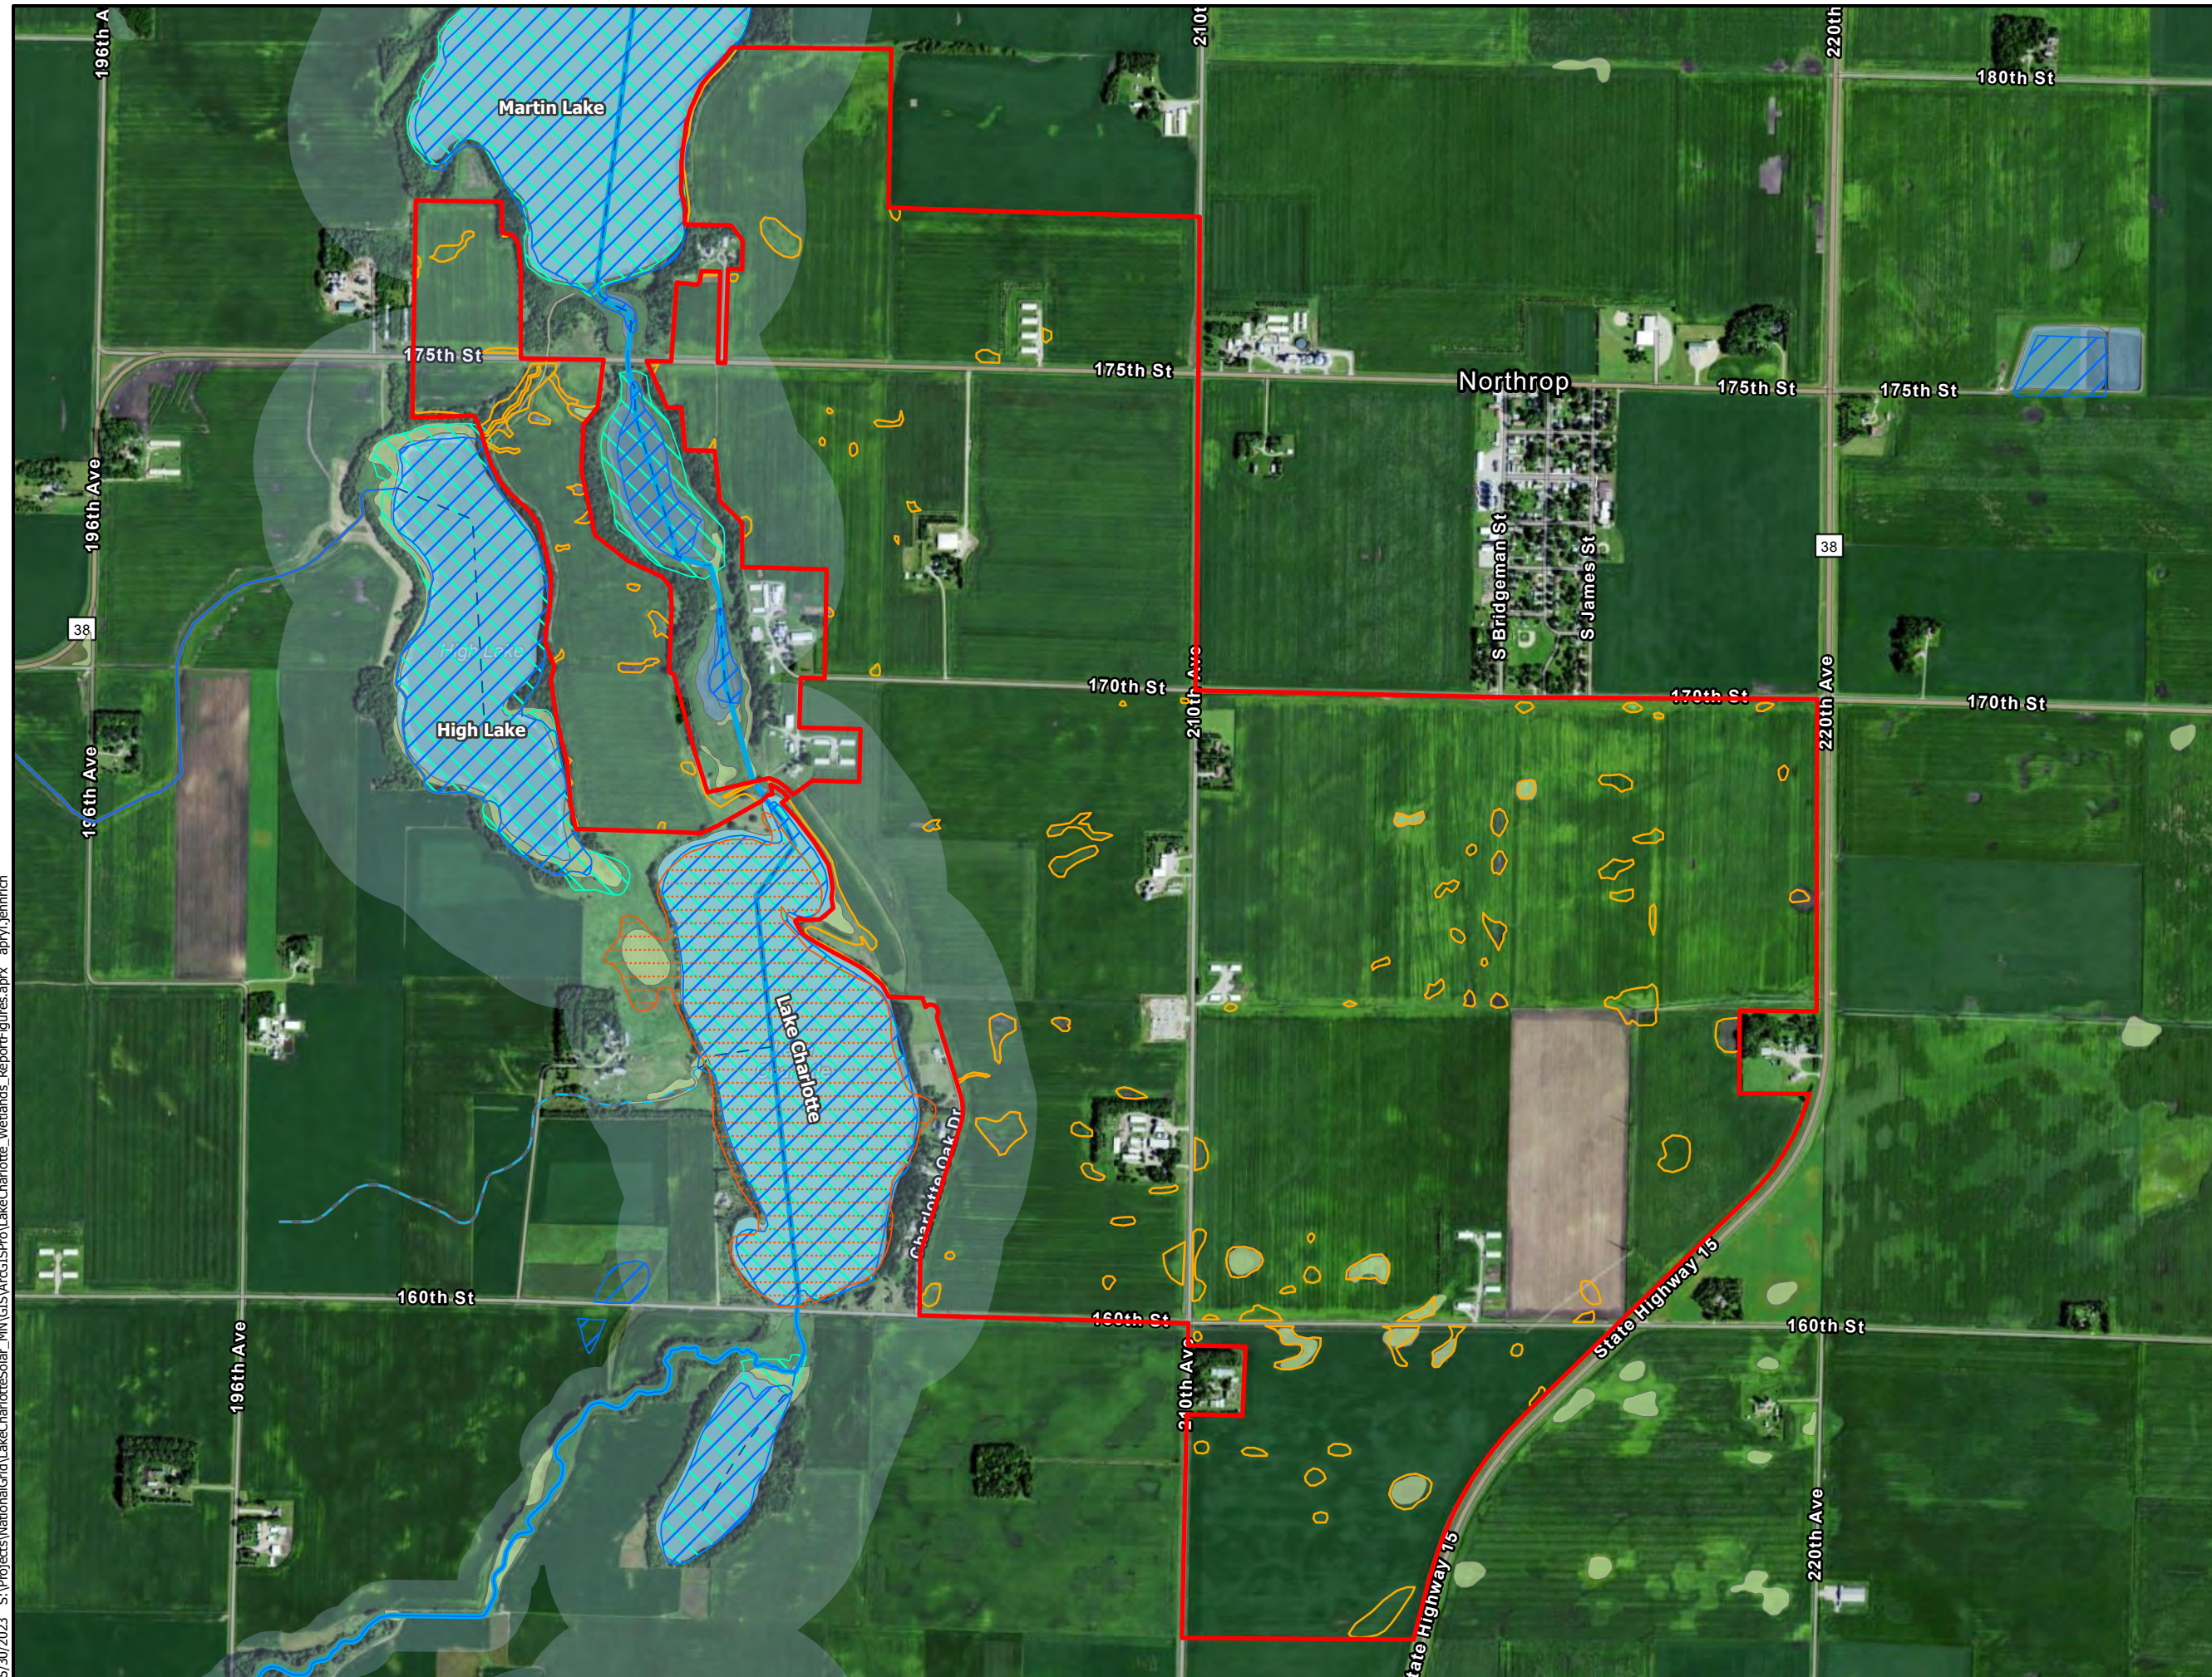
Source: Map adapted from NAIP Hybrid Server; Project Data by Lake Charlotte Solar, LLC; NWI by USFWS; NHD by USGS; Floodplains by FEMA; PWI by MN DNR; Desktop wetlands and waters by Tetra Tech. Scale: 1:16,000

The desktop data review found 113 potential wetlands and waters within the Survey Area, totaling approximately 54.4 acres (Appendix A: Figure 2). Several of these features at least partially overlap features in the NWI or NHD datasets: 13 potential wetlands and waters intersect NWI mapped resources, and 1 potential wetland/water intersects both NWI and NHD mapped resources. There were 99 potential wetlands and waters at locations that did not have any previously mapped resources in the NWI or NHD and were identified based on aerial photo interpretation and/or elevation data.

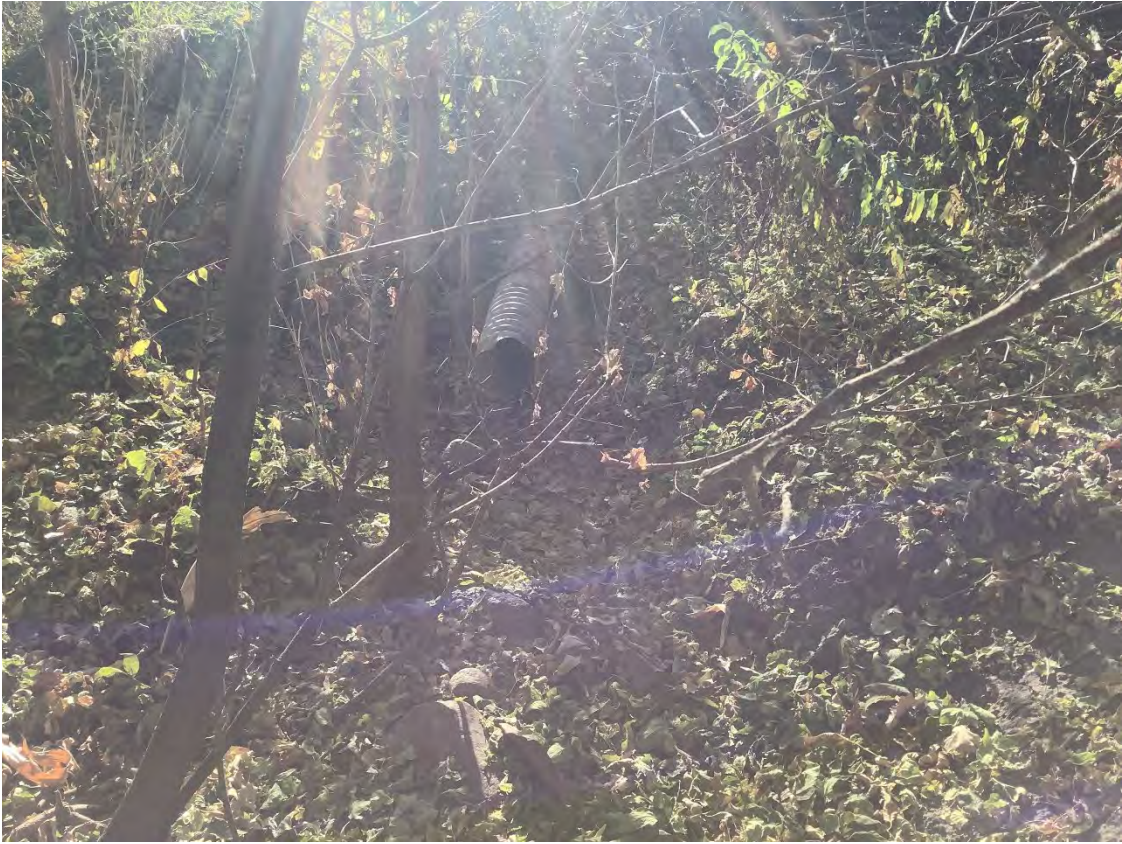
Upstream Photograph of SA001. Direction: Southwest

Three streams were documented in the Survey Area. Stream SA001 was observed to be an ephemeral stream with an average width of 6 feet and an average depth of 3 feet. The stream was dry at the time of survey and appeared to be a tributary to Martin Lake. Stream SA005 was observed to be an intermittent stream with an average

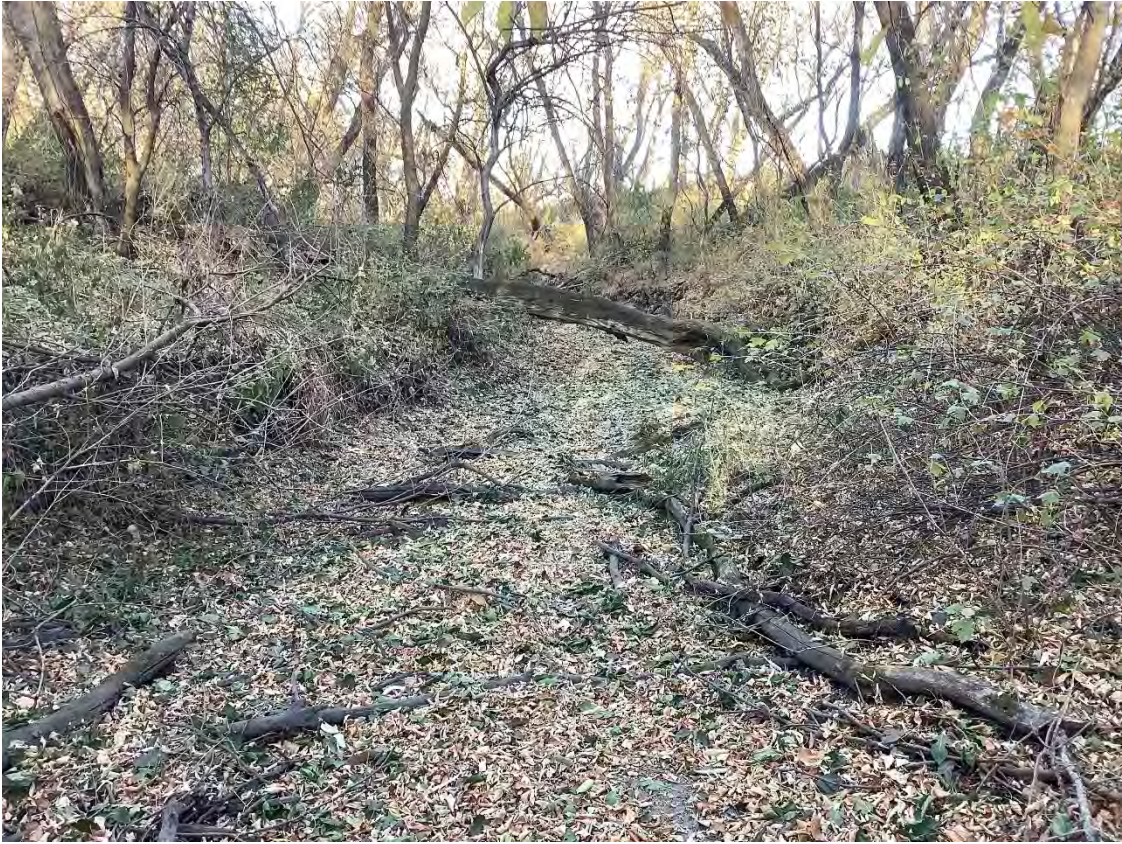
Upstream Photograph of SA005. Direction: Northeast

width of 12 feet and an average depth of 4 feet. The stream was dry at the time of the survey and appeared to be a surface connection between High Lake and Martin Lake. Stream SA016 was observed to be an ephemeral stream with an average width of 3 feet and an average depth of 2 feet. The stream was dry at the time of the survey and appeared to be a tributary to High Lake. Streams SA001 and SA016 were classified as R4SBA, and SA005 was classified as R4SBC (Appendix B: Table B-4). Stream SA005 approximately aligns with a previously mapped resource in the NWI database (Section 3.1.1). Photo documentation of the surveyed streams is provided in Appendix D.

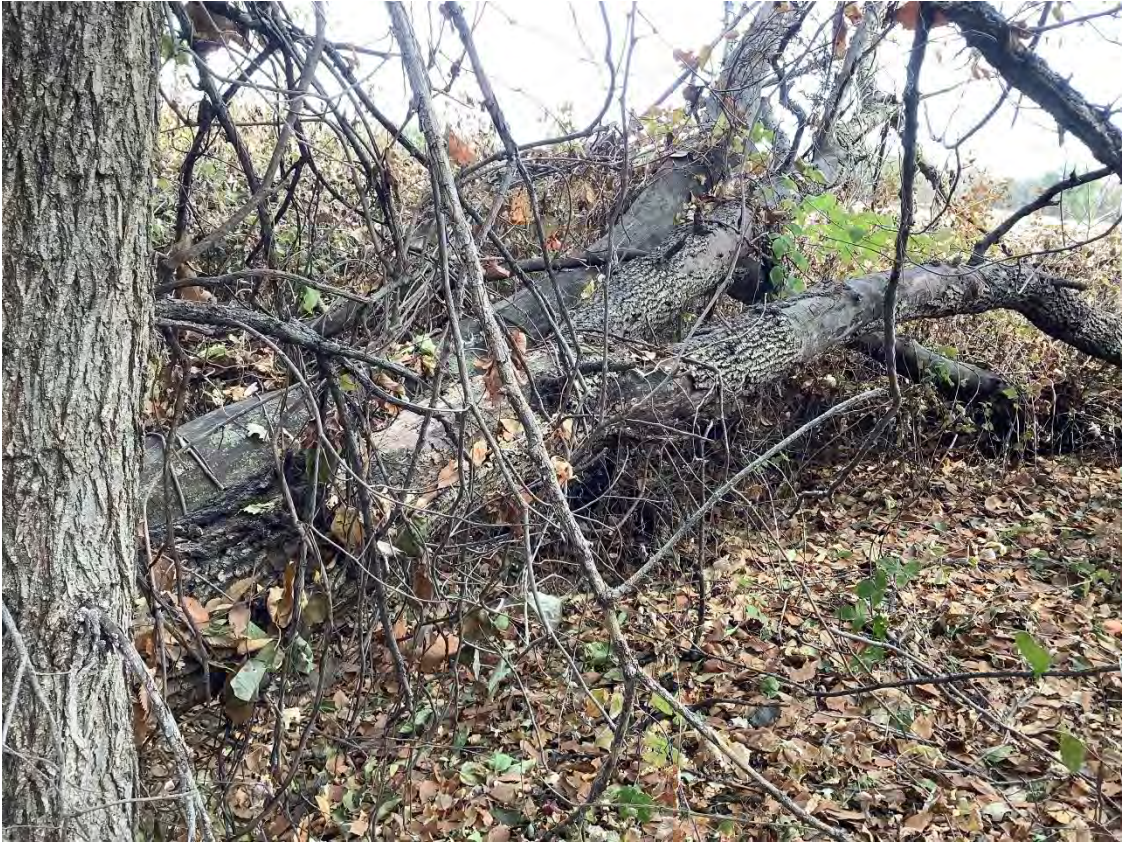
Upstream Photograph of SA016. Direction: Northeast
