DISADVANTAGES TO RAPTORS NESTING ON UTILITY STRUCTURES

NEST MANAGEMENT

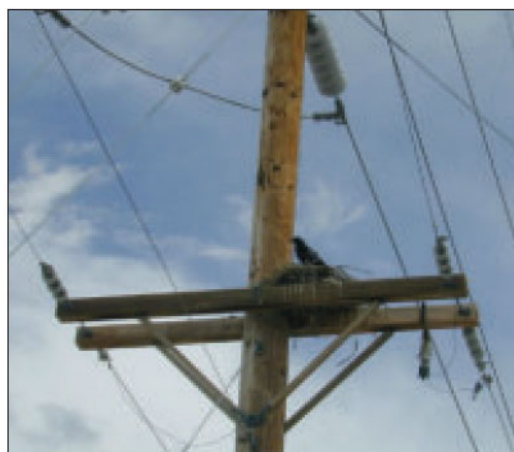
**FIGURE 6.6: Common raven nest on distribution underbuild of transmission structure.**

Common ravens often nest on utility structures (Figure 6.6). Within ten years of the construction of a 500-kV transmission line across Oregon and Idaho, 81 pairs of common ravens nested on the transmission structures (Steenhof et al. 1993). Their success was similar to or greater than nest success in natural substrates. In New Mexico, ravens preferred to nest on the configuration with two poles supporting four paired sets of

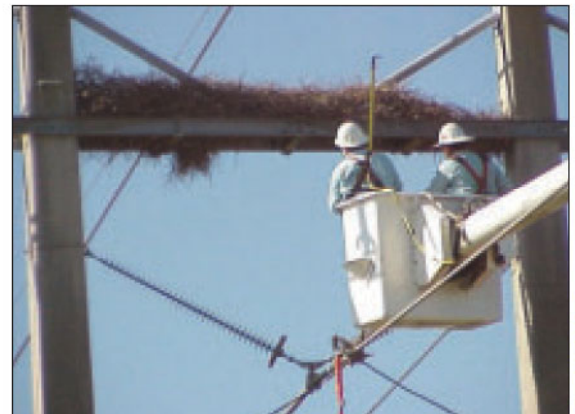
FIGURE 6.8: Monk parakeet nests on transmission tower.

Though native to South America, monk parakeets were brought to the United States in the late 1960s as pets. Escaped birds have adapted well and established populations from Florida to New York, Texas to Oregon, and in parts of southern Canada. Populations in some states have grown exponentially in the last 10 to 15 years (Pruett-Jones et al. 2005). Monk parakeets build bulky stick nests on trees, power poles, and substations (Spreyer and Bucher 1998; Newman et al. 2004). The number of nests can range from several on distribution or transmission poles to more than 50 in a single substation (Figures 6.8, 6.9). Since monk parakeets are colonial breeders, the size

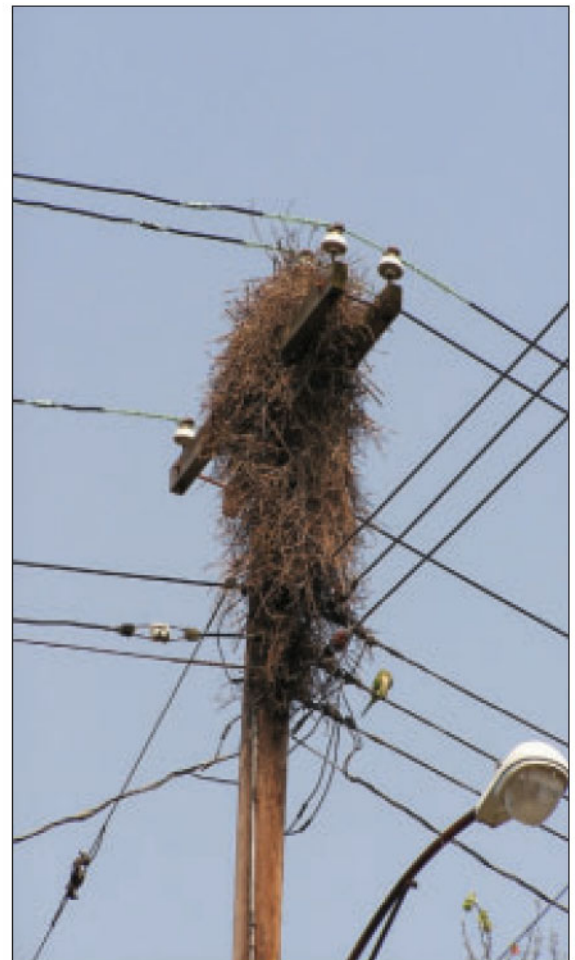
FIGURE 6.9: Monk parakeet nest on distribution pole.

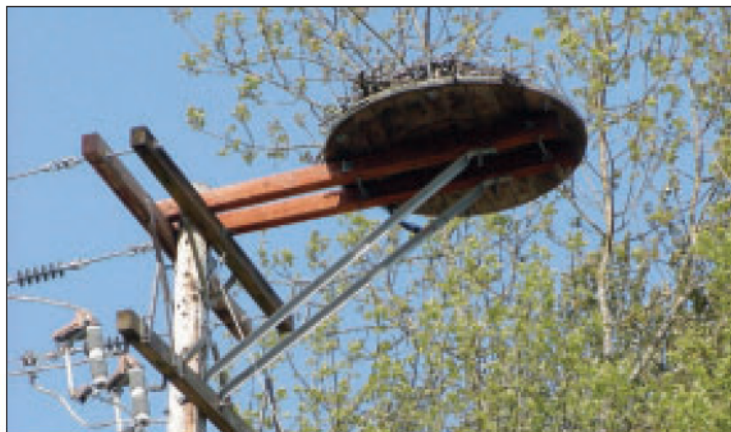
FIGURE 6.10: Osprey nest platform design developed by Portland General Electric. The platform is constructed from the end of a 1.5-meter (m) (5-foot [ft]) diameter wooden cable spool with coated cable along the edge to contain nest material. Utilities should ensure energized parts and equipment below the nest are covered to prevent electrocution of birds or outages from nest material. Consumer's Power, Inc. retrofitted this pole to their avian-safe standards.

An osprey nest structure erected above a power pole should have a well-supported platform with some nest material added to entice the birds to the new site (Figure 6.10). A perch, situated above the nest (Figure 6.11) or extending from the platform (Figures 6.12

Platforms made from discarded wooden cable spools have been used by nesting ospreys (Austin-Smith and Rhodenizer 1983) (see Figure 6.10). The offset-pallet-platform design developed in Ontario (Ewins 1994:13)

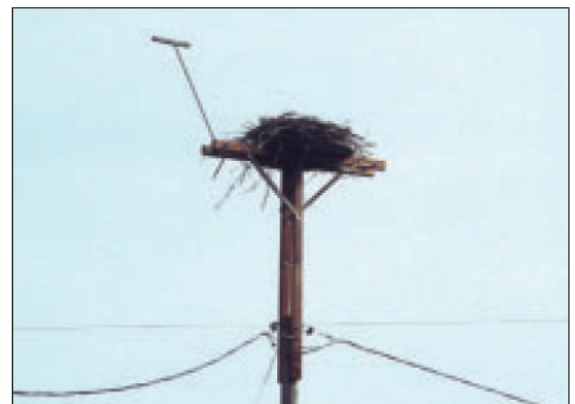
FIGURE 6.11: A nest platform built atop a pole using crossarms to extend the platform above the conductors. This design also includes an optional elevated perch to attract ospreys. The perch should be perpendicular to the prevailing wind.

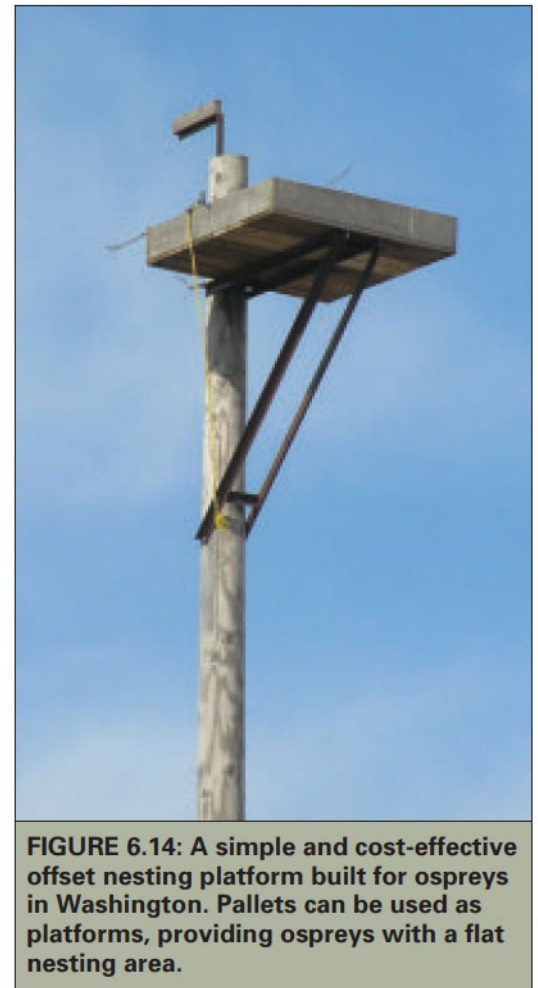
is simple and cost-effective (Figure 6.14). Figure 6.15 depicts another nest platform design that may be used for some buteos and ospreys. Grubb (1995) provides a guide for eagle nest designs.

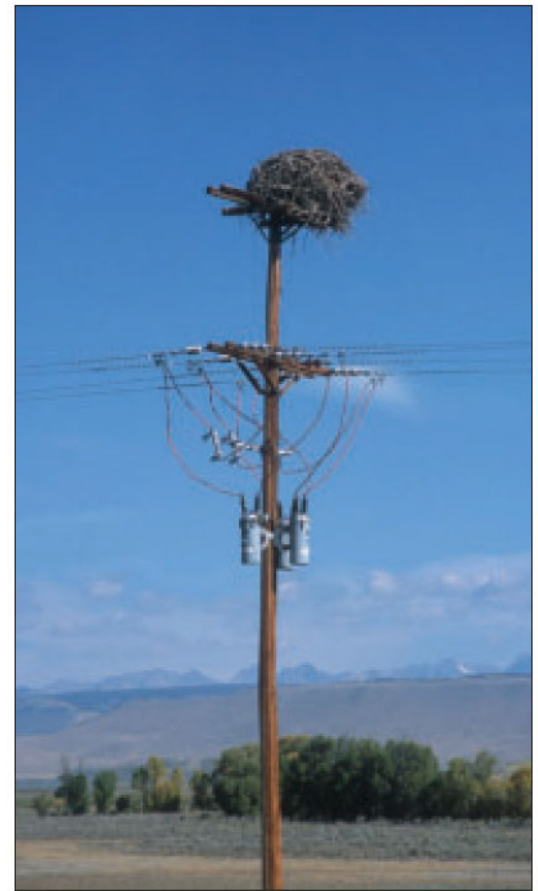
FIGURE 6.16: Osprey nest in Wyoming atop double dead-end pole. Nesting material that may drop onto the conductors or equipment poses fire, outage, and equipment damage risks.

prey remains dropping onto conductors or energized equipment (Figure 6.16). Installing a platform on a nearby non-energized pole reduces these risks.

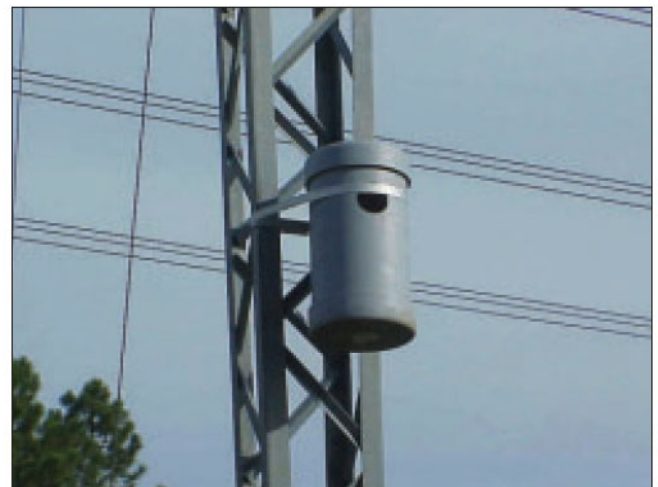
FIGURE 6.20 Kestrel nesting tube (46-cm [18-in] length) installed on transmission tower in Georgia.

Georgia Southern University and Georgia Power Company have erected nest boxes and tubes on transmission structures in Georgia for American kestrels (J. Parrish, pers. comm.). The nesting tubes were constructed of 30.5-cm (12-in) diameter, UV-resistant PVC pipe cut at lengths of either 46 or 91 cm (18 or 36 in). All tubes were drilled with drain holes in the bottom and vents on the sides, and lined with several inches of pine straw. The entrance of each nest tube was positioned to face east or south. The 91-cm (36-in) long tube included 30.5-cm (12-in) end caps with a 7.6-cm (3-in) hole cut in the middle of one of them (Figure 6.19). In 2003 and 2004, two of these tubes were mounted horizontally on transmission towers at a height of 30.5 m (100 ft). The tube mounted in 2003 was used in 2004, and both were used by nesting kestrels in 2005. The 46-cm (18-in) tube, which can be mounted either horizontally or vertically, includes a 7.6-cm (3-in) hole in either the end or the top of the tube (Figure 6.20). These tubes were installed both vertically and horizontally at a height of 4.5 m (15 ft). Kestrels used one of the four vertically mounted tubes in 2005, but did not use either of the horizontally mounted tubes that year.

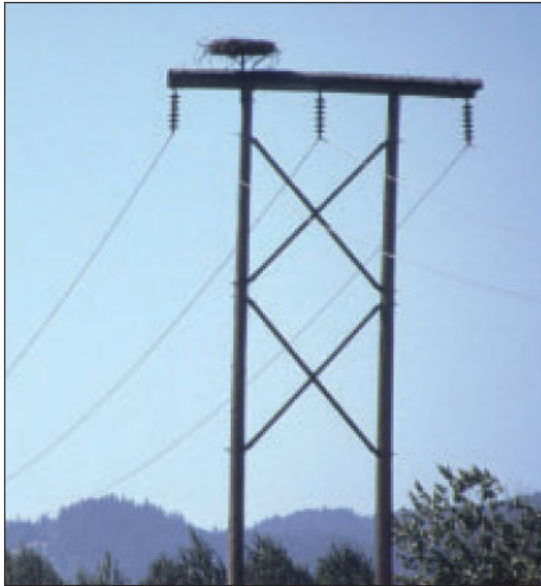
FIGURE 6.22: This osprey nest was originally located on the crossarms above the center conductor where contamination from fallen nest material and excrement accumulated. It was relocated to the platform shown. A halved, corrugated pipe was installed to prevent re-nesting on the crossarms. Relocating a problem nest to a nest platform on an adjacent non-energized pole is preferred. However, if pole cost, rights-of-way restrictions, or limited access prevent installation of a new structure, it is best to install a safe nest platform on the existing structure.

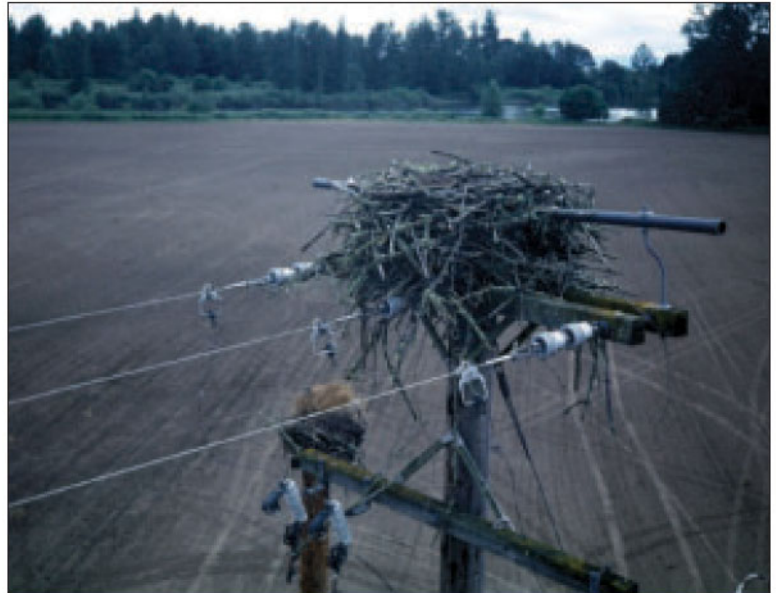
FIGURE 6.23: A segment of plastic pipe was installed on a dead-end pole in Oregon to discourage osprey nesting. However, the osprey pair continued nest construction after the pipe was installed.

Utility companies have dealt with bird-caused power reliability problems in a number of ways. One management concept is to maintain nests when they are in desirable locations (Henny et al. 2003; J. Kaiser, pers. comm.). Nest material can be trimmed away from conductors (Hobbs and Ledger 1986; Toner and Bancroft 1986). Occupied nests are well maintained by raptors, but abandoned nests may partially or completely collapse, thereby threatening electrical equipment (Ledger and Hobbs 1999). The use of perch or nest discouragers alone may not be effective in preventing nesting. In Florida, monk parakeets began using raptor perch discouragers as nest substrates in areas where they had not previously nested (J. Lindsay, pers. comm.). In the western United States, red-tailed hawks, ospreys, and common ravens have built nests around perch discouragers that were installed to discourage nesting on equipment or double dead-end poles (J. Burruss, pers. comm.) (see Figures 6.23, and 6.25 through 6.27).

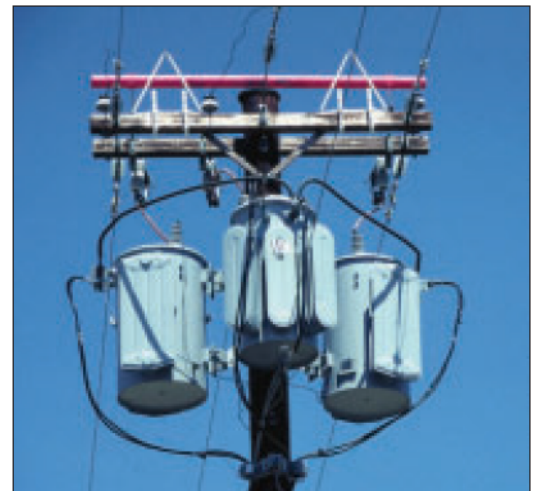
FIGURE 6.24: A pipe mounted above the conductors can be used as a nest discourager on distribution poles with insulators mounted on the crossarm. The use of triangles is cautioned against, as they may aid in the accumulation of nesting material. This design may pose an electrocution risk if exposed equipment and conductors are not covered or adequately spaced.

Nesting should sometimes be discouraged due to the risks to people, nesting birds, or the power system. PVC pipe or corrugated drain pipe banded to the crossarms can prevent birds from nesting on “H” frame transmission structures (Figure 6.21). A nest platform can then be placed above the arm and away from the insulators (Figure 6.22) or on a nearby non-energized pole. To discourage nest rebuilding on distribution poles where nests have been removed, a large plastic pipe can be installed above the crossarm (van Daele et al. 1980). In Montana, this has been effective in deterring nesting ospreys (S. Milodragovich, pers. comm.). However, in other areas, this nest discourager has been ineffective (Figure 6.23). Poles with conductors and insulators above the crossarms require a more complicated design. A PVC tube positioned above and extending the length of the crossarm with diagonal tubes extending toward the crossarms can deter nesting (Figure 6.24) (Henny et al. 2003). Such nest

discouragers should be installed close enough to the crossarm to prevent birds from nesting under them. They should be mounted securely on the arm, and should be installed so they do not reduce the BIL of the design.

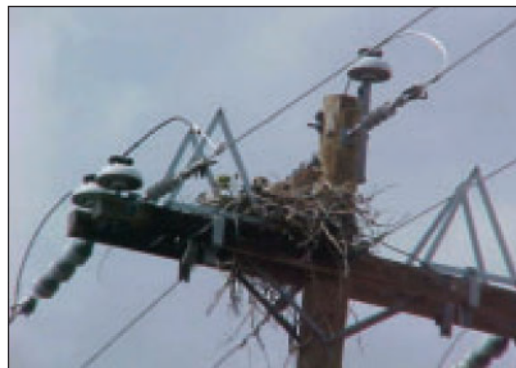
FIGURE 6.25: Red-tailed hawk nest on pole with triangle perch discouragers.

Triangles, plastic owls, and small spikes have also been used to discourage nesting on power poles. However, these devices are often unsuccessful. For example, birds may nest in open spaces adjacent to triangles (Figure 6.25), birds may initially react to plastic owls, but over time they can become habituated to them (Figure 6.26), and plastic spikes may aid in

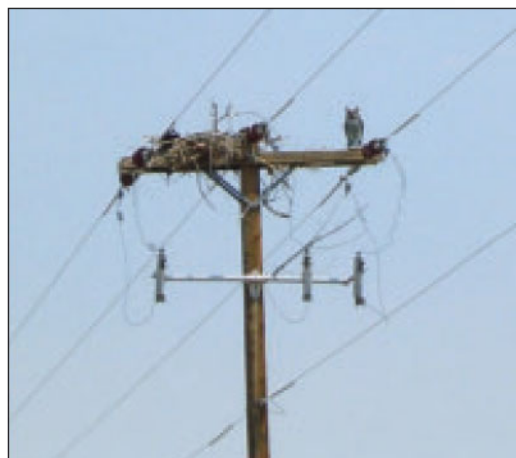
FIGURE 6.26: Osprey nest constructed on pole with plastic owl intended to haze birds.

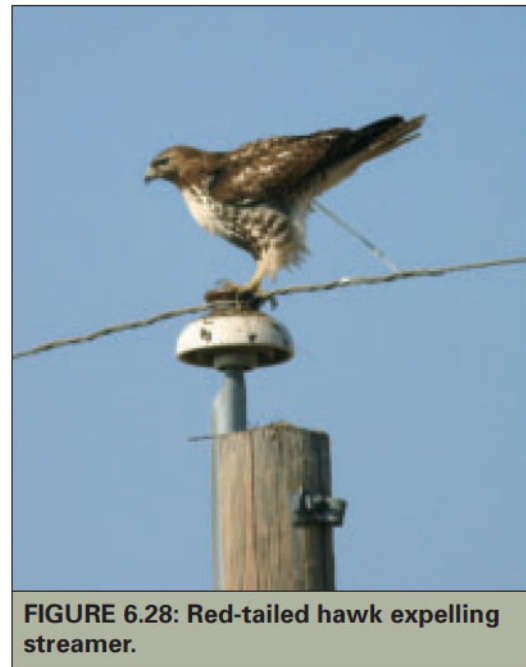
FIGURE 6.28: Red-tailed hawk expelling streamer.

Large raptors, vultures, and herons can expel long streams of excrement (Figure 6.28). These “streamers” can cause flashovers and short-outs when they span energized conductors and other line structures. Flashovers are faults that originate on live hardware and travel through the streamer to the structure. Although bird streamers were first thought to be a cause of unexplained transmission line faults in the 1920s (Michener 1924), this hypothesis has been difficult to verify because flashovers are rarely witnessed, and the resulting evidence is difficult to find. Yet, Burnham
