WETLAND DELINEATION REPORT

Iron Pine Solar Project Appendix B Wetland Determination Data Forms

Swift Current Energy Iron Pine Solar Project Number: Client: 193708962

Project: Location: Pine County, Minnesota

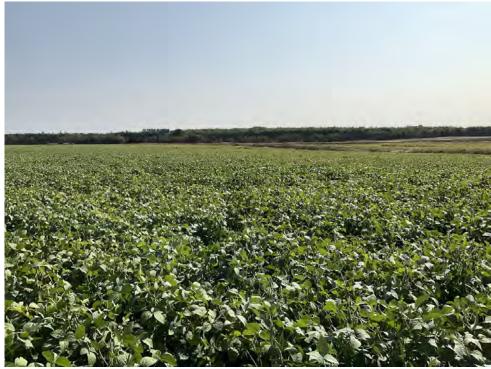
Photo 14: W4-1w - View East, September 13, 2022

Project/Site: Pine County Solar	City/County: Pine Sampling Date: 09/13/2022				
Applicant/Owner: Swift Current Energy	State: Min Sampling Point: W4-1w				
Investigator(s): AH, BB	Section, Township, Range: T044N, R020W, S23				
	relief (concave, convex, none): Linear Slope %: 3				
Subregion (LRR or MLRA): LRR K, MLRA 90A Lat: 46.273985	Long: -92.833205 Datum: WGS84				
Soil Map Unit Name: Denied Access					
Are climatic / hydrologic conditions on the site typical for this time of year?	Yes No _X (If no, explain in Remarks.)				
Are Vegetation X, Soil , or Hydrology significantly dist					
Are Vegetation , Soil , or Hydrology naturally problem	matic? (If needed, explain any answers in Remarks.)				
SUMMARY OF FINDINGS – Attach site map showing sampling p	oint locations, transects, important features, etc.				
Lhudrashutia Variation Process 2	le the Complet Area				
Hydrophytic Vegetation Present? Yes No X Hydric Soil Present? Yes X No	Is the Sampled Area within a Wetland? Yes X No

Wetland Hydrology Present? Yes X No	If yes, optional Wetland Site ID: W4				
	ii yes, optional wetianu Site ib				
Remarks: (Explain alternative procedures here or in a separate report.) Drier than normal conditions, ditched/tiled ag field					
Ener than normal containons, alterious agricia					
HYDROLOGY					
Wetland Hydrology Indicators:	Secondary Indicators (minimum of two required)				
Primary Indicators (minimum of one is required; check all that apply)	Surface Soil Cracks (B6)				
Surface Water (A1) Water-Stained Leaves (B9)	Drainage Patterns (B10)				
High Water Table (A2) Aquatic Fauna (B13)	Moss Trim Lines (B16)				
Saturation (A3) Marl Deposits (B15)	Dry-Season Water Table (C2)				
Water Marks (B1) Hydrogen Sulfide Odor (C1)	Crayfish Burrows (C8)				
Sediment Deposits (B2) Oxidized Rhizospheres on L	Living Roots (C3) X Saturation Visible on Aerial Imagery (C9)				
Drift Deposits (B3) Presence of Reduced Iron (0	C4) Stunted or Stressed Plants (D1)

Profile Desci	ription: (Describe to	the dept	h needed to docu	ment th	e indicat	or or co	nfirm the absence of	indicators.)		
Depth	Matrix		Redo	x Featur	es					
(inches)	Color (moist)	%	Color (moist)	%	Type ¹	Loc ²	Texture		Remarks	
0-13	10YR 2/1	100					Peat			
13-24	10YR 3/2	100					Peat			
¹Type: C=Co	oncentration, D=Depl	etion, RM:	=Reduced Matrix, N	лS=Mas	ked Sand	Grains.	² Location: PL=F	ore Lining, M=N	/latrix.	
Hydric Soil II	ndicators:						Indicators f	or Problematic	Hydric So	oils³:
X Histosol (A	A1)	=	Polyvalue Below	/ Surface	(S8) (LRR	R,	2 cm Mu	ıck (A10) (LRR K,	L, MLRA 14	19B)
Histic Epip	pedon (A2)		MLRA 149B)				Coast P	rairie Redox (A16)	(LRR K, L,	R)
Black Hist	tic (A3)	-	Thin Dark Surface	ce (S9) (I	RR R, ML	.RA 149B	5 cm Mu	icky Peat or Peat ((S3) (LRR K	, L, R)
Hydrogen	Sulfide (A4)	_	High Chroma Sa	ands (S11) (LRR K,	L)	Polyvalu	ie Below Surface (S8) (LRR K	, L)
Stratified I	Layers (A5)	_	Loamy Mucky M	lineral (F	1) (LRR K ,	L)	Thin Da	rk Surface (S9) (Li	RR K, L)

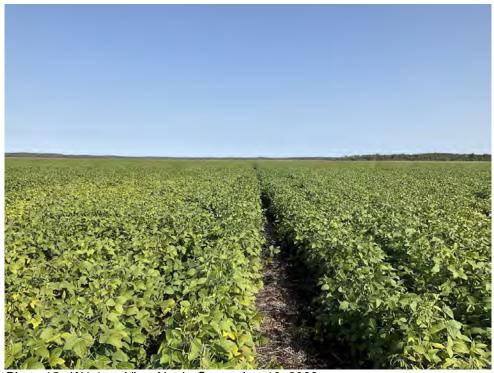
Photo 15: W4-1u - View North, September 13, 2022

Project/Site: Pine County Solar	City/County: Pine Sampling Date: 09/13/2022					
Applicant/Owner: Swift Current Energy	State: Min Sampling Point: W4-1u					
Investigator(s): AH, BB	Section, Township, Range: T044N, R020W, S23					
	relief (concave, convex, none): Linear Slope %: 5					
Subregion (LRR or MLRA): LRR K, MLRA 90A Lat: 46.274138	Long: -92.833387 Datum: WGS84					
Soil Map Unit Name: Denied Access	NWI classification: PEM1Af					
Are climatic / hydrologic conditions on the site typical for this time of year?	Yes No X (If no, explain in Remarks.)					
Are Vegetation X , Soil , or Hydrology significantly disturbed in Significantly disturbed in Significantly X	urbed? Are "Normal Circumstances" present? Yes No X					
Are Vegetation , Soil , or Hydrology naturally problem	natic? (If needed, explain any answers in Remarks.)					
SUMMARY OF FINDINGS – Attach site map showing sampling po	oint locations, transects, important features, etc.

Hydrophytic Vegetation Present? Yes No X	Is the Sampled Area					
Hydric Soil Present? Yes X No	within a Wetland? Yes No X					
Wetland Hydrology Present? Yes No X	If yes, optional Wetland Site ID: W4					
Drier than normal, ditched/tiled ag field						
HYDROLOGY						
Wetland Hydrology Indicators:	Secondary Indicators (minimum of two required)					
Primary Indicators (minimum of one is required; check all that apply)	Surface Soil Cracks (B6)					
Surface Water (A1) Water-Stained Leaves (B9)	Drainage Patterns (B10)					
High Water Table (A2) Aquatic Fauna (B13)	Moss Trim Lines (B16)					
Saturation (A3) Marl Deposits (B15)	Dry-Season Water Table (C2)					
Water Marks (B1) Hydrogen Sulfide Odor (C1)	Crayfish Burrows (C8)					
Sediment Deposits (B2) Oxidized Rhizospheres on Li	ving Roots (C3) Saturation Visible on Aerial Imagery (C9)					
Presence of Reduced Iron (C	4) Stunted or Stressed Plants (D1)

Profile Desci	ription: (Describe to	the dept	h needed to docu	ment th	e indicat	or or co	onfirm the absence of inc	licators.)
Depth	Matrix		Redo	x Featur	es			
(inches)	Color (moist)	%	Color (moist)	%	Type ¹	Loc ²	Texture	Remarks
0-12	10YR 2/1	100					Peat	
12-24	10YR 3/1	100					Peat	
¹Type: C=Co	oncentration, D=Depl	etion, RM:	=Reduced Matrix, N	лS=Mas	ked Sand	Grains.	² Location: PL=Pore	Lining, M=Matrix.
Hydric Soil I	ndicators:						Indicators for F	Problematic Hydric Soils ³ :
X Histosol (A	A1)	=	Polyvalue Below	/ Surface	(S8) (LRR	R,	2 cm Muck (A10) (LRR K, L, MLRA 149B)
Histic Epip	pedon (A2)		MLRA 149B)				Coast Prairie	e Redox (A16) (LRR K, L, R)
Black Hist	tic (A3)	-	Thin Dark Surface	ce (S9) (L	RR R, ML	RA 149B) 5 cm Mucky	Peat or Peat (S3) (LRR K, L, R)
Hydrogen	Sulfide (A4)	_	High Chroma Sa	ands (S11) (LRR K,	L)	Polyvalue Be	elow Surface (S8) (LRR K, L)
Stratified I	Layers (A5)	_	Loamy Mucky M	lineral (F	1) (LRR K,	L)	Thin Dark Su	urface (S9) (LRR K, L)

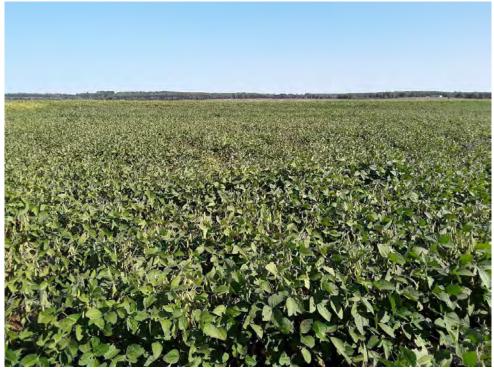
Photo 26: W5 - View East, September 12, 2022

Project/Site: Pine County Solar	City/County: Pine Sampling Date: 09/12/2022					
Applicant/Owner: Swift Current Energy	State: Min Sampling Point: W5-1u					
Investigator(s): KM, MB	Section, Township, Range: T044N, R020W, S26					
	relief (concave, convex, none): Linear Slope %: 2					
Subregion (LRR or MLRA): LRR K, MLRA 90A Lat: 46.273302	Long: -92.845146 Datum: WGS84					
Soil Map Unit Name: Denied Access						
Are climatic / hydrologic conditions on the site typical for this time of year?						
Are Vegetation X, Soil , or Hydrology significantly dist						
Are Vegetation , Soil , or Hydrology naturally problem	ematic? (If needed, explain any answers in Remarks.)					
SUMMARY OF FINDINGS – Attach site map showing sampling p	point locations, transects, important features, etc.					
Hydrophytic Vegetation Present? Yes No X	Is the Sampled Area					
Hydric Soil Present? Yes No X Hydric Soil Present? Yes X No	within a Wetland? Yes No X

Wetland Hydrology Present? Yes No X	If yes, optional Wetland Site ID: W5					
Remarks: (Explain alternative procedures here or in a separate report.)	ii yee, epitonai Wettana eite 15.					
Farmed soybean field with ditches. Precip drier than normal.						
HYDROLOGY						
Wetland Hydrology Indicators:	Secondary Indicators (minimum of two required)					
Primary Indicators (minimum of one is required; check all that apply)	Surface Soil Cracks (B6)					
Surface Water (A1) Water-Stained Leaves (B9)	Drainage Patterns (B10)					
High Water Table (A2) Aquatic Fauna (B13)	Moss Trim Lines (B16)					
Saturation (A3) Marl Deposits (B15)	Dry-Season Water Table (C2)					
Water Marks (B1) Hydrogen Sulfide Odor (C1)	Crayfish Burrows (C8)					
Sediment Deposits (B2) Oxidized Rhizospheres on L	Living Roots (C3) Saturation Visible on Aerial Imagery (C9)					
Drift Deposits (B3) Presence of Reduced Iron ((C4) Stunted or Stressed Plants (D1)

Profile Desci	ription: (Describe to	the dept	h needed to docu	ment th	e indicat	or or co	onfirm the absence	of indicato	ors.)	
Depth	Matrix		Redo	x Featur	es					
(inches)	Color (moist)	%	Color (moist)	%	Type ¹	Loc ²	Texture		Remarks	3
0 to 15	10YR 2/1	100					Peat	_		
15 to 24	10YR 3/3	100					Peat	Fibrous		
								_		
								_		
								_		
¹Type: C=Co	oncentration, D=Deple	etion, RM:	=Reduced Matrix, N	лS=Mas	ked Sand	Grains.	² Location: PL	=Pore Linin	g, M=Matrix.	
Hydric Soil II	ndicators:						Indicator	s for Proble	ematic Hydric	Soils ³ :
X Histosol (A	A1)	_	Polyvalue Below	Surface	(S8) (LRR	R,	2 cm	Muck (A10) (LRR K, L, MLRA	149B)
	pedon (A2)		MLRA 149B)						ox (A16) (LRR K ,	•
Black Hist		-	Thin Dark Surface				·		or Peat (S3) (LRR	
	Sulfide (A4)	-	High Chroma Sa						Surface (S8) (LRR	K, L)
·	Layers (A5)	<u>-</u>	Loamy Mucky M			L)			(S9) (LRR K, L)	DK I D)
	Below Dark Surface (A1	1) _	Loamy Gleyed N Depleted Matrix		i)			_	lasses (F12) (LRI ain Soils (F19) (M I	· · · · ·

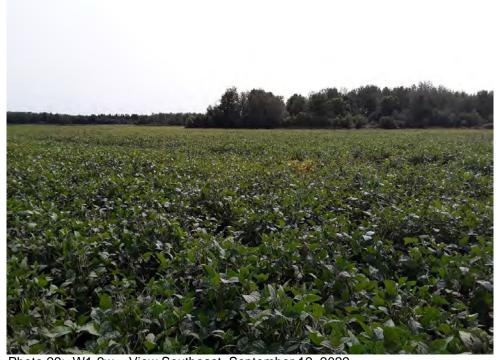
Photo 29: W1-2w - View Southeast, September 12, 2022

Project/Site: Pine County Solar	City/County: Pine Sampling Date: 09/12/2022					
Applicant/Owner: Swift Current Energy	State: Min Sampling Point: W1-2w					
Investigator(s): AH KKM	Section, Township, Range: T044N, R020W, S26					
	relief (concave, convex, none): Concave Slope %: 2					
Subregion (LRR or MLRA): LRR K, MLRA 90A Lat: 46.26262	Long: -92.84489 Datum: WGS84					
Soil Map Unit Name: Denied Access						
Are climatic / hydrologic conditions on the site typical for this time of year?	Yes No _X (If no, explain in Remarks.)					
Are Vegetation X, Soil , or Hydrology significantly dist						
Are Vegetation , Soil , or Hydrology naturally problem	matic? (If needed, explain any answers in Remarks.)					
SUMMARY OF FINDINGS – Attach site map showing sampling p	point locations, transects, important features, etc.					
Lhydrophytic Vegetation Present?	lo the Compled Area					
Hydrophytic Vegetation Present? Yes No X Hydric Soil Present? Yes X No	Is the Sampled Area within a Wetland? Yes X No

Wetland Hydrology Present? Yes X No	If yes, optional Wetland Site ID: W1					
	ii yes, optional wetiand site ib.					
Remarks: (Explain alternative procedures here or in a separate report.) Soybean field with ditches, precip drier than normal						
Soybean field with ditches, precip difer than normal						
HYDROLOGY						
	Cocoodon, Indicators (minimum of two required)					
Wetland Hydrology Indicators:	Secondary Indicators (minimum of two required)					
Primary Indicators (minimum of one is required; check all that apply)	Surface Soil Cracks (B6)					
Surface Water (A1) Water-Stained Leaves (B9)	 -					
High Water Table (A2) Aquatic Fauna (B13)	Moss Trim Lines (B16)					
Saturation (A3) Marl Deposits (B15)	Dry-Season Water Table (C2)					
Water Marks (B1) Hydrogen Sulfide Odor (C1)	<u> </u>					
Sediment Deposits (B2) Oxidized Rhizospheres on L Drift Deposits (B3) Presence of Reduced Iron (6						
	Shallow Aquitard (D3)

Profile Desci	ription: (Describe to	the dept	h needed to docu	ment th	e indicat	or or co	onfirm the absence	of indicato	rs.)	
Depth	Matrix		Redo	x Featur	es					
(inches)	Color (moist)	%	Color (moist)	%	Type ¹	Loc ²	Texture		Remarks	_
0 to 12	10YR 2/1	100					Peat	_		
12 to 24	10YR 3/4	100					Peat	Histic		
								_		
								_		
								_		
			-1					_

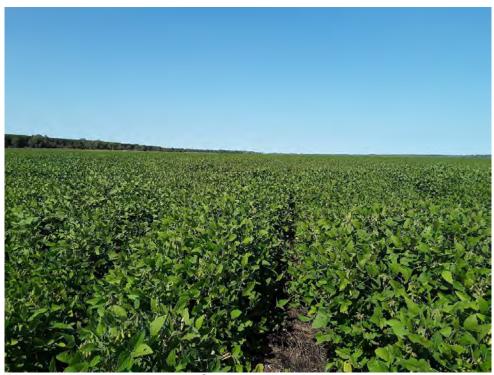
Photo 31: W3-1w - View North, September 12, 2022

Project/Site: Pine County Solar	City/County: Pine Sampling Date: 09/12/2022
Applicant/Owner: Swift Current Energy	State: Min Sampling Point: W3-1w
Investigator(s): KKM	Section, Township, Range: T044N, R020W, S26
	relief (concave, convex, none): Concave Slope %: 2
· · · · · · · · · · · · · · · · · · ·	· ———
Subregion (LRR or MLRA): LRR K, MLRA 90A Lat: 46.263152	Long: -92.842665 Datum: WGS84
Soil Map Unit Name: Denied Access	NWI classification: PEM1Af
Are climatic / hydrologic conditions on the site typical for this time of year?	Yes No X (If no, explain in Remarks.)
Are Vegetation X , Soil , or Hydrology significantly distu	urbed? Are "Normal Circumstances" present? Yes No X
Are Vegetation, Soil, or Hydrology naturally problem	natic? (If needed, explain any answers in Remarks.)
SUMMARY OF FINDINGS – Attach site map showing sampling po	oint locations, transects, important features, etc.
Hydrophytic Vegetation Present? Yes No X	Is the Sampled Area

Hydric Soil Present? Yes X No	within a Wetland? Yes X No
Wetland Hydrology Present? Yes X No	If yes, optional Wetland Site ID: W3
Remarks: (Explain alternative procedures here or in a separate report.) Soybean field with ditches. Precip drier than normal. Note this is the wetlar mislabeled as W3-1W	nd sample point - the other data sheet for the upland sample point was
HYDROLOGY	
Wetland Hydrology Indicators:	Secondary Indicators (minimum of two required)
Primary Indicators (minimum of one is required; check all that apply)	Surface Soil Cracks (B6)
Surface Water (A1) Water-Stained Leaves (B9)	Drainage Patterns (B10)
High Water Table (A2) Aquatic Fauna (B13)	Moss Trim Lines (B16)
Saturation (A3) Marl Deposits (B15)	Dry-Season Water Table (C2)
Water Marks (B1) Hydrogen Sulfide Odor (C1)	Crayfish Burrows (C8)
Sediment Deposits (B2) Oxidized Rhizospheres on Li	iving Roots (C3) X Saturation Visible on Aerial Imagery (C9)

Profile Description: (Describe to the depth needed to document the indicator or confirm the absence of indicators.)								
Depth	Matrix		Redo	x Featur	es			
(inches)	Color (moist)	%	Color (moist)	%	Type ¹	Loc ²	Texture	Remarks
0-20	10YR 2/1	100					Peat	
20-24	10YR 2/2	100					Sand	
								_
¹Type: C=Co	oncentration, D=Deple	etion, RM=	Reduced Matrix, N	//S=Mas	ked Sand	Grains.	² Location: PL=Poi	re Lining, M=Matrix.
Hydric Soil II	ndicators:						Indicators for	r Problematic Hydric Soils³:
X Histosol (A	A1)	_	Polyvalue Below	Surface	(S8) (LRR	R,	2 cm Muck	(A10) (LRR K, L, MLRA 149B)
Histic Epip	pedon (A2)		MLRA 149B)				Coast Prai	irie Redox (A16) (LRR K, L, R)
Black Hist	tic (A3)	_	Thin Dark Surface	ce (S9) (L	RR R, ML	RA 149B) 5 cm Muck	ky Peat or Peat (S3) (LRR K, L, R)
Hydrogen	Sulfide (A4)	_	High Chroma Sa	ands (S11) (LRR K,	L)	Polyvalue	Below Surface (S8) (LRR K, L)
Stratified I	Layers (A5)	_	Loamy Mucky M	lineral (F	1) (LRR K ,	L)	Thin Dark	Surface (S9) (LRR K, L)
