### **Appendix F**Wetland/Waterbody Report

### Rose Creek Wind, LLC Mower County, Minnesota

### **Wetland Delineation Report**

September 2021

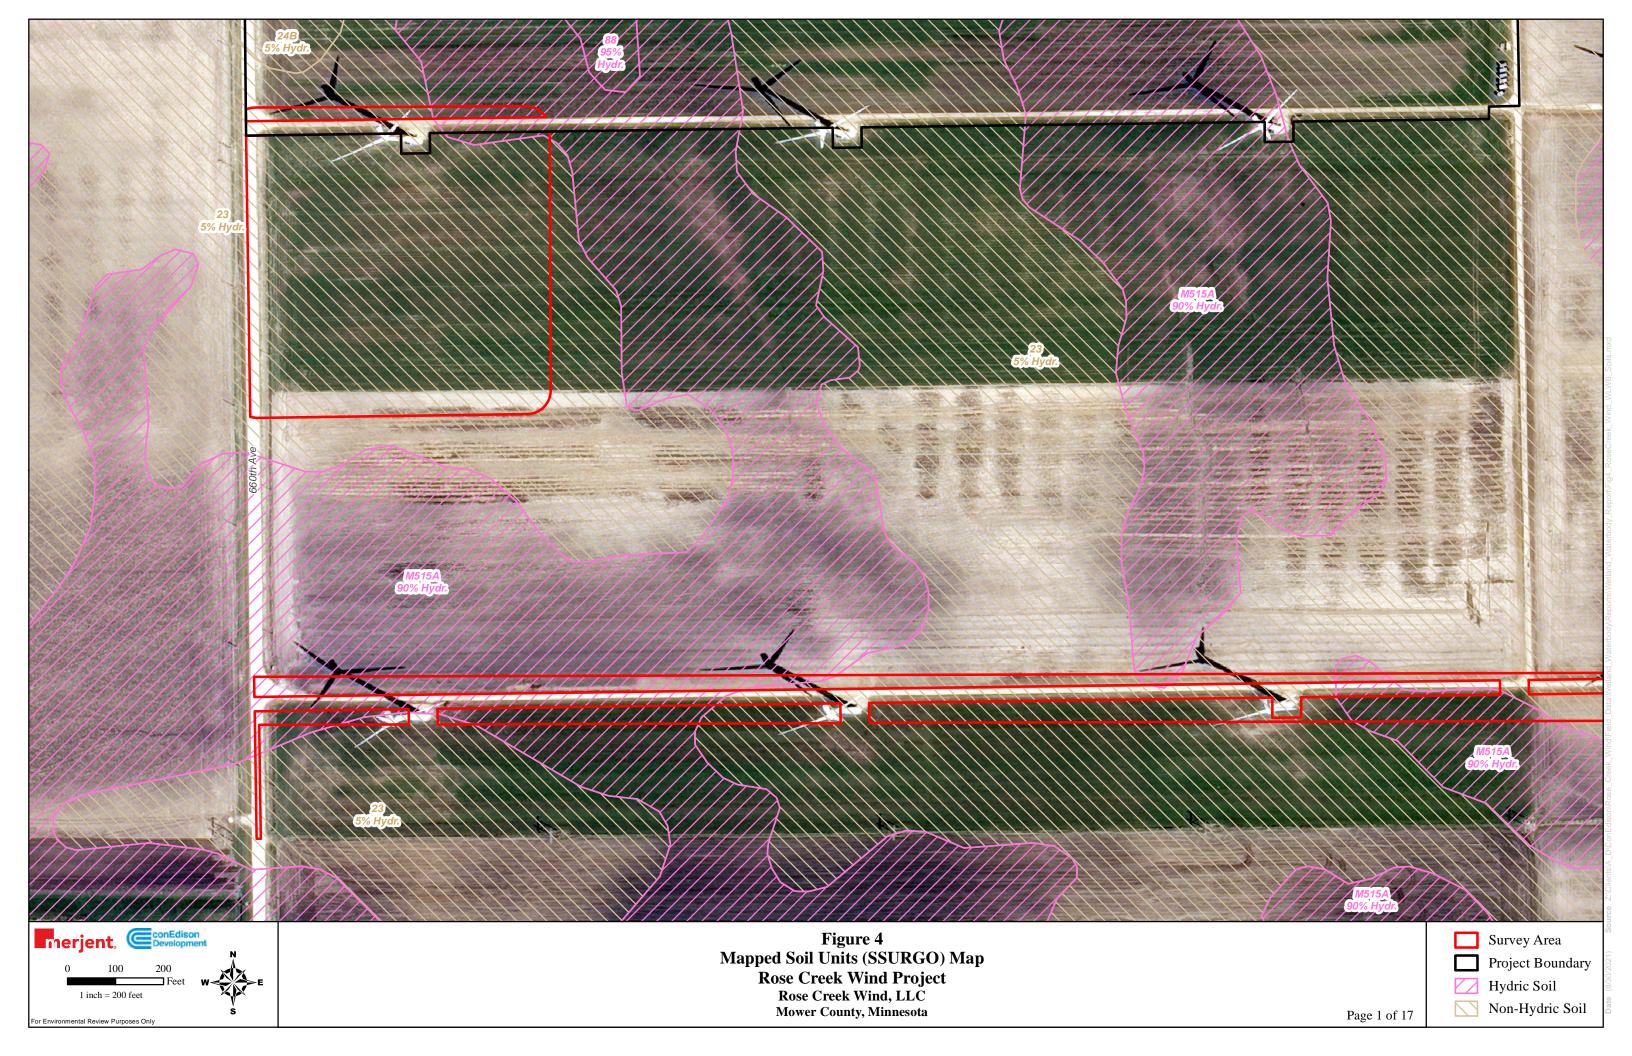
# Figure 4 SSURGO Soil Type

The NRCS soil map of the survey area (Figure 4) identified 18 soil types, four of which are classified as a hydric soil (Table 3-1).
