PHASE I RECONNAISSANCE

CONEFLOWER SOLAR PROJECT

Lyon County, Minnesota

Impact 7G, Inc. Project #MN2322012

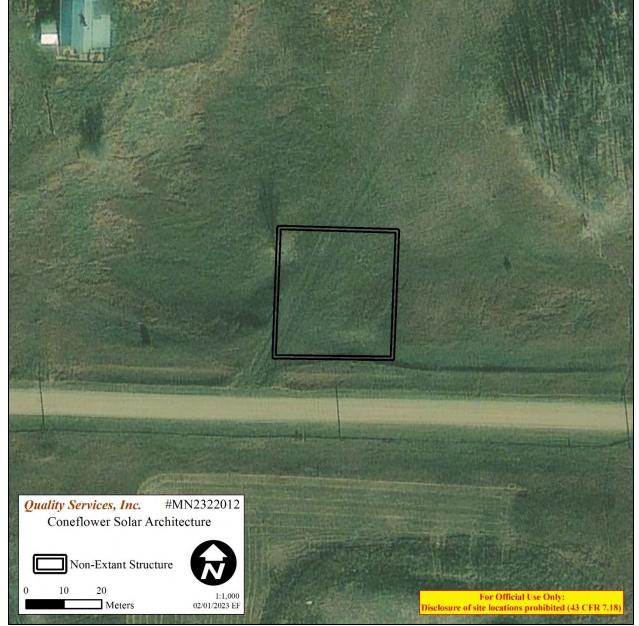
Figure 3. Site Map indicated the location of LY-CUS-00001 according to analysis of historic aerial photographs.

LY-CUS-00001 was a schoolhouse located north of 120th Street approximately 0.1 miles east of County Highway 7 in Lyon County, Minnesota. The site form was prepared in 1980 and no feature descriptions or eligibility recommendations were made at that time. The schoolhouse is no longer at this location. It was either removed or destroyed between 1992 and 2003, according to aerial photographs (Figure 4). Since this feature no longer exists it is recommended **not eligible** for the NRHP as an architectural resource and there will be **no effect** by the Project.

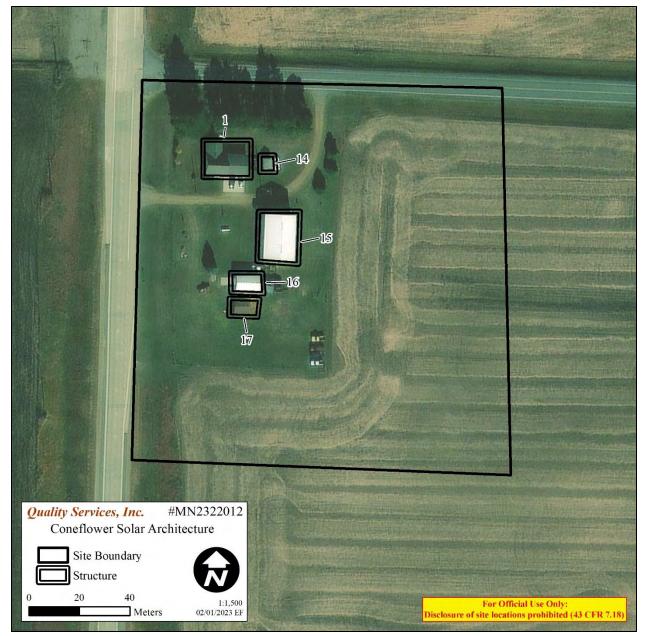
Figure 5. Site Map of LY-CUS-00003.

LY-CUS-00003 is the Kirchner Farmstead located at 1096 US Highway 59 in Lyon County, Minnesota. When the site form was created in 1994 there were four features at this location. During the 2023 site visit there were five architectural features of which only Feature 1 was still present from the 1994 site documentation. Features 2, 11, and 13 were all removed from the site between 2009 and 2013.

updated with new materials, and the garage addition has two aluminum overhead garage doors. Feature 14 is a small shed constructed between 2010 and 2013 near the location of Feature 11, according to aerial photographs it was constructed to the east of Feature 11. Feature 15 was constructed between 2013 and 2015. It is a modern, prefabricated, corrugated steel building with a gable roof. Two pedestrian doors and two horizontal sliding windows and a dog door open to the west. One horizontal sliding window and a large aluminum overhead garage door opens to the north. Two windows and another large overhead garage door open to the east. There are no openings on the south side of the building. There are two vents along the ridge of the roof and one metal chimney that extends out of the east side of the building. A foundation is not visible at this time. Feature 16 was constructed between 2015 and 2017. It is a smaller corrugated steel, prefabricated building. An aluminum garage door opens to the west, a small horizontal sliding window opens to the south and a small horizontal sliding window and pedestrian sized door with glass insert open to the north. This building rests on a poured concrete foundation. Feature 17 is a corrugated steel carport constructed between 2021 and 2023. The north, south, and west walls are all enclosed and the east wall is open. The metal frame is visible on the interior. It does not appear to have a foundation. Figure 5 presents a photograph of this site and Figure 6 presents the layout of the site features.

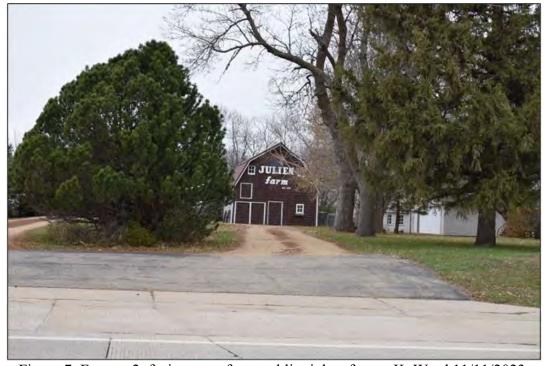
Figure 7. Feature 2, facing west from public right-of-way. K. Ward 11/11/2023.

LY-CUS-00004 is the Julien Farmstead located at 1109 US Highway 59 in Lyon County, Minnesota. When the site form was created in 1994 there were four features listed. All four features were still present at the time of the 2023 site visit. Feature 1 has been resided with modern, narrow, vinyl siding. The foundation around the enclosed porch has been covered in this siding as well. The front steps have been removed and shrubs have been planted where the steps used to be. The decorative rafter tails that were previously documented have been covered with fascia. Feature 2 exterior finishes have all been updated with new corrugated sheet metal siding and roofing. The doors have all been replaced with corrugated sheet metal. Feature 7 has modern aluminum or vinyl siding to match the siding on the house. The roof is finished with corrugated sheet metal. The windows appear to be new, vinyl frames. Feature 11 has modern vinyl or aluminum siding to match Features 1 and 7. The garage door is a modern aluminum overhead garage door. Figures 7 and 8 present photographs of this site.

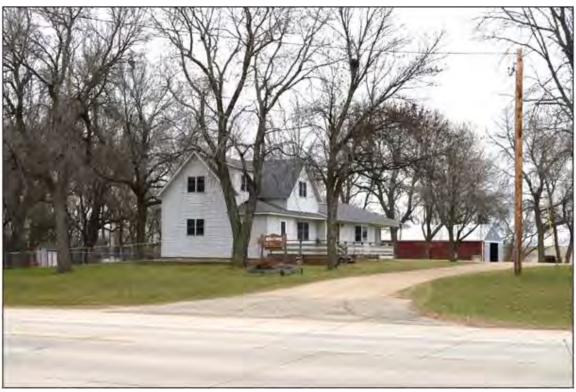
Figure 9. Feature 1 facing east. K. Ward 11/10/2023.

LY-CUS-00005 is the John S. Owens Farmstead located at 1126 US Highway 59 in Lyon County, Minnesota. This farmstead consisted of 12 features at the time the site form was created in 1994. Features 6, 11a, 11c, 19a, and 19b are no longer at this farmstead.

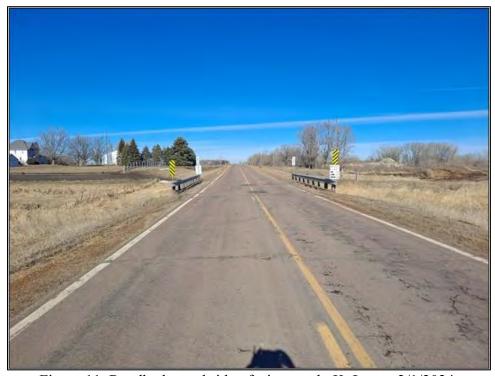
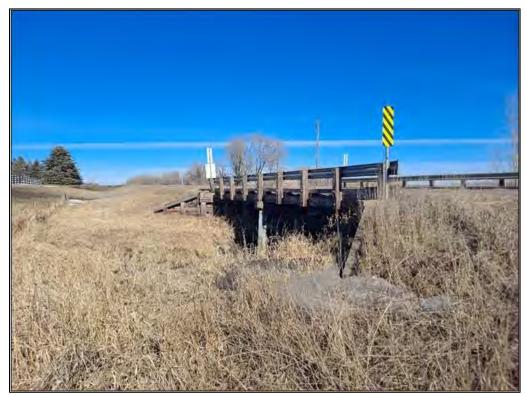
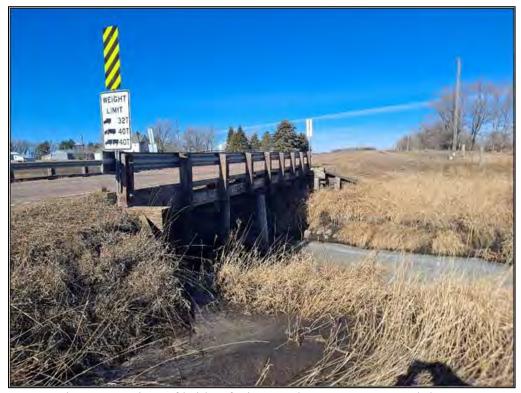
LY-CUS-00007 is a bridge along 240th Street in Lyon County, Minnesota. A date was not provided and no information was included for this feature when the site form was previously created. The bridge was constructed in 1966, the main span material is wood or timber, and the main span design is a slab. There are two spans and the bridge is 52.5 feet in length. Figures 12, 13 and 14 present photographs of the bridge. Information provided on this bridge by the United States Department of Transportation states that it is not National Register Eligible. Additionally, analysis of the structure shows that it is a common style rural bridge that does not contain any significant or distinct characteristics. It is recommended **not eligible** for the National Register of Historic Places. There will be **no effect** on this site by the Project.

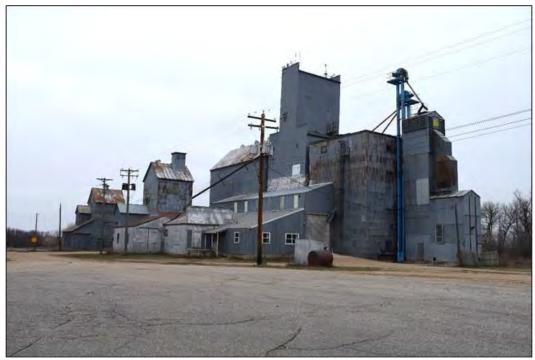
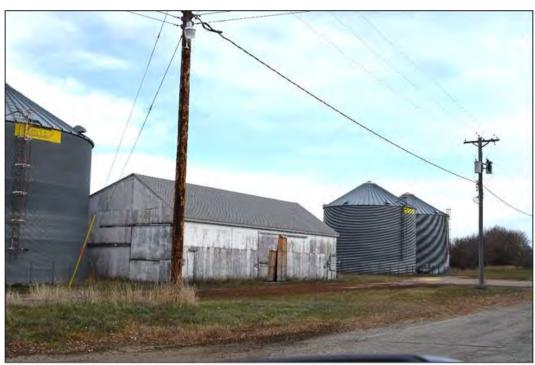
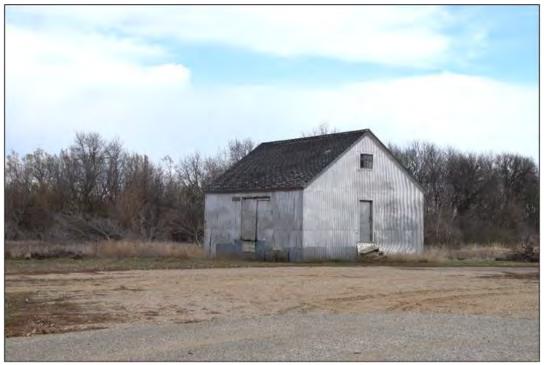
LY-GVC-00001 is the grain elevator complex located at 700 1st Street in Garvin, Minnesota. A site form prepared in 1980 does not contain a feature description or a National Register of Historic Places recommendation. During the site visit in 2023, the grain elevator has many additions and different sections combined into one large complex. The roof styles are mixed and the materials consist of older corrugated sheet metal, newer corrugated sheet metal, and asphalt shingles. The exterior finishes include narrow, smaller sheets of corrugated metal, larger panels of similar materials, and plywood. Vinyl framed windows are visible in the office area of the building. Metal, aluminum, and fiberglass doors are visible throughout the complex. Augers connect different sections to each other. This complex also has three large, corrugated steel grain bins, one older rectangular granary constructed of corrugated sheet metal sides and asphalt shingles, and a storage building made of plywood. Figures 17 through 20 present photographs of the grain elevator complex site.

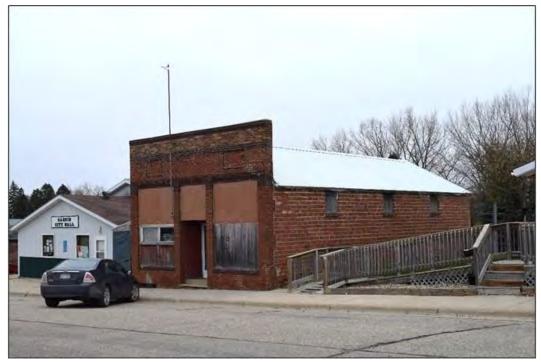
Figure 22. Additional view of front (east) and north facades facing southwest. K. Ward 11/10/2023.

retain integrity of design, materials, workmanship, or feeling. This building is recommended **not eligible** for the National Register of Historic Places and there will be **no effect** on this resource by the Project.

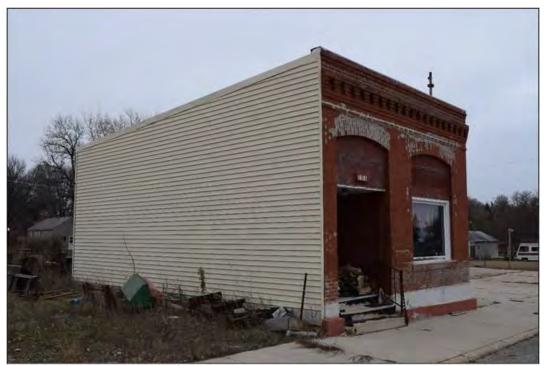
Figure 31. Front and side facade, facing southeast. K. Ward 11/10/2023.

LY-GVC-00009 is located at 104 Sherman Street in Garvin, Minnesota. The site form was originally completed in June 1980, however, there is not a feature description or NRHP statement included. During the November 2023 visit the north façade was entirely refinished in aluminum or vinyl siding. The west/front façade shows significant patching in the mortar between the brickwork, particularly in the arches over the doorway and window. The upper half of the window opening is closed with painted plywood and the upper area over the door is also covered in painted plywood. A single, wood framed storm door with three large windows covers the entry door, which also has three windows that are slightly smaller than those on the storm door. The top storm door window is taped together. Sidelights are present on each side of the entry door and consist of six panes of glass on either side of the door. Painted wood or siding is visible in the entryway. Steps into the building are poured concrete with remains of outdoor carpet still present. The two upper steps still have metal tack strip holding the carpet down. The foundation appears to be poured concrete or has a poured concrete finish that is cracked and crumbling. The south façade sits on a poured concrete foundation and the brickwork has extensive patching with concrete covering some bricks and large areas of the mortar. A brick chimney extends up from the south façade at roughly the central point of the wall. Figures 31 through 33 present photographs of the site.

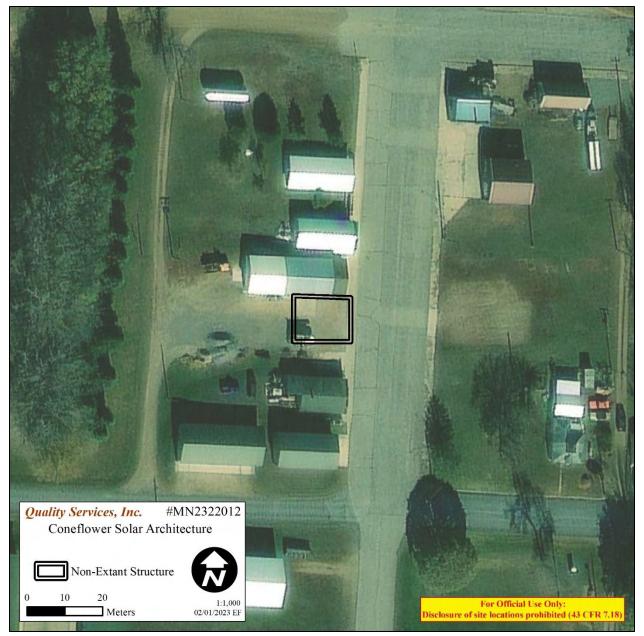
Figure 33. Aerial photograph showing LY-GVC-0009 previous location.

LY-GVC-00009 was located on Sherman Street, in Garvin, Minnesota. The building was documented in a site form in 1980. Aerial photographs show that the building was moved or destroyed between 1983 and 1991. Figure 34 presents a current aerial photograph depicting that the feature no longer exists. As this feature no longer exists at this location, it is recommended **not eligible** for the National Register of Historic Places as an architectural resource.

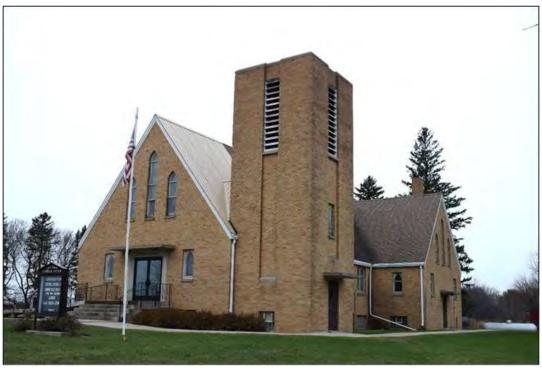
Figure 35. East and north facades, facing southwest from public right-of-way. K. Ward 11/10/2023.

LY-GVC-00011 is located at 1096 US Highway 59 in Garvin, MN and was first documented in 1994. Since then, a poured concrete wheelchair ramp has been added to the main entrance of the church on the east façade. The smaller windows along the north, south, and east facades are rectangular shaped openings but the stained glass is arched. The area surrounding the glass appears to be a concrete frame. The pair of doors at the main entrance appear to be modern metal framed doors with large glass inserts. A portion of the north roof slope and the roof connecting the main church to the bell tower has been updated with modern vinyl coated corrugated sheet metal. Glass blocks have filled in a window in the bell tower that was not mentioned in the previous site form. Glass blocks also close in space around operable basement windows. The use of glass block was not included in the original site form and the photographs are not detailed enough to determine if this was part of the design during the site visit. Figures 35 and 36 present photographs of the site.

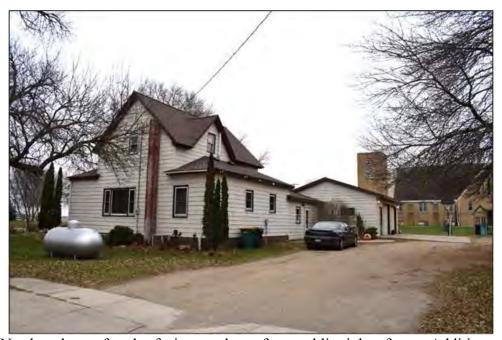
vinyl frames. The one-stall garage described in the 1994 site form has been removed. A two-stall garage to the south of the house was constructed between the previous site visit in 1994 and the next available aerial photograph taken in 2003. An addition on the house was constructed to connect the new garage with the south side of the house. What appears to be basement windows in the photographs from 1994 have been covered since the visit and are no longer visible. Figures 37 and 38 present photographs of the site.

Figure 37. North and west facades facing southeast from public right-of-way. Addition and attached garage on south side of house are visible. K. Ward 11/10/2023.

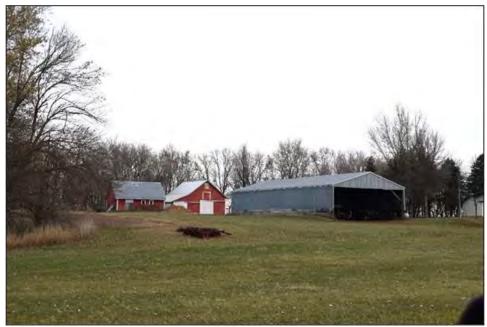
Figure 38. Overview of LY-CUS000014 facing northeast from public right-of-way. K. Ward 11/11/2023.

LY-CUS-00014 is a farmstead located at 2392 150th Street in Lyon County, Minnesota that consists of seven architectural resources. Figure 39 presents a photograph of the site. Though some of the features at this site are over 50 years of age and they are associated with the development of agriculture in the region (Criterion A), they are not associated with significant persons in our past (Criterion B). They also do not embody distinctive characteristics for these types of buildings and they do not represent the work of a master (Criterion C). They have not and are not likely to yield information important to our history (Criterion D) particularly because they do not retain the seven aspects of integrity. The updated exterior finishes have caused them to lose integrity of design, materials, workmanship, and feeling. For these reasons, all features at this site are recommended **not eligible** for the National Register of Historic Places and there will be **no effect** on these resources by the Project.

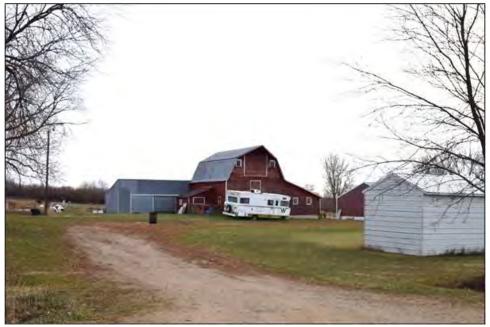
Figure 39. Feature 9 (left) and Feature 5 (right) facing southeast from public right-of-way. K. Ward 11/11/2023.

LY-CUS-00015 is a farmstead with eight architectural features located at 1470 230th Avenue. Figure 40 presents a photograph of the site. Many of the structures at this site were constructed prior to 1955 and are representative of development of agriculture in the region (Criterion A). However, they are not associated with significant persons (Criterion B) and do not embody distinctive characteristics or represent the work of a master (Criterion C). They have not and are not likely to yield information important to our history or prehistory (Criterion D). Feature 9 does meet Criterion C in that it represents the distinctive style of a Prairie Barn, however it does not retain integrity due to the large, corrugated sheet metal shed addition added to the east side of the barn. This addition has caused it to lose integrity of design, materials, workmanship, and feeling. For these reasons, all of the features at LY-CUS-00015 are recommended **not eligible** for the National Register of Historic Places and there will be **no effect** on this site by the Project.

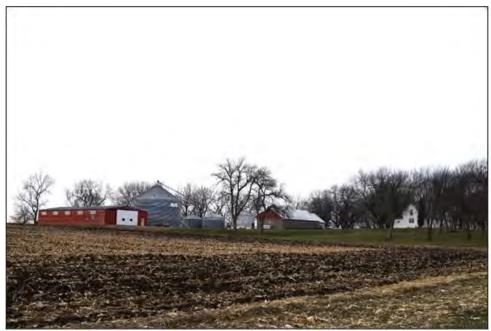
Figure 40. Overview of LY-CUS-00016 facing southwest from the public right-of-way. K. Ward 11/11/2023.

LY-CUS-00016 is a farmstead located at 2305 140th Street in Lyon County, Minnesota. The property consists of eight architectural features. Figure 41 presents a photograph of the site. All the features at this site are of a common style seen throughout the region. They are associated with the development of agriculture (Criterion A). However, they are not associated with significant persons (Criterion B) and do not embody distinctive characteristics or represent the work of a master craftsman (Criterion C) and are not likely to yield information important to our history (Criterion D). For these reasons, all the buildings at this site are recommended **not eligible** for the National Register of Historic Places and there will be **no effect** on this site by the Project.

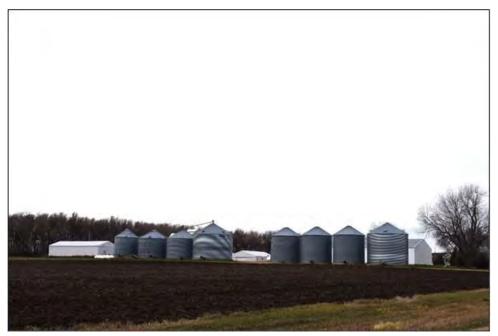
Figure 41. Overview of LY-CUS-00017 facing southwest from the public right-of-way. K. Ward 11/11/2023.

LY-CUS-00017 is a 15-feature farmstead located at 2473 150th Street in Lyon County, Minnesota. Figure 42 presents a photograph of the site. All features at this site are either modern or have undergone modern updates to exterior finishes. The modern features do not meet criteria considerations to achieve significance within the last 50 years. The other features have not retained integrity of design, materials, workmanship, or feeling. All 15 features at this site are recommended **not eligible** for the National Register of Historic Places and there will be **no effect** on this farmstead by the Project.

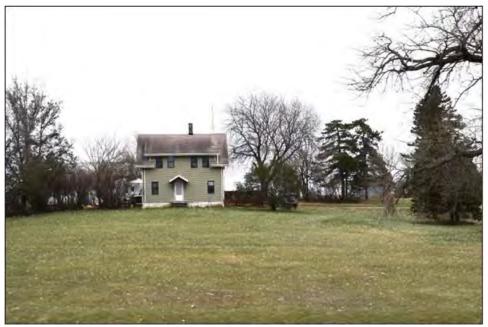
Figure 42. Overview of LY-CUS-00018 facing east from public right-of-way. K. Ward 11/11/2023.

LY-CUS-00018 is a farmstead containing five architectural features at 1366 US Highway 59 in Lyon County, Minnesota. Figure 43 presents a photograph of the site. Features 1 and 2 are old over 50 years of age, however, they have both undergone extensive updates to the exterior finishes so they do not retain integrity of design, materials, workmanship, or feeling and are recommended **not eligible** for the National Register of Historic Places. Features 3, 4, and 5 are all modern and do not contain any significant or distinct characteristics that would allow them to achieve significance within the last 50 years and are therefore recommended **not eligible** for the National Register of Historic Places. Since all features at this site are recommended **not eligible** there will be **no effect** on this site by the Project.

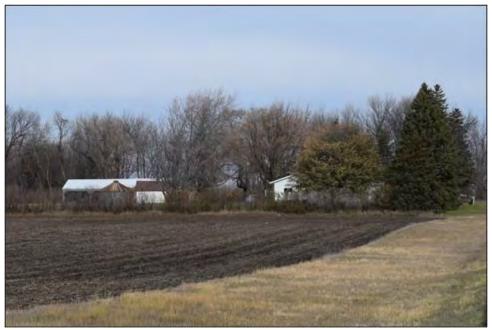
Figure 43. Overview of LY-CUS-00019 facing northwest from public right-of-way. K. Ward 11/11/2023.

LY-CUS-00019 is a farmstead with five features located at 1353 US Highway 59 in Lyon County, Minnesota. Figure 44 presents a photograph of the site. Feature 1 is over 50 years old, however, it has undergone substantial changes and does not retain integrity of design, materials, workmanship, or feeling and is recommended **not eligible** for the National Register of Historic Places. The roof on Feature 4 has been refinished and it is a common style building with no significant or distinct features. Feature 5 also does not contain any significant or distinct features. Both Features 4 and 5 are recommended **not eligible** for the National Register of Historic Places. Finally Features 2 and 3 are both less than 50 years old and have not achieved significance under the criteria considerations. They are recommended **not eligible** for the National Register of Historic Places. Since all of the features at LY-CUS-00019 are recommended **not eligible** for the National Register of Historic Places there will be **no effect** to these resources by the Project.

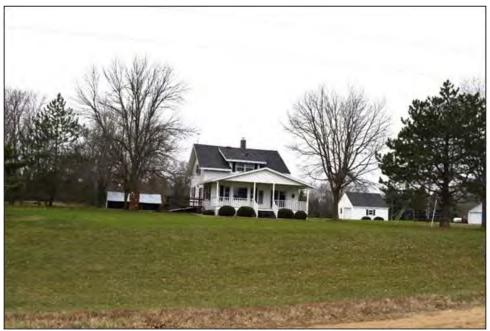
Figure 44. Overview of LY-CUS-00020 facing west from the public right-of-way. K. Ward 11/11/2023.

LY-CUS-00020 is a farmstead containing five features located at 1367 250th Avenue in Lyon County, Minnesota. Figure 45 presents a photograph of the site. Features 1, 2, and 3 have all undergone significant updates to the exterior finishes. They do not retain integrity of design, materials, workmanship, or feeling. Features 4 and 5 are common style outbuildings that do not embody significant or distinct characteristics. For these reasons, all of the features at this site are recommended **not eligible** for the National Register of Historic Places and as such there will be **no effect** on these resources by the Project.

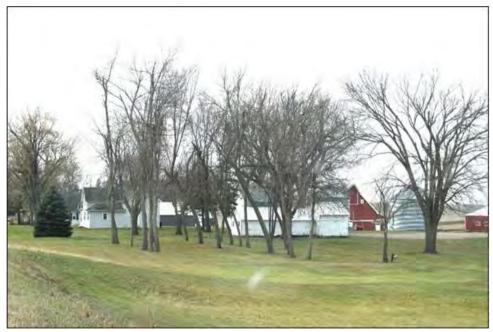
Figure 45. Overview of LY-CUS-00021 facing southwest from public right-of-way. K. Ward 11/11/2023.

LY-CUS-00021 is an 11-feature farmstead located at 1377 County Road 7 in Lyon County, Minnesota. Figure 46 presents a photograph of the site. Features 1-8, 10, and 11 have undergone substantial updates to the exterior materials, causing them to lose integrity of design, materials, workmanship, and feeling. They are recommended **not eligible** for the National Register of Historic Places. Feature 9 is not visible from the public right-of-way and is **unevaluated**. However, based on the size and location of the building it is a smaller outbuilding and not likely to contribute important information and therefore Feature 9 is also recommended **not eligible** for the National Register of Historic Places. Since all features at this site are recommended **not eligible** for the National Register of Historic Places there will be **no effect** on LY-CUS-00021 by the Project.

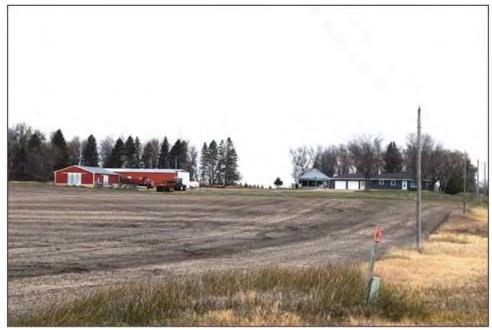
Figure 46. Overview of LY-CUS-00022 facing northwest from the public right-of-way. K. Ward 11/11/2023.

LY-CUS-00022 is a farmstead containing three architectural features at 1343 County Road 7 in Lyon County, Minnesota. Figure 47 presents a photograph of the site. Feature 1 is less than 50 years old and does not meet criteria considerations for significance within the last 50 years and is recommended **not eligible** for the National Register of Historic Places. Features 2 and 3 are common style with no significant or distinct characteristics and are also recommended **not eligible** for the National Register of Historic Places. For these reasons, there will be **no effect** on the architectural features at this site by the Project.

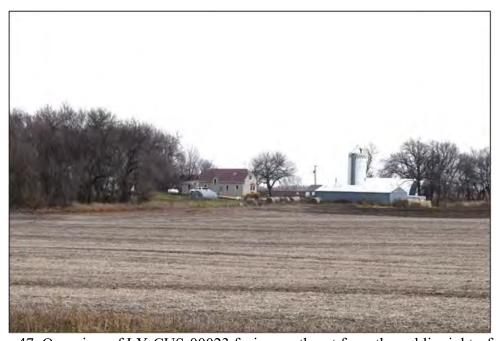
Figure 47. Overview of LY-CUS-00023 facing northeast from the public right-of-way. K. Ward 11/11/2023.

LY-CUS-00023 is a farmstead with nine architectural features located at 2317 US Highway 14 in Lyon County, Minnesota. Figure 48 presents a photograph of the site. Features 1, 2, 3, and 5 are all over 50 years of age, however they do not meet Criteria A, B, C, or D and are recommended **not eligible** for the National Register of Historic Places. Features 4, 6, 7, 8 and 9 are all less than 50 years old and do not meet the criteria considerations to achieve significance within the last 50 years and are recommended **not eligible** for the National Register of Historic Places. Therefore, there will be **no effect** on this site by the Project.

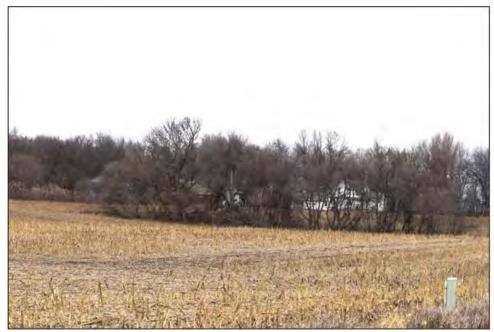
Figure 48. Overview of LY-CUS-00024 facing northwest from the public right-of-way. K. Ward 11/11/2023.

LY-CUS-00024 is a five-feature farmstead located at 1283 County Road 7 in Lyon County, Minnesota. Figure 49 presents a photograph of the site. All five features at this site are part of the broad pattern of agricultural development in the region (Criterion A). However, none of them are associated with significant people, nor do they contain any distinct characteristics or represent the work of a master craftsman (Criteria B and C). These features are also unlikely to provide important information about our history (Criterion D). Additionally, many of the structures have not retained integrity due to deterioration to the buildings or additions constructed during later time periods. For these reasons, all five features at this site are recommended **not eligible** for the National Register of Historic Places and there will be **no effect** by the Project.

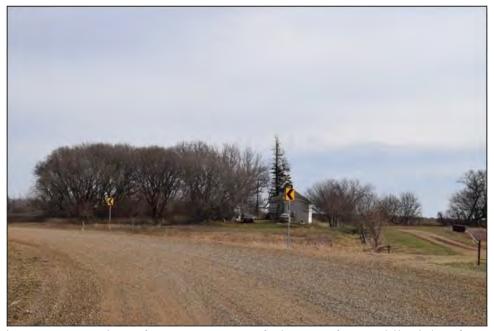
LY-GVC-00013 is a farmstead on the outskirts of the town of Garvin in Lyon County, Minnesota at 941 4th Street. Figure 75 presents a photograph of the site. This farmstead consists of two architectural resources. Feature 1 has undergone substantial updates to the exterior finishes so it does not retain integrity of design, materials, workmanship, or feeling. Feature 2 appears to at least be partly collapsed and as such has not retained integrity of design, materials, workmanship, or feeling. For these reasons both features at this site are recommended **not eligible** for the National Register of Historic Places and there will be **no effect** on these resources.

Figure 74. Overview of LY-GVC-00013 facing east from public right-of-way. K. Ward 11/11/2023.

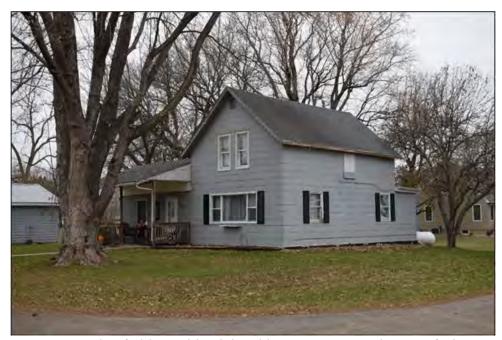
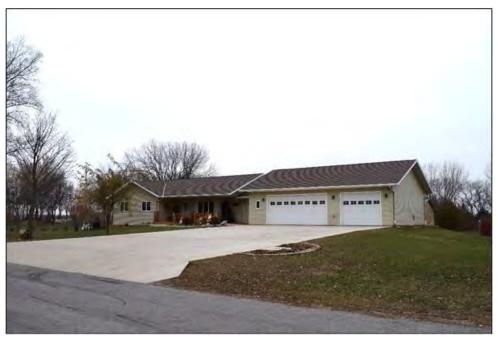
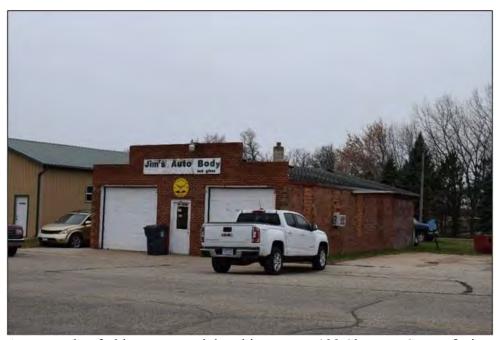
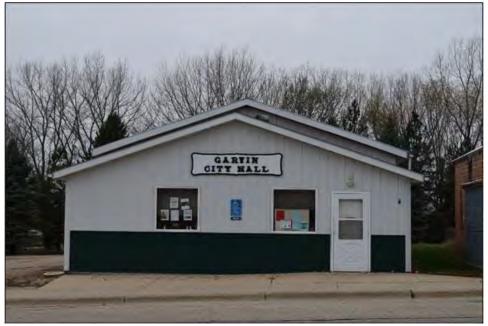
Many houses in Garvin were constructed prior to the first available aerial photograph taken in 1955. Other houses were constructed as recently as the 2010s. Old storefronts along Sherman Street have been updated or have fallen into disrepair. Some new buildings have also been added along Sherman Street. All features at this site are recommended **not eligible** for the National Register of Historic Places. Buildings within the town fall into three main categories. Older buildings that have undergone updates to exterior finishes, have had additions constructed, and/or their uses have been changed. As such they are **not eligible** for the National Register of Historic Places because they do not retain integrity for design, materials, workmanship, or feeling. Other older buildings that have not undergone changes have fallen into disrepair are recommended **not eligible** for the National Register of Historic Places due to the lack of integrity from deterioration. The third category are modern buildings that are recommended **not eligible** for the National Register of Historic Places because they have not achieved significance under the Citeria Considerations. There will be **no effect** on this site from the Project.

Figure 75. An example of older residential architecture at 200 3rd Street, facing northwest. K. Ward 11/10/2023.

Figure 76. An example of modern residential architecture at 201 Quincy Street, facing southwest. K. Ward 11/10/2023.

Figure 77. An example of older commercial architecture at 133 Sherman Street, facing southwest. K. Ward 11/10/2023

Figure 78. An example of modern commercial architecture at 125 Sherman Street, facing west. K. Ward 11/10/2023.

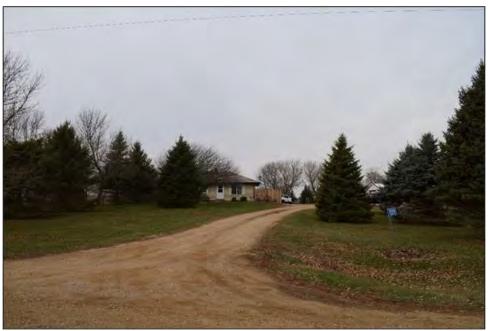
LY-RLT-00011 is a farmstead with three architectural features located at 1529 230th Avenue in Lyon County, Minnesota. Figure 80 presents a photograph of the site. Feature 1 has undergone significant updates to the exterior finishes, windows, and doors. It does not retain integrity of design, materials, workmanship, or feeling. Feature 1 is recommended **not eligible** for the National Register of Historic Places. Features 2 and 3 are both less than 50 years of age and have not achieved significance within the past 50 years under Criteria Considerations. Both Features 2 and 3 are recommended **not eligible** for the National Register of Historic Places. There will be **no effect** on this property by the Project.

Figure 79. Overview of LY-RLT-00011 facing west from public right-of-way. K. Ward 11/11/2023.

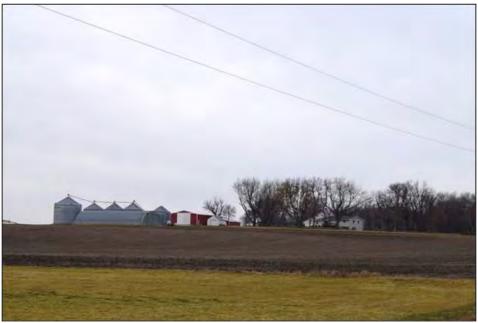
LY-RLT-00012 is a farmstead containing 10 architectural features located at 2271 150th Street in Lyon County, Minnesota. Figure 81 presents a photograph of the site. Features 1, 3, 4, 6, 7, 8, 9, and 10 are all less than 50 years old or likely less than 50 years old and have not achieved significance under Criteria Considerations within the last 50 years. They are recommended **not eligible** for the National Register of Historic Places. Feature 2 is a Western Style barn that has undergone updates to the exterior finishes so it no longer retains integrity of design, materials, workmanship, or feeling. Feature 5 was constructed prior to 1955. The exterior finishes have also been updated on this building and so it does not retain integrity of design, materials, workmanship, or feeling. Both Features 2 and 5 are also recommended **not eligible** for the National Register of Historic Places. There will be **no effect** on these resources by the Project.

Figure 80. Overview of LY-RLT-00012 facing southwest from public right-of-way. K. Ward 11/11/2023.

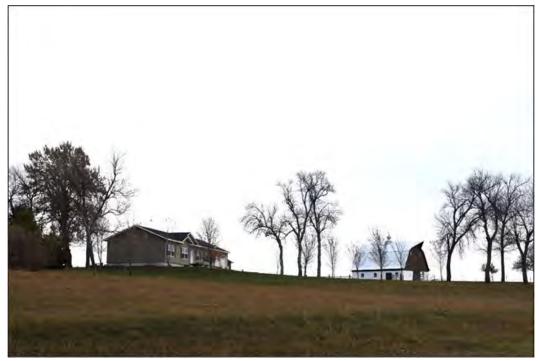
LY-RLT-00013 is a farmstead with three architectural features located at 2206 140th Street in Lyon County, Minnesota. Figure 82 presents a photograph of the site. Features 1 and 3 are less than 50 years old and have not achieved significance under the Criteria Considerations. They are recommended **not eligible** for the National Register of Historic Places. Feature 2 is a Prairie Style Barn that has updated exterior finishes, which cause it to not retain integrity of design, materials, workmanship, or feeling. Feature 2 is also recommended **not eligible** for the National Register of Historic Places. There will be **no effect** to these resources by the Project.

Figure 81. Overview of site facing northeast from public right-of-way. K. Ward 11/11/2023.

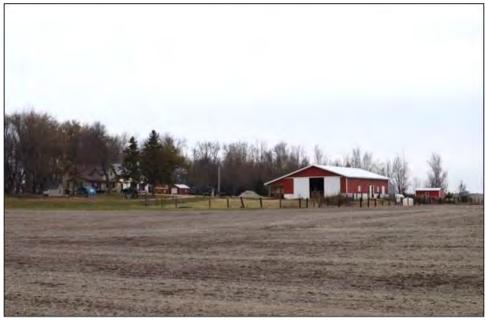
LY-RLT-00014 is a farmstead located at 2256 140th Street in Lyon County, Minnesota. The farmstead consists of five features. Figure 83 presents a photograph of the site. Feature 1 and 4 have undergone substantial changes and do not retain integrity of design, materials, workmanship, or feeling. They are recommended not eligible for the National Register of Historic Places. Features 3 and 5 are less than 50 years old and have not achieved significance under the Criteria Considerations. They are recommended not eligible for the National Register of Historic Places. Feature 2 is not visible from the public right-of-way and a determination of eligibility cannot be made at this time, it is considered unevaluated. However, due to the substantial shelterbelt surrounding the property, it is determined there will be no effect on the property by the Project.

Figure 82. Overview of LY-RLT-00014 facing northwest from public right-of-way. K. Ward 11/11/2023.

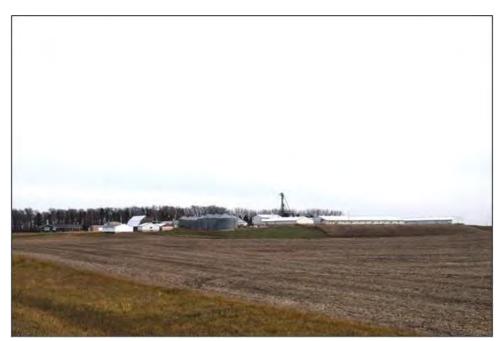
LY-RLT-00015 is a farmstead with 17 features located at 1360 222nd Avenue in Lyon County, Minnesota. Figure 84 presents a photograph of the site. Feature 7 is the only feature that is at least 50 years old. It is a Prairie Style Barn that has undergone a modern addition to the south side. For these reasons it has not retained integrity of design, materials, workmanship, or feeling. The remaining features are less than or likely less than 50 years of age and have not achieved significance under the Criteria Considerations. For these reasons, all of the features at this site are recommended **not eligible** for the National Register of Historic Places and there will be **no effect** on this property by the Project.

Figure 83. Overview of LY-RLT-00015 facing northeast from public right-of-way. K. Ward 11/11/2023.

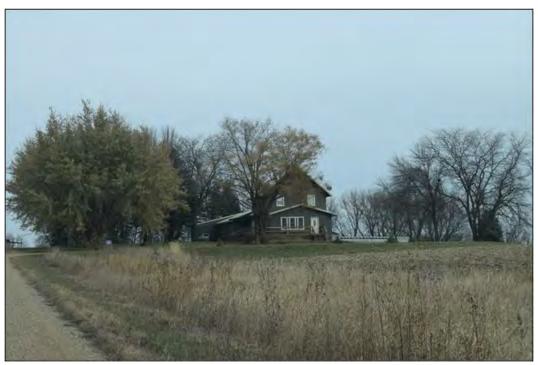
LY-RLT-00016 is a farmstead located at 1322 222nd Avenue in Lyon County, North Dakota. There are three architectural features. Figure 85 presents a photograph of the site. Feature 1 has undergone substantial additions and updates to the exterior finishes, windows, and door. It has not retained integrity of design, materials, workmanship, or feeling and is recommended **not eligible** for the National Register of Historic Places. Features 2 and 3 are likely less than 50 years of age and are common style buildings that have not achieved significance under the Criteria Considerations. They are recommended **not eligible** for the National Register of Historic Places. There will be **no effect** on these resources by the Project.

Figure 84. Overview of LY-RLT-00016 facing northeast from public right-of-way. K. Ward 11/11/2023.

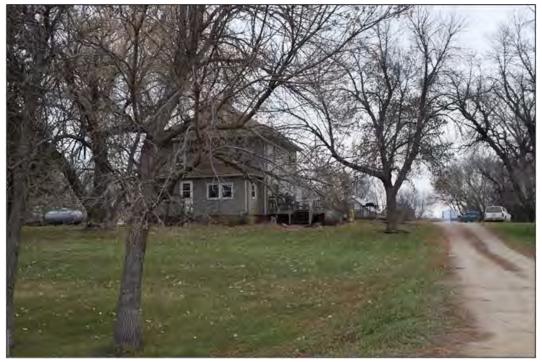
LY-RLT-00017 is a farmstead with six architectural features located at 1450 220th Avenue in Lyon County, Minnesota. Figure 86 presents a photograph of the site. Feature 1, though over 50 years of age, has undergone substantial updates to the exterior finishes that have caused it to lose integrity of design, materials, workmanship, and feeling. It is recommended **not eligible** for the National Register of Historic Places. Features 2 is not visible from the public right-of-way, however it is a small secondary feature at this site and likely not historically important. Features 3, 5, and 6 are all over 50 years of age but are common style buildings that do not make a significant contribution to our history. Feature 4 is not visible from the public right-of-way, however it is a new building and is recommended **not eligible** for the National Register of Historic Places due its age. All of the features at this site are recommended **not eligible** for the National Register of Historic Places and there will be **no effect** on these resources by the Project.

Figure 85. View of LY-RLT-00017 facing east from public right-of-way. K. Ward 11/11/2023.

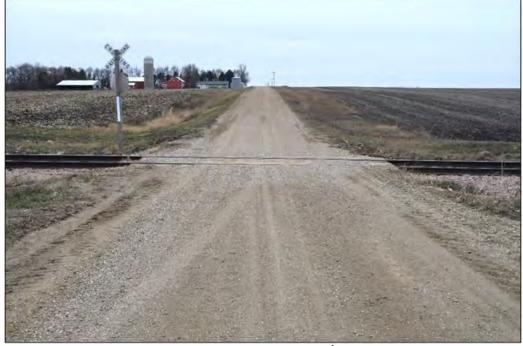
XX-RRD-SCP047 is a series of six rural railroad crossings in Custer Township, Lyon County, Minnesota between the town of Garvin to the east and Balaton to the West. Figure 87 presents a photograph of a typical crossing. These crossings meet Criterion A because they contribute to the broad patterns of our history in the development and progression of railroads in Minnesota. However, they are not associated with significant persons (Criterion B) and do not embody distinct characteristics in their type and style of construction (Criterion C). These crossings have not and are not likely to yield information important to our history. For these reasons they are recommended **not eligible** for the National Register of Historic Places as they are noncontributing elements of an eligible linear site. There will be **no effect** on these railroad crossings by the Project.

Figure 86. Example of rural crossing at 280th Avenue facing north. K. Ward 11/11/2023.

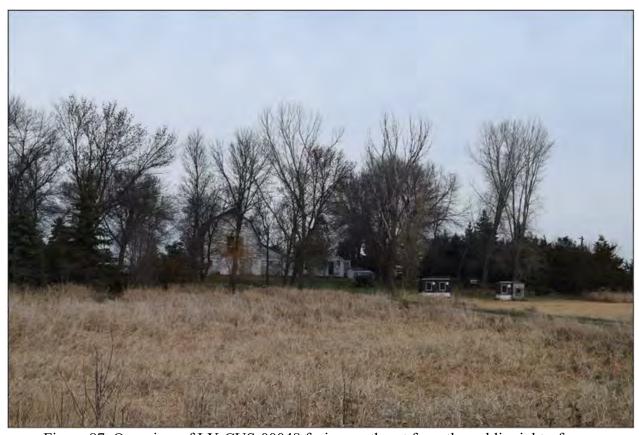
LY-CUS-00048 is a farmstead located at 22310 150th Street in Lyon County, Minnesota. The property contains three architectural resources. Figure 88 presents a photograph of the site. Feature 1 is a Ranch-style house constructed between 1984 and 1992. Feature 2 is a Prairie-style barn constructed prior to the first available aerial photograph taken in 1955. Feature 3 is a small shed constructed between 1992 and 2003.

Figure 87. Overview of LY-CUS-00048 facing northeast from the public right-of-way.

Features 1 and 3 are both common style buildings with no significant or distinct characteristics. They are also both less than 50 years of age and are recommended **not eligible** for the NRHP. The Project will have **no effect** on these features.

Feature 2 is a Prairie-style barn associated with the development of agriculture in the region as settlers homesteaded onto the Great Plains and thus meets Criterion A. It also meets Criterion C because it contains distinctive characteristics of a Prairie-style barn and the exterior finishes appear to be largely original. Feature 2 retains all seven aspects of integrity as it has been largely unchanged and has remained part of an operating farmstead. For these reasons it is recommended **eligible** for the NRHP. There will be **no effect** on Feature 2 by the Project due to the extensive shelterbelt blocking the view of the Original that the project from this site.

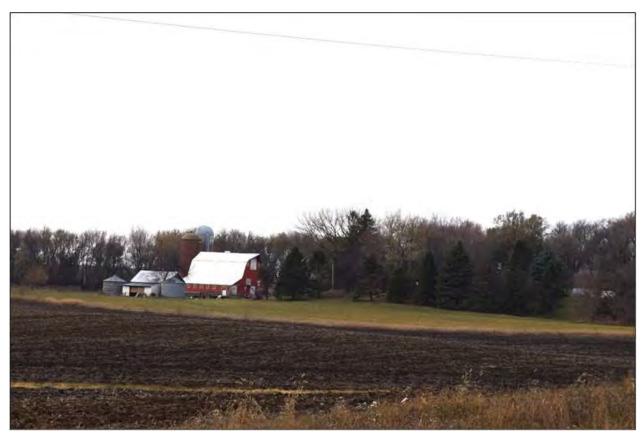
LY-CUS-00049 is a farmstead located at 2332 140th Street in Lyon County, Minnesota with eight features. Figure 89 presents a photograph of the site. Features 1 and 2 are not visible from the public right-of-way. However, an addition was added to Feature 1 between 1992 and 2003, which means it does not retain integrity of design, materials, workmanship, or feeling and is recommended **not eligible** for the NRHP. Feature 2 was constructed between 1992 and 2003 with an addition added between 2019 and 2020. It is less than 50 years old and is recommended **not eligible** for the NRHP. Feature 4 is a cement stave silo and is an extremely common style structure. It is recommended **not eligible** for the NRHP. Feature 5 is a Prairie-style barn that has undergone changes to the exterior finishes. It does not retain integrity of design, materials, workmanship, or feeling. Feature 6 has also undergone changes to the exterior including an addition on the east side. Features 5 and 6 are recommended **not eligible** for the NRHP because they do not retain the seven aspects of integrity. Features 7 and 8 are common style bins seen throughout the region and so they are recommended **not eligible** for the NRHP. There will be **no effect** on these features by the Project.

Feature 3 is a brick silo constructed between 1958 and 1965. It meets Criterion A and C and has retained all seven aspects of integrity. It is recommended **eligible** for the NRHP. There will be **no effect** on Feature 3 by the Project due to the extensive shelterbelt blocking the view of the Of the Project from this site.

Figure 88. Overview of LY-CUS-00049 facing southwest from the public right-of-way. K. Ward 11/11/2023.
