In re the Matter of Sherco Unit 3 Energy
Replacement Costs.

DIRECT TESTIMONY OF RICHARD A. POLICH

**THE MINNESOTA DEPARTMENT OF COMMERCE
DIVISION OF ENERGY RESOURCES**

June 16, 2023

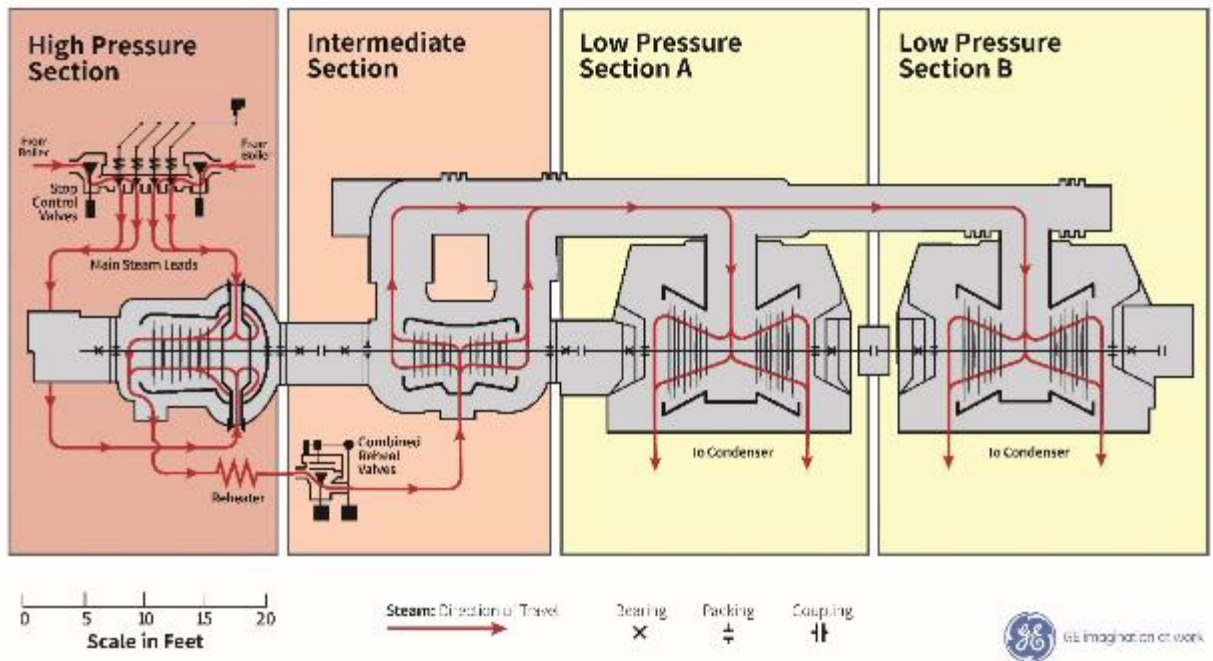
Figure 2- Sherco 3 Steam Turbine, Generator and Exciter General Configuration

1 megawatts (a megawatt (MW) a quantity of electricity and is equal to 1,000 kilowatt
2 (kW)) each and Sherco 3 is 900 MW. Unit 3 has a Babcock & Wilcox drum boiler capable
3 of producing 6,150,000 lb/hr of main steam at 1,007°F and 2,640 psig. Reheat design
4 steam flow is 5,632,000 lb/hr at 1005°F. The steam turbine model G3 was manufactured
5 by General Electric (GE) and is composed of one seven-stage high pressure (HP) section,
6 a double flow six-stage intermediate pressure (IP) section and two double-flow, six-
7 stage, low pressure turbines. Figure 2 is a general depiction of the Sherco 3 steam
8 turbine. The term “stage” in a steam turbine is used to define a row of steam turbine
9 buckets which remove energy from the steam, converting it to horsepower, resulting in
10 a reduction in steam pressure and temperature.

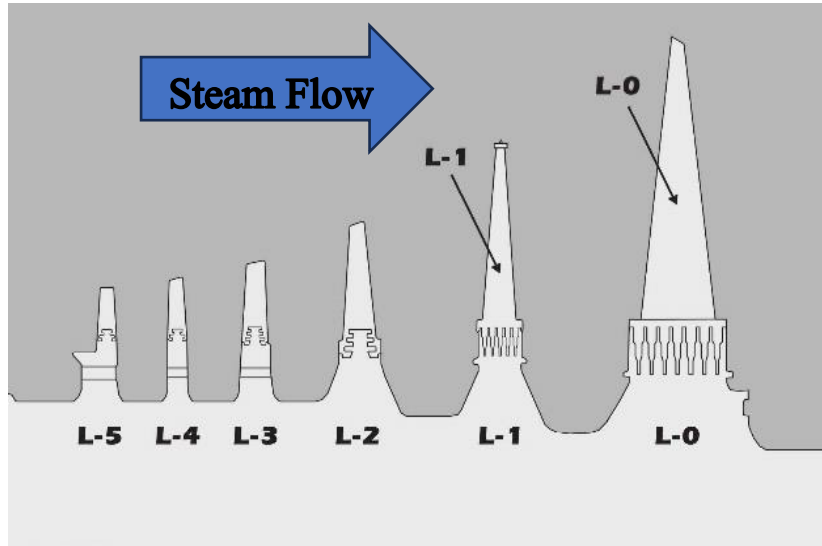
Figure 5 - Sherco 3 LP Turbine Blade Stages

9 and flows in opposite directions, exiting the last set of buckets and entering the
10 condenser. There are six stages of buckets (sometimes referred to as “buckets”) on each
11 side of the LP turbine, identified as stages L-5 through L-0 in Figure 5. The steam
12 entering the turbine first encounters the nozzles which help the steam to be distributed
13 around the entire 360 degrees of the
14 turbine and change its flow direction to
15 maximize its impingement on the first
16 stage of turbine buckets, shown as the L-5
17 buckets in Figure 5. There are nozzles

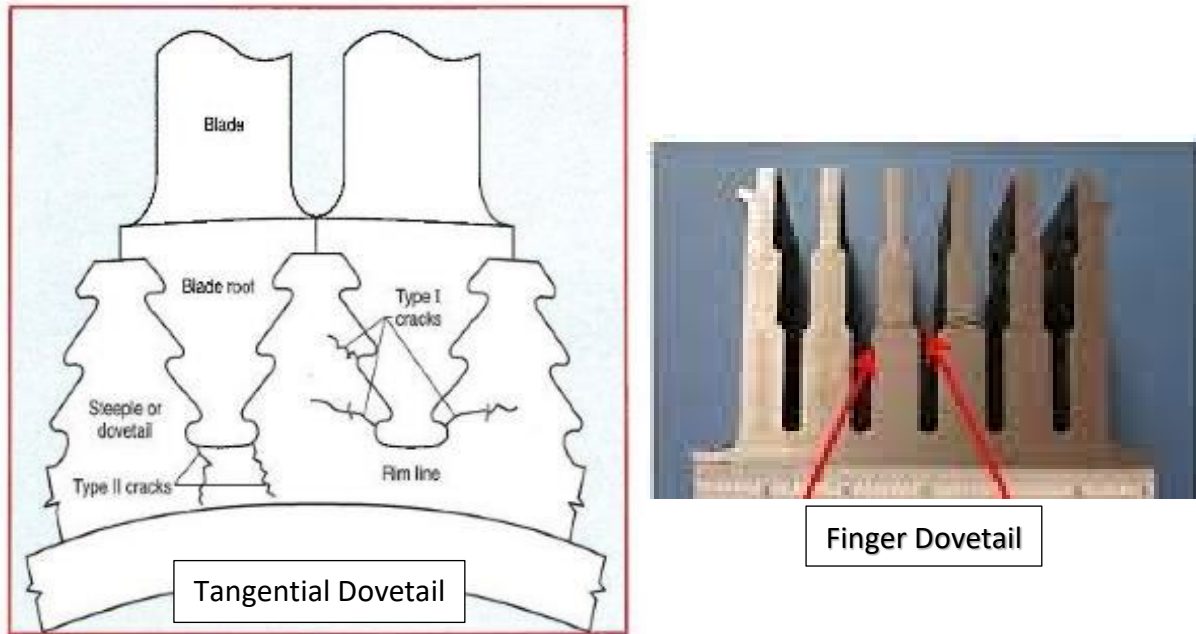
Figure 7 -Sherco LP bucket Attachment Types

5 The turbine buckets are connected to the turbine rotor through a disk at the
6 base of the buckets. The Sherco 3 LP turbine section uses two different types of
7 connections between the buckets and the disk, tangential dovetail and finger dovetail
8 (see Figure 7). The finger dovetail is held to the turbine rotor by several pins inserted
9 into the rotor disk. The L-0 and L-1 stages are connected to the rotor with finger
10 dovetails and the L-2, -3, -4, and -5 stages are connected with tangential dovetails.

15 forming a crack in the metal. These cracks will typically propagate in a high stress
16 location of a part, such as a corner or notch. An example of typical SCC locations is
17 shown in Figure 7 where the cracks are in the corner of the tangential dovetail joint. A
18 picture showing SCC in the Sherco 3 LP turbine, stage L-1 disk finger dovetail is shown in
19 Figure 10.²¹

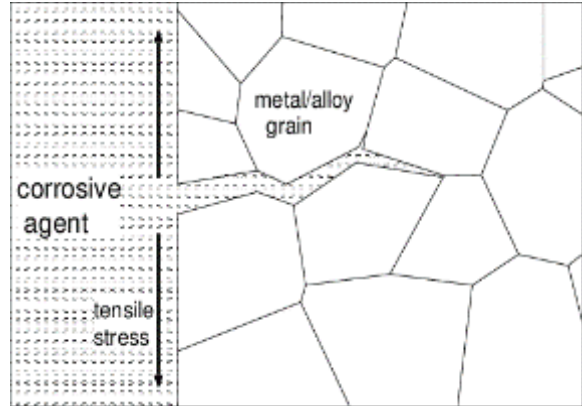
Figure 11 - Intergranular SCC

7 material, corrosive environment,
8 and high stress. The corrosion
9 typically occurs when a chemical,
10 such as sodium hydroxide,
11 penetrates a steel part and works
12 its way into the grain boundaries of
13 the steel (see Figure 11). Over time
14 the steel grain boundary separates

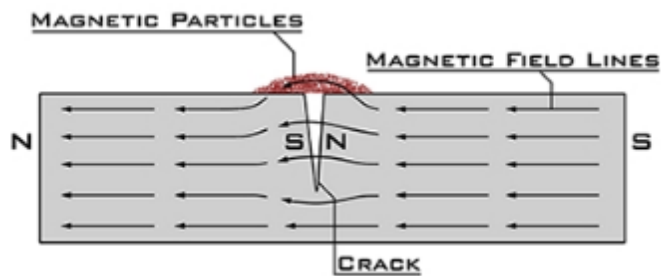
15 iron particles will collect at **Figure 12 - MPI Showing magnetic Field Distortion**
16 the magnetic field distortion. However, the magnetic flux will only leak out of the
17 material if the discontinuity is generally perpendicular to its flow. If the discontinuity,
18 such as a crack, is parallel to the lines of magnetic flux, there will be no leakage and
19 therefore no indication observed. To resolve this issue, each area needs to be examined
20 twice. The second examination needs to be perpendicular to the first so discontinuities
21 in any direction are detected.
