I.	Introduction and Qualifications	1
II.	Root Cause Investigation	3
	A. Background on Sherco Unit 3 Turbine-Generator Train	4
	B. The Event	6
	C. The Root Cause Analysis	9
III.	Determined Cause of Failure	10
IV.	Additional Observations and Opinions	17

Statement of Qualifications	Schedule 1
Root Cause Analysis Steam Turbine Generator Event of November 19, 2011	Schedule 2
Root Cause Analysis Report-Figures and Attachments	Schedule 3

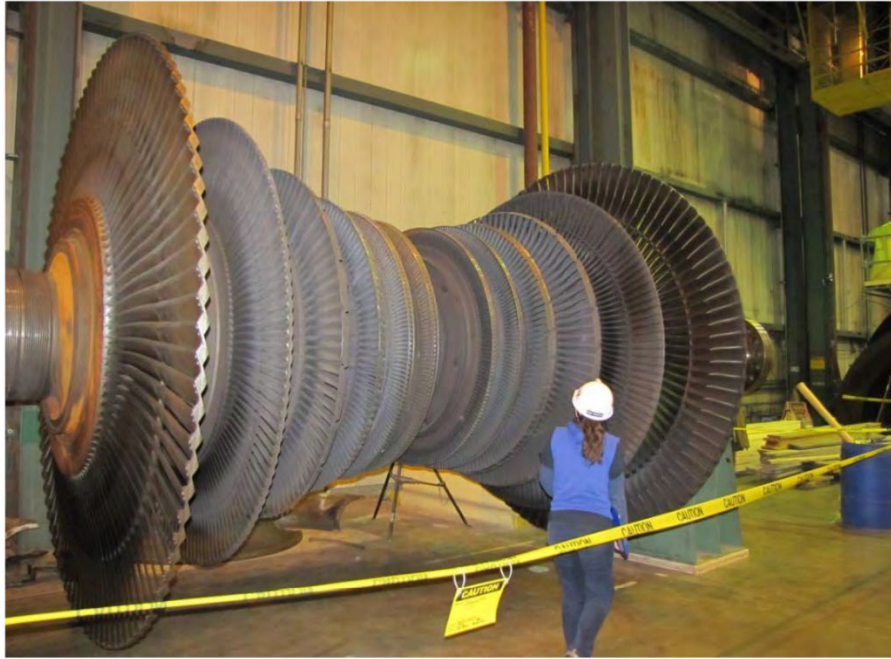
3 **Figure 1**
4 **Photograph of Unit 3 low pressure turbine rotor “A”**
5 **in stands at the Event site**

17 A. The Sherco Unit 3 LP-A turbine rotor with blades attached is shown in Figure
18 1 below. Each low pressure turbine module contains a rotor comprised of two
19 shaft ends and twelve disks to which blades are attached at the periphery of
20 each disk. The turbine rotor starts out as a large solid forging and is machined
21 radially to form the twelve disks and two shaft ends. The turbine modules are
22 fed steam from a coal-fired recirculating drum boiler which "pushes" on the
23 blade airfoils causing the rotor to rotate. The rotor shaft end is connected to
24 the generator, where the rotational mechanical energy is converted to electrical
25 energy. The LP turbine disks are numbered with the end stage being L-0, the
26 next row in being L-1, and so on. Figure 2 below depicts the blade rows, with
27 the L-5 being at the center of the turbine, and the L-0 being at the end of the

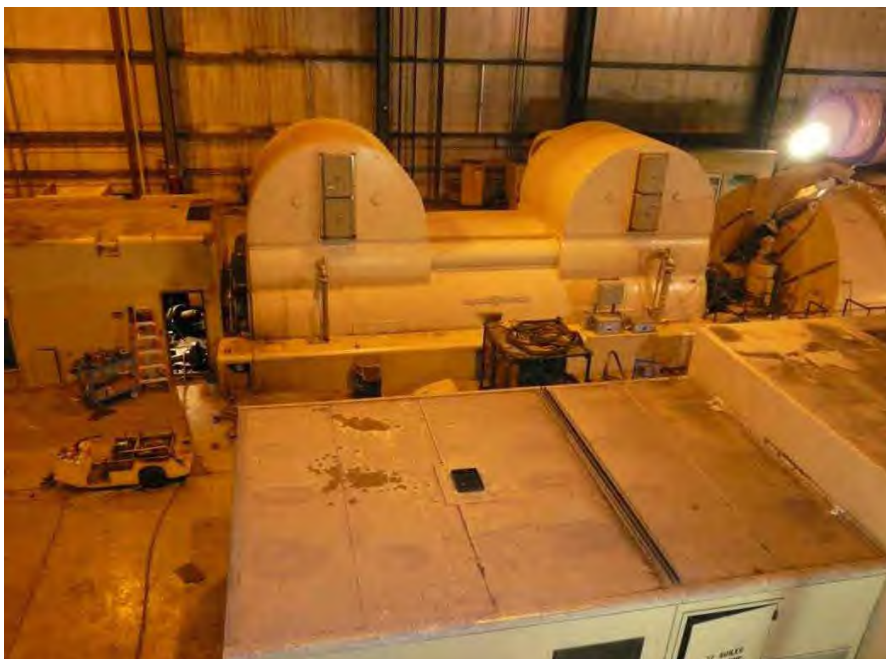
Site clean-up had already commenced prior to Thielsch Engineering's arrival at the plant. The clean-up was limited to debris generated from two localized fires, broken glass from the overhead lighting, displaced insulation and a few fasteners that had backed out of the outer casings and were lying on the turbine deck floor. Photographs of the unit and turbine deck prior to disassembly are shown in Figs. 2 through 4.

Fig. 2. Photograph of Sherco Unit 3 steam turbine generator after the event of November 19, 2011

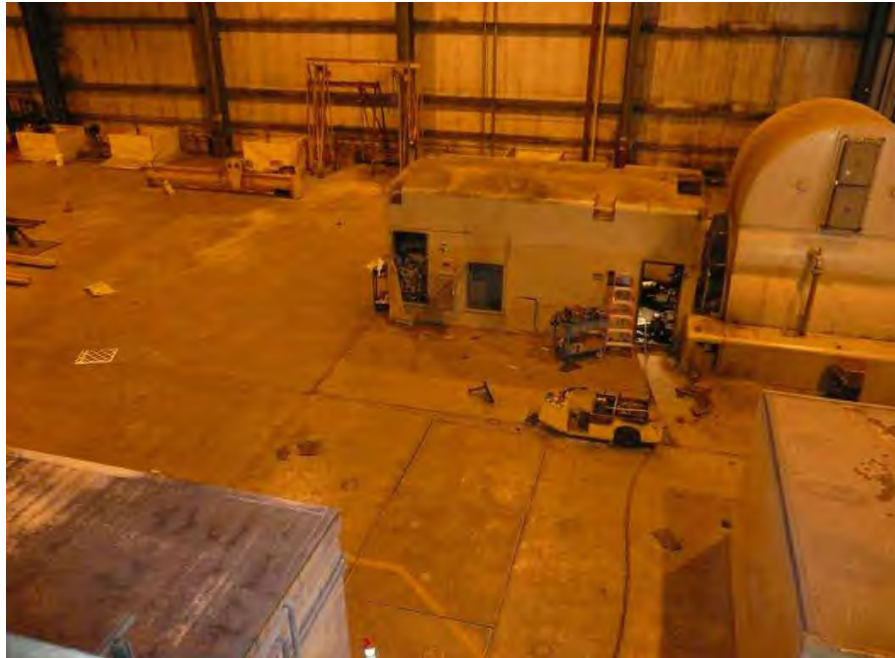
Fig. 3. Photograph of Sherco Unit 3 steam turbine generator after the event of November 19, 2011.

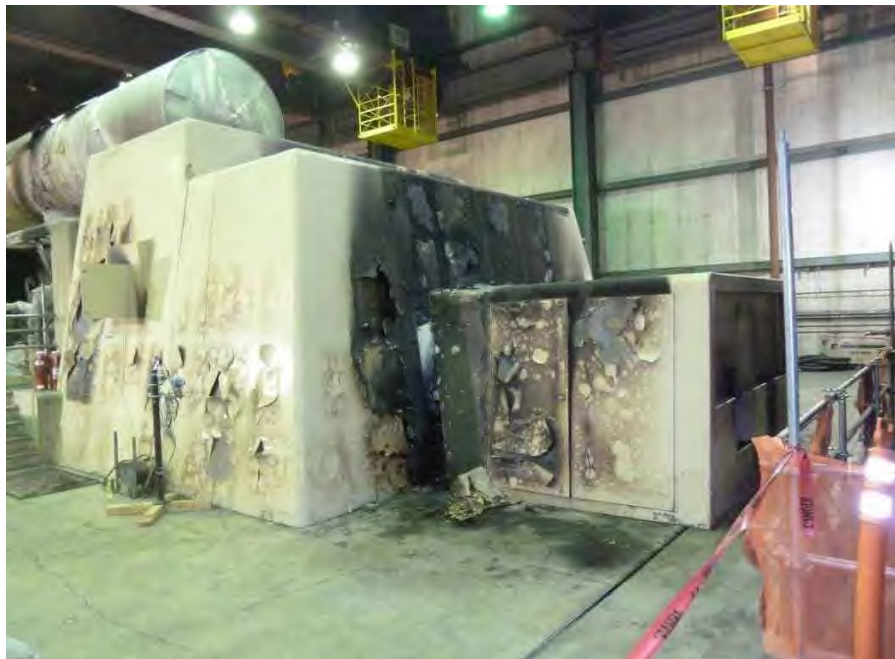
Fig. 4. Photograph of Sherco Unit 3 steam turbine generator after the event of November 19, 2011.

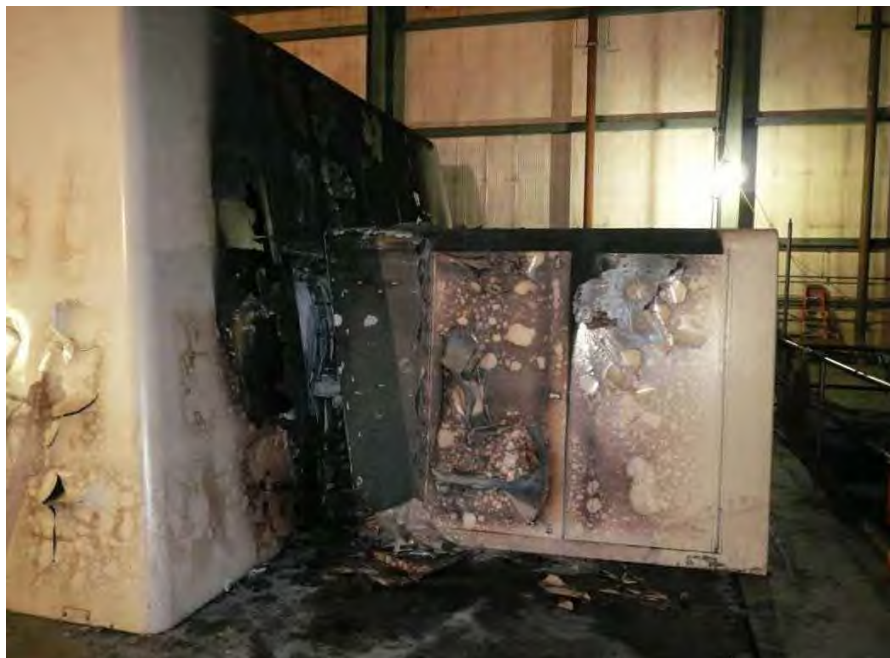
The damage to the front standard at the high pressure end of the steam turbine train, resulting from the lube oil fire, is shown in Figs. 5 and 6. Damage resulting from the hydrogen fire in the vicinity of the generator and exciter doghouse enclosure is shown in Figs. 7 and 8. Also evident in these photographs is a hole in the exciter doghouse from the liberated exciter collector. External damage to bearing and coupling covers/structures is shown in Fig. 9. Many of the outer casing fasteners were sheared or had backed partially/completely out during the failure event. An example of a casing fastener that had partially backed out is shown in Fig. 10. Detailed observations of the steam turbine teardown follow.

Fig. 5 Photograph of high pressure end of Sherco Unit 3 steam turbine generator after the event of November 19, 2011.

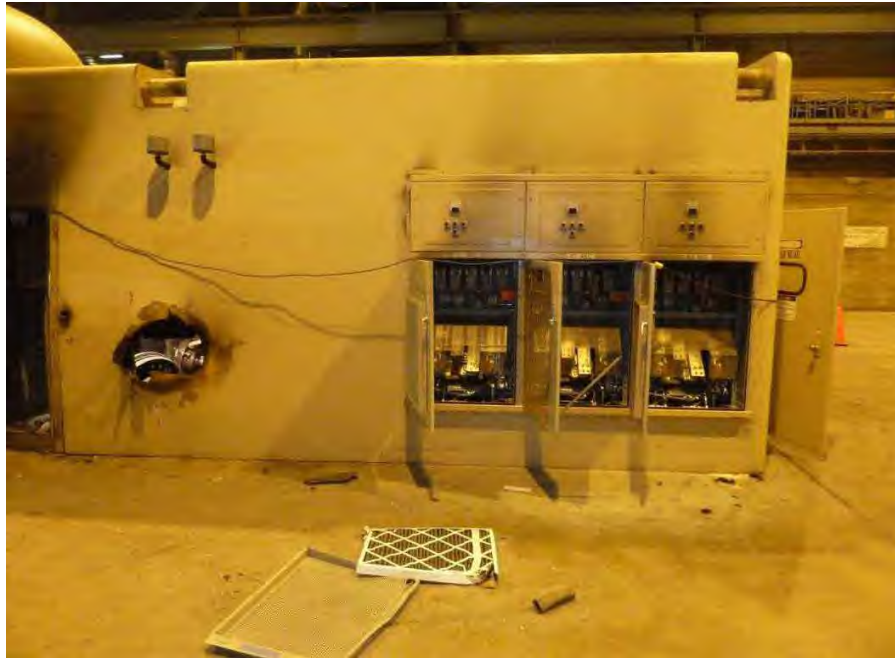
Fig. 7. Photograph of Sherco Unit 3 steam turbine generator at exciter end after event of November 19, 2011.

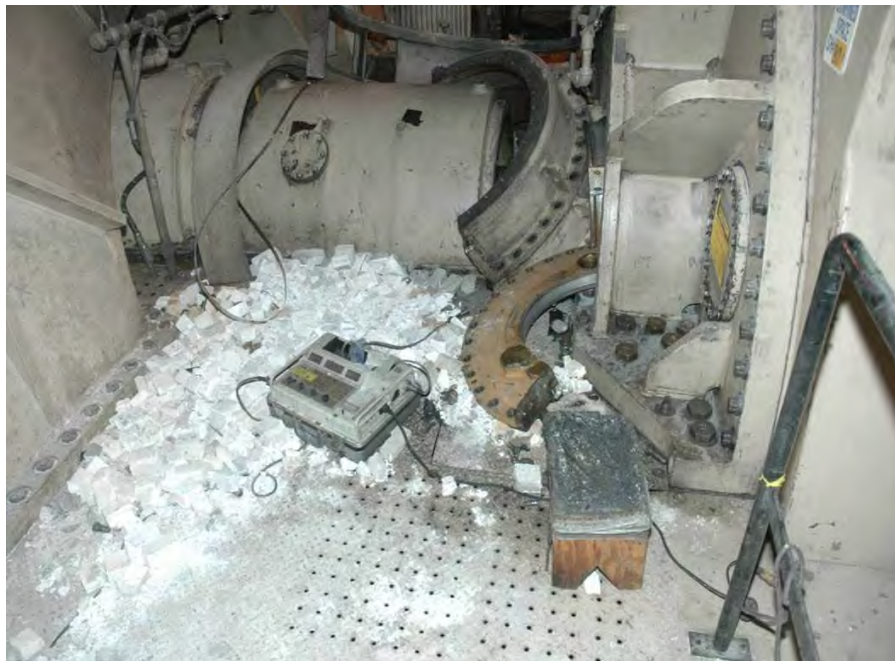
Fig. 8. Photograph of exciter "Doghouse" from Sherco Unit 3 steam turbine generator after event of November 19, 2011.

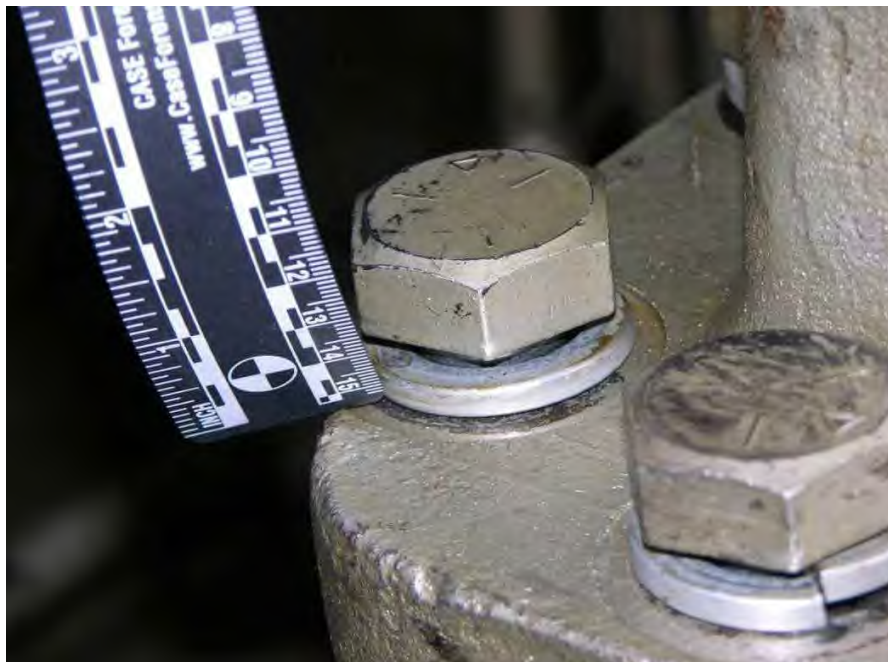
Fig. 9. Photograph of damaged coupling cover between the low pressure turbines of Sherco Unit 3 steam turbine generator after event of November 19, 2011.

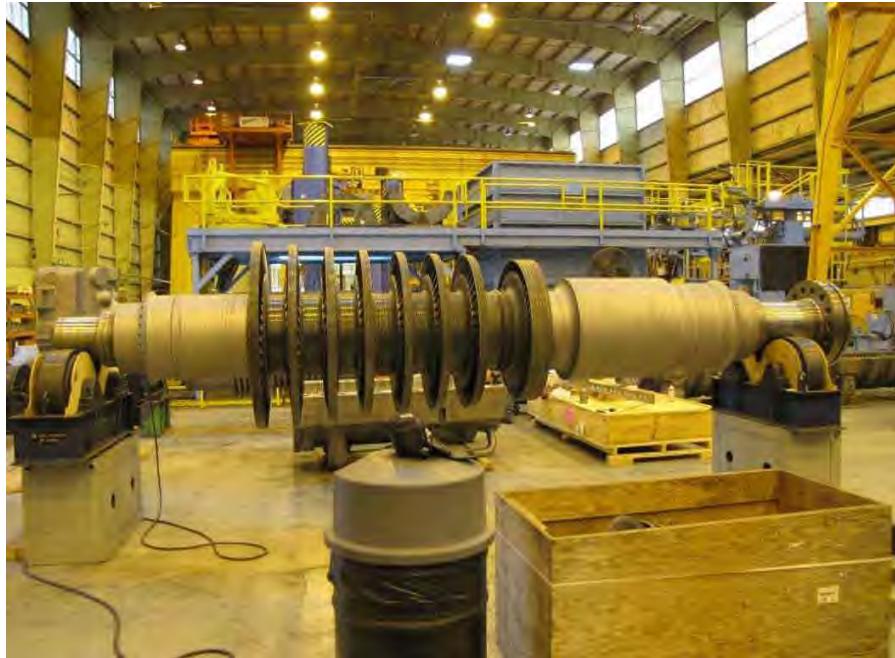
A photograph of the high pressure turbine is shown in Fig. 11. The high pressure inner casing could not be opened at the site and the turbine was shipped intact to Alstom Power, Inc. in Richmond, VA for disassembly. Alstom Power, Inc. opened the casing using hydraulic jacks. It reportedly took over 600 tons of force to separate the upper and low inner turbine casings. The rotor and diaphragms were removed from the casing. The packing seal surfaces on both ends of the rotor were grit blasted and the horizontal split surfaces on both the upper and lower half of the inner casing were "cleaned-up". The HP rotor was placed on stands as shown in Fig. 12. The integral blade shrouds on all stages exhibited moderate to heavy rub damage as shown in Figs. 13 to 15. The interstage seal surfaces exhibited light rub damage from contact with the labyrinth seals as shown in Figs. 16 to 19. Severe galling was evident in the diaphragm fit areas of the inner casing as shown in Figs. 20 to 21. The inlet gland casing exhibited severe galling where the casing mates with the turbine inner casing as shown in Fig. 22. In one galled area a piece of the inner casing had adhered to the inlet gland casing from the

Fig. 11. Photograph of the Sherco 3 high pressure turbine.

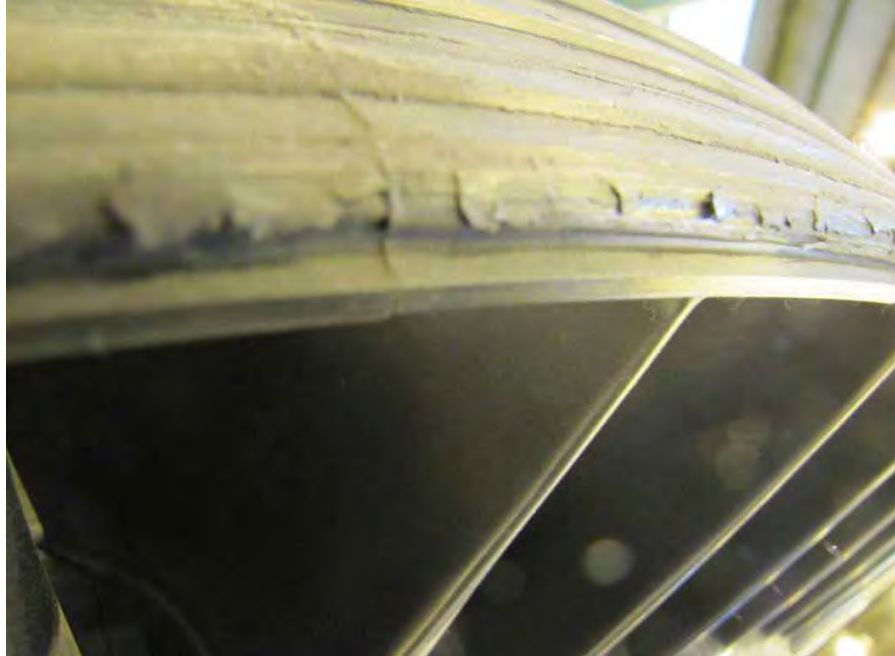
Fig. 13. Close-up photograph of high pressure turbine rotor shown in Fig. 12.

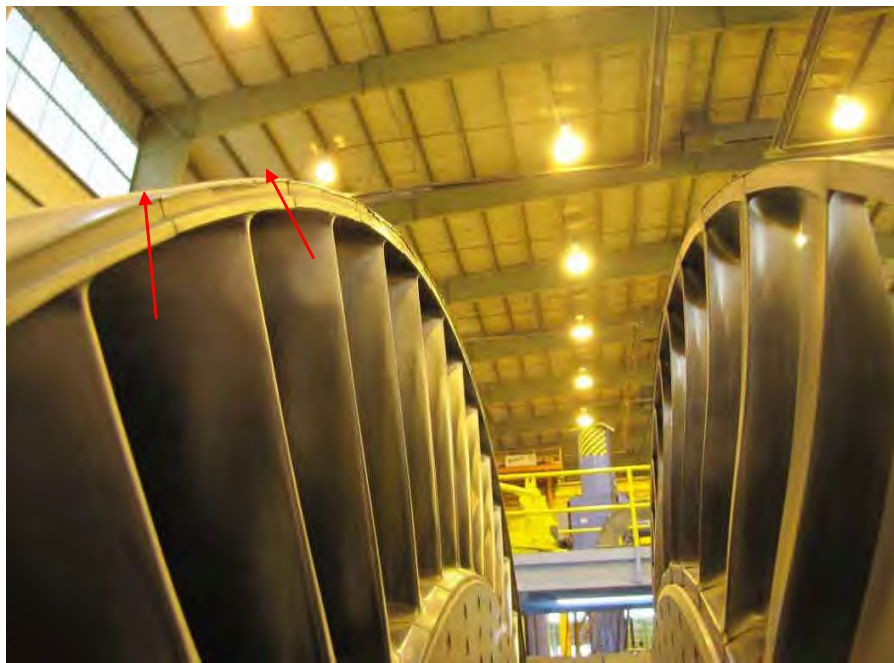
Fig. 14. Close-up photograph of high pressure turbine rotor shown in Fig. 13 showing moderate/heavy rub damage on blade integral shrouds.

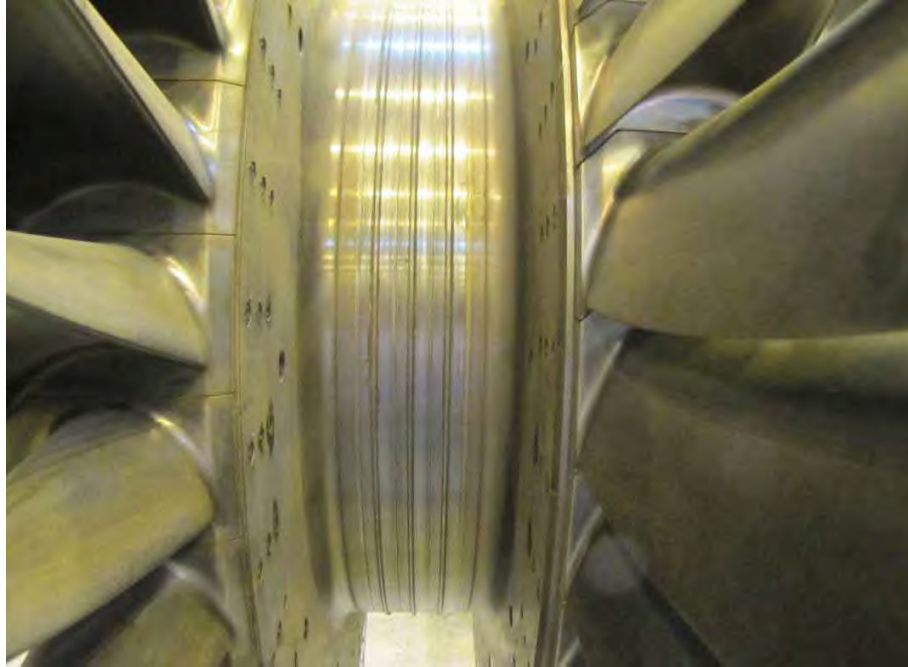
Fig. 15. Close-up of high pressure rotor shown in Fig. 12 showing rub damage (arrows) on blade integral shrouds.

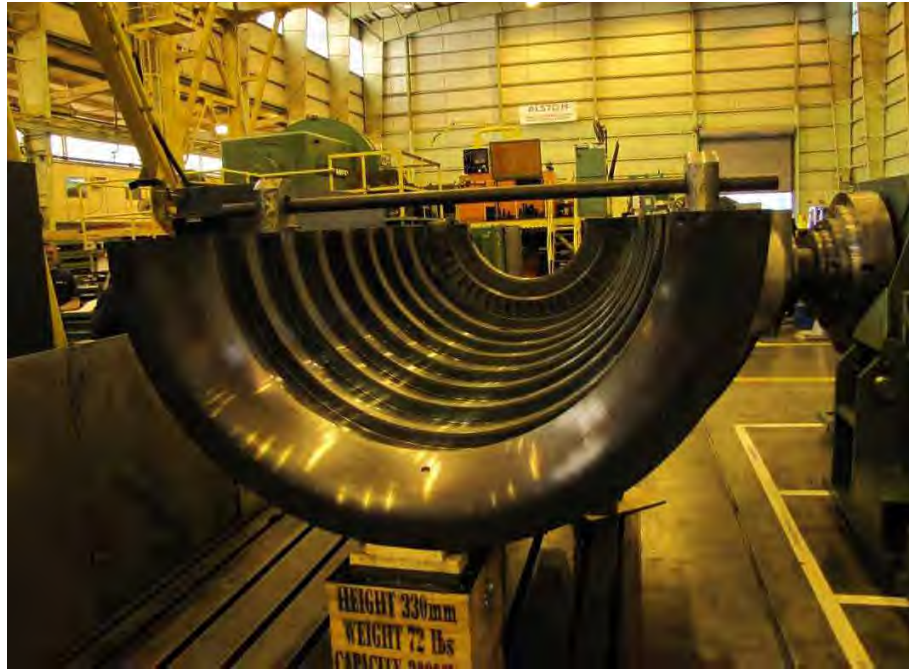
Fig. 19. Photograph of high pressure rotor shown in Fig. 12 showing rub damage to interstage seal areas.

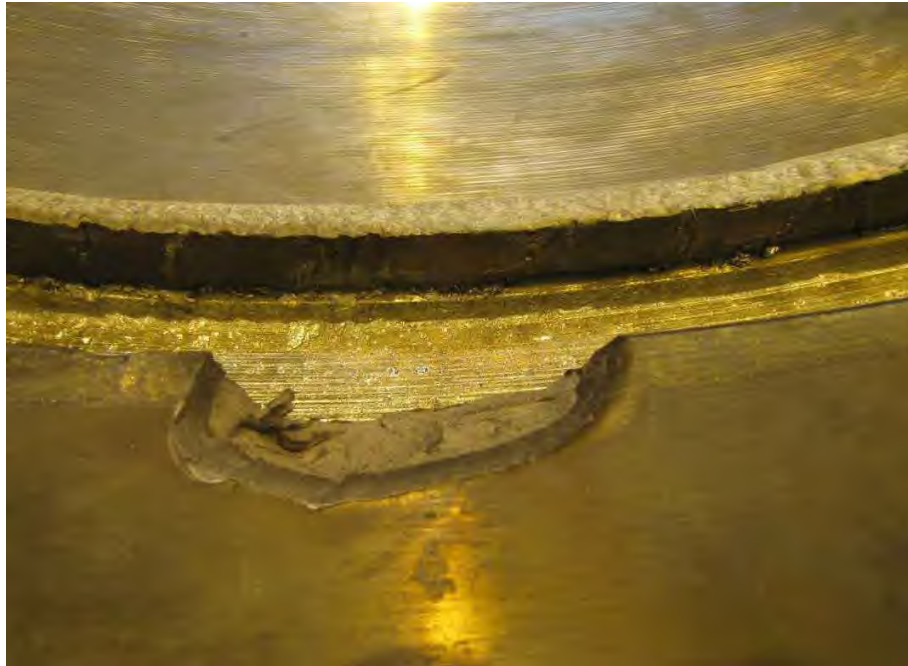
Fig. 21. Close-up of high pressure turbine inner casing shown in Fig. 20 showing extent of galling (arrows) at inlet gland seal fit area.

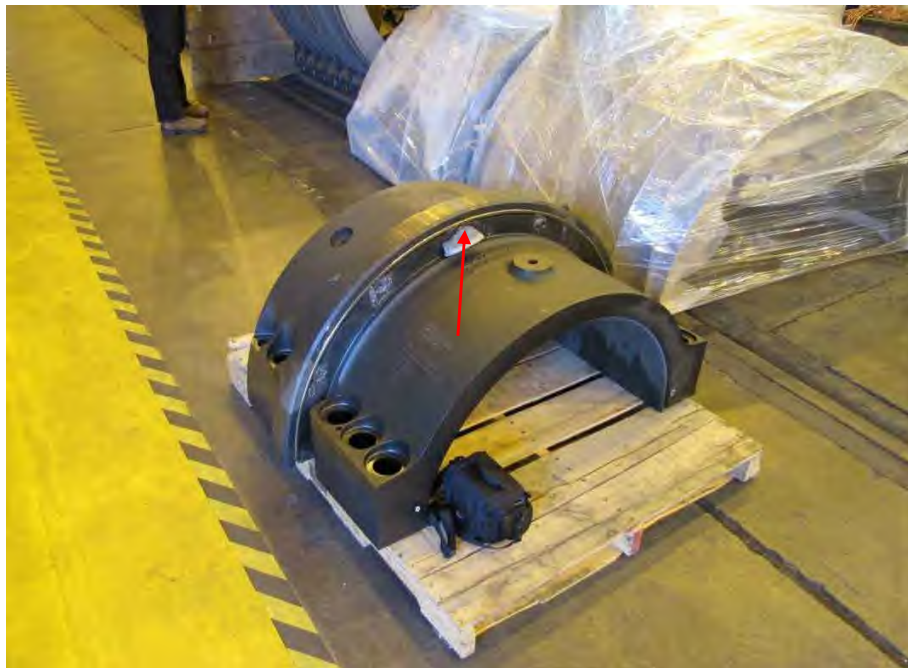
Fig. 22. Close-up of high pressure turbine inner casing shown in Fig. 20 showing fractured section of the inlet gland seal fit.

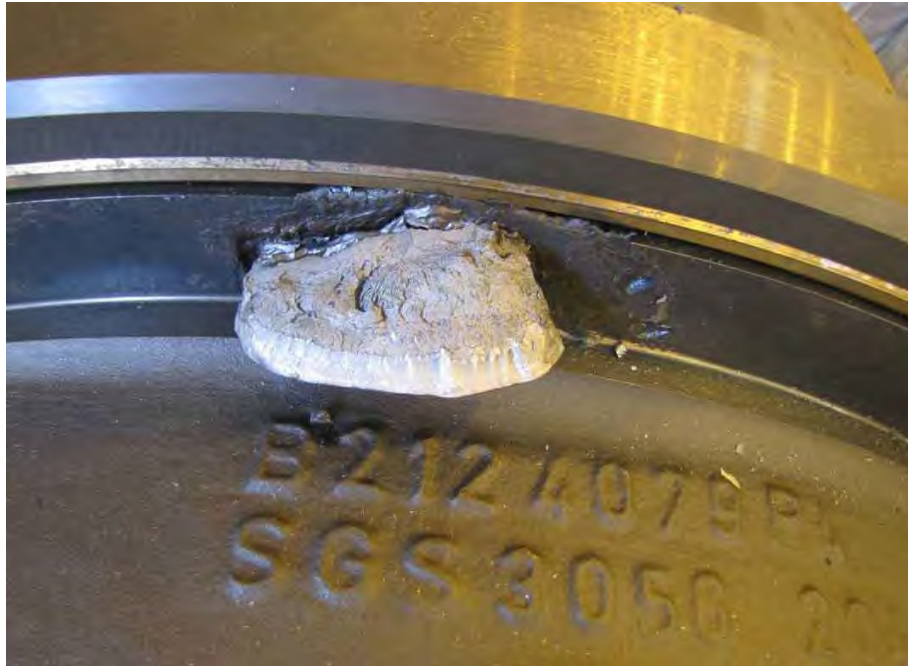
combination of frictional heat and contact pressure accompanying galling; adhesion due to galling is similar to and commonly referred to as "cold welding". During disassembly the "cold weld" between the inner casing and inlet gland casing fractured as shown in Figs. 23 to 24. The inlet gland bolts were severely deformed as shown in Fig. 25. Greyish deposits were observed on blade airfoil surfaces. These deposits were collected and submitted to Engel Metallurgical for deposit analysis as part of the forensic metallurgical analysis.

Fig. 23. Photograph of high pressure turbine inlet gland casing showing fractured casing material (arrow) attached to outer surface.

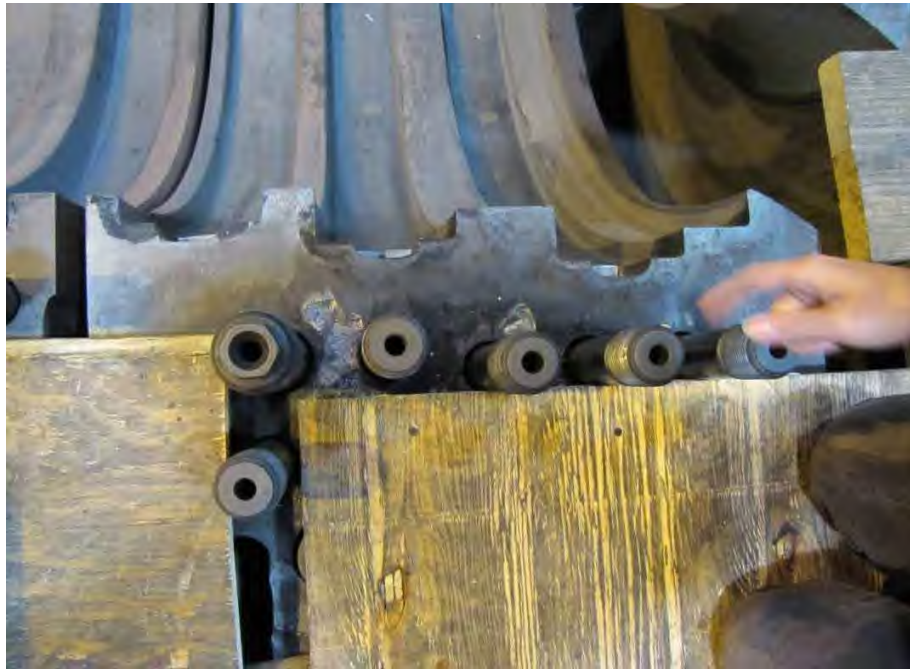
The reheat intermediate pressure turbine inner casing was opened at the Sherco plant. The inner casing exhibited a number of areas on the horizontal split sealing surface which exhibited characteristics indicative of melting as shown in Figs. 26 to 28. Similar "melted" appearing areas were observed on the outer surface of the outer casing at the alignment lug as shown in Figs. 29 to 30. The rotor was removed and shipped to Alstom Power, Inc. in Richmond, Virginia for further inspection. The rotor was placed on stands for examination as shown in Fig. 31. The blade integral shrouds exhibited moderate to heavy rub damage as shown in Figs. 32 to 33. Heavy greyish colored deposits were evident at base of airfoils and on the underside of the integral shrouds. These deposits were collected and submitted to Engel Metallurgical for inclusion in the forensic metallurgical analysis. The packing and interstage seal surfaces exhibited light rub damage as shown in Figs. 34 to 39. The machined contact faces of both the generator end and turbine end integral couplings exhibited small pits which had the visual characteristics of melted material as shown in Figs. 40 to 43.

Fig. 26. Close-up of intermediate pressure turbine inner casing showing evidence of melting (arrows) on horizontal split.

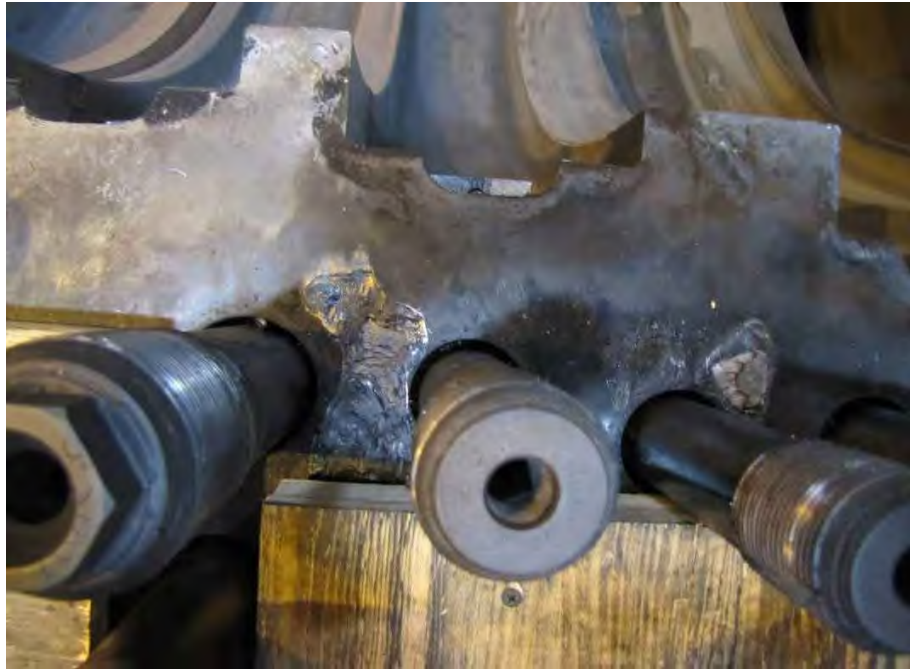
Fig. 27. Close-up of melted areas on intermediate pressure turbine inner casing, shown in Fig. 26, after removal of rotor and diaphragms.

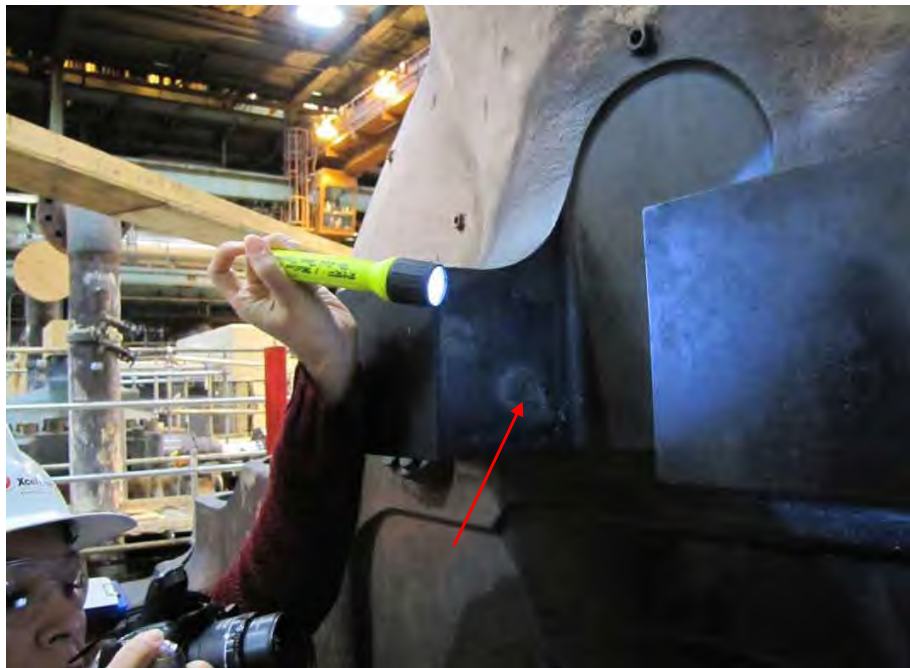
Fig. 28. Close-up of melting on intermediate pressure turbine inner casing shown in Fig. 27

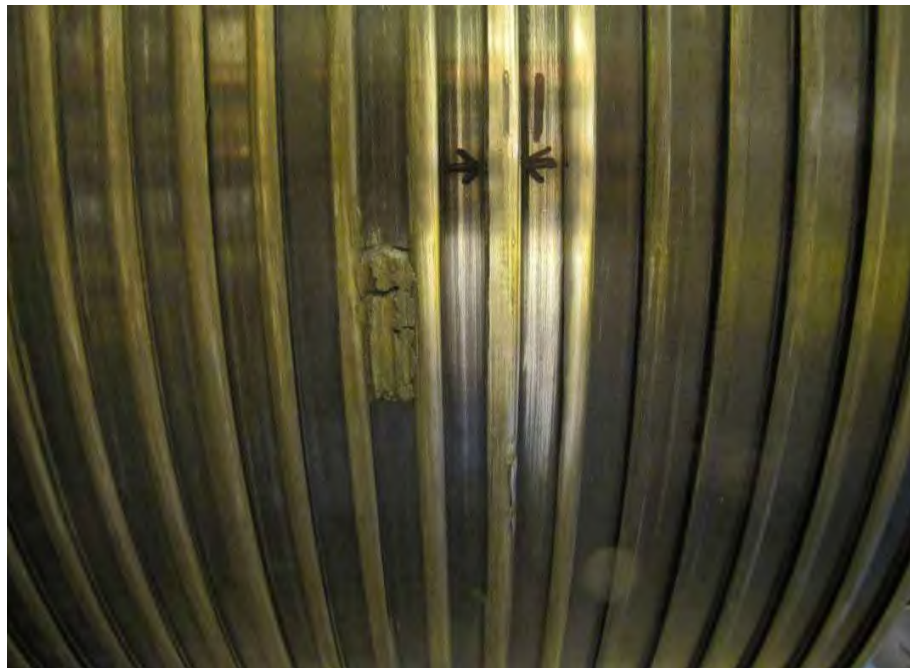
Fig. 34. Close-up photograph of intermediate pressure turbine rotor shown in Fig. 31 showing rub damage seal surfaces.

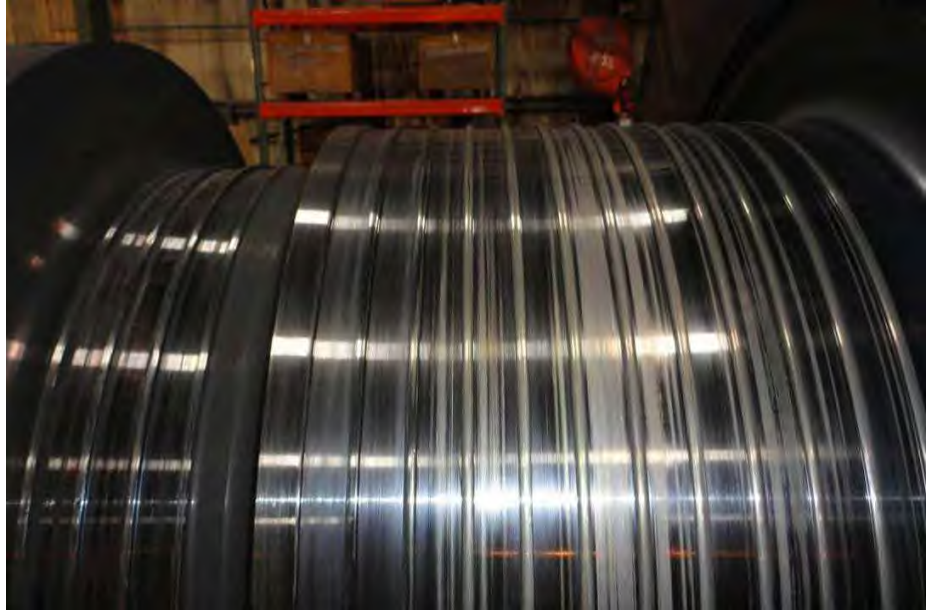
Fig. 35. Close-up photograph of Intermediate Pressure Turbine showing rub damage on seal surface.

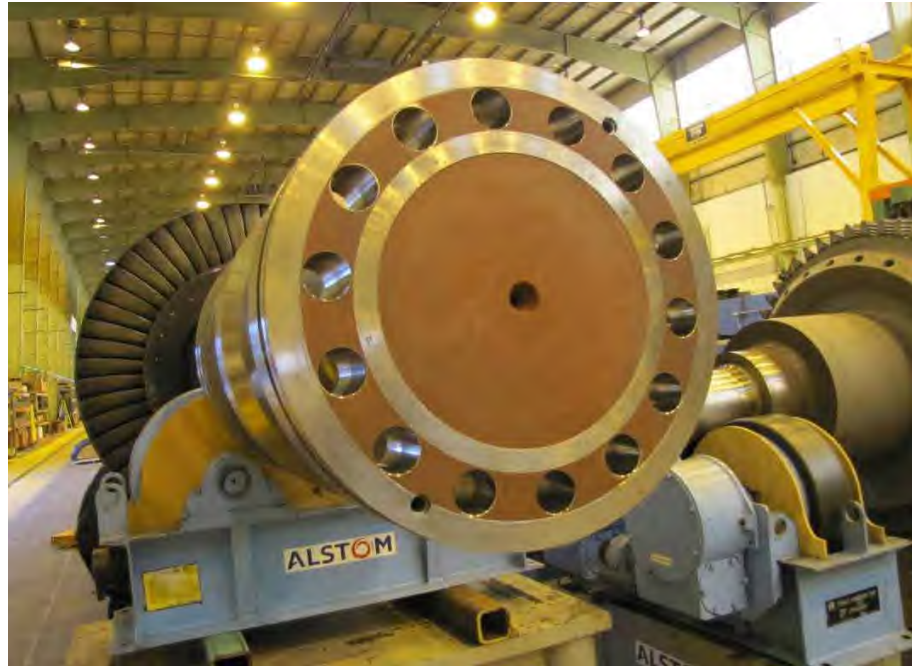
Fig. 41. Close-up photograph of intermediate pressure turbine rotor generator end coupling showing evidence of melting (arrow) on machined face.

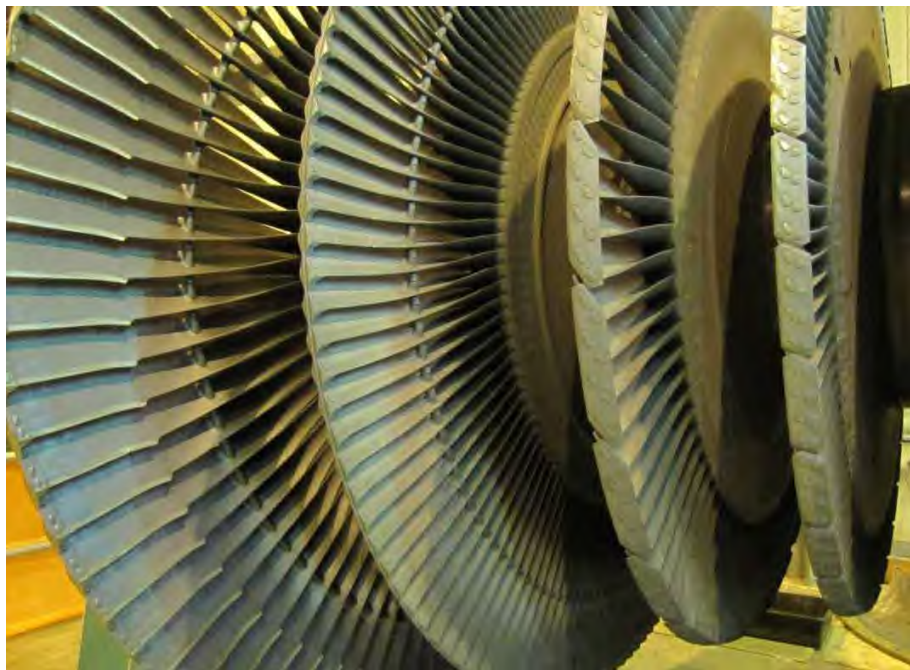
Fig. 46 Photograph of low pressure turbine rotor "A" shown in Fig. 44.

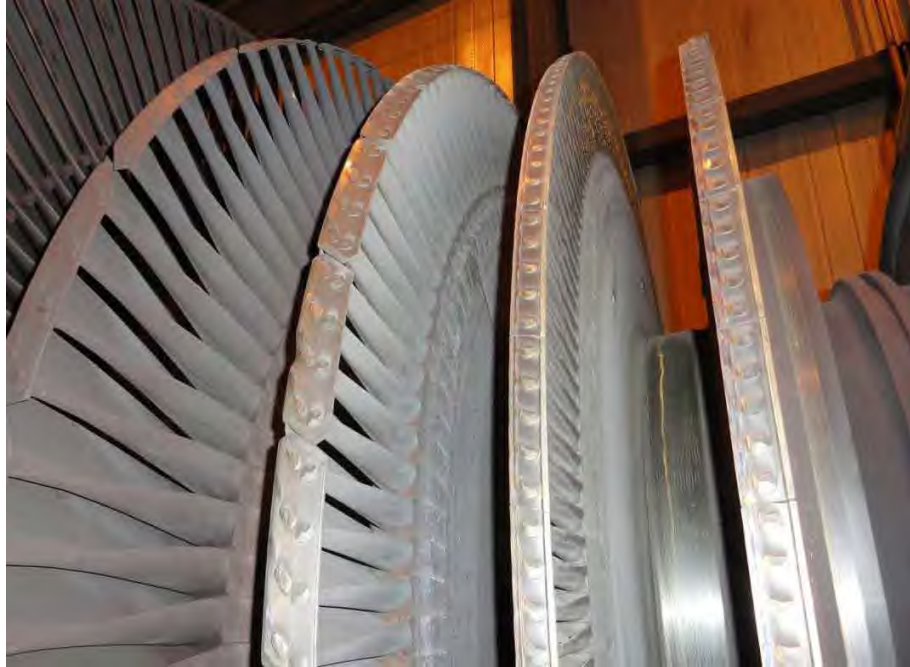
Fig. 47. Photograph of generator end of low pressure turbine "A" rotor shown in Fig. 44..

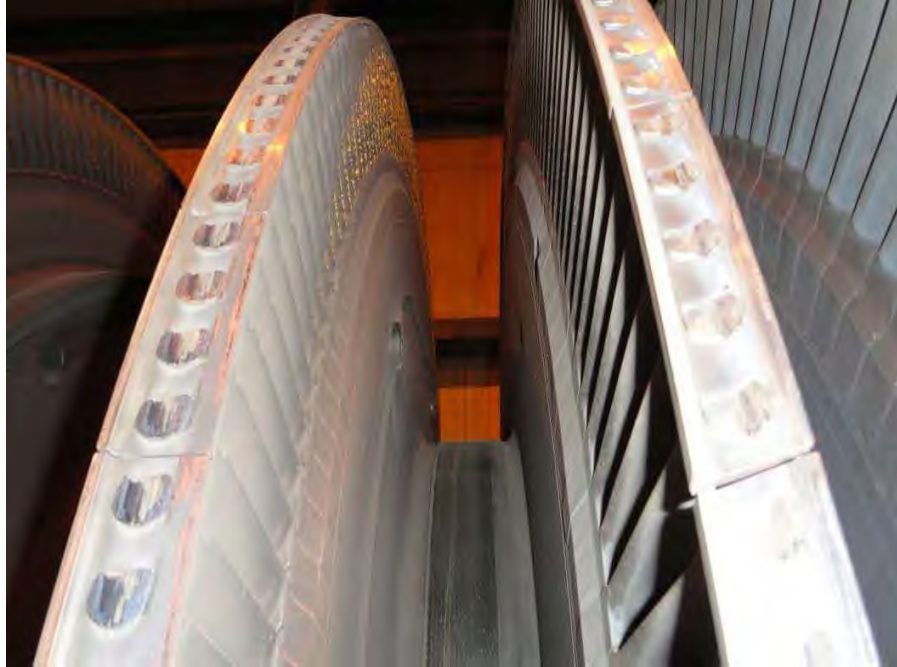
The Low Pressure Turbine "A" inner casing was opened and the rotor placed on stands at the plant for examination as shown in Figs. 44 to 47. The generator end blading exhibited light to moderate rub damage to all blade covers and tenons with the heaviest being on the L-3, L-4 and L-5 stages as shown in Figs. 48 and 49. The turbine end L-2, L-3, L-4 and L-5 blade covers and tenons exhibited moderate rub damage with the L-3 stage blading exhibiting a few bent and torn blade cover edges as shown in Figs. 50, 51 and 52. Light to moderate impact damage to blade leading and trailing edges was noted. Turbine and generator end diaphragm vanes exhibited moderate impact

Fig. 49. Generator end of low pressure turbine "A" showing extent of rub damage on L-2 blade covers and tenons.

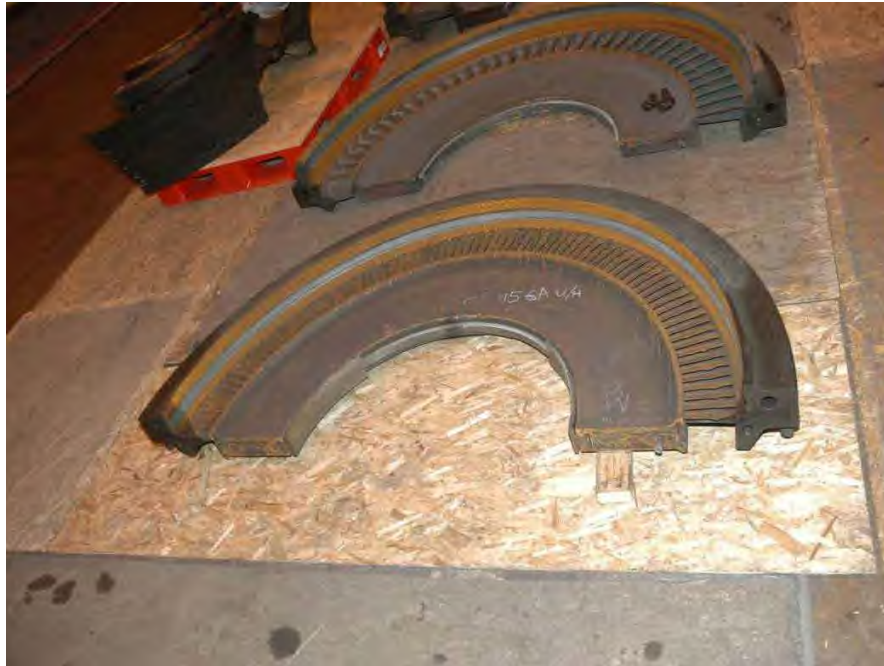
and rub damage to trailing and leading edges, Figs. 53 and 54. Moderate rub damage and transferred metal was noted on all interstage seal surfaces. Journal bearing surfaces and inlet seal surfaces exhibited moderate to heavy rub damage with substantial transferred metal present. The low pressure turbine "A" rotor was shipped to the General Electric Service Center in Chicago, Illinois for further inspection.

Fig. 53 Close-up of generator end L-4 diaphragm from low pressure turbine "A" showing rub damage to vanes.

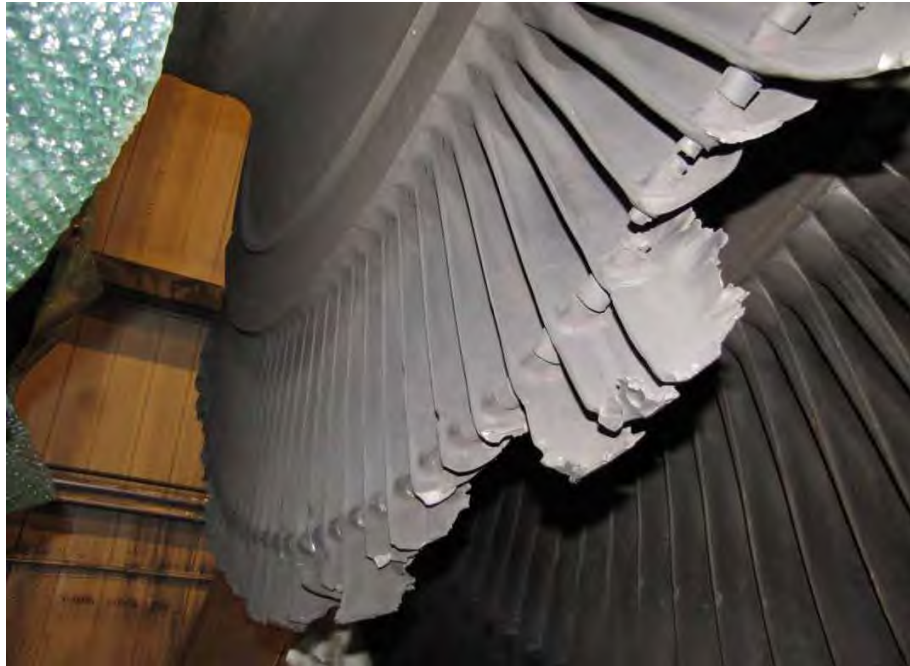
Upon opening the Low Pressure Turbine "B" inner casing it was observed that a large portion of the turbine end L-1 disk rim and associated blading was missing as shown in Fig. 55. The rotor was removed and placed in stands for further examination as shown in Fig. 56. Dark powdery deposits were present on all surfaces of the rotor including the fractured L-1 disk rim. These deposits were collected at a number of locations and submitted to Engel Metallurgical for inclusion in the forensic metallurgical examination. The aforementioned turbine end L-1 disk rim had fractured circumferentially for approximately 180°. The fractures occurred in the four internal finger pinned blade attachments; the outer fingers, which form the side faces of the disk rim, were not fractured. Figs. 57 to 59 show the extent of the L-1 disk rim fracture. The remaining intact turbine end L-1 blades were severely damaged and some had fractured outboard of the midspan attachments as shown in Figs. 60 and 61. The liberated L-1 stage blades and fractured sections of L-1 disk rim were found throughout the inner casing, Fig. 62.

Fig. 59. Close-up of fractured turbine end L-1 stage disk section of low pressure turbine "B" rotor shown in Fig. 55.

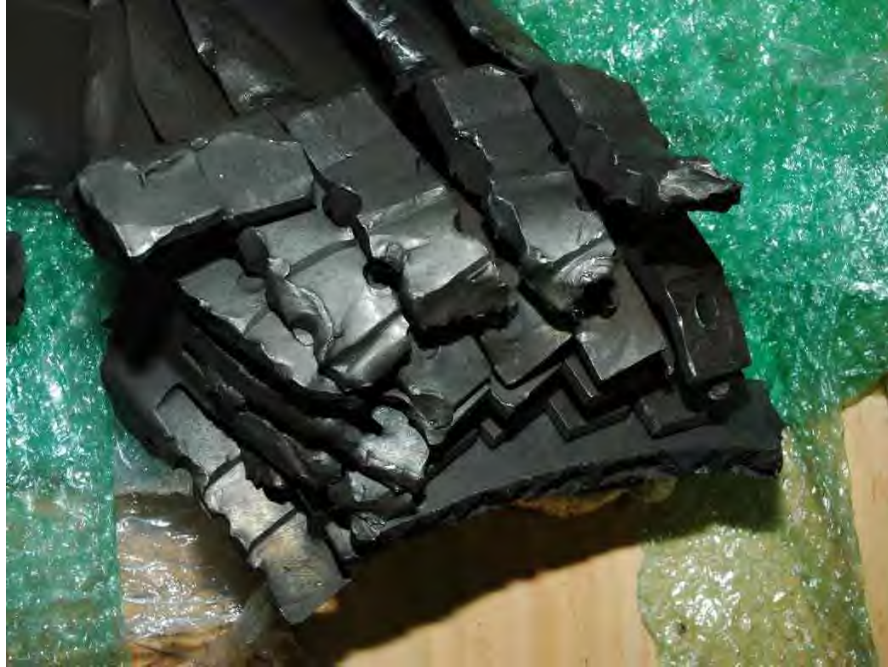
Fig. 61. Close-up photograph of turbine end L-1 stage blades from low pressure turbine "B" rotor shown in Fig. 55.

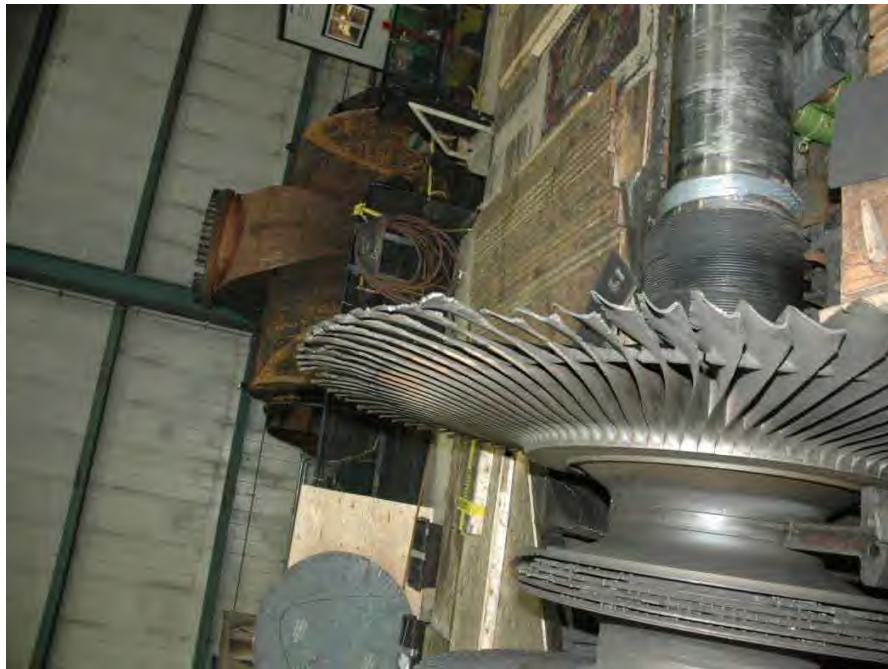
Fig. 62. Photograph of liberated turbine end L-1 blades from the low pressure turbine "B" rotor which section of fractured inner finger root attachment from disk rim.

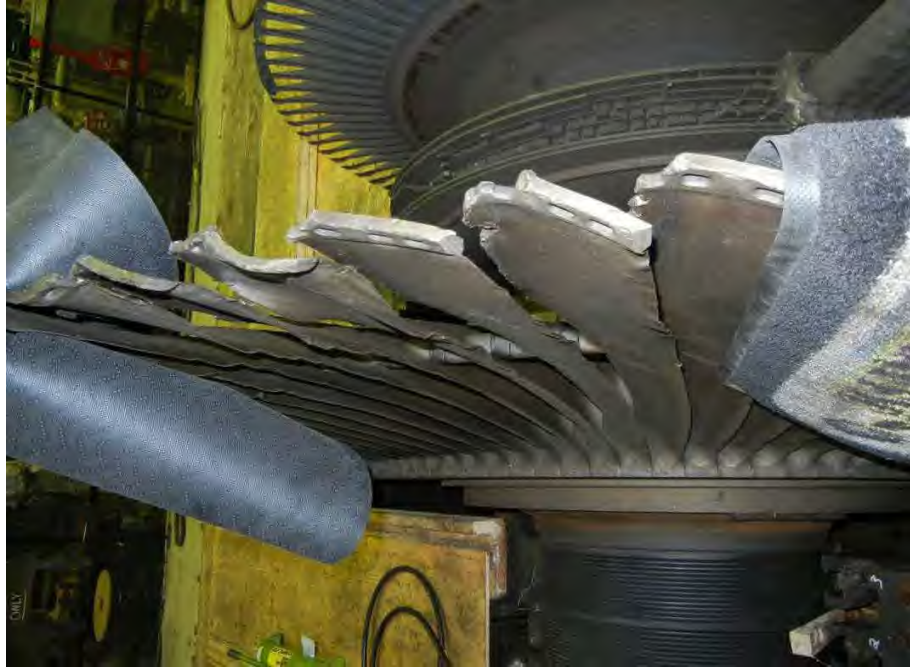
A number of the turbine end last stage blades were fractured transversely through the airfoil and all exhibited severe impact damage as shown in Figs. 63 to 65. The majority of the blade covers were missing. The turbine end L-2, L-3, L-4 and L-5 stage blades exhibited severe rub damage to the covers and tenons with some covers missing and others torn. All blading exhibited severe impact damage to leading and trailing edges of airfoils. Damage to L-2, L-3, and L-4 and L-5 blading is shown in Figs. 66 to 68.

Fig. 63. Close-up photograph of turbine end of low pressure turbine "B" showing extent of damage to last stage blades.

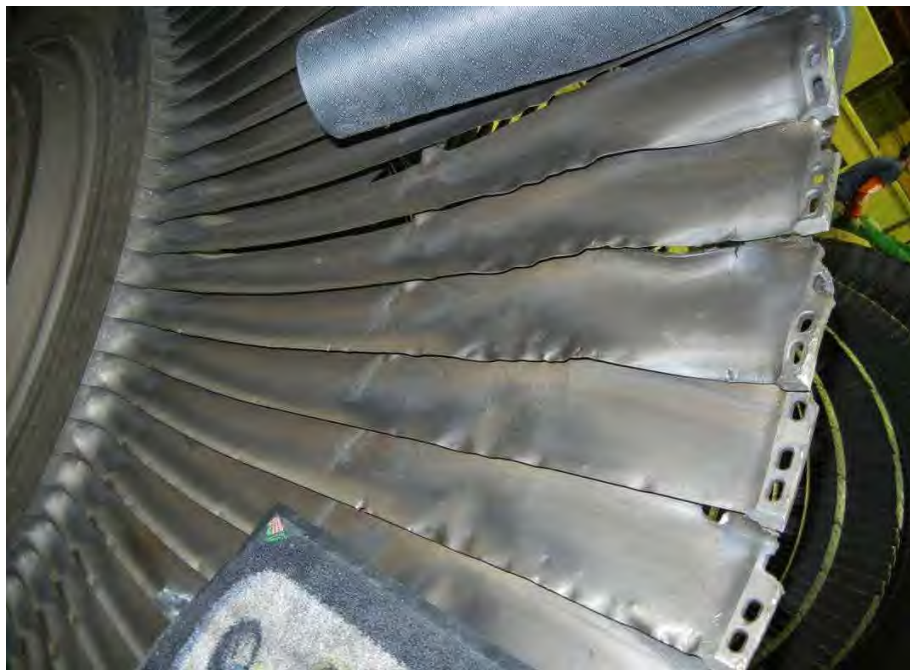
Fig. 64. Photograph of turbine end last stages blades from low pressure turbine "B" showing missing blade spacers.

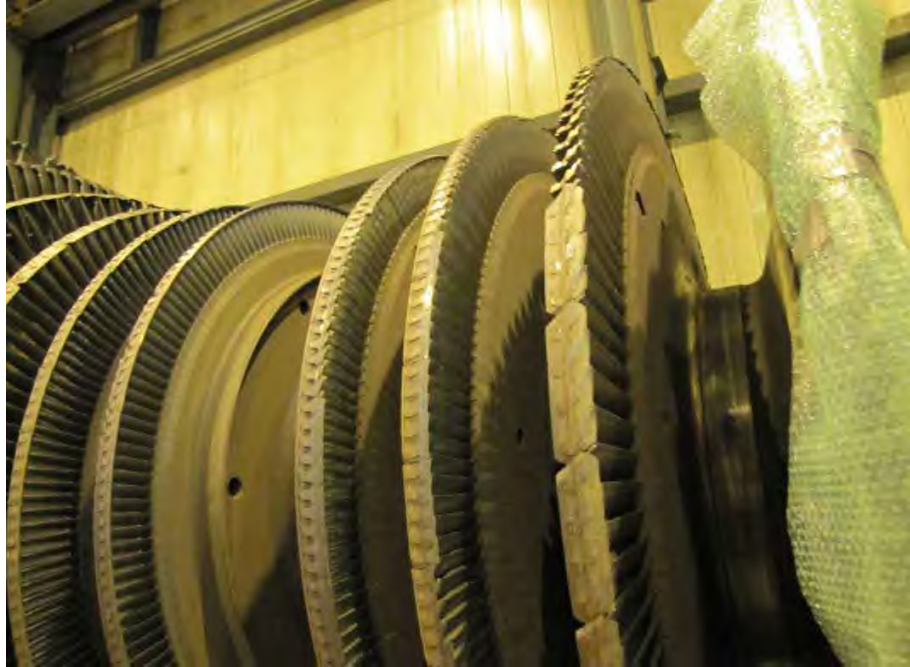
Fig. 65. Photograph of turbine end last stage blades from low pressure turbine "B".
