I.	Introduction and Qualifications	1
II.	Root Cause Investigation	3
	A. Background on Sherco Unit 3 Turbine-Generator Train	4
	B. The Event	6
	C. The Root Cause Analysis	9
III.	Determined Cause of Failure	10
IV.	Additional Observations and Opinions	17

Statement of Qualifications	Schedule 1
Root Cause Analysis Steam Turbine Generator Event of November 19, 2011	Schedule 2
Root Cause Analysis Report-Figures and Attachments	Schedule 3

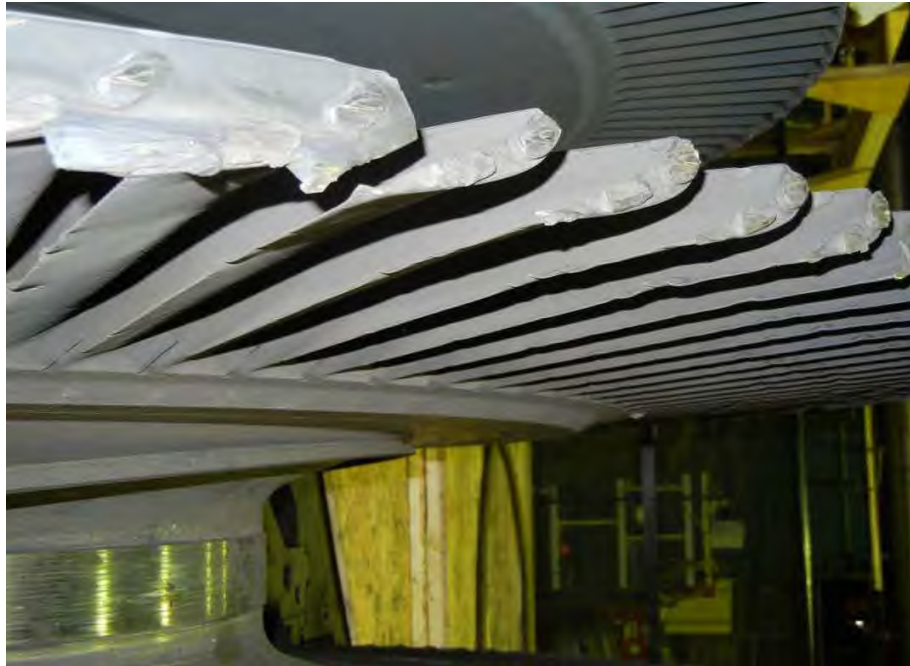
A number of the turbine end last stage blades were fractured transversely through the airfoil and all exhibited severe impact damage as shown in Figs. 63 to 65. The majority of the blade covers were missing. The turbine end L-2, L-3, L-4 and L-5 stage blades exhibited severe rub damage to the covers and tenons with some covers missing and others torn. All blading exhibited severe impact damage to leading and trailing edges of airfoils. Damage to L-2, L-3, and L-4 and L-5 blading is shown in Figs. 66 to 68.

Fig. 67. Photograph of turbine end of low pressure turbine "B" rotor showing missing covers on L-2 and L-3 stage blades.

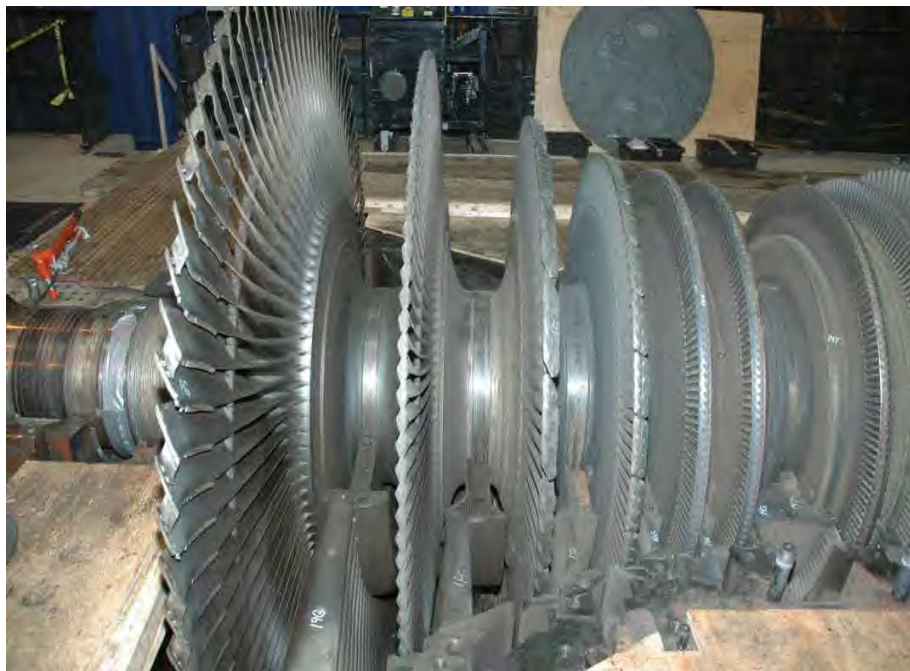
Fig. 68. Photograph of turbine end L-3 stage blading on low pressure turbine "B" rotor showing damage to covers and missing covers.

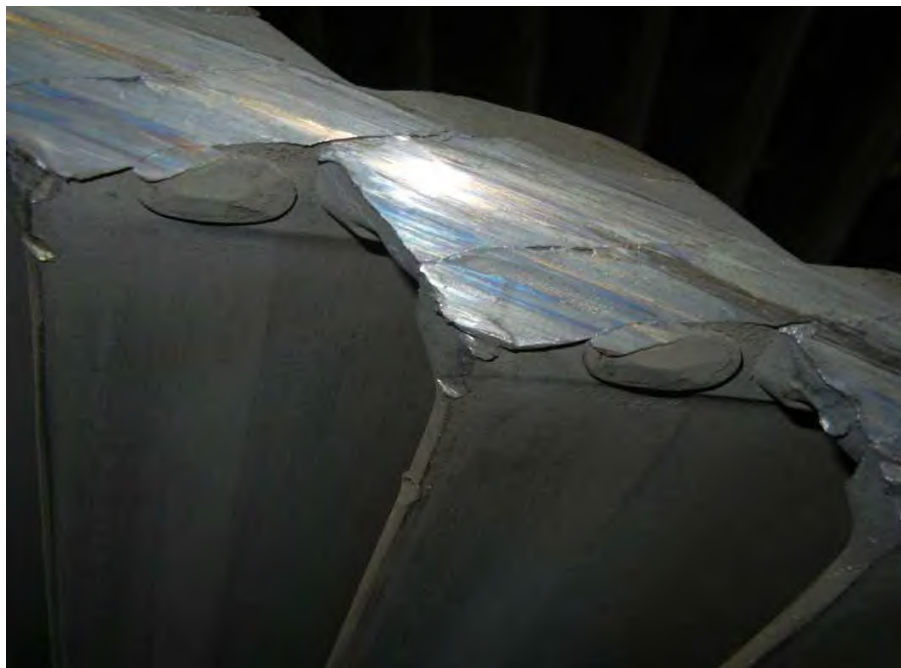
the L-2 stage blades were missing. The damage to the generator end blading is shown in Figs. 69 to 74.

Fig. 71. Close-up photograph of low pressure turbine "B" generator end L-1 blade tips and spacers showing severe rub damage.

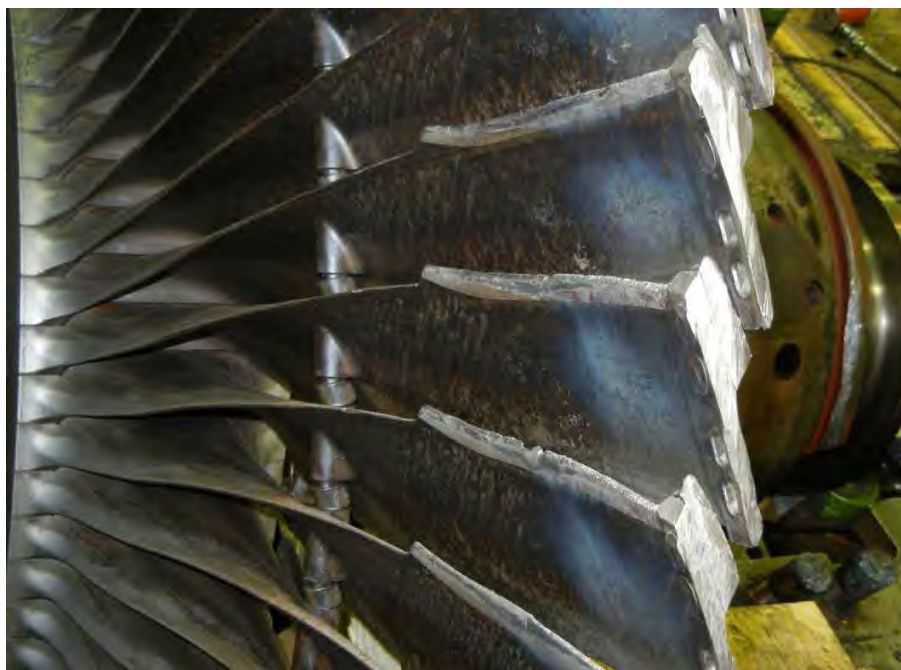
Fig. 72. Close-up photograph of low pressure turbine "B" generator end L-1 blade tips and spacers showing severe rub damage.

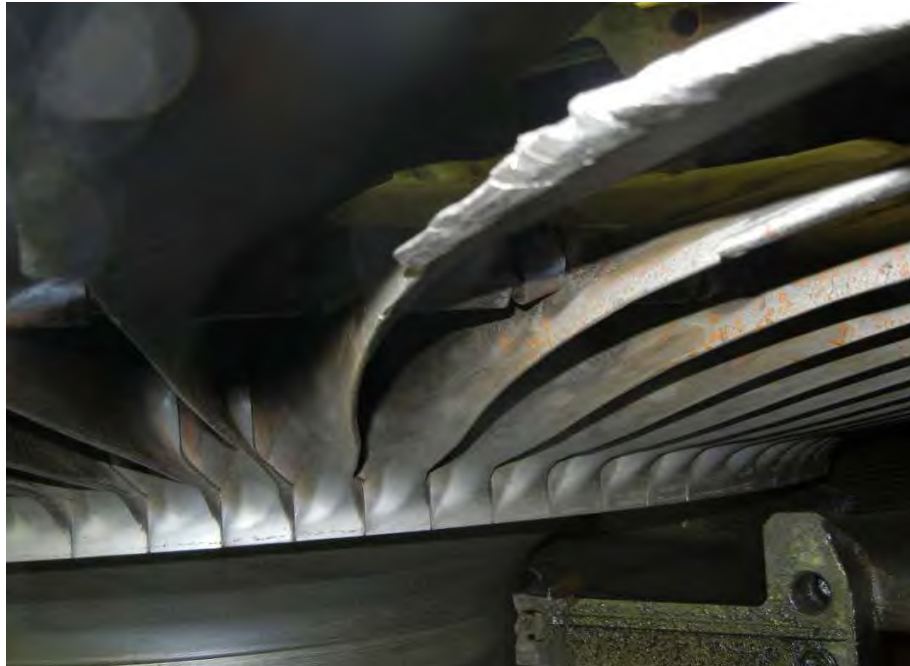
Fig. 73. Photograph of low pressure turbine "B" generator end last stage blades.

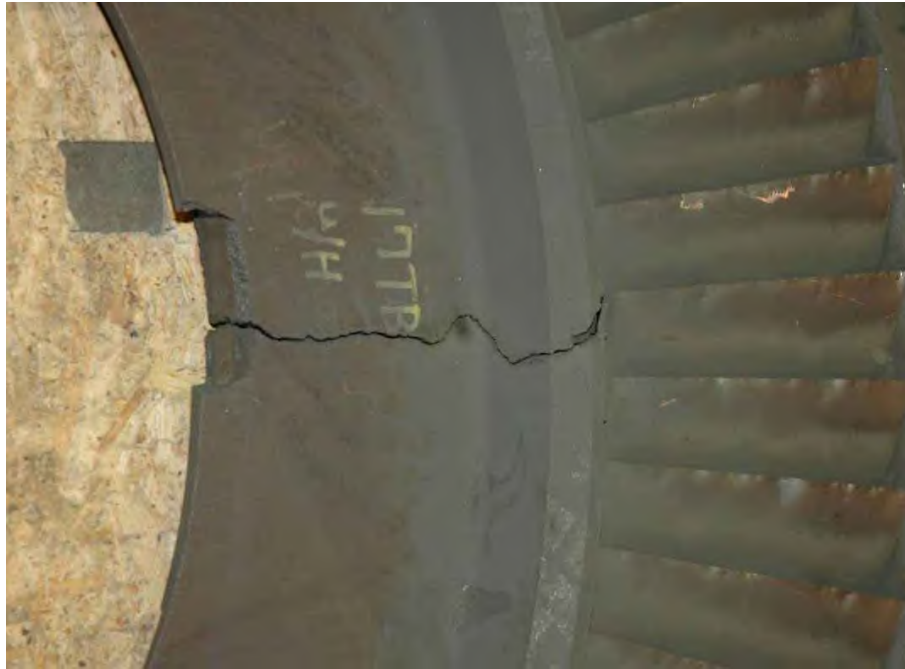
The turbine end and generator end diaphragms exhibited significant impact damage to the vane airfoils. The L-2 turbine end diaphragm exhibited a radial crack completely through the inner wall as shown in Figs. 75 to 76. The crack had not resulted in any liberated diaphragm material. The crack was wide enough to allow limited visual examination on the shop floor. The crack surfaces were coarse textured and appeared relatively fresh, i.e., they were not oxide discolored. It was concluded that the subject crack in the aforementioned diaphragm resulted from the severe vibration during the event and was not submitted for further forensic examination. Two vanes from the turbine end last stage diaphragm had fractured through the weldments at the inner and outer walls and were liberated (Fig. 77). The weld fracture surfaces were coarse textured indicative of tensile overload and exhibited no evidence of oxidation. It was concluded that the weldment fractures resulted from the severe vibration and possibly impact damage during the event and were not submitted for further examination. The L-1 stage diaphragm had fractured through the end wall adjacent to the outer diameter (Fig. 78). Examination revealed a fresh appearing coarse textured fracture morphology indicative of tensile overload (Fig. 79). It was concluded that the end wall fractures resulted from the severe vibration and possibly impact damage during the event and were not submitted for further examination. Typical examples of the damage observed to diaphragms and diaphragm vanes are shown in Figs. 80 and 81.

Fig. 75. Photograph of low pressure turbine "B" rotor L-2 stage diaphragm showing radial crack (arrow) through center section and inner wall.

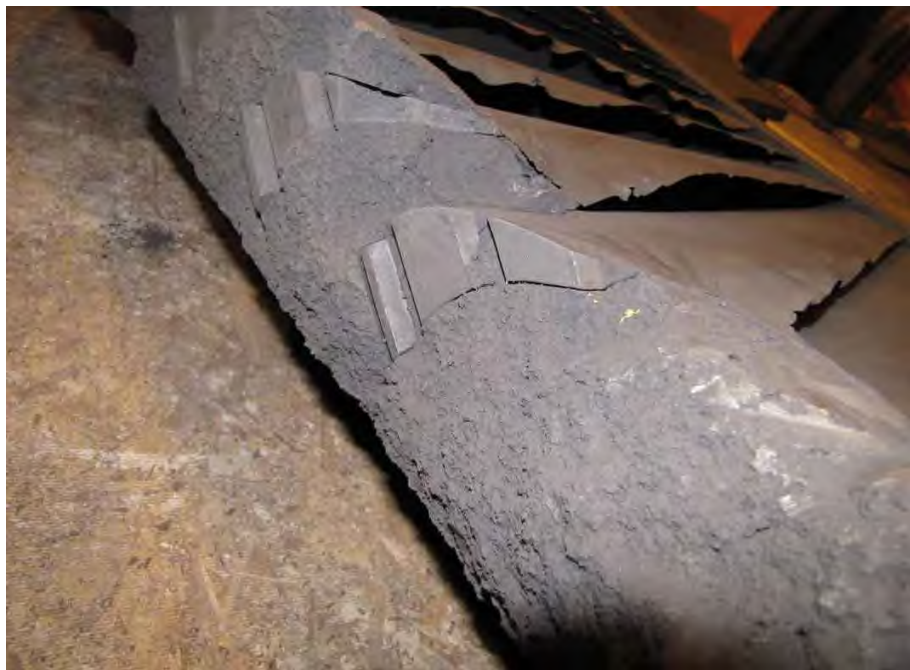
Fig. 78. Photograph of turbine end L-1 stage diaphragm from low pressure turbine "B" rotor showing extent of damage.

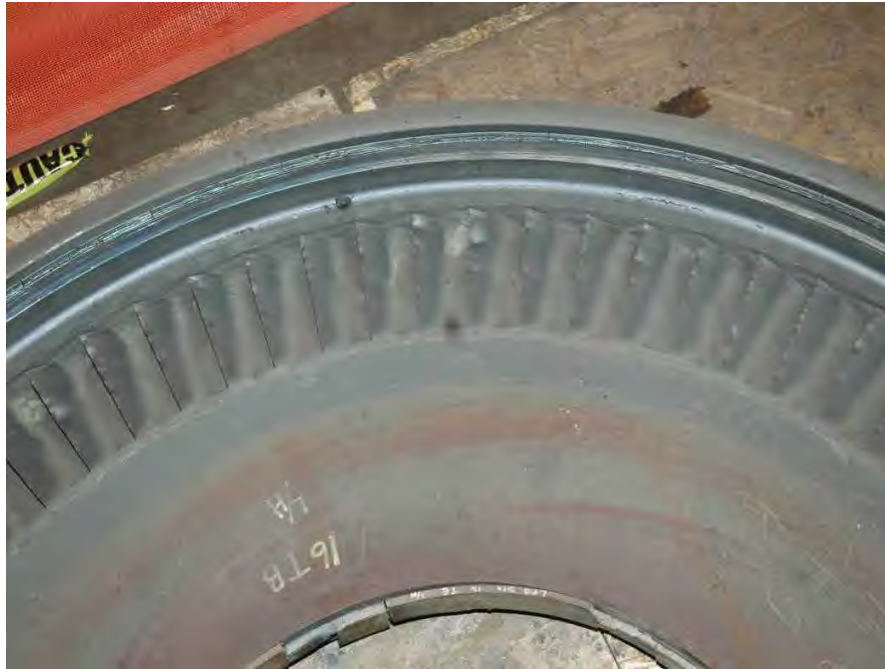
Fig. 79. Close-up photograph of diaphragm fracture surface shown in Fig. 78.

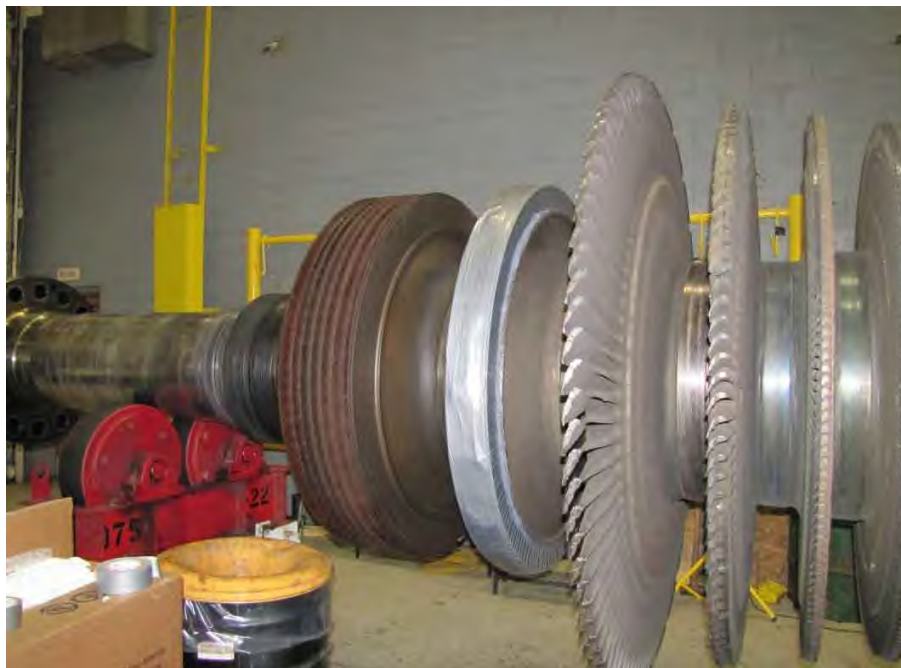
The fractured turbine end L-1 stage disk rim was protected with "bubble wrap", enclosed in a fabricated wooden box and finally the entire rotor was covered with "shrink wrap", as shown in Figs. 82 and 83, and shipped to the General Electric Service Center in Chicago, Illinois. Swabs of the deposits within the fractured area of the disk rim were taken prior to wrapping the disk. These swabs would be compared with swabs taken after receipt at the GE Service Center and after removal of the disk rim section to

Fig. 83. Photograph of low pressure turbine "B" rotor with wooden protective box built around the fractured L-1 stage disk rim.

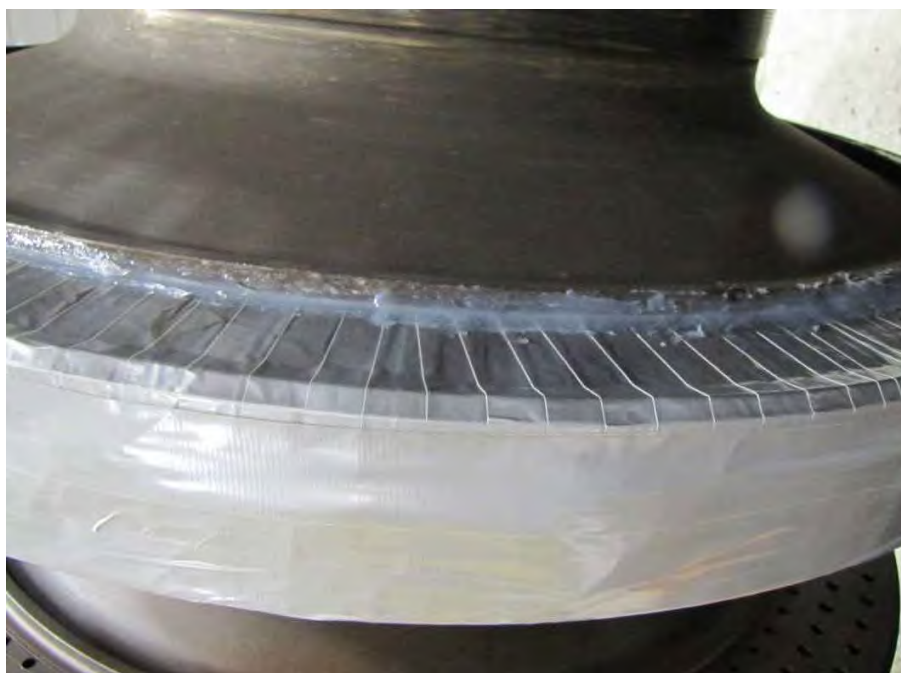
Fig. 84 Photograph of low pressure turbine "B" rotor at the GE Repair Facility in Chicago, IL., showing protective taping of fractured L-1 stage disk rim.

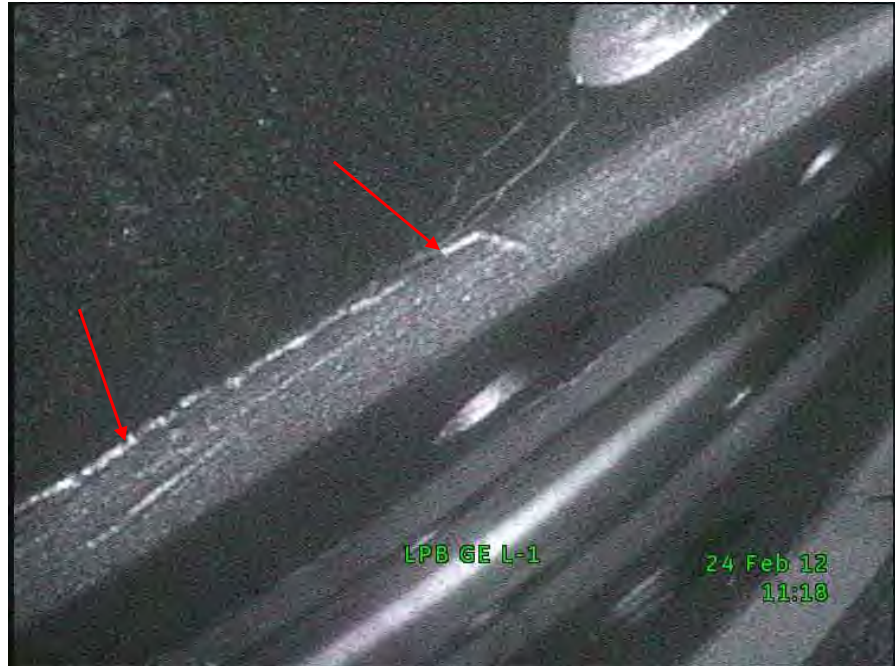
Magnetic particle and ultrasonic examination was performed on both the "A" and "B" low pressure turbine rotors at the General Electric Service Center in Chicago, IL. Magnetic Particle Inspection (MPI) revealed numerous indications on the internal finger pinned blade attachments of all remaining L-1 stage disk rims as shown in Figs. 87 to 91. These three L-1 disk rims were sectioned from the rotors using the same process as previously described for the fractured L-1 disk rim however, no protection from coolant was employed. The three L-1 disk rims were boxed and shipped to Engel Metallurgical for forensic examination.

Fig. 87 Close-up blacklight photograph of low pressure turbine "B" L-1 disk rim showing MPI indications (arrows) in finger-root attachment.

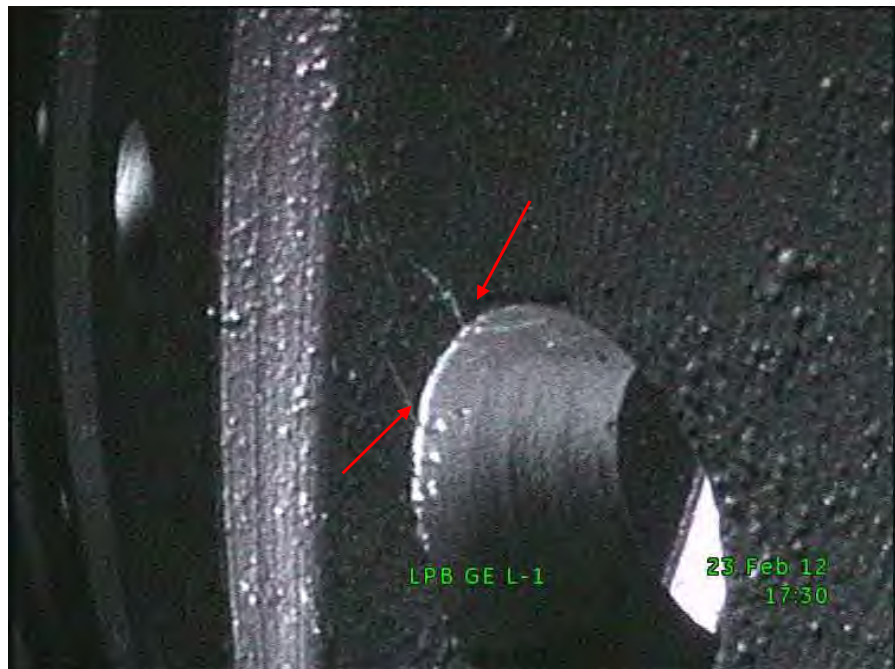
Fig. 88 Close-up blacklight photograph of Low Pressure Turbine "B" L-1 disk rim showing MPI indications (arrows) in finger-root attachment.

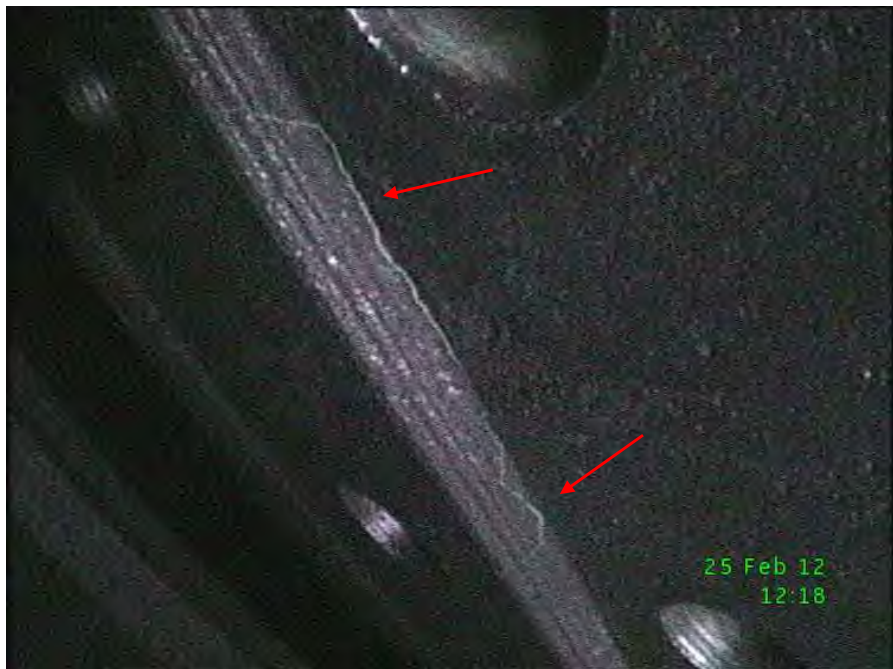
Fig. 90 Close-up blacklight photograph of low pressure turbine "A" L-1 disk rim showing MPI indications (arrows) in finger-root attachment.

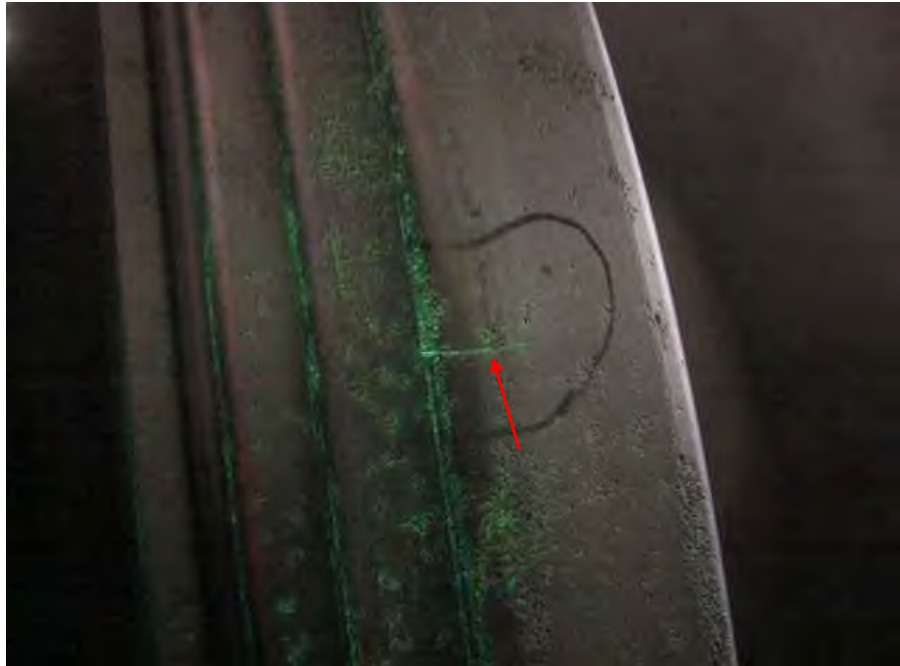
Fig. 91 Close-up blacklight photograph of low pressure turbine "A" L-1 disk rim showing MPI indication (arrows) in finger-root attachment.

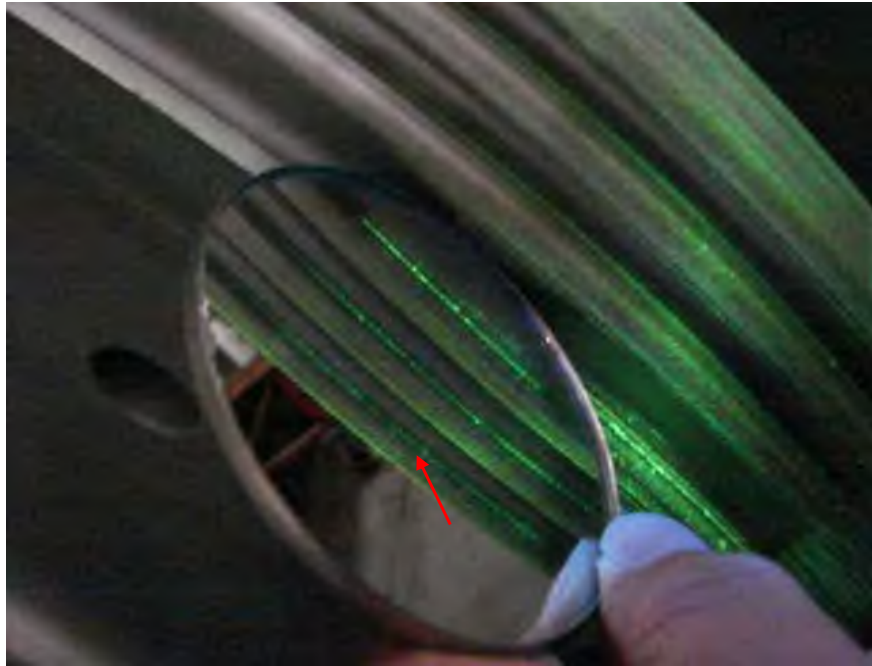
Magnetic particle inspection revealed indications in the blade attachment dovetails of the generator end L-2, L-3, L-4 and L-5 stage disks of the low pressure turbine "A" rotor as shown in Figs. 92 to 99. The indications were machined/blended out by General Electric Service Center personnel prior to any investigation. Figs. 100 to 103 show examples of the indication areas after indication removal.

Fig. 93. Close-up blacklight photograph of low pressure turbine "A" generator end L-2 stage disk on inlet side of the blade dovetail showing indication (arrow).

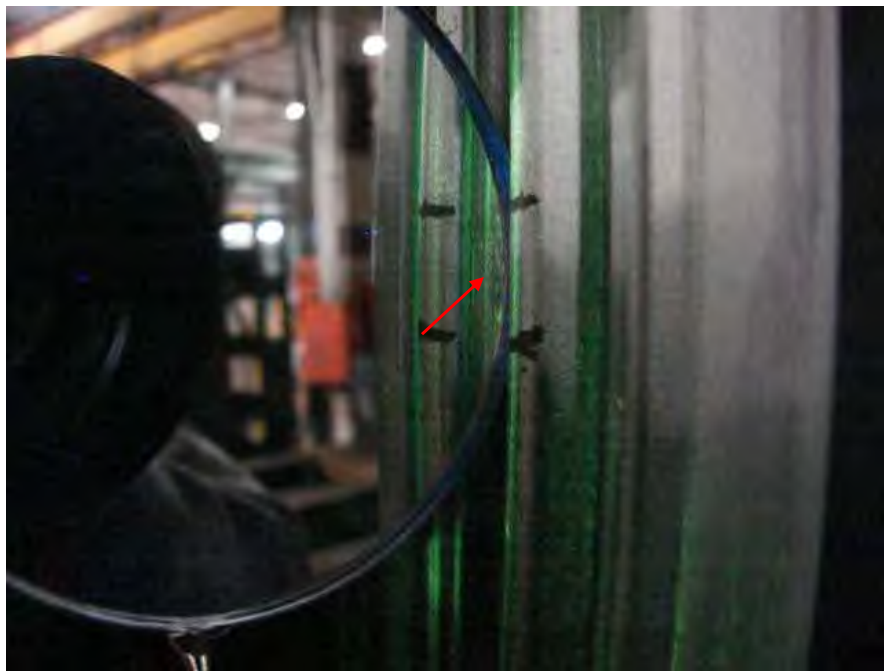
Fig. 94. Close-up blacklight photograph of low pressure turbine "A" generator end L-3 stage disk on exit side of the blade dovetail showing indication (arrow).

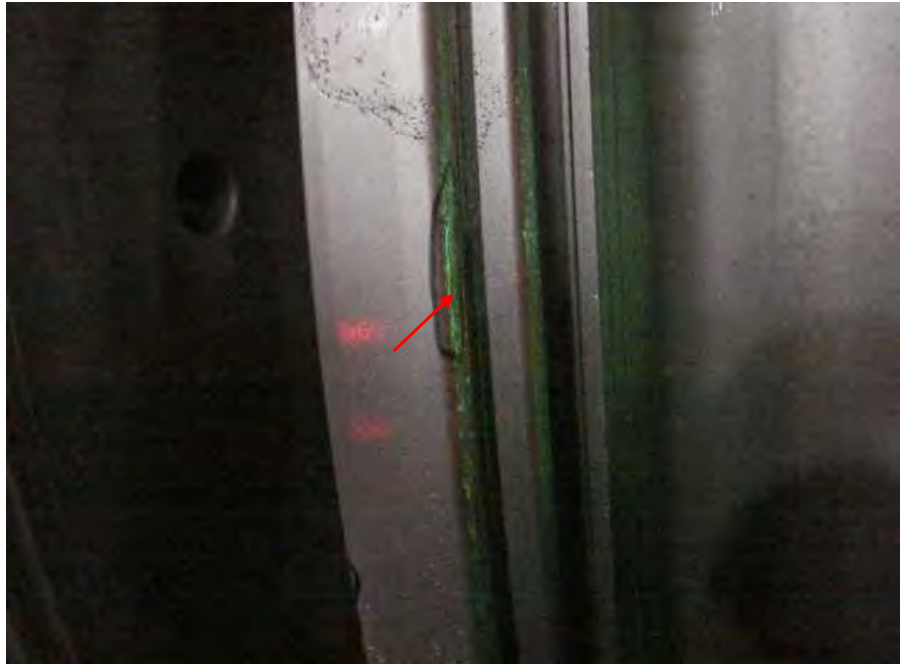
Fig. 95. Close-up blacklight photograph of low pressure turbine "A" generator end L-4 stage disk on the inlet side of the blade dovetail showing indication (arrow).

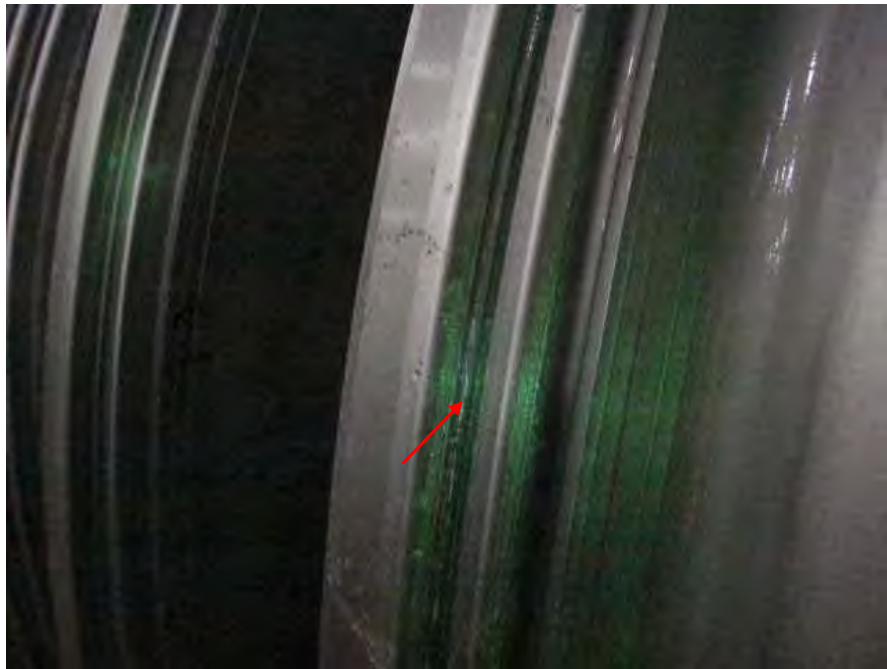
Fig. 96. Close-up blacklight photograph of low pressure turbine "A" generator end L-4 stage disk on exit side of the blade dovetail showing indication (arrow).

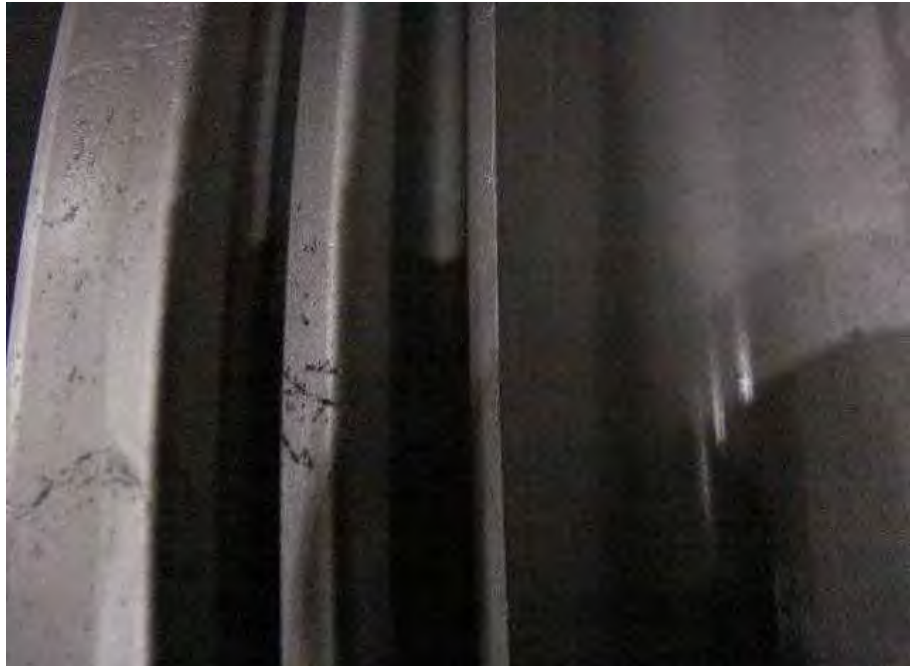
Fig. 98. Close-up blacklight photograph of low pressure turbine "A" generator end L-5 stage disk on inlet side of the blade dovetail.

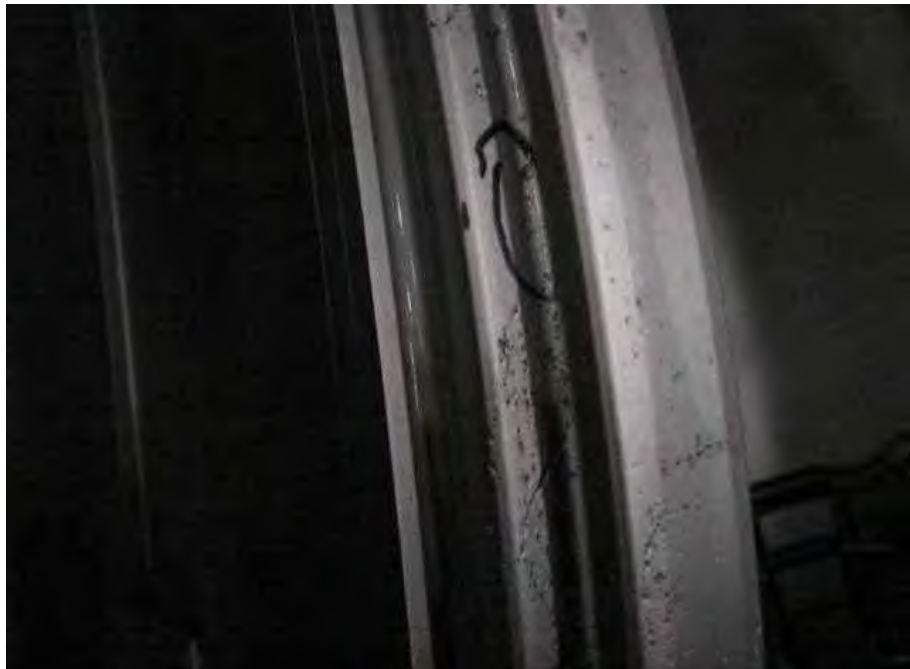
Fig. 99. Close-up blacklight photograph of low pressure turbine "A" generator end L-5 stage disk on inlet side of the blade dovetail.

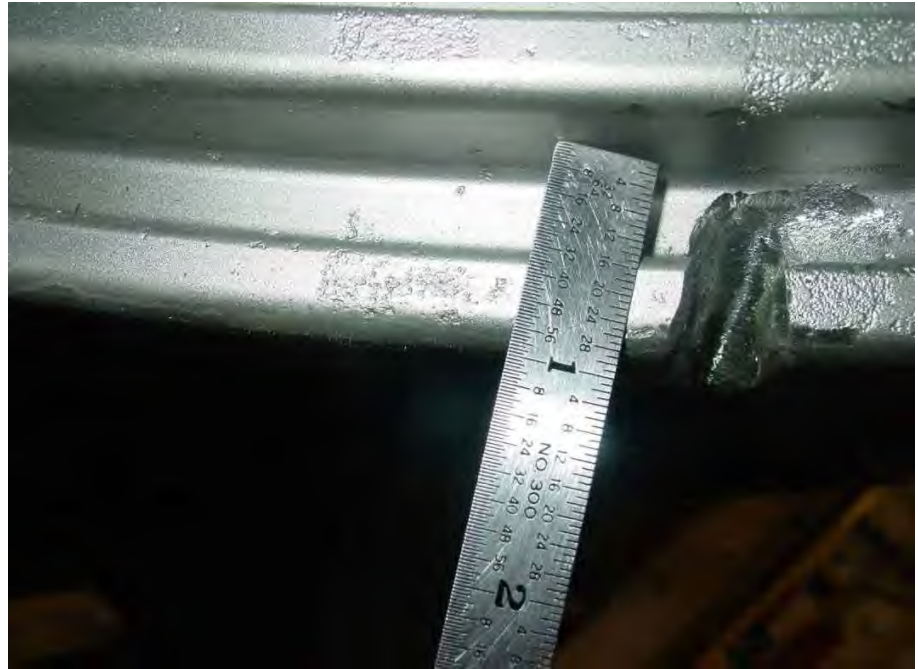
Fig. 100. Close-up photograph of low pressure turbine "A" generator end L-2 stage disk rim showing excavation of indication at 330° location. Viewed from side.

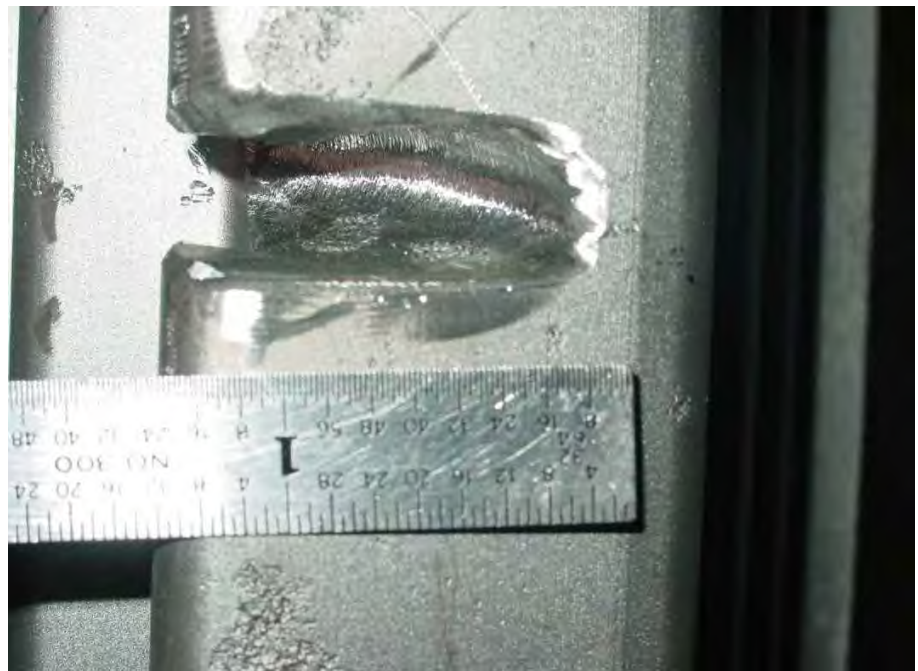
Fig. 101. Close-up photograph of low pressure turbine "A" generator end L-2 stage disk rim showing excavation of indication at 330° location. Viewed from top.

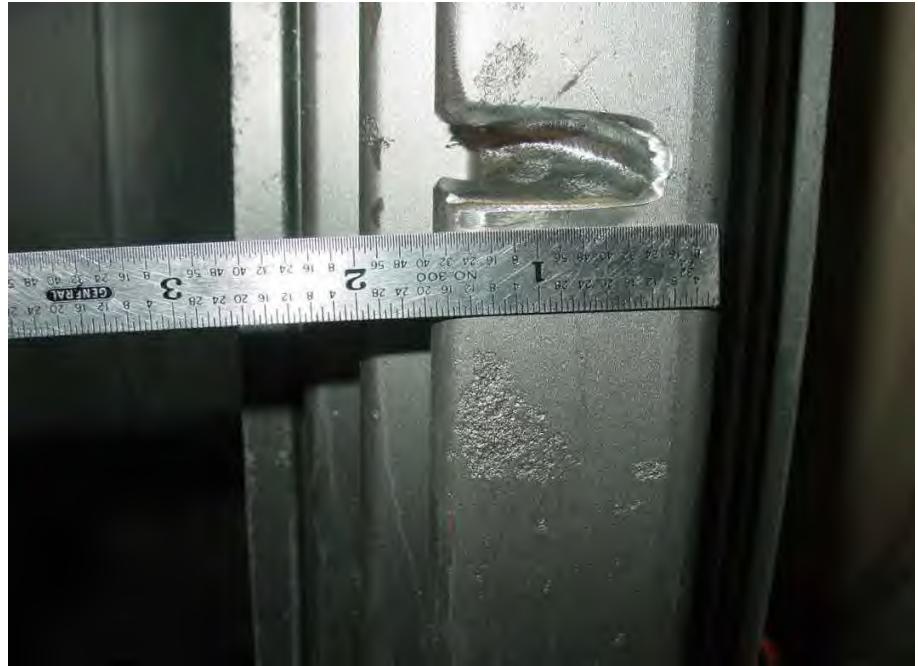
Fig. 102. Close-up photograph of low pressure turbine "A" generator end L-2 stage disk rim showing excavation of indication at 155° location.

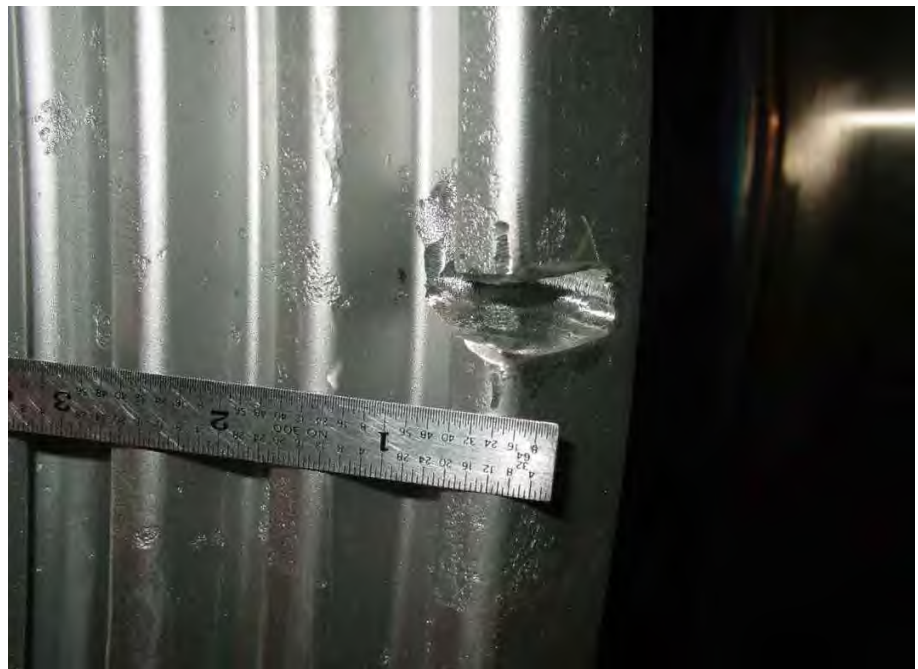
Fig. 103. Close-up photograph of low pressure turbine "A" generator end L-2 stage disk rim showing excavation of indication at 155° location.

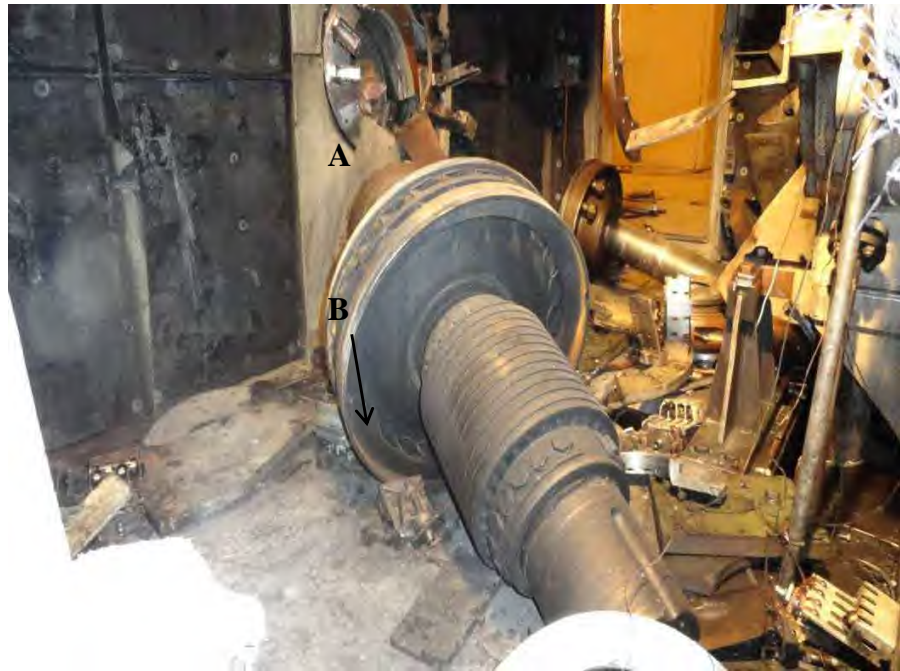
The generator shaft was found to be fractured transversely just forward of the generator collector ring as shown in Figs. 104 and 105. The generator shaft end coupling was liberated from the generator shaft during the event and found on the "doghouse" enclosure floor (Fig. 106). The exciter shaft fractured transversely at three locations, adjacent to the No. 11 bearing, adjacent to the No. 12 bearing and at the Alterex collector ring as shown in Figs. 107 to 109. The fracture at the end of the exciter shaft resulted in the liberation of the Alterex collector ring which burst through the "doghouse" enclosure and bounded across the turbine deck, through a meeting room and came to rest in the control room as shown in Fig. 110. The generator rotor and stator sustained extensive rub damage as shown in Figs. 111 to 114.

Fig. 105. Photograph of portion of fractured generator shaft shown in Fig. 104.

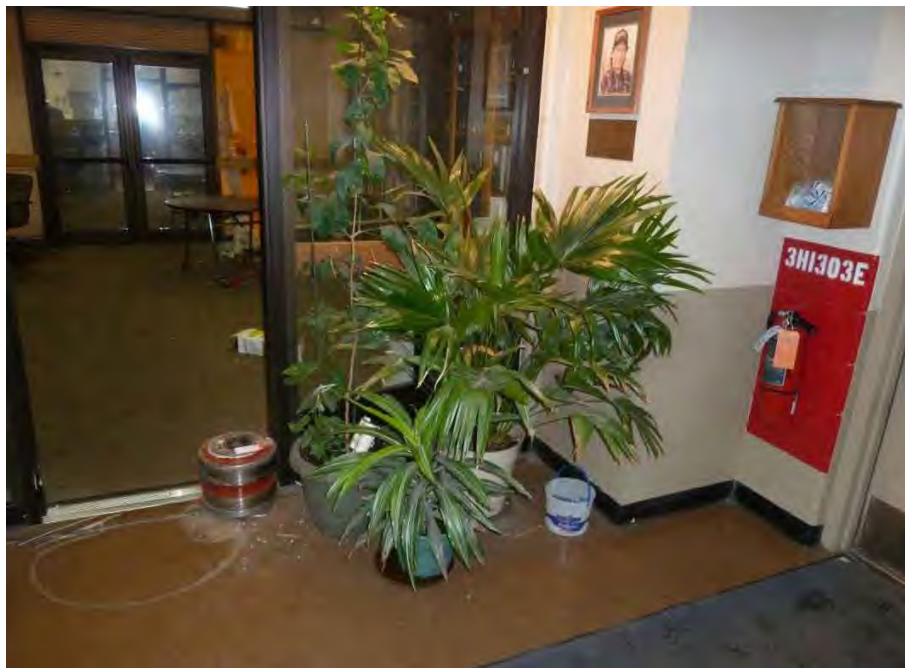
Fig. 110. Photograph of liberated exciter collector which came to rest in operator's room.

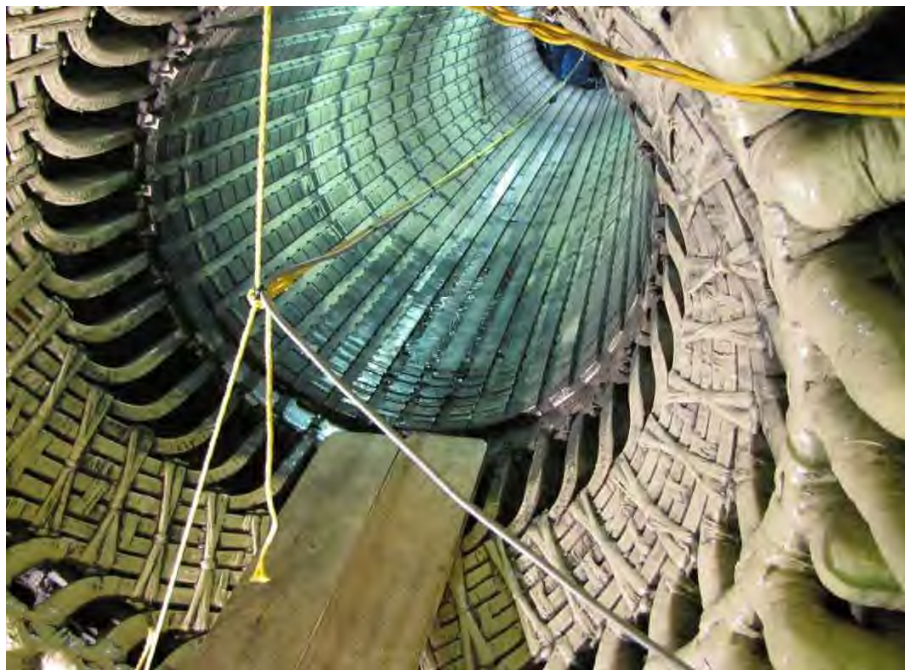
Fig. 111. Photograph of generator stator showing extent of rub damage.

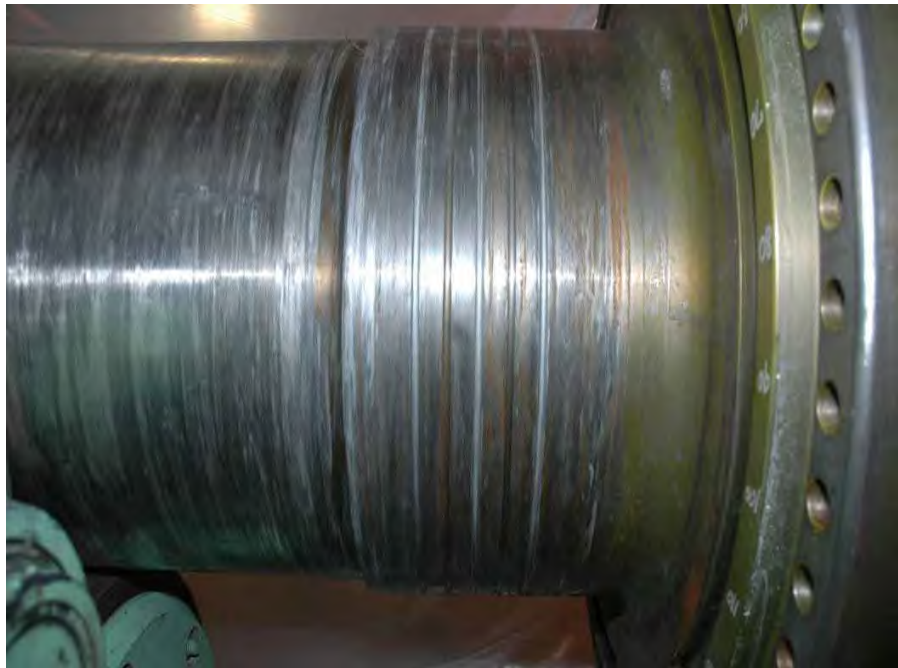
Fig. 113. Generator rotor rub damage.

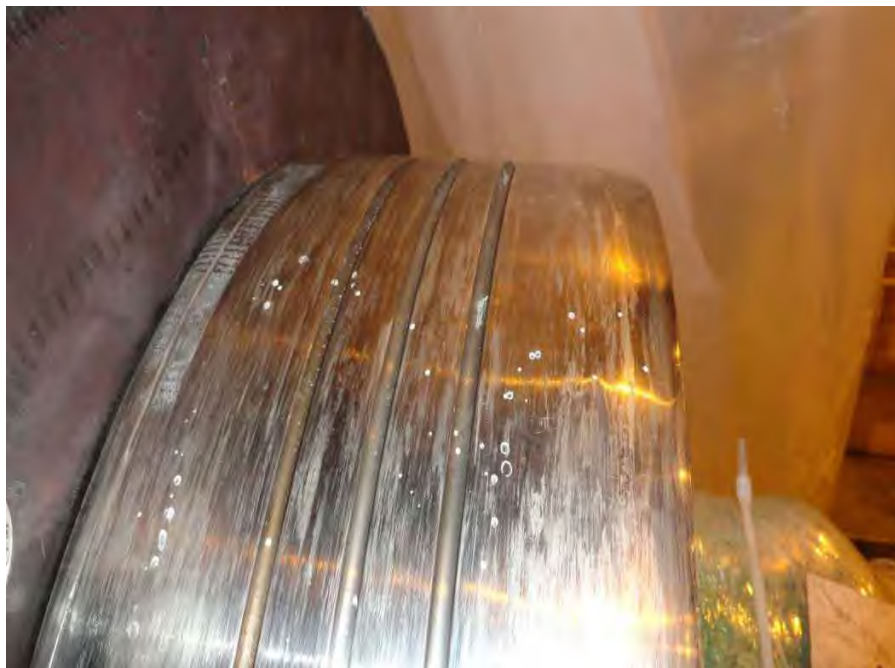
Fig. 114. Generator rotor CE oil seal journal showing extent of rub damage.

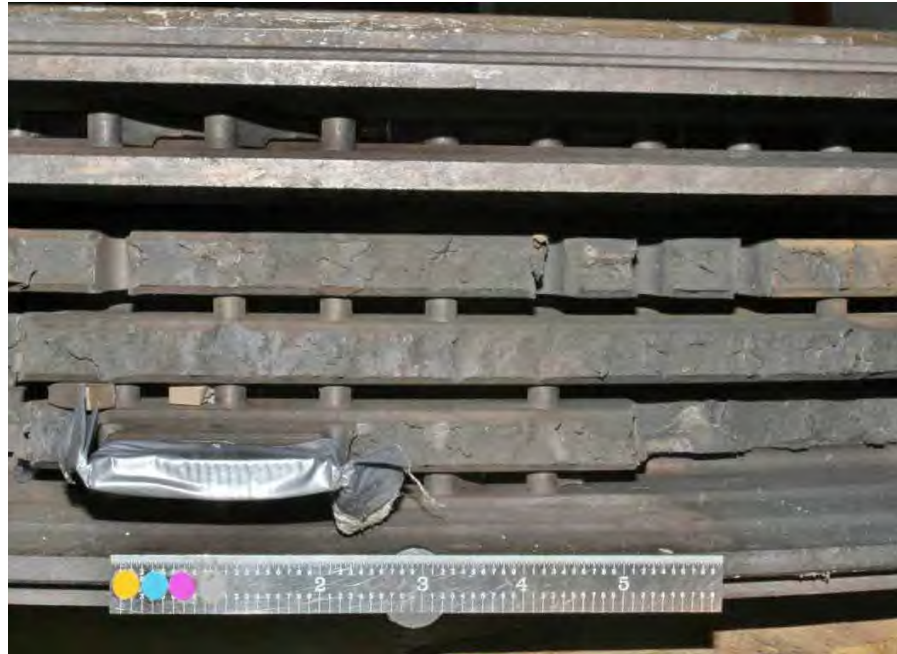
Fig. 124. Close-up photograph of fractures through internal finger pinned blade attachments in low pressure turbine "B" L-1 disk rim.

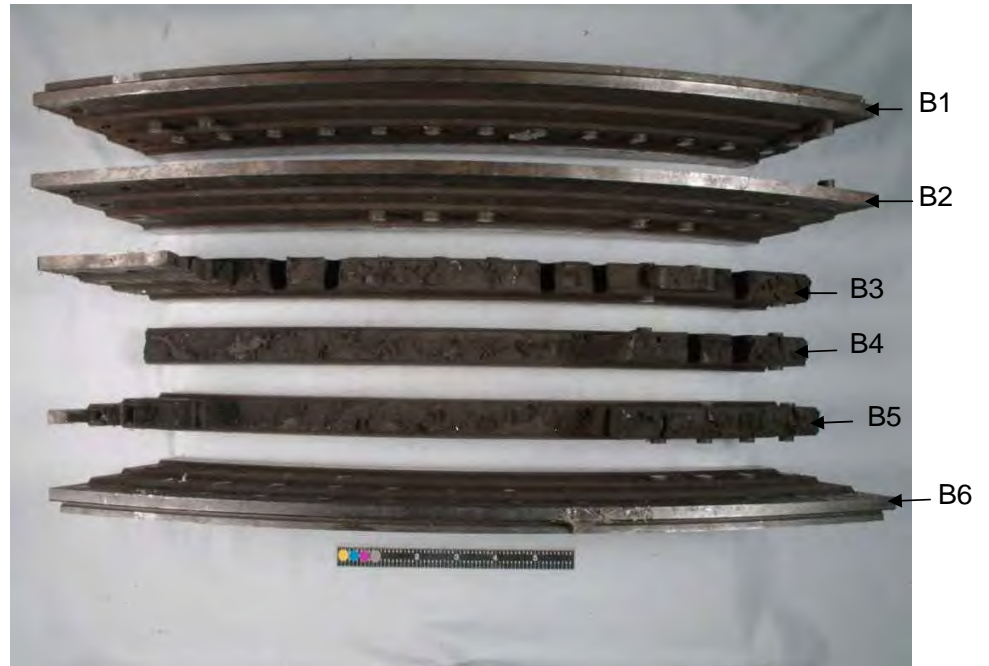
Subsegment "B" from SID 14875 was sectioned circumferentially between the finger pinned blade attachments and each finger was identified as "B1-B6" as shown in Fig. 136. Three internal finger pinned blade attachments in subsegment "B" were fractured transversely. One finger pinned blade attachment fracture occurred along the ledge at the first section thickness change above the base of the attachment, intersected multiple pin holes and extended diagonally to the disk rim OD as shown in Fig. 137. The second finger pinned blade attachment fracture occurred along the base of the attachment, extended radially outboard and along the ledge at the first section thickness change above the attachment base and intersected two pin holes as shown in Fig. 138. The third finger pinned blade attachment fracture occurred along the base of the attachment, extending radially to the disk rim OD on one end and on the other end extending radially outboard to the ledge at the first section thickness change as shown in Fig. 139. Examination revealed the fracture surfaces exhibited coarse textured fracture morphology as shown in Figs. 140 to 153. Terminal portions of fractures exhibited fracture morphology indicative of tensile/shear overload. No primary origin location(s) was identified.

Fig 136. SID 14875 subsegment "B" after circumferential sectioning.

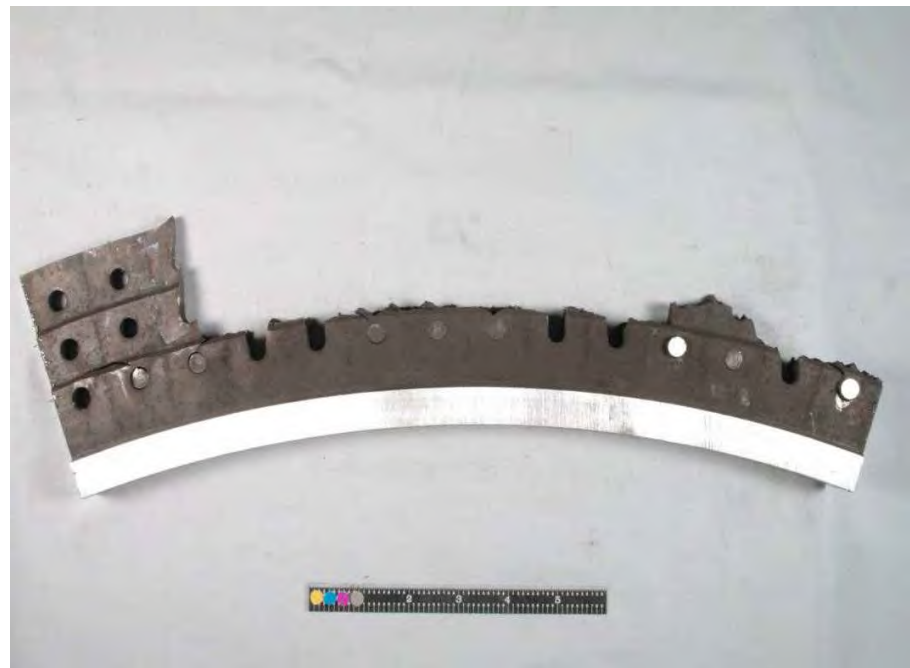
Fig. 137. SID 14875 subsegment "B3" finger pinned blade attachment, outlet side.

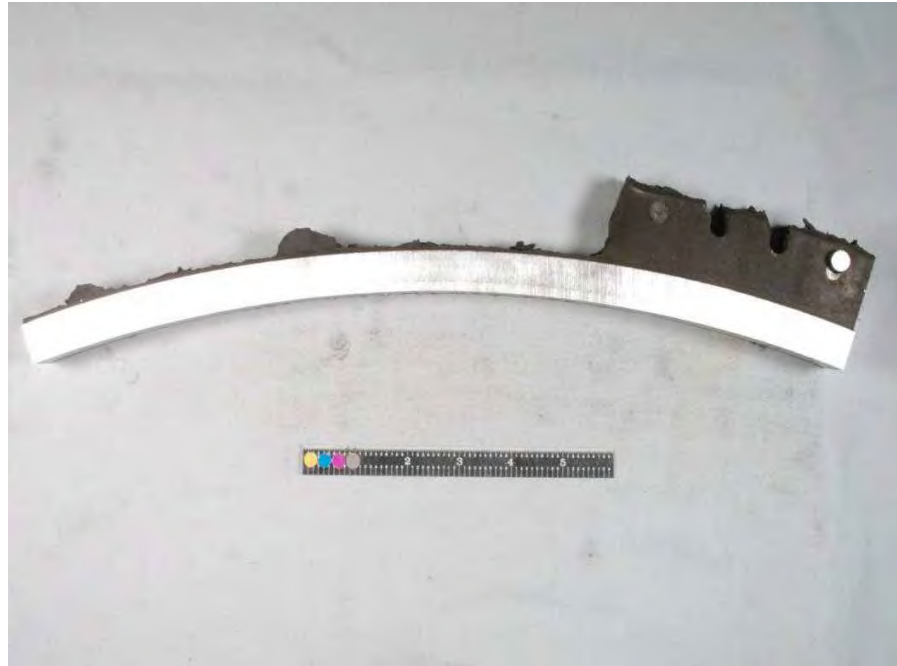
Fig. 138. SID 14875 subsegment "B4" finger pinned blade attachment, outlet side.
