I.	Introduction and Qualifications	1
II.	Root Cause Investigation	3
	A. Background on Sherco Unit 3 Turbine-Generator Train	4
	B. The Event	6
	C. The Root Cause Analysis	9
III.	Determined Cause of Failure	10
IV.	Additional Observations and Opinions	17

Statement of Qualifications	Schedule 1
Root Cause Analysis Steam Turbine Generator Event of November 19, 2011	Schedule 2
Root Cause Analysis Report-Figures and Attachments	Schedule 3

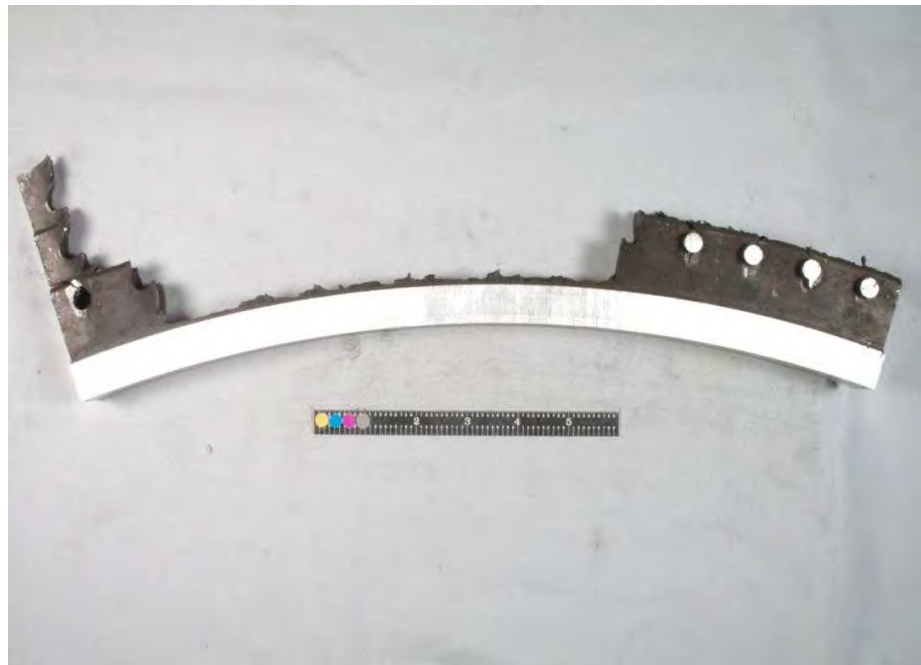
Fig. 139. SID 14875 subsegment "B5" finger pinned blade attachment, outlet side.

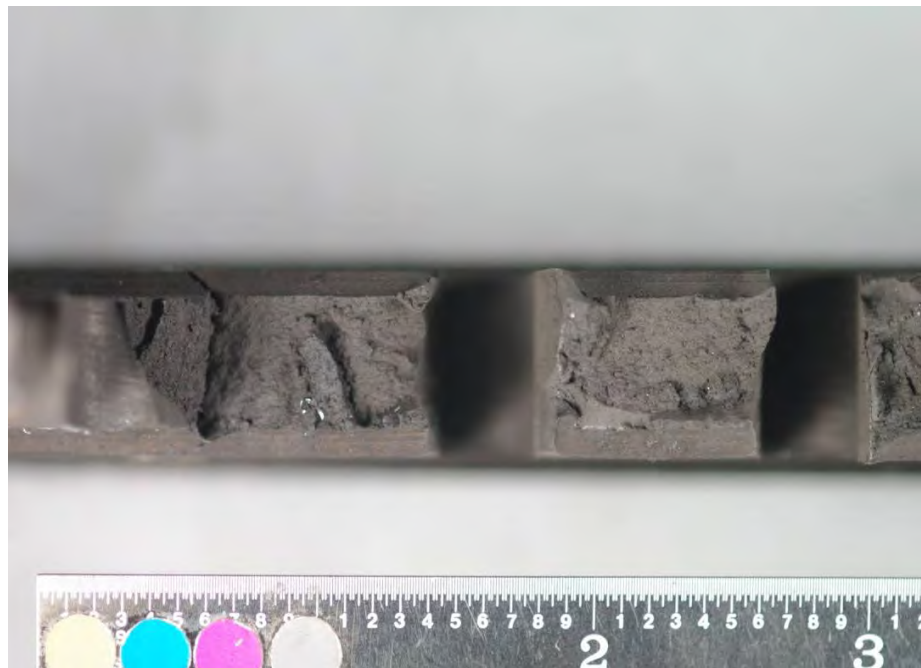
Fig. 143. Close-up of SID 14875 subsegment "B3" fracture surface shown in Fig. 140.

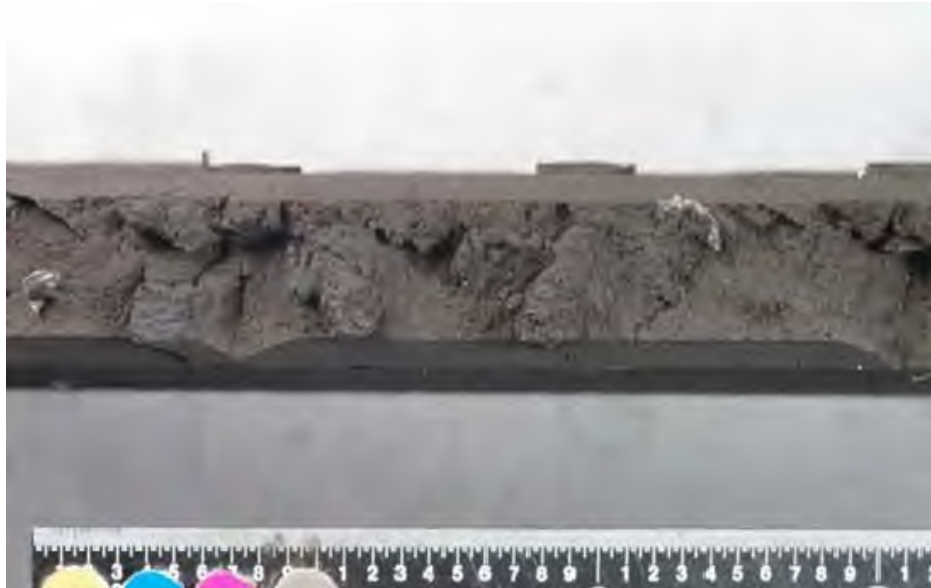
Fig. 144. Close-up of SID 14875 subsegment "B3" fracture surface shown in Fig. 141.

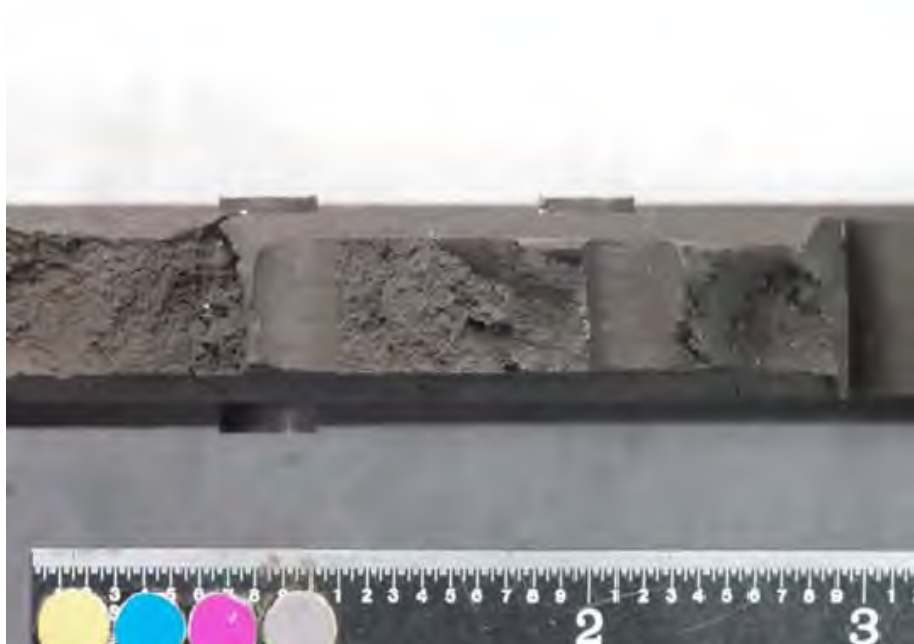
Fig. 145. Close-up of SID 14875 subsegment "B3" fracture surface shown in Fig. 142.

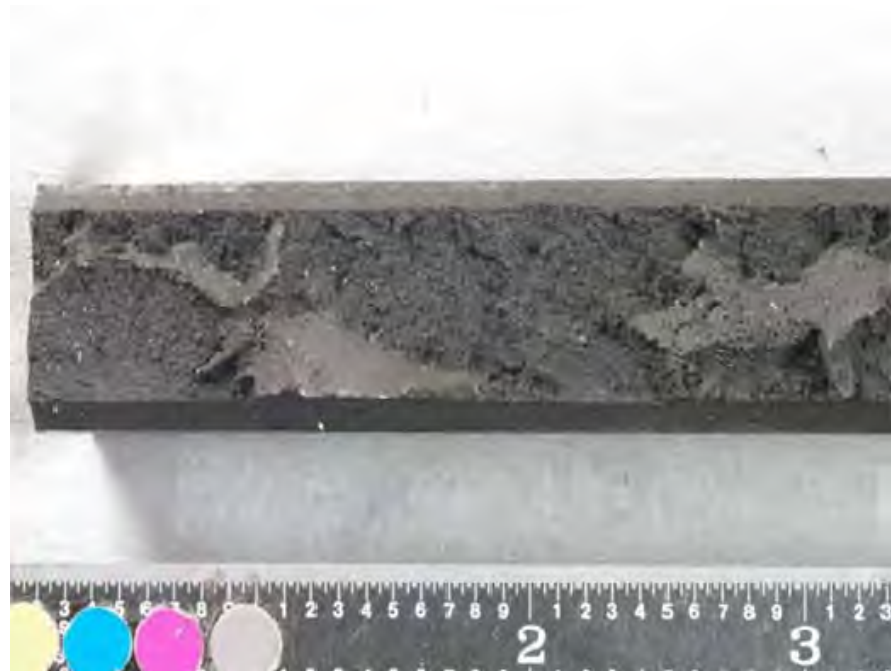
Fig. 147. Close-up of SID 14875 subsegment "B4" fracture surface shown in Fig. 146.

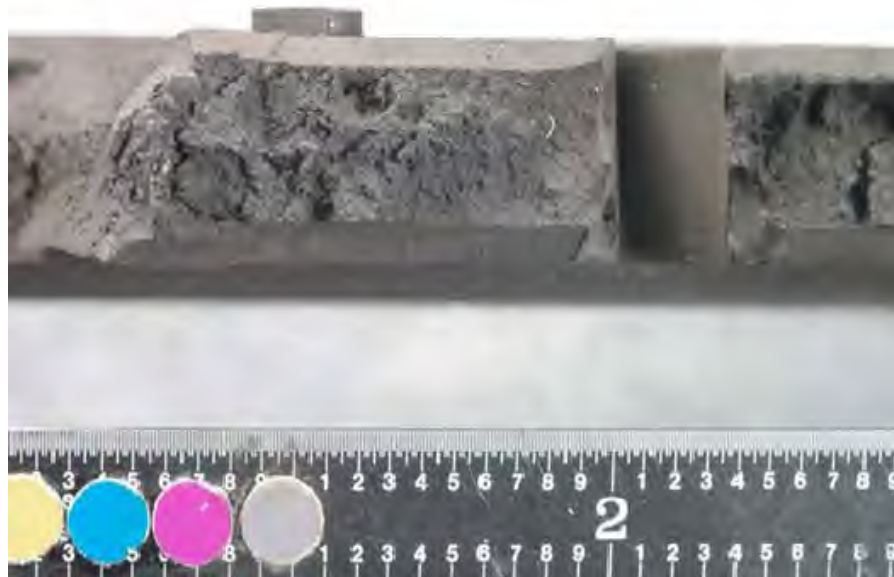
Fig. 149. Close-up of SID 14875 subsegment "B4" fracture surface shown in Fig. 148.

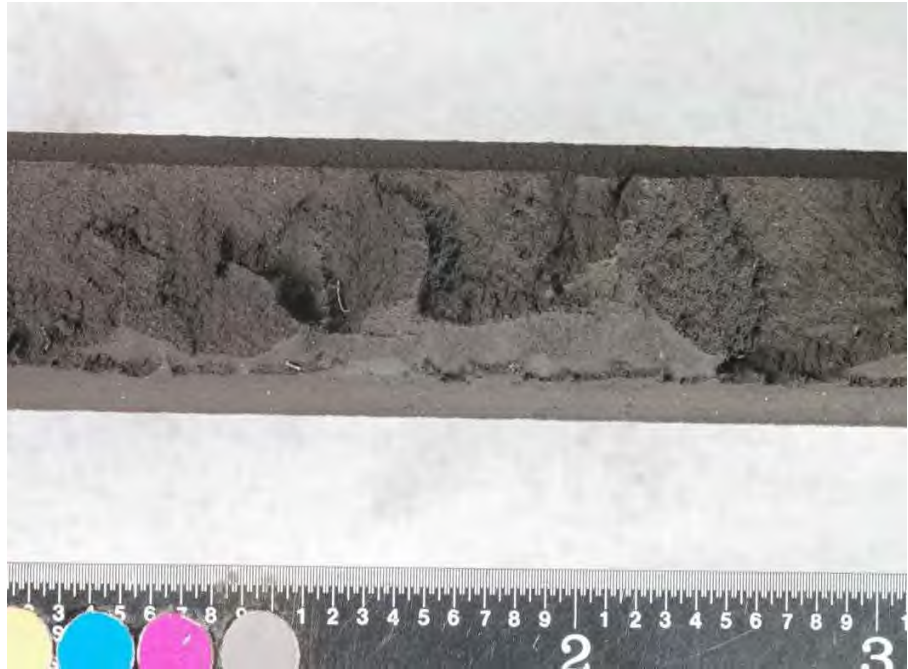
Fig. 152. Close-up of SID 14875 subsegment "B5" fracture surface shown in Fig. 150.

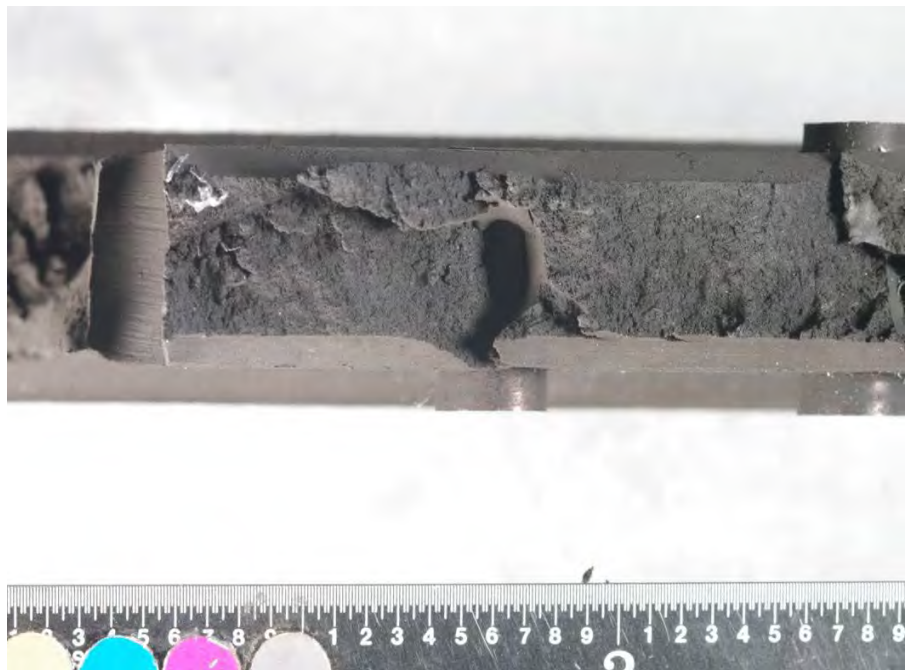
Fig 153 Close-up of SID 14875 subsegment "B5" fracture surface shown in Fig. 151.

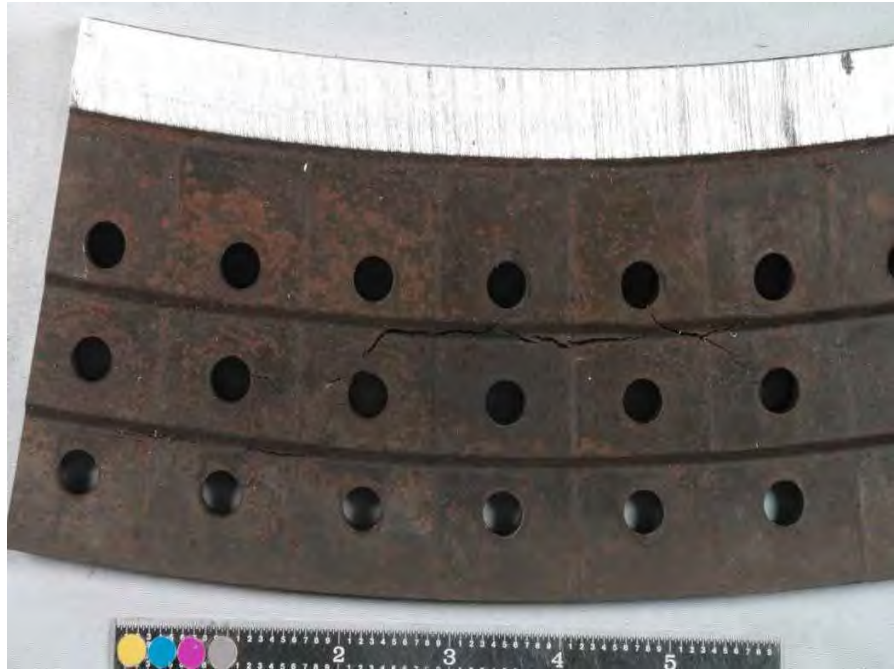
Fig 156 Close-up of SID 14875 subsegment "C4"finger pinned blade attachment shown in Fig. 155, viewed from inlet side.

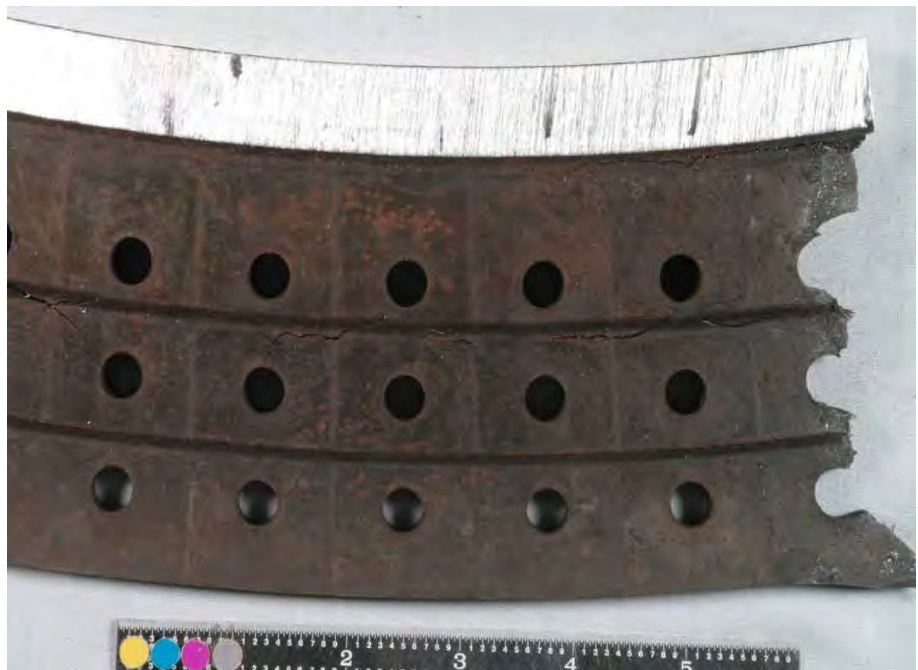
Fig. 157 Close-up of SID 14875 subsegment "C4" finger pinned blade attachment shown in Fig. 155, viewed from inlet side.

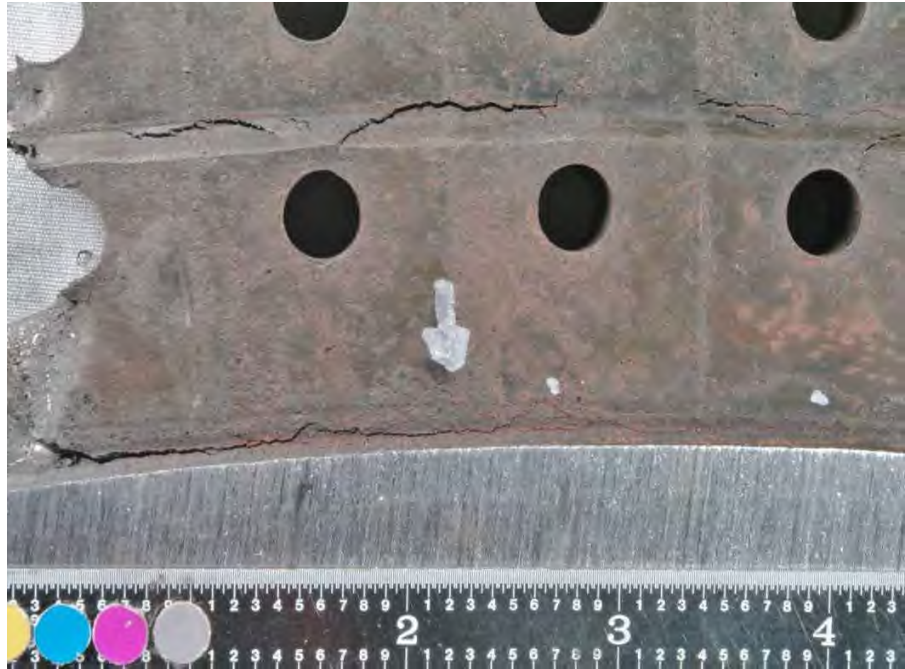
Fig 158. Close-up of SID 14875 subsegment "C4" crack 1 identified in Fig. 155, viewed from inlet side.

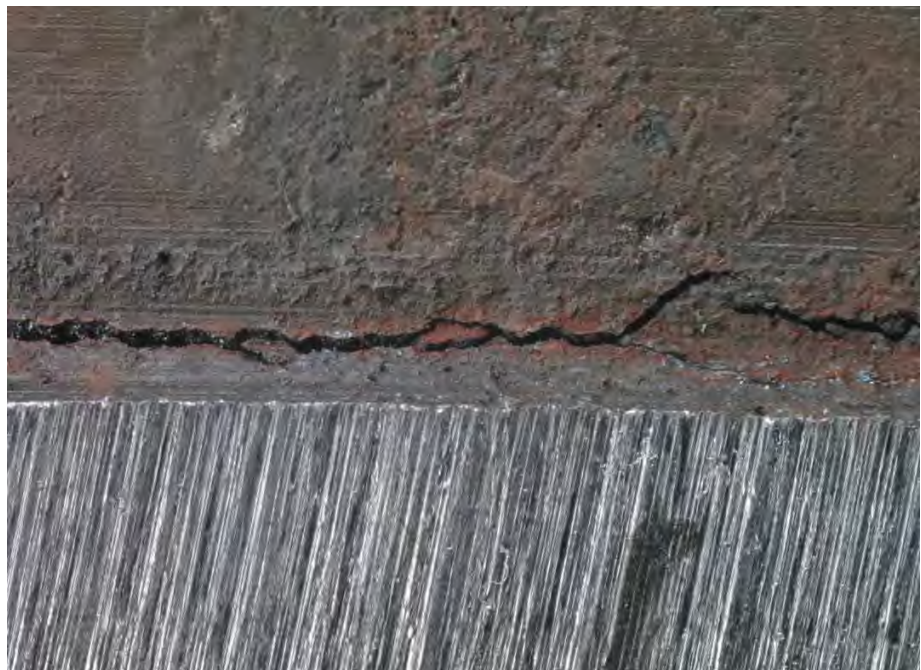
Fig 159. Close-up of SID 14875 subsegment "C4" crack No. 1 shown in Fig. 158, viewed from inlet side.

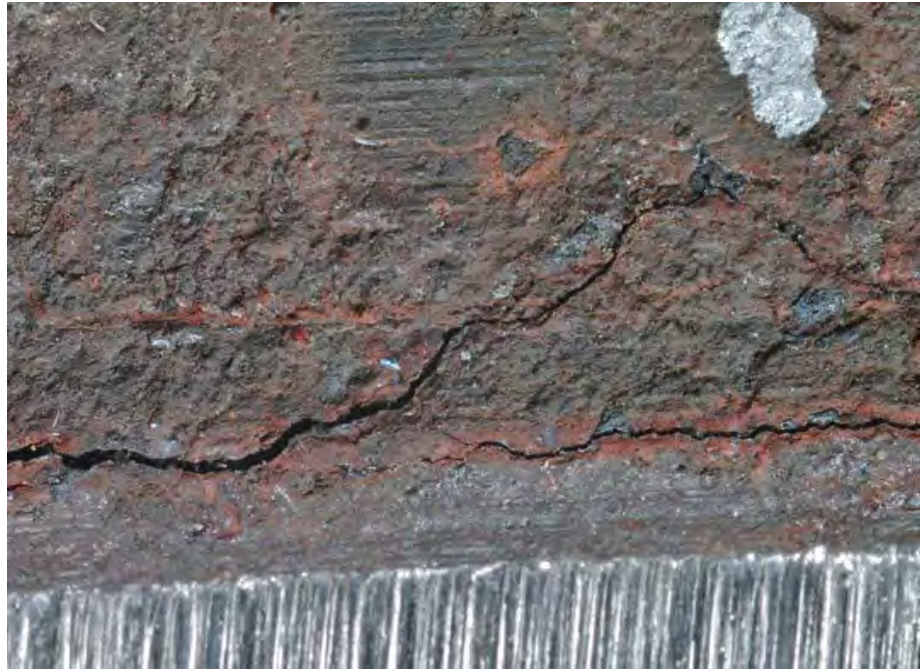
Fig 160. Close-up of SID 14875 subsegment "C4" crack No. 1 shown in Fig. 158, viewed from inlet side.

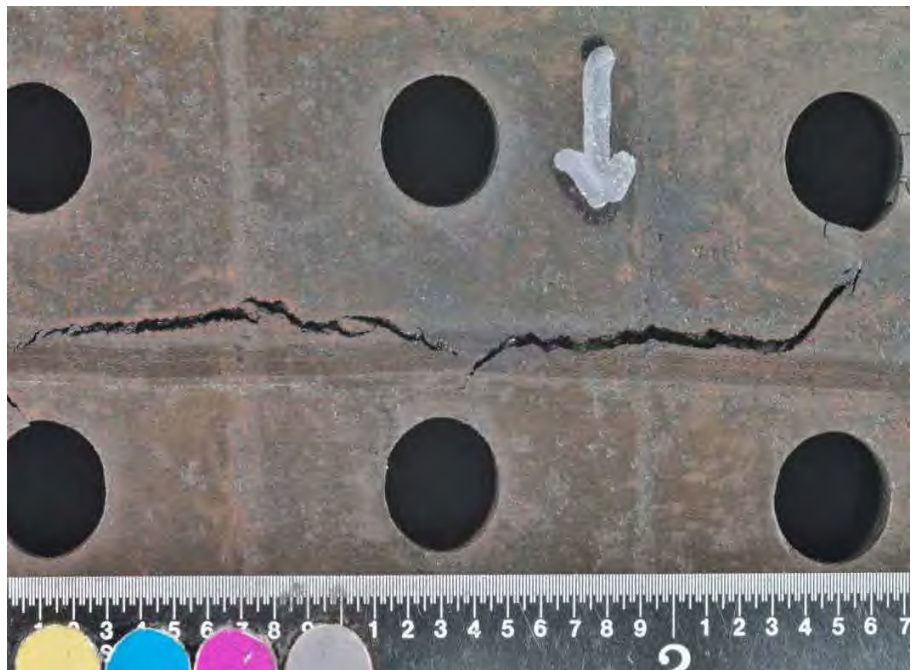
Fig 161. Close-up of SID 14875 subsegment "C4" crack No. 2 identified in Fig. 155, viewed from inlet side.

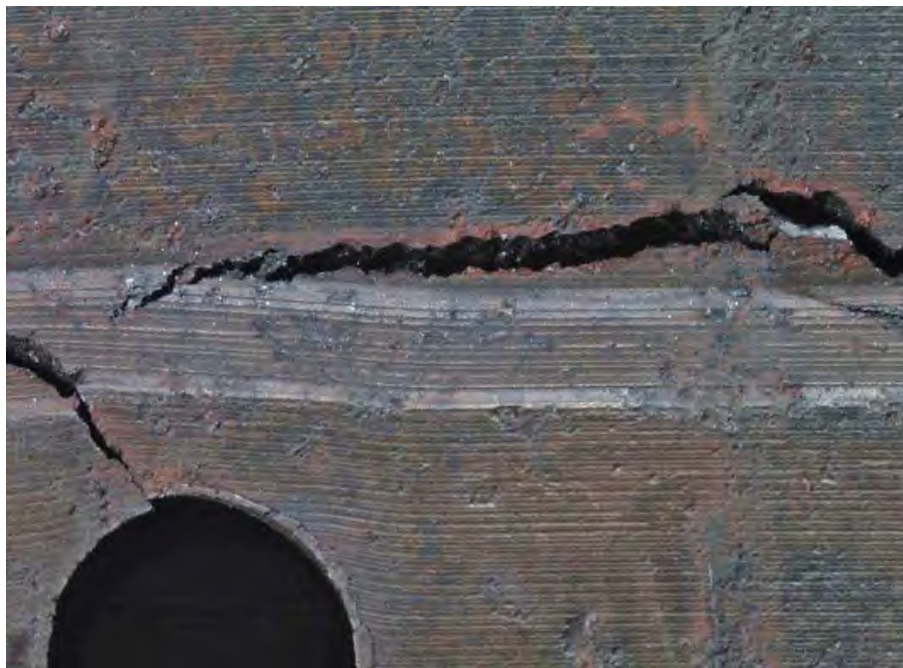
Fig 162. Close-up of SID 14875 subsegment "C4" crack No. 2 shown in Fig. 161, viewed from inlet side.

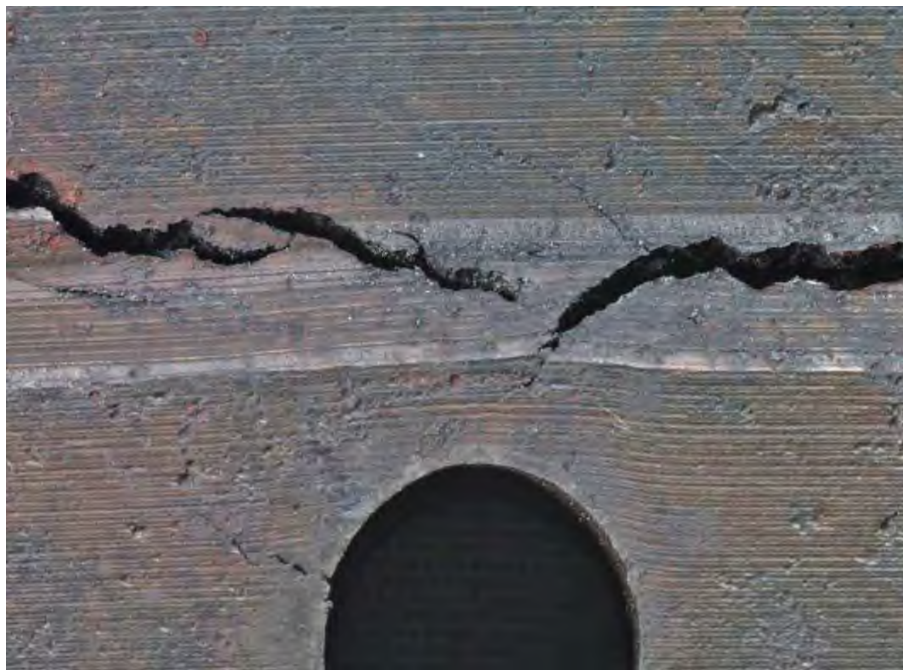
Fig 163. Close-up of SID 14875 subsegment "C4" crack No. 2 shown in Fig. 161, viewed from inlet side.

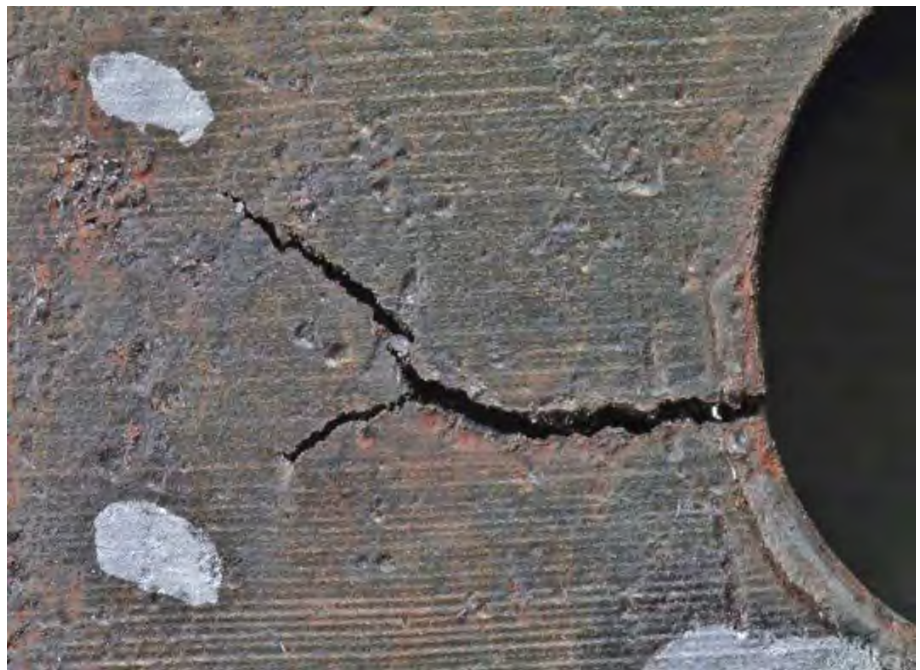
Fig 165. Close-up of SID 14875 subsegment "C4" crack No. 3 shown in Fig. 164, viewed from inlet side.

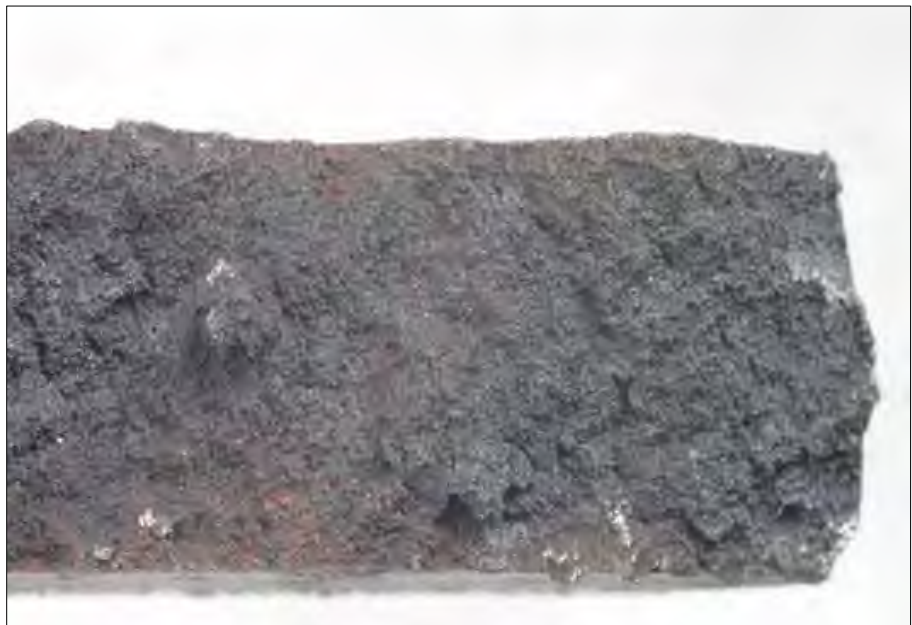
Subsegment "C" from SID 14875 was sectioned circumferentially between the finger pinned blade attachments and each finger was identified as "C1-C6" as shown in Fig. 154. No finger pinned blade attachments were fractured however, all internal fingers exhibited circumferential/radial cracks. The cracks occurred along both the inlet and outlet sides of the finger pinned blade attachments in the ledges at changes in section thickness as well as emanating from the 9:00 and 3:00 locations around the pin holes in the finger pinned blade attachments. Three representative cracks were selected for further examination as shown in Fig. 155. Close-up photographs of the three selected cracks are shown in Figs. 156 to 165. It was noted that shallow circumferential machining grooves were present on all the side faces of the finger pinned blade attachments. In some cases cracks progressed from and along the machining grooves while at other locations they did not. These machining grooves are shown in Figs. 159, 162-163 and 165. The three representative cracks were fractured open revealing coarse textured fracture morphology similar to that observed on the previously detailed fractured finger pinned blade attachments. The fractured open crack surfaces are shown in Figs. 166 to 172.

Fig 167. Close-up of surface of fracture through crack No. 1 from SID 14875 subsegment "C4" shown in Fig. 166.

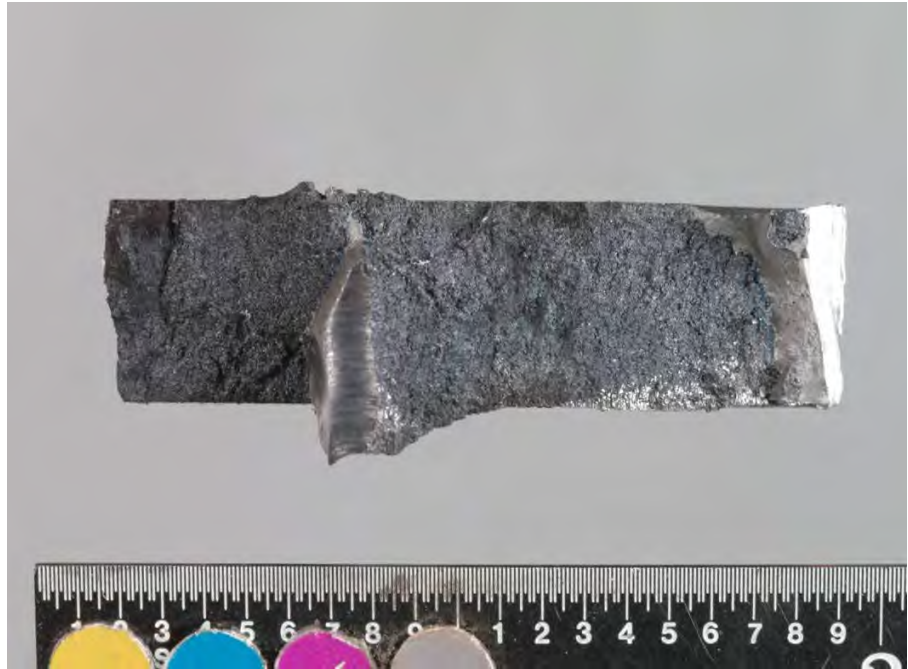
Fig. 168. Close-up of surface of fracture through crack No. 2 from SID 14875 subsegment "C4".

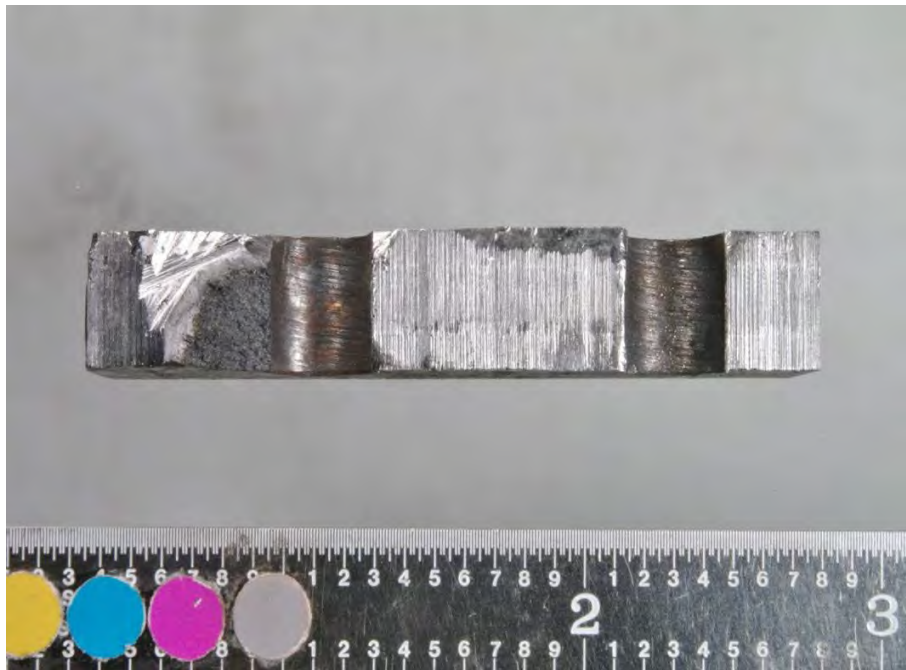
Fig 171. Close-up of surface of fracture through crack No. 3 from SID 14875 subsegment "C4".

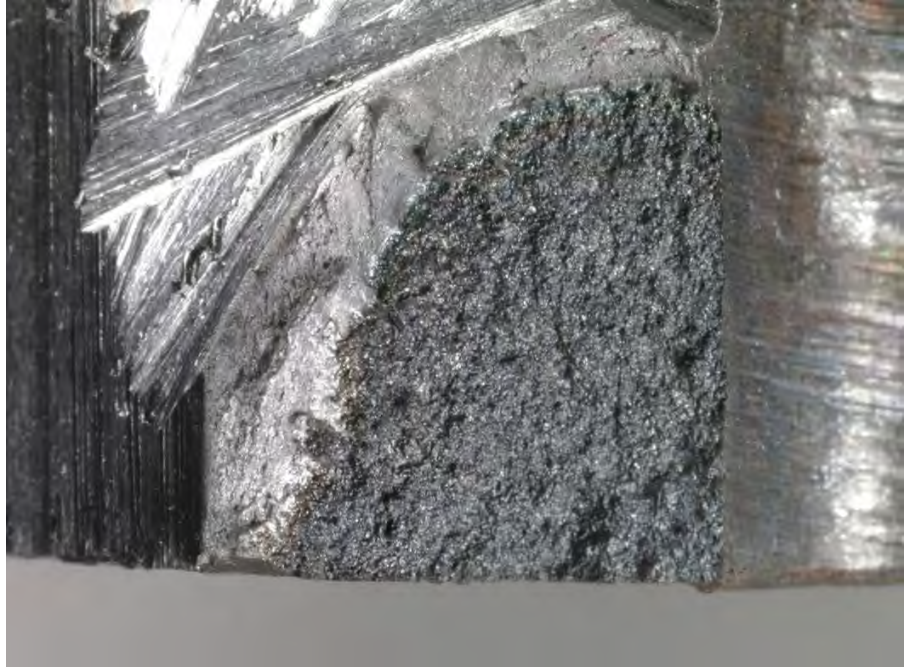
Fig 172. Close-up of surface of fracture through crack No. 3 from SID 14875 subsegment "C4" shown in Fig. 171.
