I. INTRODUCTION

A. My Rebuttal Testimony responds to the testimony filed by Mr. Richard Polich, of GDS Associates, Inc., on behalf of the Minnesota Department of Commerce (Department). In particular, I respond to Mr. Polich’s claim that Xcel Energy did not follow “good utility practice” at Sherco Unit 3.

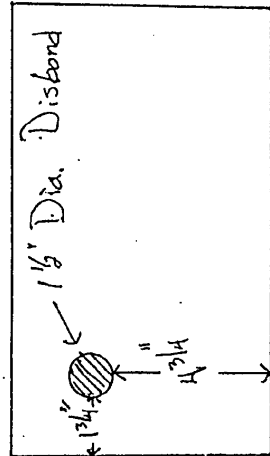
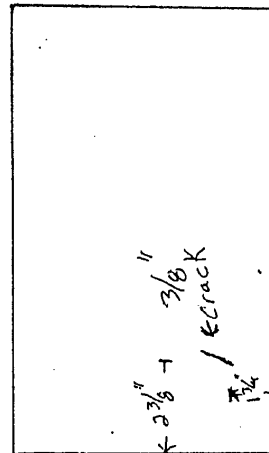
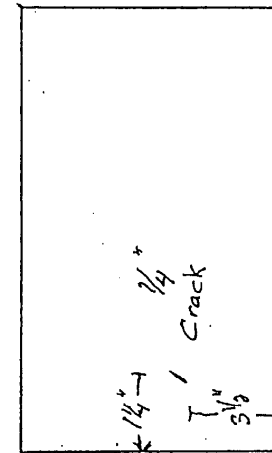
#1 Bearing Pads (Lower)

Description or Area	WLD	MIL	PIV	PUW	Damage	Location/Comments
Thrust Bearings	X		X	X		Light sporadic disbond around edges of bearings, light pitting.
#1 Bearing	X		X	X		Upper half bearing has randomly isolated 1/8" diameter areas of disbond #4 pad one area and #5 pad twelve areas.
"	X		X	X		Lower half bearing has light sporadic disbond around edges of bearing Pad #6L has a 1.5" diameter area of disbond and pads 7 and 6R have Cracks in babbit, see attached sketch for locations.

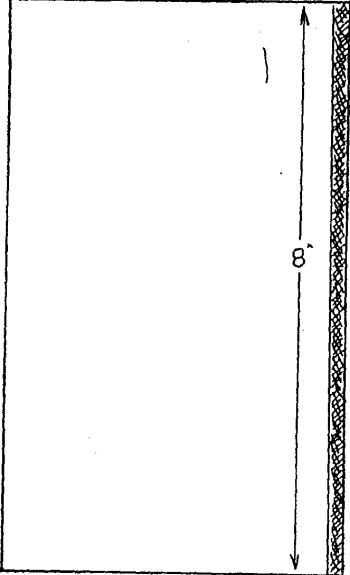
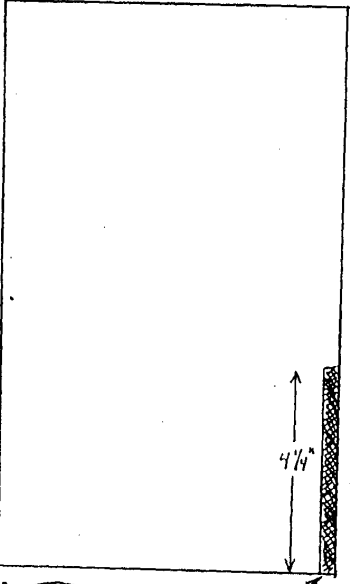
4 LOWER

Description/Location	MD	MT	ED	DD	Damage	Location/Comments
#4 Bearing	X		X	X		Upper half bearing #3 & #5 pad have light sporadic disbond around Edges, light pitting on governor end of the #5 pad.
"	X		X	X		Lower half bearing #6L & #7 have disbond on the governor end See attached sketch.
