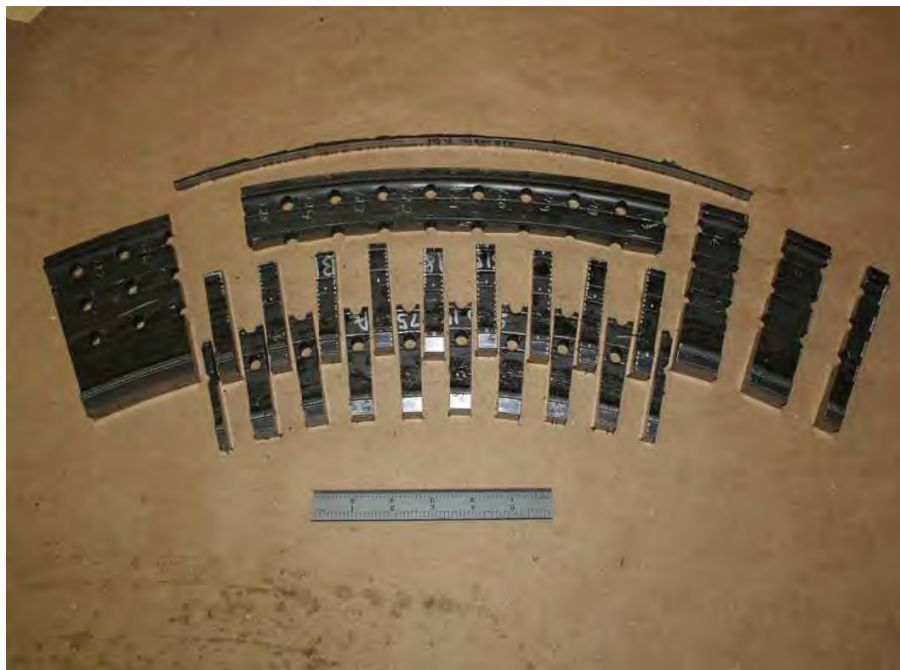
Fig. 227. Mechanical test coupons removed from SID 14875 subsegment "B1".

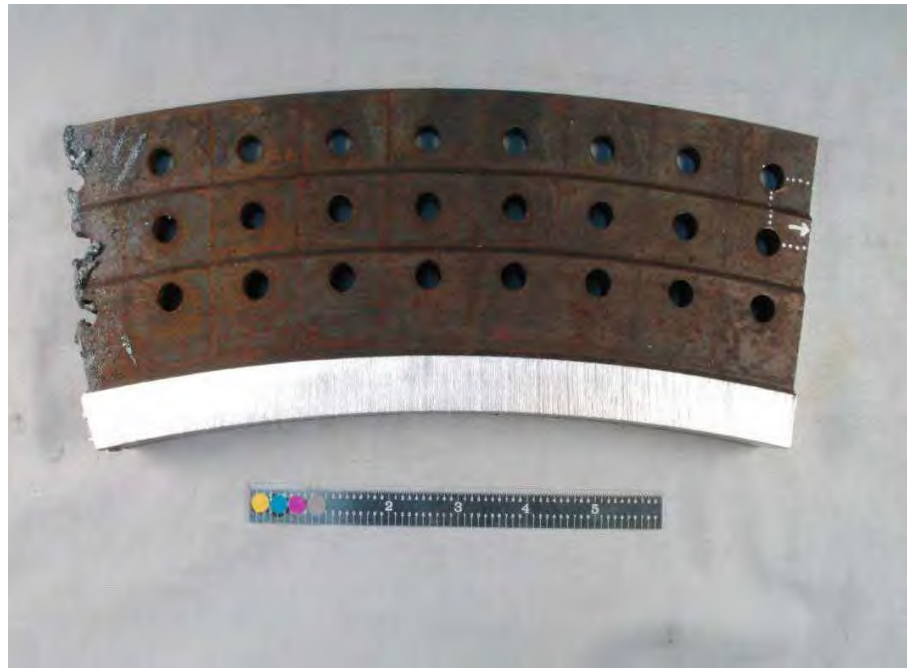
Fig. 228. SID 18475 "D2" finger pinned blade attachment showing location of met sample L349101. Arrow indicates mounting direction.

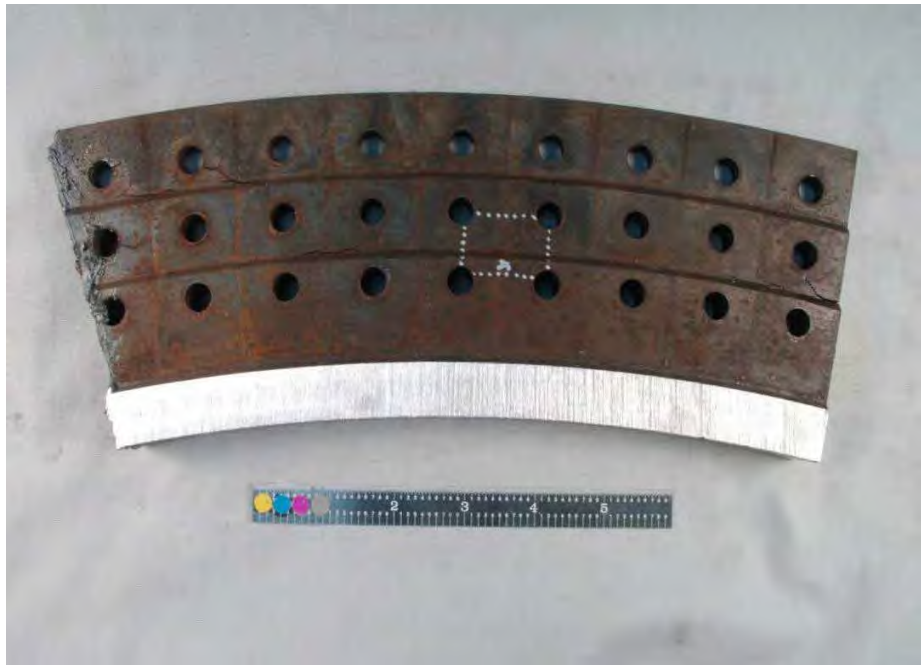
Fig. 241. SID 18475 "D3" finger pinned blade attachment showing location of met Sample L349102.

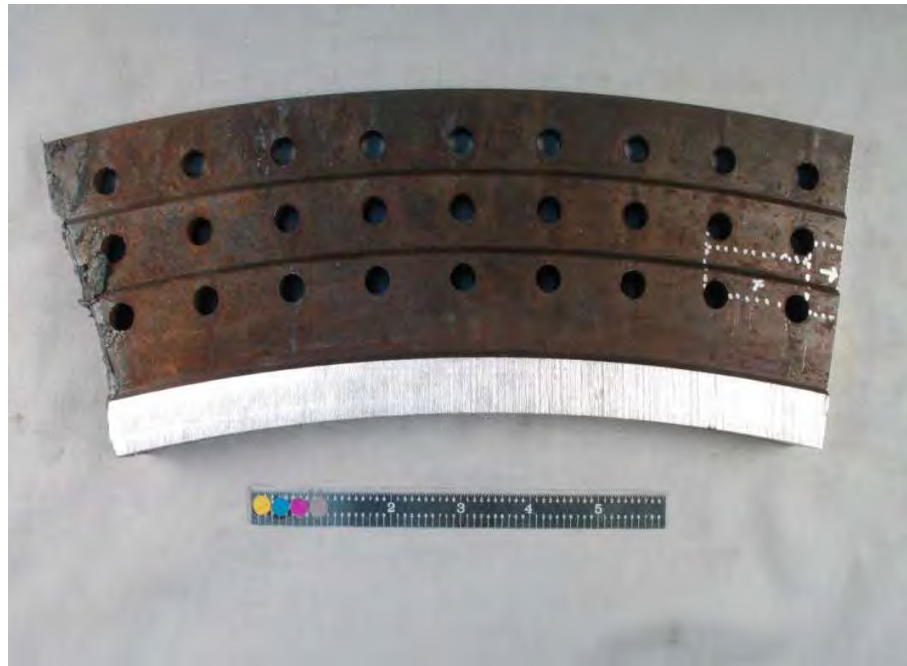
Fig. 248. SID 18475 "D5" finger pinned blade attachment showing location of met Samples L349103 and L349104.

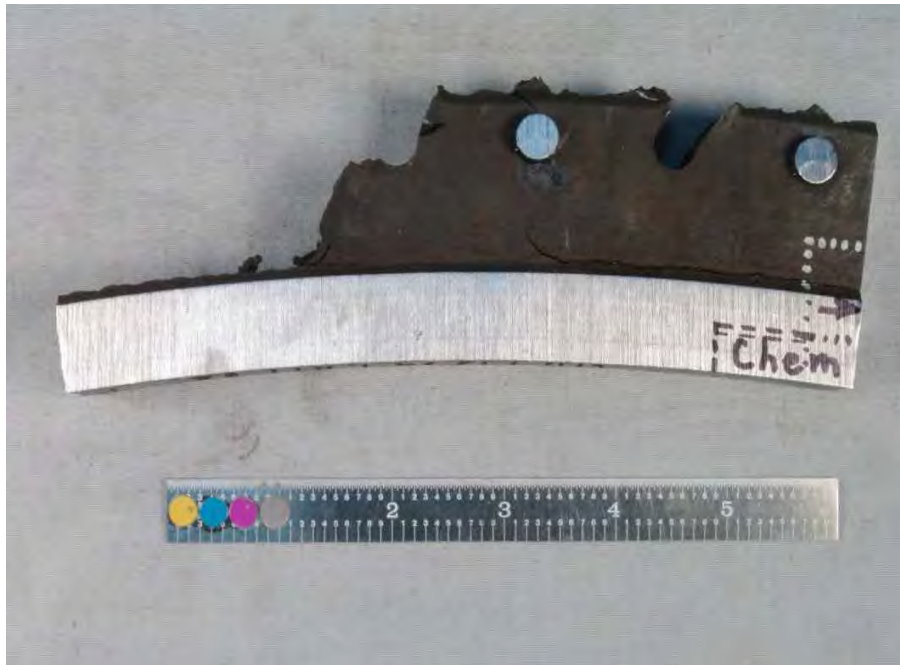
Fig. 267. SID 18474 "A4" finger pinned blade attachment showing location of met Sample L349106.

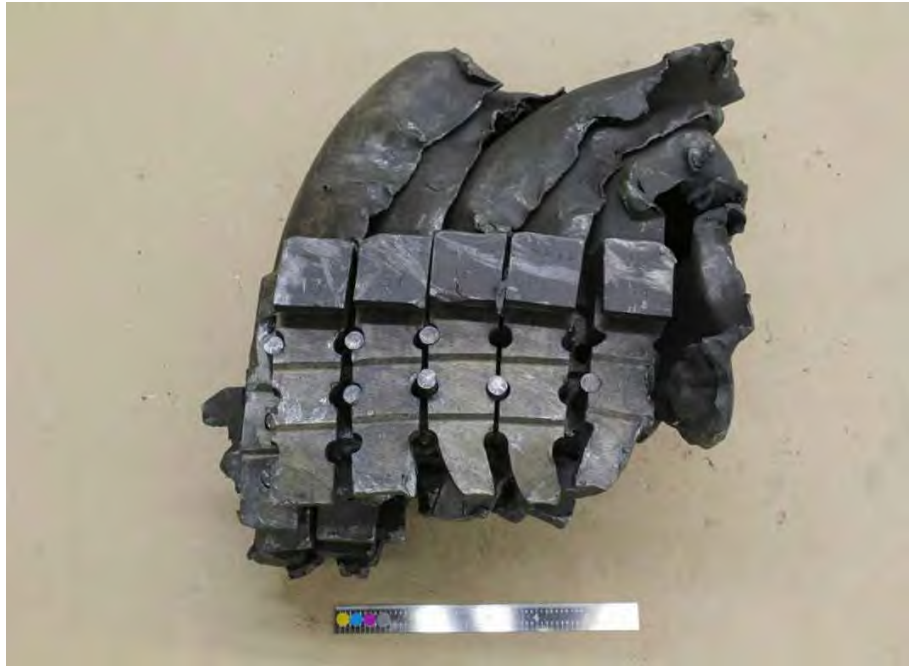
Fig. 274 . Photograph of low pressure turbine "B" turbine end L-1 blades recovered at the plant site and received for forensic examination.

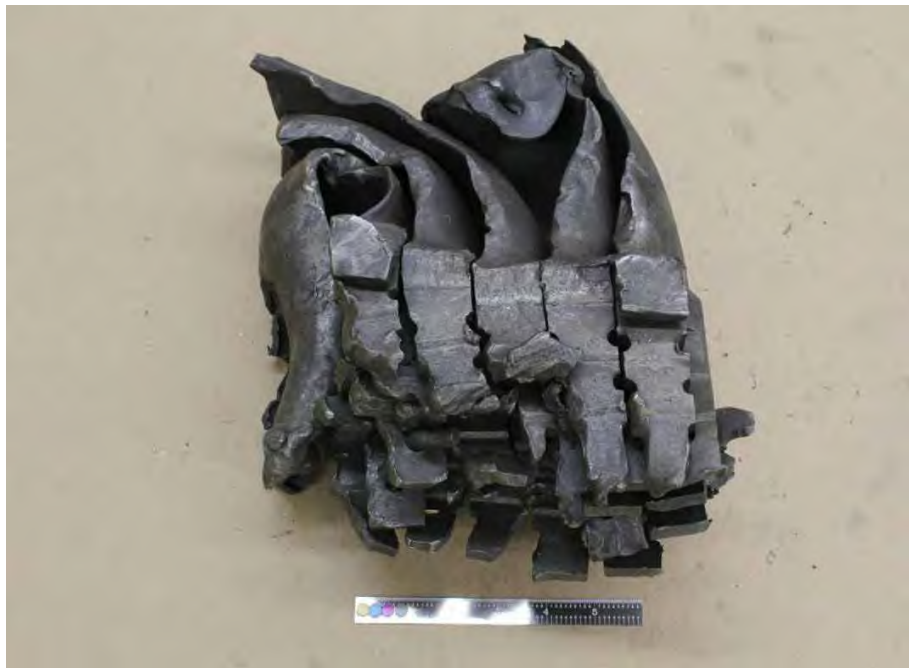
Fig. 275. Photograph of low pressure turbine "B" turbine end L-1 blades recovered at the plant site and received for forensic examination.

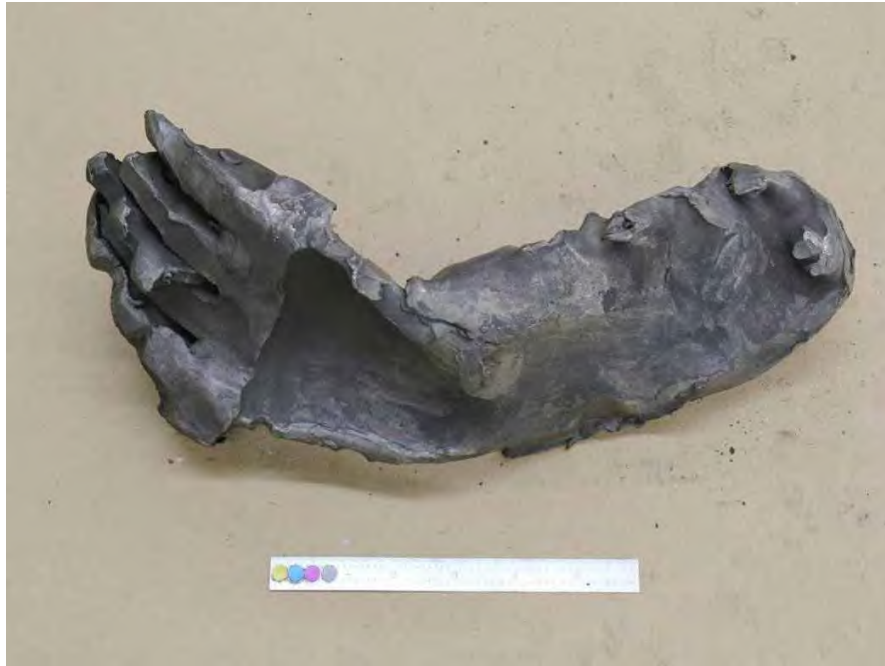
Fig. 276. Photograph of low pressure turbine "B" turbine end L-1 blade recovered at the plant site and received for forensic examination.

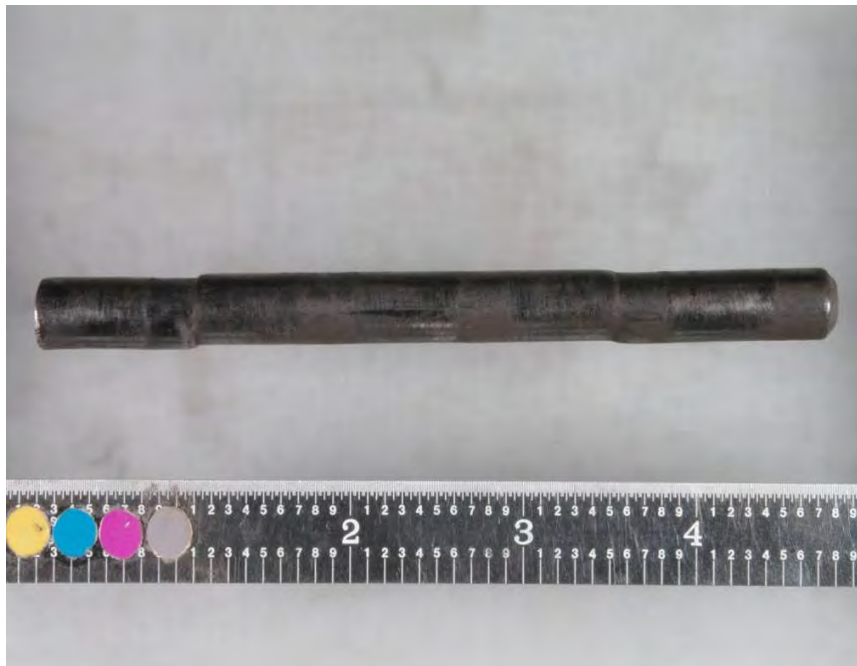
Fig. 295. Photograph of blade pin SID 14936 Pc "B" showing extent of yielding.

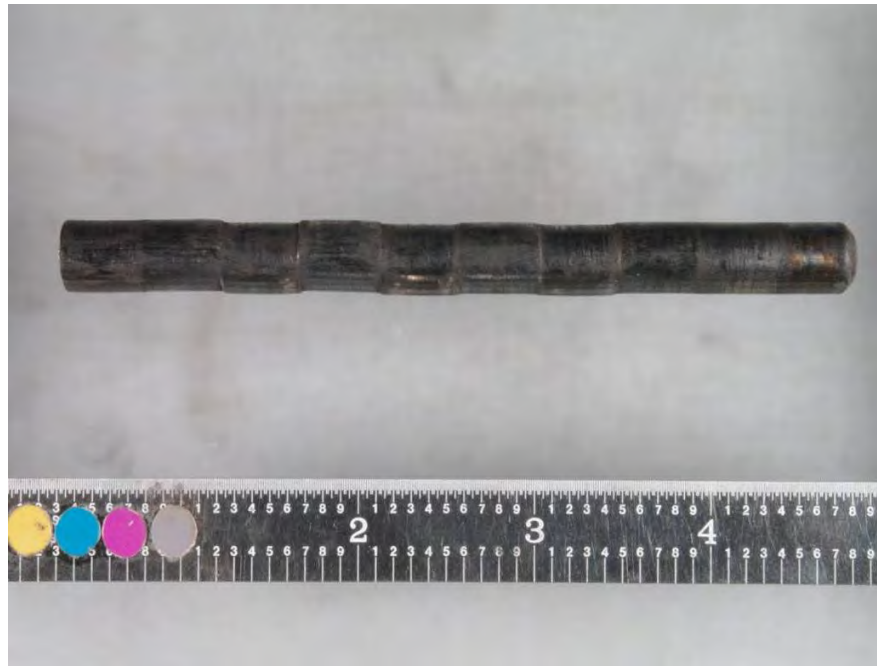
Fig. 296. Photograph of blade pin SID 14936 Pc "C" showing extent of yielding.

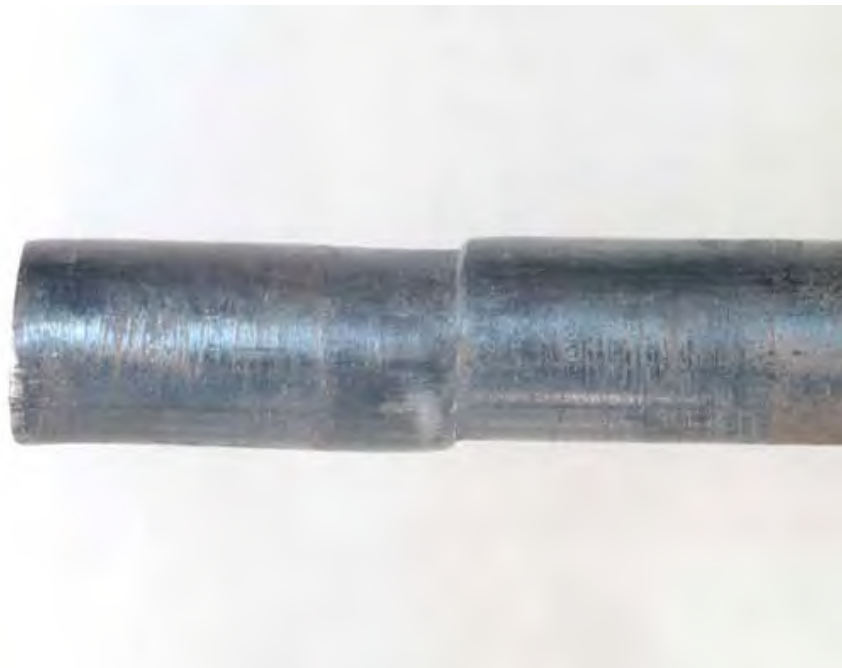
Fig 297. Photograph of blade pin SID 14936 Pc "B" showing extent of yielding.

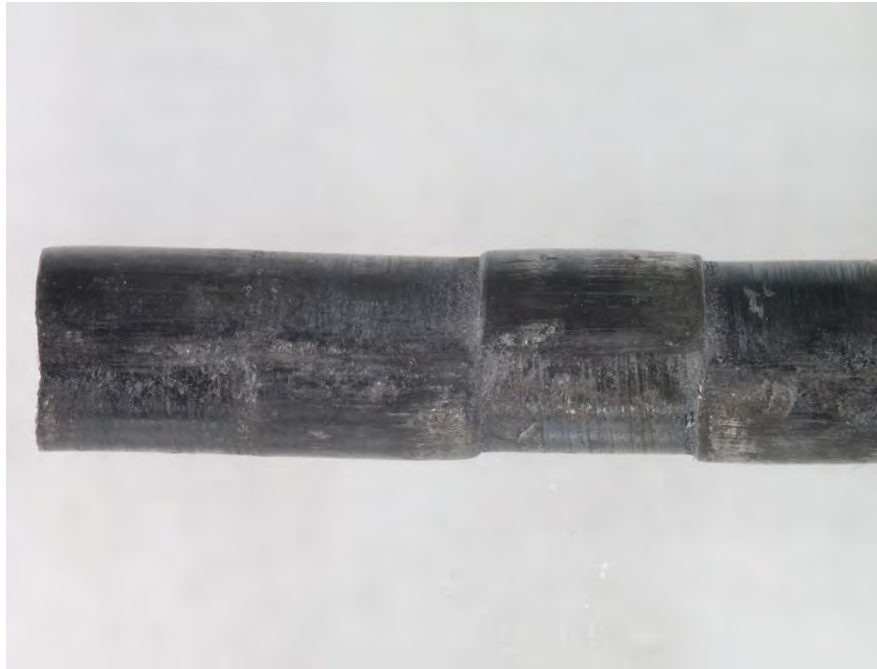
Fig. 298. Photograph of blade pin SID 14936 Pc "C" showing extent of yielding.

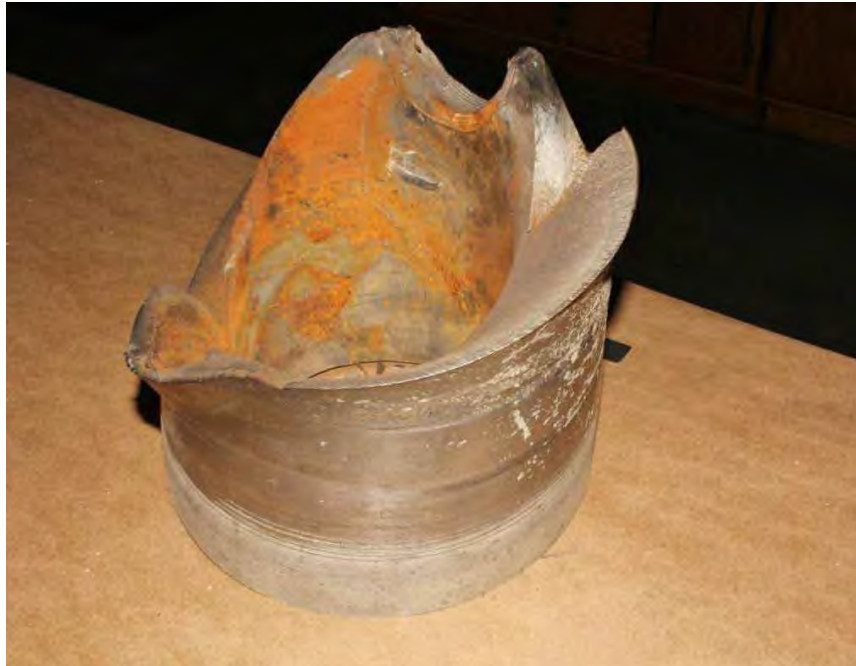
Fig. 311. Forward half of generator shaft fracture with leads removed.

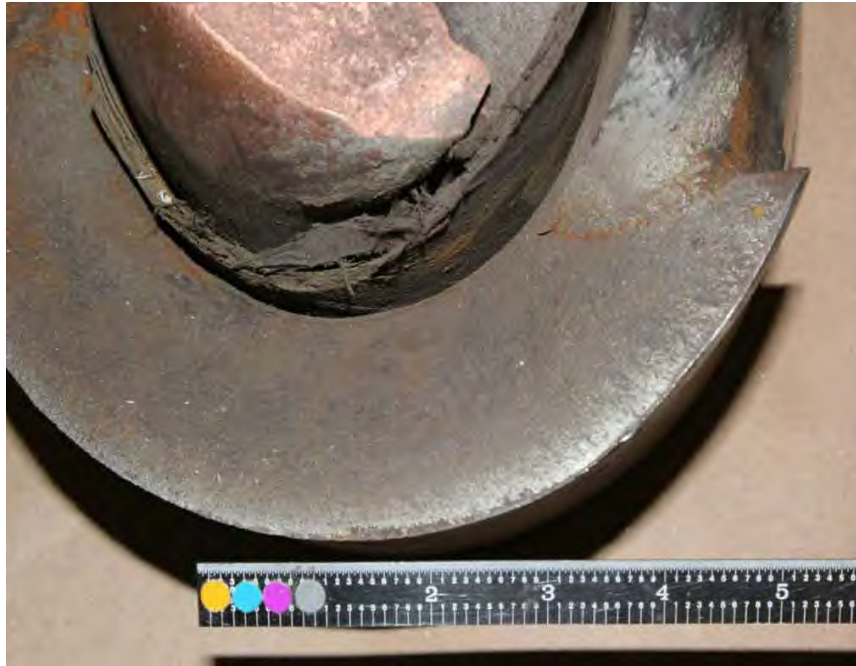
Fig. 317. Close-up photograph of fracture surface of generator shaft forward end fracture half with leads intact.
