RE: RIVERSIDE ROOT CAUSE ANALYSIS REPORT

Root Cause Investigation Report

Riverside Generating Station - Unit 7

REPORT NO. 2551958.401 Metallurgical Analysis of Failed Retaining Ring Riverside Generating Station - Unit 7

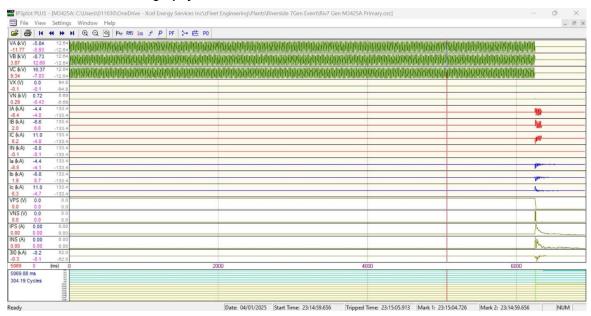
The Unit 7 turbine and generator operational data was retrieved from the unit data historian and reviewed for indications of any conditions that could have contributed to or indicated an imminent failure. The data revealed no condition that could have contributed to the retaining ring failure or gave indication of any operating conditions that indicated a potential failure. Additionally, all observed operating data indicated that the control and protection systems associated with the generator operated and responded as designed and expected, as shown below in the Unit 7 Generator Oscillography Record and Generator Differential Oscillography Record.

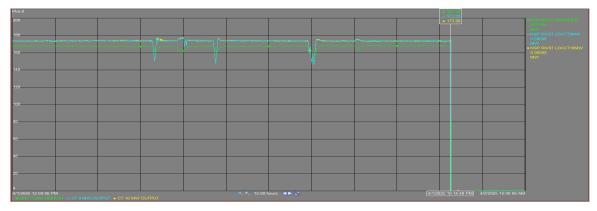
Unit Load Historical Data

At the time of the retaining ring failure, Unit 7 was running at full load and had been for a few days. The time of the trip was approximately 11:14:48 pm on 4/1/2025 Central Time. Note the image below shows 10:14:48 pm because the data server is in Colorado, logging as Mountain time.

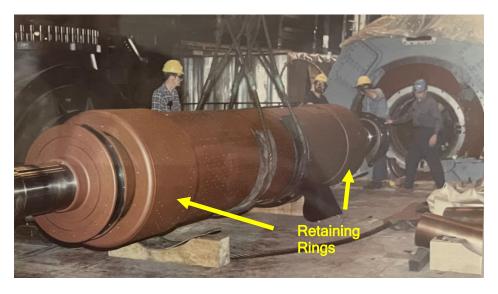
Image of the Original Installation of the Generator Rotor (Xcel Image)

The Westinghouse steam turbine and generator were reportedly constructed in the mid-1980's, with delivery to the Riverside site in approximately 1986. The steam turbine components were fabricated at Mitsubishi (Japan) under a subcontract from Westinghouse, and the generator components were delivered from a Westinghouse plant in Pennsylvania. The nominal capacity of the generator was originally reported as 150 MW. A view of the original installation of the generator rotor (in approximately 1986) is provided below:

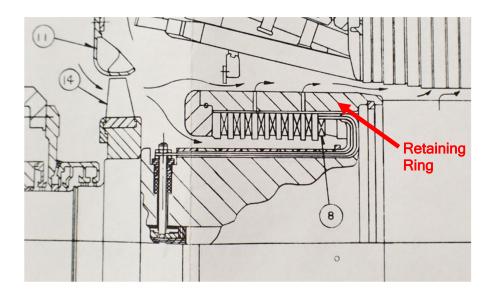
Image of a Generator Rotor Schematic Drawing in Instruction Book 2-1-192

An image of a schematic drawing showing the retaining ring at the collector end of the generator is provided below (taken from Instruction Book 2-1-192 at the Riverside plant site). Although a schematic of the turbine end retaining ring was not included in the book, the ring geometry is presumed to be similar to that shown for the collector end. The rings were reportedly manufactured from martensitic (magnetic) steel, consistent with ASTM A288 (Standard Specification for Carbon and Alloy Steel Forgings for Magnetic Retaining Rings for Turbine Generators). Specified dimensions of the retaining rings were reportedly unavailable, but measurements taken on the failed ring indicated the following approximate dimensions: 132 inch OD x 27-1/4 inch width x 2-5/8 inch thickness.

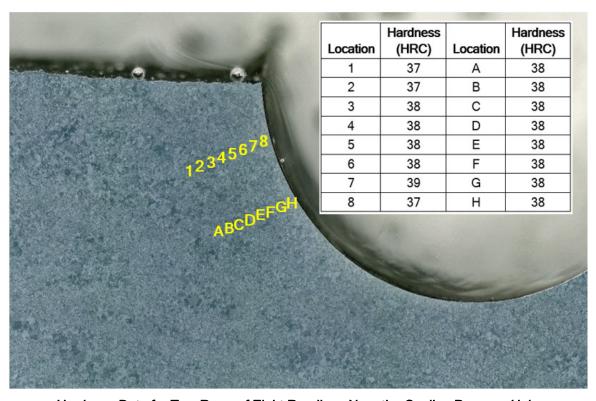
Hardness Data for Two Rows of Eight Readings Near the Cooling Passage Hole

The metallographic cross section through the cooling passage was used to perform microhardness testing at locations near the drilled hole. For this testing, an automated LECO hardness tester was used, with readings taken in a Vickers scale (HV, 500g load) and converted to Rockwell C. The measured values are shown in the images below for the locations where each test was performed; two rows of eight readings were taken along lines extending inward from the surface of the cooling passage, and one row of five readings was taken at a location closer to the fracture surface. The hardness readings were all between 37 and 39 Rockwell C, with no indications of variations near the cooling passage surface.

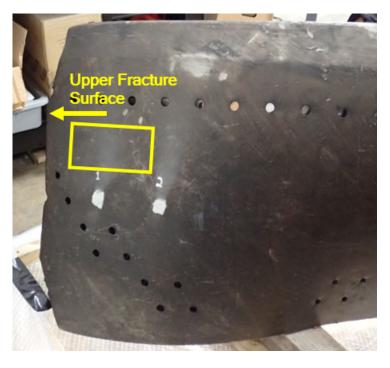
Image Showing Approximate Material Section Used for Material Property Assessment

A section of the retaining ring situated near the crack origin area at the upper fracture surface was submitted for chemical composition analysis and mechanical testing of the retaining ring material; this region is indicated by the rectangular box in the image below. Tensile and Charpy impact test samples were oriented circumferentially on the retaining ring (parallel to the long axis of the marked rectangular area). For reference, and noting that a material specification for the Riverside retaining rings was not available, mechanical properties are listed in Table 1 for ASTM A288, Standard Specification for Carbon and Alloy Steel Forgings for Magnetic Retaining Rings for Turbine Generators (data taken from the 1991 Edition, reapproved in 2013).

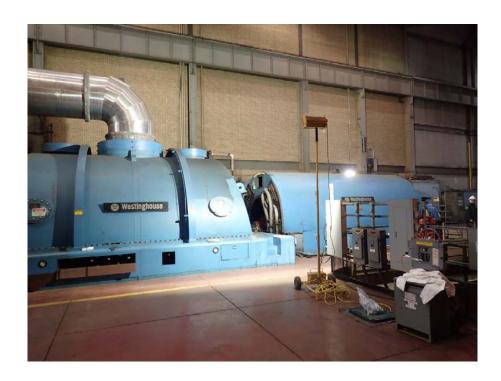
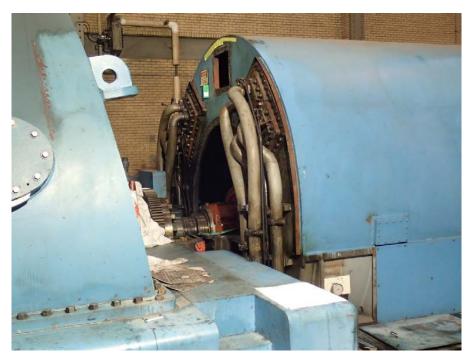
Figure 2. Northwest views of the generator and the damaged end of the generator (lower image) adjacent to the steam turbine. Some components have been removed to permit visual examination of the interior of the generator.

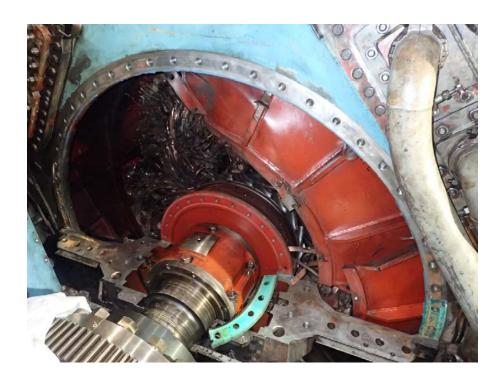
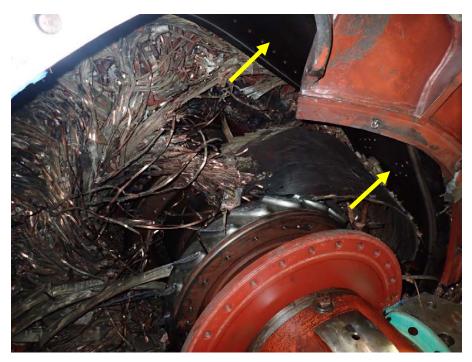
At the time of SI's initial site visit, the enclosure at the south end of the generator had been removed to permit direct visual examination of damage to the rotor, stator, and surrounding structural elements (Figures 5 through 9). Visible damage included deformed components, destroyed windings, numerous broken cooling fan blades, and a broken retaining ring, which had expanded outward as a result of the failure event. One of the retaining ring fracture surfaces was visible in the upper part of the generator (Figure 6, upper image). The mating fracture surface was situated in the lower part of the generator, and was partially blocked by debris (Figure 8, upper image). For discussion purposes, these fractures will be referred to as the upper and lower fractures, respectively, throughout this report. Some fractures on the cooling fan blades were also visible, with blade root sections still attached to the rotor (Figure 9).

Figure 5. Views of the south (turbine) end of the generator showing damage that occurred during the failure event. Note that some outer components have been removed to permit visual examination of the interior of the generator. The ID surface of the retaining ring is indicated by the arrows in the lower image.

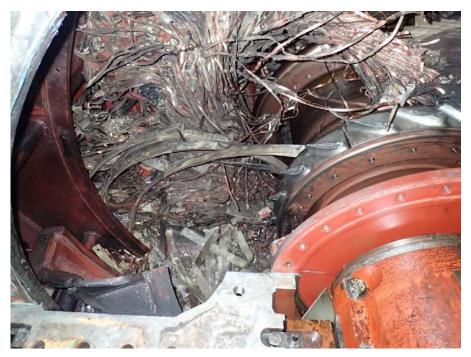
Figure 6. Additional views of the south end of the generator. The upper image shows one of the fractures on the retaining ring (arrow), and the lower image shows damaged windings, broken blades on the hydrogen cooling fan, and other damaged and displaced components.

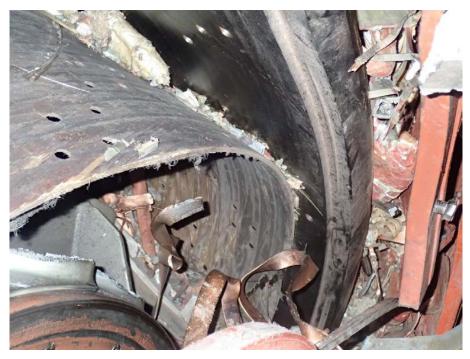
Figure 7. Closer views of the ID surface and outboard (south) edge of the retaining ring.

These images also show portions of the fiberglass liner that was situated just on the inside of the retaining ring prior to the failure event.

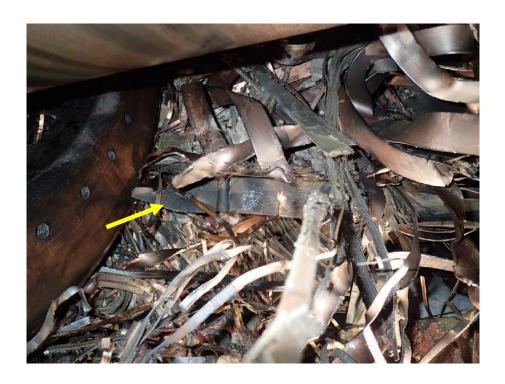
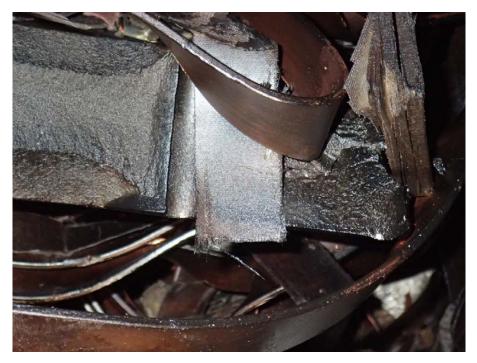
Figure 8. Views of the fracture surface at the lower end of the retaining ring (situated beneath the rotor) (arrow). The lower image is a view of the outboard side of the lower fracture. Debris was blocking clear views of much of the lower fracture surface.

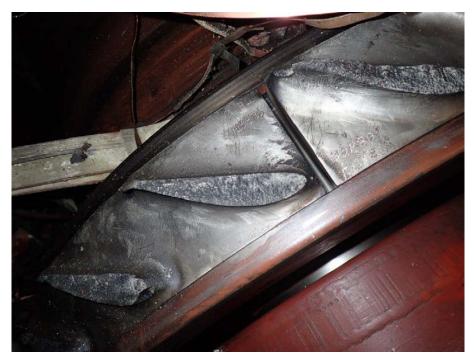
Figure 9. Views of representative blade roots on the hydrogen cooling fan adjacent to the retaining ring.

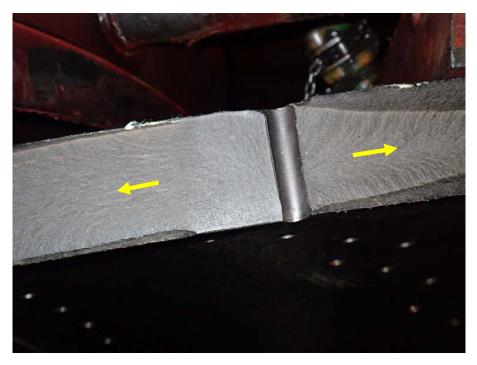
Closer examination of the upper fracture surface on the retaining ring revealed visible features (texture) that indicated the directions of crack propagation at various positions across the fracture (Figures 10 and 11). The fracture plane coincided with three cooling passages (holes) oriented radially through the ring, and the crack growth directions indicated propagation from the central cooling passage towards the outboard and inboard edges of the rings. As the cracks on either side of the central cooling passage reached the outer cooling passages, new cracks were initiated and continued outside of the outer cooling passages.

The observed texture and surrounding features on the upper fracture surface included Chevron markings, which are characteristic of fast crack propagation. At the edges of the regions containing Chevron markings, angled fracture regions were evident, consistent with ductile shear, mostly along the ring OD and ID surfaces (Figure 12). A flat region of fracture, which exhibited a finer surface texture that was different from other locations on the ring, extended

Figure 10. Views of the upper fracture surface on the retaining ring; the upper image is the inboard side of the fracture, and the lower image is the central part of the fracture. Both images include locations where the overall fracture path coincided with hydrogen cooling passages (radial holes) in the retaining ring. Chevron markings are visible on the fracture surfaces, indicating the crack growth directions (indicated by arrows).

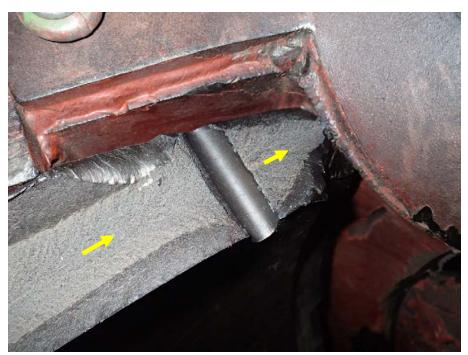
Figure 11. Views of the outboard side of the upper fracture surface on the retaining ring. Both images include a location where the overall fracture path coincided with a hydrogen cooling passage (radial hole) in the retaining ring. Chevron markings are visible on the fracture surfaces, indicating the crack growth directions (indicated by arrows).

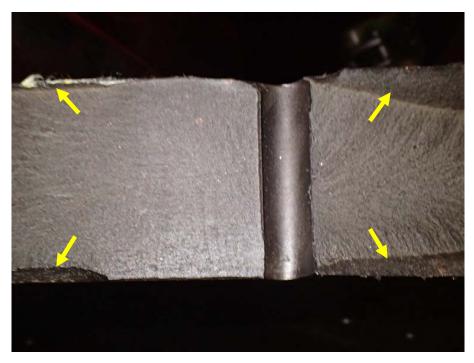
Figure 12. Closer views of the central part of the upper fracture surface on the retaining ring, including one of the cooling passage holes (upper arrow). The ring OD surface is facing up in each image. Note that shear lips are present at the ring OD and ID surfaces from the cooling hole towards the right, and at a distance of a couple of inches from the cooling hole and towards the left (lower arrows).

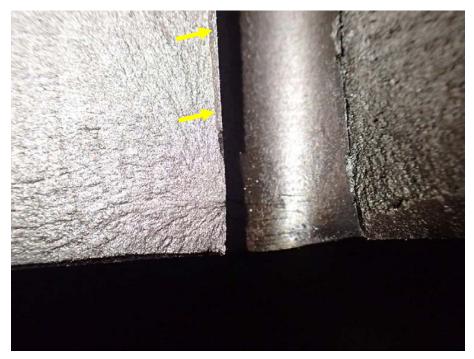
about two inches towards the inboard edge of the retaining from the central cooling passage. This area also had a very thin shear lip along the outer side of the cooling passage (Figure 13).

Figure 13. Closer views of the visible fracture surface texture close to the cooling passage hole shown in Figure 12. A thin shear lip is visible along most of the left edge of the hole (arrows).

Figure 70. Additional digital microscope images of the cleaned sample showing dark deposits near the retaining ring ID surface. These deposits were also visible on the retaining ring prior to removal from the generator (see lower image of Figure 13).

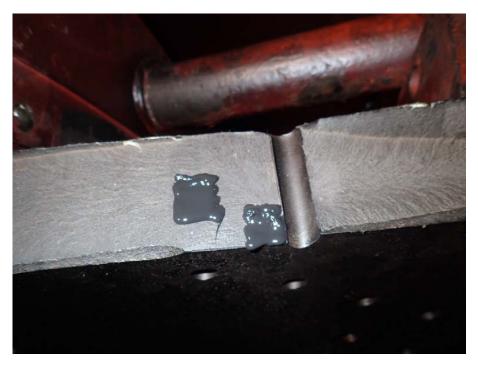
Due to uncertainty regarding the ease with which the retaining ring could be removed from the generator, and the potential for damage to occur to the fracture surfaces, fracture surface replications were taken on April 17, 2025, using RepliSet media (Figure 14). As the interior of the generator was considered to be a confined space, the replications were collected by an Xcel Riverside employee under the direction of SI, and preserved for possible future use.

Figure 20. Views of the upper fracture surface on the retaining ring during collection of fracture surface replications (using RepliSet media).

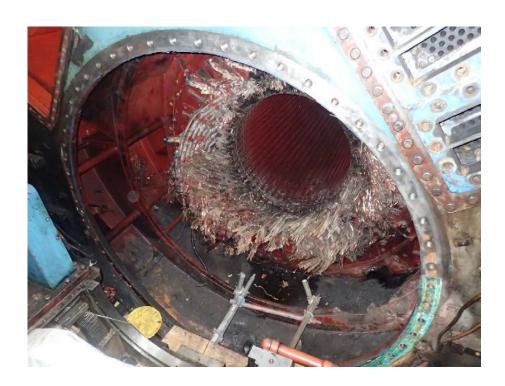
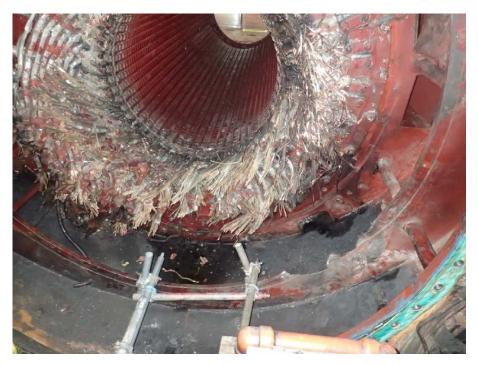
At the time of SI's return visit to the Riverside plant site on May 12th and 13th, the generator rotor had been removed from the machine, and much of the end winding debris had been cleaned up (Figure 15). The interior of the south end of the generator exhibited structural damage as a result of the retaining ring failure (Figure 16).

Figure 15. Views of the south (turbine) end of the generator after broken parts, windings, and debris have been cleared out of the machine. Note in the top right corner of the upper image that one of the hydrogen coolers is still in the generator; this cooler could not be removed due to mechanical damage from the failure event.

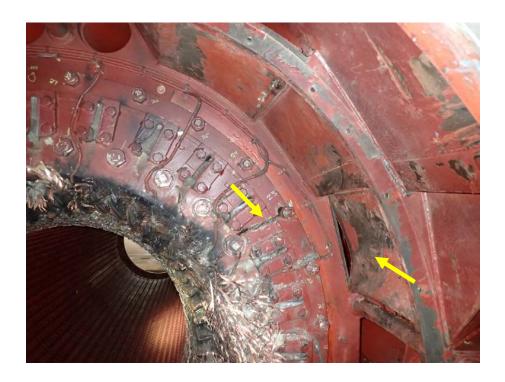
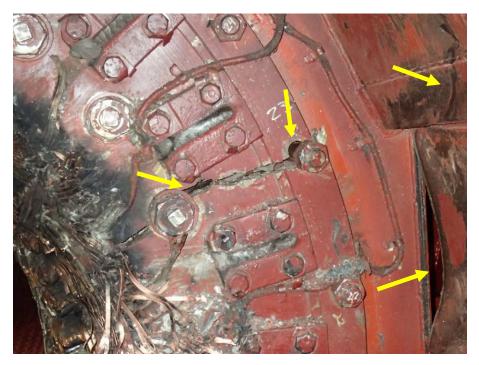
Figure 16. North views of the upper right area of the stator in the area of the failure. These images show cracks and deformed metal (arrows) that occurred as a result of the failure event.

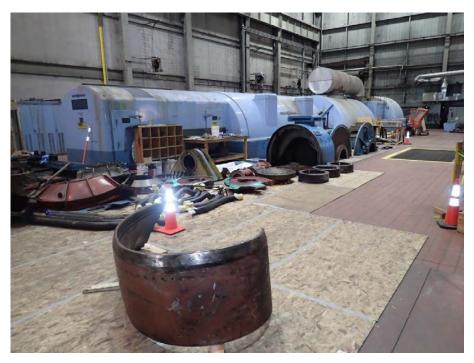
Figure 17. Views of the various components from the generator, temporarily stored on the turbine deck. The lower image also shows the failed retaining ring in the foreground.

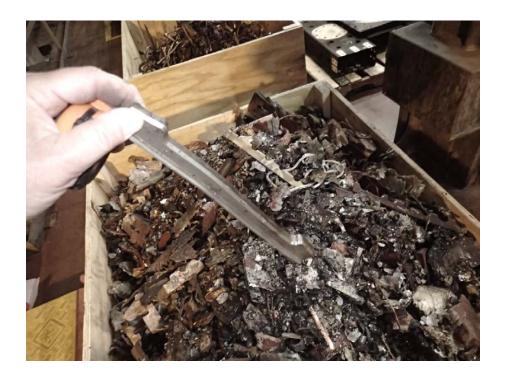
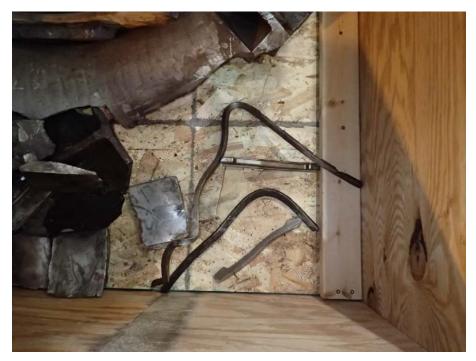
Components that had been removed from the generator, including the failed retaining ring, were observed to be stored at various locations around the turbine deck (Figure 17). In addition, multiple boxes containing winding pieces and other debris were stored on the turbine deck (Figures 18 and 19). The debris included several components that appeared to include a snap ring and keys that were associated with the retaining ring at the south end of the generator.

Figure 19. Views of some of the collected debris, which included a snap ring and keys that were associated with the retaining ring at the south end of the generator.

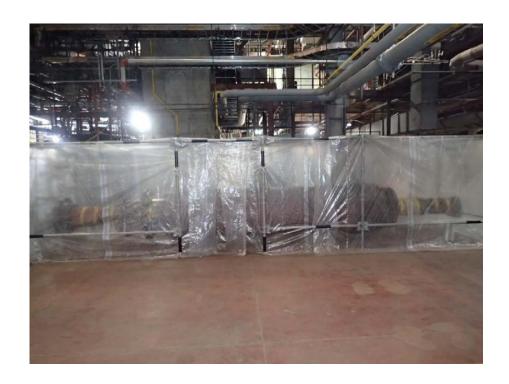
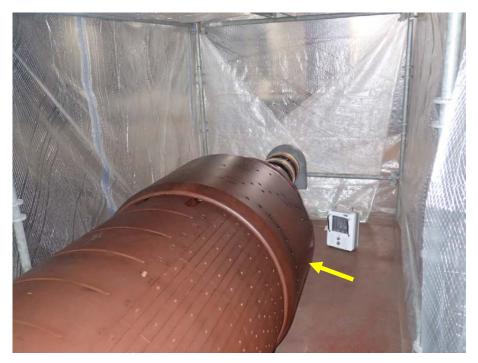
The generator rotor was stored in a tented enclosure on a level below the turbine deck (Figures 20 through 22). The enclosure had space heaters at each end to maintain a dry environment for storage. The intact retaining ring was still in place at the north end of the rotor (Figure 20, lower image). At the south end, the centering ring was temporarily blocked into its original position and held in place with tape. The cooling fan wheel was also still attached, along with the root regions of all of the blades (Figure 21, lower image). The fractures on these blade segments were visually examined and appeared to be the result of the overall failure event; no indications of pre-existing cracks were observed. Also, at the south end of the rotor, the end windings were missing from the area beneath the retaining ring location, and damage was visible in some locations around the rotor (in proximity to the snap ring slot that was beneath the inboard edge of the retaining ring) (Figure 23). This damage was consistent with the end windings losing support from the failed retaining ring. The original positions of the components at the south end of the rotor were represented by the undamaged north end (Figure 24).

Figure 20. Views of the stored generator rotor, which was tented to maintain a dry storage environment. The lower image shows the intact retaining ring (arrow) at the north (collector) end of the rotor.

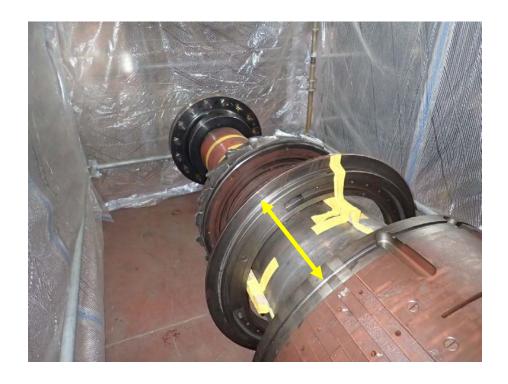
Figure 21. Views of the south end of the generator rotor. The arrow in the upper image indicates the approximate location where the retaining ring was attached, between the centering ring and the end of the rotor, and on the outside of the end windings. The arrow in the lower image shows the location of the hydrogen cooling fan.

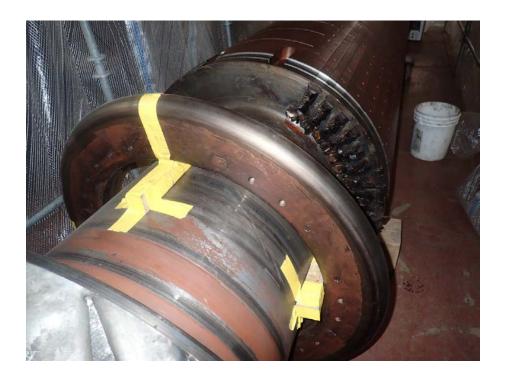
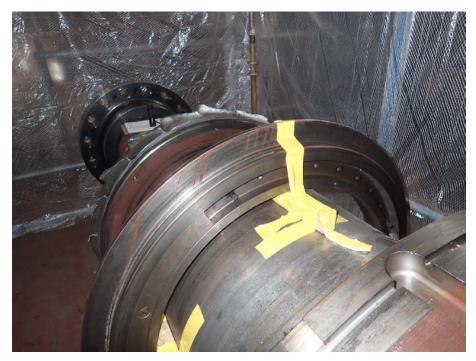
Figure 22. Closer views of the centering ring, which is temporarily supported by wooden blocks and tape.

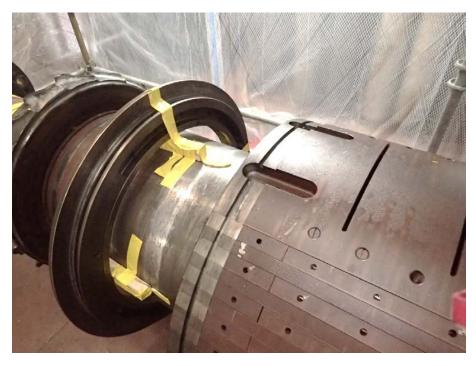
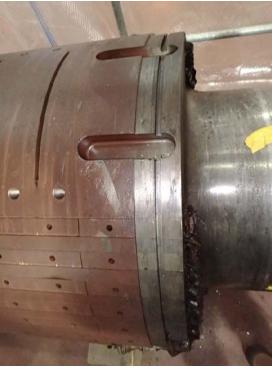
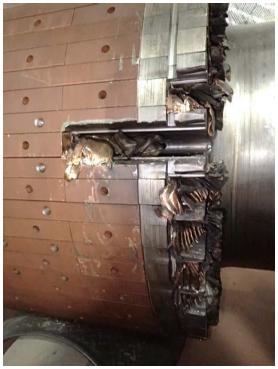
Figure 23. Additional views of the centering ring (upper image) and rotor windings in proximity to the snap ring slot. Localized damage to the rotor is visible in the lower-right image.

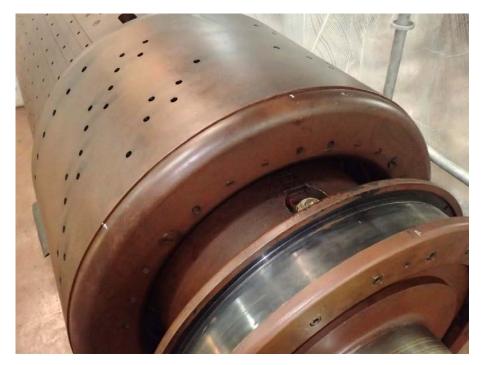
Figure 24. Views of the intact retaining ring and centering ring at the north end of the generator rotor. The pattern of cooling passages in the retaining ring are a result of the positions of end winding components and cooling pathways between or through components inside of the retaining ring. Note that in the lower image, the cooling fan (ring) is near the centering ring, but the blades have been removed.

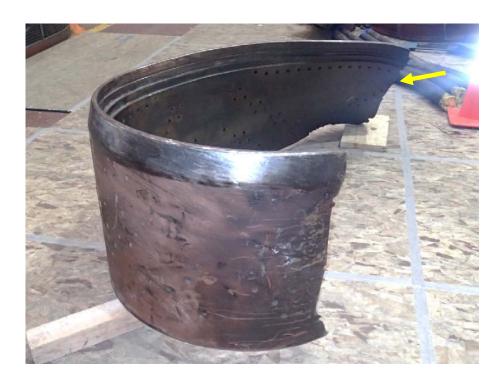
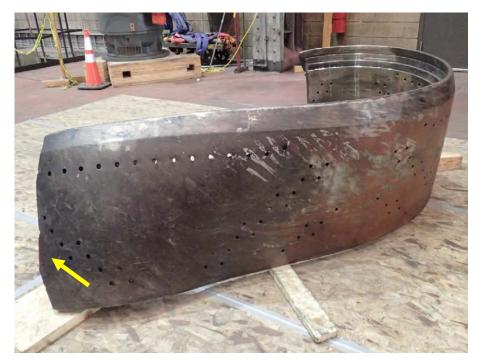
Figure 25. Views of the OD surface of the retaining ring from two different positions. For discussion purposes, the "upper fracture surface" (indicated by the arrows) will reference the fracture surface that was situated at the upper part of the generator in the as-found condition.

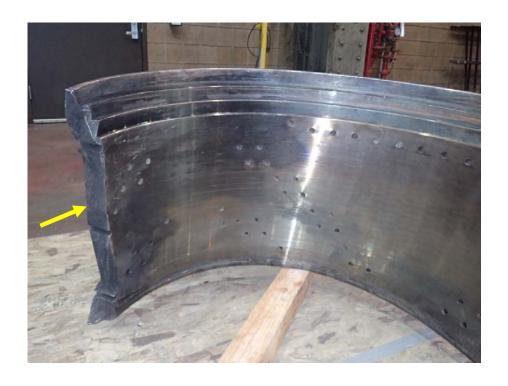
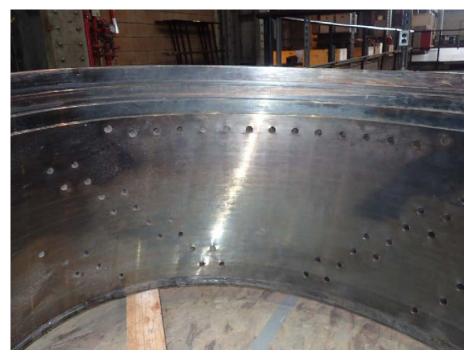
Figure 26. Views of the ID surface of the retaining ring showing the lower fracture surface (arrow) and a location near the lower fracture surface (lower image). The outboard edge of the retaining ring is oriented down in these images.

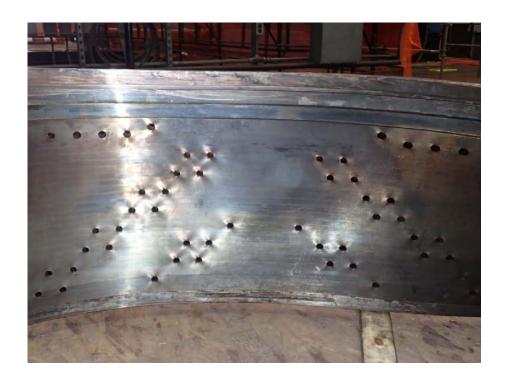
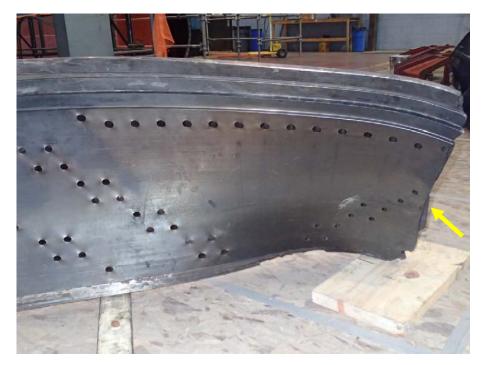
surface revealed evidence of deformation (elongation) at the cooling passage holes (e.g., Figure 27, upper image). Snap ring and key slots were also visible on the ID surface at the outboard and inboard edges of the retaining ring (Figures 28 and 29). A location on the outboard edge of the retaining ring had scalloped damage (Figures 30 and 31). Close examination of the features in this location revealed that the damage was caused by impact to the outer edge of the ring, with localized deformation and shear indicating the direction of impact.

Figure 27. Additional views of the ID surface of the retaining ring, including the upper fracture surface (arrow). In the upper image, visible light variations around the cooling passage holes are due to deformation (elongation) of the ring metal in the areas around the holes.

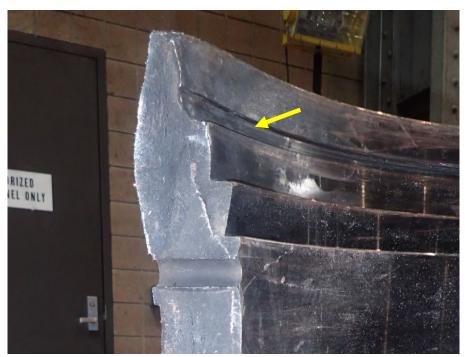
Figure 28. Views of the ID surface profile at the inboard edge the ring (taken at the upper fracture surface (upper image) and lower fracture surface (lower image). The ID slot for the snap ring is indicated by the arrows in each image.

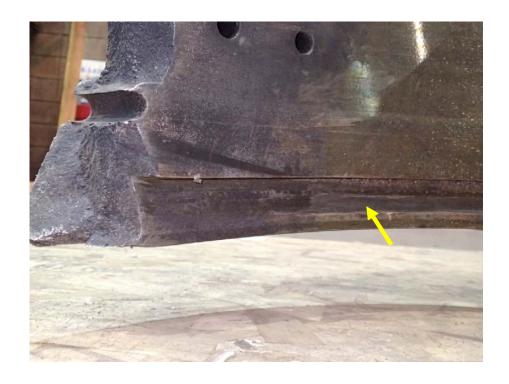
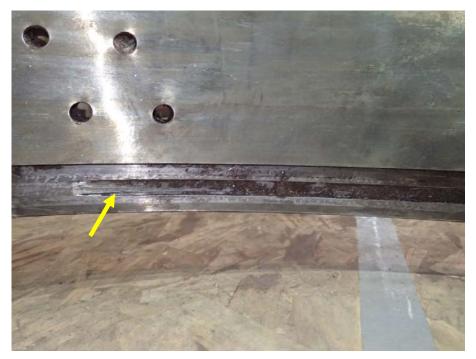
Figure 29. Views of the ID surface profile at the outboard edge the ring (taken at the lower fracture surface (upper image) and at a location between the fractures (lower image). An intermittent keyway slot is indicated by the arrows in each image.

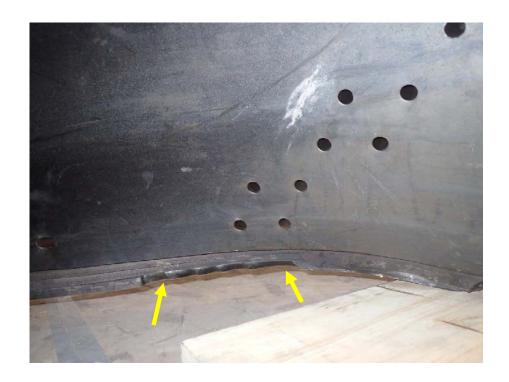
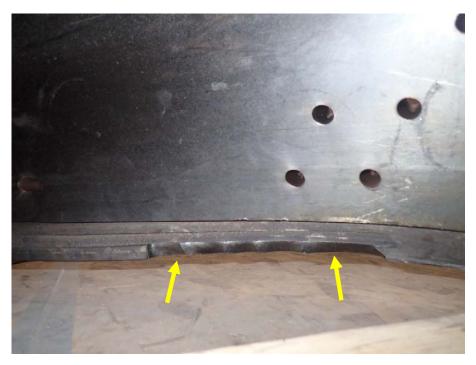
Figure 30. Views of a location of mechanical damage at one of the keyways along the outboard edge of the retaining ring.

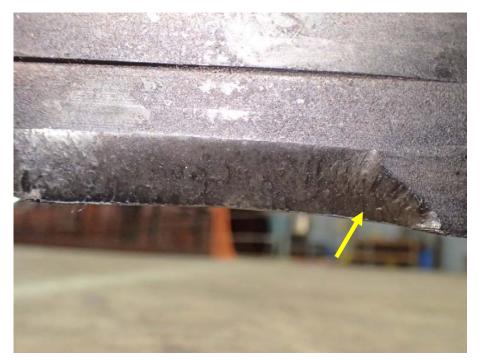
Figure 31. Close views of the mechanical damage at the outboard edge of the retaining ring. These features were along one side of one of the intermittent slots, and exhibited deformation and sheared metal (indicated by the arrows) that indicated mechanical impact from the outside toward the inside.

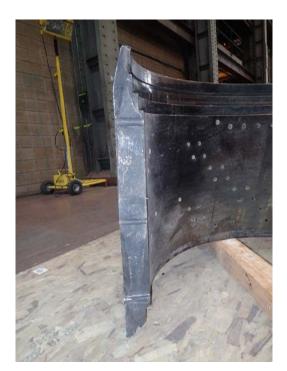
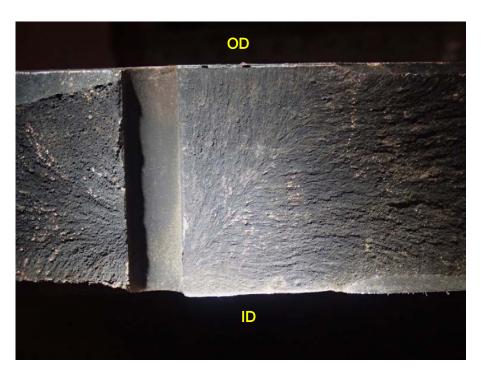
The mating fracture surfaces at each end of the deformed ring appeared to be in the same condition as observed inside of the generator during the April 17th site visit (Figures 32 through 37). On the lower fracture surface, the relatively flat region of fracture located adjacent to the central cooling passage exhibited a clear texture that indicted that the crack origin area was located at the cooling passage wall at a location close to the ID surface of the ring (Figures 33 and 34). This apparent origin area was situated at a location where distinct features were visible on the surface of the cooling passage (Figures 35 and 36).

Figure 32. Views of the lower fracture surface on the retaining ring. The upper right image is a closer view of the area near the central cooling passage, and the lower image is a closer view of the same area (rotated 90 degrees clockwise) with side lighting to highlight the fracture surface texture.

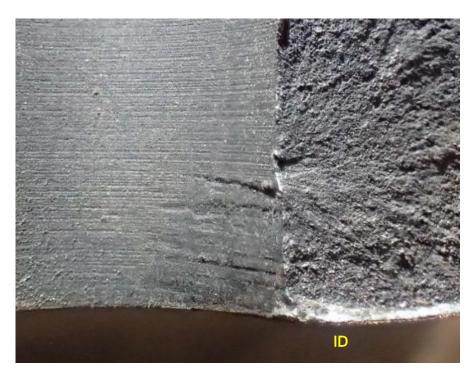
Figure 36. Closer views of the area shown in Figure 35 after blowing off the fiberglass particulate with air.

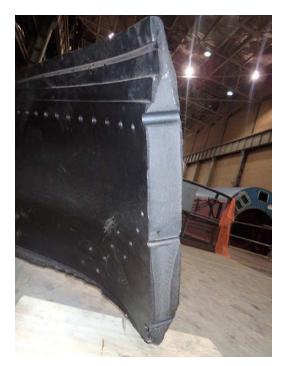
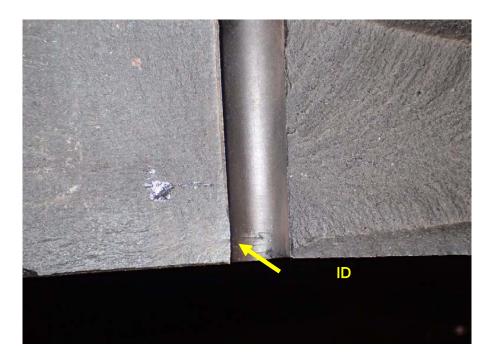
The upper fracture surface exhibited a similar surface texture (as well as a small region with remnant material from the RepliSet sampling effort) (Figures 37). The cooling passage surface at the upper fracture surface also exhibited features (gouges in the metal surface) that coincided with the apparent crack origin area (Figures 38 and 39). The damage at this location included an angled feature with a small amount of metal that appeared to have piled up during the damage process. The observed features were only located close to the ID surface of the ring, and were coarser than the fine machining marks that were visible on the remainder of the cooling passage surface.

Figure 37. Views of the upper fracture surface on the retaining ring. The upper right image is a closer view of the area near the central cooling passage, and the lower image is a closer view of the same area (rotated 90 degrees counterclockwise); the shiny spot in the lower image is remnant material from the RepliSet sampling. The apparent origin area at the edge of the cooling passage hole is indicated by the arrow.

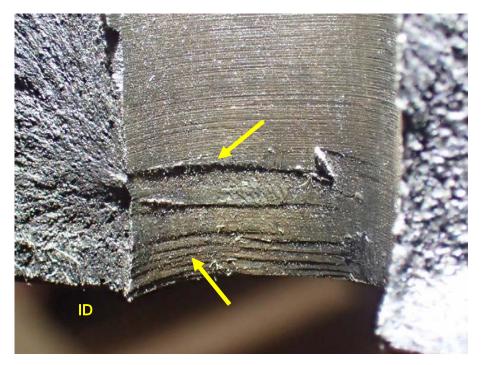
Figure 38. Closer views of the area shown in the lower image of Figure 37, with side lighting to highlight surface texture. Features that are visible on the cooling passage surface (arrows) coincide with the apparent crack origin area at the edge of the cooling passage hole.

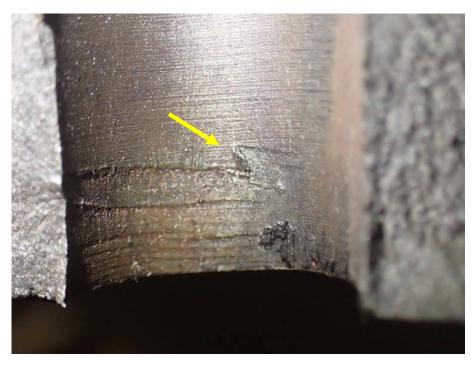
Figure 39. Additional close views, under more direct lighting, of features on the cooling passage surface in proximity to the apparent crack origin area. The visible surface damage included an angled mound of metal that appeared to have been "piled up" during the damage process (arrows).

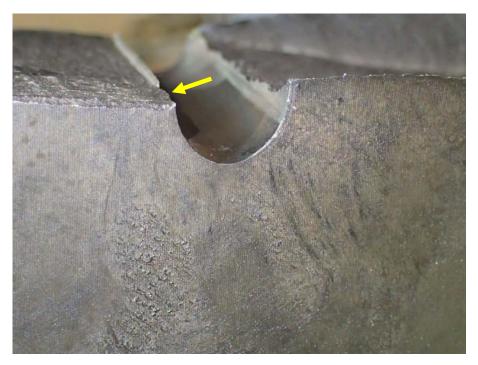
The flat region of the fracture extended a couple of inches towards the inboard edge of the retaining from the cooling passage, and within this region were several faint, curved marks that were consistent with beach marks (Figure 40). The beach marks were also consistent with the apparent crack origin, with propagation occurring towards the inboard edge of the ring and towards the ring OD surface.

Figure 40. Alternate views of the central cooling passage hole at the upper fracture surface. The ID surface of the retaining ring is visible in each image. In the upper image, the right arrow indicates the crack origin area and the left arrow indicates the location of an apparent beach mark; other possible beach marks are visible between the left and right arrows. The arrow in the lower image also indicates the location of the apparent crack origin.

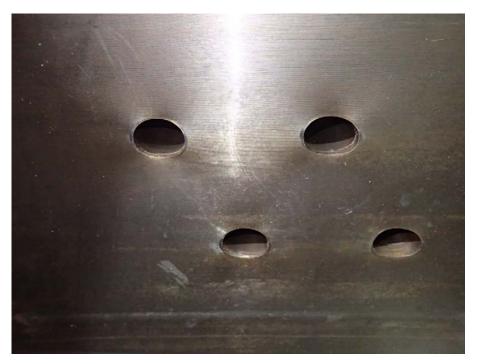
Figure 41. Views of a group of four cooling passage holes that were elongated (consistent with the opening or straightening of the retaining ring, and also exhibited indicates of mechanical damage at the hole ID surfaces near the ring ID surface.

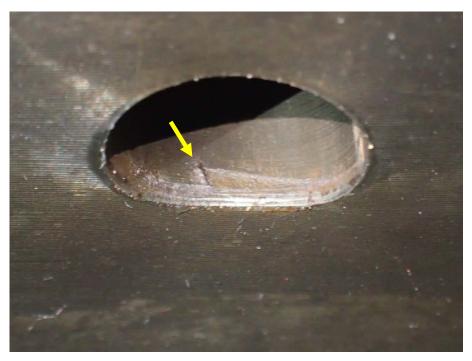
indications of mechanical damage or coarse features near the ring ID surface, some were identified that had similar features to those observed in the central cooling passage at the crack origin area. In particular, cooling passage holes exhibited damage that included surface gouges near the ID surface of the ring, and angled features at the edges of the gouges with small amounts of deformed (piled-up) metal (e.g., Figures 42 and 44).

Figure 42. Close views of the interior of two of the elongated cooling passage holes in Figure 41. The arrows indicate the locations where internal surface damage is visible. Both of these locations also exhibited an angled featured with a small amount of piled up metal that was similar to that observed in the cooling passage at the crack origin area (arrows).

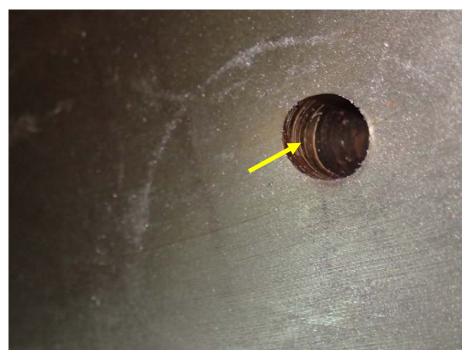
Figure 43. Additional views of a cooling passage hole with internal damage near the ring ID surface (arrow). The area shown is close to the upper fracture surface, which is toward the right in each image.

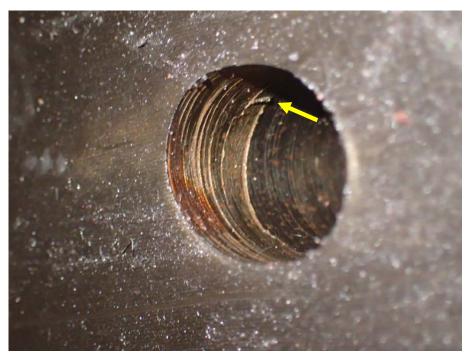
Figure 44. Closer views of the hole ID surface damage shown in Figure 43. This location also exhibited an angled featured with a small amount of piled up metal that was similar to that observed in the cooling passage at the crack origin area (arrows).

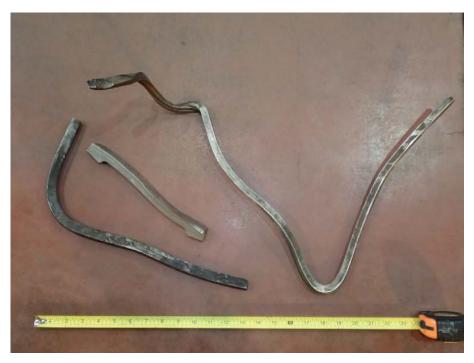
Additional parts (and fragments) that appeared to be part of the retaining ring retention components were visually examined during the May site visit. These included a deformed bar that was part of the snap ring, two deformed key-like components, and an additional section of square bar (the source of this item was not clear) (Figure 45). The ends of the square bar were flat, with no indications of fracture (Figure 46). One end of the snap ring bar was fractured and deformed, and the other end was damaged (Figures 47 and 48). The key-like components were deformed, and one exhibited a cracked edge that appeared to be associated with localized bending or impact during the failure event (Figure 49).

Figure 45. Views of the parts and fragments of material that appeared to be part of the ring retention snap ring and keys. The parts were deformed to various degrees and one of the ends of the snap ring was fractured.

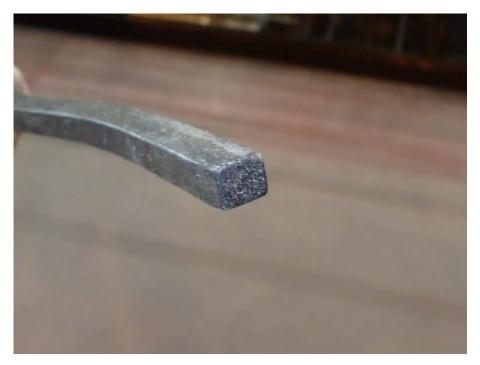
Figure 46. Close views of the end of the deformed bar shown in Figure 45.

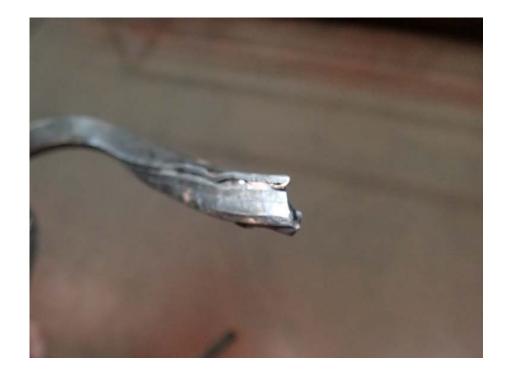
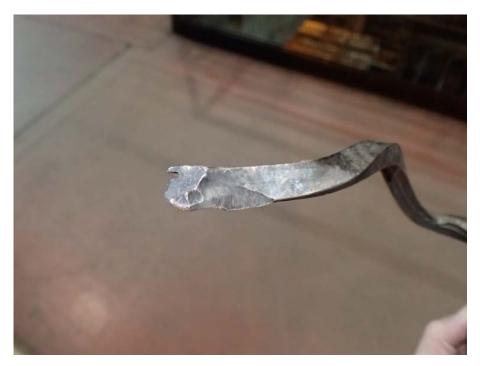
Figure 47. Close views of one end of the snap ring shown in Figure 45.

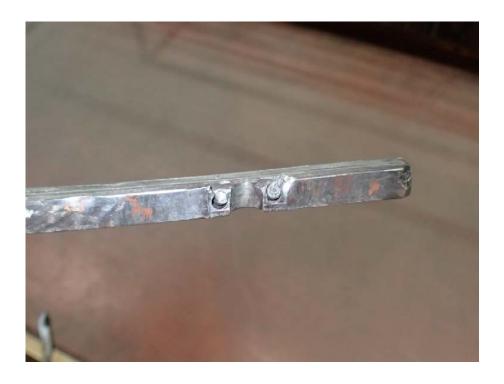
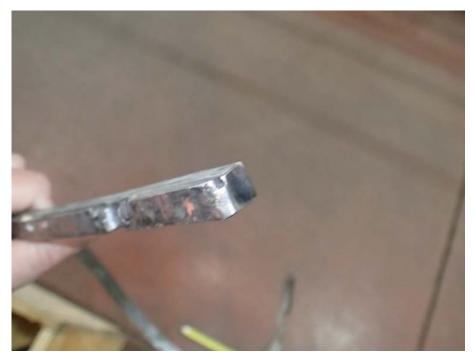
Figure 48. Close views of the other end of the snap ring shown in Figure 45. This end was damaged but not fractured, and the tool fitting has broken off at the location of the pins (visible in the upper image).

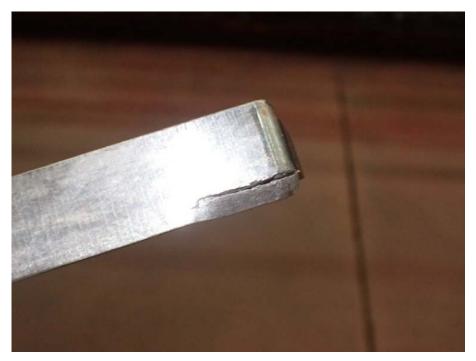
Figure 49. Views of deformation and damage on a ring attachment (key) component.

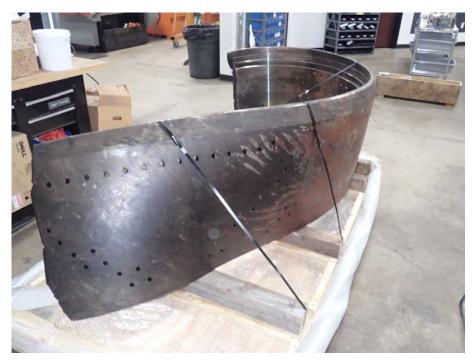
Figure 50. Views of the retaining ring in the as-received condition at SI's metallurgical laboratory. The ring was enclosed in a crate, which has been disassembled.

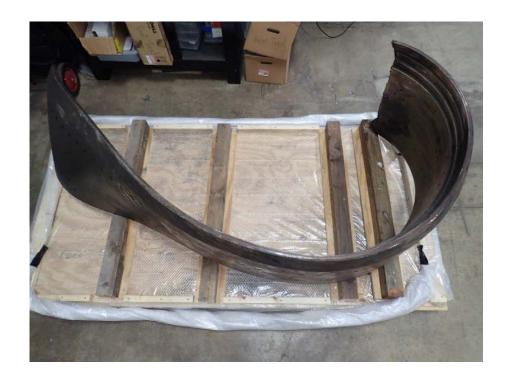
Figure 51. Additional views of the retaining ring in the as-received condition at SI's metallurgical laboratory.

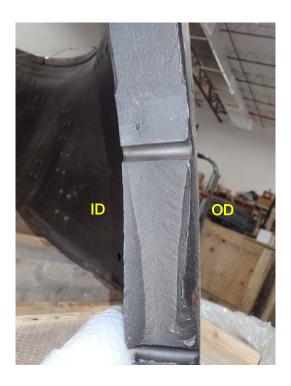
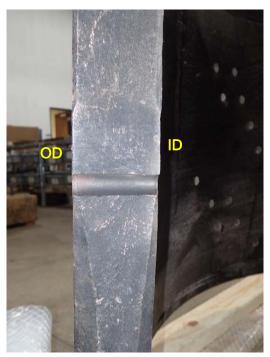
Figure 52. Views of the central cooling passage on the upper (upper image) and lower (lower image) fracture surfaces of the retaining ring, in the as-received condition.

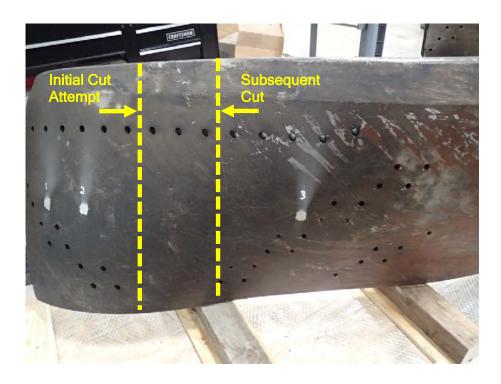
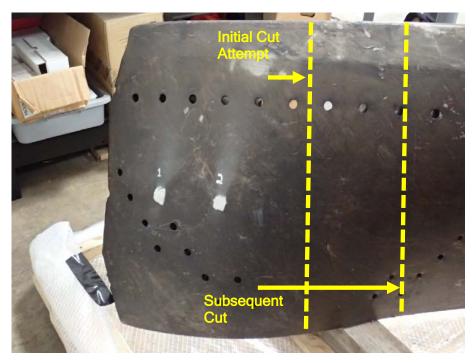
Figure 53. Views of the OD surface of the retaining ring near the upper fracture. The cleaned spots (numbered 1, 2, and 3) are locations where hardness testing was performed, and the dashed lines indicate the approximate locations where an initial cut attempt (via plasma cutter) was made, and where the complete cut was made to remove the upper fracture (and adjacent material) from the retaining ring.

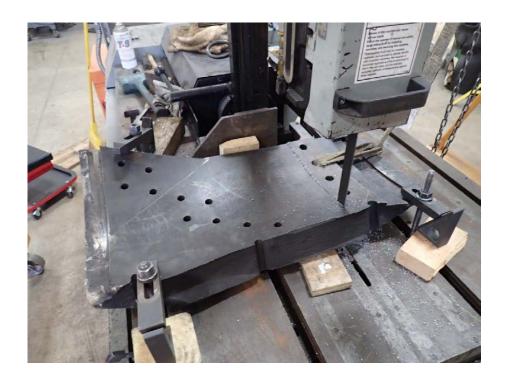
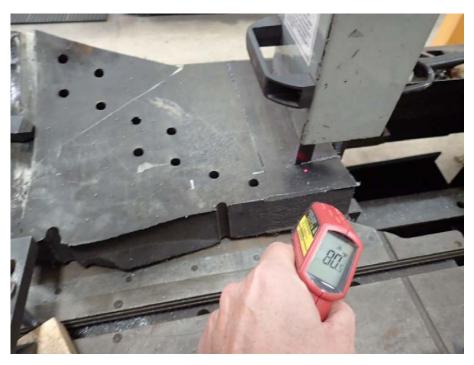
Figure 54. Views of the dry (bandsaw) cutting process during sectioning of the upper end of the ring. The metal temperature was monitored during cutting to ensure that no significant heating occurred.

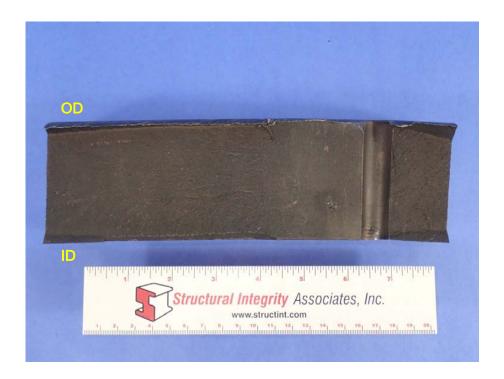
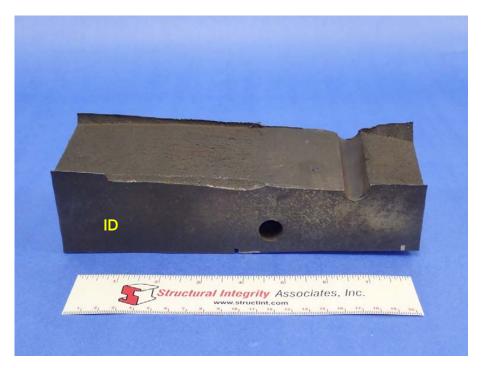
Figure 55. Views of the fracture region of interest (adjacent to the central cooling hole on the upper fracture surface) after removal from the retaining ring.

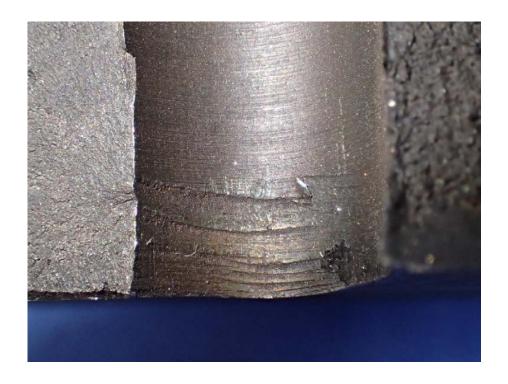
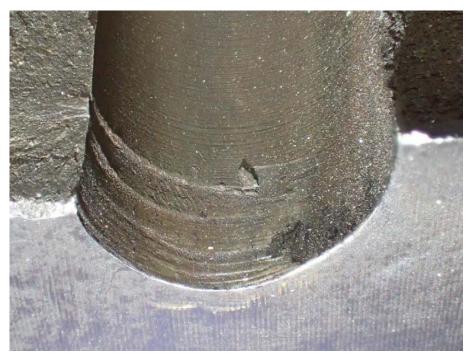
Figure 56. Close views of the central cooling passage and adjacent fracture surface, on the section shown in Figure 55.

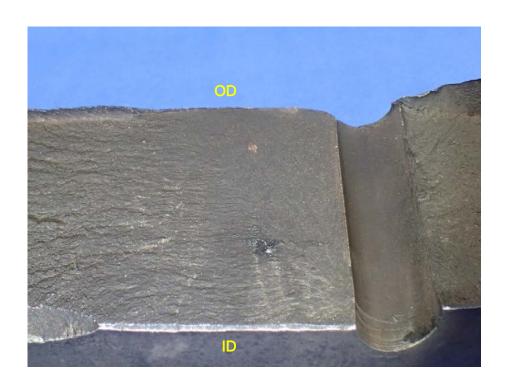
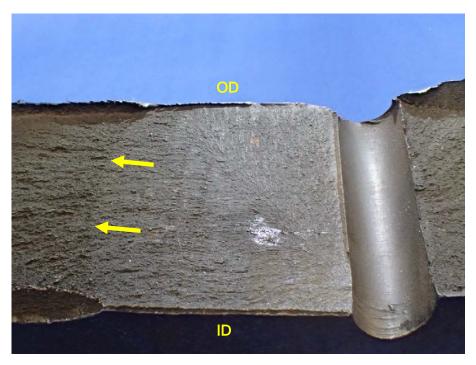
Figure 57. Views of the flat fracture region on the removed ring section shown in Figure 55. The lower image was taken with alternate lighting to highlight the fracture surface texture. The arrows in the lower image indicate the apparent position of the crack tip when the final fast rupture occurred. The localized area with remnant RepliSet material is also visible in both images (gray in the upper image and shiny in the lower image).

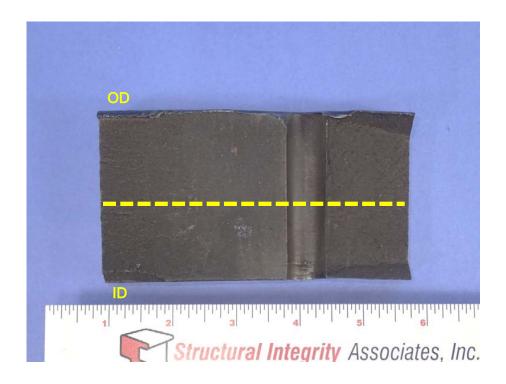
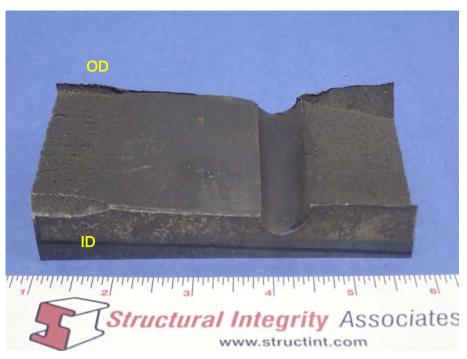
A smaller segment of the upper fracture was removed to facilitate further examination (Figure 58). The crack origin area and adjacent cooling passage damage were documented prior to cleaning using a digital microscope (Figures 59 through 62). The crack origin area, which was identified through small ridges emanating from the cooling passage surface, was coincident with mechanical gouges within the cooling passage. At higher magnifications, the fracture surface features and cooling passage surface were covered with a thin film of slightly oily grime and debris, possibly including residue or soot from the failure event.

Figure 58. Views of a reduced section that was cut from the sample shown in Figure 55. The dashed line shows the location where this sample was cut to remove the area of interest near the retaining ring ID surface.

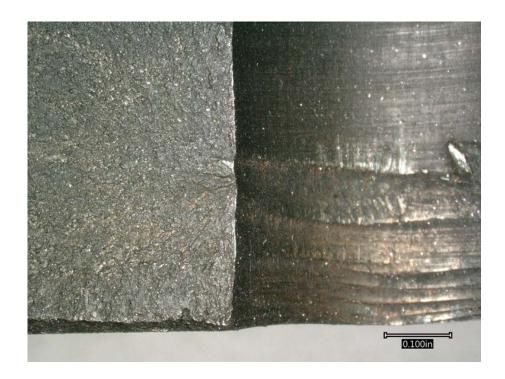
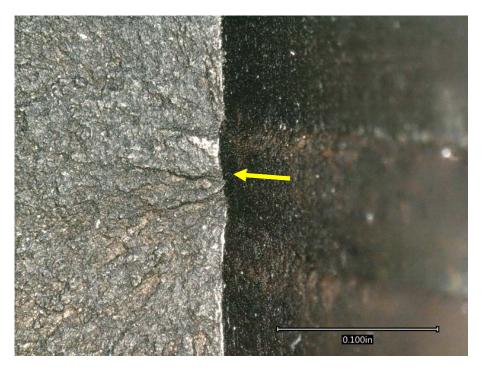
Figure 59. Digital microscope images of the central cooling passage and adjacent fracture surface, on the extracted section shown in Figure 58. Damage to the cooling passage surface is visible adjacent to the crack origin identified by the fracture surface texture (arrow).

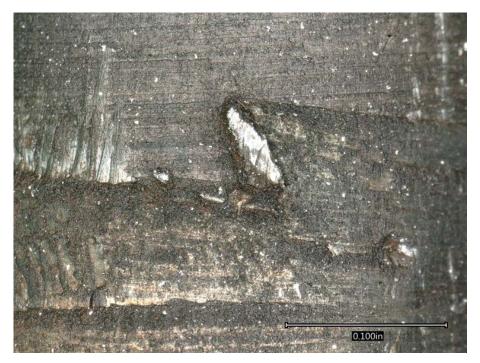
Figure 60. Additional close images of damage at the cooling passage surface. The lower image shows a close view of an angled feature with metal that has been piled up at the edge of the gouge.

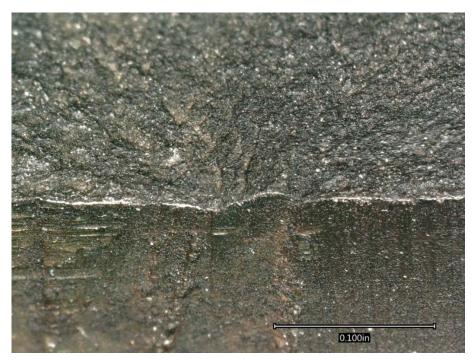
Close examination of the region of piled up metal that was visible on the cooling passage surface revealed that the shape of this feature was similar to the shape of the crack origin area (Figure 61). In addition, the mechanical gouges generally appeared to be a result of a tool rotating clockwise as it moved into the cooling passage hole from the ID side of the retaining ring (Figure 62).

Figure 61. Additional views of the cooling passage and crack origin area (in these views, the sample has been rotated 90 degrees from the images shown in Figure 60). In the upper image, note that the edge of the piled up metal is similar in shape to the crack origin area (arrows).
