RE: RIVERSIDE ROOT CAUSE ANALYSIS REPORT

Root Cause Investigation Report

Riverside Generating Station - Unit 7

REPORT NO. 2551958.401 Metallurgical Analysis of Failed Retaining Ring Riverside Generating Station - Unit 7

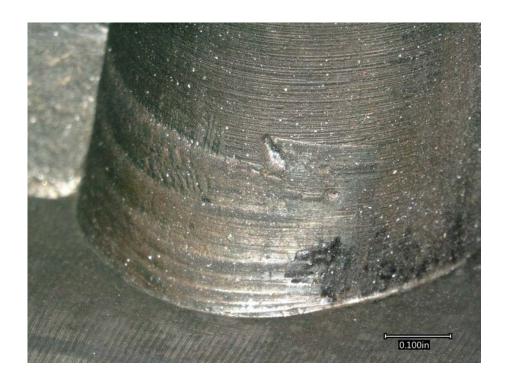
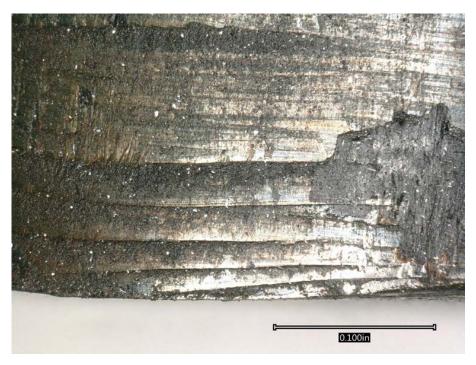
Close examination of the region of piled up metal that was visible on the cooling passage surface revealed that the shape of this feature was similar to the shape of the crack origin area (Figure 61). In addition, the mechanical gouges generally appeared to be a result of a tool rotating clockwise as it moved into the cooling passage hole from the ID side of the retaining ring (Figure 62).

Figure 62. Additional digital microscope images of the damaged cooling passage and features near the ID surface of the retaining ring.

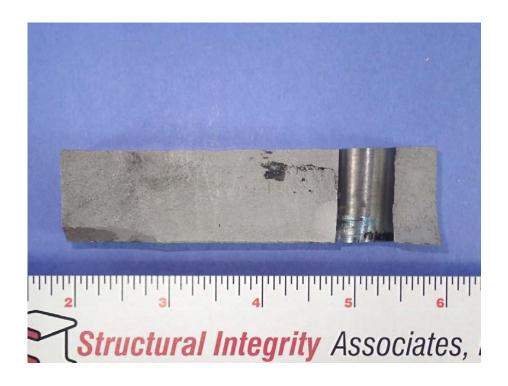
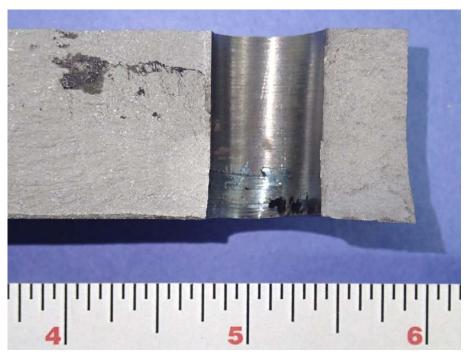
The ring segment containing the crack origin area was cleaned in an ultrasonic bath with a mild Alconox solution, then rinsed with acetone and dried (Figure 63). The cleaning process did not remove the RepliSet residue or the dark deposits that were present at a location close to the ring ID surface and within the cooling passage, but otherwise the cleaning removed much of the deposits and debris that were on the sample surfaces. In the crack origin area, the cleaned surface exhibited faint beach marks, and a brighter thumbnail feature that was centered around the origin area (Figure 64).

Figure 63. Views of the fracture surface section from the location below the dashed line in the upper image of Figure 58. The removed section is shown after cleaning in an ultrasonic bath with a mild Alconox solution.

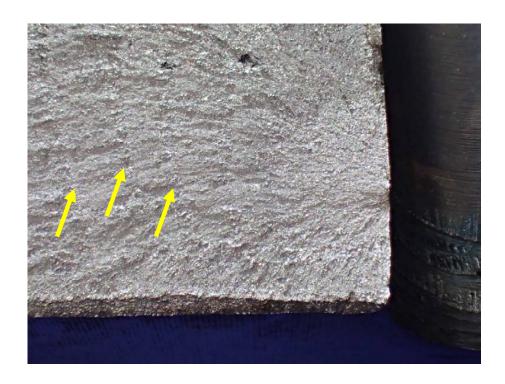
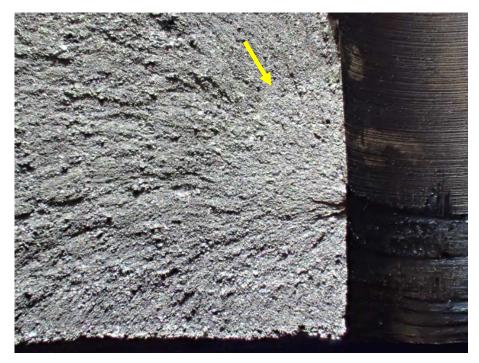
Figure 64. Close views of the crack origin area after cleaning the sample. The upper arrows show the locations of faint beach marks that are visible on the surface, and the lower arrow shows a thumbnail feature that is lighter in color than the surrounding fracture surface.

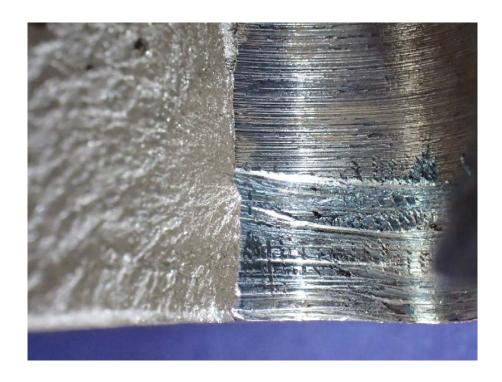
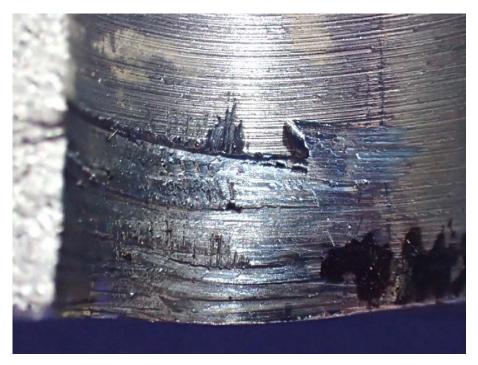
On the cooling passage surface, the cleaning process revealed a bluish tint in locations where mechanical damage was present (Figure 65). On the ring ID surface adjacent to the cooling passage, arc-shaped scratches were visible after the cleaning process (Figure 66).

Figure 65. Close views of the cooling passage near the ring ID surface, after cleaning in an ultrasonic bath. Locations with mechanical damage exhibited a bluish tint after cleaning.

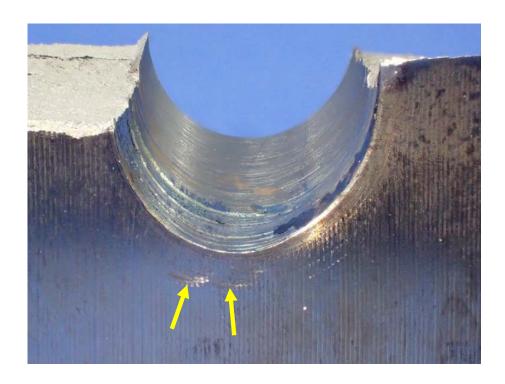
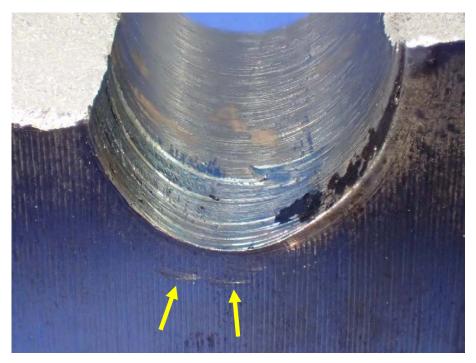
Figure 66. Alternate views of the cooling passage near the ring ID surface, after cleaning in an ultrasonic bath. Arc-shaped markings were visible on the ring ID surface in locations near the cooling passage hole (arrows)

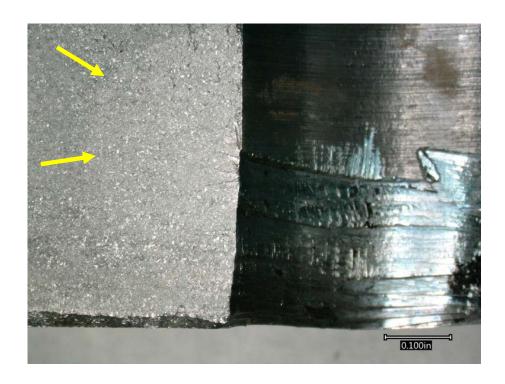
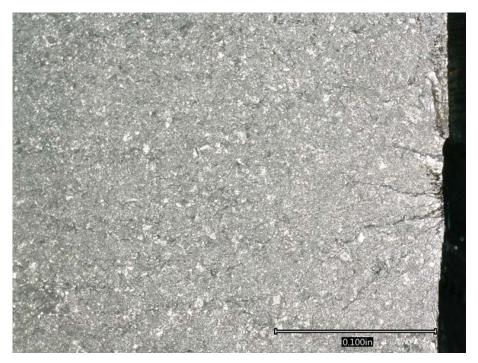
The cleaned crack origin area was also examined and documented using a digital microscope (Figures 67 through 70). The origin area was located approximately 0.25 inches from the ID surface of the ring, and the radius of the brighter "thumbnail feature" around the origin area was

approximately 0.20 inches. In proximity to the crack origin, the fracture surface exhibited ridges radiating outward (Figure 67, lower image, and Figure 68). These features were consistent with ratchet marks, which occur when incipient fatigue cracks form in close proximity, but on slightly different (nearly colinear) planes. As the incipient cracks propagate, they combine onto a single fracture plane and the ridges end.

Figure 67. Digital microscope images of the cleaned crack origin area. The lighter thumbnail feature is visible in the upper image (arrows), and the lower image is a closer view of the origin at the cooling passage. Ridges (ratchet marks) extending outward from the origin area are approximately 50 mils (0.050 inches) in length.

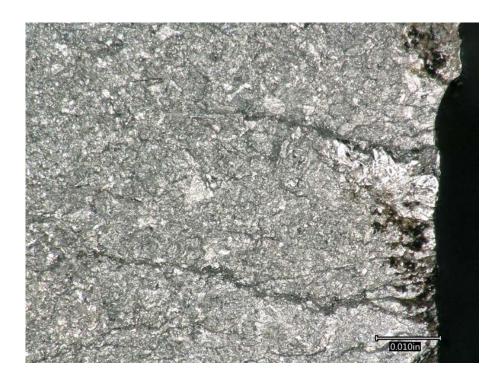
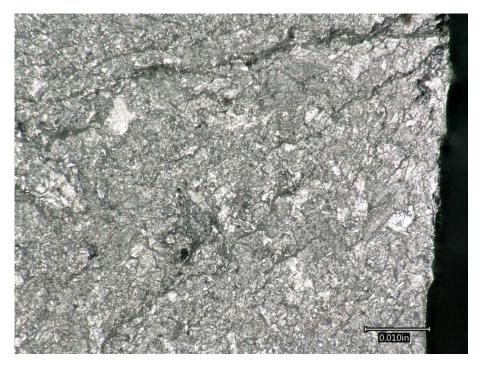
Figure 68. Higher magnification images of the crack origin area on the cleaned sample. Ridges extending to the left from the edge of the cooling passage are consistent with fatigue crack origin sites, where initial cracks are nearly coplanar and propagate together into one crack plane.

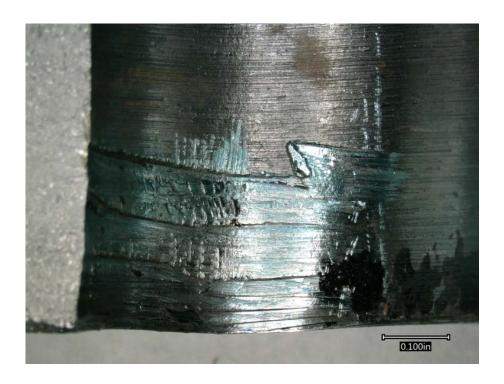
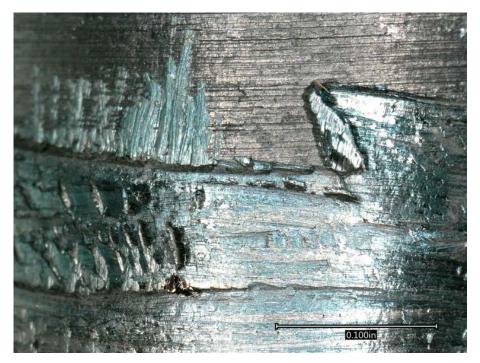
Examination of the cleaned features in the cooling passage revealed circumferential gouges, along with the piled-up metal feature, additional light scratches that were aligned with the cooling passage axis, and dark deposits on the cooling passage surface near the interior of the ring (Figures 69 and 70). A comparison of the cleaned sample to images of the ring prior to removal from the generator revealed that the dark deposits at this location were present prior to the ring removal (lower image of Figure 13).

Figure 69. Digital microscope images of the cleaned sample showing damage features at the cooling passage surface. After cleaning in an Alconox solution, the damaged surfaces exhibited a bluish tint. The piled up metal on the cooling passage surface was approximately 60 mils (0.060 inches) in length.

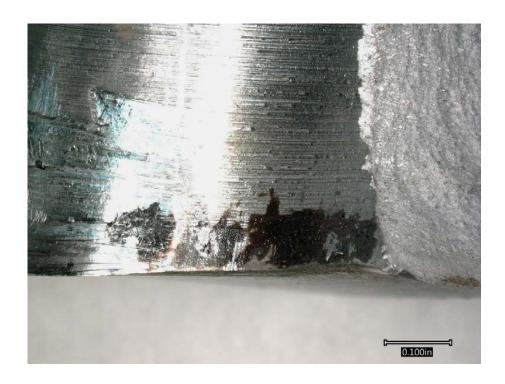
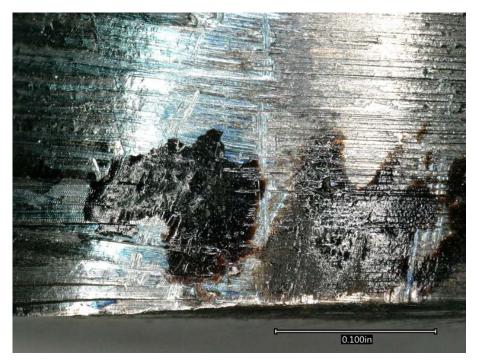
Figure 70. Additional digital microscope images of the cleaned sample showing dark deposits near the retaining ring ID surface. These deposits were also visible on the retaining ring prior to removal from the generator (see lower image of Figure 13).

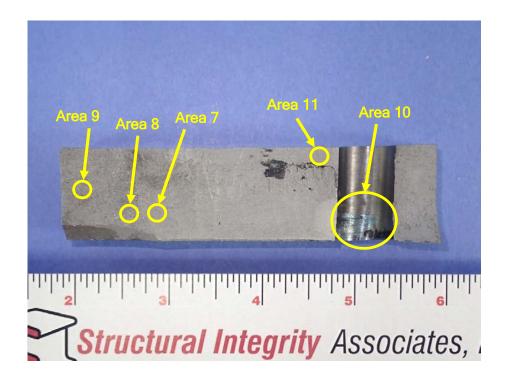
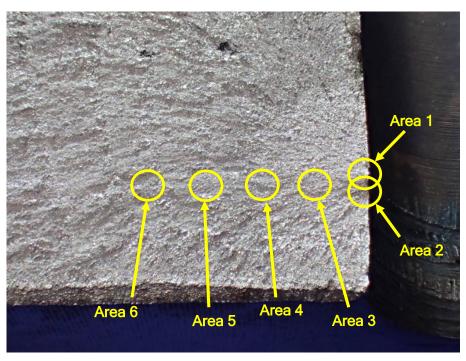
Figure 71. Labeled images showing the approximate locations that were examined using a scanning electron microscope (SEM). These individual areas are referred to, aslabeled, in the following figures.

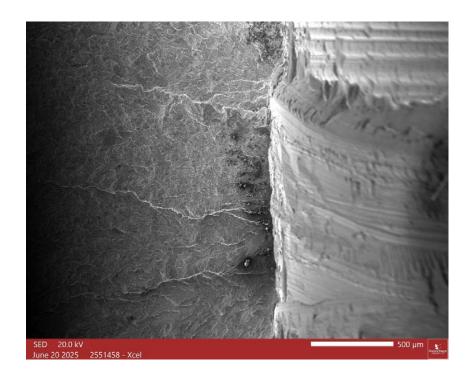
In Area 1, which represented the upper portion of the crack origin area, the crack initiation site was clearly associated with the gouging at the cooling passage surface (Figures 72 through 74). The mechanical gouges appeared to be significantly deeper than the machine marks that were from the original fabrication of the cooling passage hole. At higher magnifications, the ridges were evident, extending away from the cooling passage. These were surrounded by areas with angular features that were probably influenced by the microstructure. In addition, at higher magnifications, features that were consistent with fatigue striations were observed, although these were not widespread (Figure 74). Fatigue striations are approximately parallel features that are associated with the positions of an advancing crack under cyclic or vibrational loading.

Figure 72. Scanning electron microscope (SEM) images of Area 1 in Figure 71. These images show the crack origin area at the edge of the mechanical gouge at the cooling passage surface. Original machining marks are visible above the gouge in the cooling passage.

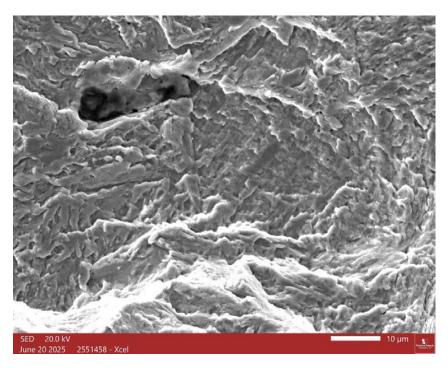
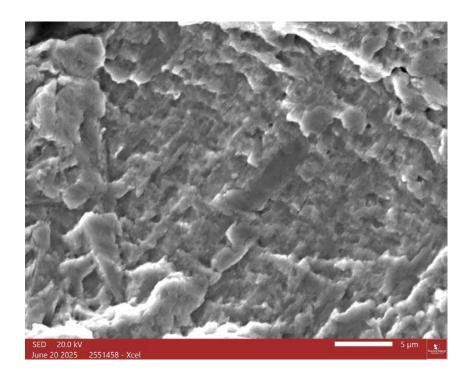
Figure 73. Additional SEM images of Area 1 in Figure 71. In the lower image, the crack propagation direction is approximately lower-right to upper-left.

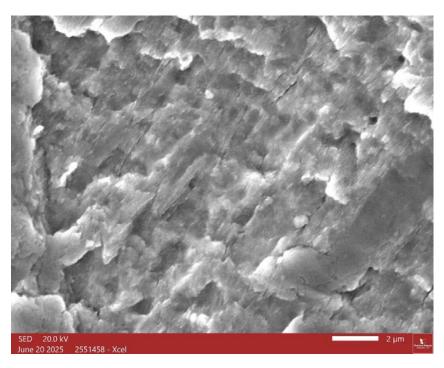
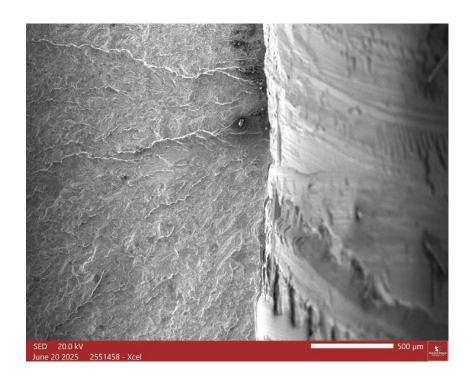
Figure 74. Higher magnification SEM images of Area 1 in Figure 71. In these images, the crack propagation direction is approximately lower-right to upper-left.

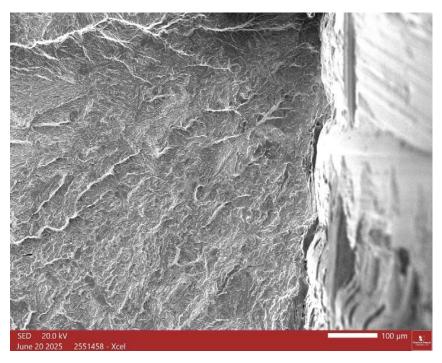
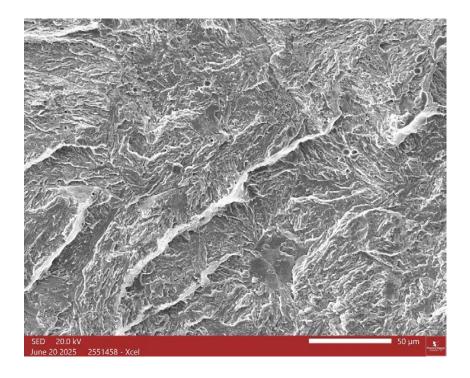
Figure 75. SEM images of Area 2 in Figure 71. These images show the crack origin area at the edge of the mechanical gouge at the cooling passage surface.

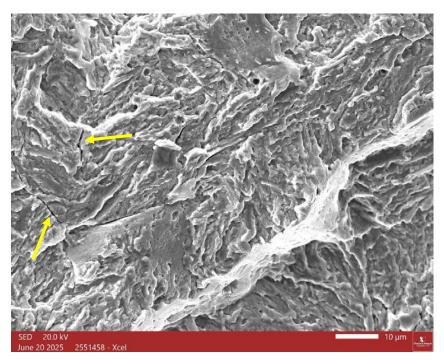
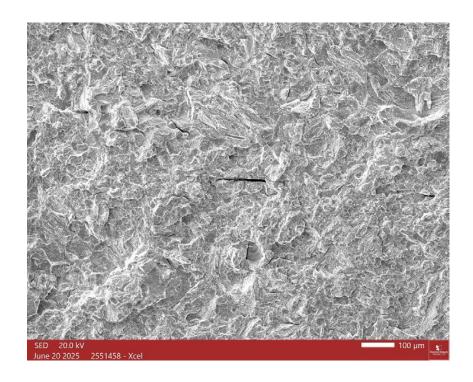
Figure 76. Additional SEM images of Area 2 in Figure 71. In these images, the crack propagation direction is approximately upper-right to lower-left. Indications of secondary cracks or tears are also evident in the lower image (arrows).

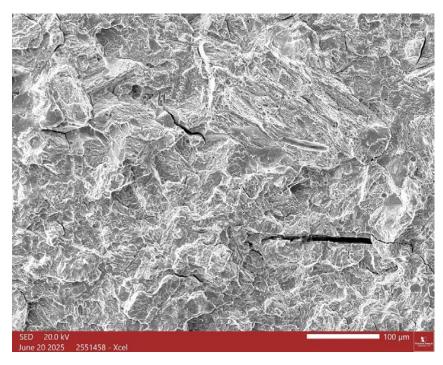
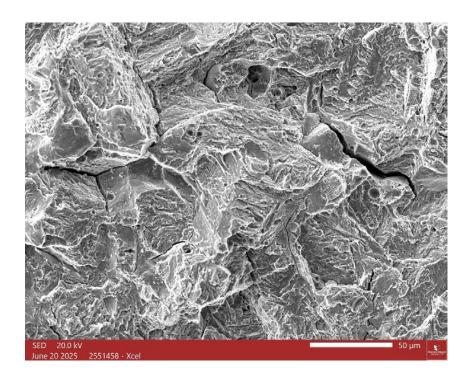
Figure 77. SEM images of Area 3 in Figure 71. This location is approximately at the middle of the bright thumbnail region (see Figure 67, upper image). In these images, the crack propagation direction is approximately right to left.

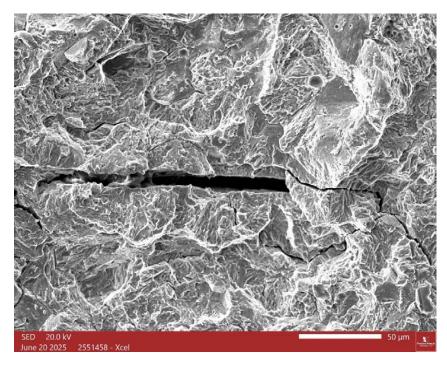
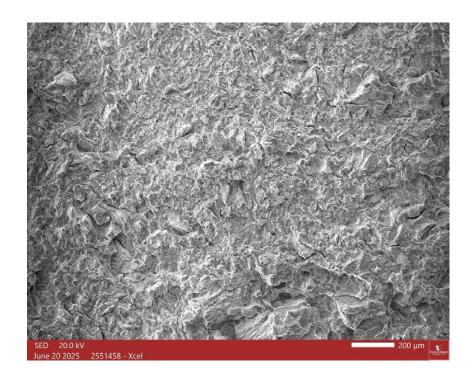
Figure 78. Higher magnification SEM images of Area 3 in Figure 71. In these images, the crack propagation direction is approximately right to left.

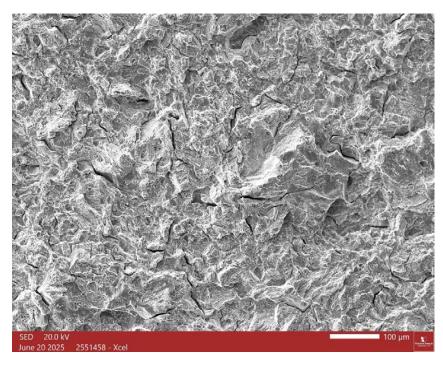
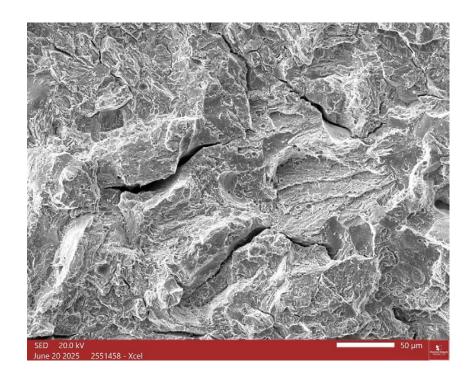
Figure 79. SEM images of Area 4 in Figure 71. This location is approximately at the edge of the bright thumbnail region (see Figure 67, upper image). In these images, the crack propagation direction is approximately right to left.

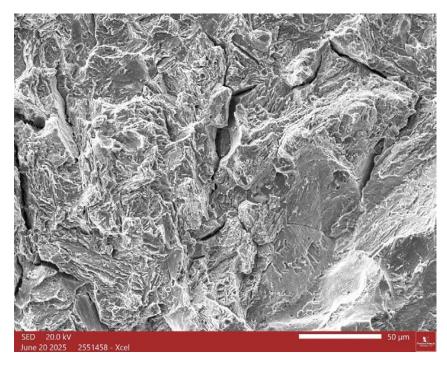
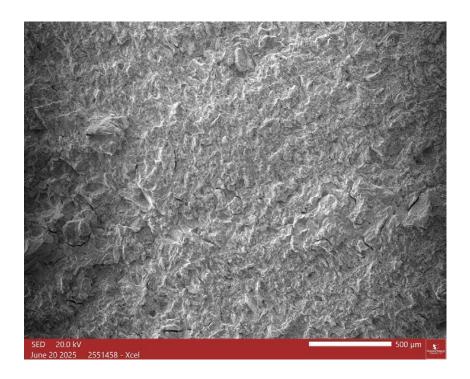
Figure 80. Higher magnification SEM images of Area 4 in Figure 71. In these images, the crack propagation direction is approximately right to left.

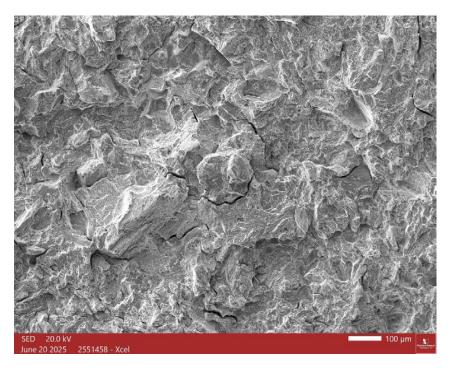
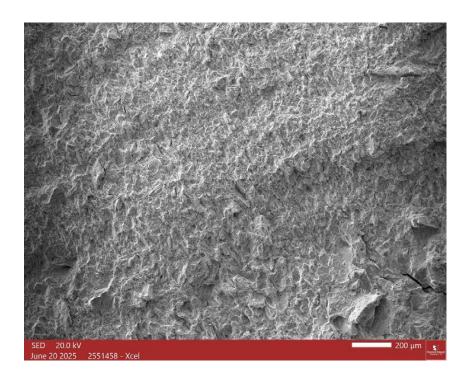
Figure 81. SEM images of Area 5 in Figure 71. In these images, the crack propagation direction is approximately right to left.

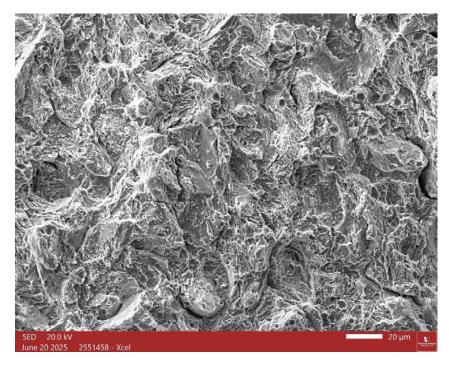
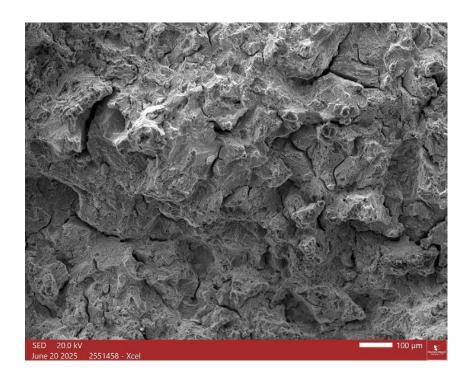
Figure 82. SEM images of Area 6 in Figure 71. In these images, the crack propagation direction is approximately right to left.

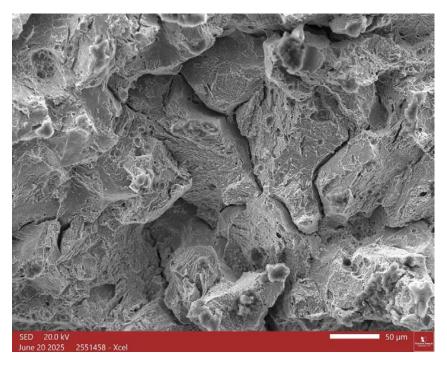
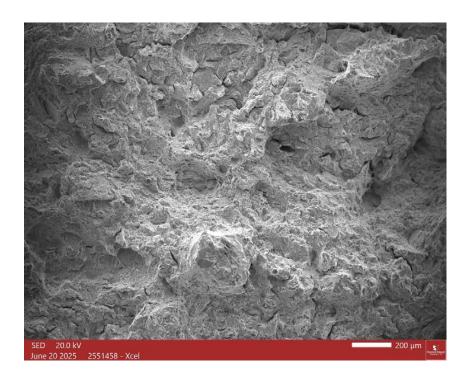
Figure 83. SEM images of Area 7 in Figure 71. This location is just to the right of the beach mark indicated in the lower image of Figure 57. In these images, the crack propagation direction is approximately right to left, and features exhibited a blocky appearance with mostly cleavage and some dimpled rupture, along with larger secondary cracks or tears.

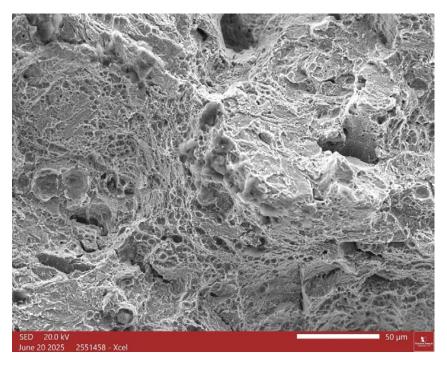
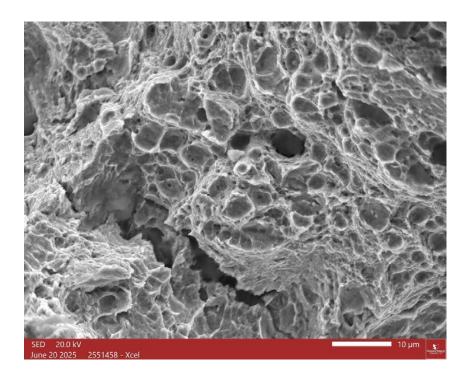
Figure 84. SEM images of Area 8 in Figure 71. This location is just to the left of the beach mark indicated in the lower image of Figure 57. In these images, the direction of cracking is approximately right to left, and features consistent with dimpled rupture mixed with cleavage fracture are present.

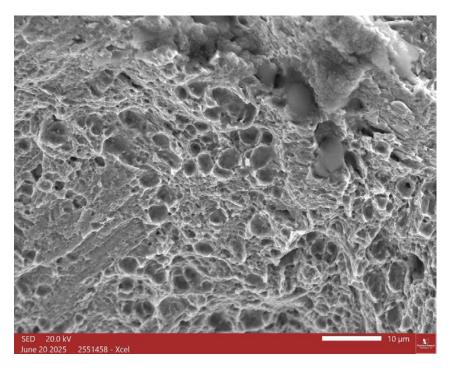
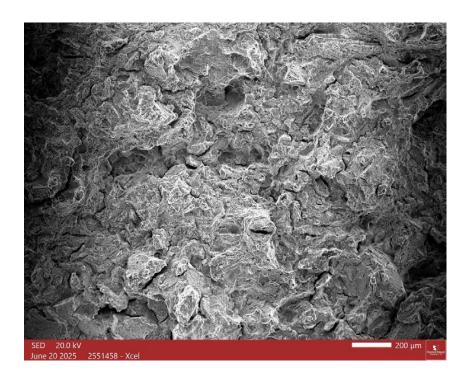
Figure 85. Higher magnification SEM images of Area 8 in Figure 71. In these images, the direction of cracking is approximately right to left, and features consistent with dimpled rupture are present.

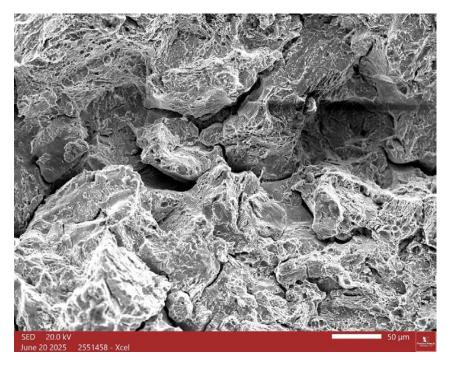
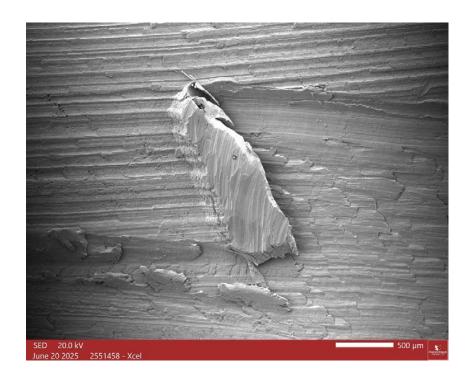
Area 9 was situated farther into the fast (final) fracture region (approximately 2.75 inches from the cooling passage, and approximately 0.6 inches from the large beach mark at the transition to fast fracture). At this location, the fracture surface exhibited a coarse, blocky appearance with a mixture of cleavage and dimpled rupture, along with secondary cracks or tears (Figure 86).

Figure 86. SEM images of Area 9 in Figure 71. In these images, the direction of cracking is approximately right to left. The fracture surface at this location exhibited a coarse, blocky appearance with a mixture of cleavage and dimpled rupture, along with secondary cracks or tears.

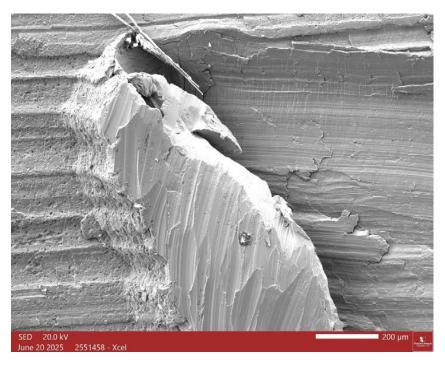
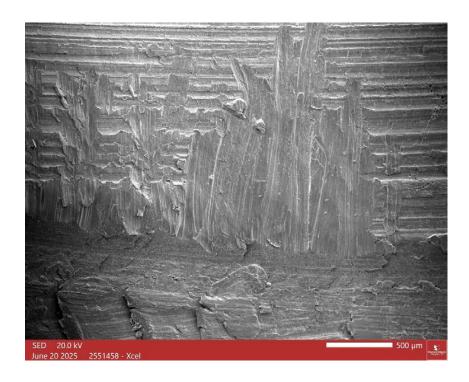
Features within the cooling passage (Area 10) were also examined (Figures 87 and 88). The piled up metal at the leading edge of one of the gouges was clearly evident, along with smeared metal in nearby locations. The original parallel machine marks were also evident on the cooling passage surface. One region exhibited relatively shallow scratches that were oriented approximately parallel to the cooling passage hole, and other features within the gouged region exhibited separated areas of smeared metal, possibly caused by smearing in two different directions.

Figure 87. SEM images of Area 10 in Figure 71. These images show the piled up metal at the edge of one of the mechanical gouges on the cooling passage surface.

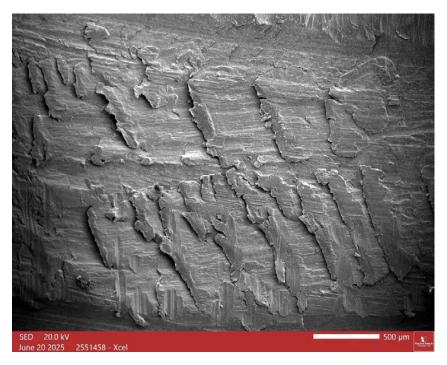
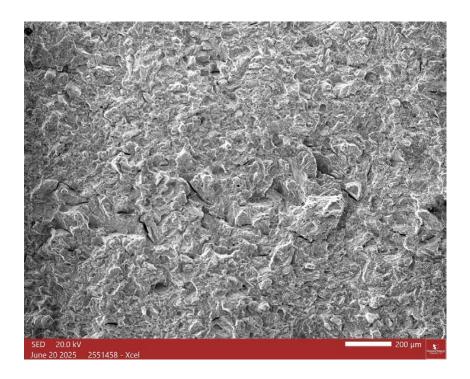
Figure 88. Additional SEM images of Area 10 in Figure 71. These images show various scratches and smeared metal on the cooling passage surface.

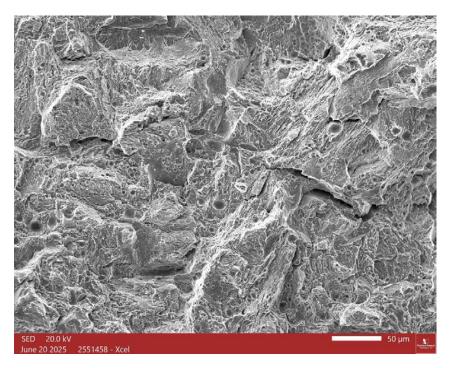
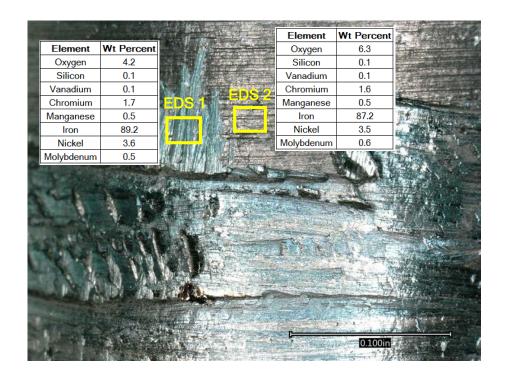
Area 11, situated relatively close to the cooling passage, and also closer to the interior of the retaining ring, was also examined in the SEM. In this region, the surface texture had indicated that localized crack propagation was upward and slightly towards the left (when viewing the fracture surface with the ring ID oriented down). The fracture surface at this location exhibited a slightly blocky appearance with indications of cleavage and secondary cracks or tears visible at higher magnification (Figure 89).

Figure 89. SEM images of Area 11 in Figure 71. In these images, the direction of crack propagation is approximately lower-right to upper-left, and the surface exhibited a slightly blocky appearance with indications of cleavage and secondary cracks or tears.

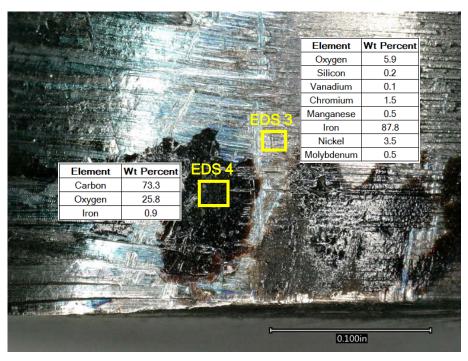
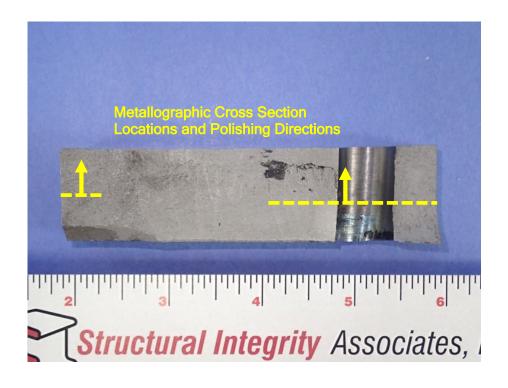
During the SEM examinations, locations on the cooling passage surface were analyzed using energy dispersive spectroscopy (EDS²) to evaluate the elemental composition of locations on the sample surface. An area identified as EDS 1 was located in a blue-tinted region of surface damage, and EDS 2 was located at an adjacent location with no surface damage (Figure 90, upper image). There was no discernible distinction between the blue-tinted surface and the adjacent machined surface. EDS 3 was performed at a separate location of machined surface, and EDS 4 was within an adjacent region with dark deposits (Figure 90, lower image). The analysis of the dark deposits revealed mostly carbon and oxygen, and the adjacent clean metal was similar in composition to the EDS 1 and 2 locations.

Figure 90. Images of the features in the cooling passage where energy dispersive spectroscopy (EDS) was performed to analyze the elemental compositions at the sample surface.

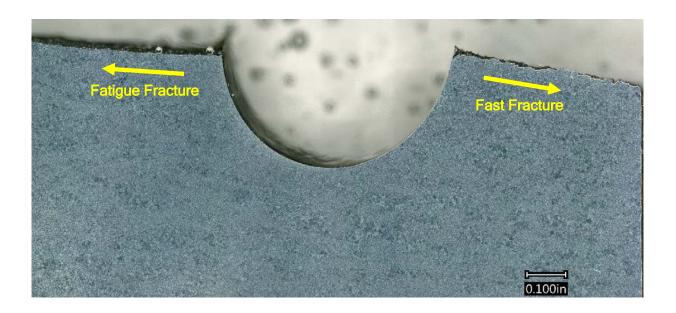
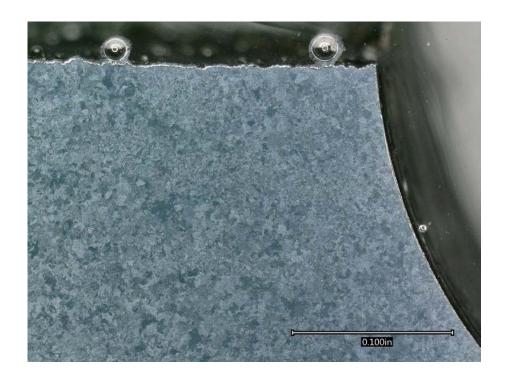
Two metallographic cross sections were removed from the previously cleaned section of ring. These samples were prepared using standard laboratory methods, and examined and documented, unetched and etched, using digital and metallographic microscopes. The cross section locations included one section through the cooling passage at a location close to the crack origin and one section through the fast fracture region (Figure 91). The location close to the crack origin was selected adjacent to the gouges within the cooling passage, and this cross section included a portion of the fast fracture on the opposite side of the cooling passage.

Figure 91. Upper image showing the locations where metallographic cross sections were removed from the ring sample. The cross section at the right side is just above Area 1 in Figure 71, and the cross section at the left side is situated in Area 9 of Figure 71. The lower image is a digital microscope image showing the prepared cross section on the right side of the upper image, with labels indicating the fatigue fracture and fast fracture sides of the cooling passage. (Etchant: Nital)

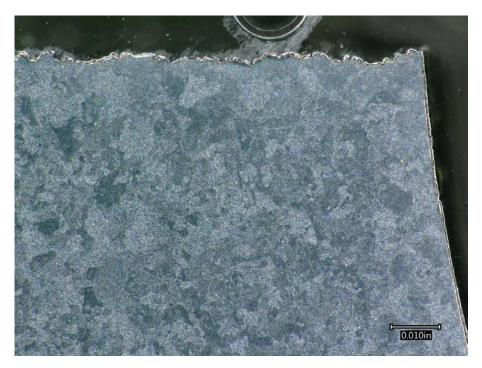
Examination of the prepared samples using a digital microscope revealed a variable grain size that resulted in a patchy appearance (Figures 92 through 94). In the fatigue fracture region, the crack path was relatively straight (flat), with a slightly jagged appearance at higher magnifications (Figure 92). The fast fracture region on the opposite side of the cooling passage exhibited a coarser (more jagged) fracture morphology (Figure 93). Similarly, the cross section through the fast fracture away from the crack origin was jagged in appearance (Figure 94).

Figure 92. Additional digital microscope images of the fatigue fracture region on the cross section shown in Figure 91. The crack path is relatively straight, and slightly jagged at higher magnifications. In these images, variations in the grain size are evident across the polished sample surface. (Etchant: Nital)

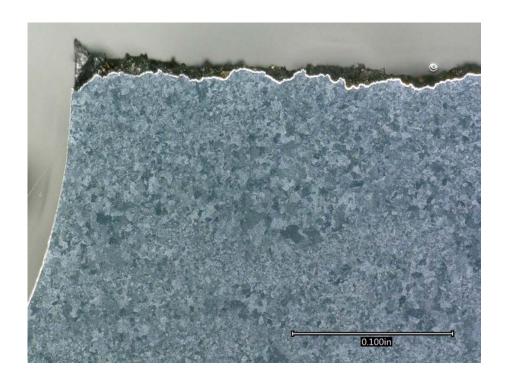
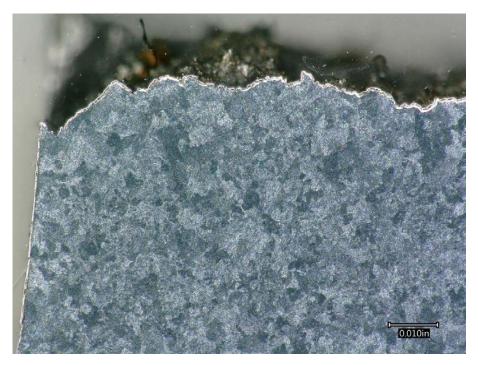
Figure 93. Additional digital microscope images of the fast fracture region on the cross section shown in Figure 91. At this location, which is on the opposite side of the cooling passage from the crack origin area, the crack path is relatively jagged. In these images, variations in the grain size are evident across the polished sample surface. (Etchant: Nital)

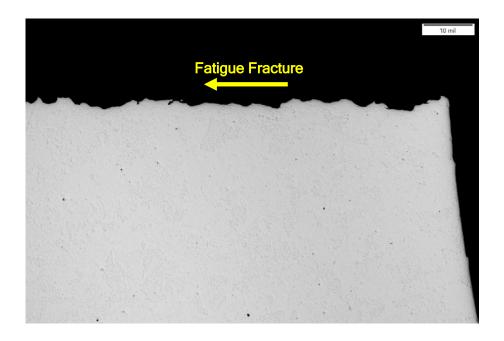
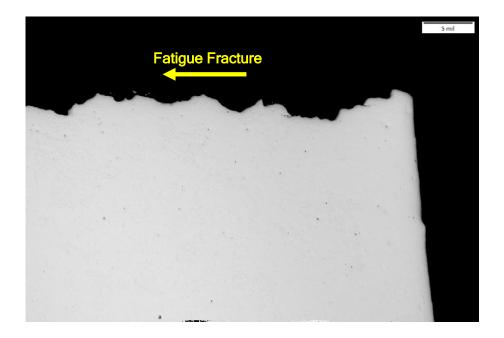
Examination of the fatigue fracture region using a metallographic microscope revealed a similar crack morphology, with a slightly jagged appearance across the sample (Figures 95 through 97).

Figure 95. Metallograph images of the fatigue fracture region near the cooling passage, which is visible at the right side. The crack path is relatively straight, and slightly jagged at higher magnifications. (Unetched)

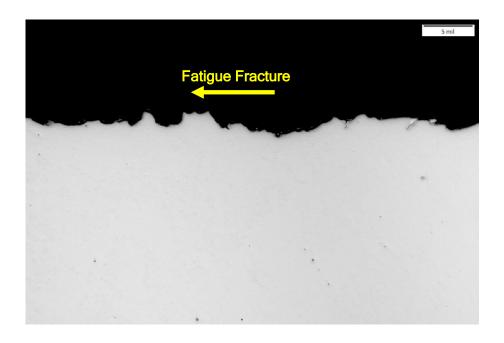
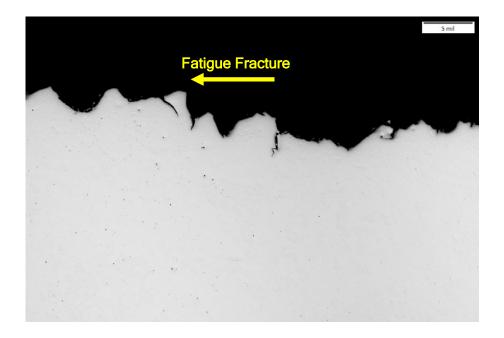
Figure 96. Higher magnification metallograph images of the fatigue fracture at locations along the crack path. In some locations, short secondary cracks or tears are evident. (Unetched)

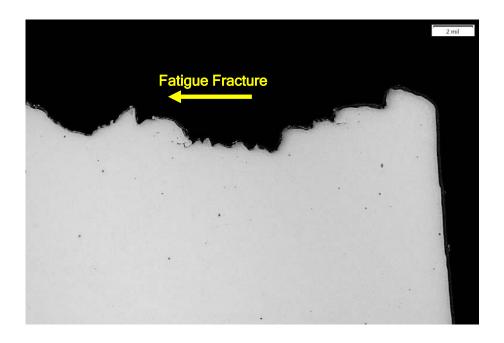
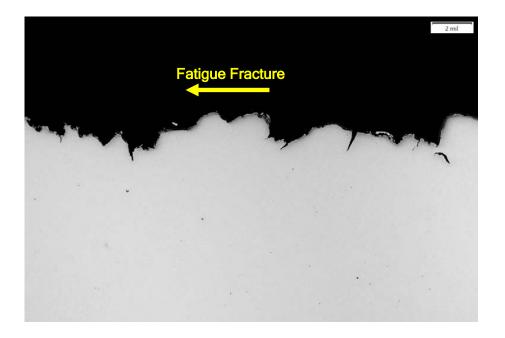
Figure 97. Higher magnification metallograph images of the fatigue fracture at locations adjacent to the cooling passage (upper image) and along the crack path (lower image). In some locations, short secondary cracks or tears are evident. (Unetched)

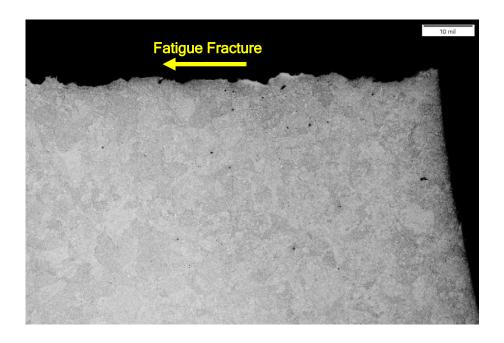
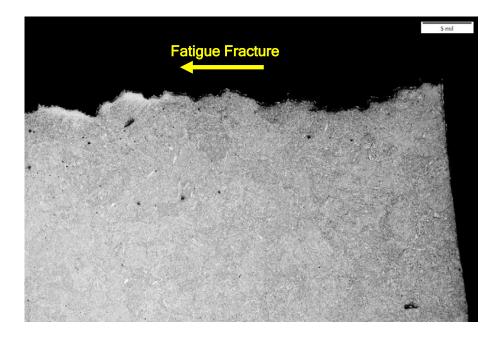
Etching the sample revealed a tempered martensite microstructure with more pronounced inclusions (emphasized by the etching process) (Figures 98 through 101). Although the grain size was variable within the sample, there was no correlation of microstructural variations with the crack path.

Figure 98. Metallograph images of the fatigue fracture region near the cooling passage, after etching to reveal the microstructure. The crack path is relatively straight, and slightly jagged at higher magnifications. Etched inclusions are also evident as dark features. (Etchant: Nital)

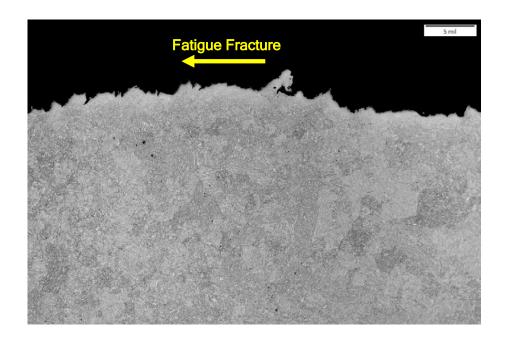
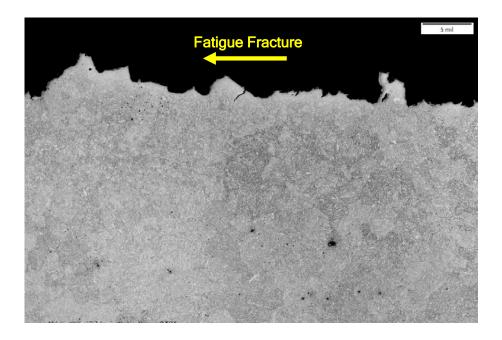
Figure 99. Higher magnification images of features along the fatigue crack path. Etched inclusions are also evident as dark spots. (Etchant: Nital)

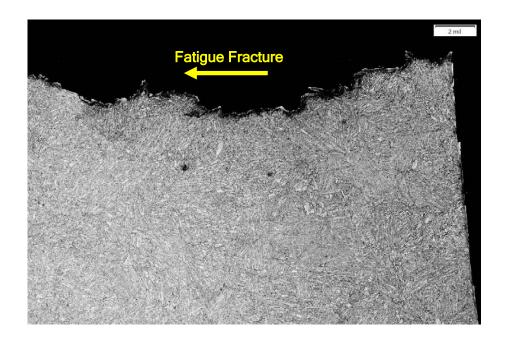
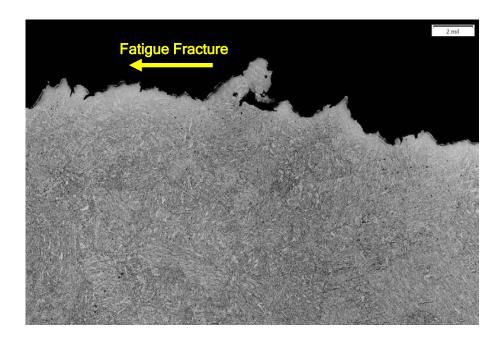
Figure 100. Higher magnification images of features near the cooling passage (upper image) and along the fatigue crack path (lower image). (Etchant: Nital)

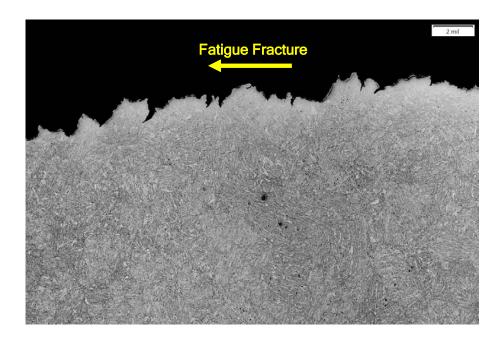
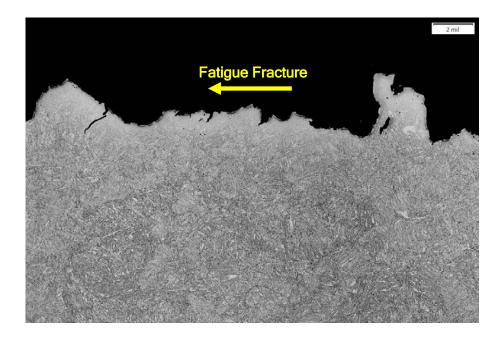
Figure 101. Additional higher magnification images of features along the fatigue crack path. (Etchant: Nital)

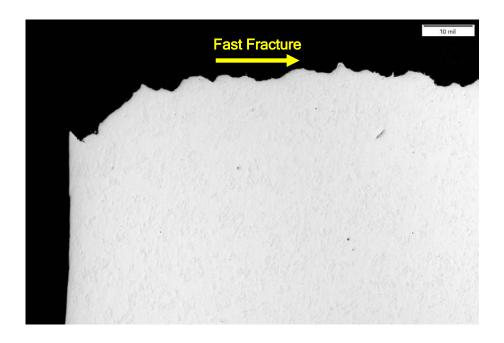
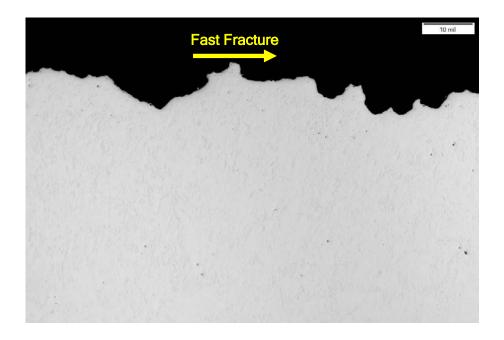
The fast fracture region on the opposite side of the cooling passage was more jagged in appearance with very few secondary cracks or tears (Figures 102 and 103). Dispersed small inclusions were present in the sample, with no indications of internal cracks or fissures.

Figure 102. Metallograph images of the fast fracture region on the opposite side of the cooling passage from the crack origin area. The crack path is relatively jagged in appearance. (Unetched)

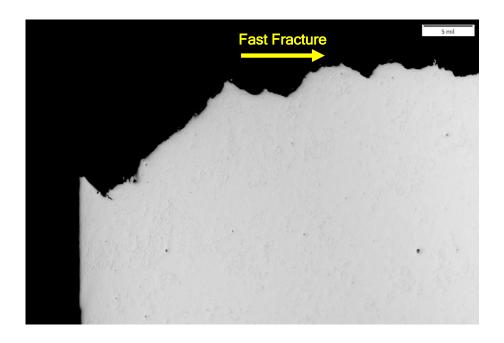
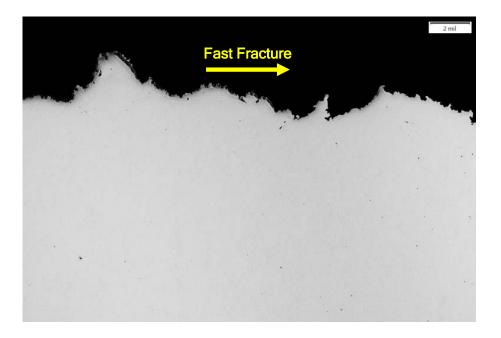
Figure 103. Higher magnification images of the fast fracture region on the opposite side of the cooling passage from the crack origin area. (Unetched)

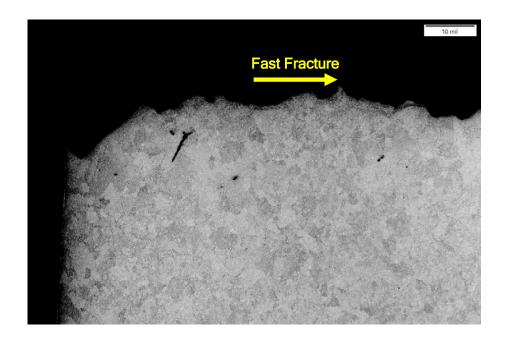
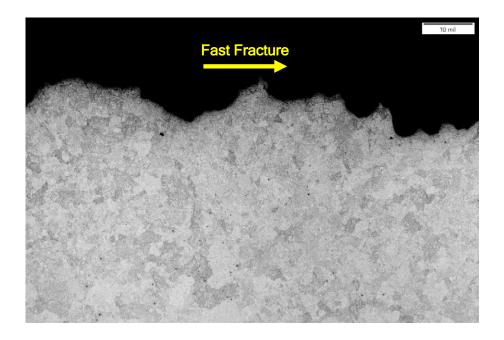
In the etched condition, the fast fracture region revealed no correlation of microstructural variations with the crack path (Figures 104 and 105). The etching process highlighted many of the inclusions as dark spots, as well as a larger dark feature that was an artifact of the etching process (i.e., not associated with an inconclusion).

Figure 104. Views of the fast fracture region near the cooling passage, after etching to reveal the microstructure. The crack path is relatively jagged in appearance. The dark feature in the upper image is an artifact of the etching process. (Etchant: Nital)

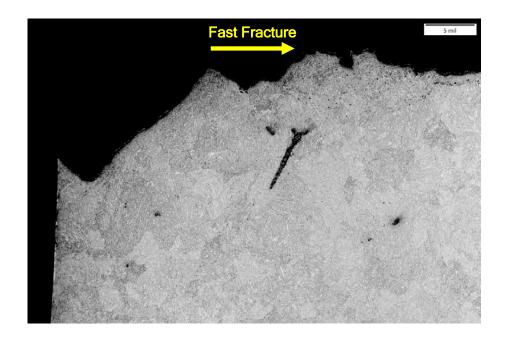
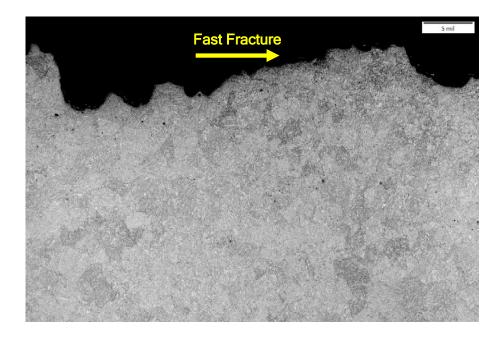
Figure 105. Higher magnification images of the fast fracture region on the opposite side of the cooling passage from the crack origin area. The dark feature in the upper image is an artifact of the etching process. (Etchant: Nital)

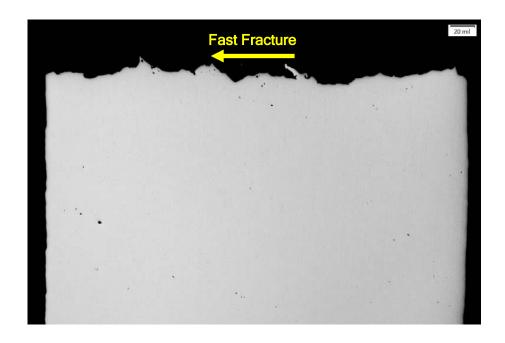
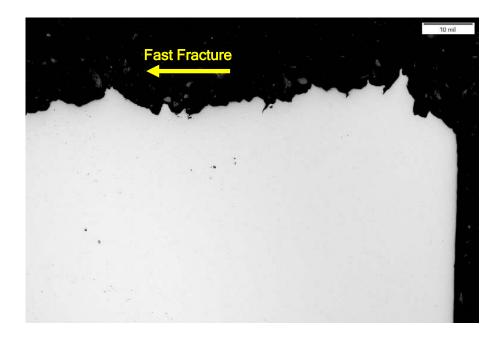
The remote fast fracture region in the unetched condition also exhibited a jagged fracture morphology, but with a higher number of secondary cracks or tears (Figures 106 through 109). Some of these were up to about 5 or 10 mils (0.005 to 0.010 inches) in length (e.g., Figure 107, lower image). Dispersed inclusions were present in the ring metal, but no internal cracks or fissures were observed.

Figure 106. Metallograph images of the fast fracture region shown at the left side of the upper image of Figure 91. The crack path is relatively jagged in appearance. (Unetched)

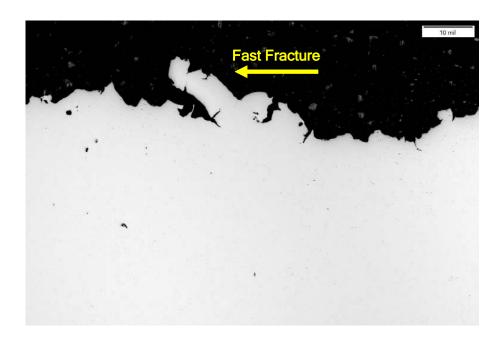
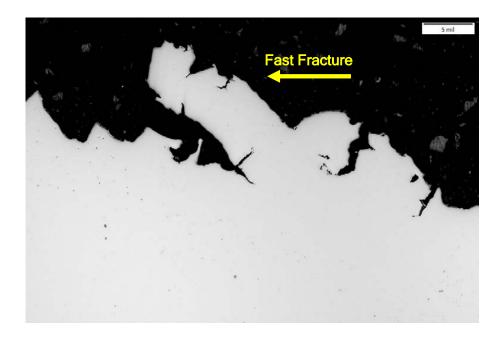
Figure 107. Additional metallograph images of features along the crack path shown in Figure 106. (Unetched)

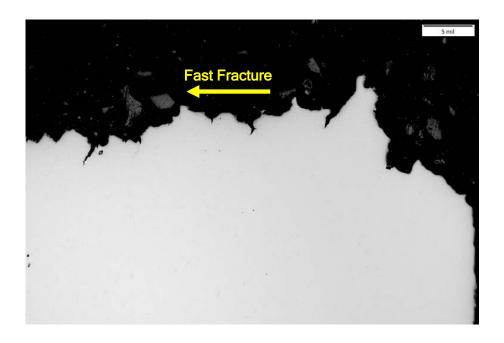
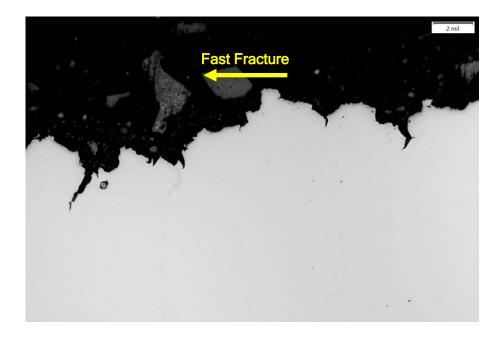
Figure 108. Additional metallograph images of features along the crack path shown in Figure 106. (Unetched)

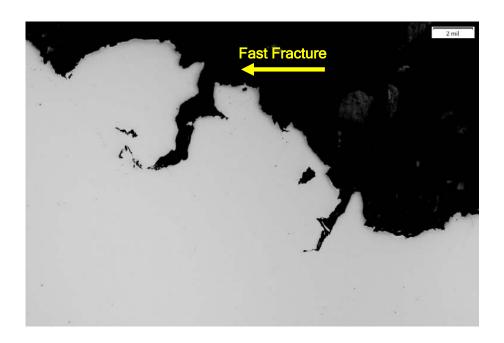
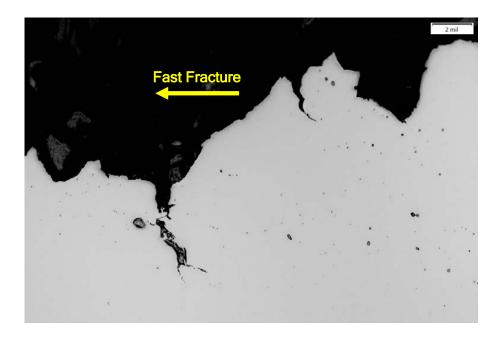
Figure 109. Higher magnification images of features along the crack path shown in Figure 106. (Unetched)

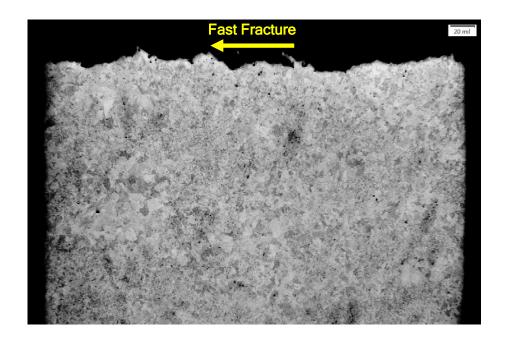
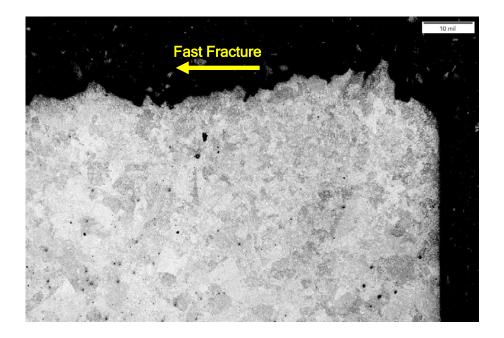
After etching, the remote fast fracture region exhibited a variable microstructure with a patchy appearance, but with no correlation between the grain structure and crack path (Figures 110 through 113). The etching process also highlighted many of the inclusions throughout the sample.

Figure 110. Metallograph images of the fast fracture region shown at the left side of the upper image of Figure 91, after etching to reveal the microstructure. The crack path is relatively jagged in appearance. Etched inclusions are also evident as dark features. (Etchant: Nital)

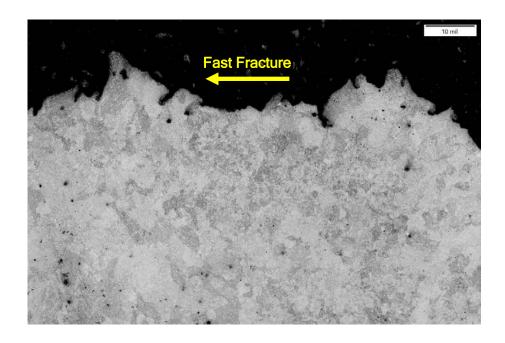
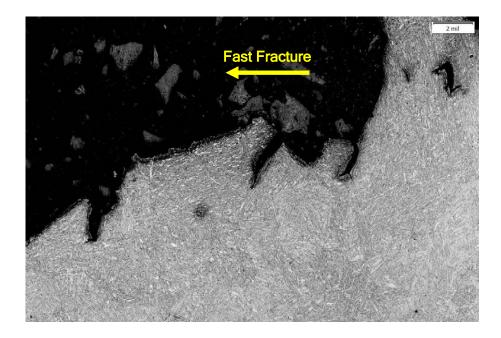
Figure 111. Additional metallograph images of features along the crack path shown in Figure 110. Etched inclusions are also evident as dark features. (Etchant: Nital)

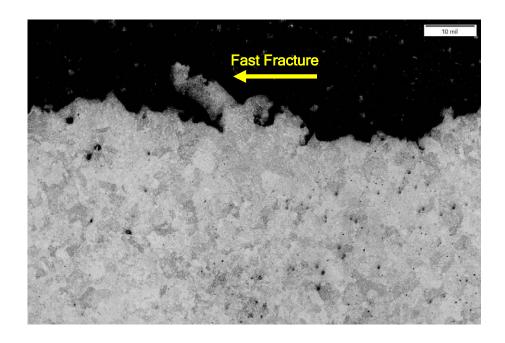
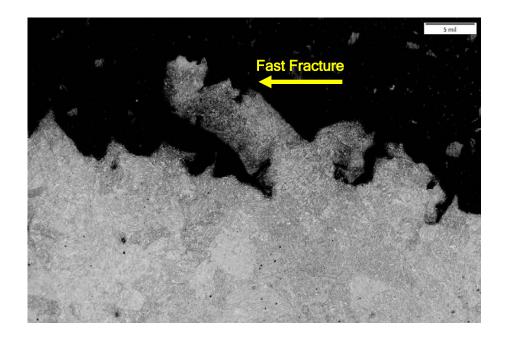
Figure 112. Additional metallograph images of features along the crack path shown in Figure 110. Etched inclusions are also evident as dark features. (Etchant: Nital)
