RE: RIVERSIDE ROOT CAUSE ANALYSIS REPORT

Root Cause Investigation Report

Riverside Generating Station - Unit 7

REPORT NO. 2551958.401 Metallurgical Analysis of Failed Retaining Ring Riverside Generating Station - Unit 7

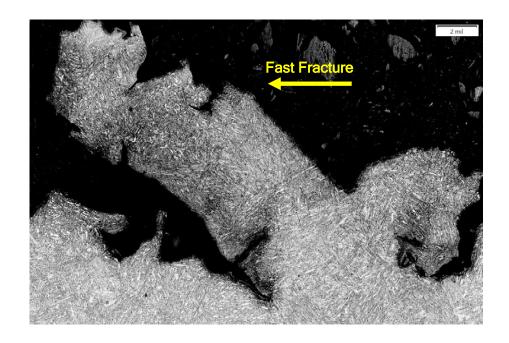
After etching, the remote fast fracture region exhibited a variable microstructure with a patchy appearance, but with no correlation between the grain structure and crack path (Figures 110 through 113). The etching process also highlighted many of the inclusions throughout the sample.

Figure 113. Higher magnification images of features along the crack path shown in Figure 110. (Etchant: Nital)

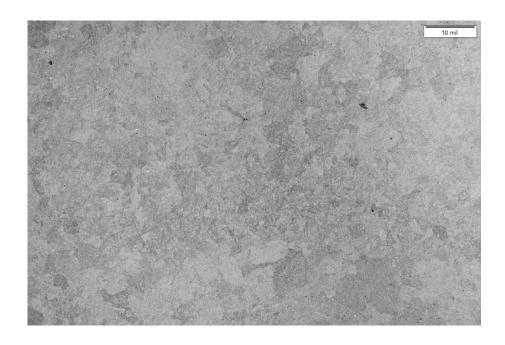
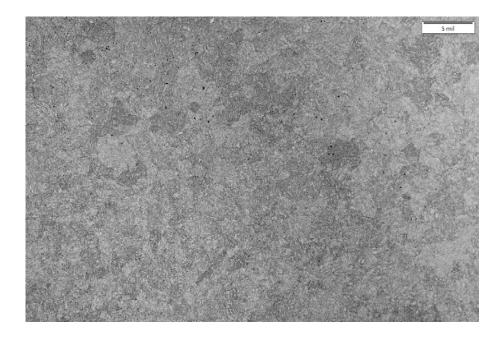
Overall, the typical microstructure of the retaining ring consisted of tempered martensite with scattered non-metallic inclusions (Figures 114 and 115). The density of inclusions seemed to vary, with some locations exhibiting many small, round features in the same general area. However, the observed microstructural features did not appear to have any correlation with the crack path within the retaining ring.

Figure 114. Metallograph images showing the typical retaining ring microstructure. The microstructure consisted of tempered martensite with variable grain size and with scattered nonmetallic inclusions. (Etchant: Nital)

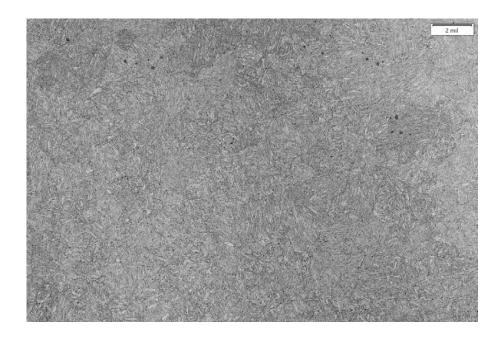
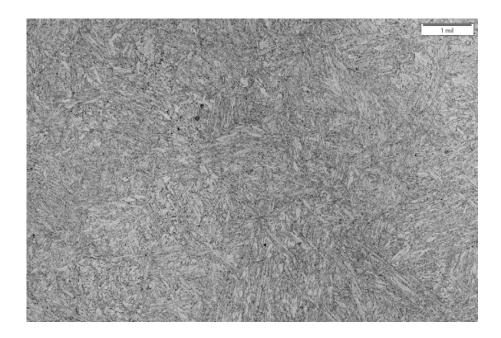
Figure 115. Higher magnification images showing the typical retaining ring microstructure. The microstructure consisted of tempered martensite with variable grain size and with scattered nonmetallic inclusions. (Etchant: Nital)
