GE International, Inc.

DESCRIPTION	AMOUNT
SHERBURNE COUNTY GENERATING STATION BECKER, MN UNIT #3, TURBINE S/N 170X819 L-1 BUCKET UPGRADE, NON-DESTRUCTIVE ROTOR EXAMINATION, FIELD ENGINEERING SERVICES	1,300,000.00
<p>FIRM PRICE:</p> <p>MATERIAL PO PN613MM \$1,800,000.00 LABOR PO PN7053MS \$550,000.00</p> <p>*** SEPERATE INVOICE FOR TAX TO BE ISSUED AT COMPLETION OF WORK SCOPE ***</p>	
TO INVOICE FOR PAYMENT #2 UPON SHIPMENT OF BUCKETS	1,300,000.00

TECHNICAL INFORMATION LETTER

To inform users of need to inspect low pressure rotor wheel dovetails on steam turbines to detect possible Stress Corrosion Cracking.

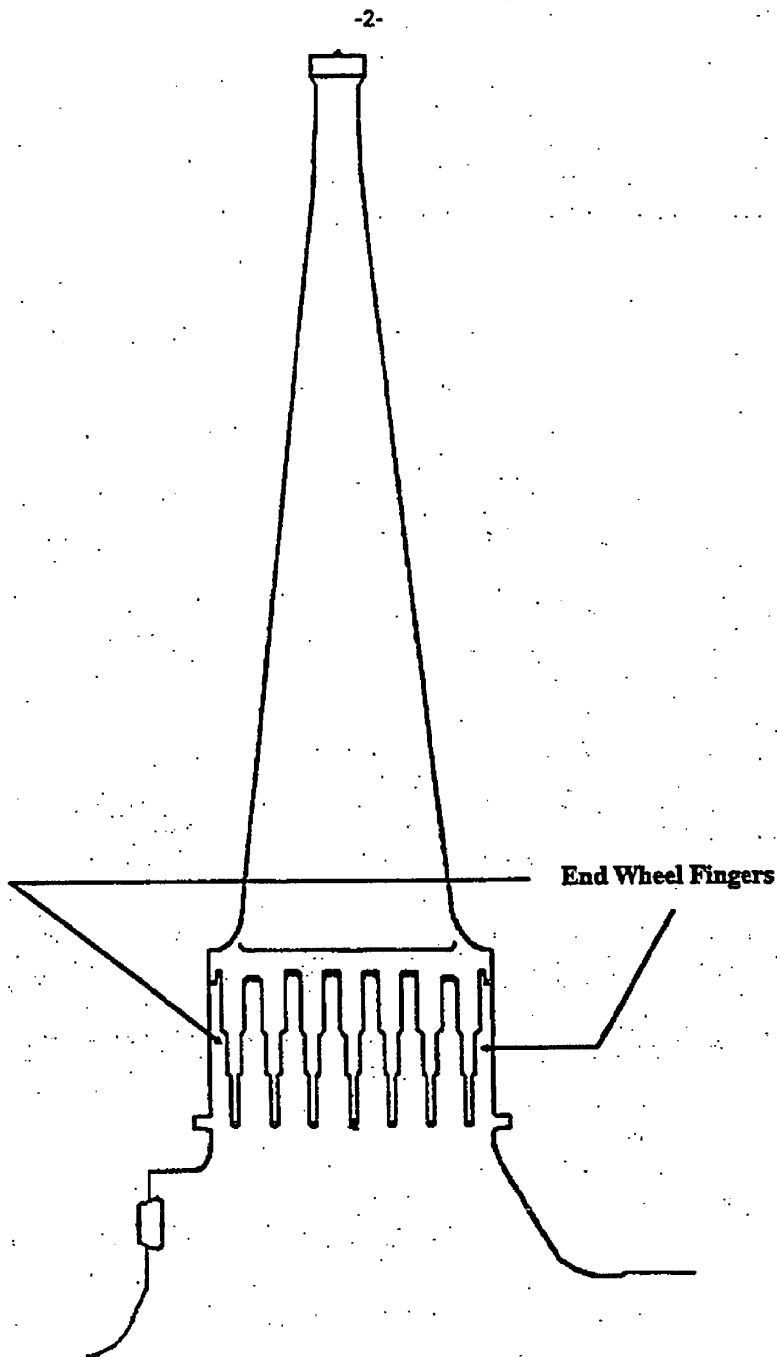
Figure 1
Steam Turbine Rotor Wheel
with Finger Dovetails

2. Abnormal events or operational anomalies that cause concern for long term reliability of the unit may be reason to consider removal of buckets, before normal replacement, for MPI of the dovetail area. Abnormal events or operational anomalies are any out-of-the-ordinary occurrences, during operation or maintenance, which may increase the risk of stress corrosion and/or fatigue cracking, such as but not limited to the following:

- a. caustic or chemical ingestion or contamination
- b. carryover from boiler
- c. leaking condenser heater tube
- d. overspeeds
- e. water ingestion

1. Whenever buckets are removed, a detailed MPI should be performed on the rotor wheel finger dovetails in accordance with the attached procedure. This inspection should be performed as early as possible within the outage period, and the test results sent immediately to GE for evaluation and recommendations. Your local GE field service representative can forward the data to the proper GE organization, and can also provide assistance with obtaining testing services.

Although GE will perform the attached MPI, it is not necessary that GE do so. It is highly recommended that, regardless of who performs the inspection, the attached procedure be followed.

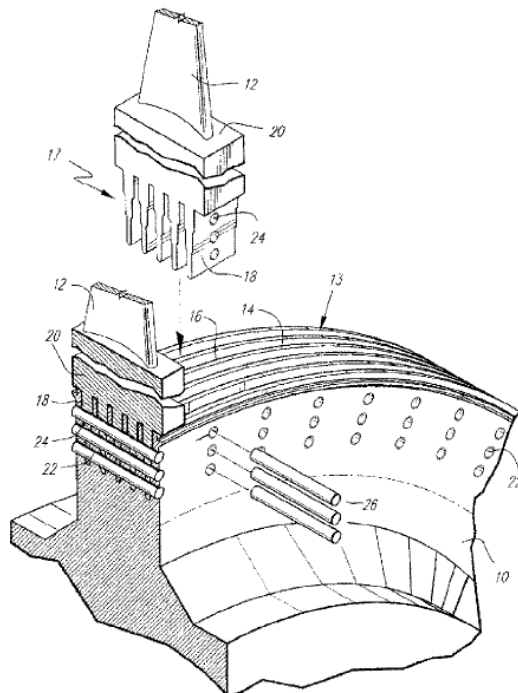
Figure 1: Finger dovetail attachment configuration.

Over the past several years, cases of Intergranular Stress Corrosion Cracking (SCC) have been observed in low pressure dovetails of fossil fueled steam turbine units with drum boilers. These rotors had been in service for extended periods. Several of the cases have involved L-1 stage finger dovetails, Figure 1.

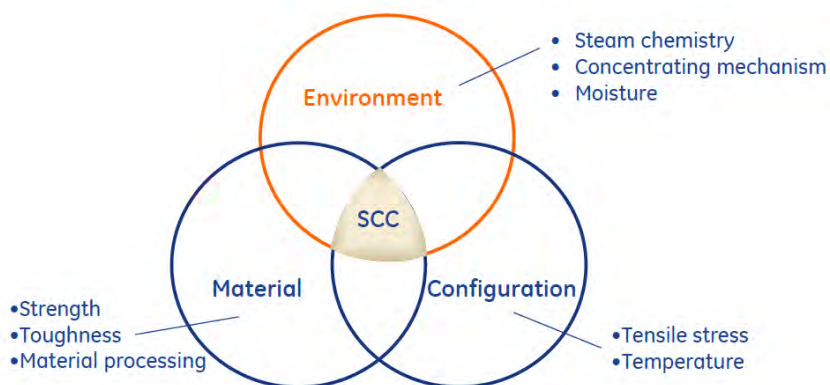
Figure 2: Conditions typically necessary for stress corrosion cracking to occur.

Units with drum boilers, including heat recovery steam generators, may be susceptible to SCC. There are many factors that influence SCC, including condensate polisher type and feed water treatment histories. Specific recommendations for maintenance of steam chemistry may be found in GEK 72281. The most vulnerable location in the steam turbine for SCC is believed to be the Wilson line, or the point at which saturation occurs. This region is typically the L-1 or L-2 stage for conventional reheat steam turbines. The quality of the steam, or moisture level, at the L-0 stage is typically such that water droplets preclude the formation of corrosive deposits on the wheel dovetail surfaces. For these reasons, incidents of SCC in L-0 wheel finger dovetails are extremely limited whereas multiple incidents of SCC in L-1 wheel finger dovetails have been observed.
