RE: In the Matter of Otter Tail Power Company 2015 Annual Safety, Reliability and Service Quality Report and Proposed SAIFI, SAIDI and CAIDI Reliability Standards for 2016
Docket No. E017/M-16-___

Docket No. E017/M-16-_____

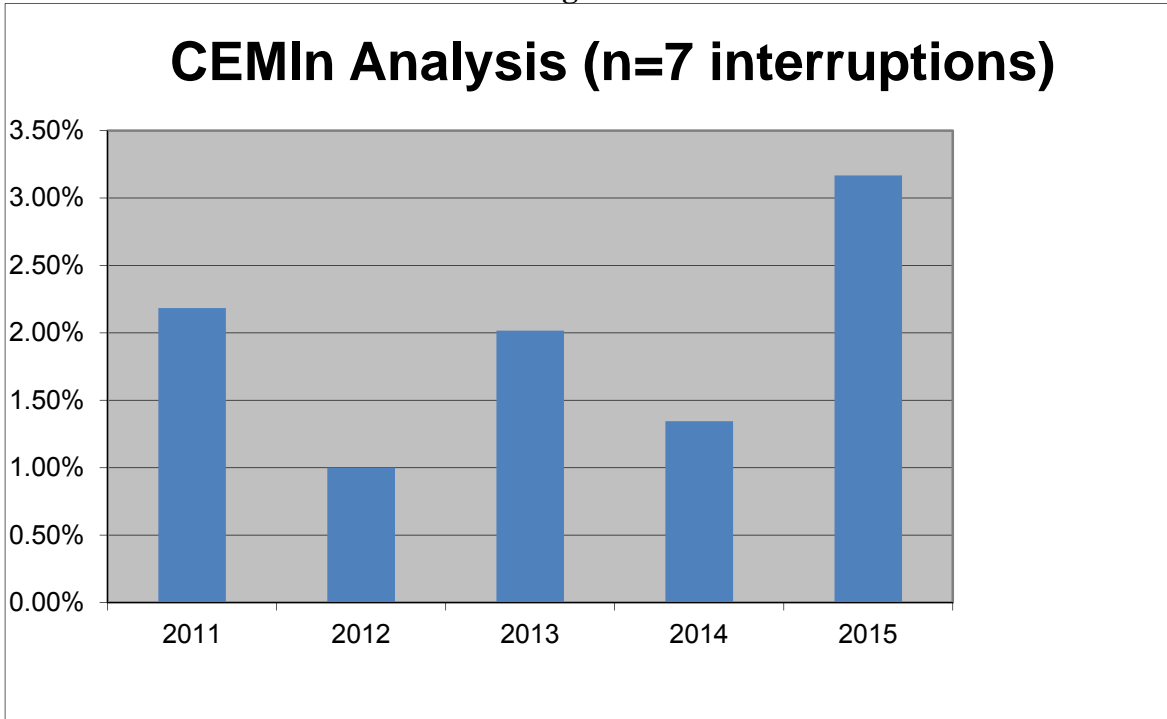
Figure 8

3. **Measuring reliability:** Otter Tail continues to calculate the Customers Experiencing Multiple Interruptions (CEMI_n) index. The CEMI_n index is an excellent indicator of how system improvements directly affect customer service. Deployment of resources on worst performing circuits has direct effects on the reliability indices and customer reliability. **Figure 8** shows the system CEMI_n results from 2011 to 2015. This graph shows how many customers on a company-wide basis experienced seven or more interruptions. For example in 2015 the percentage of customers experiencing seven or more interruptions was just over 3 percent, compared to 2014, which was 1.3 percent.
