**RE: In the Matter of Otter Tail Power Company 2019 Annual Safety, Reliability and Service Quality Report and Proposed SAIFI, SAIDI and CAIDI Reliability Standards for 2020
Docket No. E017/M-20-**

Safety, Reliability, and Service Quality Report for 2019

Proposed SAIFI, SAIDI, and CAIDI
Reliability Standards for 2020
Including Additional Compliance Obligations

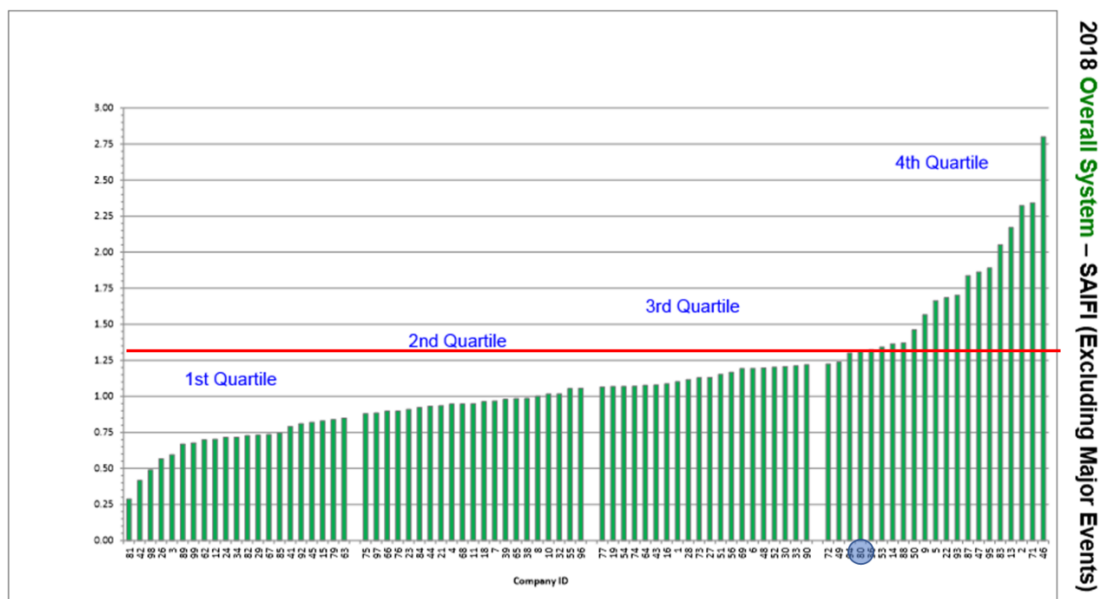
Figure 10

The 2018 EEI Reliability Survey collected data from 99 utility companies. Summarizing, Otter Tail performs in the first quartile for CAIDI, Mid quartiles for SAIDI, and bottom quartiles for SAIFI and MAIFI. **Figure 10** through **Figure 13** below, provide a visual summary of charts indicating where Otter Tail (#80) fits in terms of the benchmarked results. Otter Tail’s results are represented by the red line on the bar graphs. Note that there are fewer respondents for the MAIFI survey due to participating utilities lack of reporting regarding this index.
