**RE: In the Matter of Otter Tail Power Company 2016 Annual Safety, Reliability and Service Quality Report and Proposed SAIFI, SAIDI and CAIDI Reliability Standards for 2017  
Docket No. E017/M-17-**

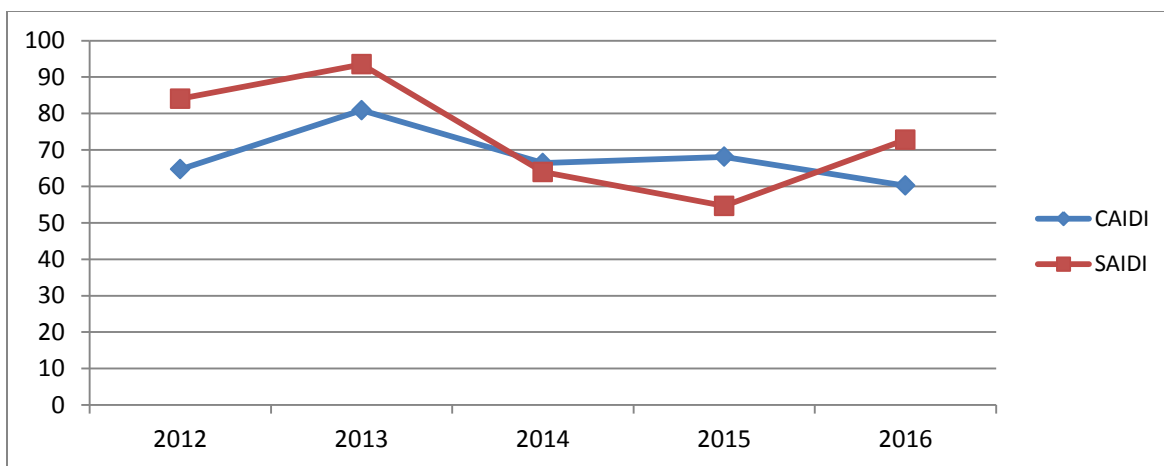
**Figure 1 - Historic Minnesota SAIDI and CAIDI**

Otter Tail Power MN Customers saw improvement in CAIDI and an increase in SAIDI for 2016 compared to 2015 results.

As previously included Otter Tail provides a summary table that allows the reader to more easily assess the overall reliability of the system and identify the main factors that affect reliability. Figure 1 through Figure 6 below provides a brief summary of Otter Tail's overall reliability and service quality for the years 2012 through 2016.

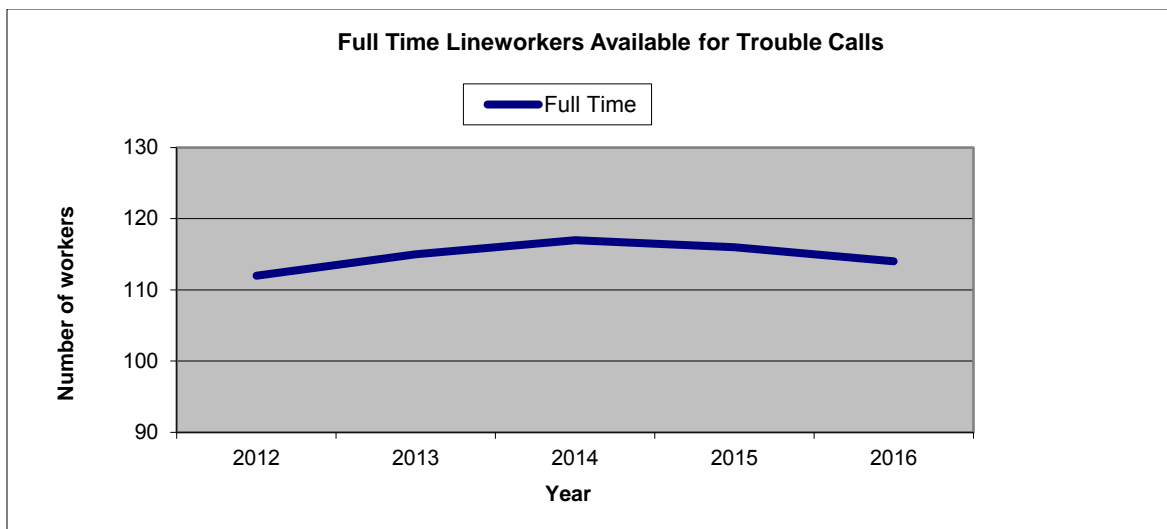
**Figure 7** below depicts by year the number of full time line workers available for trouble and for the operation and maintenance of distribution lines.

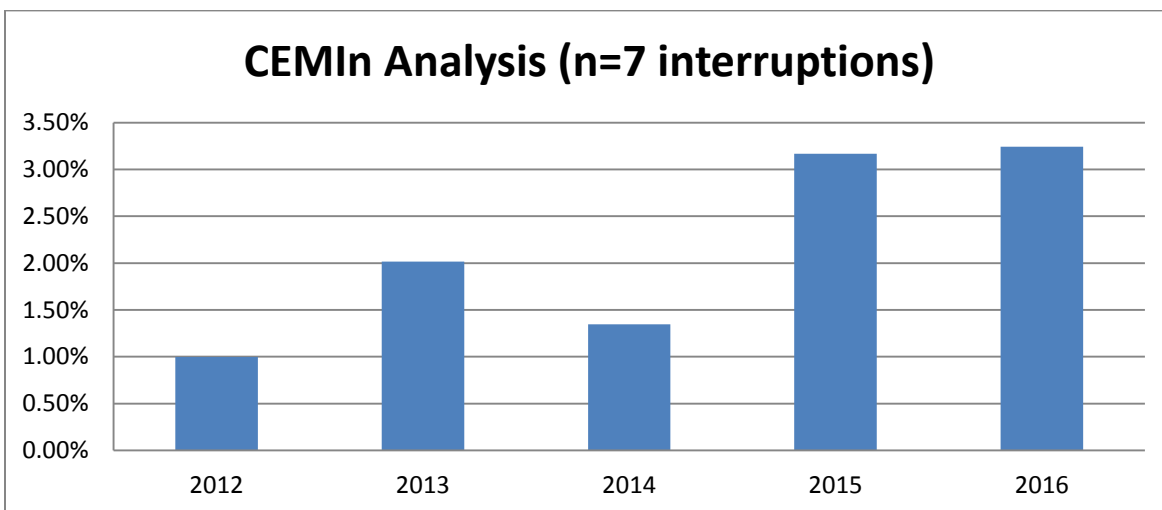
- 3. Measuring reliability:** Otter Tail continues to calculate the Customers Experiencing Multiple Interruptions (CEMIn) index. The CEMIn index is an excellent indicator of how system improvements directly affect customer service. Deployment of resources on worst performing circuits has direct effects on the reliability indices and customer reliability. **Figure 8** shows the system CEMIn (n = 7 interruptions) results from 2012 to 2016. This graph shows how many customers on a company-wide basis experienced seven or more interruptions. For example in 2016 the percentage of customers experiencing seven or more interruptions was just over 3.24 percent, compared to 2015, which was 3.17 percent.

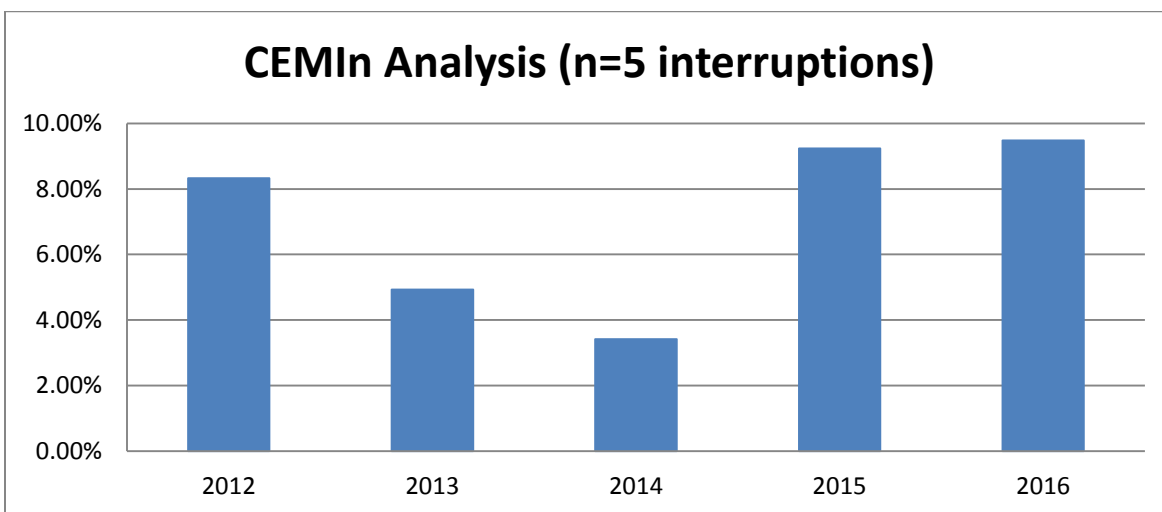
**Figure 9** below shows the percentage of customers on a company-wide basis who have experienced five or more sustained interruptions.

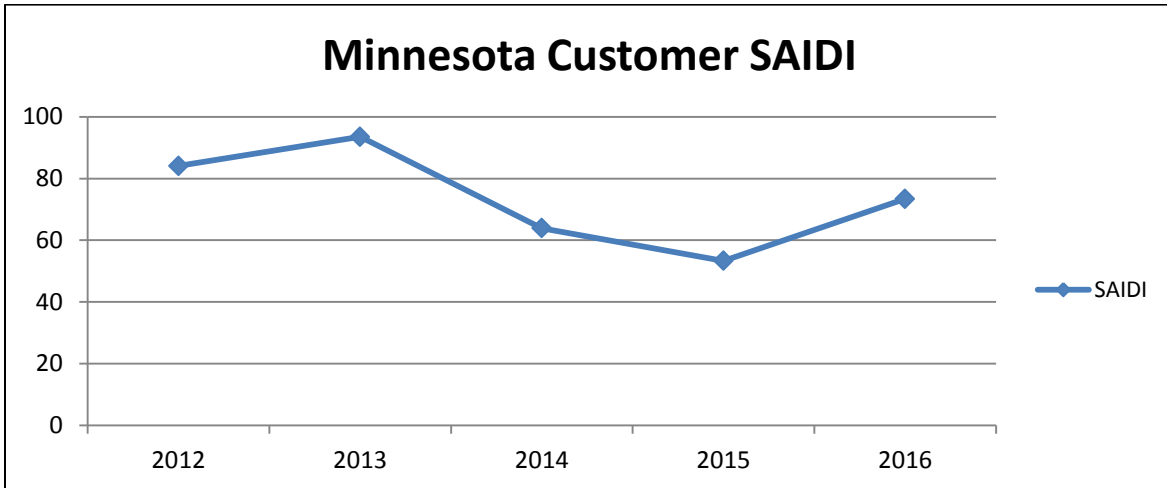
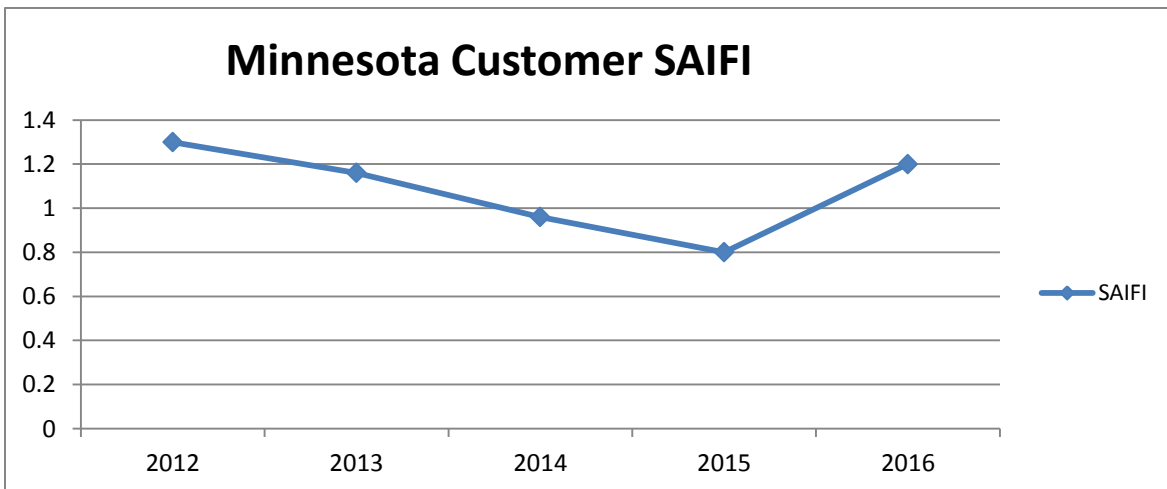
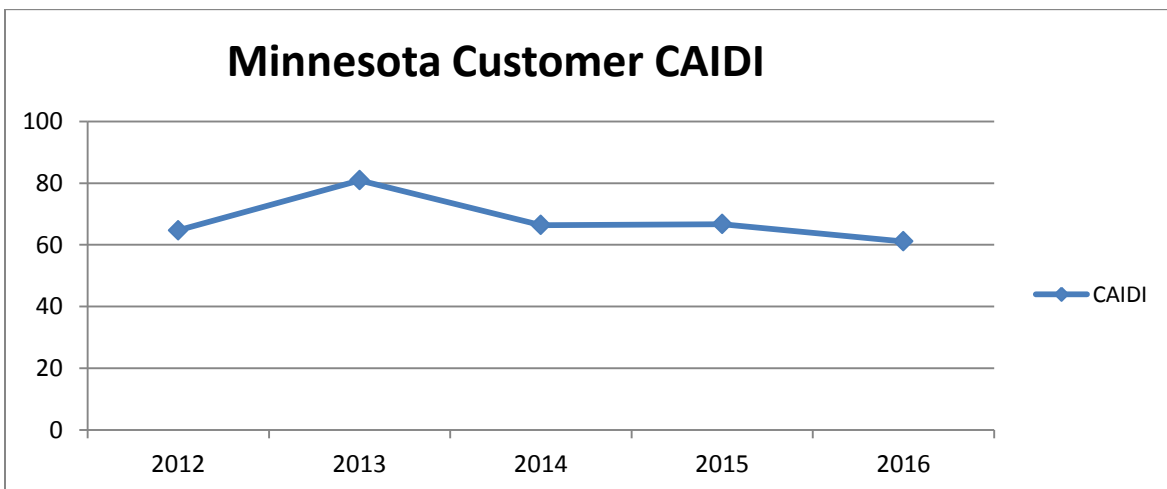
**Figures 10, 11, and 12.** The following graphs show Otter Tail’s SAIDI, SAIFI and CAIDI for the period of 2012 through 2016. When compared to 2015 results, Minnesota customers experienced an increase in overall SAIDI and SAIFI, while CAIDI was slightly lower.
