215 South Cascade Street  
PO Box 496  
Fergus Falls, Minnesota 56538-0496  
218 739-8200  
[www.otpc.com](http://www.otpc.com) (web site)

**RE: In the Matter of Otter Tail Power Company 2018 Annual Safety, Reliability and Service Quality Report and Proposed SAIFI, SAIDI and CAIDI Reliability Standards for 2019  
Docket No. E017/M-19-**

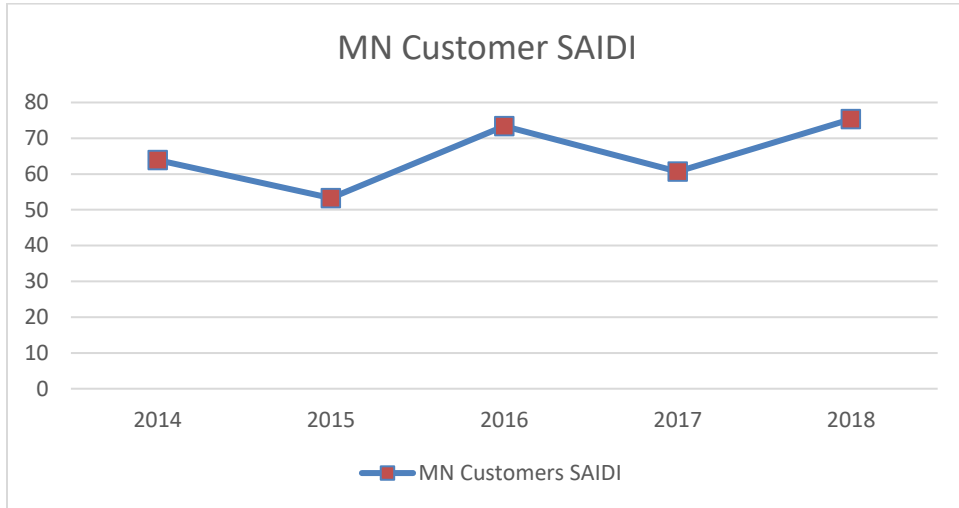
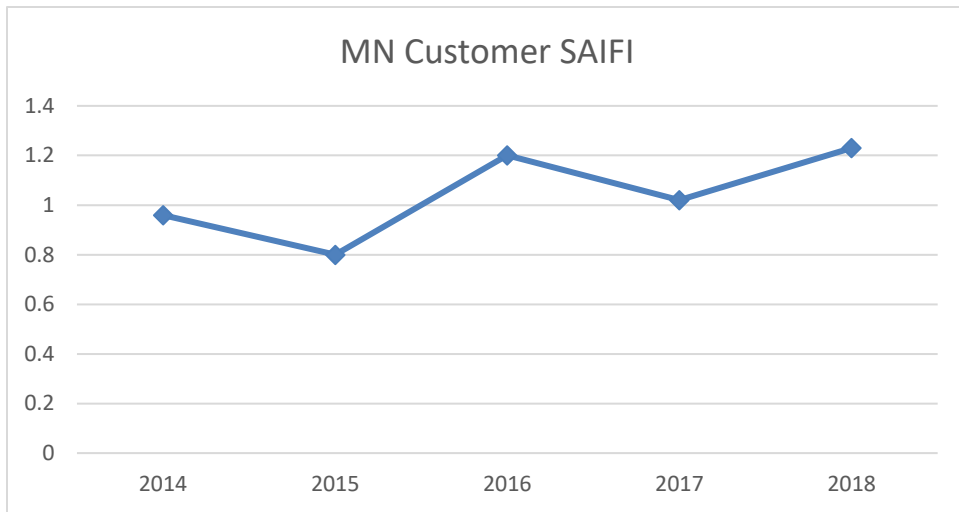
**Figures 10, 11, and 12.** The following graphs show Otter Tail’s SAIDI, SAIFI and CAIDI for the period of 2014 through 2018. When compared to 2017 results, Minnesota customers experienced an increase in overall SAIDI, SAIFI, and CAIDI.

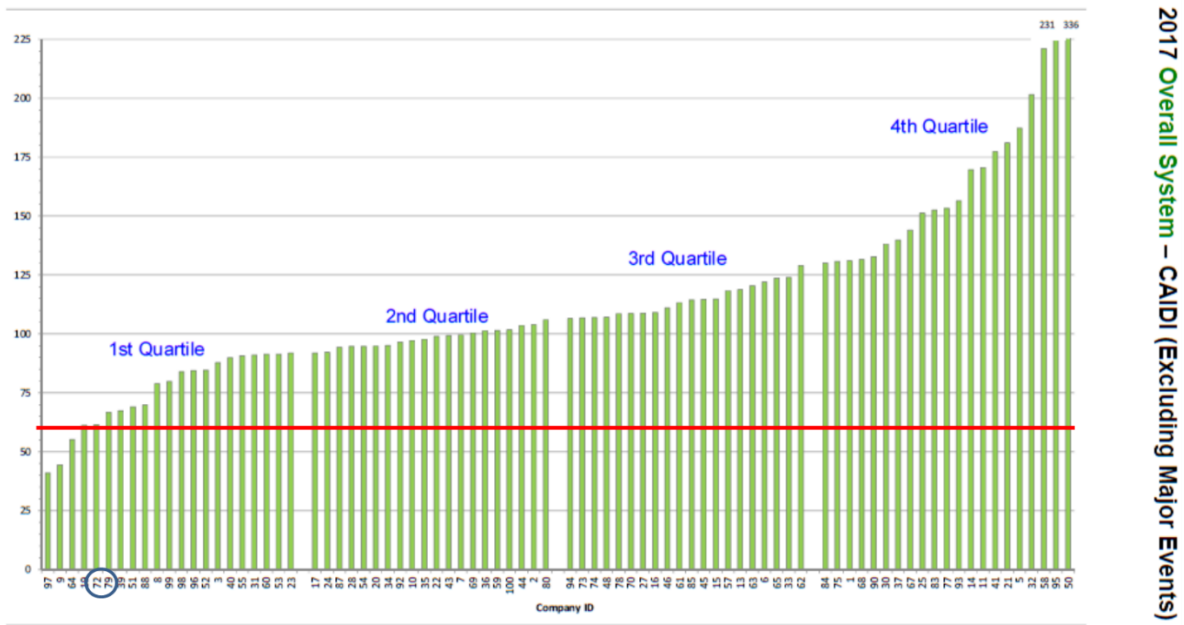
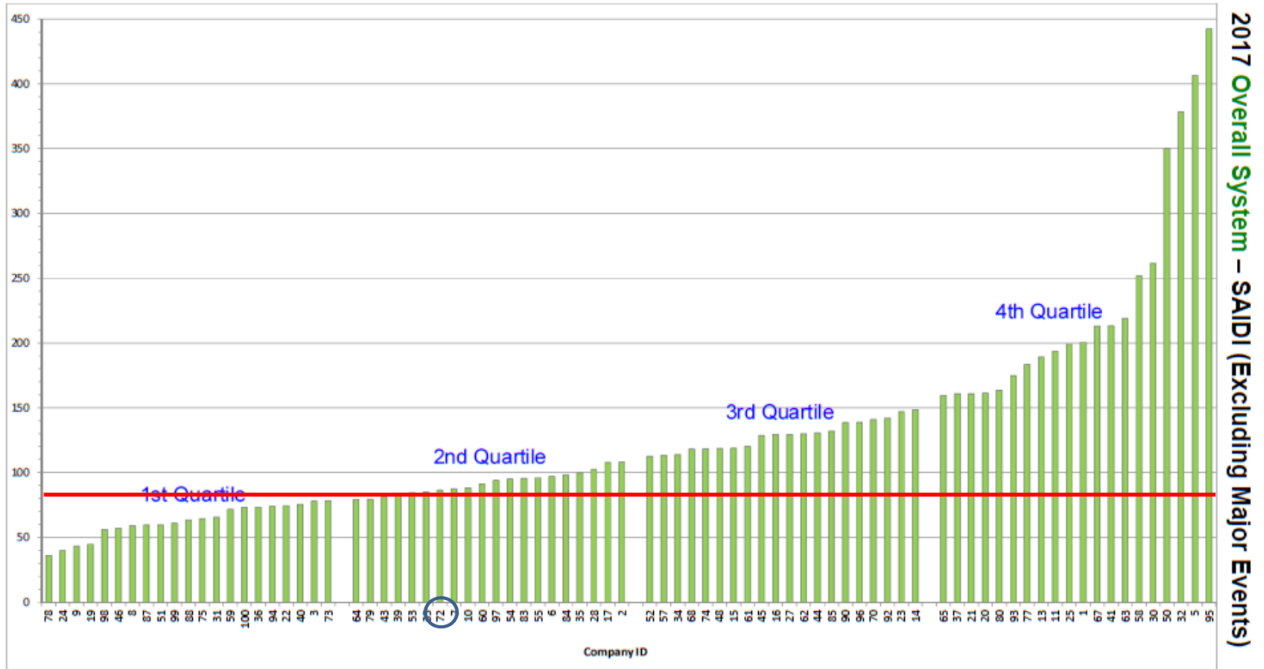
- 1. Benchmarking of Otter Tail's performance using the Institute of Electrical and Electronics Engineers (IEEE) reliability standards.** Otter Tail is a member of Edison Electric Institute (EEI) and has been participating in their Reliability Benchmark Survey for the past six years. Otter Tail provides the performance comparison utilizing the 2017 EEI Reliability Survey. The 2017 EEI Reliability Survey collected data from 89 utility companies. Summarizing, Otter Tail performs in the first quartile for CAIDI, Mid quartiles for SAIDI, and bottom quartiles for SAIFI and MAIFI. In **Figure 13** through **Figure 16** below is a visual summary of charts indicating where Otter Tail (#72) fits in terms of the benchmarked results. Otter Tail's results are represented by the red line on the bar graphs. Note that there are fewer respondents for the MAIFI survey due participating utilities lack of reporting regarding this index.
