**RE: In the Matter of Otter Tail Power Company 2017 Annual Safety, Reliability and Service Quality Report and Proposed SAIFI, SAIDI and CAIDI Reliability Standards for 2018
Docket No. E017/M-18-**

Docket No. E017/M-18-

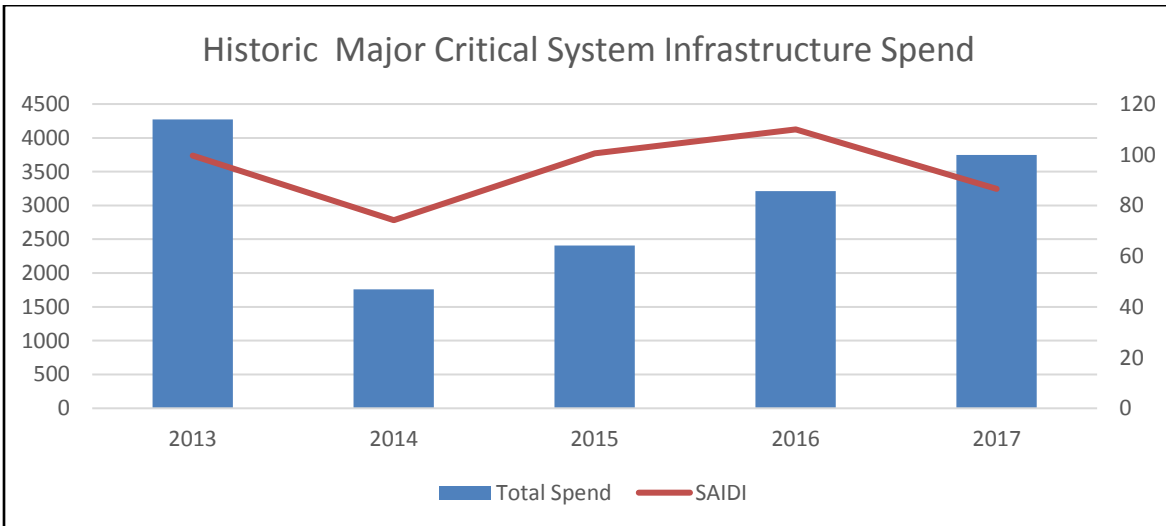
Figure 3 –Historic Expense of Major Critical System Infrastructure Items

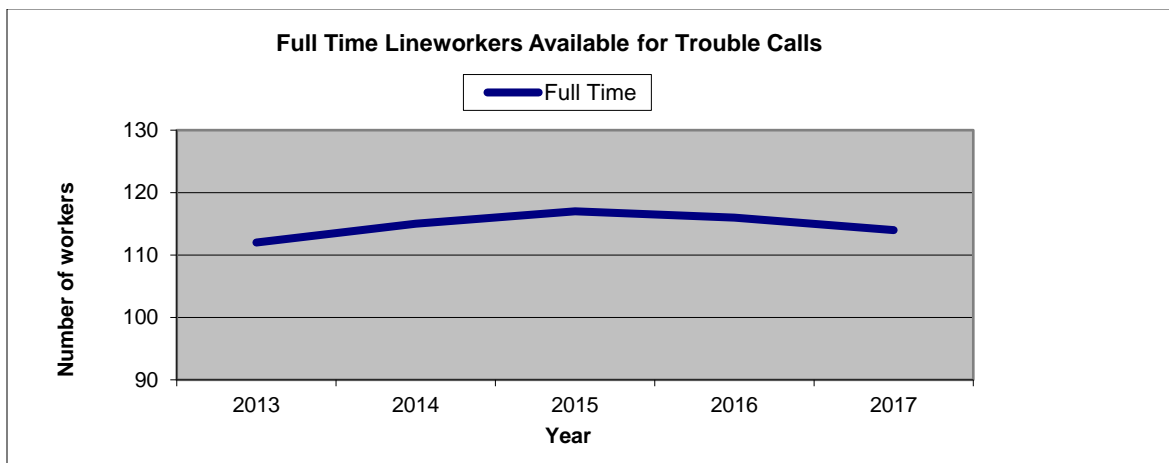
Figure 7 below depicts by year the number of full time line workers available for trouble and for the operation and maintenance of distribution lines. Otter Tail also has a reliability engineer who supports system reliability related functions. This individual is not included in the above staffing level information. Additionally, Otter Tail has engineers in its Asset Management area who, due to the nature of their roles, support reliability on a daily, weekly, monthly, and annual basis.

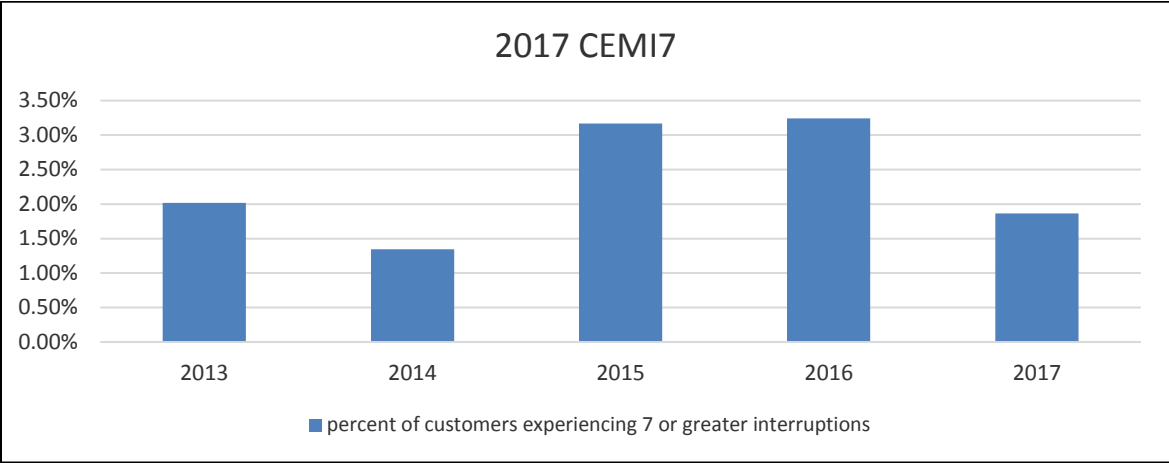
Figure 8

excellent indicator of how system improvements directly affect customer service. Deployment of resources on worst performing circuits has direct effects on the reliability indices and customer reliability. **Figure 8** shows the system CEMIn (n = 7 interruptions) results from 2013 to 2017. This graph shows how many customers on a company-wide basis experienced seven or more interruptions. For example, in 2017 the percentage of customers experiencing seven or more interruptions was just under 1.9 percent, compared to 2016, which was 3.24 percent.

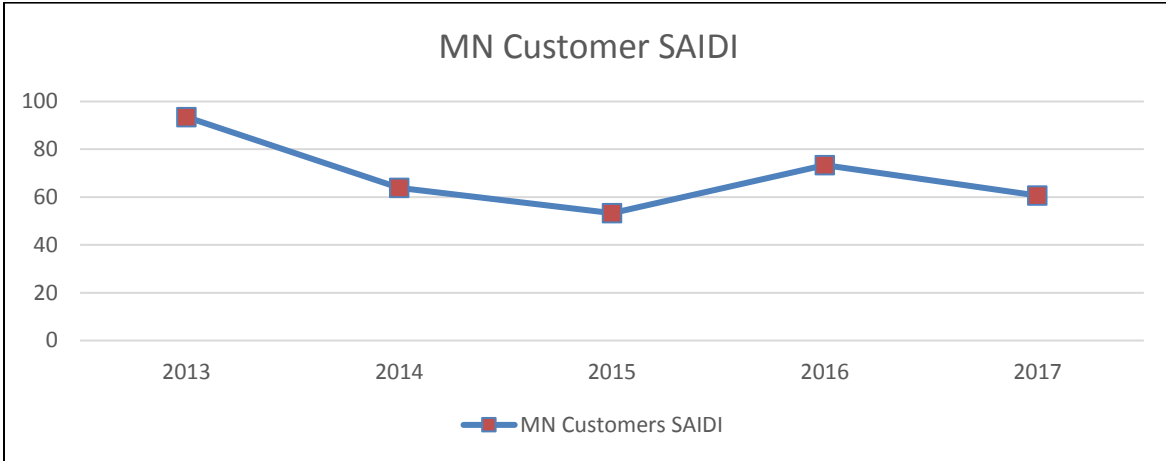
Figure 10

Figures 10, 11, and 12. The following graphs show Otter Tail’s SAIDI, SAIFI and CAIDI for the period of 2013 through 2017. When compared to 2016 results, Minnesota customers experienced a decrease in overall SAIDI, SAIFI, and CAIDI.

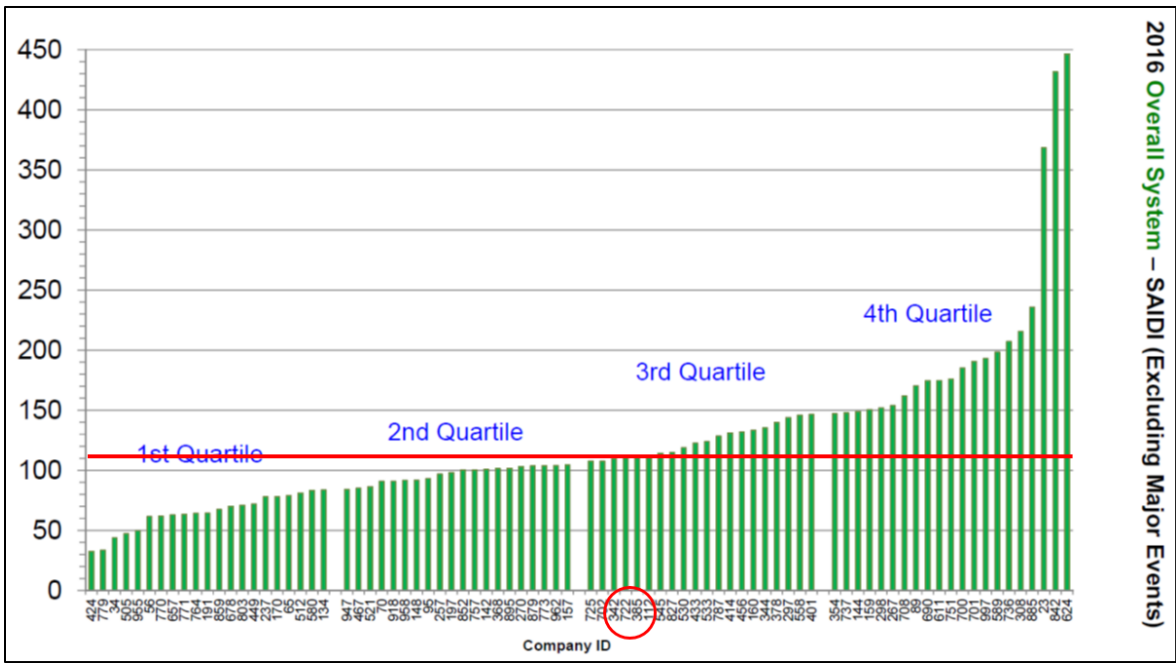
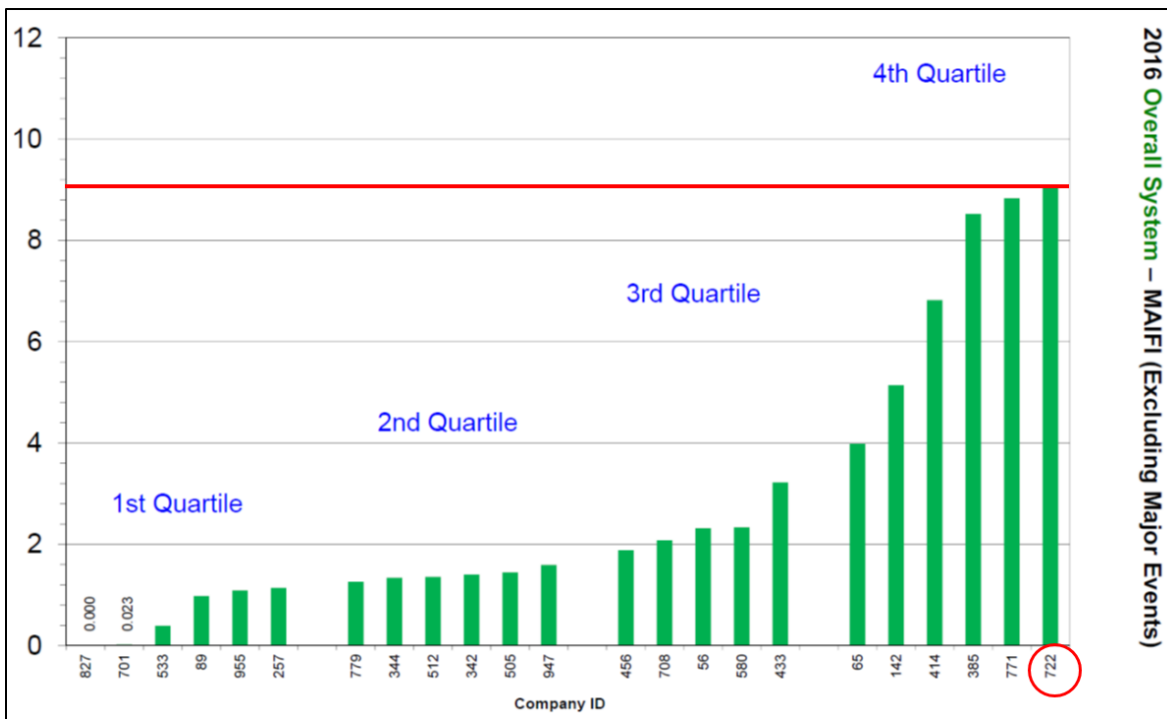
- A. **Benchmarking of Otter Tail’s performance using the Institute of Electrical and Electronics Engineers (IEEE) reliability standards.** OTP is a member of Edison Electric Institute (EEI) and has been participating in their Reliability Benchmark Survey for the past five years. OTP provides the performance comparison utilizing the 2016 EEI Reliability Survey. The 2016 EEI Reliability Survey collected data from 92 utility companies. Summarizing, OTP performs in the first quartile for CAIDI, Mid quartiles for SAIDI, and bottom quartiles for SAIFI and MAIFI. Below is a visual summary of charts indicating where OTP fits in terms of the benchmarked results. OTP’s results are represented by the red line on the bar graphs. Note that there are fewer respondents for the MAIFI survey due participating utilities lack of reporting regarding this index.
