RE: In the Matter of Otter Tail Power Company 2013 Annual Safety, Reliability and Service Quality Report and Proposed SAIFI, SAIDI and CAIDI Reliability Standards for 2014

#### II. OTTER TAIL 2012 SUMMARY GRAPHS

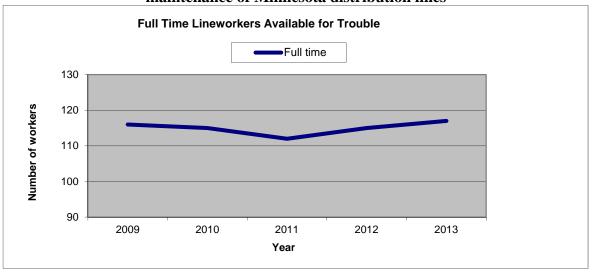
Figure 5 – Full Time Lineworkers available for trouble and for the operation and maintenance of Minnesota distribution lines

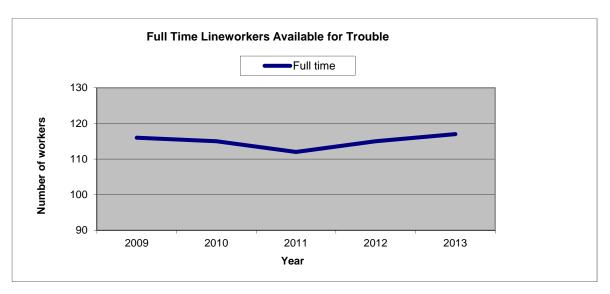
Figure 7

**Figure 7** below depicts by year the number of full time line workers available for trouble and for the operation and maintenance of distribution lines.

<sup>\*\*\*</sup>Operations Support is based in Fergus Falls and the field employees are dispatched to assist CSC's in need throughout the entire system. The office employees coordinate resources.

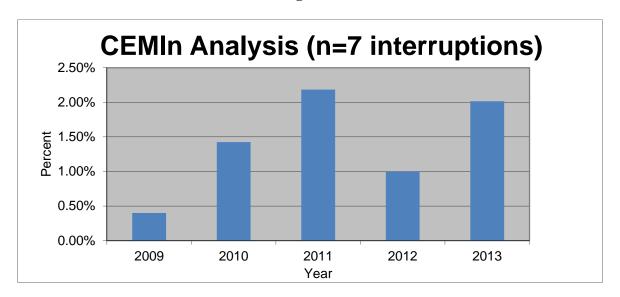
Figure 8

Deployment of resources on worst performing circuits has direct effects on the reliability indices and customer reliability. **Figure 8** shows the CEMIn results from 2009 to 2013. This graph shows how many customers on a company-wide basis experienced seven or more interruptions. For example in 2013 the percentage of customers experiencing seven or more interruptions was 2 percent.

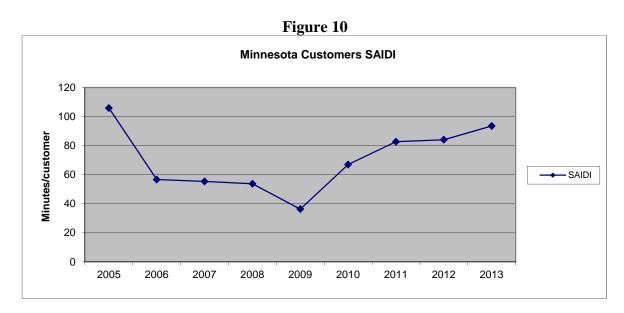
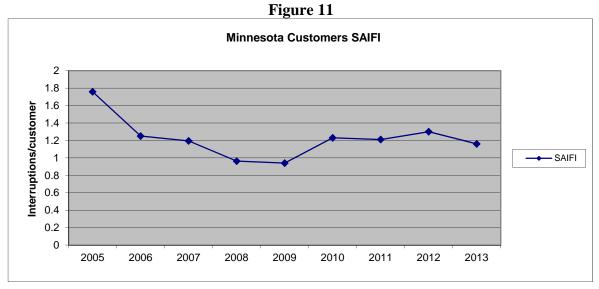
**Figures 10, 11, and 12.** The following graphs show Otter Tail's SAIDI, SAIFI and CAIDI for the period of 2005 through 2013. When compared to 2012 results, Minnesota customers experienced an increase in overall SAIDI and CAIDI and a decrease in SAIFI.

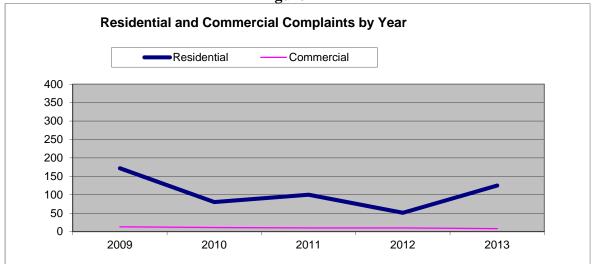
Figure 14 below is a graph showing complaints by customer class for the previous five years.
